Date: October 2009

Project code: TGSK09

Archaeological Survey, Aglish Graveyard, Aglish, Co. Kerry.

RMP No.: KE058 024

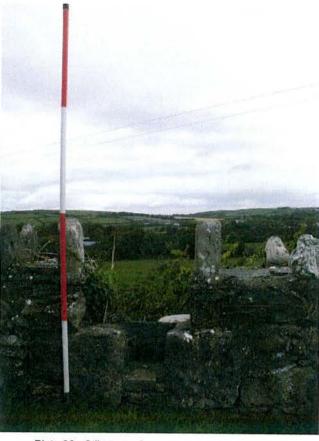
Plate 02 - Stile to northeast corner of graveyard.jpg

There are two pedestrian entrances to the earlier graveyard, the first being a rubble stone stile (plate 2) to the northeast corner comprising of dressed limestone plinth blocks flanking a narrow opening with a rubble step and slate traversing stone. This stile is most likely a relic of a now absent mass path that would have once traversed the field to the north. The second entrance is a pedestrian gate located to the west (plate 3), having square-profile gate piers carrying a wrought-iron gate which opens directly onto the roadside.

The stile is in very good condition despite the encroachment of vegetation, including ivy, to its exterior elevation (north). The entrance gate is also in a good state of repair.

The stile is an interesting and important example of vernacular craftsmanship and as such should be maintained in its current state. Encroaching vegetation may be controlled but full removal, especially of Ivy, is not recommended as this may lead to destabilisation of the stile and also a loss of habitat for local wildlife. All metal gates should be treated for rust and painted as and when such measures are needed.

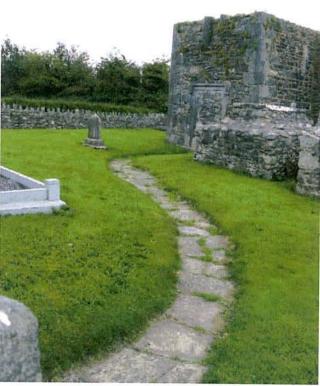
Plate 04 - Flagged path to west of graveyard.jpg

There is a single flagged path to the earlier graveyard which follows a curvilinear route from the western gate to what was the front entrance of the more recent ruinous church (KE058-024002) (plate 4). This path appears to be in good condition, with some minor encroachment of grass and weeds between the flags.

Gentle clearing of encroaching vegetation to the flagged path could be carried out by hand and without the use of broad spectrum weed killers. The flags themselves should not be moved as this will disturb the ground and may interfere with unmarked burials and archaeological remains in the area.

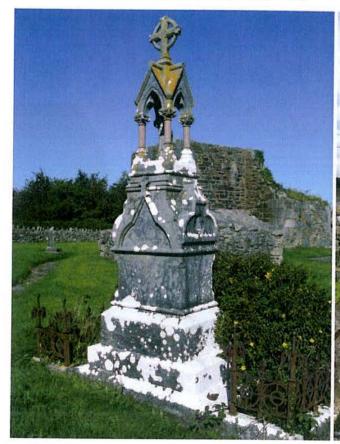
Plate 11 - Rear and side elevations of memorial to grav...

A particularly elaborate burial monument numbered grave no. 102, is of fine ashlar limestone built in a gothic style featuring a cruciform finial, pointed arches and red marble columns (plate 11). Its associated plot is also enclosed by a low limestone plinth with cast-iron railings which are themselves

In general the headstones and grave plots are in good condition and as such should not be interfered with. Continued close monitoring and upkeep of the grounds should ensure that this continues. The single possible exception to this is grave no. 102 where its cast-iron railings could be treated to prevent further rusting and deterioration.

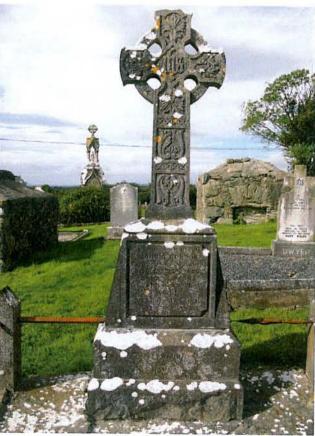
of artistic interest. Another elaborate burial monument, grave no. 189 which dates from 1920, is of a high cross style displaying numerous elaborate carvings (plate 12).

Plate 12 - High cross style headstone to grave no. 189.j...

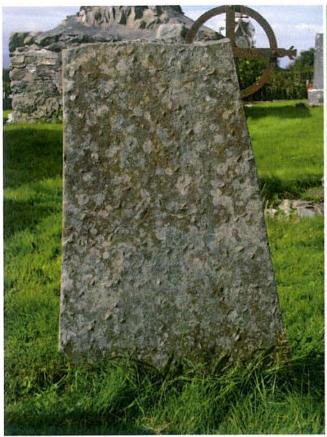
There are very few unnamed headstones within Aglish graveyard. Only three were recoded, these being grave no's. 023, 068 and 130 (plate 13). The ground surrounding these stones is well kept and all of them appear to be securely set.

Plate 13 - Unamed headstone to grave no. 130.jpg

In general the unnamed headstones are in good condition and as such should not be interfered with. Continued close monitoring and upkeep of the grounds should ensure that this continues.

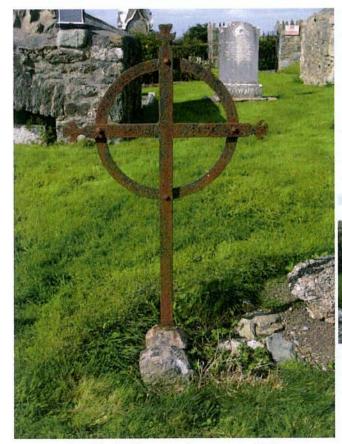
There are a total of 56 unnamed grave markers and they are the most common form of grave marker to be found in the Aglish graveyard. These range from the simple stone markers found at grave no's. 001, 008 and 063 (plate 14), to simple cast-iron crosses such as 127 (plate 15) and 053. The ground surrounding these markers is well kept and all of them appear to be securely set.

Plate 15 - Cast-iron cross to grave no. 127.jpg

In general the gravemarkers are in good condition and as such should not be interfered with. Continued close monitoring and upkeep of the grounds should ensure that this continues. The castiron crosses could be treated to prevent rusting and deterioration.

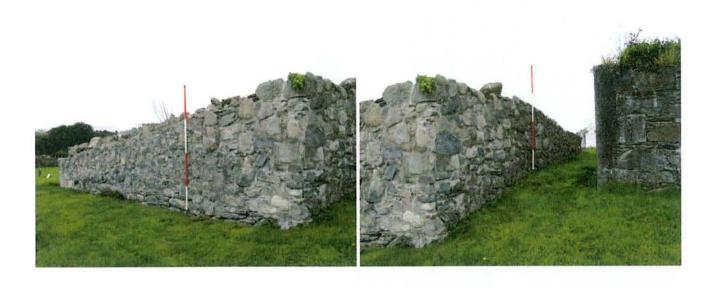
Plate 21 - East elevation of church wall from northeast.j...

Located just to the south of this structure are the fragmentary remains of a second older church ruin, listed on the RMP as KE058-024001 which survives as an L-profile section of rubble stone wall approximately 1.5m high (plates 21, 22). To the southern end of the north-south aligned section of wall is a small area of partial collapse though this appears to be in a relatively stable state. Also of note is a small divot in the ground located just west of the north-south aligned wall (plate 23).

Both church ruins appear to be stable and regular monitoring and control of attached vegetation should ensure that this remains so.
