Archaeological Survey, Aghavallen Graveyard, Rusheen, Ballylongford, Co. Kerry.

September 2010

Client: The Heritage Office,

RMP No.: KE002-058 Church

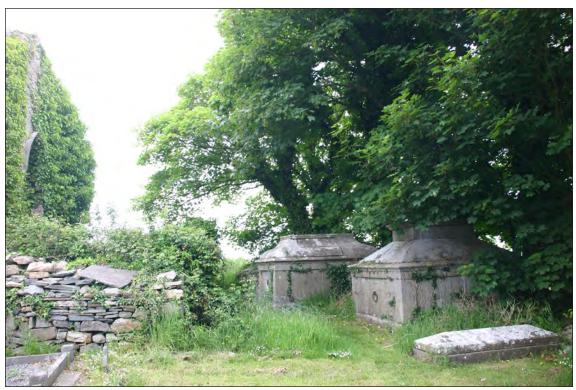
The graveyard is well tended especially at the western area where the grass is kept low and neat and has a managed appearance (Plate 2). There is also plenty of open grassy space that is not taken up by modern grave settings. However, the eastern older area of the graveyard does not extend much beyond the east gable of the church and contains several uncared for and dilapidated tombs. Furthermore, the presence of mature trees and vegetation has made this area very untidy difficult and dangerous to negotiate (Plate 3).

Plate 3: View of the eastern limits of Aghavallen Graveyard, at the rear of church. Note numerous mature sycamore trees and neglected and overgrown tombs

The tombs behind the rear eastern limits of the graveyard should be cleared of vegetation and repaired. This work should only be carried out under archaeological expert advice and supervision. Sycamore trees are deeply rooting species and cause havoc to tombs, graves and other structures. They should also be cut down and roots killed by qualified tree surgeons under archaeological guidance.

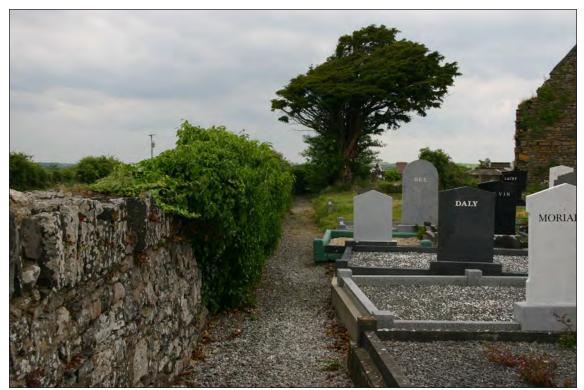
Boundary walls are constructed with uncoursed rubble sandstone and limestone bedded in mortar and capped with 'soldiers' and are generally in good condition (Plates 4 & 5). The north boundary wall diminishes in height as it runs east and is covered in ivy and near impossible to examine. The eastern boundary wall is very difficult to examine and survives merely as an earthen field boundary covered in mature sycamore trees and other bushes making the entire eastern limits of the graveyard and church overgrown, very difficult to negotiate, damp and dark. It is clear also that graveyard rubbish is disposed of here.

Plate 5: View of the gravelled pathway along the southern boundary of graveyard from east. Note also heavy growth of ivy

The ivy and other vegetation should be removed and the damaged masonry joints raked out, re-pointed and repaired with a similar lime mortar. This work should only be carried out as a single piece of work. Walls whose ivy is removed and not repaired quickly will degenerate quicker and collapse. All work should only be carried out following expert archaeological advice and supervision.

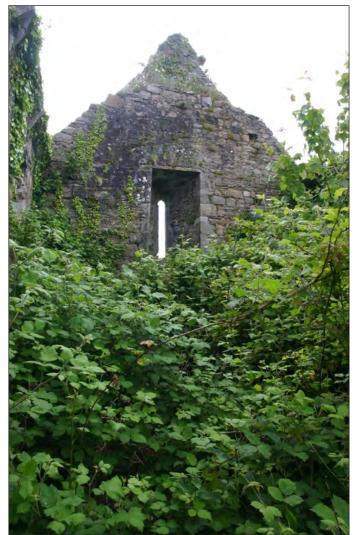
Plate 9: View of completely overgrown western limits of interior of Aghavallen Church. Note upper level window and beam slot

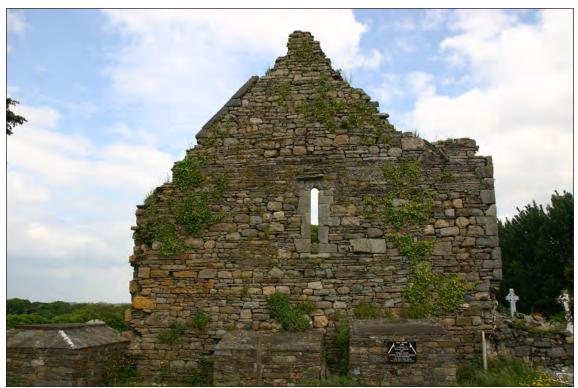
Plate 13: View of the exterior west gable of Aghavallen Church. Note lean-to tombs and robbed out quoins. Further note projecting drip stone over window and surviving cut stone coping on gable as well as surviving gable shoulder on right (south)

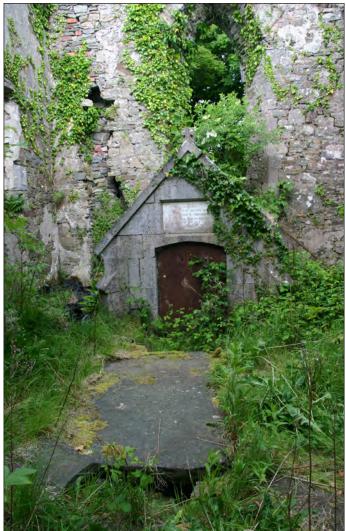
Plate 14: View of the overgrown, interior, eastern limits of Aghavallen Church. Note the grave slab in the foreground of Dr. John Cresswell (269) who was interred in 1702 and house-shaped ashlar tomb of Honoria Ponsonby (268) who was interred in 1864. Further note possible ragged flue on left or north side of east gable

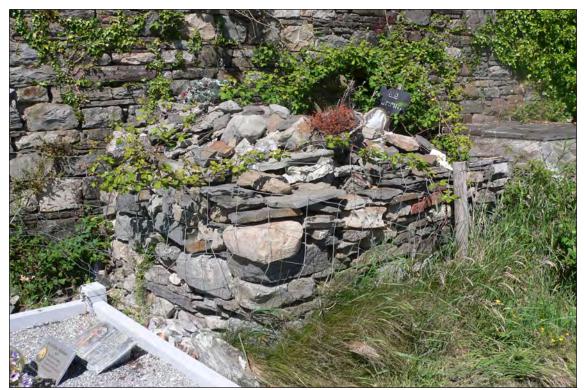
Three unnamed tombs were recorded in various states of preservation (Appendix 2). One tomb (257) located outside the south-western limits of the church is a collapsed tumble enmeshed in wire and briars (Plate 15). Another (243) consists today of a grass covered mound while the third (256) is covered in foliage (Plates 3, 16 & 17 & Figure 5).

Plate 15: View of the collapsed and overgrown, unnamed tomb (257) at south-western limits of Aghavallen Church. Note partially collapsed wire fence and No Dumping sign

Refurbishment and conservation work of the collapsed tomb (257) should be undertaken. Tombs often contain medieval architectural fragments in them and these can be recorded and preserved. This work should be undertaken with expert archaeological advice and guidance.

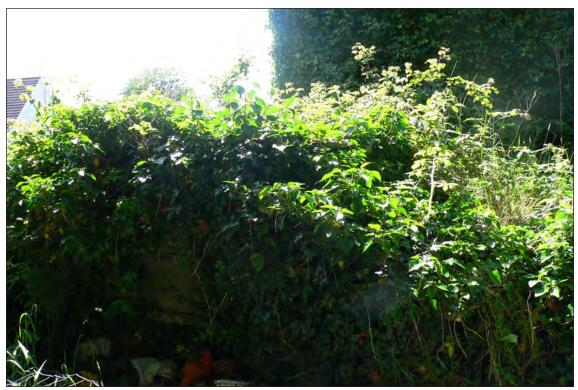
Plate 17: View of the completely overgrown, illegible tomb (263) at rear east end of graveyard

The vigorous growth of ivy, bushes and trees on and around Tombs 209, 214, 224, 262, 263, 265, 266 and 268 should be cut back and then fully removed after a further assessment. This work should be undertaken following expert archaeological advice and supervision.

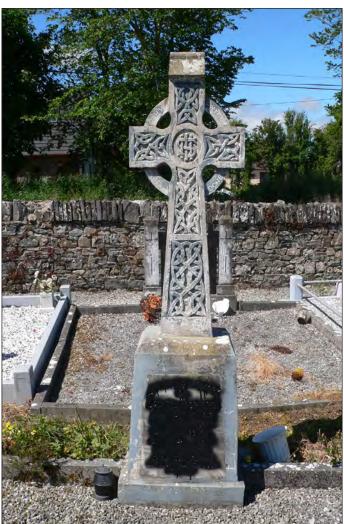
A total of 131 named headstones (HN, Appendix 3) were recorded in Aghavallen graveyard. The majority of them are modern and are in good order. However, there are four that have been vandalised (13, 82, 190 & 197, Figure 5) by the crude application of black paint across the inscription to read the names (Plates 18-19).

Plate 18: View of the High Cross headstone of Moriarty (13). Note black paint sprayed over inscription on basal plinth

The four painted, vandalised headstones (13, 82, 190 & 197) should be cleaned. This work should only be carried out by professionals experienced in such work and with a proven track record. Expert archaeological advice on this work should be taken in advance.

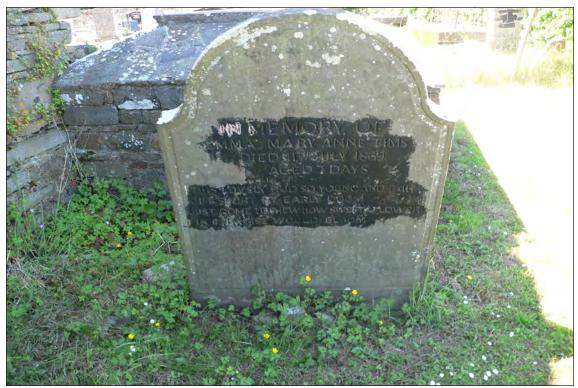
Plate 19: View of the headstone of Emma Mary Anne Tims, a child of 7 days of age who died in 1869 (197). Note black paint sprayed over inscription

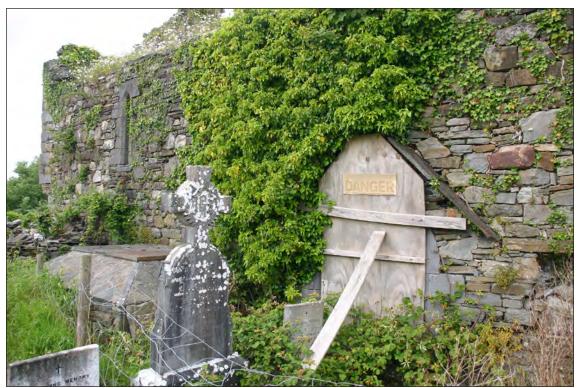
The doorway is situated on the south elevation towards the west end. Access to the doorway is difficult due to growth that has built up around a wire fence. The door opening itself is blocked off with plywood (Plate 25). However, it is clear that the pointed doorway is constructed of dressed limestone and has a projecting hood or canopy of undressed stone over it. Although much broken, a possible double-entry stoup still survives on the right side (eastern) of the interior of the door opening (Plate 32). The doorway, hood and stoup are identical to that at Kilnaughtin.

Currently, Kerry County Council have in place danger signs warning visitors not to approach (Plate 26). They have also put up a wire fence and blocked off access by sheets of plywood (Plate 25). However, while this reduces risks to the public at large it does nothing to protect the medieval structure itself. Indeed since the wire fence (now neglected and broken down in places) was put in place outside the church, uninhibited growth has occurred in particular along the south elevation. Internally the situation is much worse. The prevention of access has accelerated the growth enormously. The growth has increased exponentially and is seriously undermining the physical fabric of the church and the internal tombs and burials.

Plate 25: View of the boarded up doorway on the south elevation of Aghavallen Church. Note the overgrown nature of area including wall and ground compounded by the insertion of a temporary and ineffective post and wire fence

At the outset and also as a matter of urgency, the plywood and other provisions for protection of the public should be replaced with more meaningful adaptable ones that protect the public but also allow access by professionals and experienced maintenance staff to manage the growth around and inside the church.

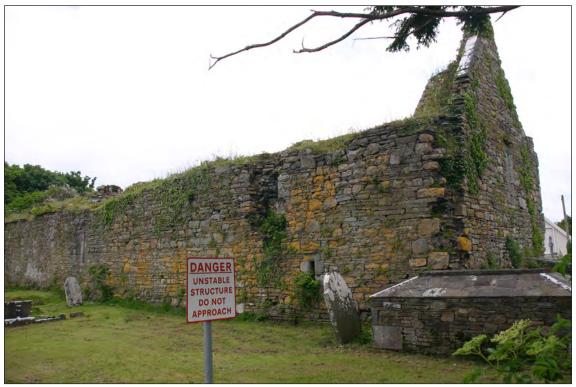
Plate 26: View of north elevation at west end of Aghavallen Church. Note ragged and dangerous upper window, robbed out quoins and DANGER sign

A targeted standing historic building conservation survey should be carried out as a matter of urgency by professionals with a proven track record of such work. The growth should be cut back to enable the conservation study be carried out. The study should make costed best practice recommendations for the conservation of the structure through time.

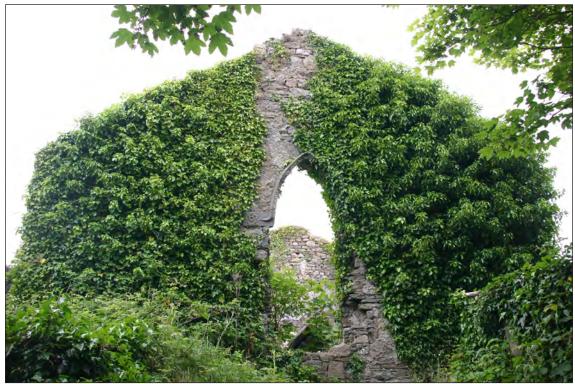
The east gable, virtually completely overgrown with ivy, is pierced by a central tall window (Plate 28). Most of its dressed masonry has been robbed out and it may have had twin lights as is found in a similar sized window ope at Kilnaughtin. The east window does retain a hood moulding on the exterior that finishes in a wonderful flourish depicting a rose motif terminal on its south or left side (Plate 29).

Plate 28: View of the exterior, overgrown east gable of Aghavallen Church. Note large central window, largely robbed out but still retaining sections of its dressed masonry including its hood moulding

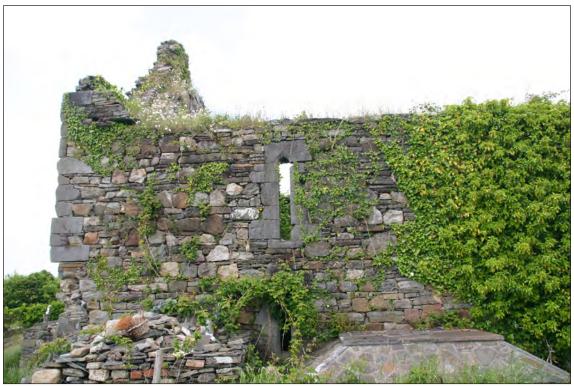
Plate 30: View of western limits of south elevation. Note upper and lower windows. Further note remains of gable shoulder, robbed out lower quoins and overgrown walls

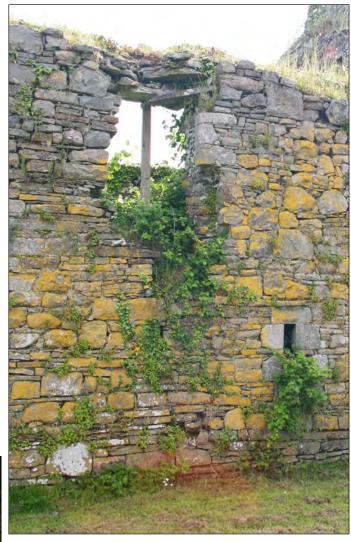
Plate 31: Close up view of upper level partially collapsed and ragged window at western limits of north elevation. Note temporary and ineffectual prop

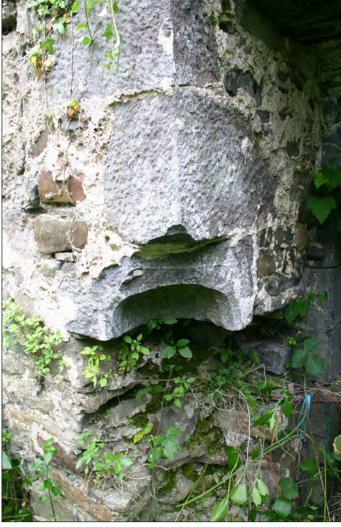
Plate 32: Close-up view of partially destroyed, possibly double entry, stoup on inside east side of doorway on south elevation
