Archaeological Survey, Ballyseedy Graveyard, Tralee, Co. Kerry.

#### October 2008

Client: The Heritage Office,

RMP No.: KE038-021

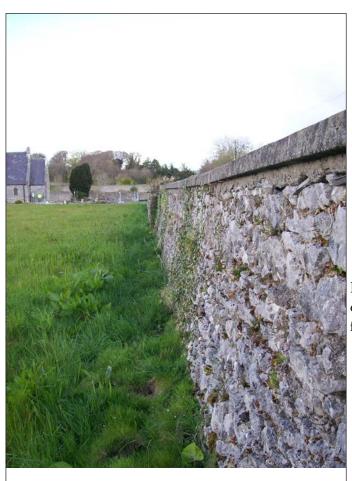
crete. A slight batter was also discernible along this boundary (Plate 4). Two entrances are located in the eastern boundary: one is currently in use while the other is located towards the southern end and is blocked up.

Plate 4: View of slight batter present along eastern boundary wall of newer graveyard, from south

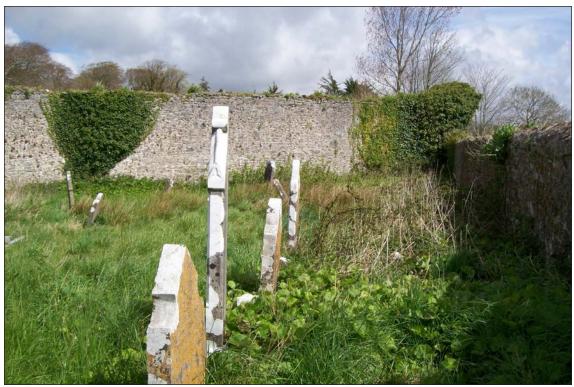
The older area of the graveyard is bounded by a limestone rubble wall over 2m high to the north which is overgrown with ivy in places (Plate 5). The southern boundary is also of the same construct and is irregular in height due to collapse etc. The entrance gate is located in the eastern boundary. The western boundary was inaccessible due to the presence of tombs and the overgrowth of brambles at the western end of the graveyard.

Plate 5: View of eastern and northern boundary walls of older graveyard, from south

The overgrowth of ivy and brambles should be removed where possible, under archaeological supervision and guidance, from the boundary walls of the old graveyard and the wall assessed and made good.

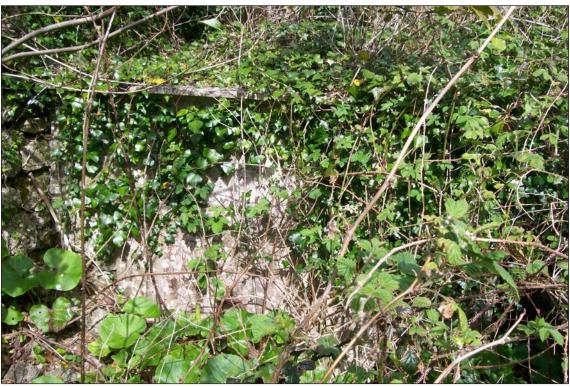
The remainder of the named tombs are in a poor state of repair, being almost completely overgrown, collapsing in parts or other structural defects (Plate 8).

Plate 8: View of the Hurly tomb (ref. no. 280) on the interior of the church which is heavily overgrown and obscured by ivy

Focused targeted archaeological refurbishment and conservation should be undertaken where the tombs are collapsed. This work may require Ministerial Consent.

All vegetation on the tombs should be cut back and removed.

The tombs can then be reconstructed, repaired and repointed sensitive to their original construction. This work may require Ministerial Consent.

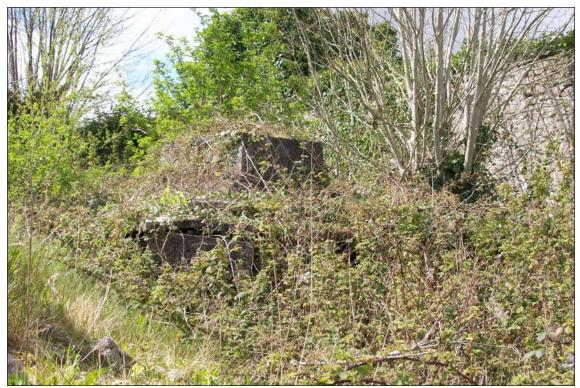
23 unnamed tombs were recorded. Approximately two additional tombs could be seen through the overgrowth to the east of the church. These tombs were inaccessible and could not be surveyed or assessed as a direct result of the poor state of the graveyard interior (Plate 9).

Plate 9: View of inaccessible, overgrown tomb located towards the northwestern area of the older graveyard. There is no reference number for this tomb due to inaccessibility.

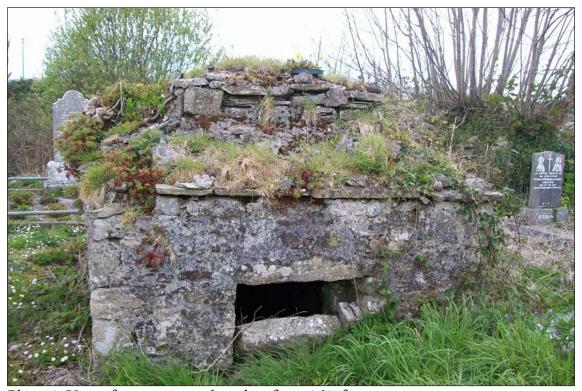
All the unnamed tombs were in various poor states of repair while the entrance to one tomb (ref. no. 260) had fallen outwards, exposing the human remains interred within (Plate 10).

Plate 10: View of open unnamed tomb, ref. no. 260, from east

All open and exposed tombs should be fully repaired and sealed. This work may require Ministerial Consent.

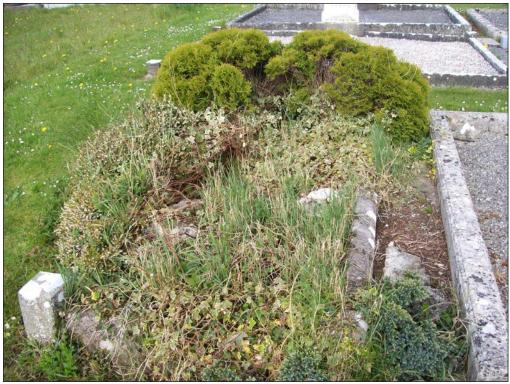
The Benner grave (ref. no. 51) is completely overgrown with shrubs which conceal the headstone (Plate 11).

Plate 11: View of overgrown Benner grave (ref. no. 51) from east

The overgrowth of vegetation on graves 40, 51, 176, 197, 204 and 224 should be cut back and removed.

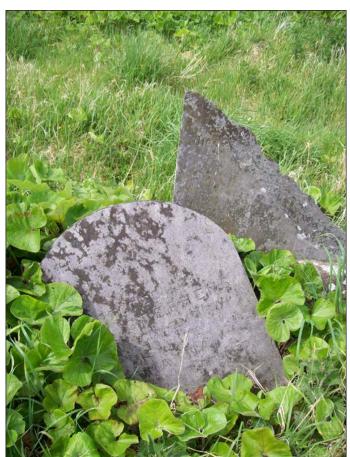
The Stephens grave (ref. no. 197) is heavily overgrown and the headstone itself is broken (Plate 12).

Plate 12: View of broken Stephen's headstone (ref. no. 197), from east

Repairs should be made to the broken headstone for grave 197.

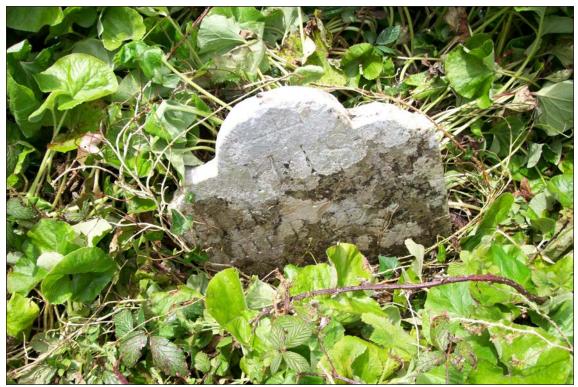
A partially named grave (ref. no. 224) of Catherine? is heavily overgrown and concealed with brambles (Plate 13). This was also the oldest recorded headstone in the graveyard and dated to 1766.

Plate 13: View of overgrown and sunken headstone dating to 1766 (ref. no. 224), from east

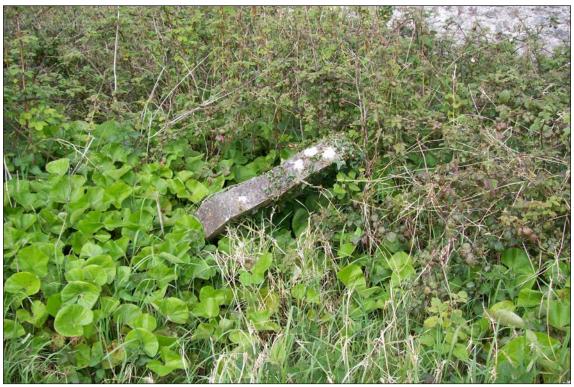
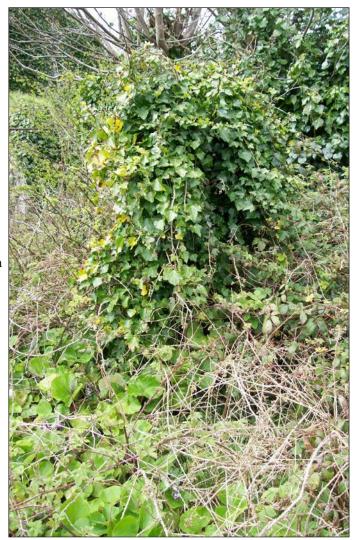
Several headstones could not be accessed due to the severe overgrowth of brambles within the older area of the graveyard, and should this vegetation be removed, these headstones maybe found to be inscribed with names (Plates 14 & 15).

Plate 14: View of inaccessible headstone in the northern area of the old graveyard, from south. There is no reference number for this headstone due to inaccessibility.

Plate 15: View of inaccessible headstone in the northern area of the old graveyard, from east. There is no reference number for this headstone due to inaccessibility.

The severe overgrowth of vegetation would need to be removed/reduced by hand under archaeological guidance and supervision to fully expose the full extent and nature of the burial markers.

Any new inscribed headstones should then be added to the survey.

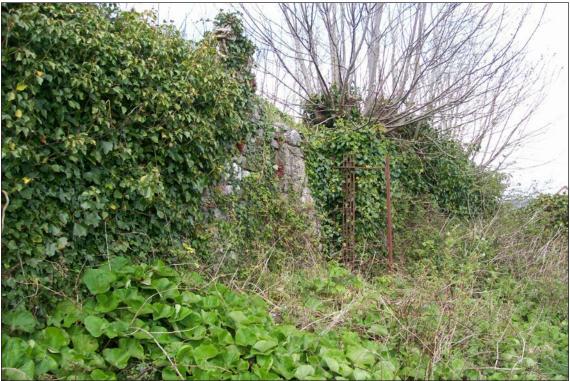
Plate 16: View of southern elevation of ruined church showing extent of overgrowth on and in immediate vicinity of the church, from west
