Archaeological Survey,
Ballywiheen Church & Graveyard,
Ballineanig-Churchquarter,
Co. Kerry.

September 2007

Client: The Heritage Office,
Kerry County Council,
County Buildings,
Ratass,
Tralee,
Co. Kerry.

RMP No.: KE042-103

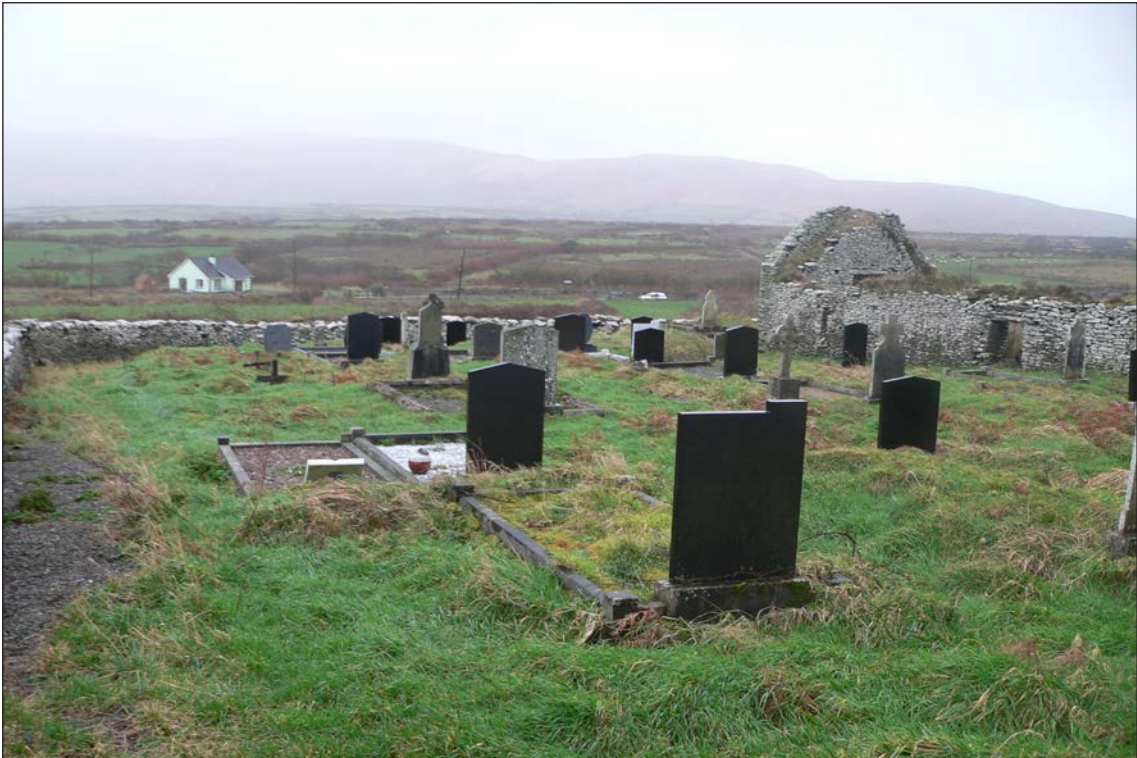
Plate 1: View of Ballywiheen church and graveyard, taken from northwest

Ballywiheen church and graveyard is located within the townland of Ballineanig Church-quarter, c.1km southeast of Ballyferriter village on the Dingle Peninsula, (Figure 2, Plate 1). Ballywiheen is recorded in the Record of Monuments & Places (RMP) as KE042-103 as 'ecclesiastical remains' with sub-classifications of KE042-103:01 church, KE042-103:02 graveyard, KE042-103:03 font and KE042-103:04 cross-inscribed stone (Figure 3).

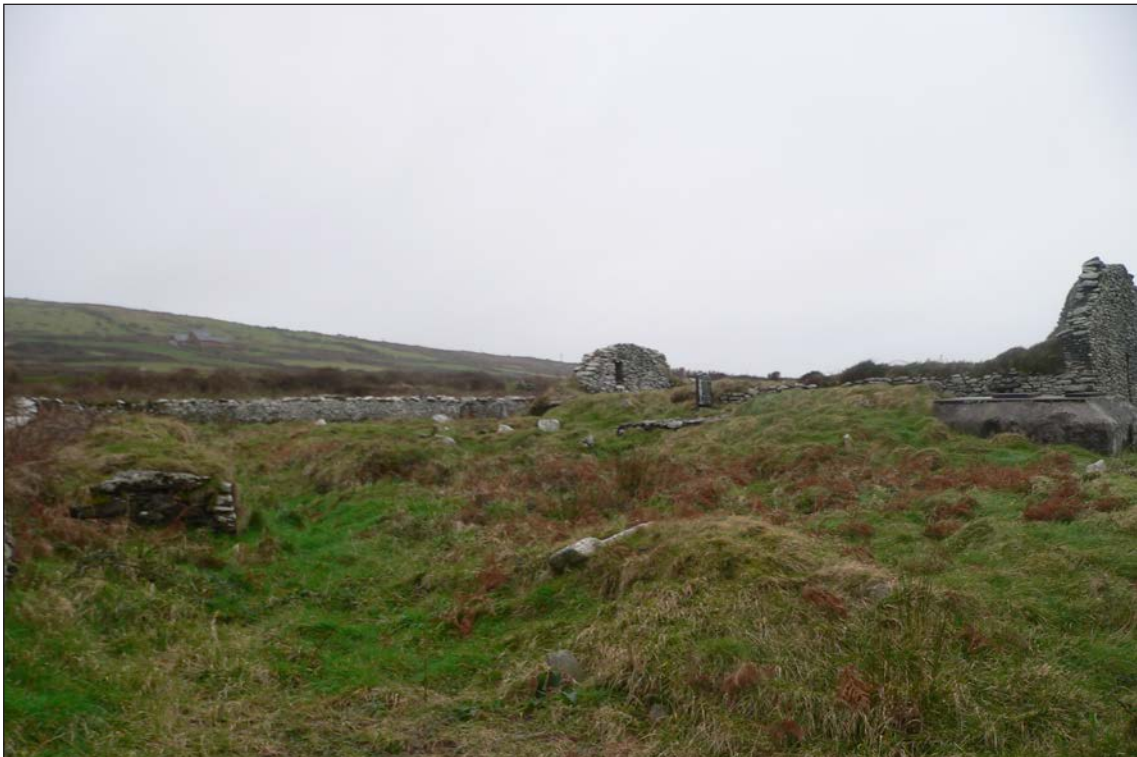
Plate 2: View of overgrown and undulating nature of the graveyard interior, taken from southeast

There are no trees or cultivated plants growing within the graveyard which slopes from west to east and is irregular in nature, most likely due to obscured and overgrown grave-markers (Plate 2).

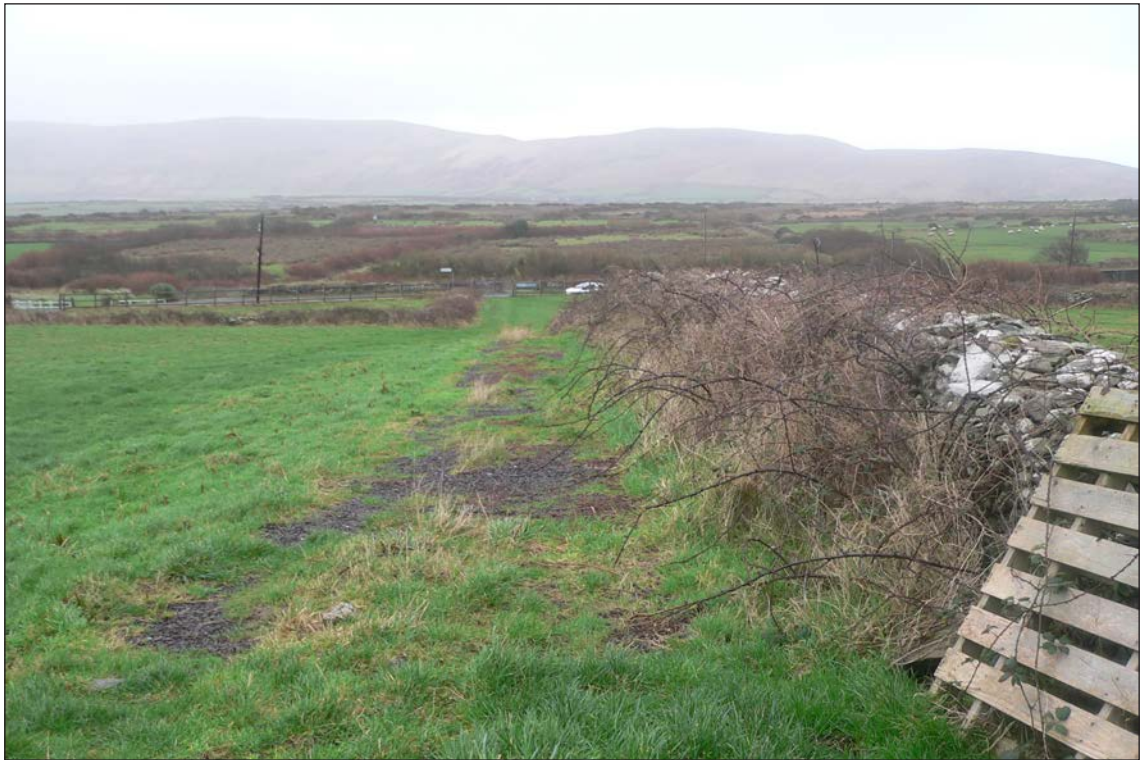
Plate 3: View of overgrown trackway which leads from the road to the graveyard entrance gates, taken from northwest

The roadside entrance gate is difficult to open due to overgrowth and the approach to the grounds is over what was originally a gravel trackway but is now overgrown with grass and neglected (Plate 3).

- The remaining three areas of collapse should also be repaired and made good with sheep wire constructed on the exterior of the wall.
- The grassed over gravel pathway leading to the graveyard should be returned to its original condition and maintained on a regular basis to allow easier access/egress to the grounds for visitors and mourners alike.

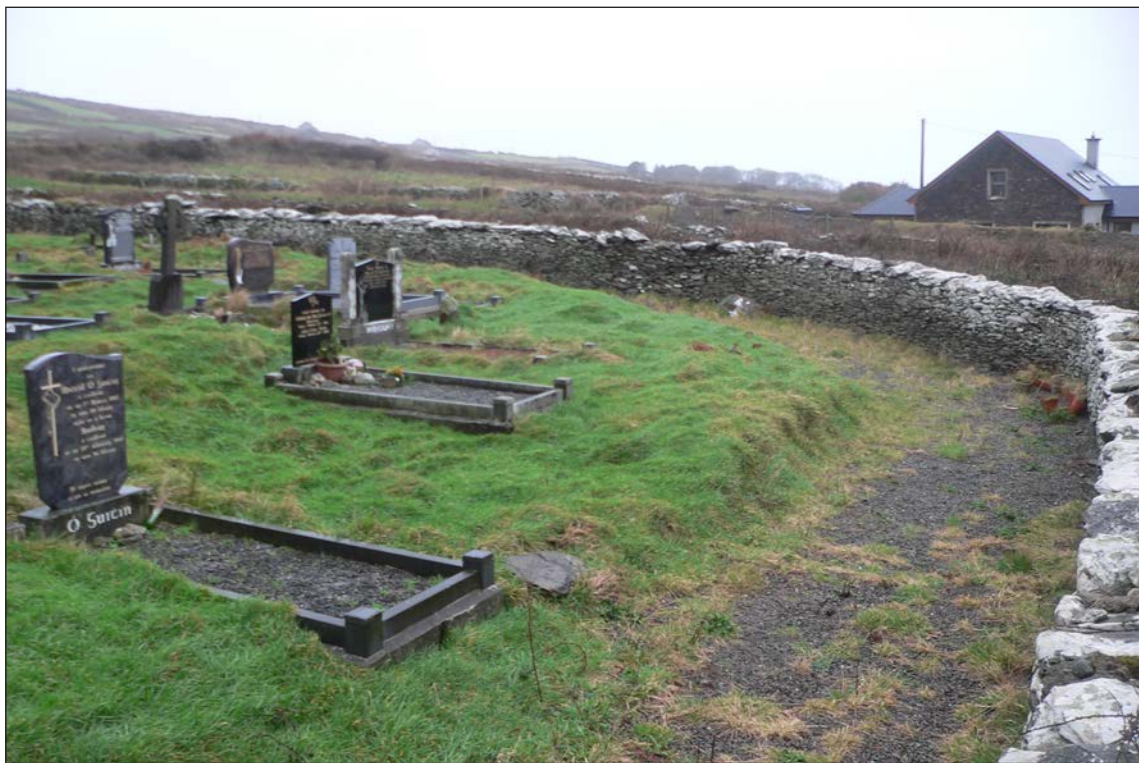
The graveyard is bounded by low drystone walls of local sandstone with additional sheep-wire fencing (Plate 4).

The majority of the walls are overgrown with fuchsia, nettles, yellow-flag and grass.

A section of the southern boundary wall has collapsed and has been partially and poorly repaired while the capping is entirely missing from the western wall.

Plate 4: View of boundary wall and perimeter pathway taken from south

The boundary wall around the cemetery itself is in general good repair with only a small portion along its southern limits partially collapsed. This should be repaired and made good. A sheep wire fence should be constructed around the outer wall to prevent animals from rubbing off or climbing onto it.

The remaining three areas of collapse should also be repaired and made good with sheep wire constructed on the exterior of the wall.

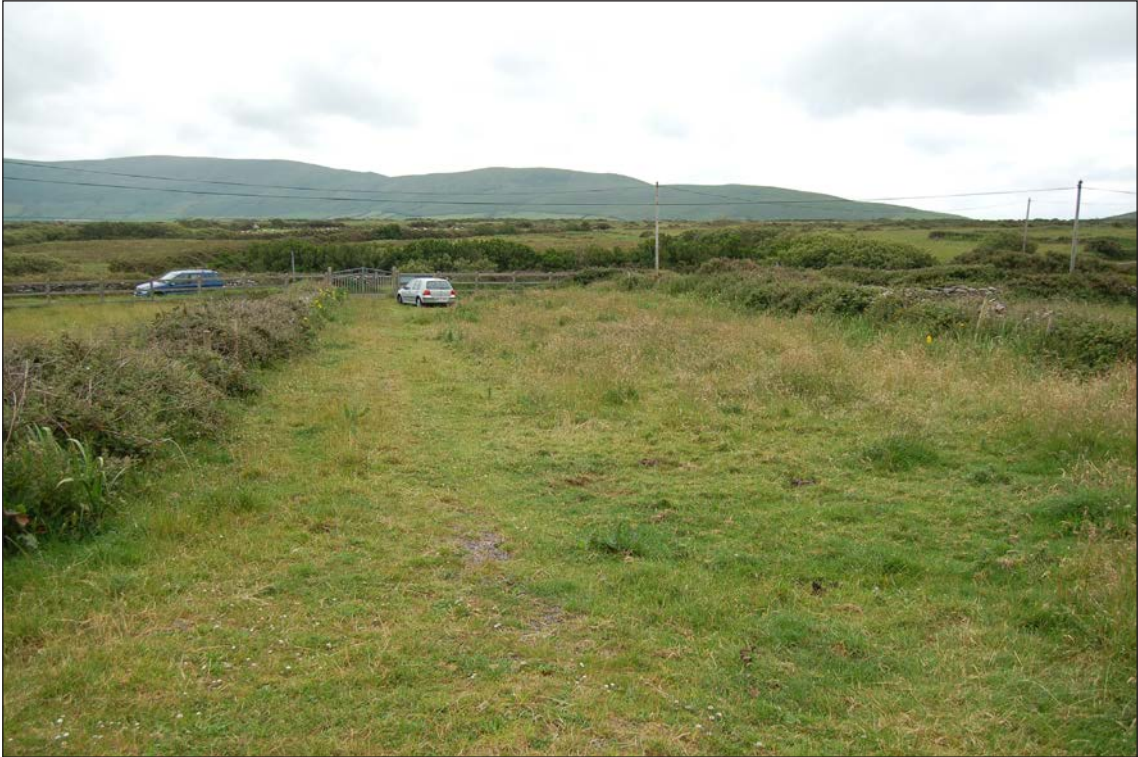
The roadside entrance to the graveyard grounds is comprised of a pair of modern galvanised gates set between two square concrete capped piers (Plate 5). Due to the overgrown and sloping nature of the interior, the gates are difficult to open. The entrance way is also difficult to navigate for vehicular traffic and should be set back with proper sightlines.

The entrance to the graveyard itself comprises a simple galvanised farm gate. This should be removed and replaced with a pair of suitable wrought iron gates as well as a pedestrian stile. At present, there is no designated area for parking and given the location of the entrance to the graveyard on a bend of the road, it is not safe to park outside the entrance gates. There is ample space for parking immediately inside the roadside entrance gates (Plate 5).

Plate 5: View of area immediately inside the roadside entrance gates, taken from northwest

Independent pedestrian stiles should be installed.

Proper signage should be erected.

Interior parking area should be properly set out and defined.

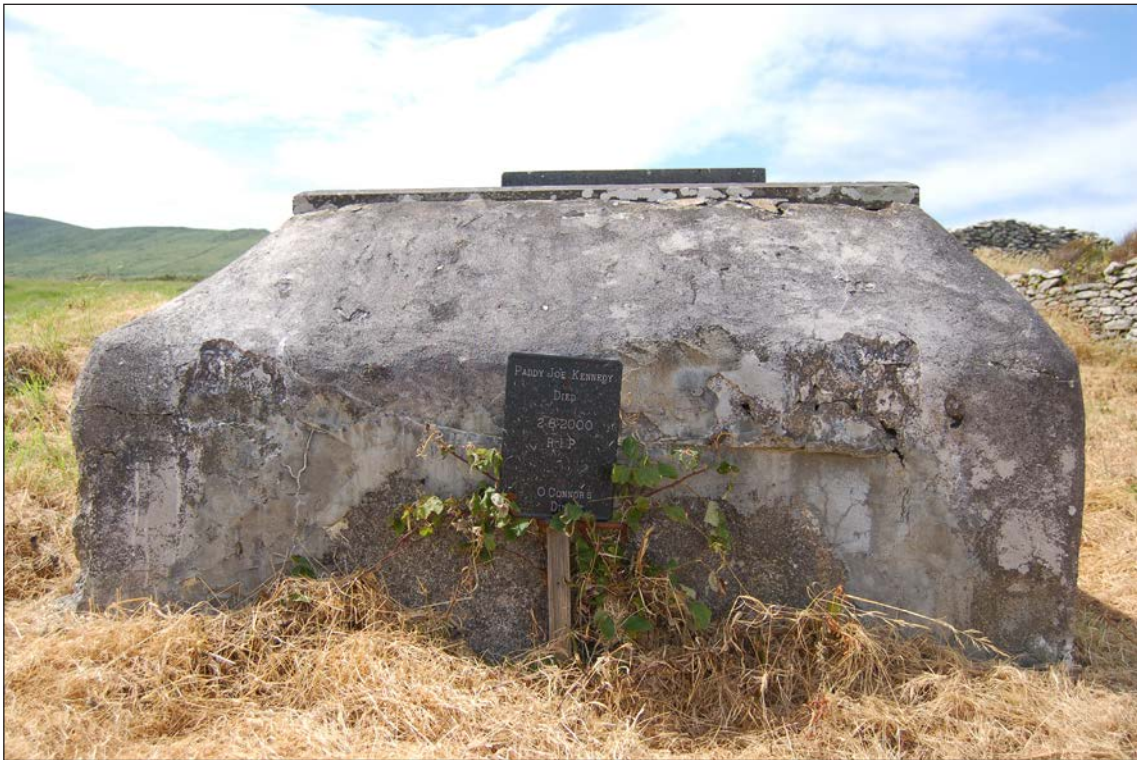
Tomb (ref. no. 76) is in good repair with the earliest internment dated to 1869 when Mary Kennedy of Clounties died on 16th May aged 25.

Two other gravemarkers have been attached to the capping slab of the tomb while a recent temporary metal cross is located on the eastern side of the tomb and records the death of Paddy Joe Kennedy who died on 2nd August 2000 (Plate 6).

Plate 6: View of Kennedy family tomb (ref. no. 76), taken from east

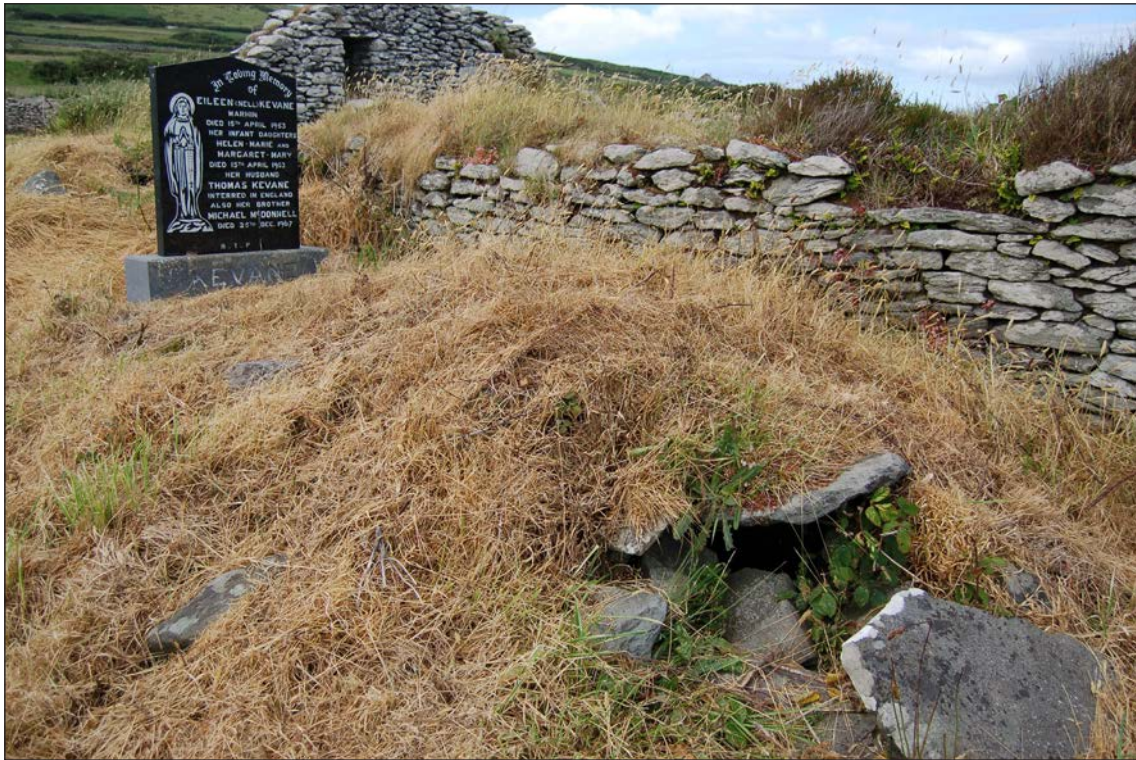
Tomb (ref. no. 81 with associated headstone ref. no.74) is in a partially collapsed state and grassed over (Plate 7).

The eastern end of the tomb is open.

Plate 7: View of Kevane family tomb (ref. no. 81), taken from east

The Kevane tomb should be sealed correctly to prevent disturbance of human remains.

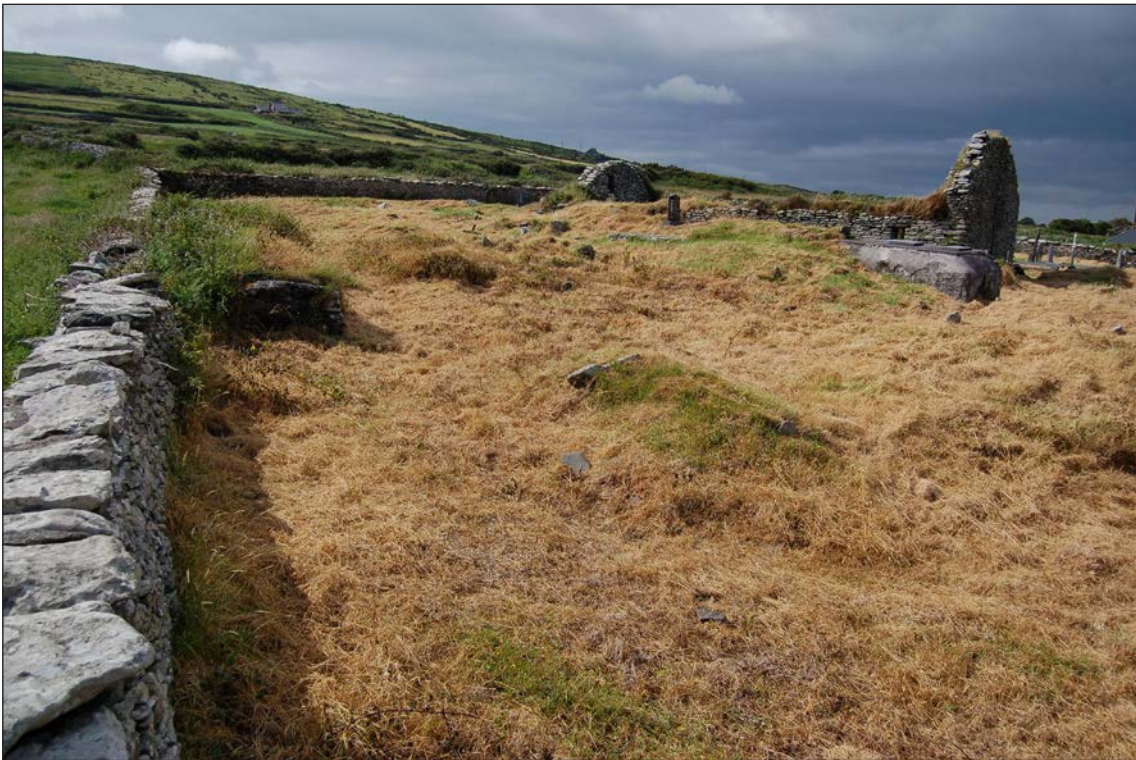
Twelve unnamed tombs were recorded in various states of preservation (Plate 8).

Five tombs are in a partially collapsed condition.

Six are partly or completely grassed over and are recognisable as rectangular mounds with the construct of the remaining two tombs in relatively good condition.

Plate 8: View of unnamed tombs, taken from southeast

Focused targeted archaeological excavation should be undertaken where the tombs are collapsed.

Construction of new tombs should not be allowed and others requiring repair should be undertaken using best practice. An information booklet should be provided on this.

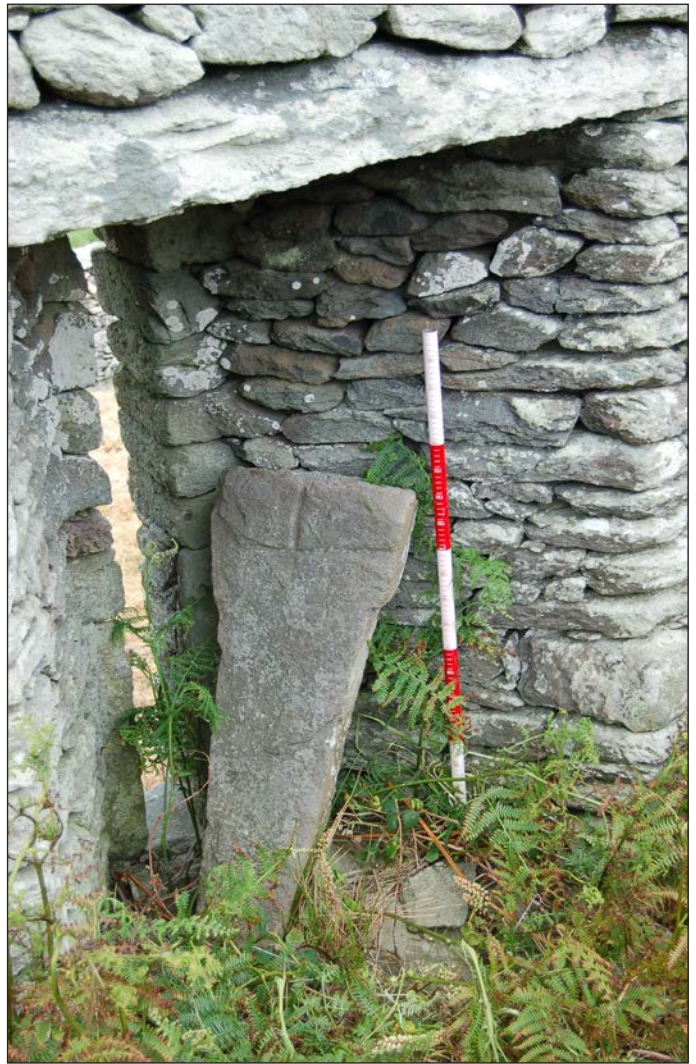
Plate 9: View of cross slab within interior of ruined church

The cross slab currently located within the window ope on the interior of the church, (Plate 9) should be secured *in situ* as it has been moved slightly since *The Archaeological Survey of the Dingle Peninsula* (ibid, 365).

The cross slab currently situated loosely within the embrasure of the east window (Plate 9) should be permanently secured within the church (see above).

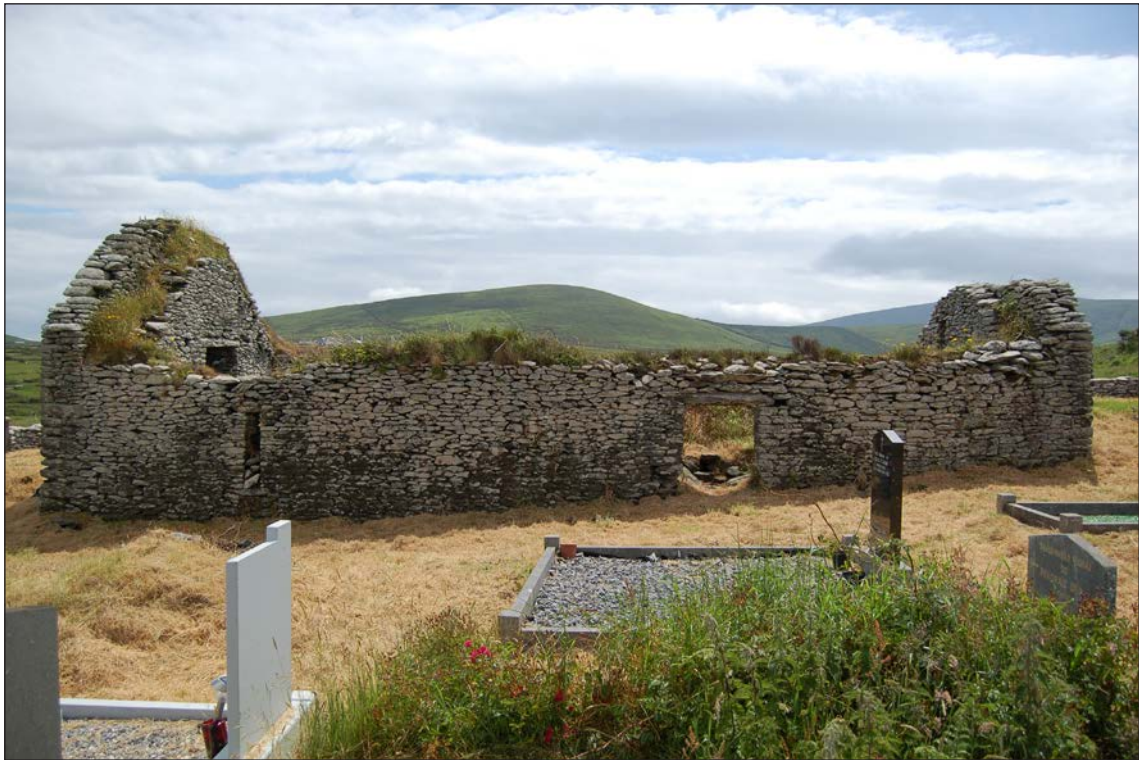
This current survey undertaken in 2007 found that the church has remained in a relatively good state of repair since the 1980’s (Plate 17).

All four walls remain standing with the gables almost surviving to full height.

Plate 17: View of ruined church, taken from north

The building has been thoroughly surveyed but the upper levels of the walls were not accessible. Consequently, it is recommended that the vegetation cover be removed under archaeological supervision and the exposed fabric recorded. Samples of *in situ* fabric, stone, mortars, renders etc should be recorded and removed. Where possible and in principle, all original fabric should be re-used or similar substitutes sourced and matched.

The ruined church should be preserved and protected. The building should be securely fenced off during construction works in case of accidental damage.

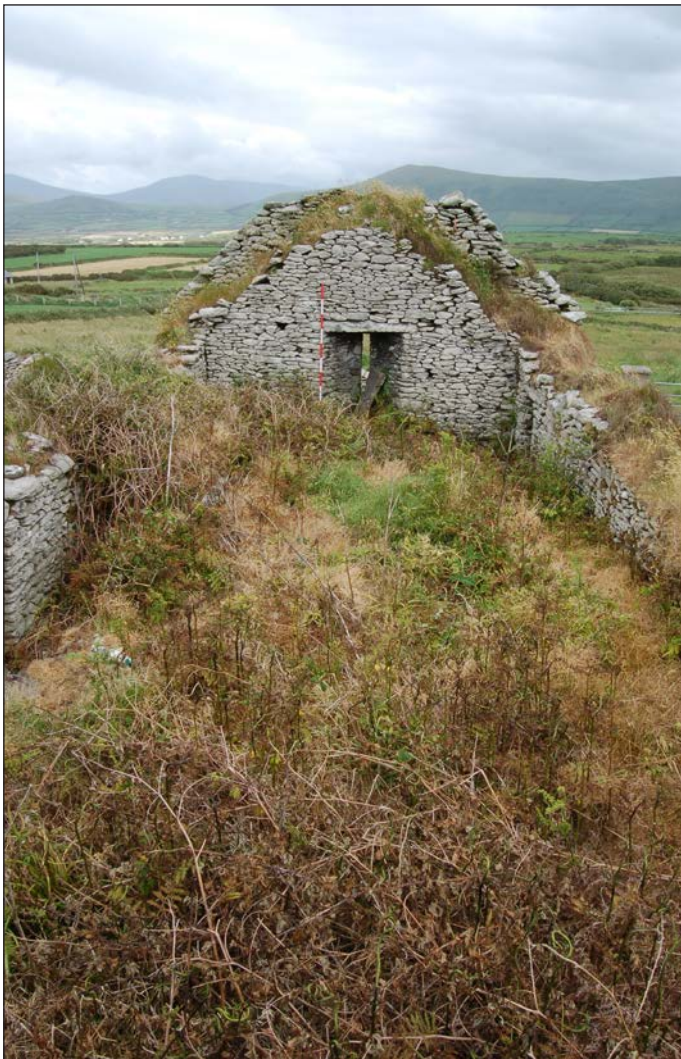
The upper levels of the walls are overrun with grass and the church interior and the graves located within are heavily overgrown with grass and brambles (Plate 18). Access into the church is very difficult as a partially open tomb is constructed across the interior of the doorway. Furthermore other deep partially open tombs are located within the interior. Combined with dense vegetation and brambles and uneven and open tombs, the interior is consequently very dangerous. The cross slab recorded by the Dingle Survey is now standing loosely with the east window embrasure. There is no sign of the font fragments also recorded in the Dingle Survey (*ibid*) however, this may be due to the overgrown nature of the interior.

Plate 18: View of overgrown interior of church, taken from west

The church interior should be cleared of brambles.

There are several collapsed and dangerous tombs within the interior, one of which partially blocks the entrance doorway. The tombs should be removed and no further burials allowed within the interior.
