Archaeological Survey,
Church Island Graveyard,
Lough Currane,
Waterville,
Co. Kerry.

September 2012

Client: The Heritage Office,
Kerry County Council,
County Buildings,
Ratass,
Tralee,
Co. Kerry.

RMP No.: KE098-039

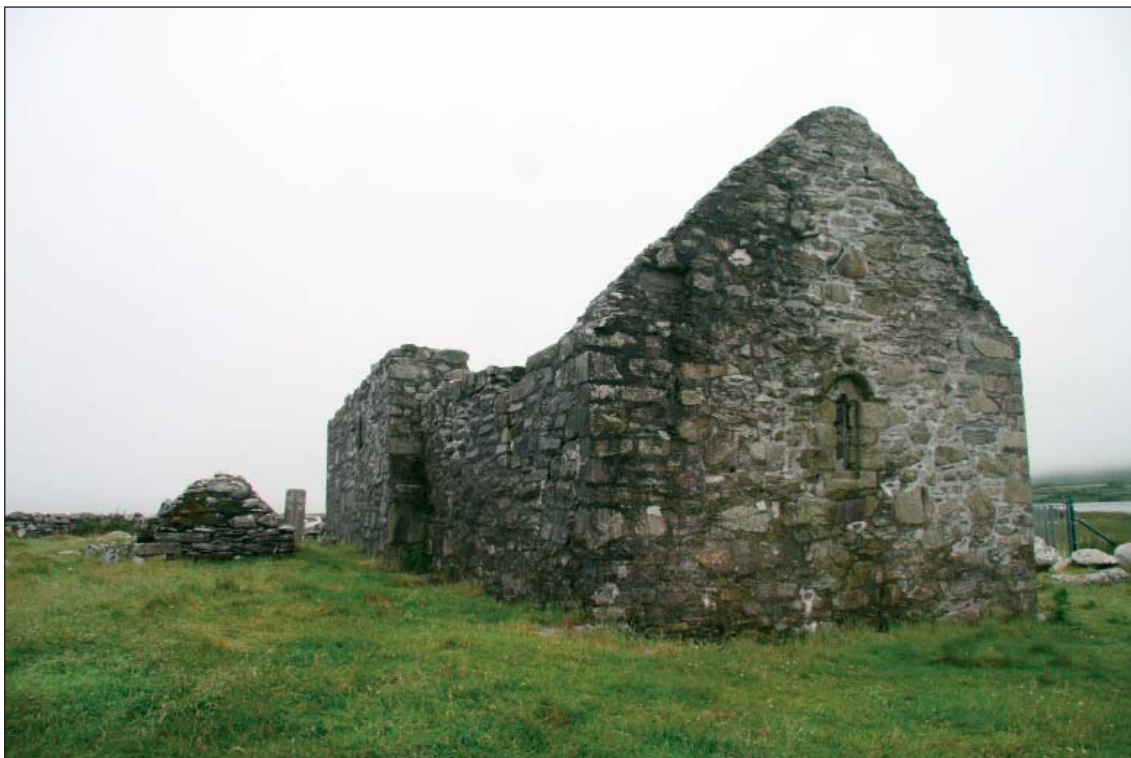
Plate 1: View from S-E of interior of Church Island burial ground. Note the absence of the E gable buttresses and the two abutting tombs at the S elevation

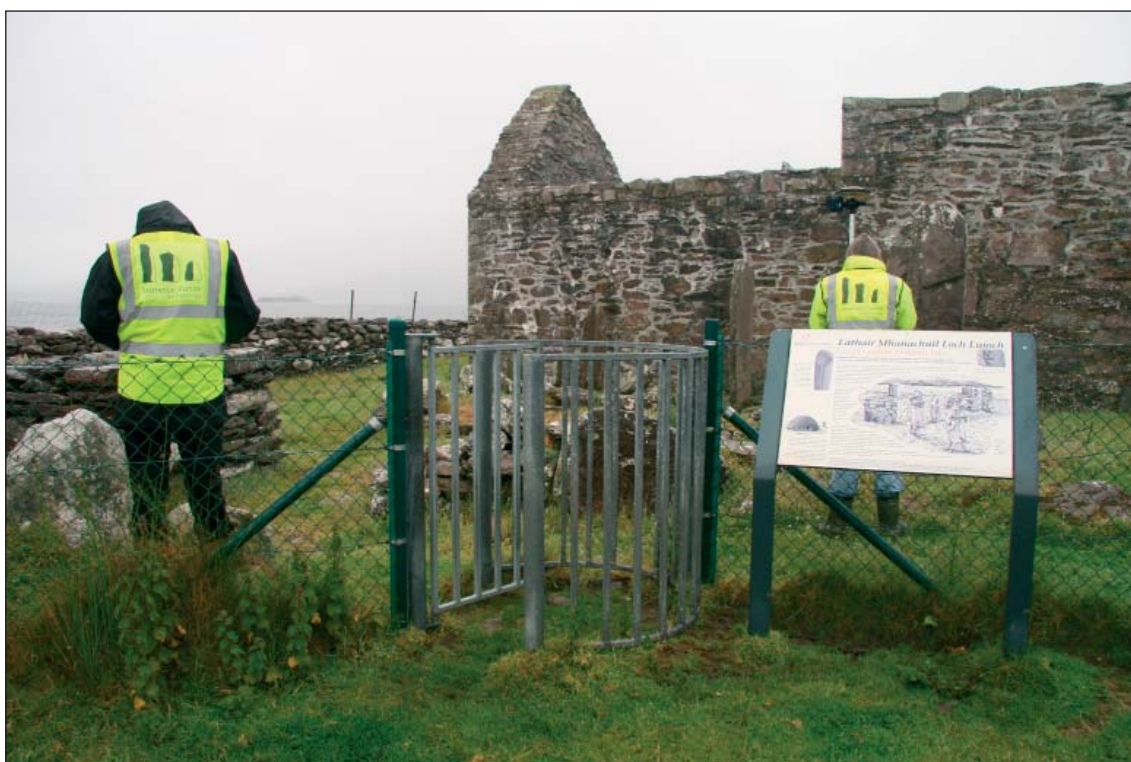
Services are not provided. However, a dedicated all weather information sign is provided beside the stile (Plate 2).

Plate 2: View of modern chain-link fence, swing-stile and information sign at Church Island from N

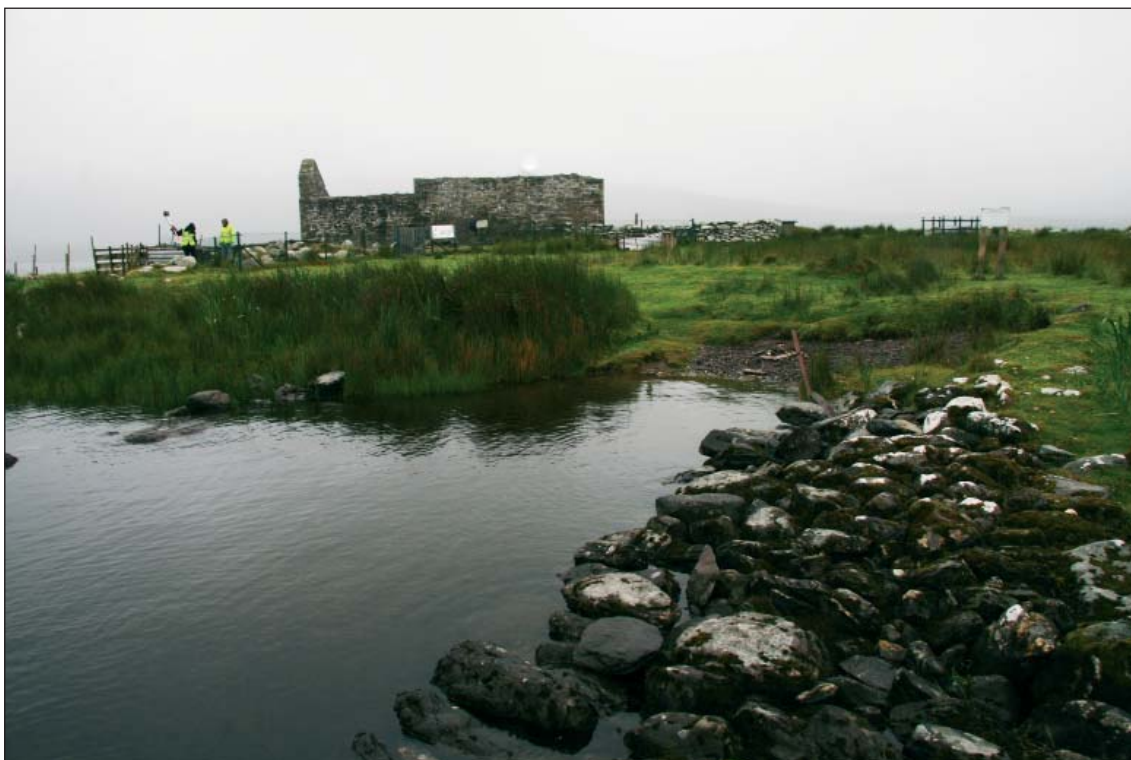
Church Island is accessible by boat hire only. The informal, somewhat difficult, uneven, landing point is situated 150° N of the early medieval ecclesiastic complex (Plates 3-4).

Plate 3: View S from northernmost limits of landing point at Church Island

The landing place should be improved, consolidated, made safer and a mooring bollard provided.

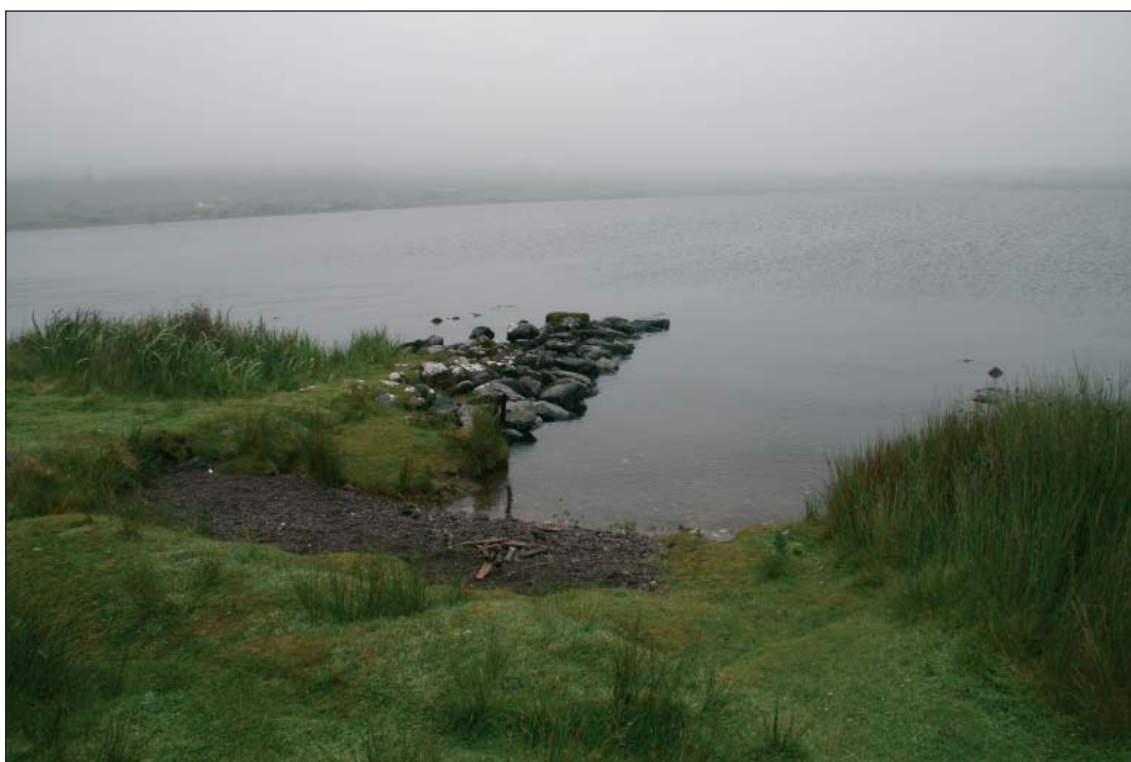
Plate 4: View from S of landing point at Church Island

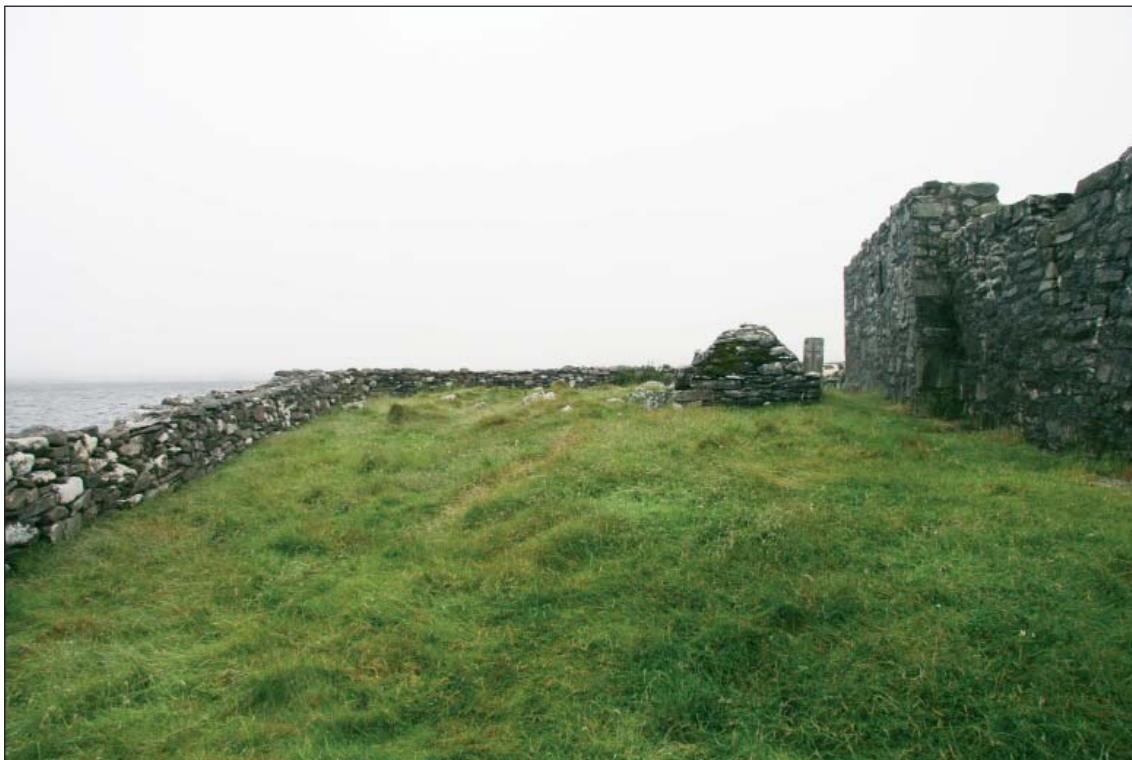
Plate 7: View on interior S limits of Church Island burial from E. Note breach in boundary wall on left of plate

The breach in the south should be repaired.

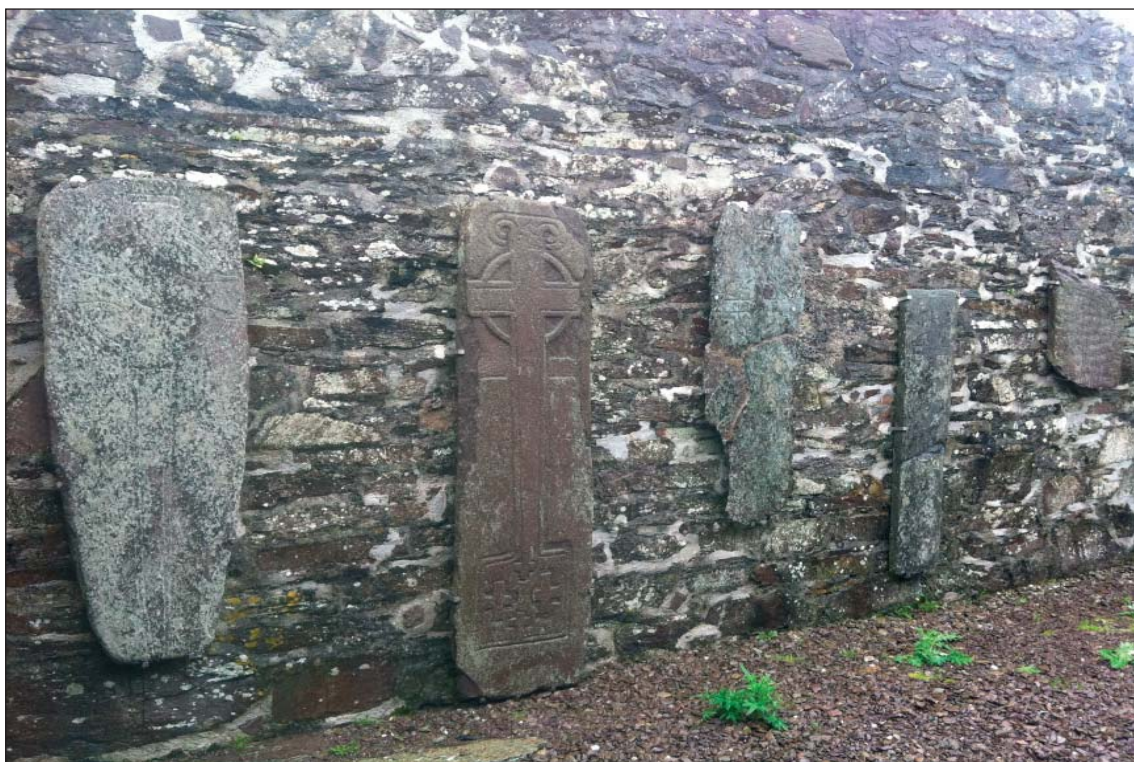
It is possible that GRVS 6 is a modern replacement for the fractured cross-slab CS 5 now attached to the interior of the nave (Figure 2 & Plate 8). It seems likely that the moved cross-slab, CS5, was then substituted with the current GRVS 6, (*ibid*, 317).

Plate 8: View of recently attached cross-slabs on the interior north elevation of the nave of the Romanesque church at Church Island

Enquiry should be made to the OPW regarding the possible substitution of the fractured cross-slab (CS5) and replacement with another slab GRVS 6.

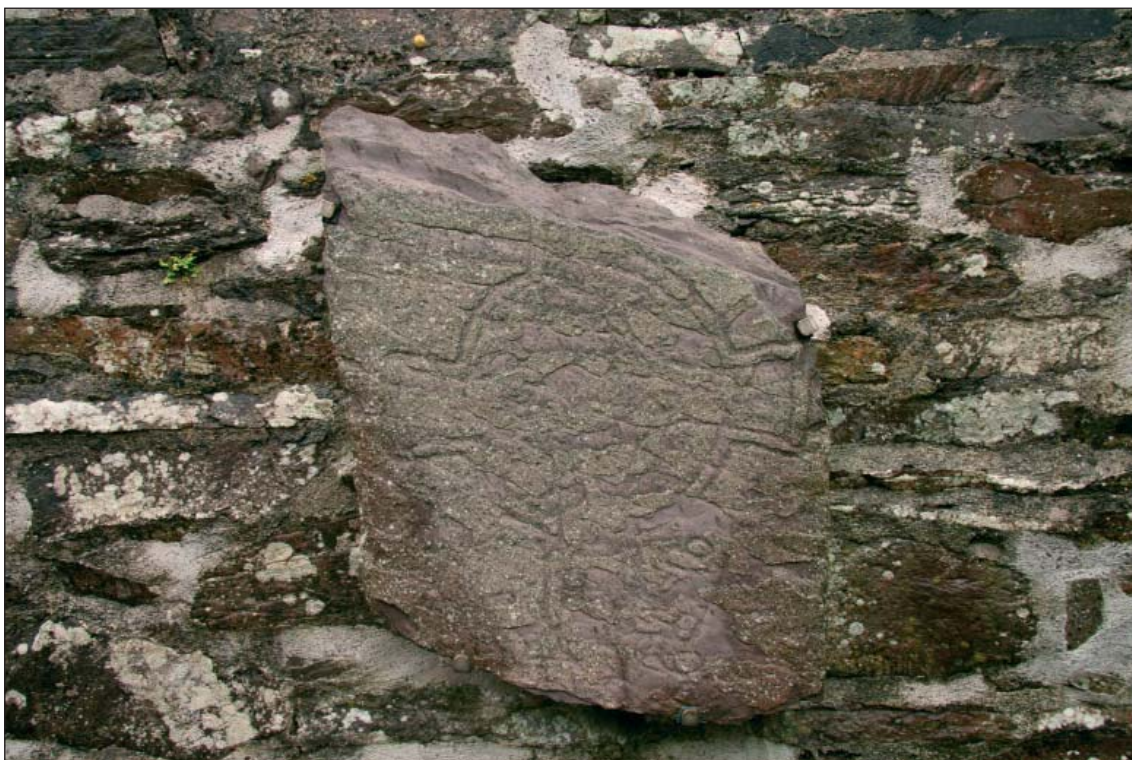
The motif on the broken slab fragment is a ringed cross-form with equal arms contained within a two-line outline design similar to the Anmchad slab (CS1) and CS3 (Figure 2, Plates 18 & 24). The face of the stone is much decayed with the outer lamination missing in patches. The somewhat kite shaped fragment is also spalled at the top and bottom where the breaks appear fresh. The lack of any lichen growth on the spalling indicate that that the breaks occurred in the recent past.

In total it would appear that **twelve** cross-slabs and not eleven are known from Church Island. The additional cross-slab, CS7 was recently attached to the nave of the church by the OPW but its original provenance or the other fragments from it are unknown.

Plate 15: Close-up view of cross-slab CS7 on the nave of the church. Note the fresh spalling at the top and the surviving patch outer lamination of its face

Enquiries into the recent work by the OPW should be undertaken to update the existing files and tease out some of the issues raised in this survey regarding the cross-slabs, especially CS7 and their recent movement etc.

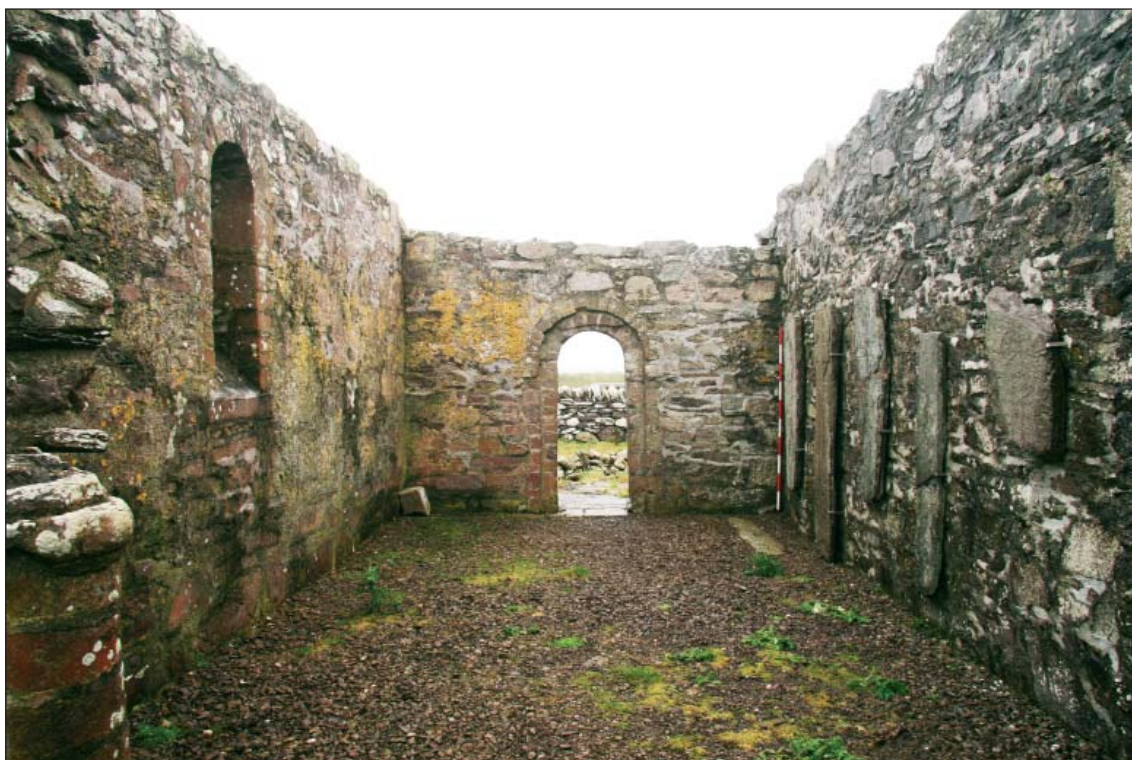
Plate 16: View of nave from the chancel arch. Note the cross-slabs attached to the wall and the loose architectural fragment at the S-W corner

These three small loose mobiliary architectural fragments should be secured *in situ* if possible otherwise they should be removed to a safe repository for their preservation.

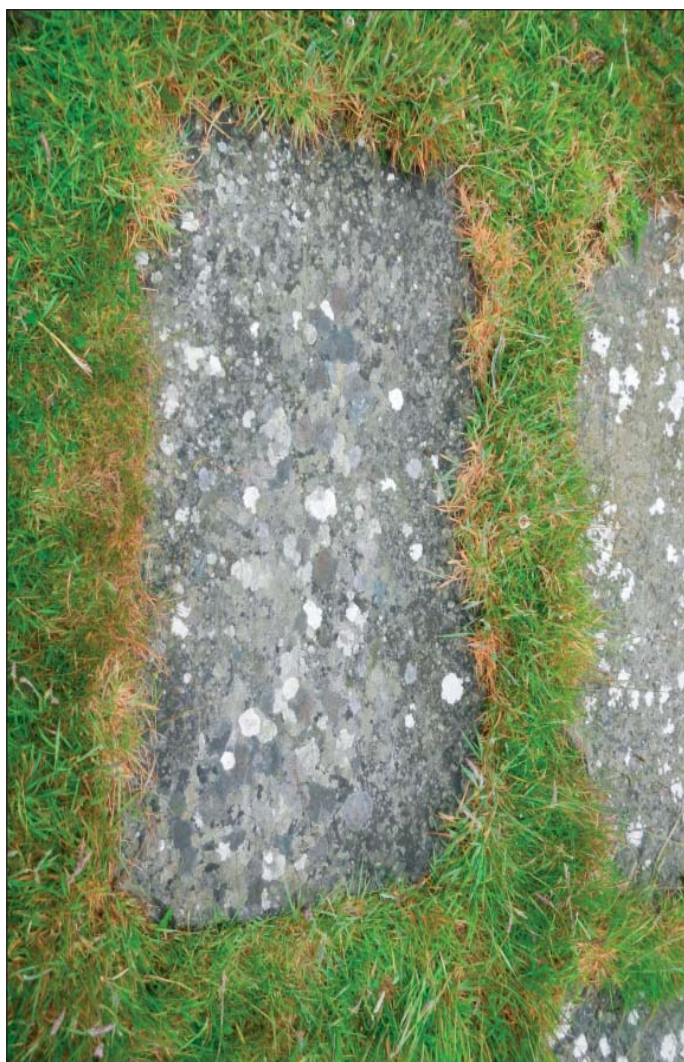
CS10 is the southernmost recumbent slab of a row situated to the N-E of the church (Figure 2 & Plate 20). The inscribed cross is now hardly visible and barely discernible. It was recorded by the SKAS as cross-slab no. 9, (*ibid*, 321).

Plate 20: View of recumbent cross-slab, CS10, from E

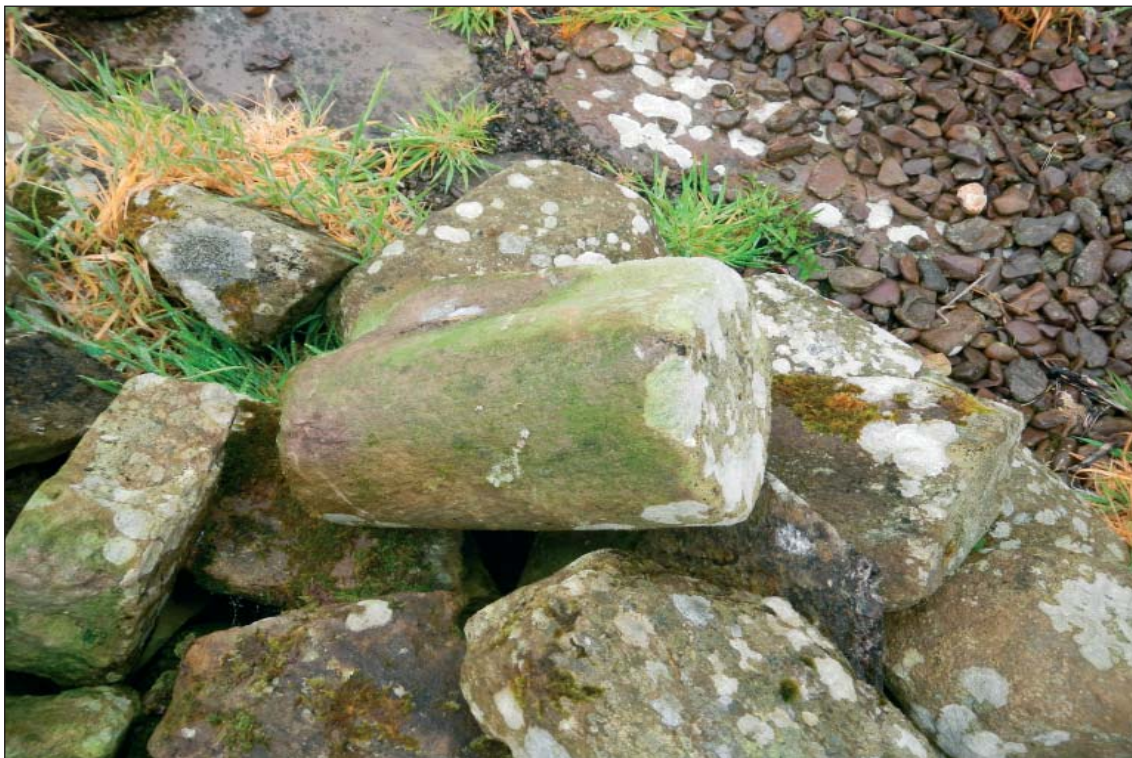
Plate 29: View of roll-moulding fragment, (AF2), lying loose on a pile of stones outside the doorway on the W gable of the church

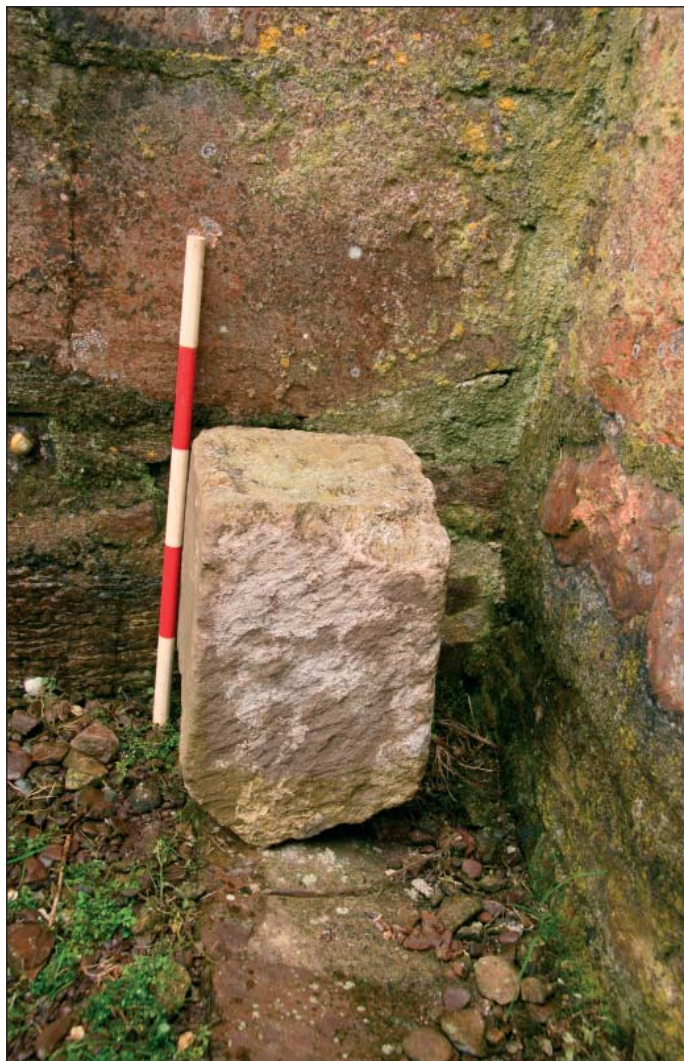
AF 3 comprises a rectangular block, 0.20m X 0.20m X 0.40m, of sandstone with a possible stylized zoomorphic interlaced motif featured on its short face (Figure 2 & Plates 30-31). These loose, small, mobiliary architectural fragments, especially AF3, will disappear if they are not secured or removed.

Plate 30: Upright view of architectural fragment, (AF3), in the SW corner of the nave of the church

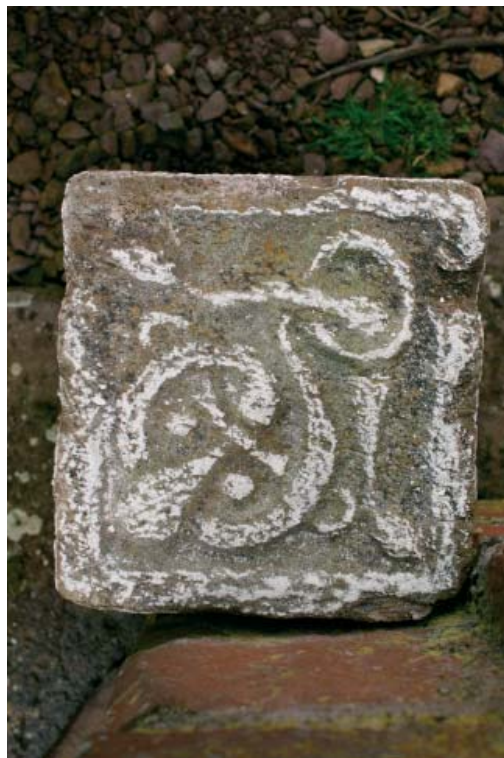
Plate 31: Close-up view of the motif on the short face of AF3
