Archaeological Survey, Dunurlin Church and Graveyard, Ballyferriter, Co. Kerry.

October 2010

RMP No.: KE042-041 church and graveyard

Written by: Laurence Dunne

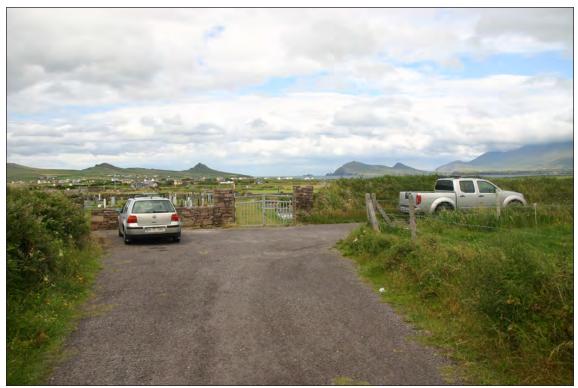
Plate 5: View of parking and entrance area to Dunurlin Graveyard. Note lack of adequate parking or turning area

- A proper area to park and turn should be created in front of the entrance to Dunurlin Graveyard.
- The dense grass and untended areas at the NE corners of the old and new burial grounds should be cut low with non-bladed strimmers and maintained low. Grass clippings should be removed from the graveyard and properly disposed.
- Focused archaeological / historic architectural conservation and repairs should be undertaken on the damaged, partially covered and grass covered named and unnamed tombs.
- All vegetation on the tombs should be cut back and removed. The tombs should then be repaired re-pointed, re-rendered and restored sensitive to their original construction. This work should be done under the supervision of an archaeologist qualified in this area or a conservation architect experienced in this field and may require Minis-

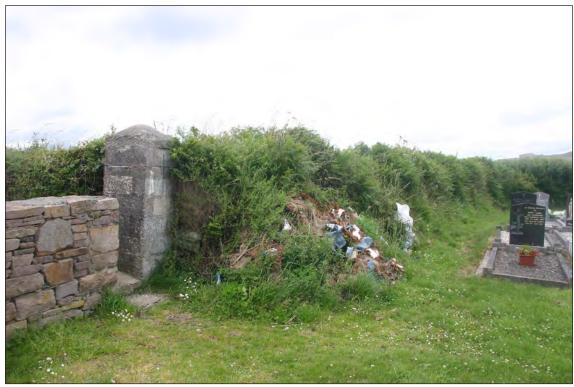
The medieval ruined church and graveyard of Dunurlin is situated on a fairly level pasturage at 16m OD *circa* 1.5km from Smerwick Harbour to the NE and 1.0km from Ferriter's Cove to the W (Figure 1). There is a new modern graveyard attached to the medieval burial ground at the south (Figure 5). The straight approach to the graveyard is along a narrow lane but has no adequate carparking or proper turning area and motorists have severe difficulty especially during funerals (Plates 4-5). There is no water or waste collection area or bins provided and rubbish is dumped inside the NW corner of the new graveyard section immediately beside the squeeze stile and modern burials (Plate 6).

Plate 6: View of SW pedestrian entrance area to Dunurlin Graveyard . Note dumping of rubbish beside grave 78

- Provision for the proper disposal of waste and vegetation cutting should be put in place.
- A water tap and water container should be provided.
- An information board similar to one already existing at Killury graveyard, in Lissycurrig townland near Causeway, should be established at a suitable location at the graveyard, most likely beside the entrance gate on its interior.

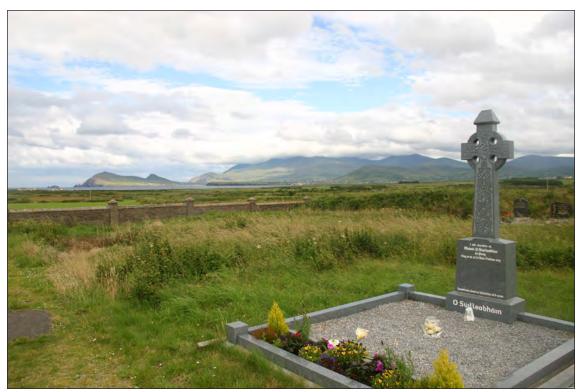
Apart from the lack of proper waste collection / disposal area, the graveyard is generally well tended although there are areas where vegetation growth is wild and unmanaged especially at the NE corner of the new burial ground where grass cuttings are also dumped (Plates 7-8).

Plate 7: View from SW of unmanaged, overgrown area at NE corner of the new section of Dunurlin Graveyard

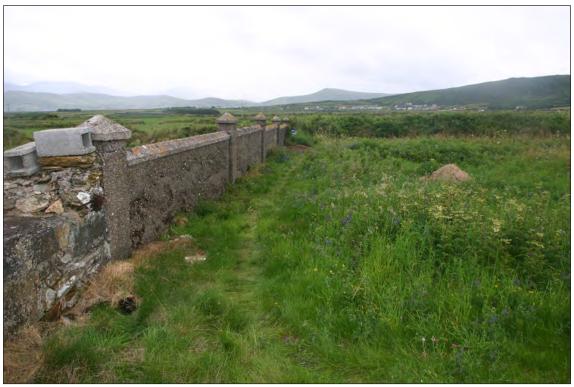
Plate 8: Close-up view from W of unmanaged, overgrown area at NE corner of the new section of Dunurlin Graveyard

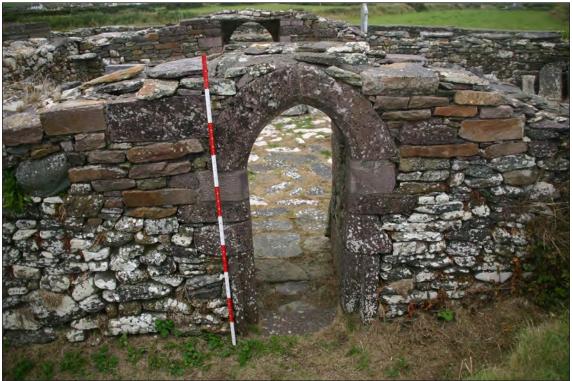
Today the four walls of the rectangular church are upstanding (Plates 1 & 9), however, several sections of these walls were totally re-built after excavation in 1991 including a large section of the south wall, east gable and w gable (Plates 10-11). There are several other noticeable cut stone insertions which are amateurishly and poorly cut and dressed with marks of an angle grinder clearly visible. The N doorway is especially poor and should be re-placed (Plate 12 - 14) & Figure 5). In reality much of the re-building undertaken after the excavations in 1991 is an example of how not to undertake conservation works!

Plate 10: View of exterior of S doorway of Dunurlin Church. Note extent of rebuilding works undertaken in 1991

The most obvious and inappropriate replacement masonry that was inserted into the structure in 1991 should be replaced as they diminish the cultural value and aesthetics of the medieval church ruins. This work should only be carried out by experienced masons who have a proven track record of conservation and restoration of historic buildings and in the use of lime mortars. This work should only be undertaken following a thorough conservation study of the standing remains and under the supervision and guidance of an archaeologist or a conservation architect who have proven track records of such work. Other recommendations with regard to the architectural fragments and archaeological objects are discussed below.

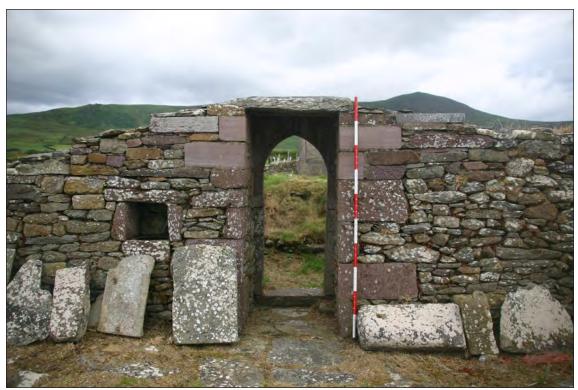
Plate 11: View of interior of S doorway of Dunurlin Church. Note extent of rebuilding works undertaken in 1991. Further note medieval architectural fragments lying loose against wall and intra-mural Holy Water stoup on left

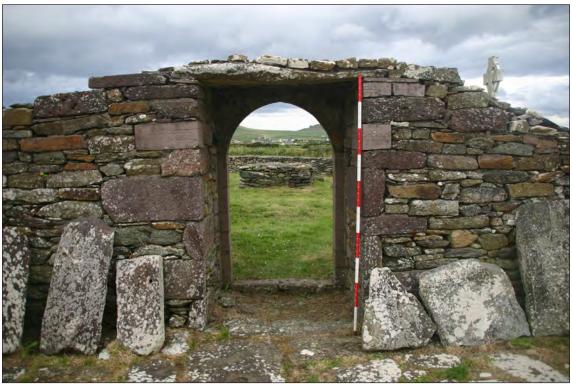
Plate 12: View of interior of N doorway of Dunurlin Church. Note extent of rebuilding works undertaken in 1991. Further note medieval architectural fragments lying loose against wall

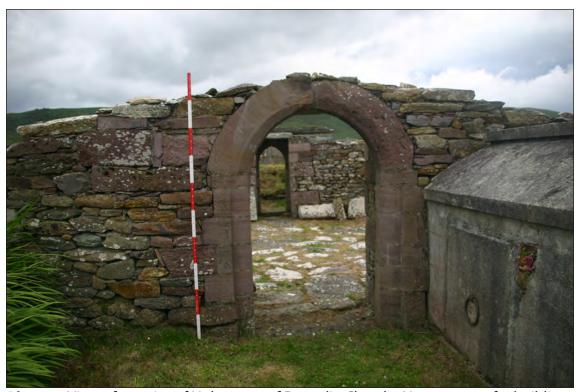
The N doorway is virtually entirely rebuilt apart from a single arched fragment with a chamfered edge (Plate 13).

Plate 13: View of exterior of N doorway of Dunurlin Church. Note extent of rebuilding works undertaken in 1991

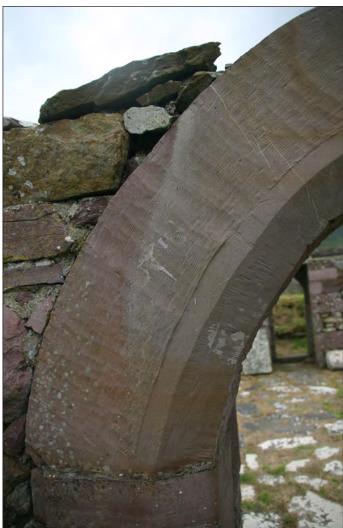
Plate 14: Close up view of very poor work on replacement arch stone on N doorway of Dunurlin Church. Note extensive amateurish, inappropriate machine and angle grinder marks

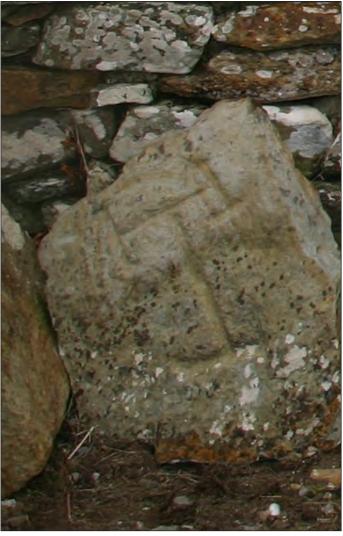
Plate 24: View of easily movable crossslab (535) standing loose at NE corner of Dunurlin Church

The entire architectural fragments should be fully recorded and illustrated and catalogued. The records from the excavation should be compared to the fragments that are currently in the church. Some of these fragments are mobile and should be removed to the Ballyferriter Museum for safe keeping. Of particular relevance in this regard are the loose cross-slab (535, Plate 24) and the holed stone that lies on top of the NW corner of the church walls.

- The loose cross-slab, holed stone and possibly other easily removable architectural fragments within the medieval church ruin should removed to the Ballyferriter or Kerry County Museum for safe keeping.

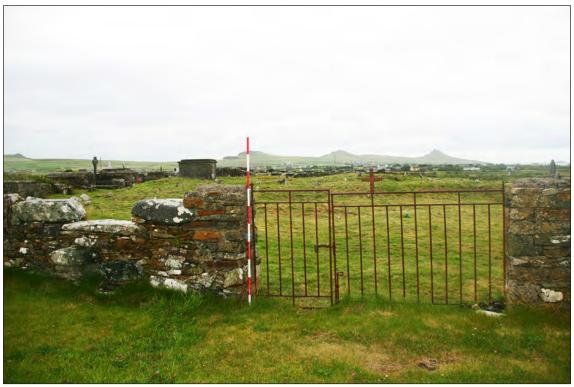
Another gate entrance provides access from the new graveyard into old (Plate 28 & Figure 5). This original entrance comprises of a pair of rusted gates set between two square low piers built of rubble stone and set in mortar. Immediately beside the gate to the W or left is a two step stile while a second stile is built into the W limits of the wall (Plates 29-30). A third disused step stile is located on the N boundary wall (Plate 25).

Plate 28: View of disused, late 19th century entrance into the old medieval graveyard at Dunurlin. Note step-stile on left

The old rusted gates should be cleaned, rust removed and re-painted and made operational again as the main entrance into the old graveyard.

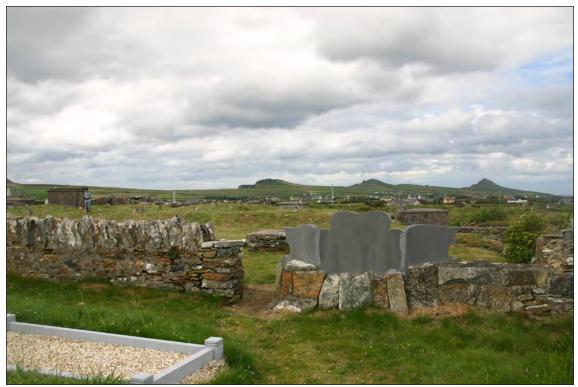
The old rusted gateway is now no longer in use as a modern gap has been cut through the 19<sup>th</sup> century wall a little to the E to accommodate a rather kitsch bench seating/patio area that was constructed from a grant from the Dunfey family through the American Ireland Fund (Plates 31-32).

Plate 31: View of modern gap into the medieval area of Dunurlin Graveyard beside modern culturally inappropriate bench. Note inappropriate repairs to late 19th century boundary wall

The boundary wall that was broken to construct the bench seating area should be repaired and the associated gap closed.

- The rusted gates between the old and new graveyards should be cleaned, repainted and reused.
- The current modern gap beside the bench / patio area should be sealed up and the wall beside repaired to its former condition.

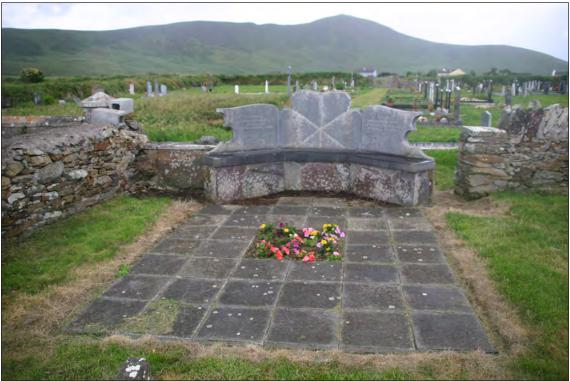
Plate 32: View of large, modern, bench seating / patio arrangement inappropriately situated in SE corner of medieval section of Dunurlin Church

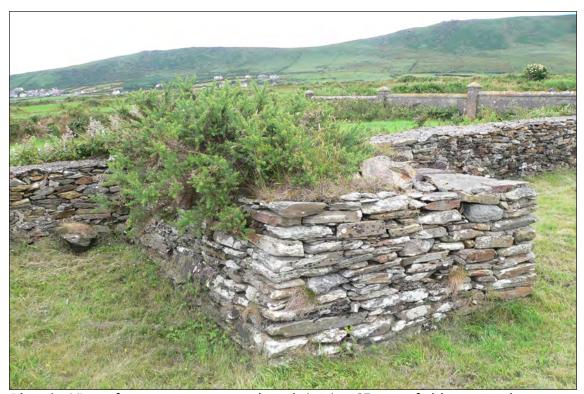
The majority of the tombs are of the box variety. Others comprise low rectangular flat tombs built with small rubble stones. Several of the tombs are un-rendered, covered or partially covered in grass, briars, furze and in need of repair and maintenance (Plate 41). The smallest tomb which abuts the N wall of the church (216) is collapsed (Plate 42). However, in the main the tombs are generally in good order requiring only basic maintenance and vegetation clearance.

Plate 41: View of overgrown unnamed tomb (166) at SE area of old graveyard at Dunurlin

The grass and other vegetation partially covering some of the tombs should only be fully removed as the primary element of an agreed inclusive strategy of repairs and other conservation and restoration works. Tombs that are fully covered in grass should be cut back for further evaluated to determine the nature and extent of further conservation / restoration works. This work should be undertaken with expert archaeological advice and supervision. Tomb 316 should be fully repaired.

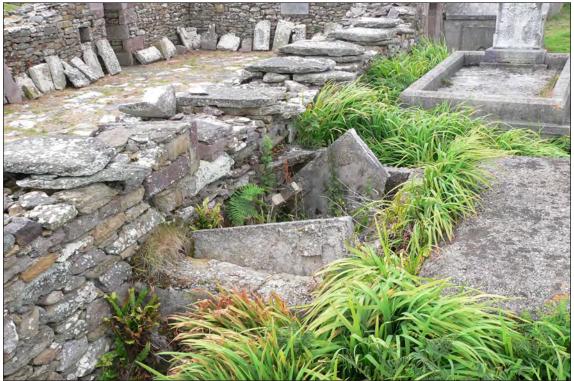
Plate 42: View of collapsed child's tomb (216) abutting exterior of N wall of Dunurlin Church
