Project code: KCCG11
Client: Kerry County Council
Date: July 2011

Archaeological Survey of Dysert Burial Ground, Farran, Castleisland, County Kerry

Surveyors: Ann Frykler & Robert Hanbidge
Report Author: Robert Hanbidge

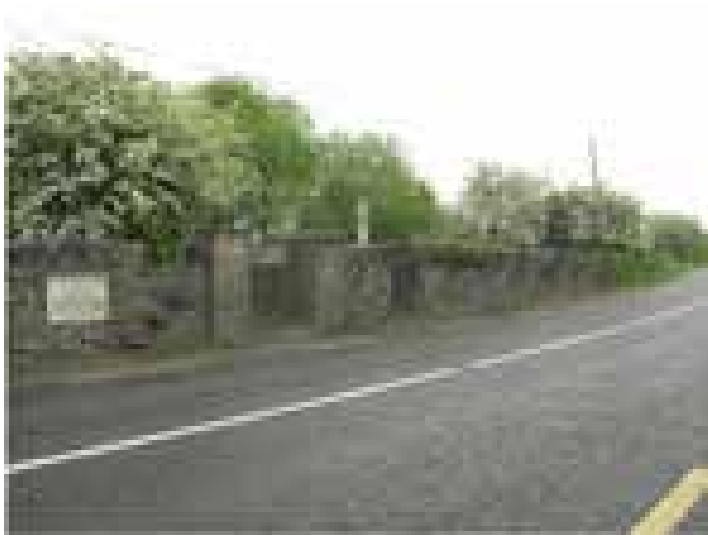
Access to the graveyard is extremely hazardous. Since the graveyard fronts directly on to a main road and is sited on a bend, the visibility of oncoming traffic is restricted (Plates 1 and 8). There is no substantial hard shoulder or verge to provide an adequate or sufficient safe area to walk along the road to the graveyard. Parking facilities are very limited with only a wide verge located approximately 20 m to the northwest of the graveyard at the road junction available. On entering the graveyard, there is little space to stand in away from passing traffic while opening and closing the gate.

Plate 1-View of graveyard from northwest

The provision of a suitable and adequate car parking facility would be advantageous for attracting visitors to the graveyard. The establishment of a suitable path to provide safe access to the graveyard along with a possible speed restriction would improve safety for those entering and leaving the graveyard. Rumble strips and adequate signage along with other measures would be a suitable method of informing drivers of the potential hazards and of potential pedestrians walking on the road. If this is not possible, the establishment of a new entrance to the graveyard to the north would provide a safer alternative for access.

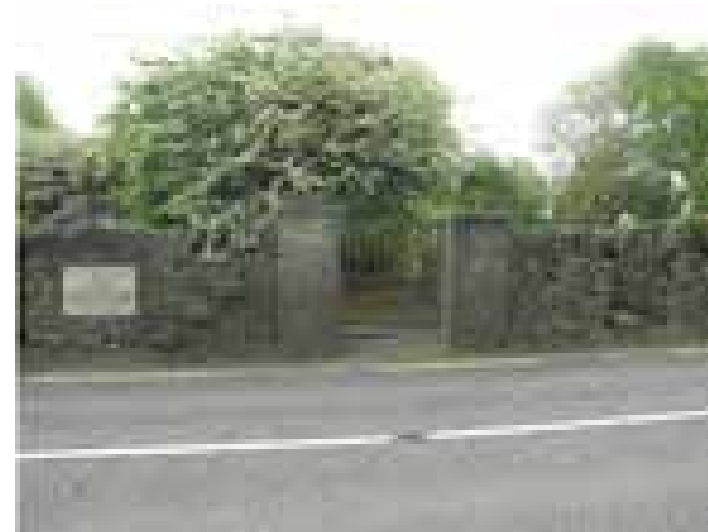
The piers survive in fair condition, however they are in need of repointing. There is also notable damage to the flagstone capping with the stone cap of the northern pier appearing to be loose and in danger of been hit by oncoming traffic. The gate survives in good condition and only has surface rust.

Plate 8-View of entrance from northwest

Cleaning of the entrance will rejuvenate the appearance of the graveyard as would the application of a rustic inhibitor and paint to the entrance gate.

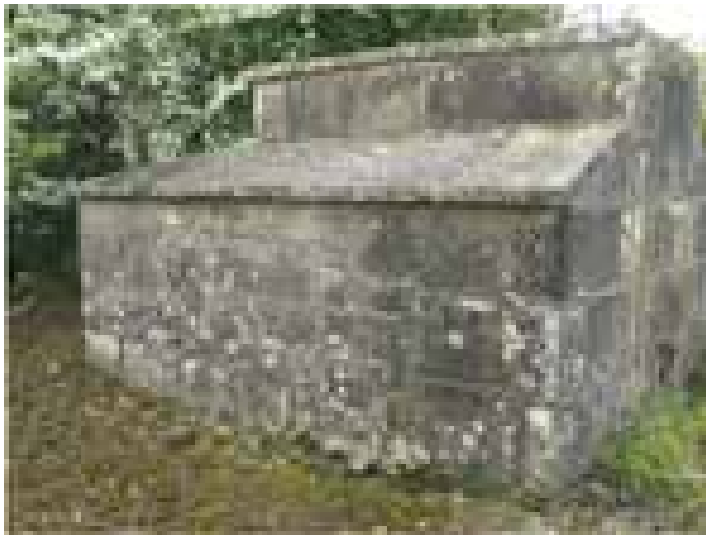
The O'Connor family tomb (Grave No. 23) is one of the more elaborate examples of tomb architecture within this graveyard and is positioned to the northeast of Grave No. 5. It is positioned in the general vicinity of where the northern church wall would have been located. This tomb is in good condition, probably owing to its high quality tooled limestone construction (Plate 13).

Plate 13-View of tomb (Grave No. 23) from northwest

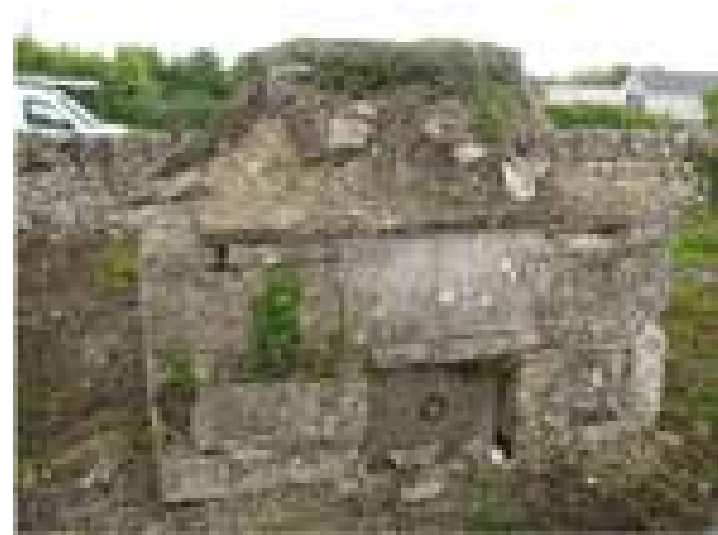
Located close to the southern boundary of the graveyard, the Carroll Family tomb (Grave No. 13) is in poor condition (Plate 14). Much of the walls survive intact and are constructed from dressed and

Plate 14-View of tomb (Grave No. 13), from southeast

A sign in the graveyard interior erected by the Water Services Department of Kerry County Council which states that it is intended to seal the tombs within the graveyard is welcome, given the poor condition of some of these features. However, such works should use the necessary skills and materials which are both sympathetic to and complement the historic character of the tombs and the graveyard. Since the majority of these tombs date to the early nineteenth century, the mass use of Portland type cements should be avoided as this will have a detrimental effect on the historic character of the graveyard. Attention should be drawn to the use of historic materials instead of modern materials.

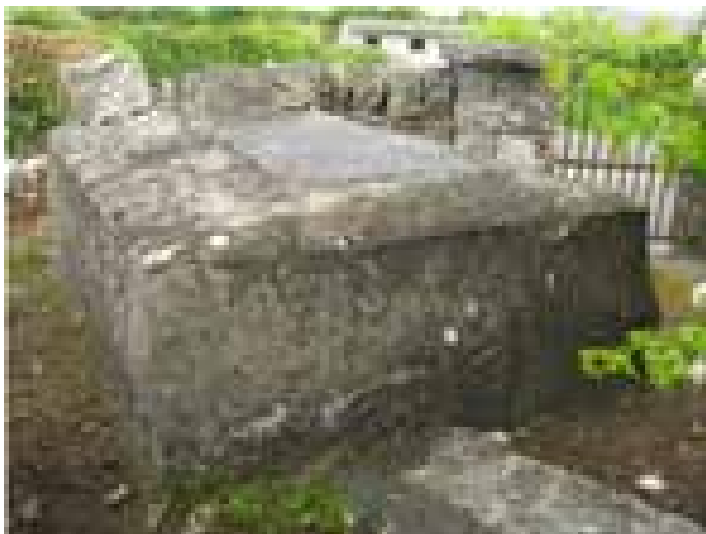
The O'Rourke tomb (Grave No. 8) is an unusual tomb, not for its low design but for its location within a recess of the north-western boundary (Plates 1, 6, 8 and 15). The tomb does not occupy a perpendicular angle in the boundary and thus its north-western corner abuts the interior of the boundary wall. A short section of rubblestone walling fills the sides of the gap between the tomb's south-western corner and the boundary, thus effectively maintaining the external boundary. The rubblestone coping is continued across the western end of this tomb. The tomb is in good condition owing to the relatively recent restoration works which have been applied to the exterior. The original capstone survives at the top of the tomb and is inscribed, though weathering has made it virtually illegible.

Plate 15-View of tomb (Grave No. 8) from east

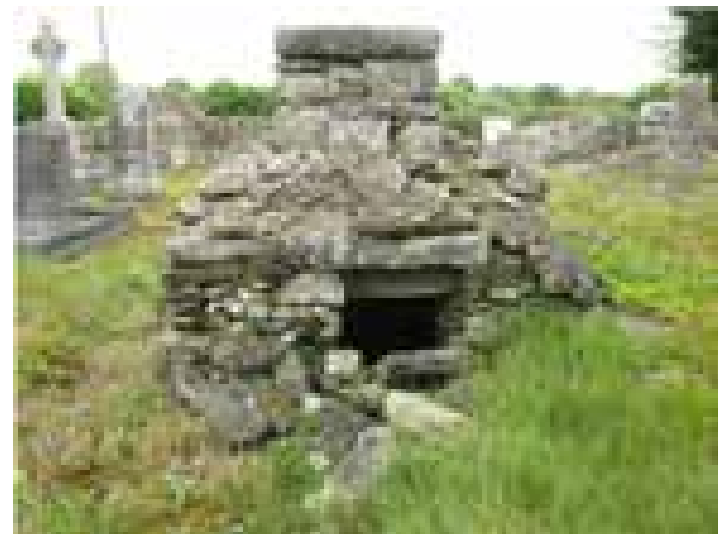
All of the unnamed tombs are in poor condition with many in a ruinous state. Several tombs have large breaches in their walls. As an example Grave No. 20 (Plate 16) has a large breach in the east elevation and has been vandalised, with some human remains having been extracted and partially scattered on the ground to the east of the tomb. Several other tombs have completely collapsed and have been filled with rubble e.g. Grave No. 24 (Plate 18). Other partially underground tombs have had damage to the lintels which has caused some collapse, creating a series safety issues e.g. at Grave No. 49 which is sited at the eastern end of the church wall (Plate 19).

Plate 16-View of Grave No. 20 from east

Restoration works to the collapsed tombs will require further investigation. It is highly unlikely that it will be possible to clear out the rubble from these in filled tombs, as this would require archaeological supervision due to the disturbed/crushed human remains that would be uncovered. The laying of a protective geotextile and the construction of a low rectangular structure to cap the tomb would be one suitable remedy if a stable foundation can be laid to maintain the tomb.

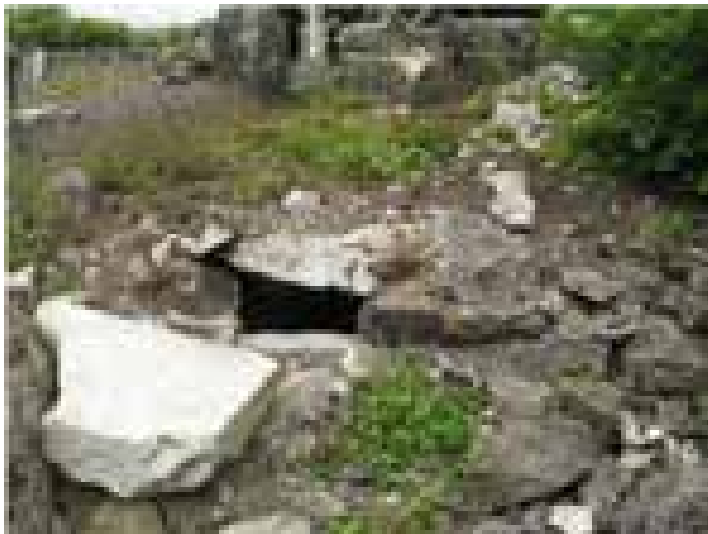
Plate 19-View of collapse to Grave No. 49, from east

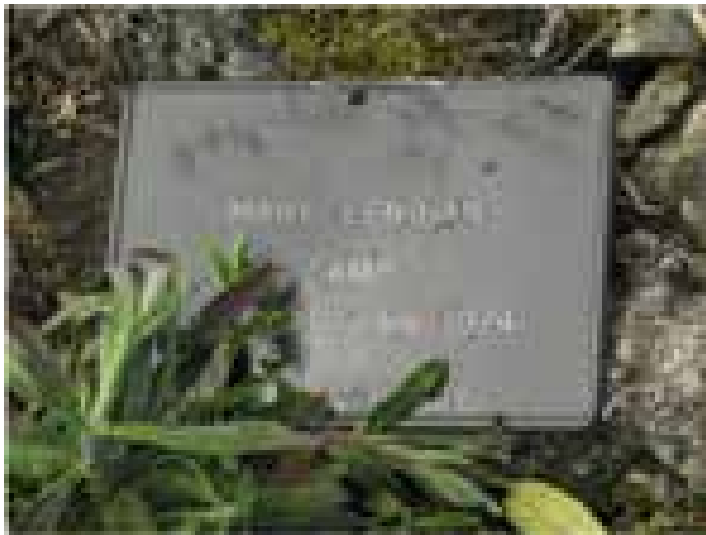
Grave No. 33 was a similar named plaque, however the provenance for this grave marker is unknown as the plaque is unsecured and loose. The plaque commemorates Mary Lenihan and may have originated from elsewhere within the graveyard (Plate 25). Its current location is on top of a collapsed tomb (Grave No. 35) and it seems unlikely that this tomb is the burial place of this person, although this is mere speculation. No other Lenihan graves were recorded within the graveyard.

Plate 25-View of named plaque representing Grave No. 33, from west

- Any damaged graves, collapsed or broken headstones, collapsed or damaged tombs should be repaired and re-erected if they have fallen over.
- Efforts should be made to locate the burial place associated with the disturbed grave plaque that represents the burial place of Mary Lenihan (Grave No. 33).

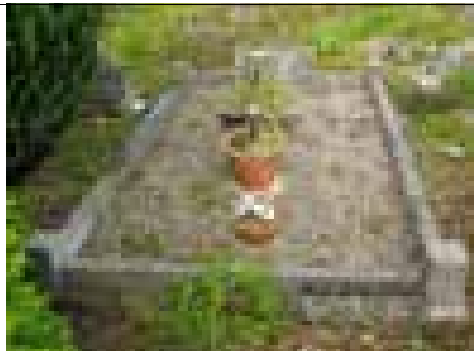
Grave_No	Family Name	Photo_Name
31	Brosnan	IMG_0069
Notes		
Plot in moderate condition, iron railing is broken to the east

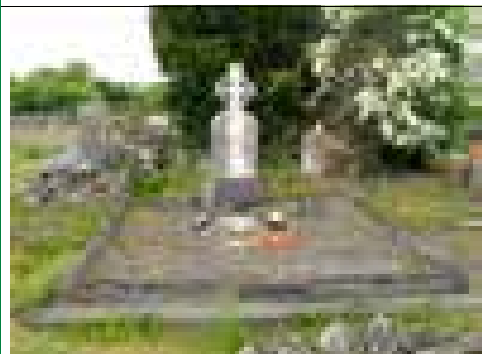
Grave_No	Family Name	Photo_Name
79	Hanafin	IMG_0145
Notes		
Plot in poor condition, plot markers and railings fallen down and headstone fallen over and broken

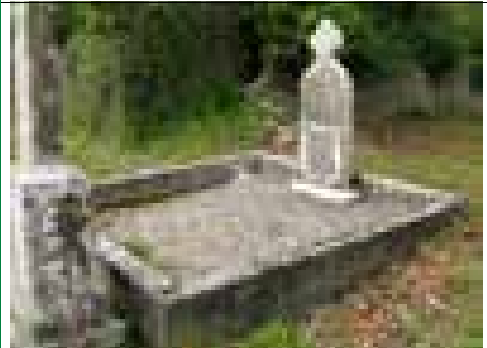
Grave_No	Family Name	Photo_Name
78	Hickey	IMG_0143
Notes		
Plot in moderate condition, wrought and cast iron railings are in parts broken, subsiding

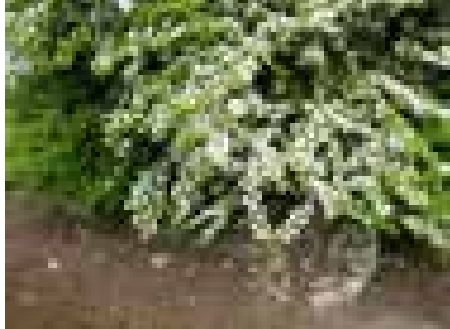
Grave_No		Photo_Name
20		IMG_0040
Notes		
Tomb in moderate condition. Entrance has collapsed and human remains are clearly visible inside tomb, a skull fragment is also located just outside the tomb,
