Project code: KCCG11
Client: Kerry County Council
Date: June 2011

Archaeological Survey of Dysert Burial Ground, Lixnaw, Co. Kerry.

Surveyors: Ann Frykler & Robert Hanbidge
Report Author: Robert Hanbidge

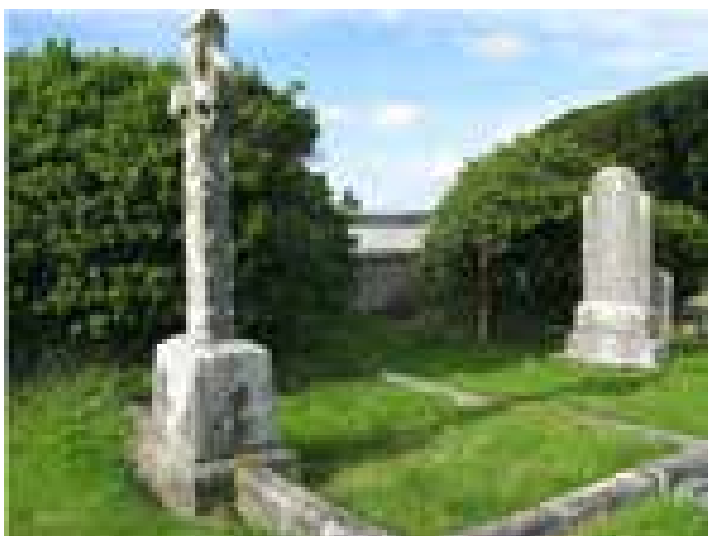
The church ruin is listed in the RMP as KE010-062 and is in fair to poor condition, with only the north, south and west walls remaining (Miscellaneous No. 01; Plates 3-5). The east wall has completely disappeared, so the full dimensions of the church could not be taken. The church is orientated on an east/west axis. From what remains, the church had a minimum length of 10 m and measured 6.5 m wide. The walls consist of roughly dressed rubble-stone with a lime and gravel mortar.

All the walls are severely impacted on from excess ivy growth which has resulted in some loosening of the masonry. No windows or doors were observed in the ruins, however the excessive amount of ivy growth may have hidden any such remains. Some ivy was cleared from the interior of the western wall around the location of the plaque for grave 42.

Of the three walls, the western wall appears the most intact with part of a pitched gable visible indicating the church had a pitched roof. The southern wall survives in poor condition and has an opening possibly representing the site of a doorway (Plate 3). The northern wall survives only to a height of approximately 1 m and is impacted on by the presence of the tomb (Grave No. 41) and the adjacent plot (Grave No. 40) immediately to the north. A large mound of rubble is located to the

Plate 3-View of south wall of church ruin from south

Measures should be taken to secure the existing ruin from further collapse; this could primarily be achieved through the control and management of the attached vegetation and preventing it from spreading further. The ivy should not be removed however as this would leave the building in need of immediate conservation, without which structural collapse may occur. Such work would involve the re-pointing of the walls using correct (lime) mortars with flush or recessed pointing. Ribbon pointing must be avoided as its use would damage the structure's historic character. The complete removal of the ivy would also result in a loss of a natural habitat and should be avoided given that the graveyard is in use by nesting birds. Any such works should be avoided during the period between the 1st day of March and the 31st day of August in accordance with Section 46 of the Wildlife (Amendment) Act 2000 to avoid disturbance to wildlife. The structural stability of the buildings needs to be frequently monitored to ensure the site remains safe and stable.

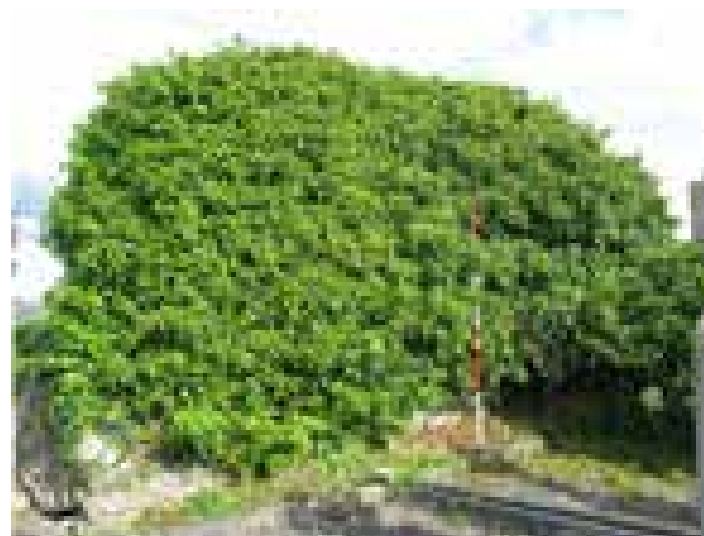
Plate 4-View of west wall of church ruin from west

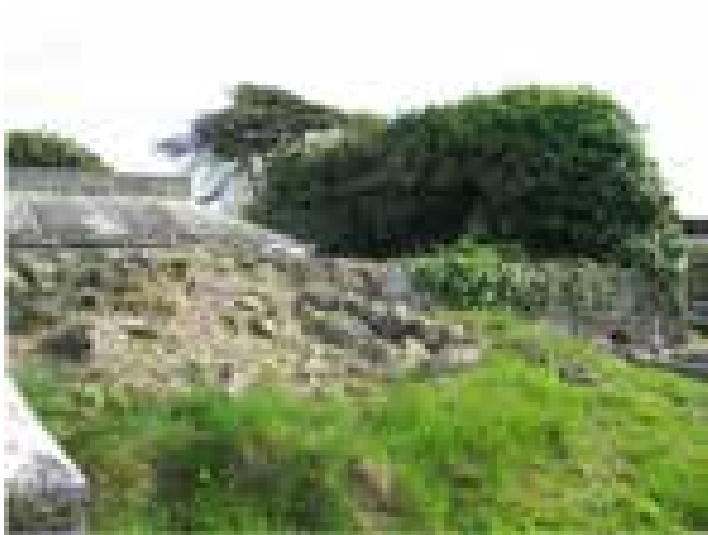
exterior of this wall and probably relates to collapsed wall material (Plate 5); it presents a health and safety concern as the area is unsafe to walk.

Plate 5-View of north wall of church ruin from north

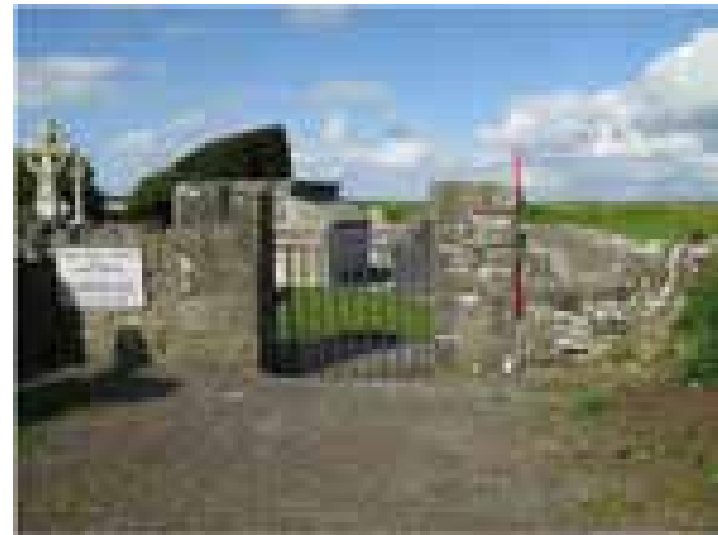
Access to the graveyard is from the car parking area through a pedestrian gate (Plates 6 & 10). The entrance comprises of a pair of square-profile dressed limestone gate piers with dressed limestone coping and a single-leaf wrought-iron gate. Both piers appear in good condition with the only exceptions been the occasional areas of missing pointing and the partially disturbed stones to the upper portion of the exterior (west) elevation to the southern pier. However the gate is in fair to poor condition due to internal rusting of the wrought-iron bars, especially to the base of the gate, which will shortly impact on the structural integrity of the gate.

Plate 6-View of entrance from southwest

The entrance requires minor works. Missing sections of pointing between the masonry should be re-pointed using correct (lime) mortars with flush or recessed pointing which are sympathetic to the historic character of the graveyard. Ribbon pointing must be avoided as its use would damage the structures historic character.

Disturbed masonry to the southern pier should be repaired to match the original masonry.

Provisions should be made for the future replacement of the entrance gate. Consideration should be given in obtaining a gate that will be of certain design and construction which will be sympathetic to the historic character of the graveyard as this would also further enhance the visual impression of the graveyard to its many visitors.

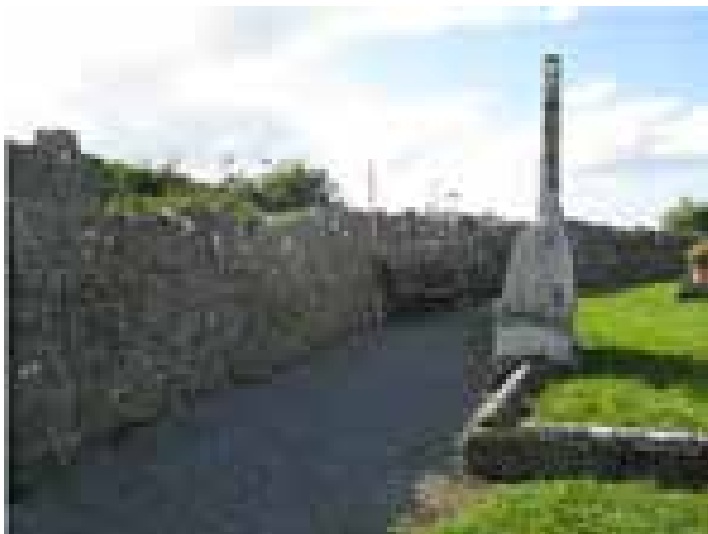
The boundary walls surrounding the graveyard consist of roughly dressed, mortared rubble-stone with rubble-stone coping and for the most part are in good condition (Plates 7-9). Occasional gaps are noted to the external elevations of the boundary walls where one or more stones have fallen out, but overall the masonry is in good condition. There is however one noticeable gap in the coping to the east where short length of the coping has been removed. Otherwise occasional minor patches of ivy growth are found along the top of the boundary and some overgrowth including brambles is found to the external elevation of the north-eastern section of the boundary.

There is recent evidence of broadcast spraying of herbicides to the boundary walls including wilted weeds and stunted bramble growth along with the flaking of lichens from the wall surfaces.

Plate 7-View of south-western boundary wall from southeast

Restore missing section of the coping and repair of any holes within the wall masonry.

Spraying or broadcast application of herbicides to boundary walls must be avoided. 'Guidance for the Care Conservation and Recording of Historic Graveyards' issued by the Heritage Council (2010) states that:

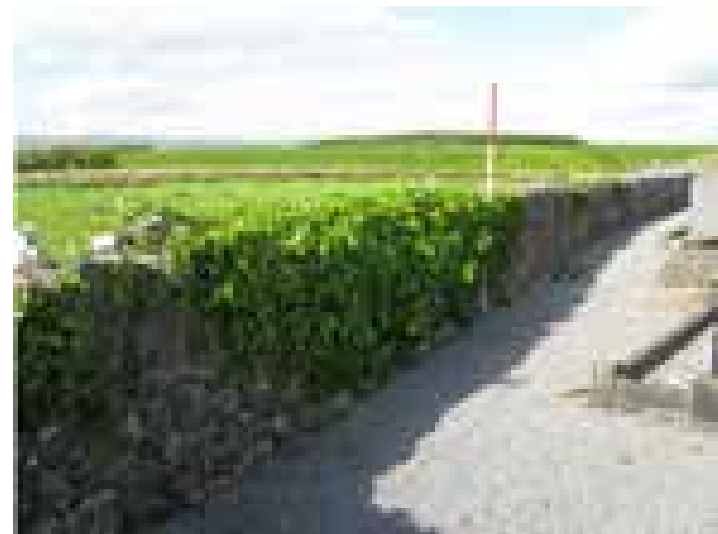
Plate 8-View of northern boundary wall from southwest

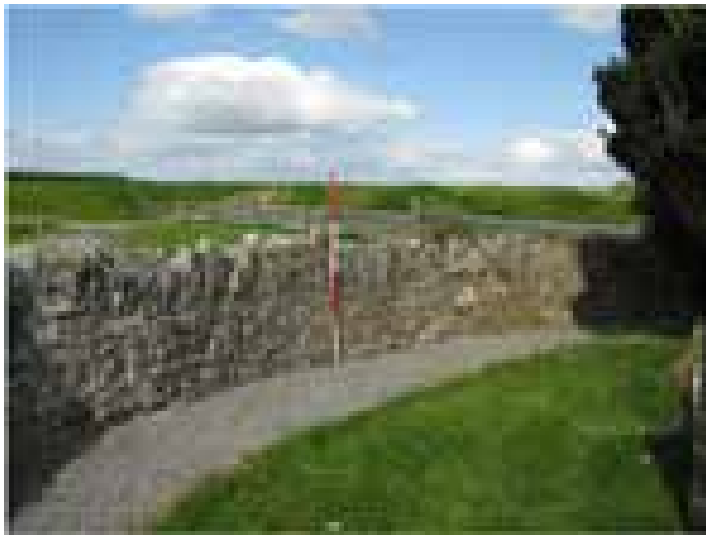
Plate 9-View of eastern boundary wall from west

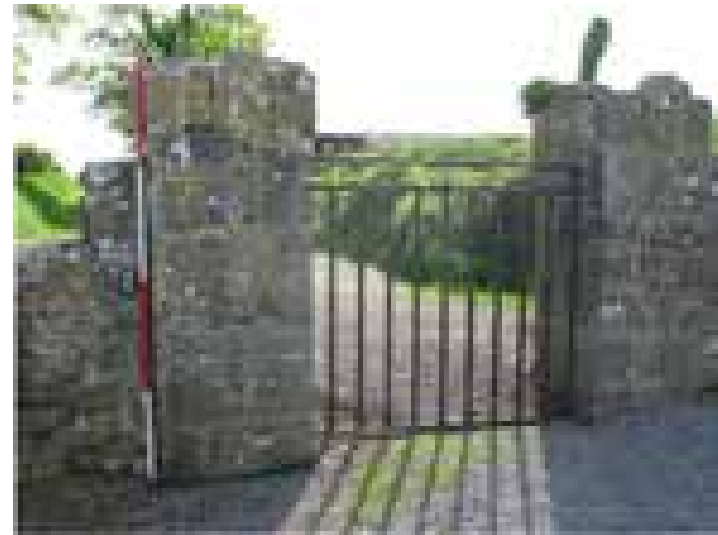
Plate 10-View of entrance from northeast

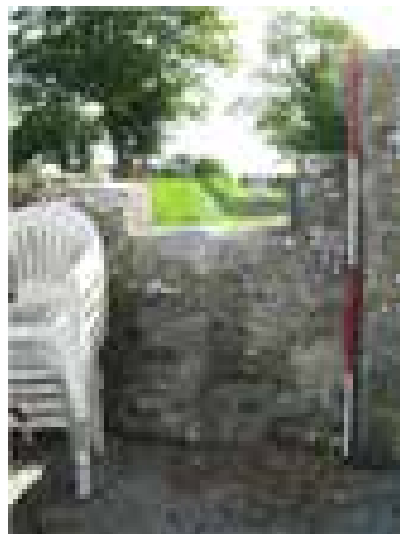
A secondary method of entry is provided by the stone stile to the south of the entrance (Plates 6 & 11). This stile consists of a recess within the coping to the boundary wall which is formed by a large horizontally bedded stone. Originally projecting stones from the wall to both the interior and exterior elevations formed steps up the wall. However the two stone steps to the external (west) elevation have been completely destroyed and prevent the use of the stile, as well as detracting from the visual appearance of the entrance.

Plate 11-View of stile from northeast

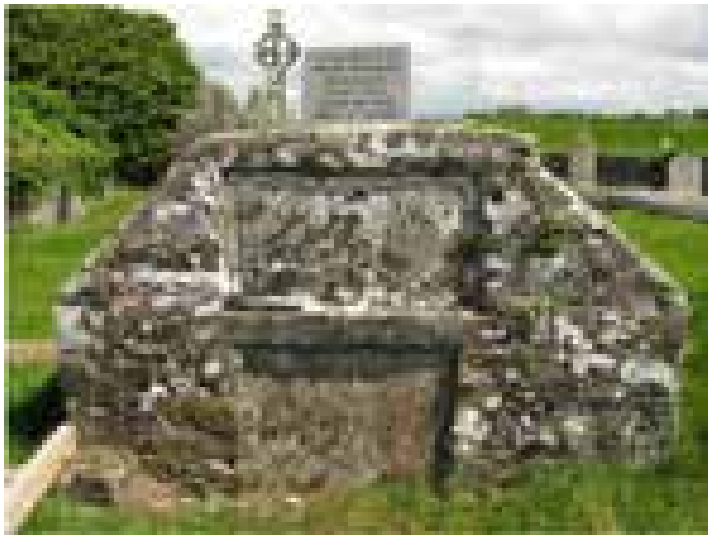
Plate 13-View of Grave No. 4 from west

The oldest tomb (Grave No. 4) requires repointed to the rubblestone walls to enhance the tombs resistance to the weather.

Any re-pointing works to the walls should use the correct (lime) mortars with flush or recessed pointing which are sympathetic to the historic character of the graveyard. Ribbon pointing must be avoided as its use would damage the structures historic character.

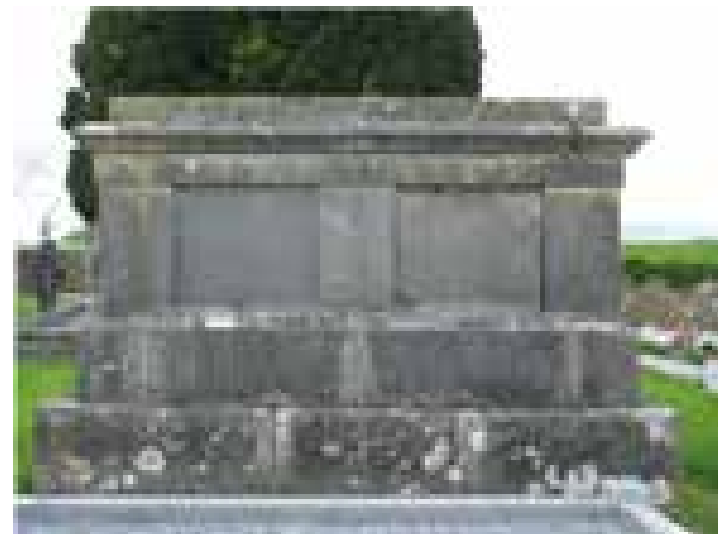
Plate 16-View of Grave No. 32 from south

Since all tombs survive in good condition, limited maintenance is currently necessary. The limestone tomb (Grave No. 32) may require some monitoring of the masonry work because of the effects of the settling of the foundations. Some resetting of the stones, especially to the cornice may be required in the future to improve the tomb's resistance to the weather.

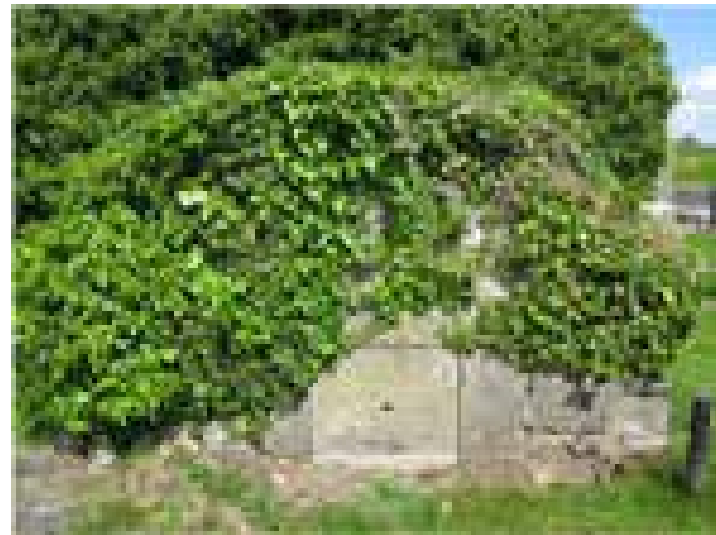
The second unnamed tomb (Grave No. 46) is located adjoining the church's western elevation. The tomb is heavily overgrowth by ivy, which may conceal a name plaque. Structurally, from what is not impacted on from vegetative overgrowth, the tomb appears in reasonable condition with dressed limestone block walls (Plate 18).

Plate 18-View of Grave No. 46 from southwest

Removal of the overgrowth to the overgrown tomb (Grave No. 46) will expose the structure further to the elements, which will necessitate immediate restoration of the tomb, including repointing and the possible application of rendering to the roof to ensure its resistance to the weather. The re-pointing of the walls should use the correct (lime) mortars with flush or recessed pointing which are sympathetic to the historic character of the church. Ribbon pointing must be avoided as its use would damage the structures historic character. The complete removal of the ivy would also result in a loss of a natural habitat and should be avoided as during the survey, a number of active bird nests were present within the foliage surrounding the church ruin.

- The vegetation overgrowth to the church ruins and the tomb (Grave No. 46) should be controlled and tended to regularly in order to prevent future degradation and collapse of walls and interior features including tombs, gravemarkers and headstones. This should not, however, be done at the expense of the natural habitats that this vegetation provides to local wildlife.

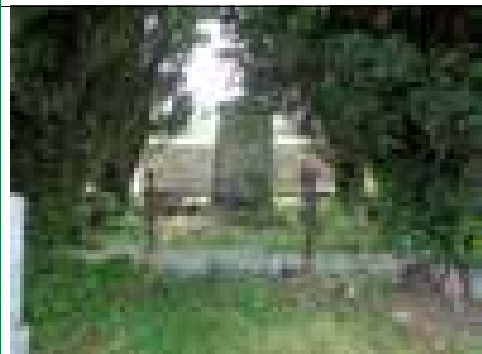
The majority of the headstones and plots are in good condition. One area of concern is the plot to Grave No. 38, where four substantial yew trees are growing in the corners of the plot and have caused significant disturbance to the enclosing plinth walls, which also feature decorative cast-iron railing (Plate 21). The root disturbance from these trees has also caused the headstone to lean. The headstone to this plot commemorates George Hewson grandfather to the world famous Irish artist Paul David Hewson, who is better known as Bono from U2.

Grave_No	Family Name	Photo_Name
38	Hewson	IMG_0082
Notes		
Poor condition, four yew trees in each corner, cast iron railings are broken and missing

In general the majority of the graves are well maintained and are easy accessed. In regards to Grave No. 38, the yew trees to the corners of the plot need to be managed to ensure that the plots survive and that the headstone remains upright. Clipping of the internal branches will enhance access to this plot and will prevent damage to the headstone.

- The yew trees to the corners of the plot to Grave No. 38 require management to ensure that this plot and neighbouring plots remain intact and that the headstones remain upright. Clipping of the internal branches will enhance access to this plot and will prevent damage to the headstone.

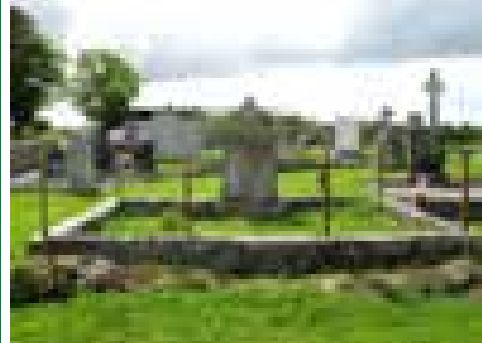
The majority of the plots are grass covered, although many of the recent plots have render platforms which are sometimes covered by gravel. Some plots are noted as having a wrought iron railing, however, for Grave No. 28 in particular, much of this railing is missing.

Grave_No	Family Name	Photo_Name
28	Naughten	IMG_0060
Notes		
Plot in moderate condition, Wrought iron railing is gone in many places

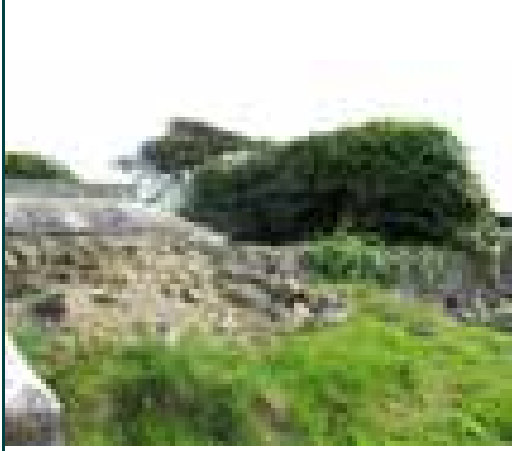
46 Tomb overgrown by ivy in moderate condition

Grave_No		Photo_Name
46		IMG_0099
Notes		
Tomb overgrown by ivy in moderate condition
