Project code: KCCG11
Client: Kerry County Council
Date: June 2011

Archaeological Survey of Galey Graveyard, Listowel, Co. Kerry.

Surveyors: Ann Frykler & Robert Hanbidge
Report Author: Robert Hanbidge

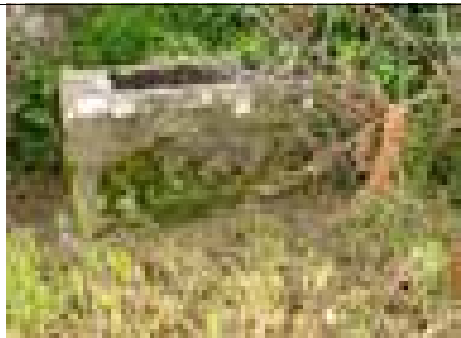
Grave_No	Family Name	Photo_Name
132	Collins	IMG_0224
Notes		
Broken headstone only the plinth left

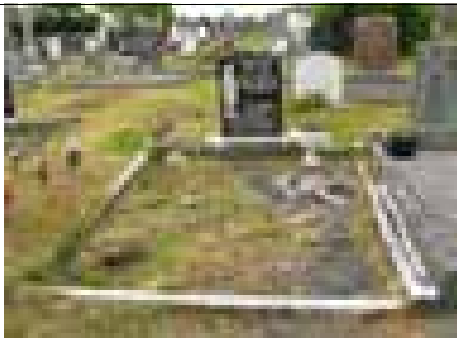
Grave_No	Family Name	Photo_Name
30	Daly/Nash	IMG_0054
Notes		
Plot in moderate condition, concrete subsiding

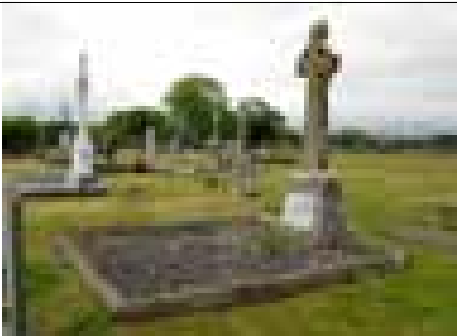
Grave_No	Family Name	Photo_Name
300	Galvin	IMG_0540
Notes		
Plot in moderate condition, subsiding

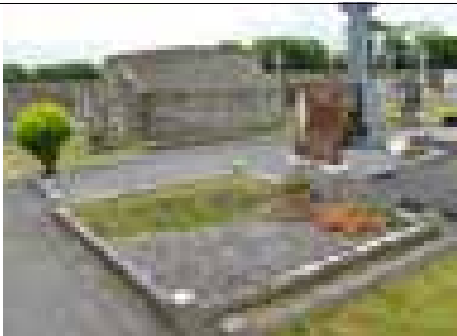
Grave_No	Family Name	Photo_Name
21	Linnane/Scanlon	IMG_0031
Notes		
Plot in moderate condition, subsiding

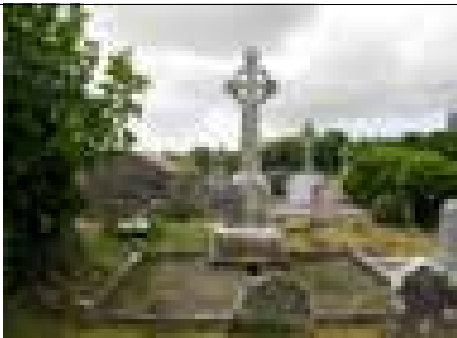
Grave_No	Family Name	Photo_Name
154	O'Connor	IMG_0262
Notes		
Plot in moderate condition, subsiding, weeds

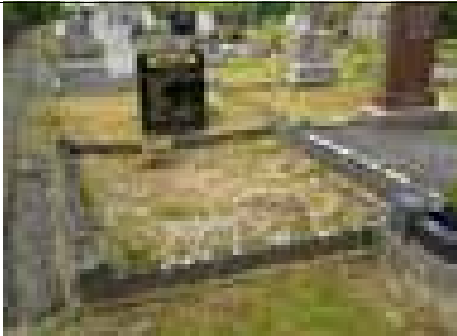
Grave_No	Family Name	Photo_Name
80	O'Sullivan	IMG_0133
Notes		
Plot in moderate condition, subsiding, grass and weeds

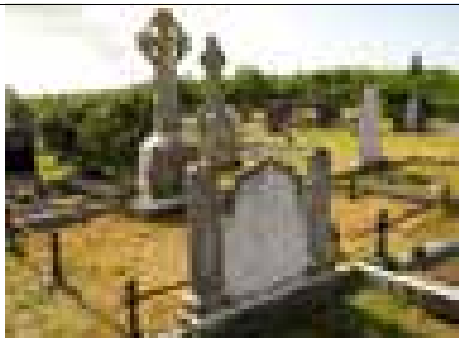
Grave_No	Family Name	Photo_Name
177	Quinlon	IMG_0315
Notes		
Grass covered plot in moderate condition, wrought iron railings corroded and broken
