Date: September 2009 Client: The Heritage Office, Kerry County Council Project code: TGSK09

## Archaeological Survey, Killaha Graveyard, Killaha, Co. Kerry.

RMP No.: KE067 057

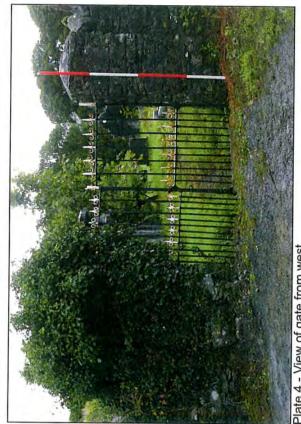
The entrance gate to the original graveyard is in good condition with the exception of a large amount of vegetation growing on and within the northern gate pier. The gate is partially blocked by gravel making up the car park and by long grass and vegetation within the graveyard. All other entrances are in a good usable condition.

Plate 4 - View of gate from west.

Vegetation should be removed from the gates piers to the main entrance of the original graveyard. The entrance should be cleared of any material blocking the opening and closing of the gate or the entrance should be closed and locked permanently to preserve it. All metal gates should be treated for rust and painted as and when such measures are needed.

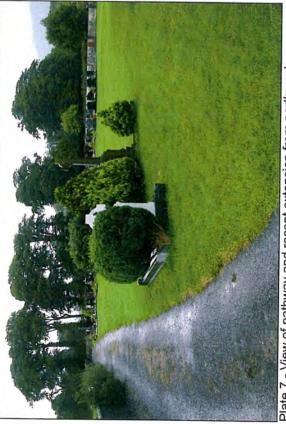
No pathways exist within the original graveyard. There is single gravel road that services the recent graveyard extension (Plate 7), it starts to the north of the original graveyard and runs along that border and then along the entire perimeter of the recent extension stopping half way up the southern wall. There are evenly spaced concrete and grass pathways between these more recent rows of graves.

Plate 7 - View of pathway and recent extension from northwest.

The pathways are in good condition due to their recent construction. Regular vegetation removal should be maintained. The addition of properly maintained gravel pathways to the original graveyard would help reduce foot traffic on inappropriate areas of the graveyard and would help people avoid stumbling on the uneven ground and semi-obscured d gravemarkers and crumbling headstones. However the positioning of new pathways could be difficult given the frequency of graves and the apparent evidence for many more unmarked graves. The results of this survey could help in such measures, yet a full archaeological investigation may be required. With this is in mind the maintenance or consolidation of desire lines should be considered as an alternative.

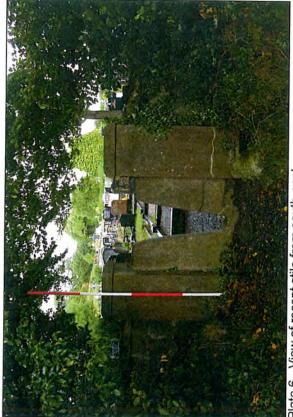
The extension is accessed through a gate comprising capped and rendered square profile gate piers holding a double-leaf metal gate. Connected to the southern gate pier is another stile comprised of concrete (Plate 5). A third stile is located in the centre of the eastern wall of the extension; this comprises capped and rendered square profile piers flanking a V-shaped concrete stile (Plate 6).

Plate 6 - View of recent stile from south-east.

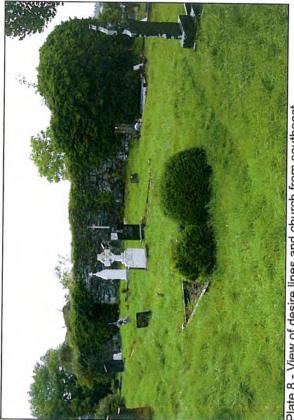
There are several desire lines located throughout the original graveyard due to an absence of pathways (Plate 8). These are located in the areas of highest traffic near the entrances to the graveyard and the church.

Plate 8 - View of desire lines and church from southeast.

The safest and most ideally located desire lines could be modified for use as pathways. The grass could be mowed along these lines to allow for easy access to the more popular areas of the graveyard. Alternatively a discrete amount of gravel could be added to the base of the desire lines to improve the

walking surface and in turn identify the desire line as approved pathways. The gravel would prevent further erosion of the soil beneath.

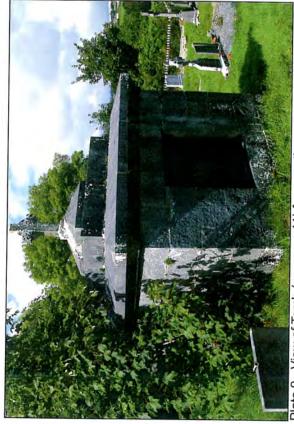
There are three tombs located within the original graveyard (Plate 9). These are all located within the centre of the graveyard towards western half in front of the main entrance. These tombs are all in good condition, with solid doors and of solid construction. Grave No. 035 has a small amount of vegetation growing on it. There is a maturing tree abutting the south side of grave No. 41.

Plate 9 - View of Tomb (grave no.41) from south-east.

The vegetation at grave No. 035 and the tree on the south side of grave No.41 should removed to prevent any future damage to the structures.

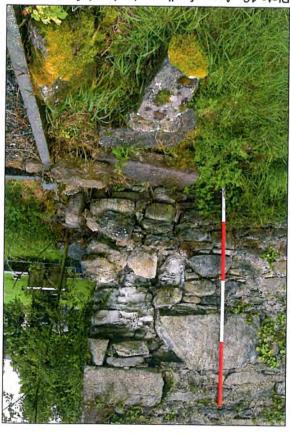
In the northern half of the graveyard stand the ruinous remains of a single-cell single-storey church, built c.1500. The building is of a coursed, roughly dressed rubble stone construction with substantial walls (approx 0.65 metres thick). Lime render can be seen in patches throughout the church with concentrations to the interior and the base of the northern exterior wall (Plate 14). There is vegetation growing in heavy volumes throughout the building with a substantial amount found on the eastern elevation (Plate 15) and large amounts found along parts of the southern and northern walls (Plate 12). It is mainly concentrated in amongst the looser masonry to the upper courses of the walls. The southwest exterior corner has recently deteriorated (Plate 16). Areas of rubble from the church were also surveyed next to the eastern exterior side of the door opening and a substantial pile lies along the interior of the southern wall.

Plate 16 - Area of collapse to church from southwest.

Steps should be taken to secure the ruin from further collapse through the removal of all vegetation from the walls and then re-pointing the structure. The main body of the church appears to be in relatively good condition with just a few sections needing attention. Immediate action should be taken to reinforce the southwest corner that has started to deteriorate as this could swiftly destabilize

the adjoining walls. No more burials should be added to the interior of the church to avoid overcrowding and the possibility of undermining the walls.

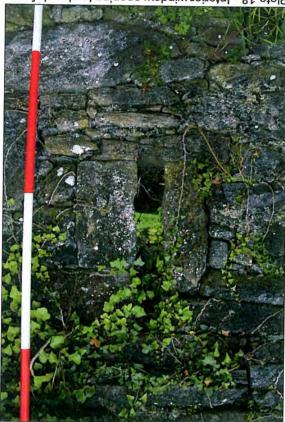
A single thin square-headed window can be seen in the interior, now blocked and having a rubble stone sill, surrounds and lintel (Plate 18). The lower half of another window can be seen at the top of the western wall. A pointed arch door opening is located to the front (south) elevation having roughly dressed rubble stone voussoirs and surround (Plate 17). To the interior lie 18 graves, making use of most of the space within.

Plate 18 - Interior window opening to church from south.
