Project code: KCCG11
Client: Kerry County Council
Date: July 2011

Archaeological Survey of Kilmurry Burial Ground, Cordal, Co. Kerry.

Surveyors: Ann Frykler & Robert Hanbidge
Report Author: Robert Hanbidge

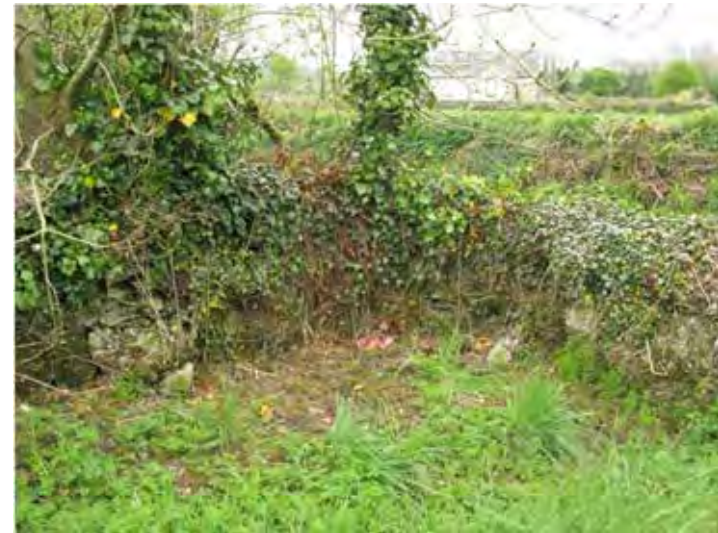
The boundary walls surrounding the graveyard are of roughly dressed mortared rubble stone with roughly dressed rubble stone coping (Plates 1-6). For the most part the walls appear in good structural repair with the only area of concern the south-western corner. Here the rounded corner is in poor condition and is collapsing outwards (towards the road) (Plates 7 and 8). Areas of overgrowth are another area of concern with stretches of the eastern and southern boundaries badly affected. Generally the northern and eastern boundaries are not affected to the same degree with some ivy growth and areas of moss and grass growth beginning to establish within the crevices of the masonry.

Plate 8-Internal detail to south-western corner from northeast

Repair the collapsing section of wall at the south-western corner. This is an immediate area of concern as the wall is leaning towards the roadside.

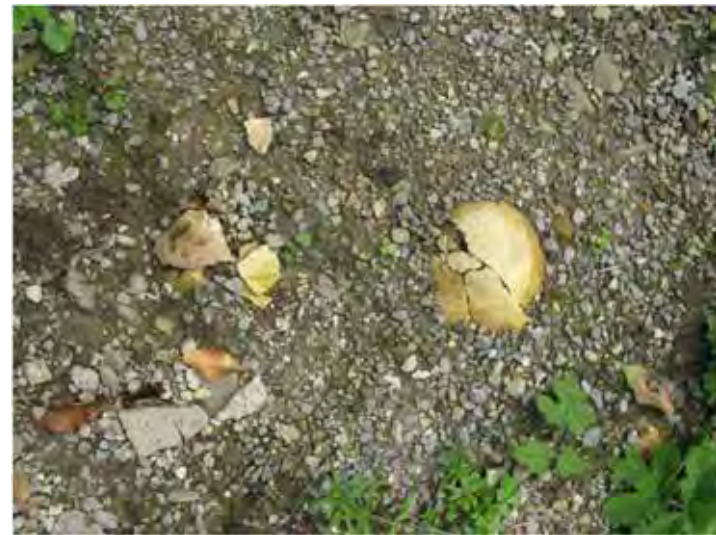
Within the church ruin, some of the burials are disturbed, especially the plot of Grave No. 126 belonging to the Horan Family, which is located in the south-eastern corner of the church ruin (Plate 37). Here the overgrowth has been removed from the church ruin leaving exposed masonry in need of conservation. It also appears that the plot is being prepared for the insertion of a plinth to enclose it, as a concrete foundation has been partially laid. In doing these preparatory works, the ground over this grave has been cleared of excess vegetation and topsoil, and the resulting spoil has been thrown on top of the overgrowth by the eastern wall. Unfortunately it is evident that human remains were uncovered during this work as a number of bones (femurs and smaller long bones) have been deposited along with the spoil on top of the church ruin. Further human remains are visible within the central area of this plot as the craniums of three separate skulls are protruding from the subsoil (Plate 38). The presence of green algae and moss on the bones indicates that they have been exposed for a prolonged period.

Plate 38-Detail to disturbance to Grave No. 126, showing recently exposed human remains

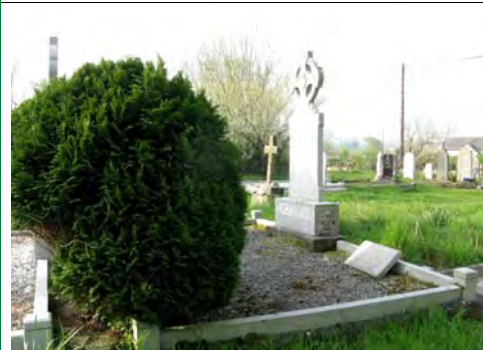
Some plots have trees growing within them which appear to be unmanaged, e.g. Grave No. 6 has two leylandii trees which if left unattended will outgrow the plot and cause disturbance to the headstone and surrounding graves (Plate 34).

Grave_No	Family Name	Photo_Name
6	O'Connor	IMG_0010

Plot in good condition, two large laylandy growing on plot

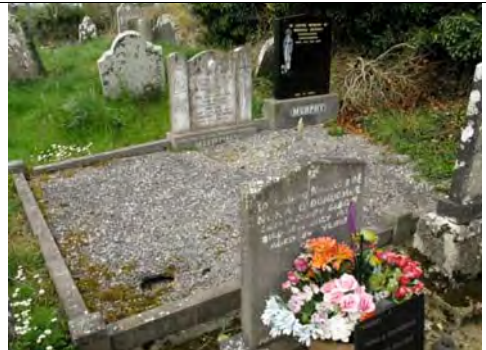
Grave_No	Family Name	Photo_Name
72	Murphy	IMG_0145
Notes		
Plot in moderate condition, concrete underneath gravel is subsiding and holes are visible

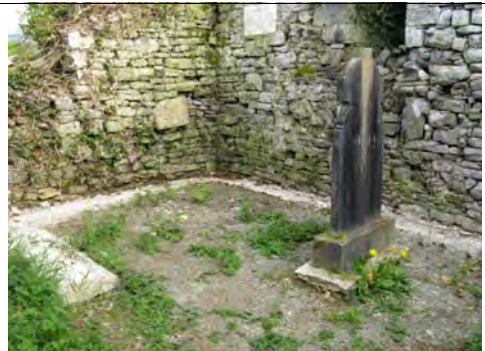
Grave_No	Family Name	Photo_Name
126	Horan	IMG_0251
Notes		
Plot in poor condition, topsoil very thin and in centre 2 skulls are visible

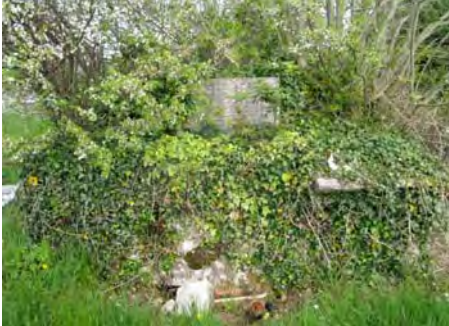
The second unnamed tomb (Grave No. 113) is located in the east of the western terminus of the northern elevation of the church. The tomb is in fair condition and is upstanding; however it is severely overgrown with ivy. A number of trees are also growing out of the tomb and have dislodged some of the masonry (Plate 27). This tomb is inscribed; the plaque is in Irish and appears to be a poetic verse rather than a commemorative plaque to an individual- a date of 1798/1804 indicates the tomb's age (Plate 28). Access to this plaque is partially restricted by tree growth.

Grave_No		Photo_Name
113		IMG_0223
Notes		
From 1798/1809, tomb in moderate condition, overgrown by ivy and trees growing out of it
