Project code: KCCG11
Client: Kerry County Council
Date: June 2011

Archaeological Survey of Derryco Burial Ground, Ballyduff, Tralee, Co. Kerry.

Surveyors: Ann Frykler & Robert Hanbidge
Report Author: Robert Hanbidge

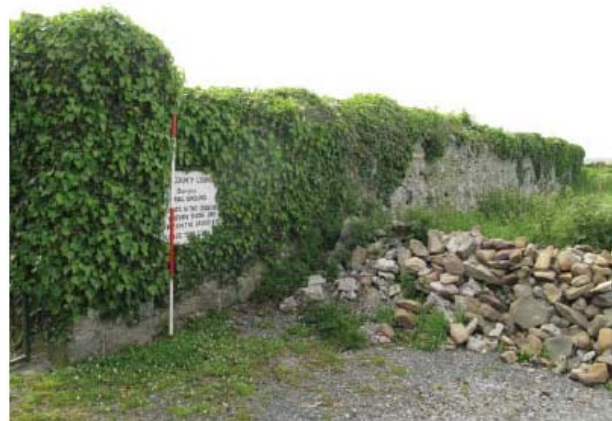
Plate 6 View of eastern boundary wall from south-east.JPG

The graveyard is enclosed by mortared rubblestone walls using locally sourced sandstone and limestone. Surmounting the wall is rubblestone coping. For the most part the north, east and west enclosing walls remain in good condition (Plates 6, 7, 8 & 9) with the exception of a few small areas where some stones are missing from the coping. However much of these walls are overgrown with ivy which could be covering other defects within the wall (Plates 6 & 7). The ivy growth has been assisted by the application of herbicide sprays which have removed any weed or lichen growth, leaving the area open for colonisation by ivy. It appears that the majority of the ivy growth has been monitored and managed as it has been cut low and tight to the wall, although substantial ivy overgrowth does still remain in the south-western corner of the graveyard. Some holes are visible in the external elevations of these boundary walls where stones have fallen out

Restore the damaged areas of the coping and external elevations using suitable locally sourced stone and using correct (lime) mortars with flush or recessed pointing, which are sympathetic to the historic character of the walls.

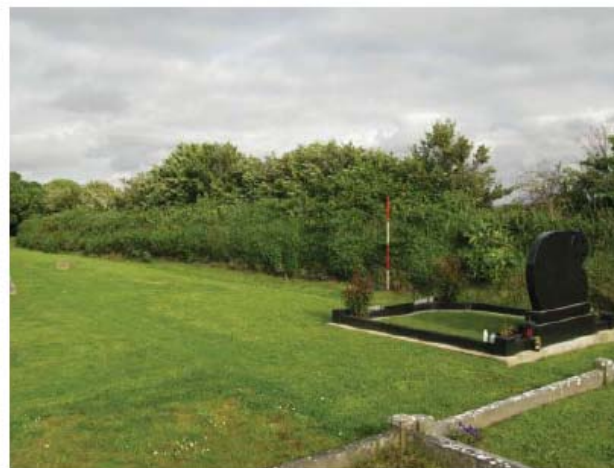
Plate 10 Interior view of southern boundary from northwest.JPG

The boundary wall to the south differs to that elsewhere in that it consists of drystone facing to an earthen bank surmounted by a hedgerow (Plate 10). This boundary is quite overgrown with grass and shrub growth with only small patches of the drystone facing visible. Root activity and soil movement within the earthen bank has had a detrimental effect on the drystone masonry. Disturbed stones appear not to be replaced and have been recently discarded. A large tree positioned in the south-eastern corner of the graveyard adjacent the stile and entrance obscures the intersection between this southern boundary and the mortared eastern boundary wall. This specific corner is also used as a dumping area for mown grass clippings and as a collection area for discarded rubbish (Plate 11) which includes a removed wooden gravemarker (Plate 12).

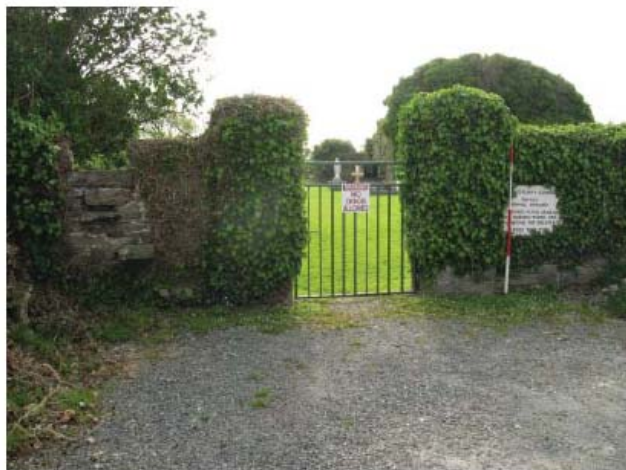
Plate 13 View of entrance from east.JPG

There is only pedestrian access to this graveyard from the car park area to the east (Plates 13 & 14). The entrance comprises of a pair of square-profile dressed limestone gate piers with rubblestone coping and a recent single-leaf wrought-iron gate. Both piers appear in good condition but are unfortunately completely covered by ivy. The gate, although maintained and painted, is in fair condition. However the structural integrity of this gate will quickly deteriorate as the metal is quite thin and has almost rusted through from the inside.

Some improvements should be made to the entrance which will greatly enhance the character of the graveyard. The covering ivy growth to the piers should be removed. As an entrance feature, gate piers often display fine stone work which form an essential element to the historic appeal of the associated graveyard as they are often the first and last feature which people see entering and leaving a graveyard. Provisions should be made for the future replacement of the entrance gate. Consideration should be given to obtaining a gate that will be a design sympathetic to the historic character of the graveyard.

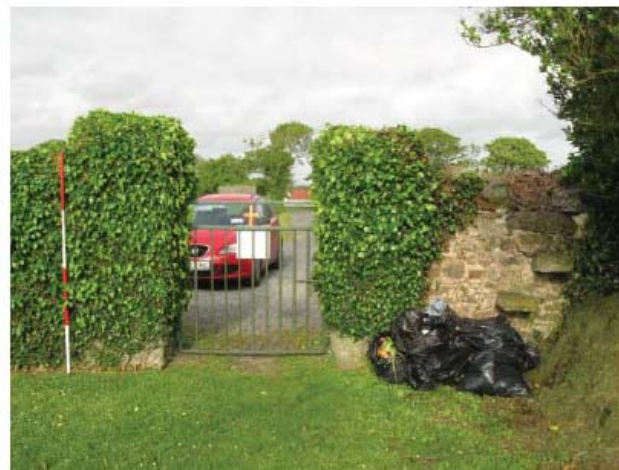
Plate 14 Interior view of entrance from west.JPG

A secondary method of entry is provided by the stone stile to the south of the entrance. This stile consists of a recess within the vertical coping to the boundary wall formed by a large horizontally bedded stone. Projecting stones from the wall to both the interior and exterior elevations form steps up the wall. For the most part the stile remains in good condition overall with the only exception been to the exterior side where the bottom step has been broken making the stile unsafe to use. Further obstructions caused by the recent dumping/collection of rubbish and grass clippings to the interior make entering and exiting the stile extremely unsafe.

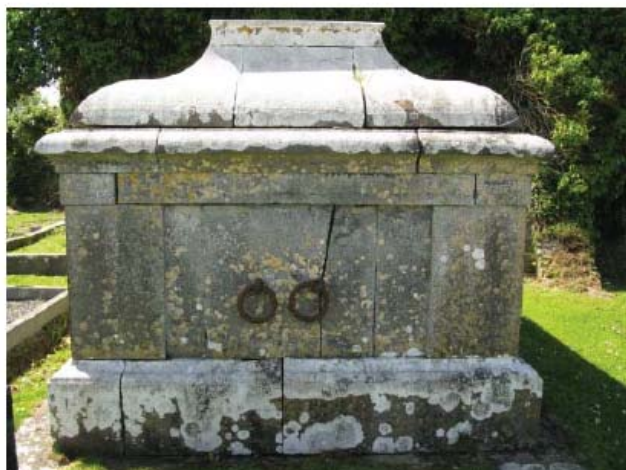
Plate 15 Front (east) elevation of tomb (Grave No. 15).JPG

Grave No. 15 is the eastern most tomb, has a rectangular shape in plan and follows a neo-Classical design with recessed panels flanked by pilasters to the sides and surmounted by an architrave, moulded cornice and an ogee-curved hipped roof (Plate 15). Finely constructed utilising high quality tooled limestone, the tomb is in very good condition. However some settling of the foundations is causing some of the joints to part and a crack to form in the entrance slab (Plate 15).

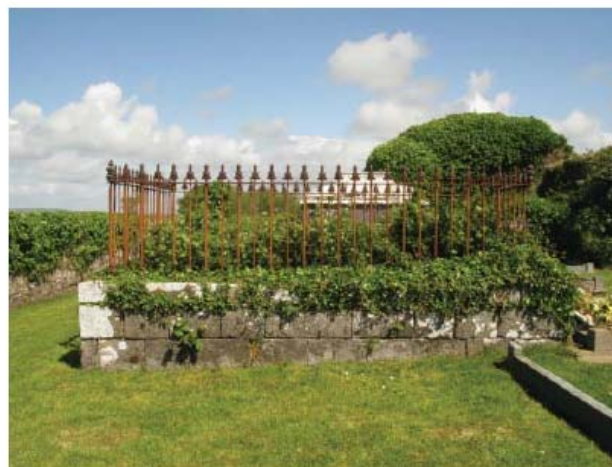
Plate 18 View of overgrown plot (Grave No. 43) with cast-iron railing, from west.JPG

There are 2 unnamed plots at Derryco Burial Ground (Grave Nos. 43 & 55). The first, Grave No. 43 is an enclosed plot which is located in the north-western quadrant of the graveyard and consists of ashlar tooled limestone plinth surmounted by cast-iron railing. Unfortunately, the internal area of this plot along with areas of the plinth walls and railing, are overgrown with ivy which is forcing the bedding planes in the masonry to part (Plate 18). The railing survives in fair condition with only surface rust and a loose entrance gate being the only major concern here. No headstone or inscriptions were visible with the possibility of these being hidden by the overgrowth.

Removal of the overgrowth to Grave No. 43, the application of a suitable rust inhibitor and painting of the cast-iron railing will enhance and preserve the railing. With the removal of the ivy, repointing of the bedding plains will be required to the plinth walls to stabilise structural integrity.

- Removal of vegetative overgrowth to Grave No. 43 would allow for a full assessment of the plot's condition and would facilitate restoration of the plot.

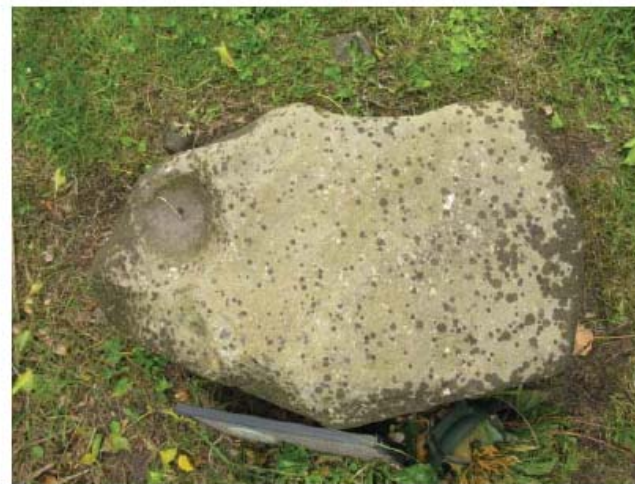
Plate 34 View of fontbullaun within boulder, from east.JPG

An unrecorded font/bullaun stone was found immediately to the north of the north elevation of the church ruins beside Grave No. 55 (Plates 34 & 35). The font/bullaun is located close to the western edge of a large irregular-shaped boulder and has a diameter of approximately 25 cm and a depth of c. 8 cm. The boulder appears to have been moved to its current location so the original provenience is unknown this position.

- The Record of Monuments and Places (RMP) should be updated with the recently found font/bullaun stone.
- The publications: *Guidance for the Care, Conservation & Recording of Historic Graveyards* by the Heritage Council (October 2010). And *The Care and Conservation of Graveyards* by the Office of Public Works should be consulted prior to the carrying out of any maintenance work on the burial grounds or church.

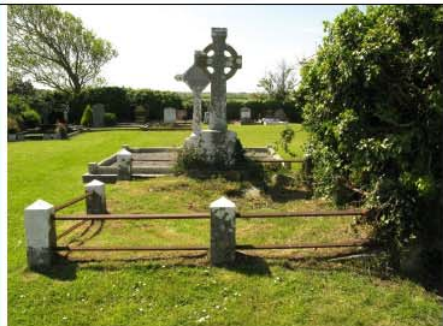
Grave_No	Family Name	Photo_Name
22	Joyce	IMG_0045
Notes		
Plot in moderate condition, subsiding and broken and corroded wrought iron railings

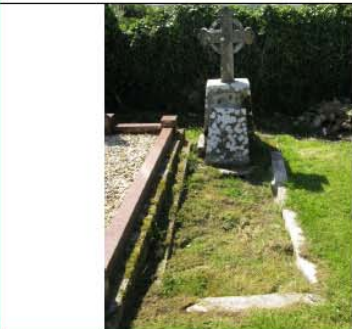
Grave_No	Family Name	Photo_Name
34	Sullivan	IMG_0067
Notes		
Plot in moderate condition, subsiding, headstone broken

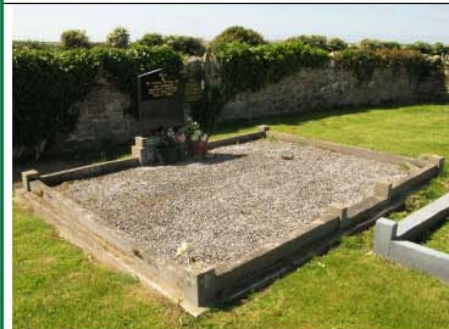
Grave_No	Family Name	Photo_Name
37	Horgan	IMG_0073
Notes		
Plot in good condition, headstone moderate, gold writing is flaking

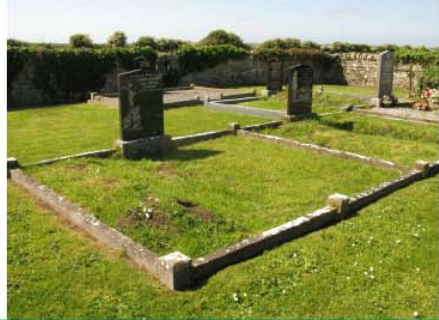
Grave_No	Family Name	Photo_Name
40	Stack	IMG_0079
Notes		
Grass covered plot in moderate condition subsiding

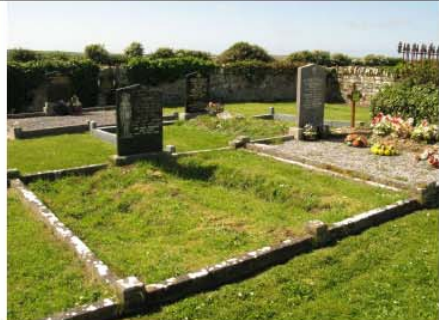
Grave_No	Family Name	Photo_Name
41	Stack	IMG_0081
Notes		
Grass covered plot in moderate condition, subsiding

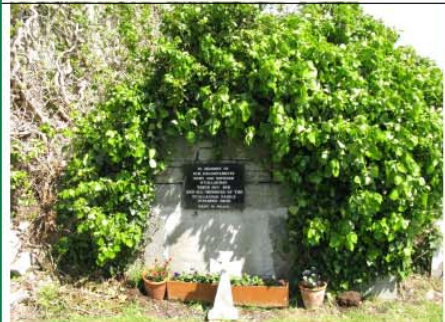
Grave No. 21, positioned adjacent the southern elevation of the church, is a more modestly constructed tomb with dressed rubble limestone walls having tooled limestone quoins rising to a hipped roof. The tomb is in moderate condition but is severely overgrown by ivy.

Grave_No	Family Name	Photo_Name
21	O'Callaghan	IMG_0043
Notes		
Tomb in moderate condition, overgrown

Generally the majority of the tombs are in good condition with the exception of Grave No. 21 which urgently requires repointing to ensure the tomb remains structurally intact. Excessive areas of ivy growth to this tomb (Grave No. 21) along with tombs (Grave Nos. 46, 49 & 50) should be managed and ideally removed, especially in regard to Grave No. 21 which would facilitate full access for maintenance works. Repointing is also required to some of the other tombs where some movement of the foundations has occurred causing some joints to part. Repointing is also required to the walls of Grave No. 50. Such work would involve the re-pointing of the walls using correct (lime) mortars with flush or recessed pointing which are sympathetic to the historic character of the church. Ribbon pointing must be avoided as its use would damage the structures historic character.

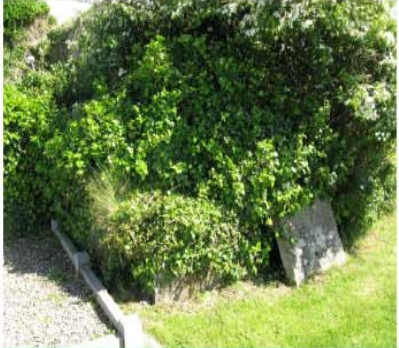
A single unnamed tomb (Grave No. 47) was located immediately to the south of the named tomb (Grave No. 46). The tomb has a rectangular shape in plan and is constructed in tooled limestone. It is in poor condition and has suffered a partial, if not full collapse of the roof along with and part of the walls. Subsequently the tomb is not maintained and is very overgrown with ivy and grass, and has a

Grave_No		Photo_Name
47		IMG_0101
Notes		
Heavily overgrown tomb in moderate condition

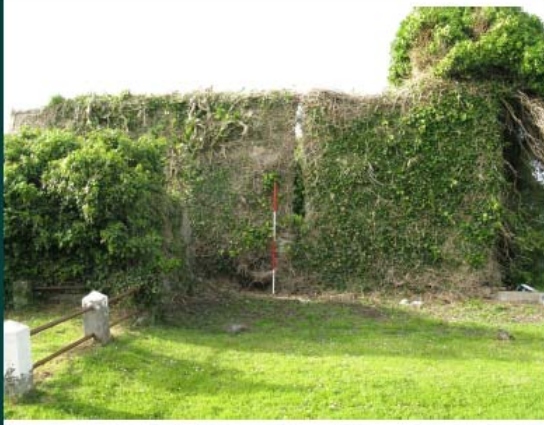
Misc_Item_No	Photo_Name
2	IMG_0141
Notes Remains of church ruin, only the east gable and part of the north and south walls remain, the western edges of the south and north walls have been rendered rounded, probably to prevent further collapse and destruction of the walls, one window is still visible and intact on the east church wall and one on the south wall, a small recess on the south walls interior in the east could be associated with a piscina
