Project code: KCCG11
Client: Kerry County Council
Date: July 2011

Archaeological Survey of Murher, Moyvane, County Kerry

Surveyors: Ann Frykler & Robert Hanbidge
Report Author: Robert Hanbidge

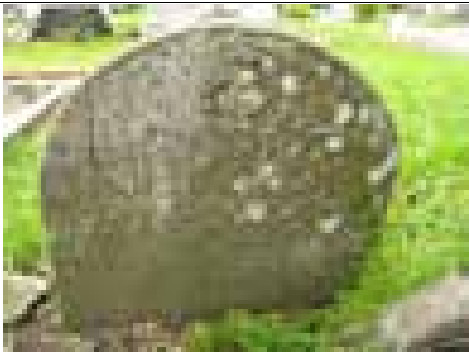
Grave_No	Family Name	Photo_Name
67	Barrett	IMG_0131
Notes		
Headstone from 1800 in good condition

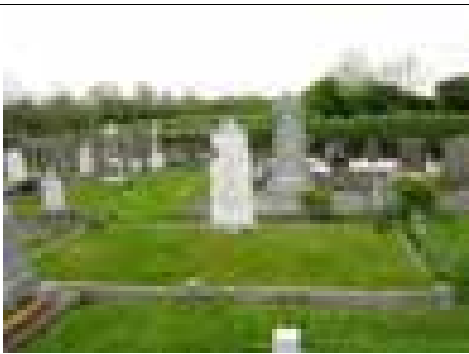
Grave_No	Family Name	Photo_Name
38	Buckley	IMG_0075
Notes		
Plot in good condition covered by grass, maintained at a low level

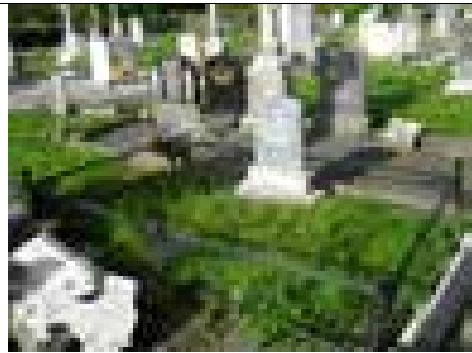
Grave_No	Family Name	Photo_Name
113	Connolly	IMG_0222
Notes		
Plot in moderate condition, fence in cast and wrought iron

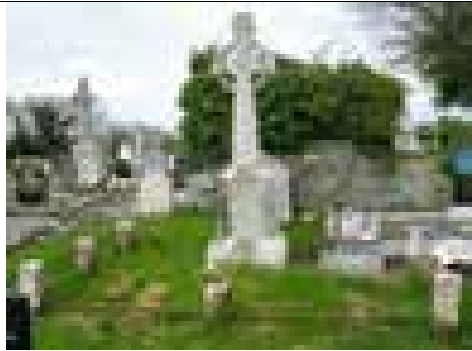
Grave_No	Family Name	Photo_Name
131	Dore/O'Connor	IMG_0262
Notes		
Overgrown plot in moderate condition

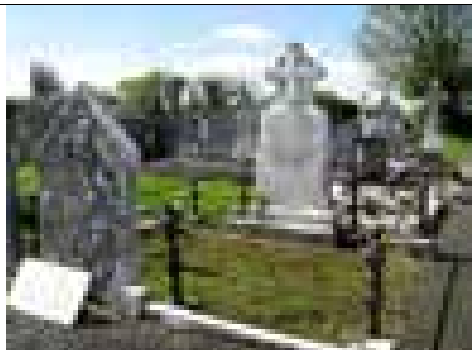
Grave_No	Family Name	Photo_Name
187	Fitzmaurice	IMG_0413
Notes		
Plot in moderate condition

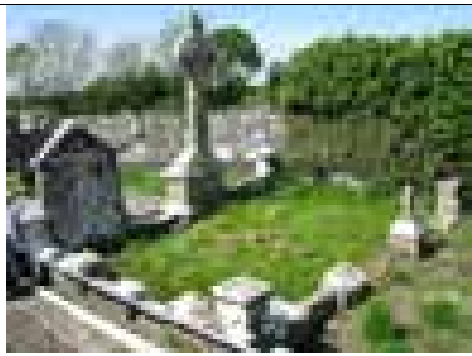
Grave_No	Family Name	Photo_Name
202	Kennelly	IMG_0451
Notes		
Plot in moderate condition, southern headstone heavily weathered from 1851

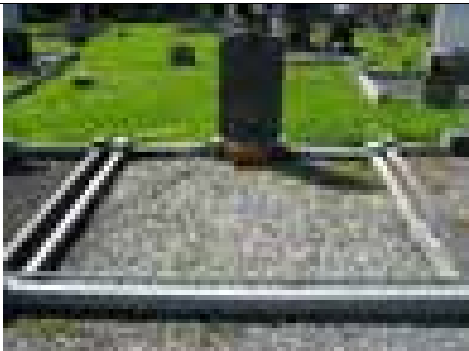
Grave_No	Family Name	Photo_Name
83	Mulvihill	IMG_0160
Notes		
Plot in moderate condition, concrete cracked and subsiding

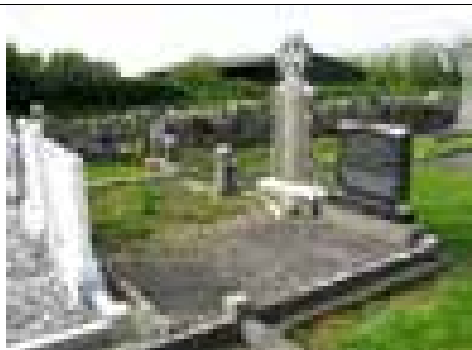
Grave_No	Family Name	Photo_Name
140	Mulvihill	IMG_0282
Notes		
Plot in partly poor condition, half has been sprayed other half covered with gravel

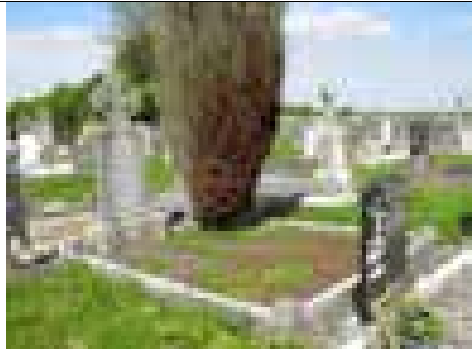
Grave_No	Family Name	Photo_Name
160	Mulvihill	IMG_0326
Notes		
Plot in good condition, some weeds growing and a dead yew tree

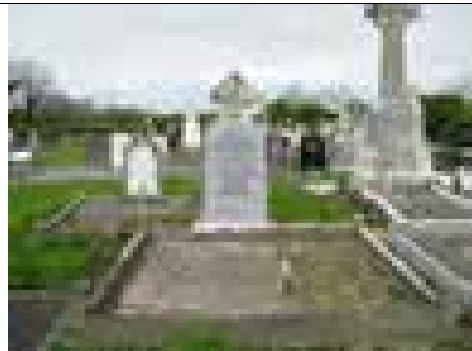
Grave_No	Family Name	Photo_Name
119	O'Connor	IMG_0235
Notes		
Plot in moderate condition, concrete partly removed from plot

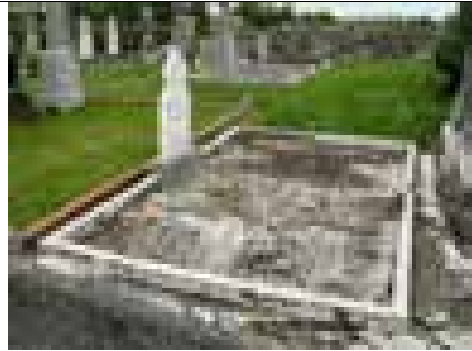
Grave_No	Family Name	Photo_Name
50	Sandes	IMG_0101
Notes		
Plot in moderate condition, concrete subsiding and moss growth

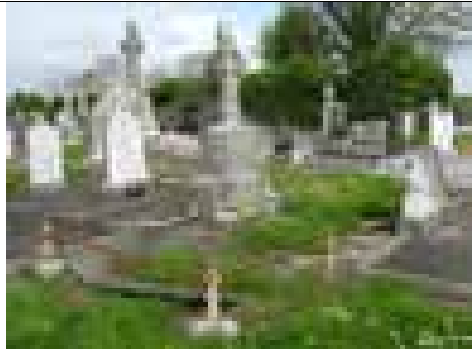
Grave_No	Family Name	Photo_Name
135	Scanlan	IMG_0274
Notes		
Plot in poor condition, wrought iron fence broken and covering stone slabs broken and subsiding

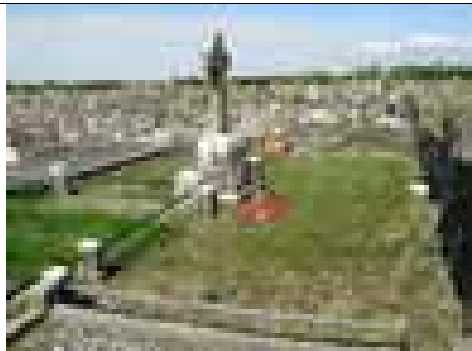
Grave_No	Family Name	Photo_Name
190	Scanlan	IMG_0418
Notes		
Plot in moderate condition

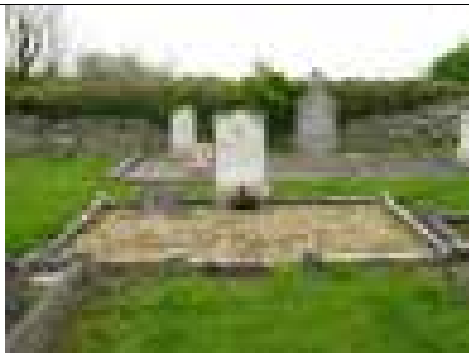
Grave_No	Family Name	Photo_Name
24	Thornton	IMG_0041
Notes		
Plot in moderate condition flint based plot gravel, subsiding in centre

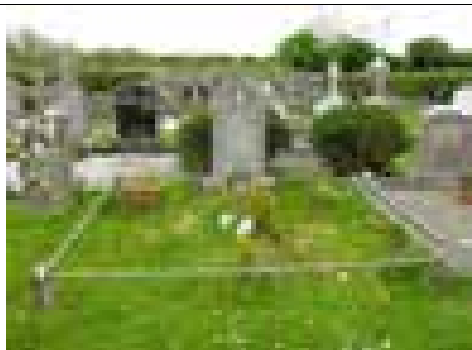
Grave_No	Family Name	Photo_Name
40	Walshe	IMG_0079
Notes		
Plot in moderate condition, subsiding and slightly overgrown
