Appropriate Assessment Screening – Ballynamona Upper Bridge, Co. Kerry

NRA Programme of Bridge Rehabilitation Works, Counties Cork, Clare and Kerry

Client:	Transport Infrastructure Ireland/ Kerry County Council
Project Title:	Kerry, Cork and Clare Bridge rehabilitations, 2016
Document Title:	Appropriate Assessment Screening – Ballynamona Upper Bridge, Co. Kerry
Document No:	MCT0668Rp002eP02

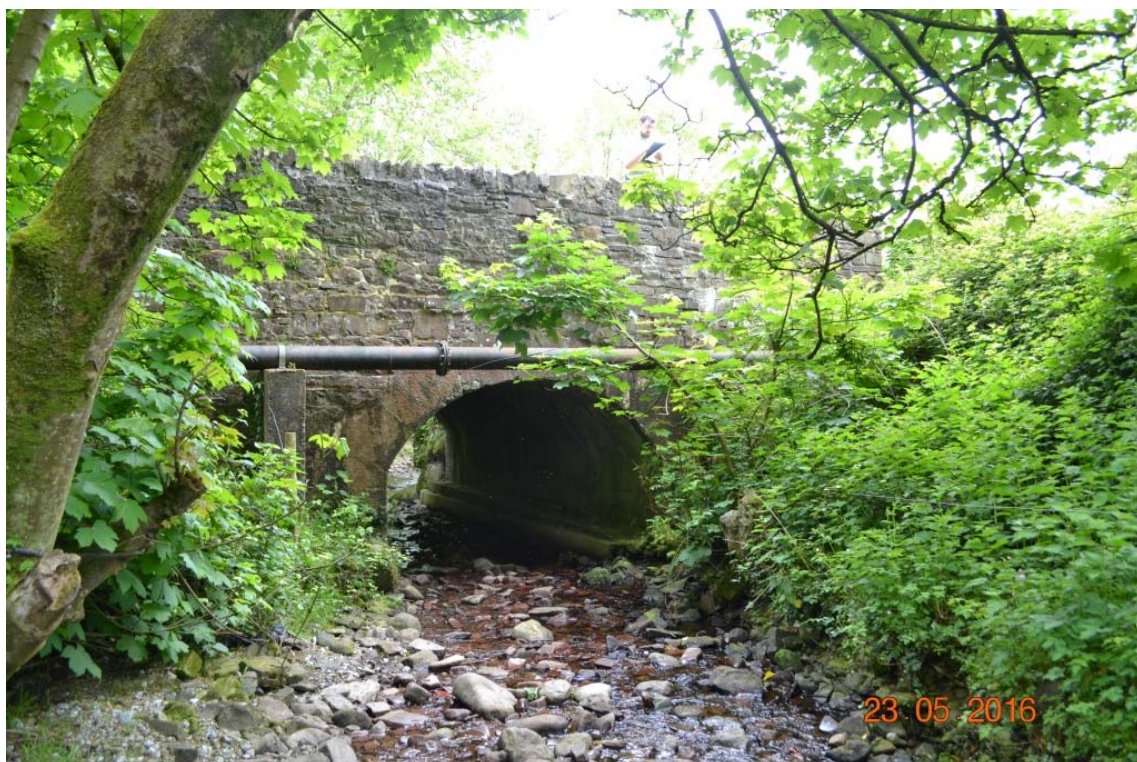
Figure 1.1: Photograph of Ballynamona Upper Bridge

The Bridge carries the N70 over a tributary of River Maine. This tributary is referred to as the Cloghleagh Stream by the EPA (<http://gis.epa.ie/Envision>). It is a single span structure with a clear span of 3m located on the N70, approximately 3km north of Castlemaine, County Kerry (see **Figure 1.1**). The nearest European Site is the Slieve Mish Mountains SAC, which is located 1.4km to the north and west of the Bridge. The location of the Bridge is illustrated in **Figure 2.2**.

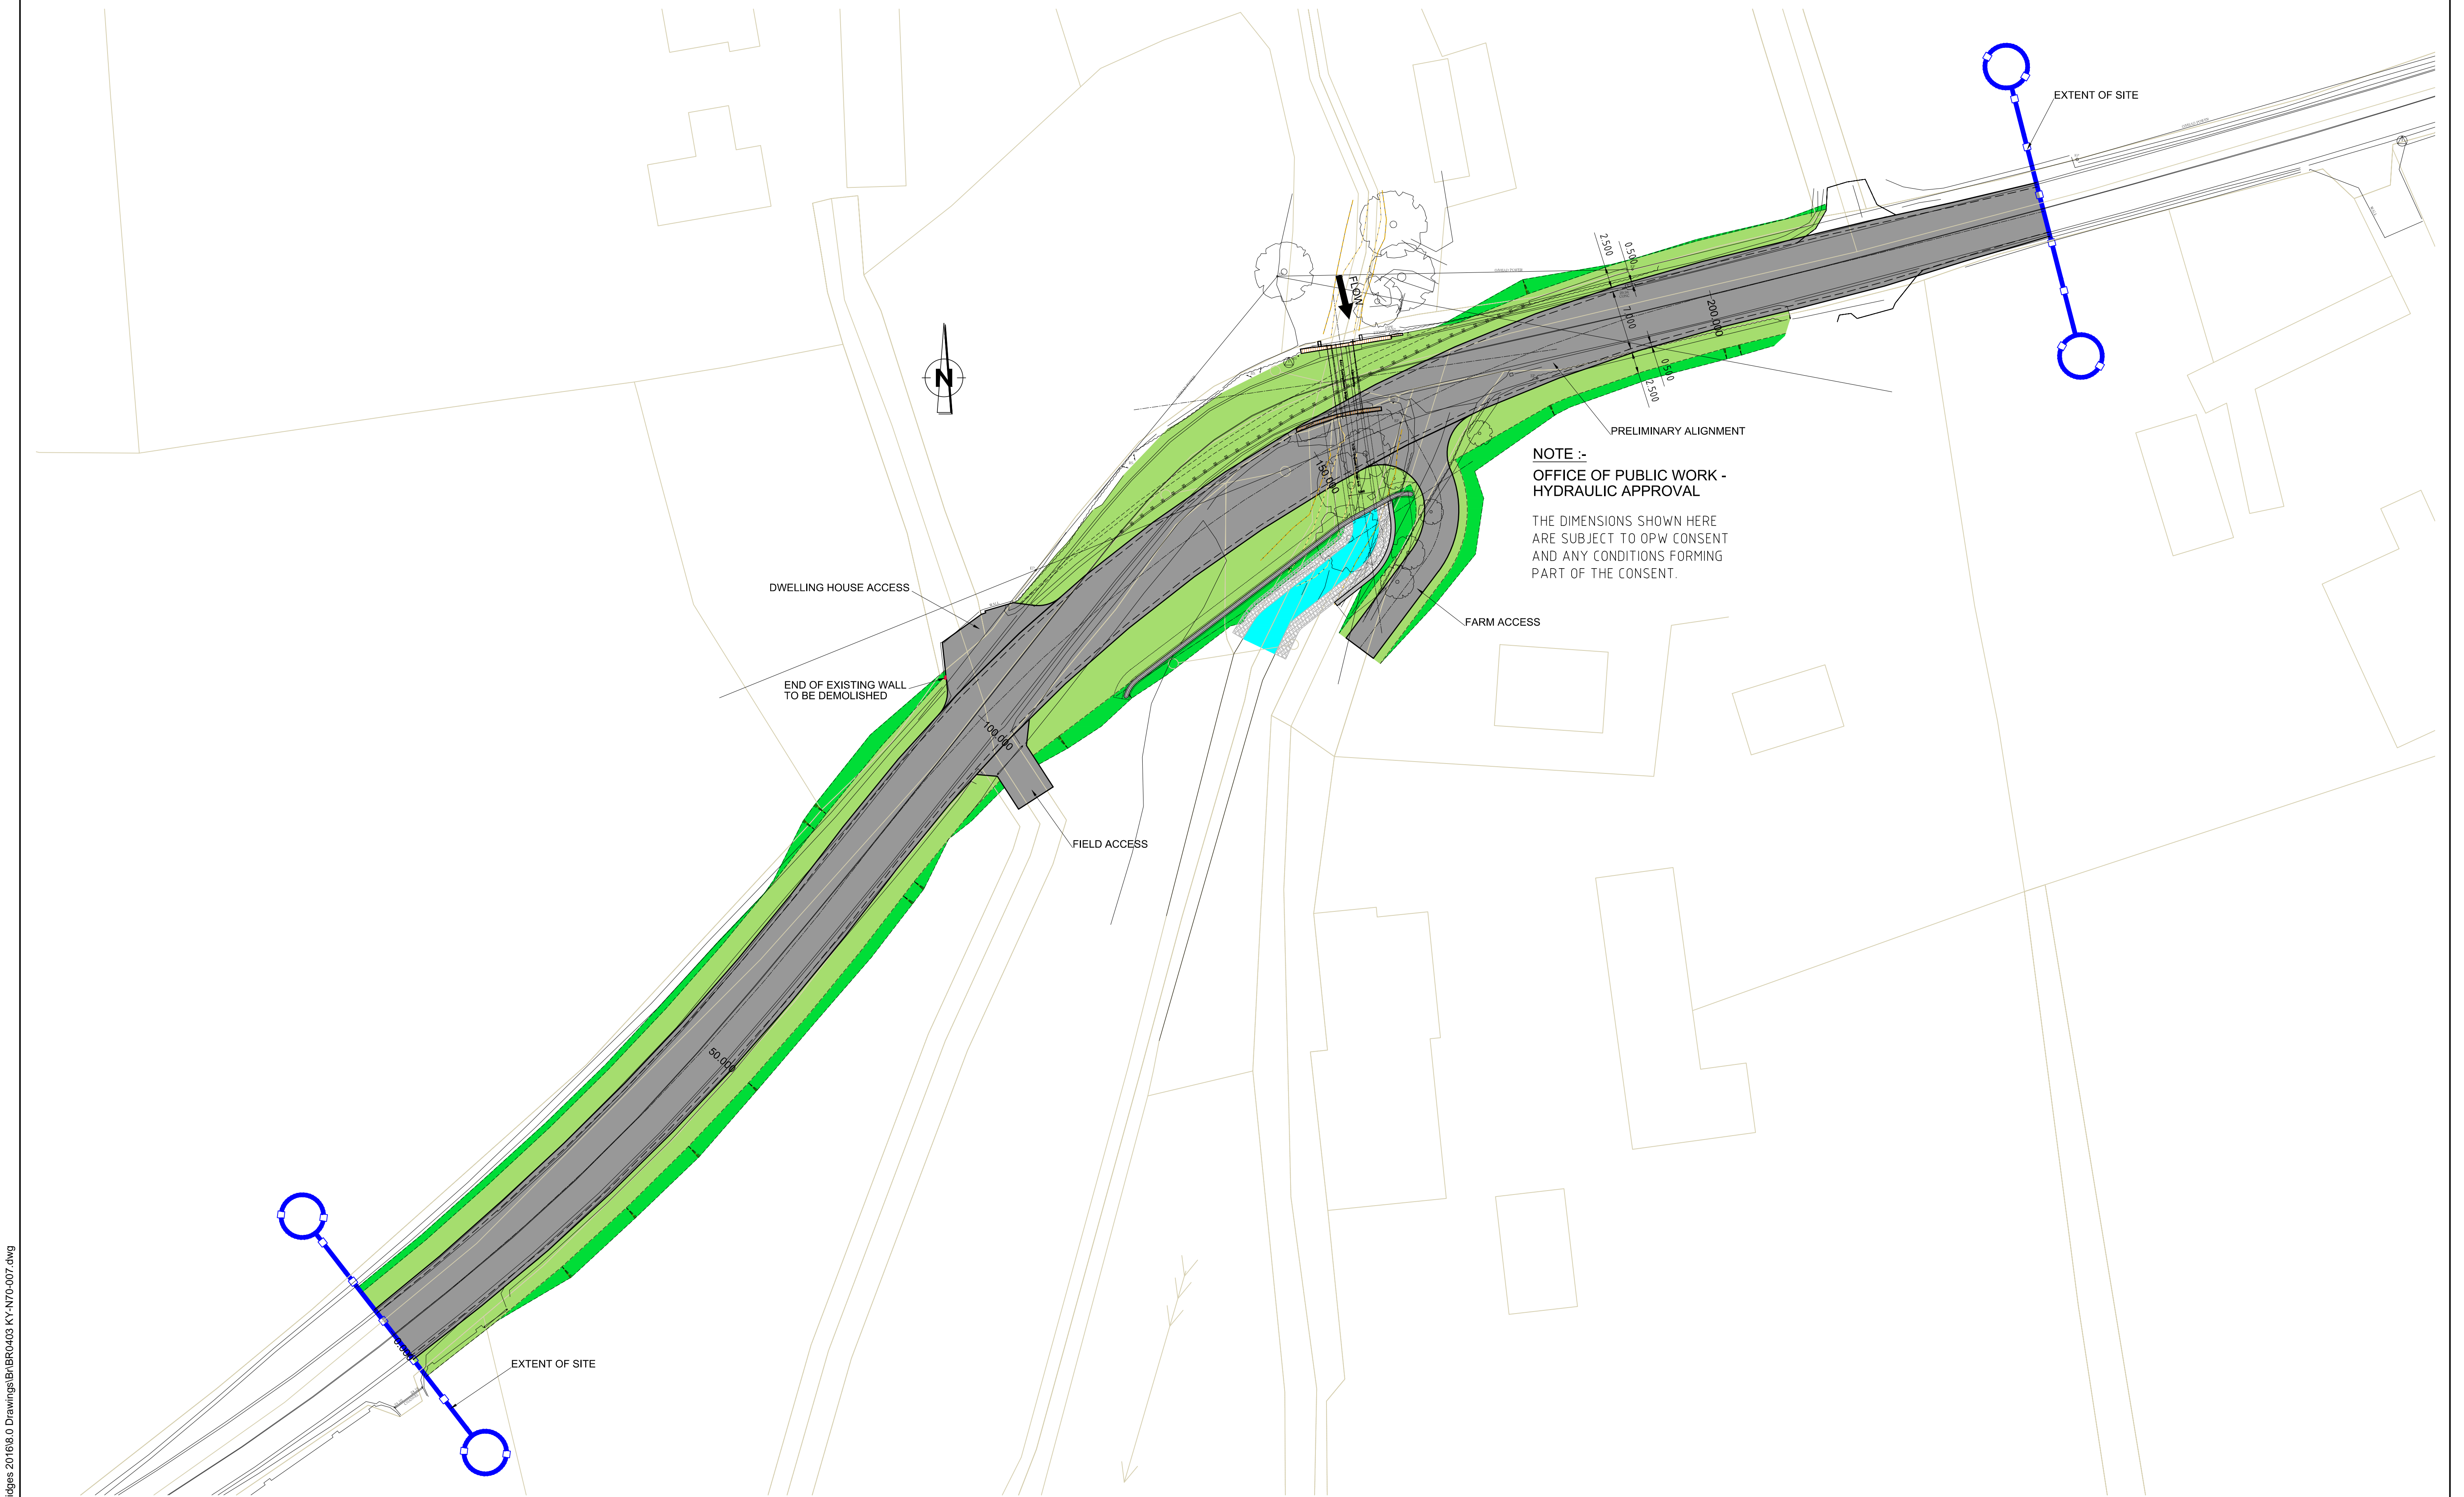
PLAN LAYOUT - OVERALL SCHEME
(Scale 1 : 350)

Project	Eirspan TO 269 Kerry, Cork & Clare Bridge Rehabilitation Works 2016
Title	ST4 Ballynamona Upper Bridge KY-N70-007 Bridge Location
File Ref.	MCT0668BR0007.dwg
Drg. No.	BR0007b
Rev	P02

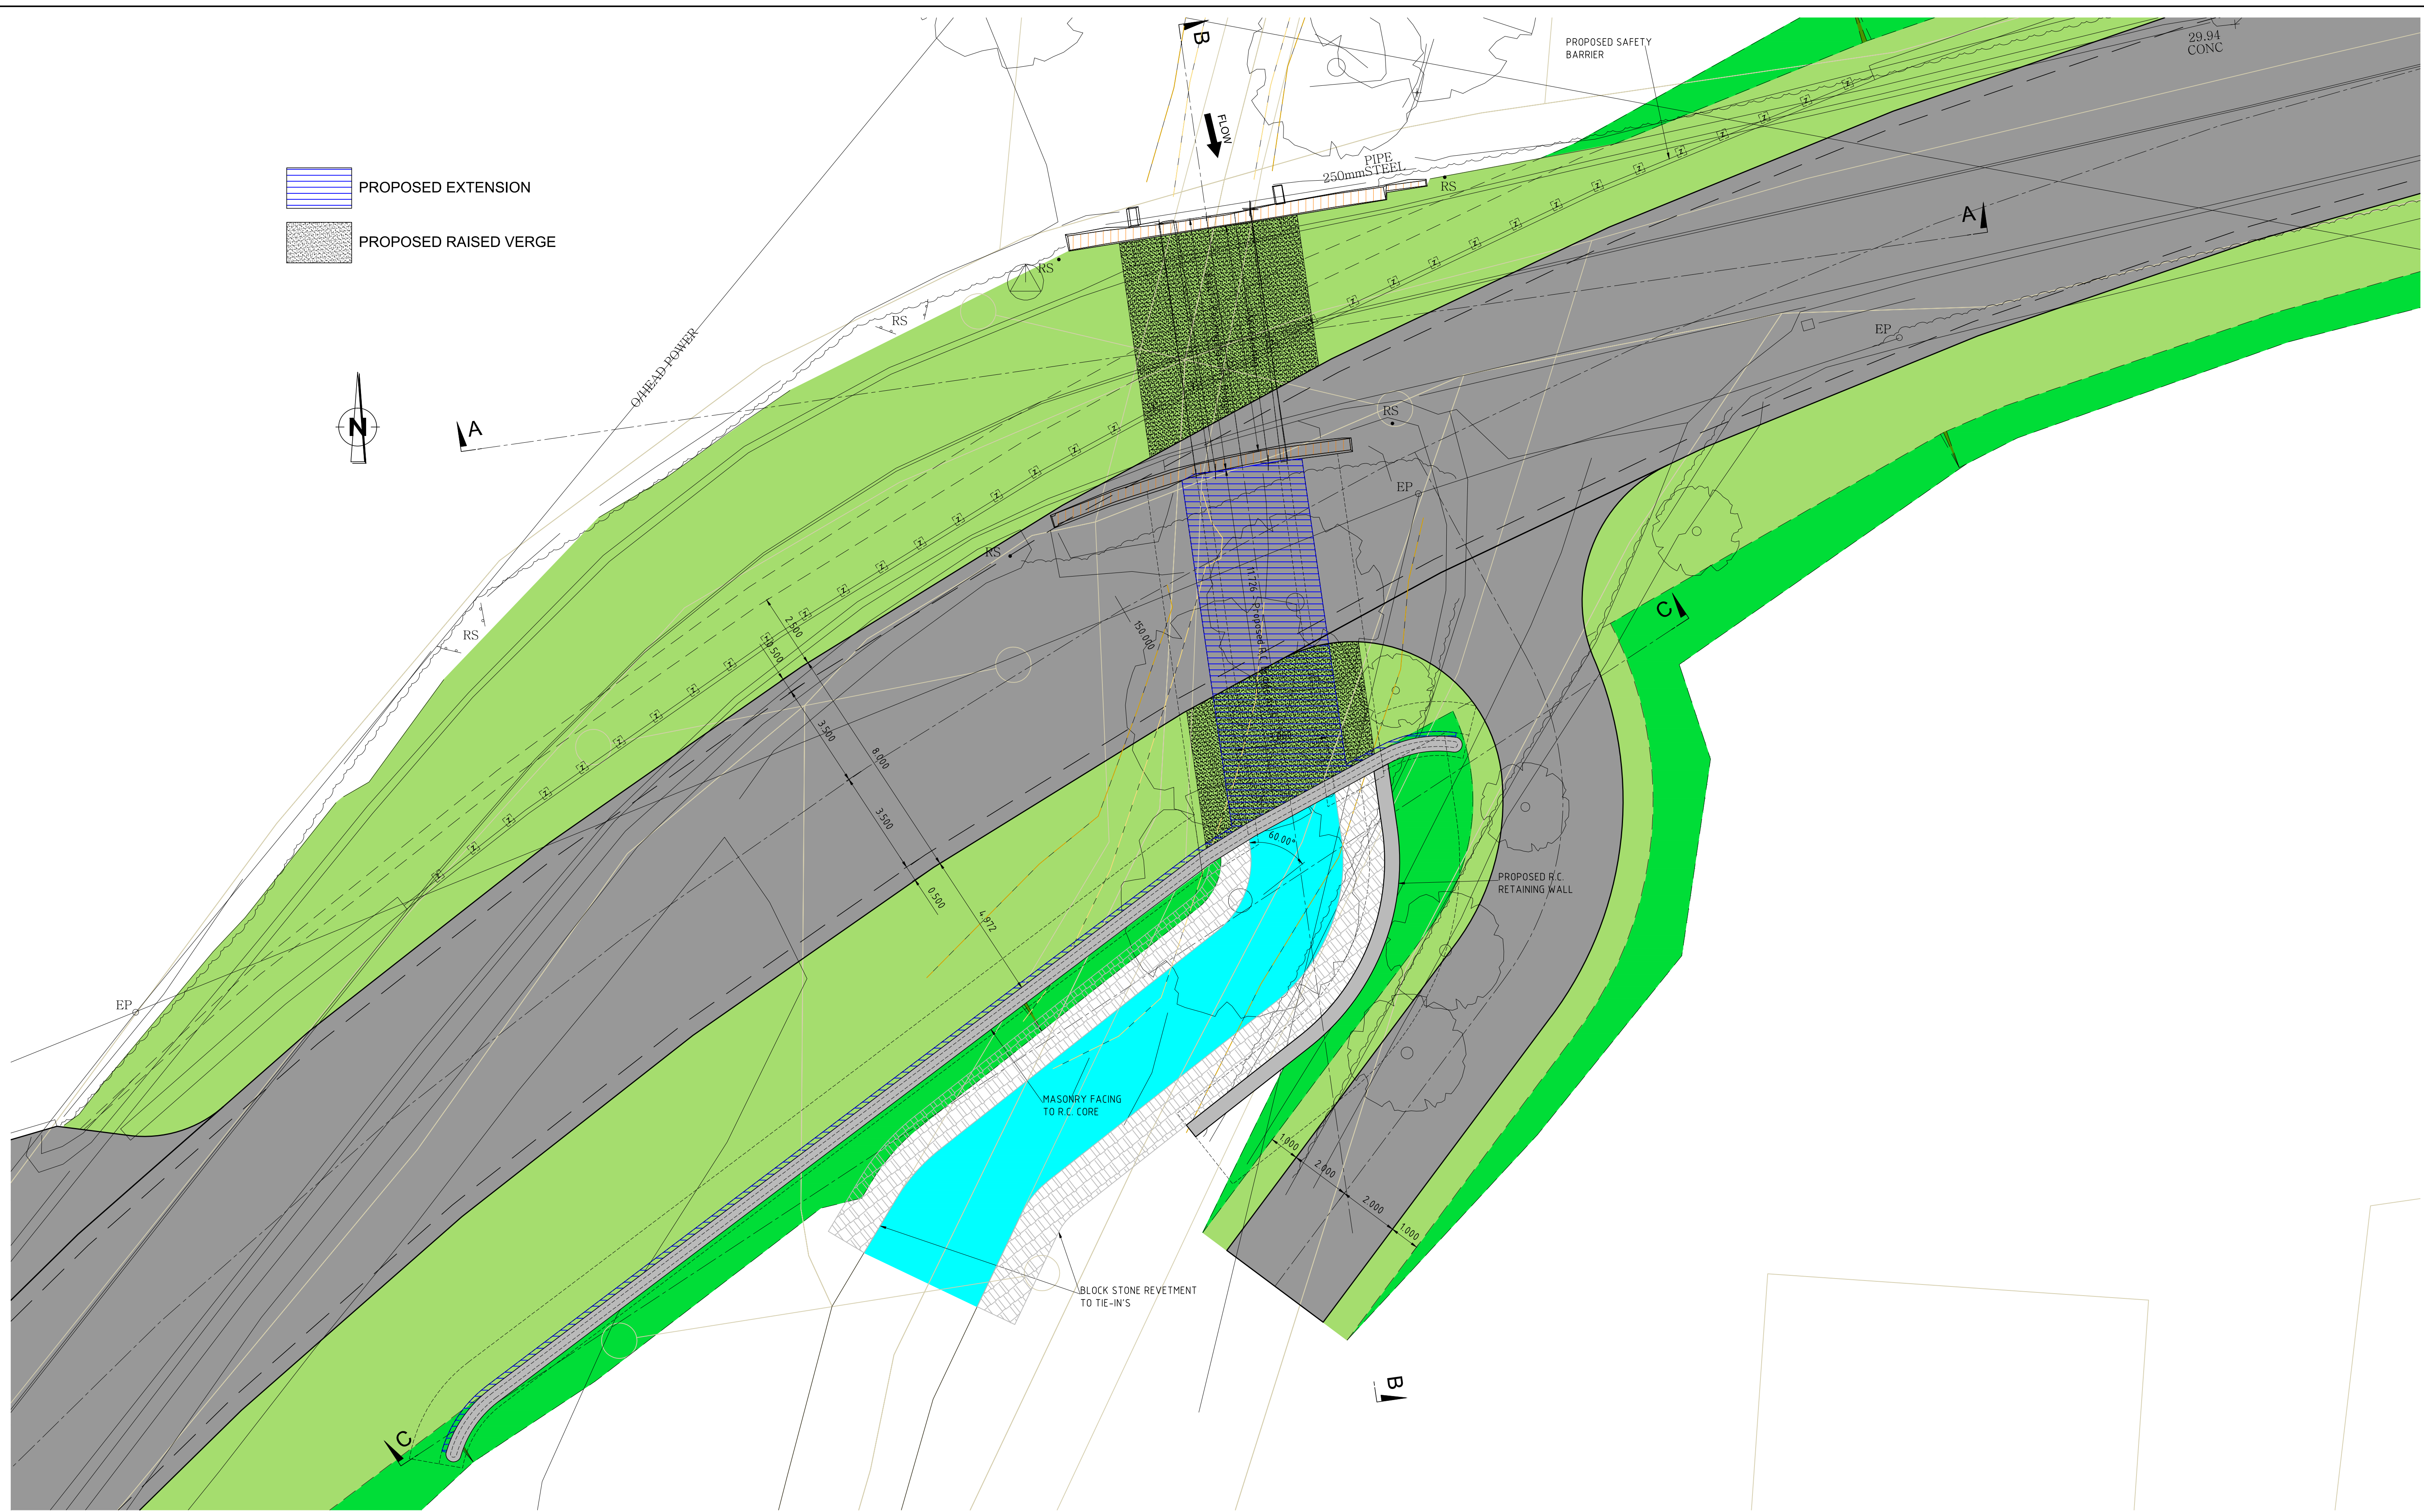
PLAN LAYOUT
(Scale 1 : 100)

Project	Eirspan TO 269 Kerry, Cork & Clare Bridge Rehabilitation Works 2016
Title	ST4 Ballynamona Upper Bridge KY-N70-007 Proposed Overall Layout
File Ref.	BR0403 KY-N70-007.dwg
Drg. No.	BR0403
Rev	P02

PROPOSED EXTENSION
PROPOSED RAISED VERGE

- Provision of traffic management including a bailey bridge, site clearance and erection of contractor's compound;
- Earthworks (import and export of fill materials) for the construction of the widened road base and embankments;
- Provision of water management: the existing river shall be dammed and flumed to allow the foundations for the bridge extension to be constructed;
- Excavation for the new bridge foundations;
- Construction of new in-situ concrete bridge foundations, abutments and bridge deck;
- Application of bridge deck waterproofing and installation of new bridge parapets and safety barrier;
- Masonry cladding to the widened reinforced concrete section;

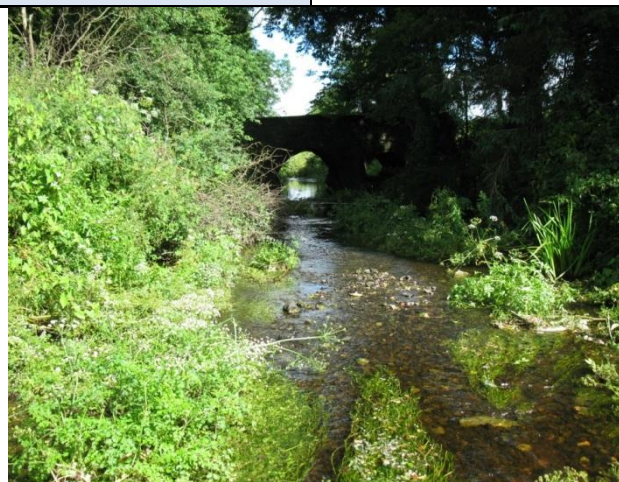
Plate 9: View d/s towards Dysert Bridge showing braided gravelly channel suitable as with *Ranunculus* and *Oenanthe crocata*. Suitable salmonid nursery habitat. (15/07/2016)

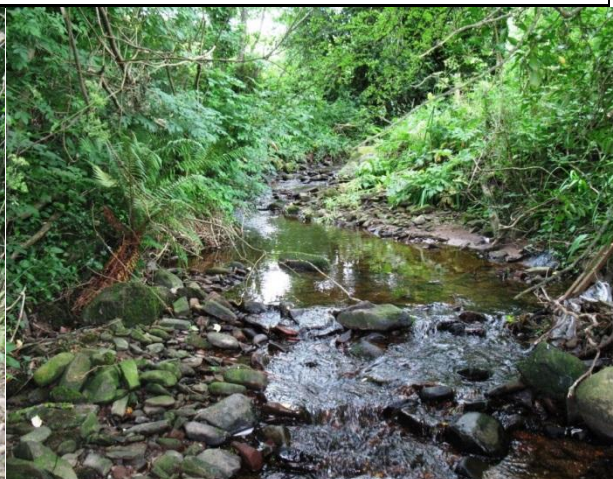
Plate 12: Typical habitat of the stream where a juvenile trout was captured (15/07/2016).

An aquatic ecology survey conducted at Ballynamona Upper Bridge in July 2016 found that the Cloghleagh Stream is a small, fairly low volume stream that may support trout downstream of the bridge. It is too small and unstable for salmon and generally lacks silt deposits suitable for lamprey nursery, although brook lamprey (*Lampetra planeri*) cannot be ruled out. The stream is currently affected by milking cows accessing regularly therefore habitat around the bridge itself is not highly suitable, even for trout. There is a risk of indirect impact to aquatic habitats downstream of the bridge as a result of construction activities, as detailed in **Table 3.2**.

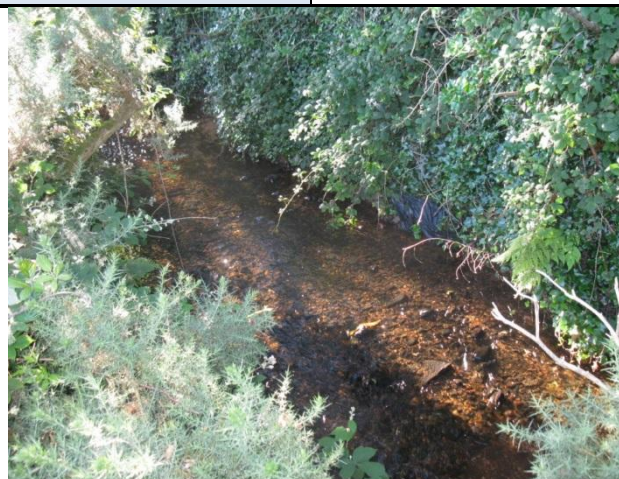
Plate 19: Typical habitat d/s of Enrights Bridge showing pebble/gravel substrates and riffle/run nature which has recovered within the historically realigned and deepened channel (14/07/2016)

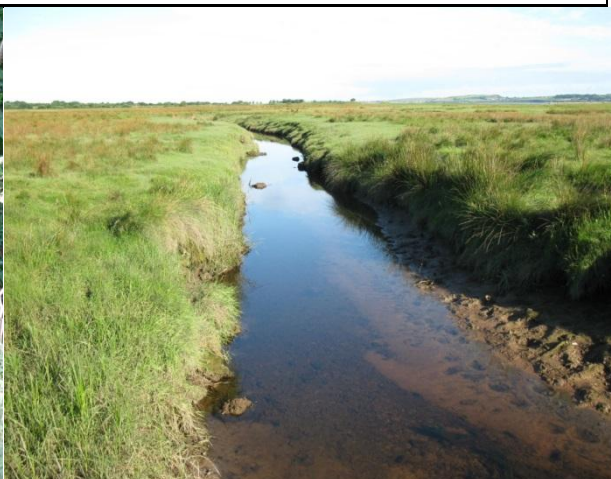
Plate 20: View downstream from c300m d/s of the bridge showing estuarine nature of the streams tidal head (14/07/2016)

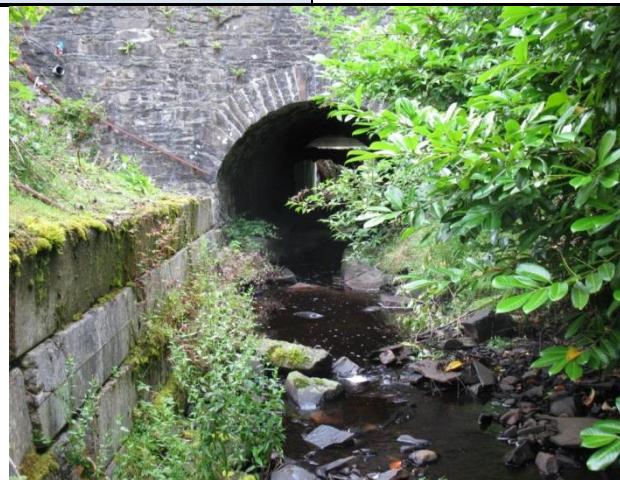
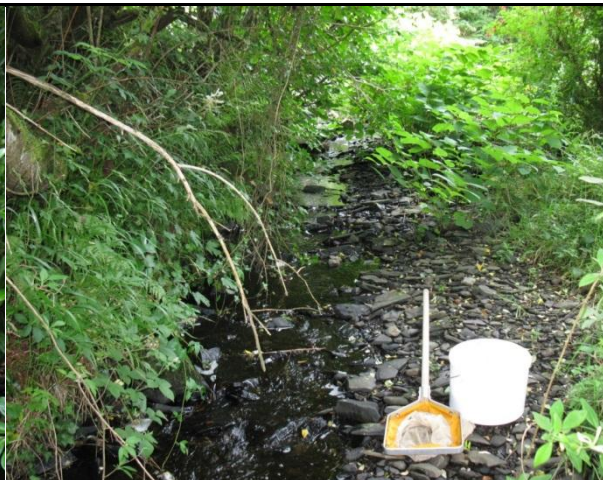
Plate 27: View of Liscasey Bridge East looking u/s showing cobbly substrates and bank reinforcement (22/07/2016)	Plate 28: Channel d/s of the weir showing typical riffle/run nature of stream over cobble/pebble/gravel substrates (22/07/2016)

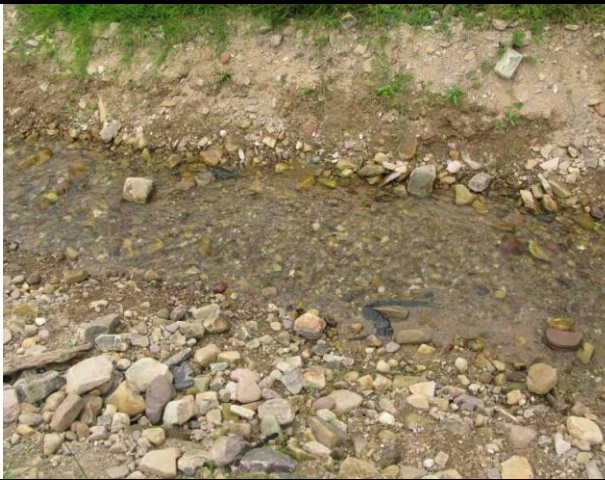
Plate 33: View u/s to bridge (26/07/2016)		Plate 34: Cleared and straightened stretch (26/07/2016)
