Appropriate Assessment Screening – Beheenagh Bridge, Co. Kerry

TII Programme of Bridge Rehabilitation Works, Counties, Cork, Clare and Kerry

Client:	Transport Infrastructure Ireland(TII)/ Kerry County Council
Project Title:	TII Programme of Bridge Rehabilitation Works, Counties Cork, Clare and Kerry
Document Title:	Appropriate Assessment Screening – Beheenagh Bridge, Co. Kerry
Document No:	MCT0668Rp002GP02

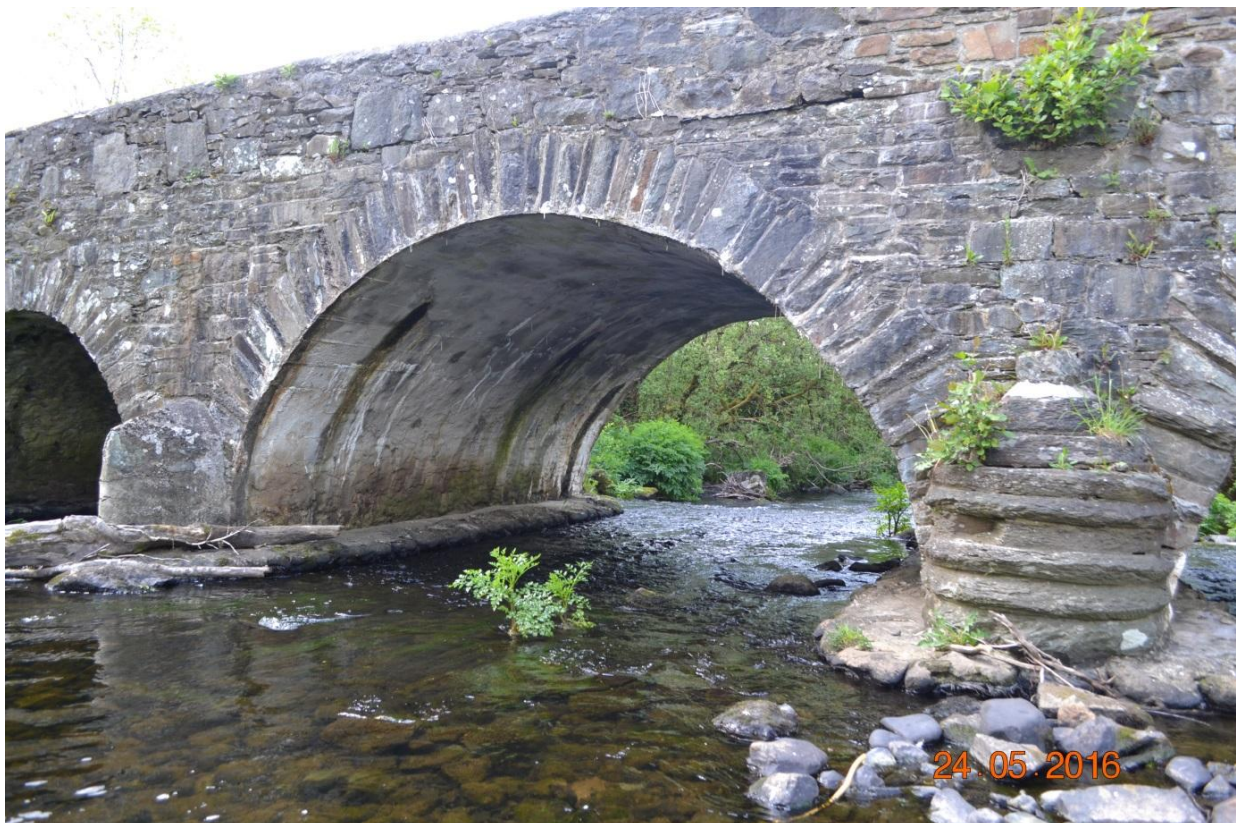
Figure 1.1: Photograph of Beheenagh Bridge

The masonry arch of the bridge has been treated with shotcrete (sprayed concrete) and does not contain any crevices that are of potential use as roosting or resting places by bats. No evidence of nesting birds or kingfisher was observed in the bridge or adjacent riverbanks (wagtail was spotted upstream). No invasive non-native species were observed at the bridge itself; however Cherry Laurel (*Prunus laurocerasus*) and Japanese Knotweed (*Fallopia japonica*) is present in the garden of the derelict house to the north-east of the bridge.

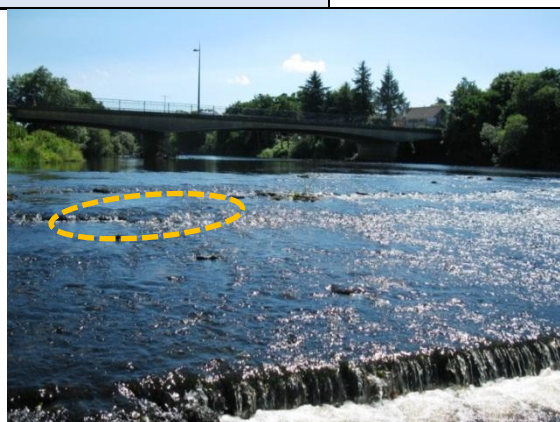
Plate 3: View u/s over glide/riffle habitat in the upper section of the survey reach d/s of bridge. Circle marks location of 5 mussels. (19/07/2016)

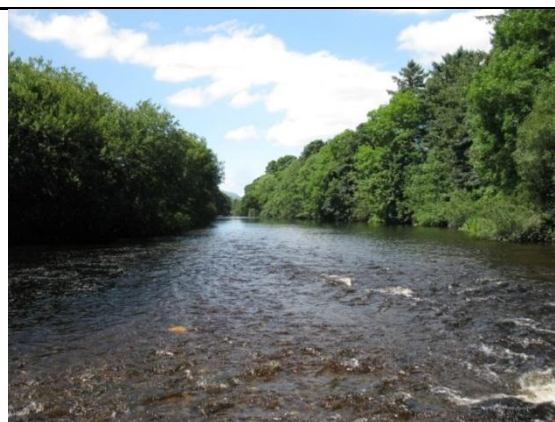
Plate 4: Lower end of survey reach comprising a long glide/run over cobble/gravel/boulder substrates. No mussels (19/07/2016)

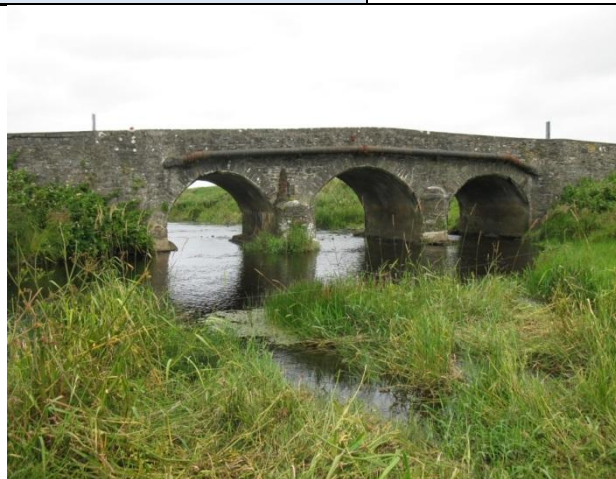
Plate 7: View from u/s of MountRivers Bridge showing in channel growth of emergent vegetation. Unsuitable for mussel (22/07/2016)

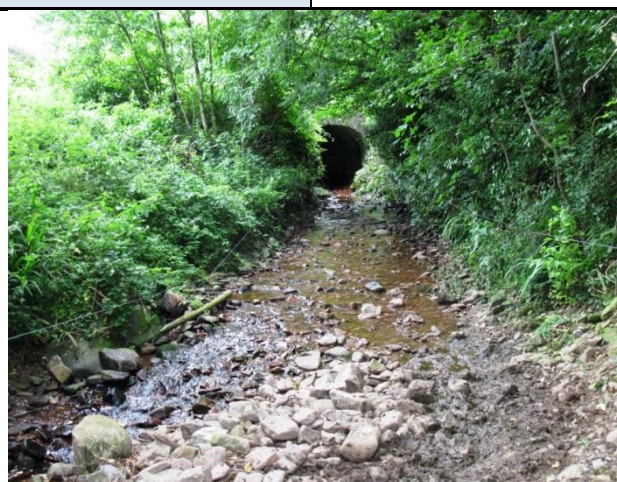
Plate 11: View u/s towards Ballynamona Upper Bridge showing the route that milking cows take along the streambed and through the bridge (15/07/2016).

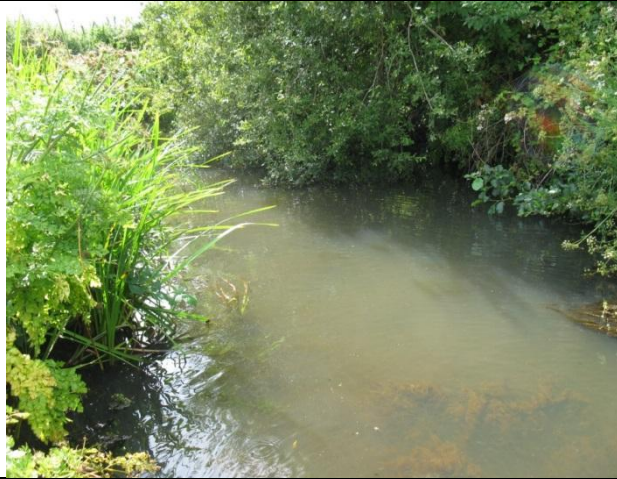
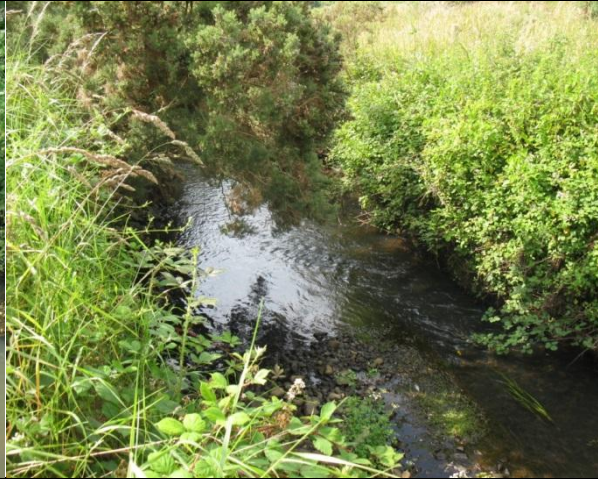
Plate 13: View d/s from Ballymalis Bridge showing turbid, fetid smelling waters forming a sluggish glide (22/07/2016)		Plate 14: Faster flowing pebble/gravel reaches downstream of the bridge which would be suitable (probably trout) nursery habitat (22/07/2016)

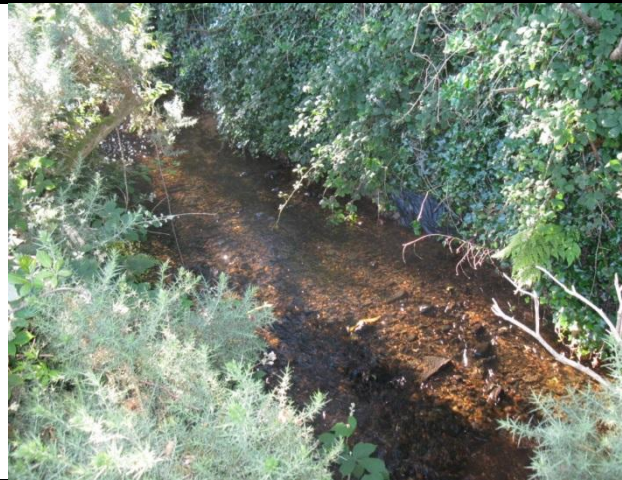
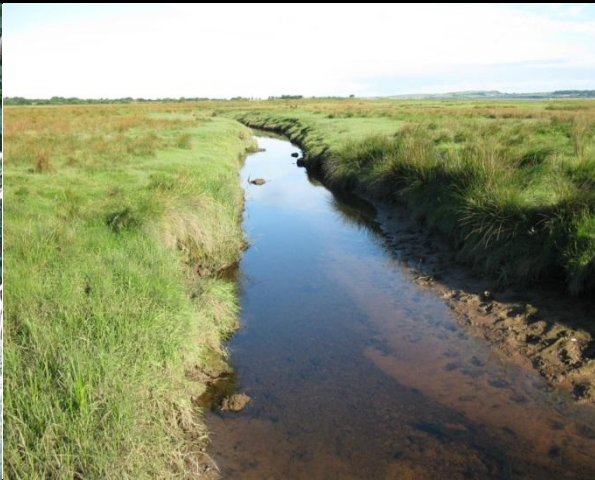
Plate 19: Typical habitat d/s of Enright's Bridge showing pebble/gravel substrates and riffle/run nature which has recovered within the historically realigned and deepened channel (14/07/2016)		Plate 20: View downstream from c300m d/s of the bridge showing estuarine nature of the streams tidal head (14/07/2016)

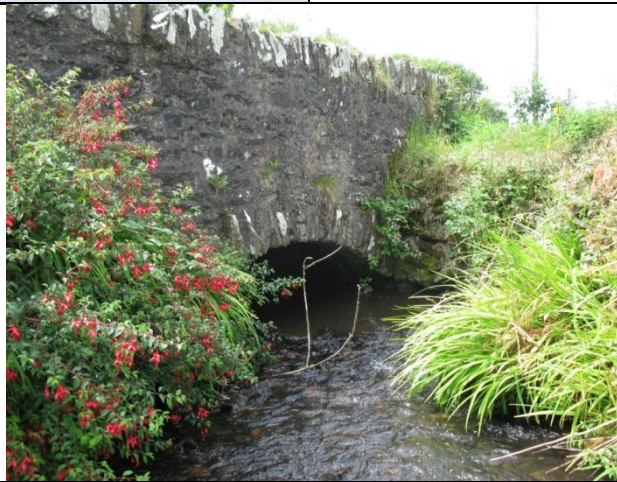
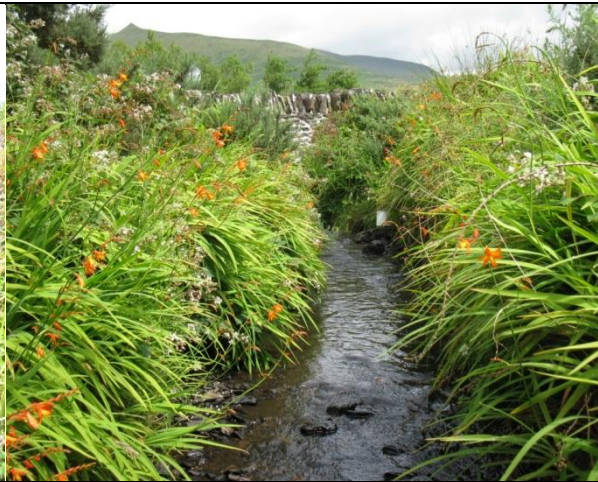
Plate 23: View of Clooncurra Bridge looking u/s showing low clearance (13/07/2016)		Plate 24: Channel d/s of the bridge showing typical riffle/run nature of stream over cobble/pebble/gravel substrates (13/07/2016)

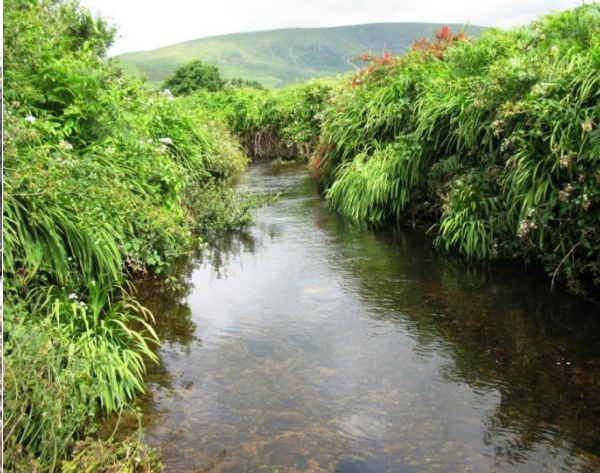
Plate 25: View of Garfinny Bridge looking d/s from just above the road (13/07/2016)		Plate 26: Channel d/s of the bridge showing typical riffle/glide nature of stream over cobble/pebble/gravel substrates (13/07/2016)

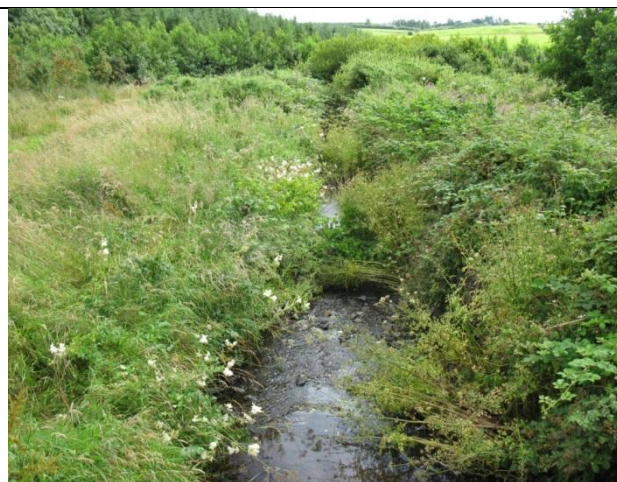
Plate 31: Channel d/s of bridge showing riffle-run over cobble, pebble, gravel substrates (22/07/2016)
