# Appropriate Assessment Screening – Dysert Bridge, Co. Kerry

# Kerry, Cork and Clare Bridge Rehabilitations, 2016: AA Screening- Dysert Bridge, Co. Kerry

Client:	Transport Infrastructure Ireland/ Kerry County Council		
Project Title:	Kerry, Cork and Clare Bridge rehabilitations, 2016		
Document Title:	Appropriate Assessment Screening – Dysert Bridge, Co. Kerry		
Document No:	MCT0668Rp002fP02

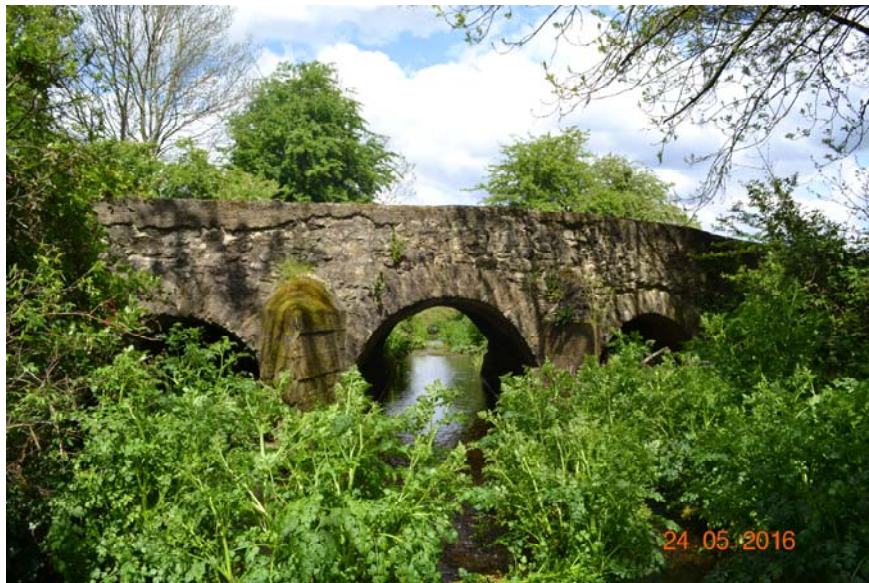
**Figure 1-1: Photograph of Dysert Bridge**

A replacement of the bridge structure is required to improve the safety of the bridge structure and alleviate flood risk; these replacement works are the subject of this Appropriate Assessment Screening (AA).

they forage throughout the Maine catchment area, including the Parknamulloge River. The arch of the bridge has been sprayed with concrete and there are no cracks or crevices suitable for use by bats within the bridge structure.

The river is highly modified by drainage, especially downstream of the bridge where it is mostly canalised. Upstream and for a short distance downstream of the bridge there are braided gravelly channels. The bridge footprint has a concrete reinforced bed. The stream is generally 3.5m wide and 0.15-0.35m deep with steep clay banks overgrown with bramble and tall herb. In general there was no riparian tree cover observed during the site visits. Substrates comprised some cobble and pebble embedded in clay with a layer of loose fine silt. There were patches of cleaner gravels nearer the bridge which would be suitable for salmonid spawning (mainly trout) and nursery and perhaps lamprey spawning. There was good eel habitat and it is considered a very good trout nursery stream.

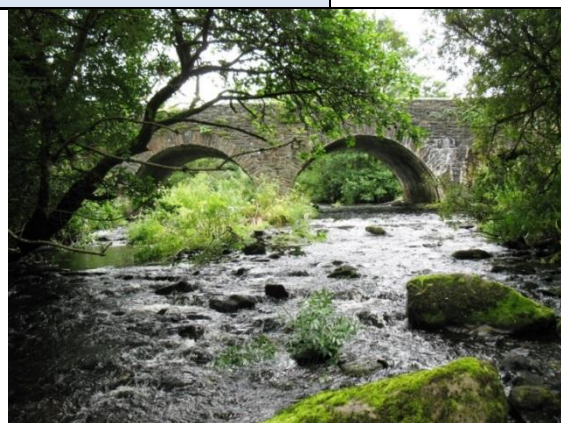
**Plate 1:** Beheenagh River from d/s of N72 bridge

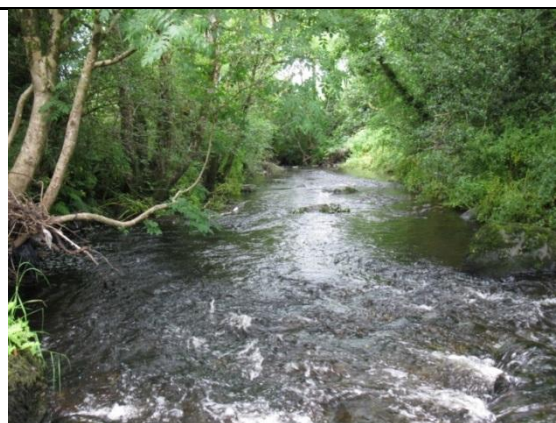
**Plate 2:** Beheenagh River - high energy, fast

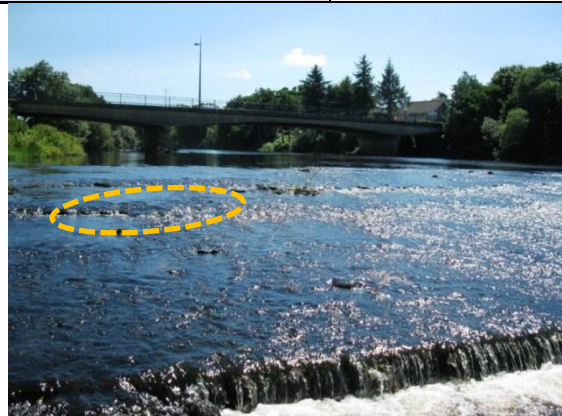
<p><b>Plate 3:</b> View u/s over glide/riffle habitat in the upper section of the survey reach d/s of bridge. Circle marks location of 5 mussels. (19/07/2016)</p>	<p><b>Plate 4:</b> Lower end of survey reach comprising a long glide/run over cobble/gravel/boulder substrates. No mussels (19/07/2016)</p>
--	---

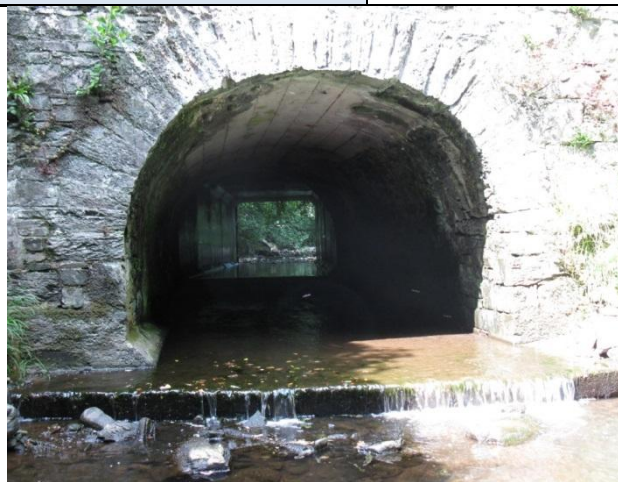
**Plate 5:** Footprint of bridge showing concrete bed reinforcement. No mussels. (19/07/2016)

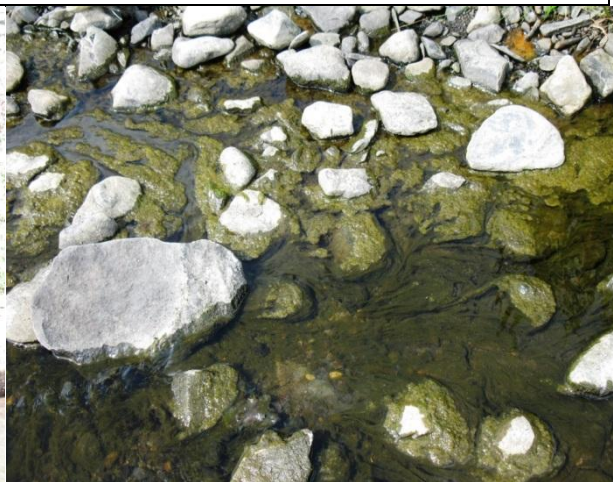
**Plate 6:** Excessive filamentous algal growth on all substrates. Completely unsuitable for mussels. Poor quality habitat for salmonids. (19/07/2016)

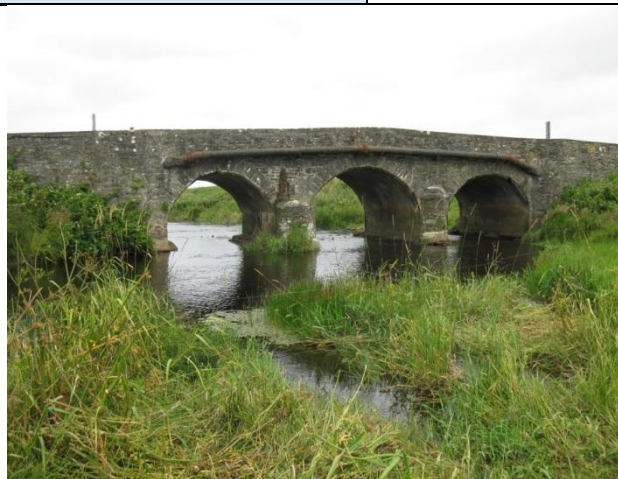
**Plate 7:** View from u/s of MountRivers Bridge showing in channel growth of emergent vegetation. Unsuitable for mussel (22/07/2016)

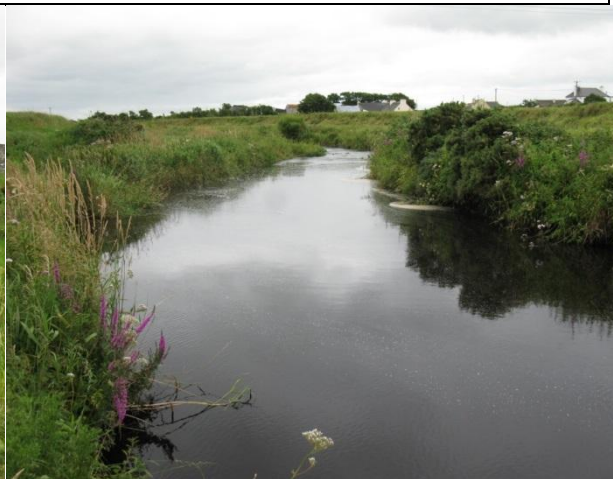
**Plate 8:** Highly coloured, sluggish glide over embedded clay/cobble substrates with layer of silt. Unsuitable for mussels (22/07/2016)

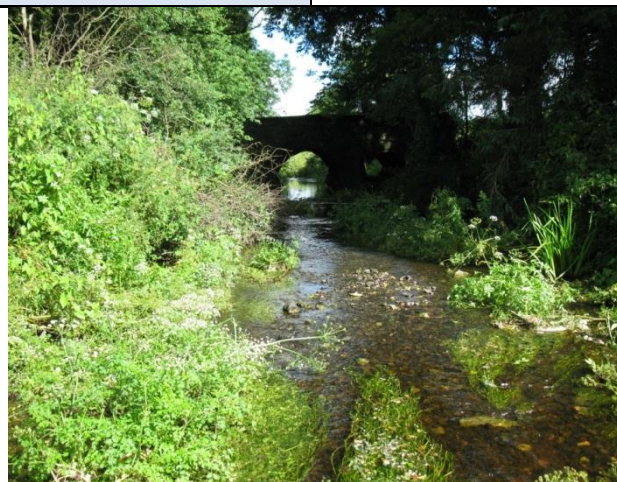
**Plate 9:** View d/s towards Dysert Bridge showing braided gravelly channel suitable as with *Ranunculus* and *Oenanthe crocata*. Suitable salmonid nursery habitat. (15/07/2016)

An aquatic ecology survey conducted at Dysert Bridge in July 2016 found that there were patches of cleaner gravels nearer the bridge (upstream) which would be suitable for salmonid spawning (mainly trout) and nursery. There is therefore a risk of direct impact on salmonids in proximity to the bridge as a result of construction activities, as detailed in **Table 3.3**.

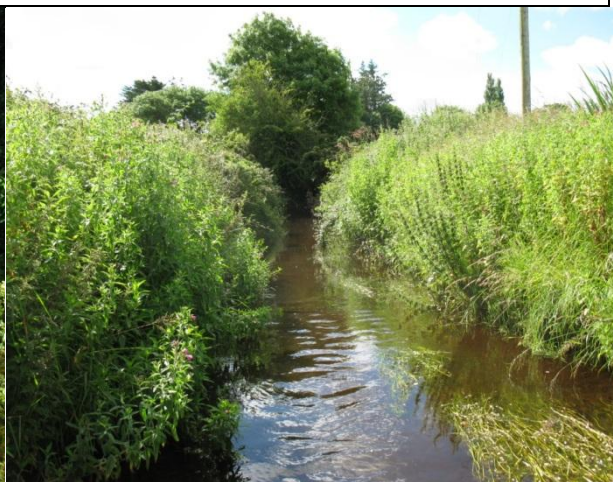
**Plate 10:** Turbid, sluggish glide typical d/s of Dysert Bridge. Not suitable spawning or nursery habitat for salmonids and limited suitability for brook lamprey nursery. (15/07/2016)

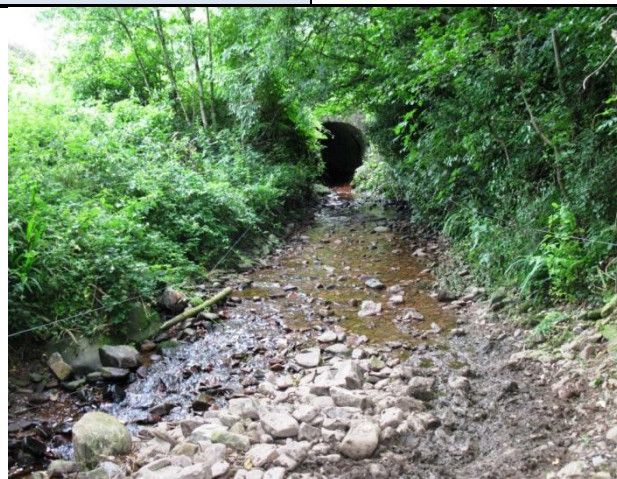
**Plate 11:** View u/s towards Ballynamona Upper Bridge showing the route that milking cows take along the streambed and through the bridge (15/07/2016).

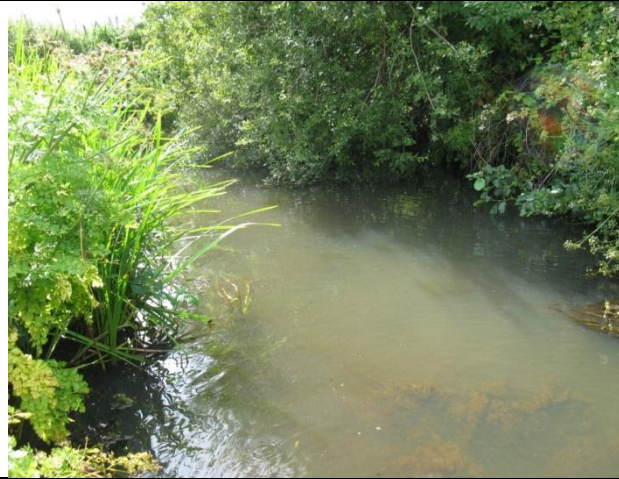
<b>Plate 13:</b> View d/s from Ballymalis Bridge showing turbid, fetid smelling waters forming a sluggish glide (22/07/2016)		<b>Plate 14:</b> Faster flowing pebble/gravel reaches downstream of the bridge which would be suitable (probably trout) nursery habitat (22/07/2016)

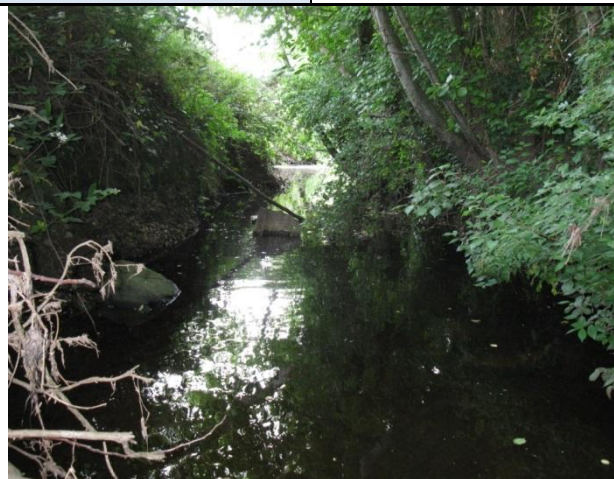
**Plate 15:** View d/s from Coolroe South Bridge showing general nature of drained stream with steep unstable banks, limited flow and substrate diversity and turbid waters (22/07/2016)

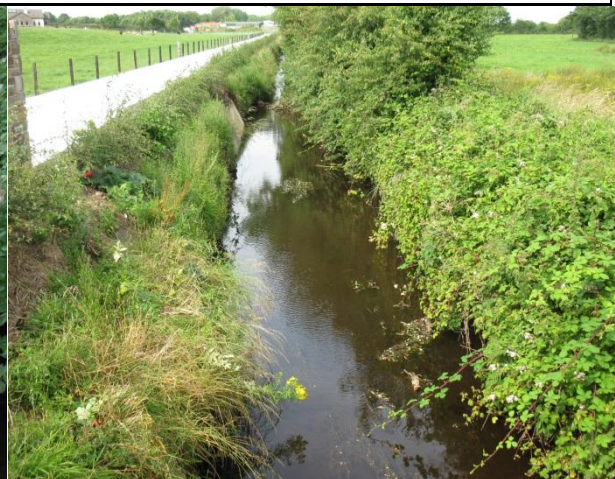
**Plate 16:** View u/s from the bridge showing turbid, sluggish glide with limited flow diversity and open banks (22/07/2016)

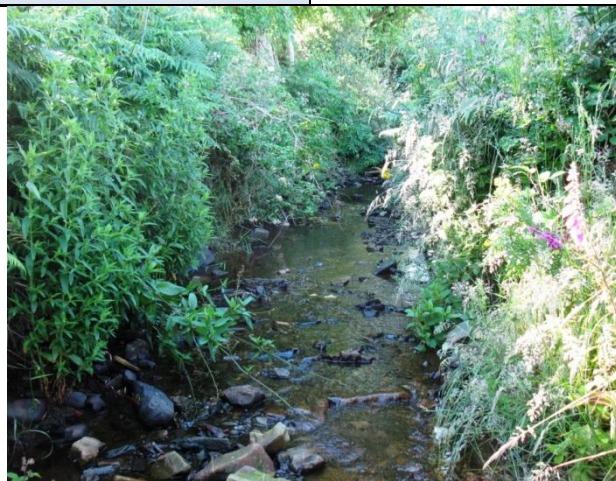
**Plate 17:** Typical habitat d/s of Pallas Bridge showing pebble/gravel substrates and riffle/run nature which has recovered within the historically drained channel (14/07/2016).

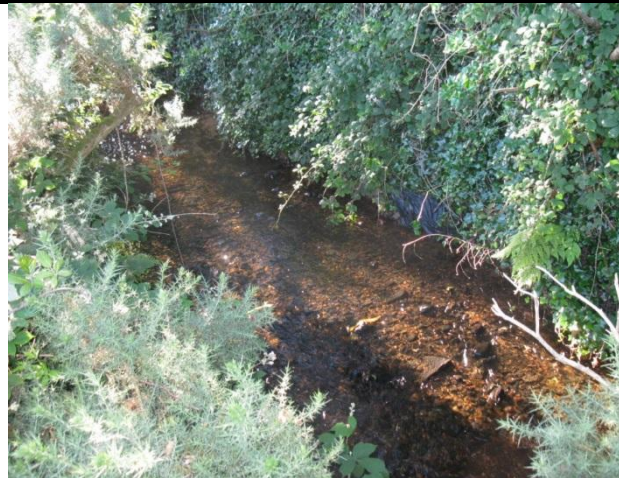
<b>Plate 19:</b> Typical habitat d/s of Enright's Bridge showing pebble/gravel substrates and riffle/run nature which has recovered within the historically realigned and deepened channel (14/07/2016)		<b>Plate 20:</b> View downstream from c300m d/s of the bridge showing estuarine nature of the streams tidal head (14/07/2016)

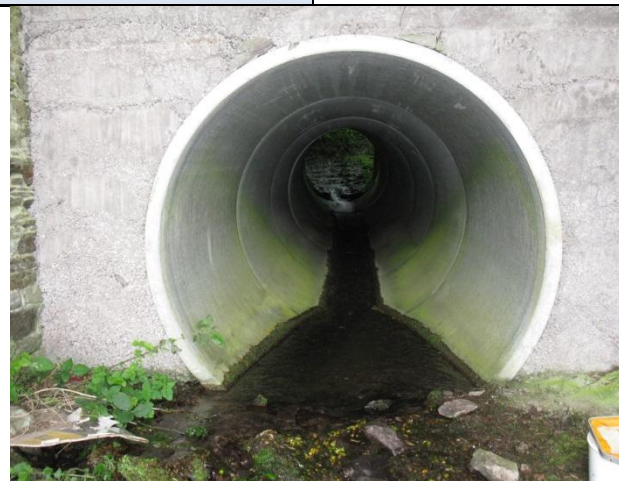
**Plate 21:** View of Gort na Chorráin stream looking upstream into N86 culvert (13/07/2016)

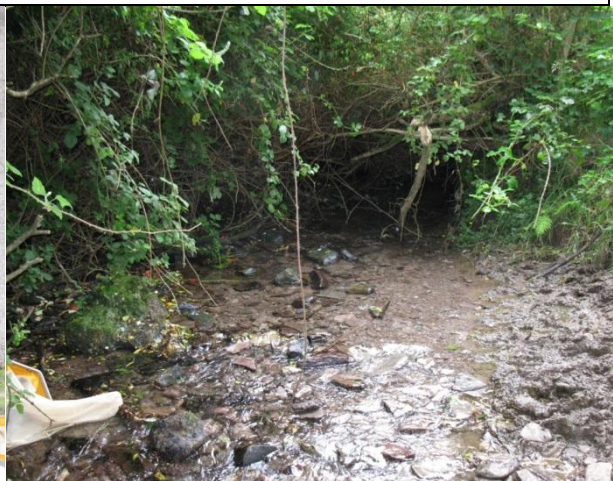
**Plate 22:** Nature of substrates downstream of the road (13/07/2016)

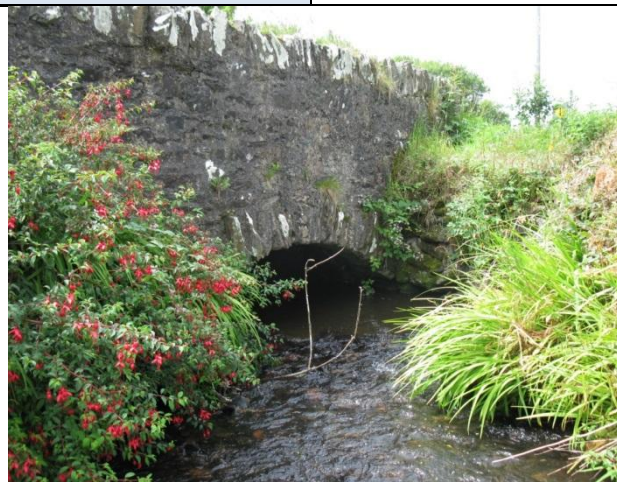
Plate 23: View of Clooncurra Bridge looking u/s showing low clearance (13/07/2016)	Plate 24: Channel d/s of the bridge showing typical riffle/run nature of stream over cobble/pebble/gravel substrates (13/07/2016)
--	---

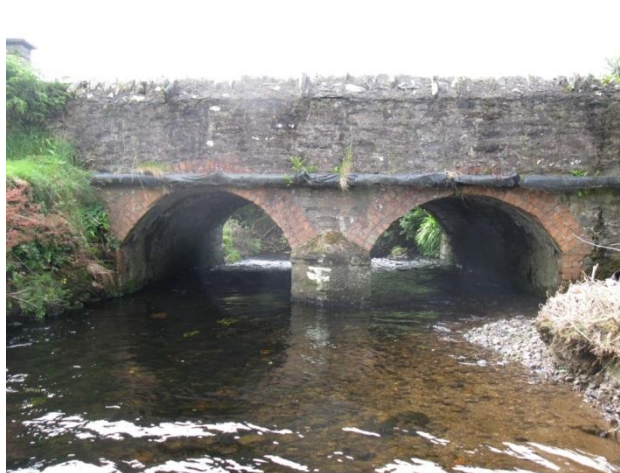
<b>Plate 25:</b> View of Garfinny Bridge looking d/s from just above the road (13/07/2016)		<b>Plate 26:</b> Channel d/s of the bridge showing typical riffle/glide nature of stream over cobble/pebble/gravel substrates (13/07/2016)

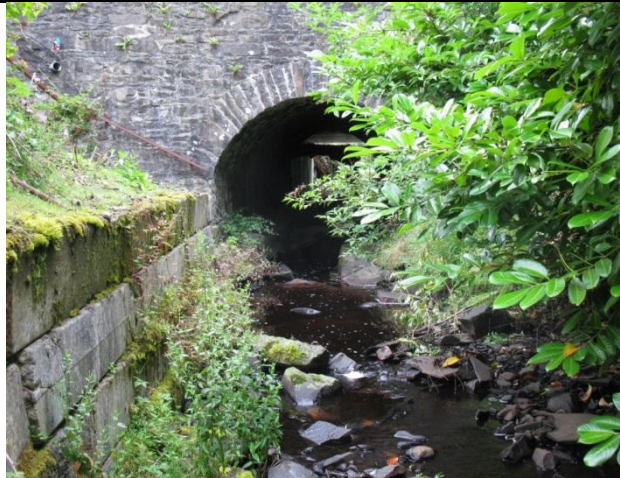
<b>Plate 27:</b> View of Liscasey Bridge East looking u/s showing cobbly substrates and bank reinforcement (22/07/2016)	<b>Plate 28:</b> Channel d/s of the weir showing typical riffle/run nature of stream over cobble/pebble/gravel substrates (22/07/2016)

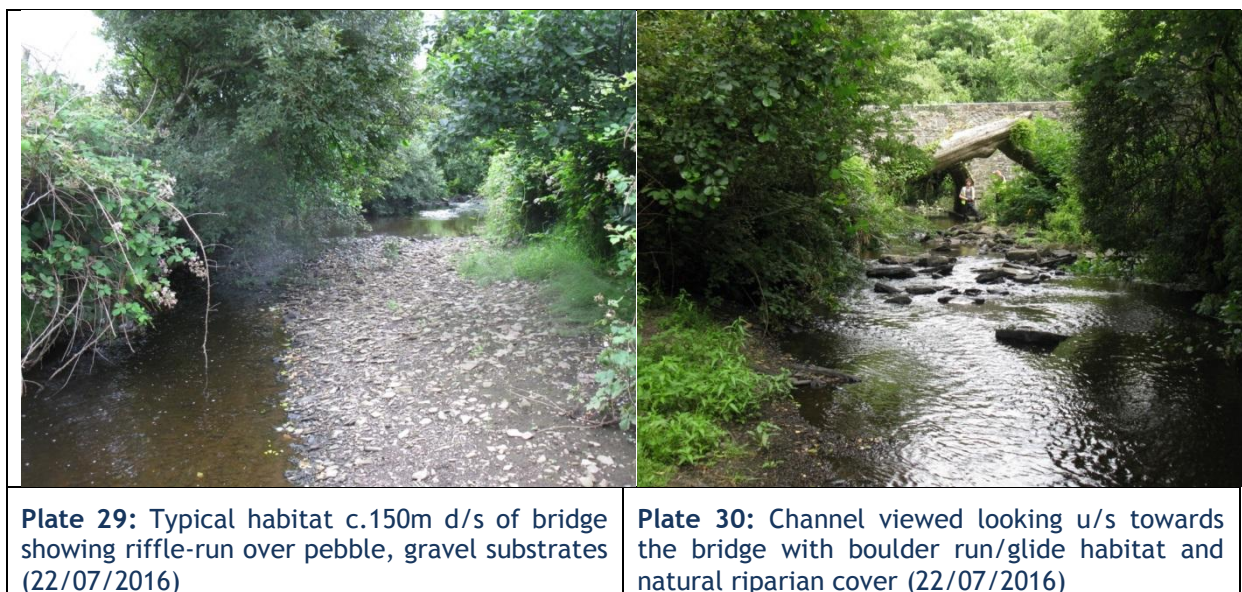
**Plate 29:** Typical habitat c.150m d/s of bridge showing riffle-run over pebble, gravel substrates (22/07/2016)

**Plate 30:** Channel viewed looking u/s towards the bridge with boulder run/glide habitat and natural riparian cover (22/07/2016)

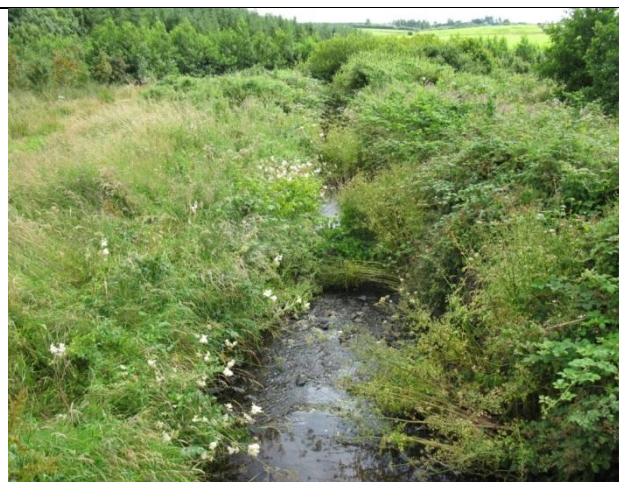
**Plate 31:** Channel d/s of bridge showing riffle-run over cobble, pebble, gravel substrates (22/07/2016)

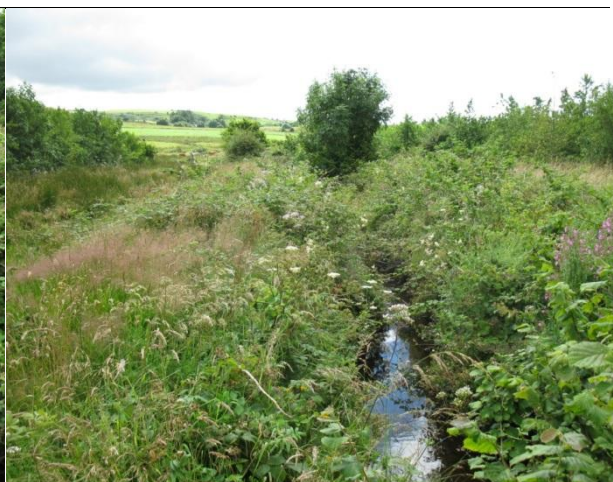
**Plate 32:** Channel further downstream showing deeply drained nature with overgrown banks (22/07/2016)

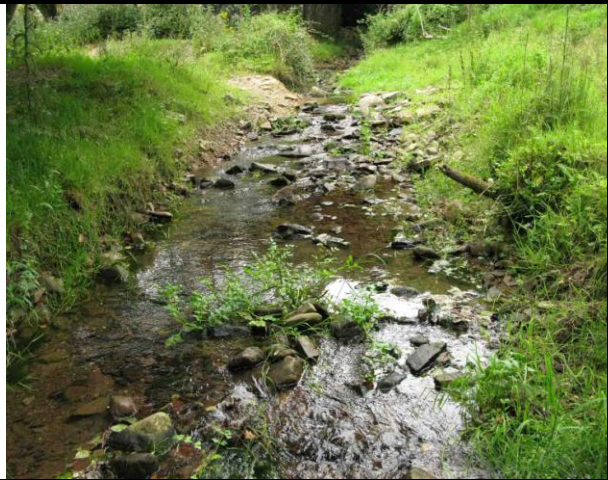
<b>Plate 33:</b> View u/s to bridge (26/07/2016)		<b>Plate 34:</b> Cleared and straightened stretch (26/07/2016)
