Date: October 2009

Archaeological Survey, Abbey Island (Derrynane)_Graveyard, Abbey Island, Co. Kerry.

RMP Number: KE106 077

Headland Archaeology (Ireland) Ltd,
Unit 1 Wallingstown Business Park,
Little Island,
Co. Cork

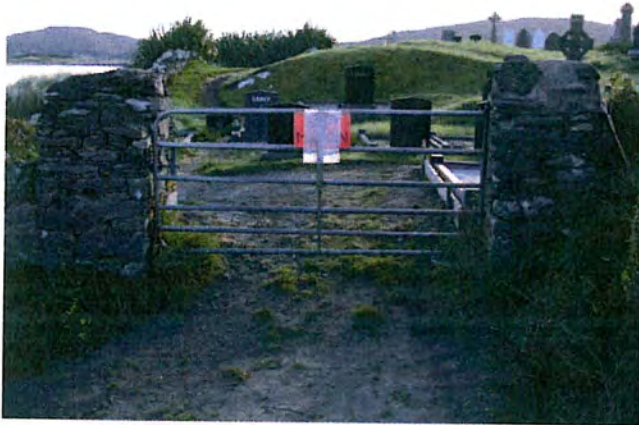
Plate 04_Secondary entrance via laneway from north.jpg

Access to the graveyard is from the car park across a sand bar. One life buoy is installed beside the car park. There are two entrances to the graveyard; both are located at the northwest corner of the graveyard. The primary entrance which is located on the north wall consists of a rendered and rubble stone piers with rendered and rubble stone capping respectively. No gates remains, but there are hinges within the piers suggesting that there was once a gate here at an earlier stage (Plate 12). A central timber post divides this entrance in half, forming a stile-like feature. Render steps form an approach to this primary entrance. The secondary (larger) entrance located in the western wall, consists of a pair of rubble stone piers with rubble stone capping supporting a galvanised field gate. This gate is in good repair (Plate 13). The entrance is accessed mainly via a lane which curves towards the northwest. This becomes the primary access route during high tide.

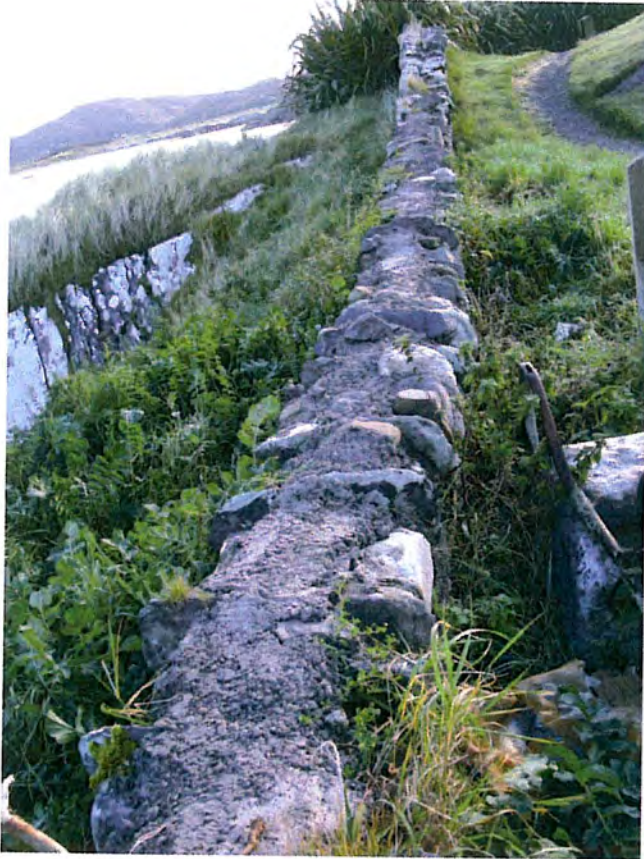
Plate 09_ Wall from west.jpg

The boundary walls surrounding the graveyard are of roughly dressed mortared rubble stone with rubble stone coping. However there are parts of the wall where inappropriate rendering containing large aggregates has been applied to the coping (Plate 9). In places along the west wall it has been truncated by grave plots (e.g. Grave no. 058). The wall varies in height throughout the graveyard, with an average height of around 1.25 m. There is no boundary wall defining the eastern side of the graveyard, except for a cliff face dropping to the ocean. There is however, a small section of wall to the northern area of the eastern side, which represents the foundation of a boundary wall which has subsequently collapsed. This creates a significant safety issue, since the graveyard is frequented by families visiting the site (Plates 10 and 11). An important safety concern was observed to the southern area of the eastern limit where overgrown grass conceals this steep drop; continuous sea action has resulted in an unstable edge that may collapse.

Rendered and rubble stone piers flank the entrances with rendered and rubble stone capping respectively. For the most part the walls appear stable with very little vegetation on their interior elevations. The occurrence of distinctive pale lichens are a frequent feature of the walls and compliment their charm and character.

Remove any inappropriate rendering to the graveyard wall and prevent further disturbance to the wall by not allowing any more graves next to the wall.

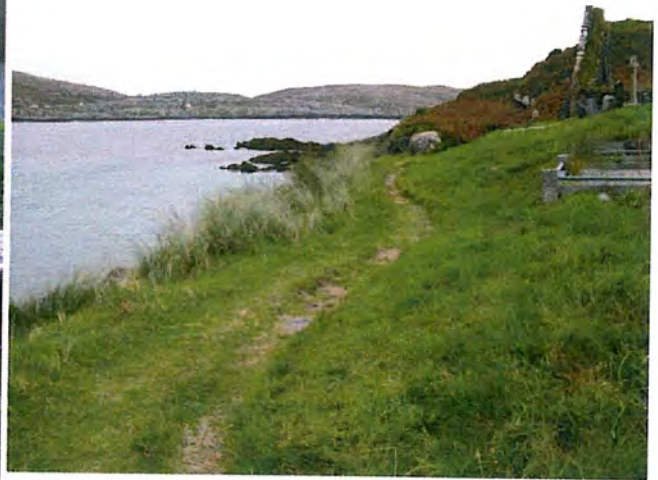
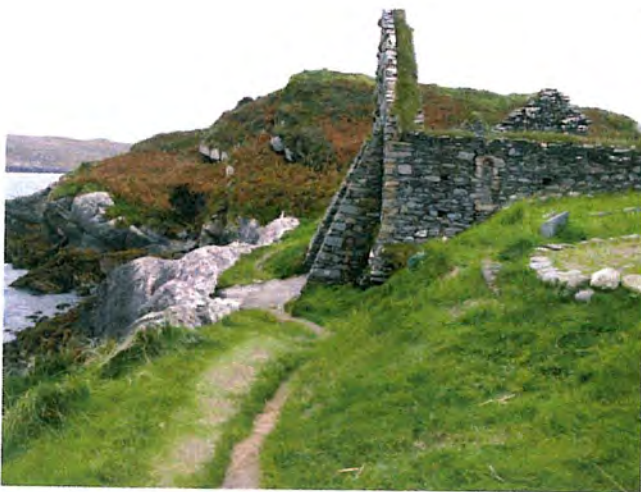
Plate 10_ Desire line and cliff edge from north.jpg

There is one primary pathway located in the northwest corner beside the entrances. Constructed from gravel, the path lead towards the east where it ends and a desire line continues towards the eastern parts of the graveyard and up to the church (Plates 11 and 14)

Create a low rubble stone wall along the east part of the graveyard. The wall should be sympathetic to the historic character of the graveyard. Signs should be posted warning of the potential dangers that are encountered along this area of the site.

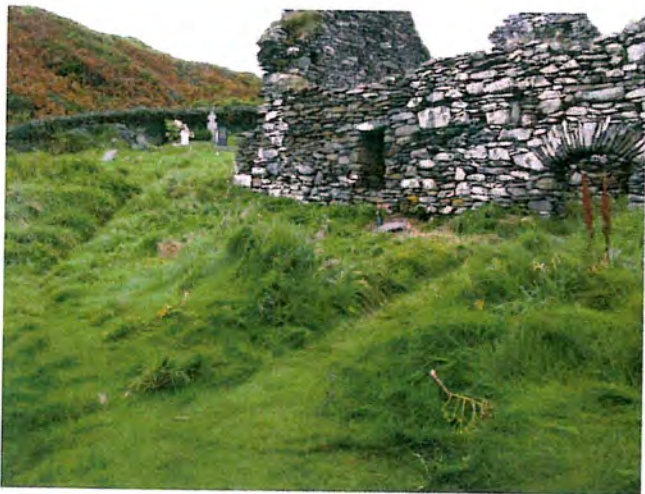
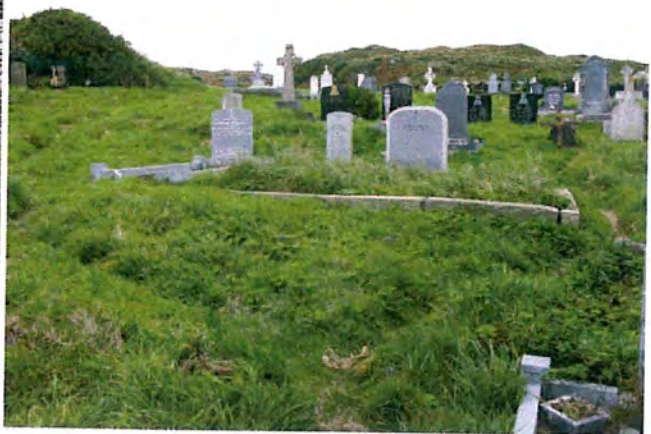
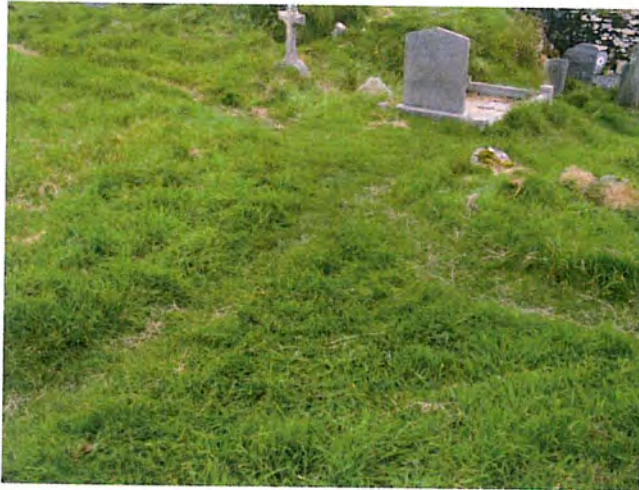
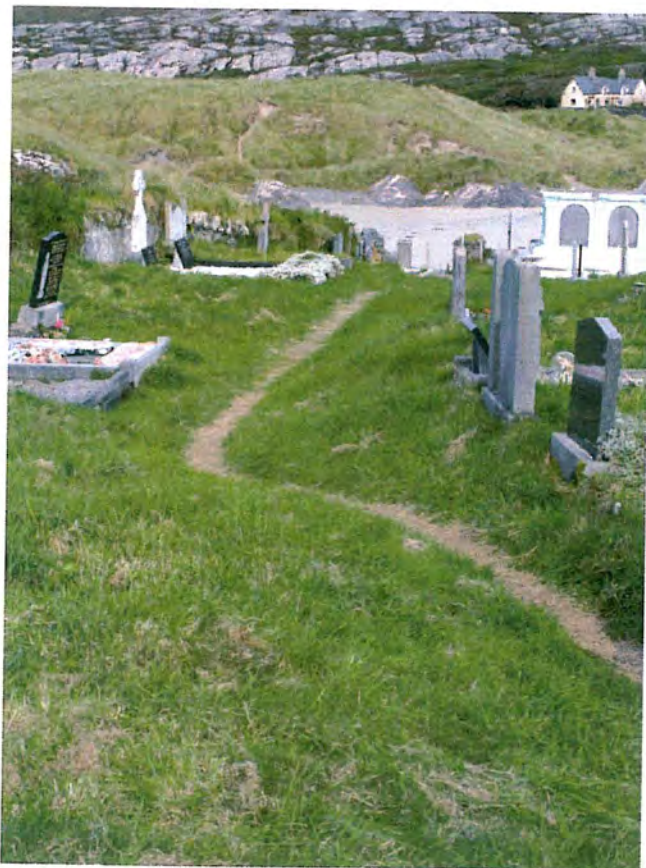
Plate 15_Desire lines from northeast.jpg

Desire lines are represented in abundance at Abbey Island burial grounds indicating the frequency of visitors to the graveyard. In some cases desire lines were found to be cutting across marked and unmarked graves e.g. grave no's: 060,136, 290 and 278. The desire lines lead around and across the graveyard, with the majority of them leading to the church and other structural remains. There are even junctions where the desire lines meet or cross (Plates 15, 16 and 17). One of the main desire lines leads from the entrance through the western half the graveyard to the south wall (Plates 18 and 19). There is also a desire line that starts on top of Grave no. 559 (Plate 20) and continues on top of the southern wall of the church ruin.

Transform some of the bigger desire lines into gravel paths and respect any graves that may have been truncated by them. This will prevent further damage and disturbance to the graveyard.

Prevent further usage of desire line on top of church wall, which represents a serious safety issue. Access to this desire line also starts by clambering over a collapsing tomb.

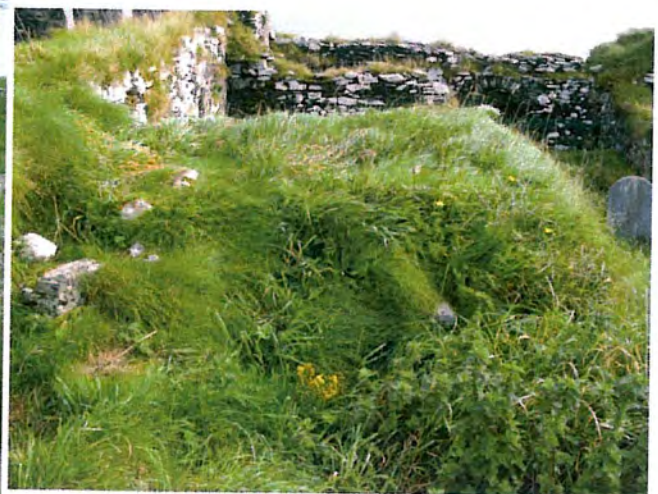
Plate 20_Grv No. 559.jpg

The unnamed tomb, (Grave no. 559) is located adjacent to the southern wall of the church and is rectangular in profile with rubble stone walls. This tomb is excessively overgrown and partly collapsed to the south, and it is used as a starting point for a desire line that continues along the southern wall of the church.

The prevention of access to the top of Grave no. 559, as it is already partially collapsed. Additional stress to the structure could make it collapse completely.

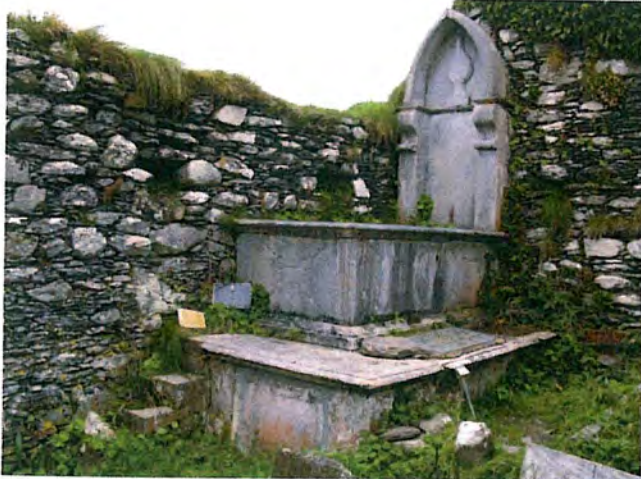
Plate 21_Grv No.565.jpg

The two named tombs (Grave No's: 092 and 565) within the graveyard represent the Galvin and O'Connell family's respectively and both are in good condition. The O'Connell tomb (Plate 21) inters the family of Daniel O'Connell The Liberator, who lived at Darrynane Abbey/House. This tomb also represents the oldest named grave with the date 1770. Partly illegible the date possibly refers to the father or uncle of Daniel O'Connell. The tomb comprises of two ornately carved tooled limestone altars with fluted pilasters enclosing decorative panels to the sides. An inscribed grave slab to the upper tomb is surmounted by fluted pilasters with scrolled consoles flanking a cross inscribed plaque to the west having a moulded architrave surmounted by a pointed-arch enclosing a second plaque

with a carved urn motif. A tooled stone stepped approach to the east provides access to the top tomb. The tomb is beautifully ornate, constructed from high crafted tooled stone displaying classical inspired decoration and deserves a special mentioning for its appearance; the tomb is still in use with the most recent burial taking place in 2007.

Since the O'Connell tomb is one of the main tourist attractions of the graveyard, the construction of path leading to the tomb would be a recommendation. Also historical information on Daniel O'Connell would be of benefit, detailing in particular the fact that the man himself is not buried there, that it is only his family, as this is a major cause confusion for visitors. This extra attention given to a specific tomb is increasing the wear of detail on the grave slabs and as such they are becoming gradually illegible. At present a copper plaque states part of the information from the original capstone, but chooses to ignore some of the earlier detail. Some sort of measure needs to be put in place to deter people from climbing up on the tomb. This would contribute significantly in the preservation of the tomb. A detailed record of the inscribed capstone would ensure that the information is not lost.

- Preservation of Daniel O'Connell's family tomb should be a priority. Deterring people from climbing on the tomb would aid in the preservation of the inscriptions and the structural stability of the tomb. A detailed structural assessment should be made of the two remaining tombs (Grave No's: 092 and 559). These assessments should then be used to aid in the planning and execution of remedial works designed to secure the structures and make repairs

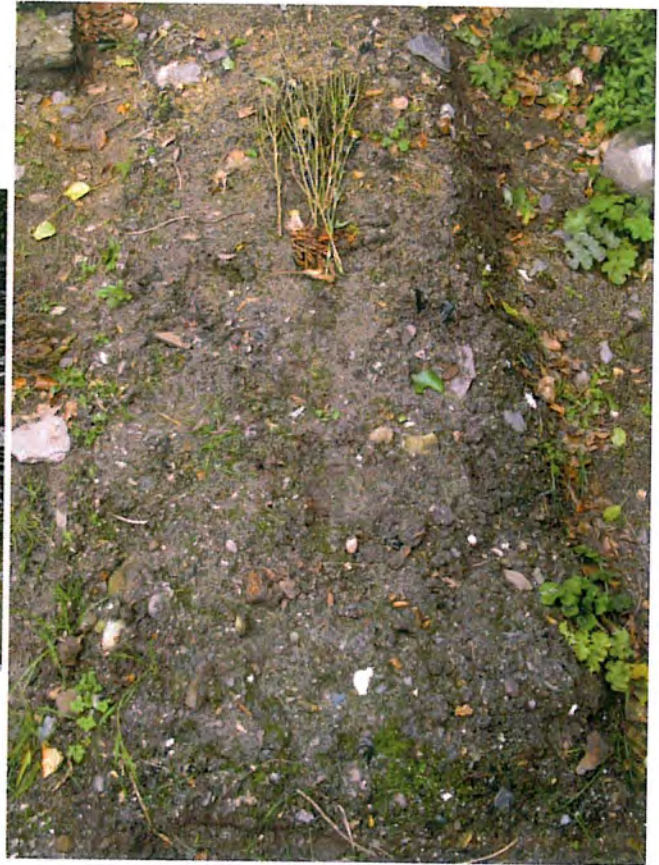
Plate 22_Grv No. 560.jpg

There are 189 inscribed headstones and plots within the graveyard and most of these are in good condition. The majority of the graves date to the 20th century, however there are more recent graves from the 21st century e.g. Grave no. 013 from 2007 and Grave no. 560 from 2009. The latter grave is located inside the church ruin and during this burial, it disturbed earlier burials evident by the large amount of human remains that now lay scattered on top of the grave and next to it, (Plate 22).

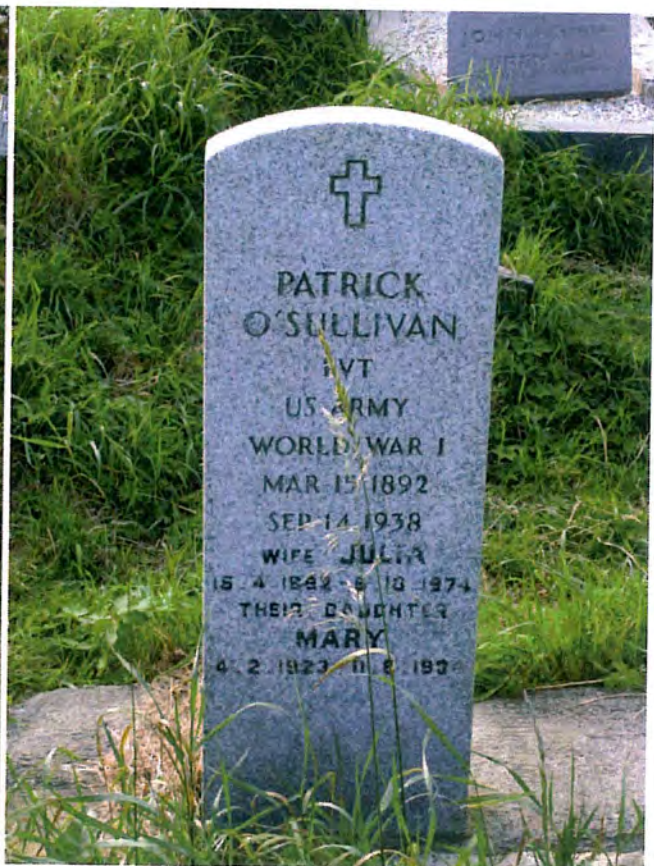
Plate 23_Grv No. 284.jpg

There are three World War 1 veterans buried within the graveyard; grave no. 270 is that of Humphrey O'Sullivan who was part of PVT CO D 312 Engrs 87 Division, grave no. 284 is that of Mary Fenton White Army Nurse Corps during the war (Plate 23) and grave no. 336 was erected to the memory of Patrick O'Sullivan PVT US Army (Plate 24).

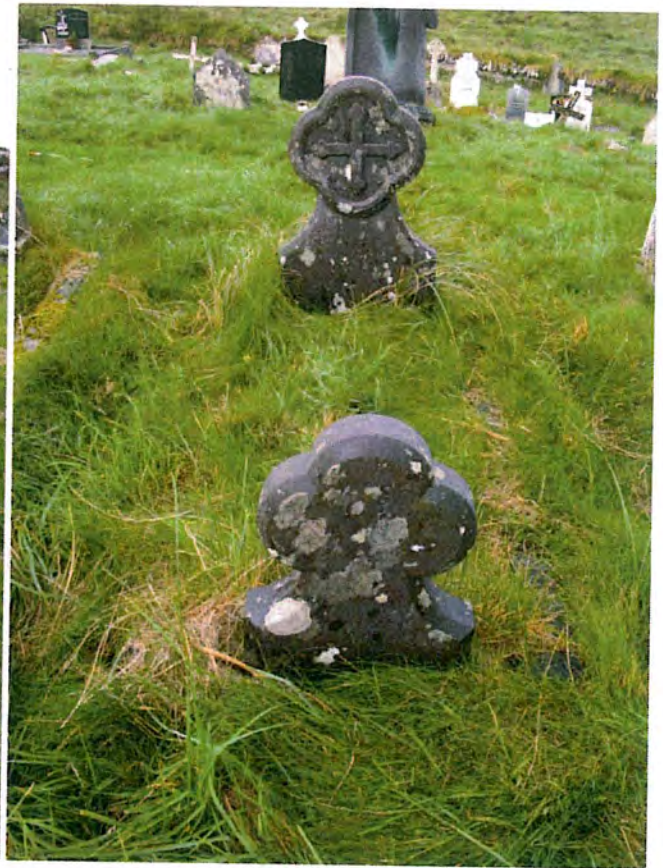
Plate 25_Grv No.368.jpg

There are also graves from the 19th century; the most ornate of these is grave no. 368 of the well know local poet Tomas Ruad Ua Suilliovain. (Plate 25)

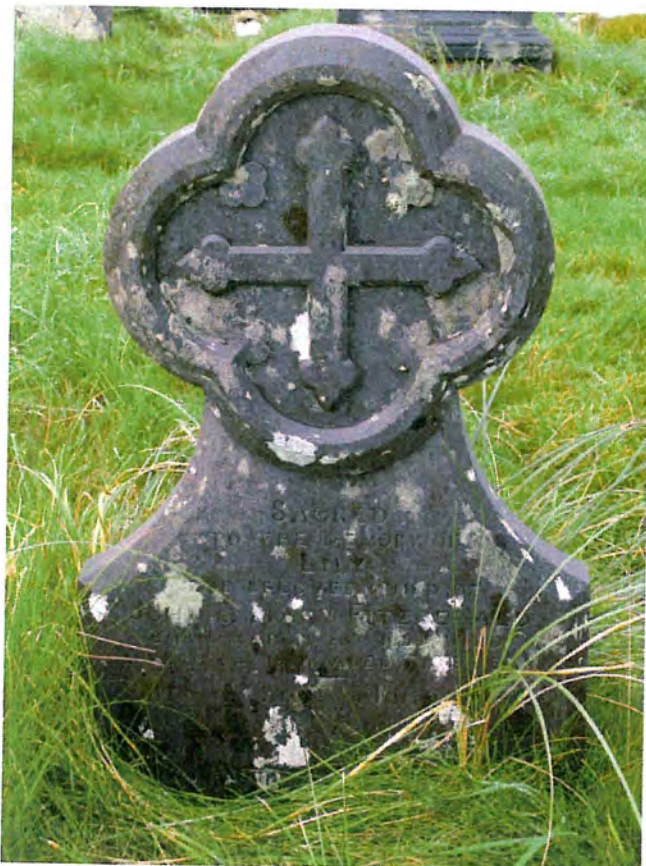
Plate 26_Grv No. 506 from east.jpg

beautifully carved headstone following a quatrefoil pattern and accompanying carved footstone in a trefoil pattern. This was erected for Lily Fitzgerald who died in March 1864 aged 5 (Plates 26 and 27).

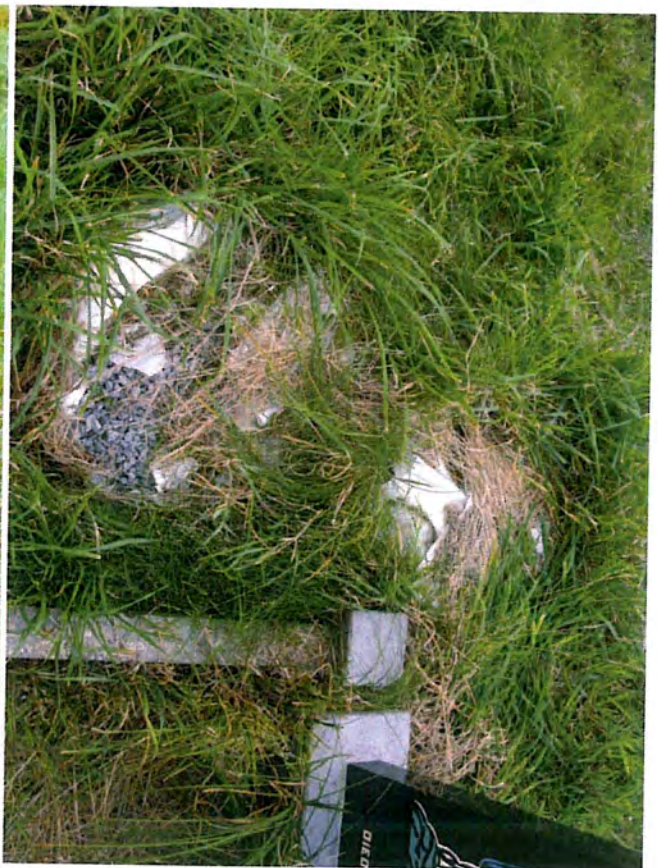
Plate 28_Gravel bags.jpg

Located close to some of the graves and plots are both empty and half-full bags of gravel. Most of which lay hidden under vegetation.

In general the majority of the graves and areas surrounding them are overgrown. In order to protect and preserve the graves and also for the safety of the visitors the grass needs to be cut and any bags of gravel that are laying about, should be removed (Plate 28).

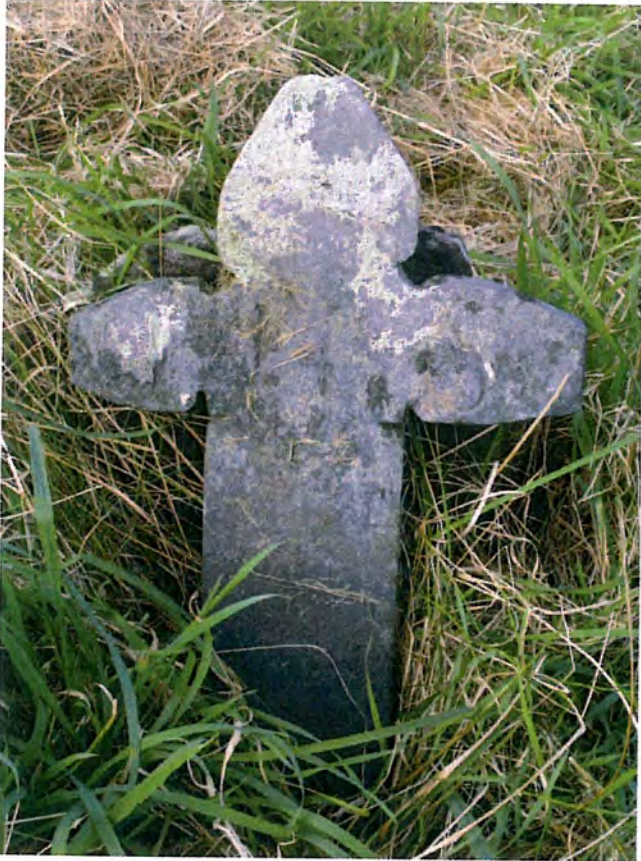
Plate 29_Grv No.212.jpg

There are 22 unnamed or illegible headstones and plots at Abbey Island. The majority of these are wrought iron or wooden crosses, but there are also heavily eroded stone crosses. Grave no. 213 is an example of a fine stone cross but unfortunately it is broken and is leaning loosely against grave no. 212 (Plate 29).

General maintenance of the grave markers insuring that these forms of vernacular headstones do not disappear.

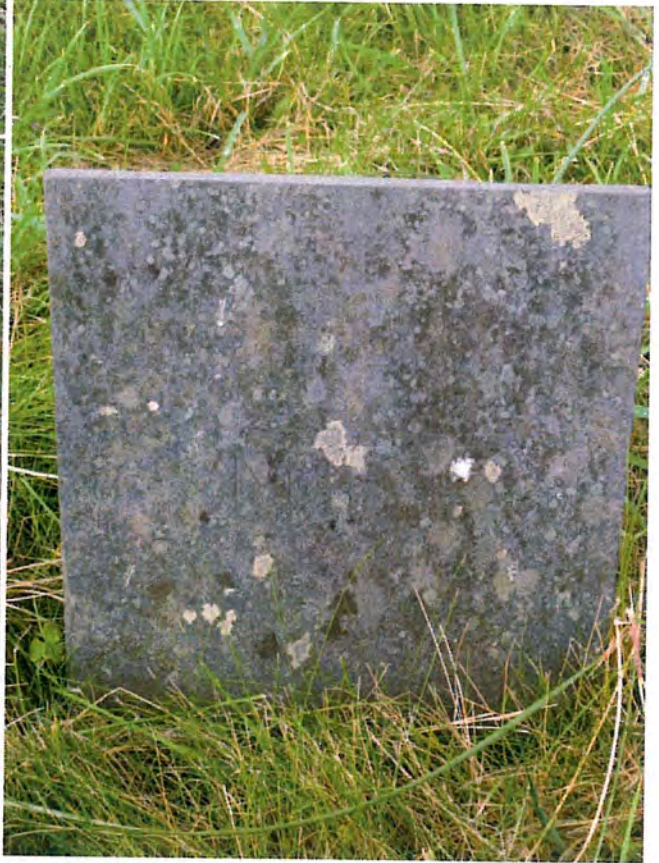
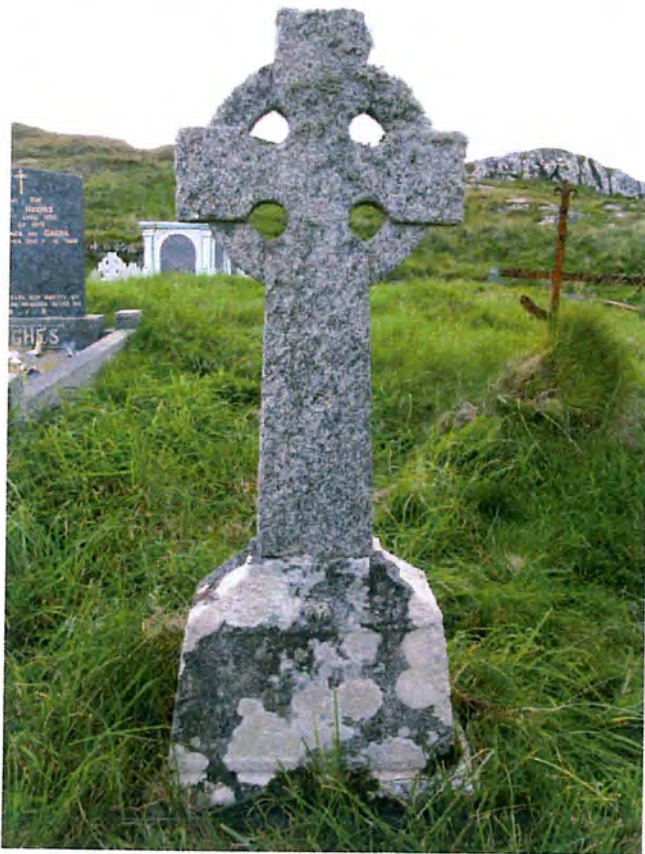
Plate 30_Grv No.448.jpg

Grave no. 448 (Plate 30) and grave no. 460 (Plate 31) are examples of eroded headstones. Although they are firmly positioned in the ground and in good condition, they are illegible.

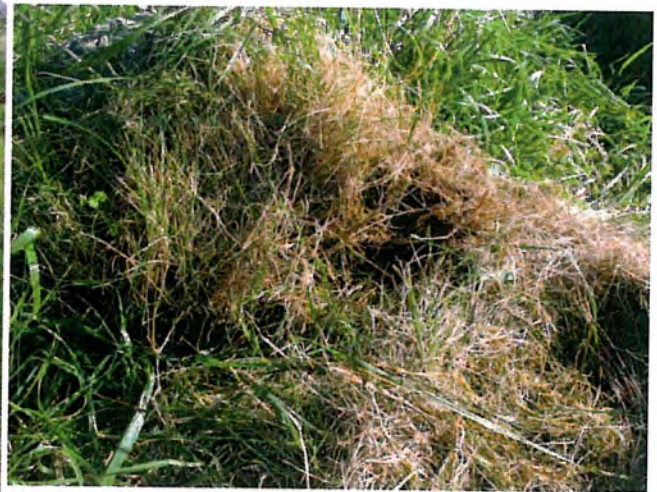
Plate 32_Grv No. 237.jpg

The vast majority of graves at Abbey Island are plain unnamed gravemarkers; 351 in total were recorded, however due to tall grass and excessive overgrowth in some areas, especially to the south, some may have been overlooked. On occasion possible gravemarkers were detected underfoot through the overgrowth, but due to the nature of the project and the disturbance required to find and interpret whether these were indeed gravemarkers, such possible gravemarkers were not surveyed or photographed, with the exception of grave no. 237 (Plate 32).

The control of overgrown vegetation should be the primary concern in this case as this will make the markers more clearly visible and prevent accidental damage being done by visitors to the grounds. The control of the vegetation may also reveal other gravemarkers that were not visible at the time of survey. It should be noted that the clearing of vegetation from deeply buried grave markers may create excessive disturbance. Archaeological instruction/supervision may be necessary.
