Archaeological Survey,
Aglish Graveyard,
Minard,
Co. Kerry.

September 2010

Client: The Heritage Office,
Kerry County Council,
County Buildings,
Ratass,
Tralee,
Co. Kerry.

RMP No.: KE054-032-graveyard

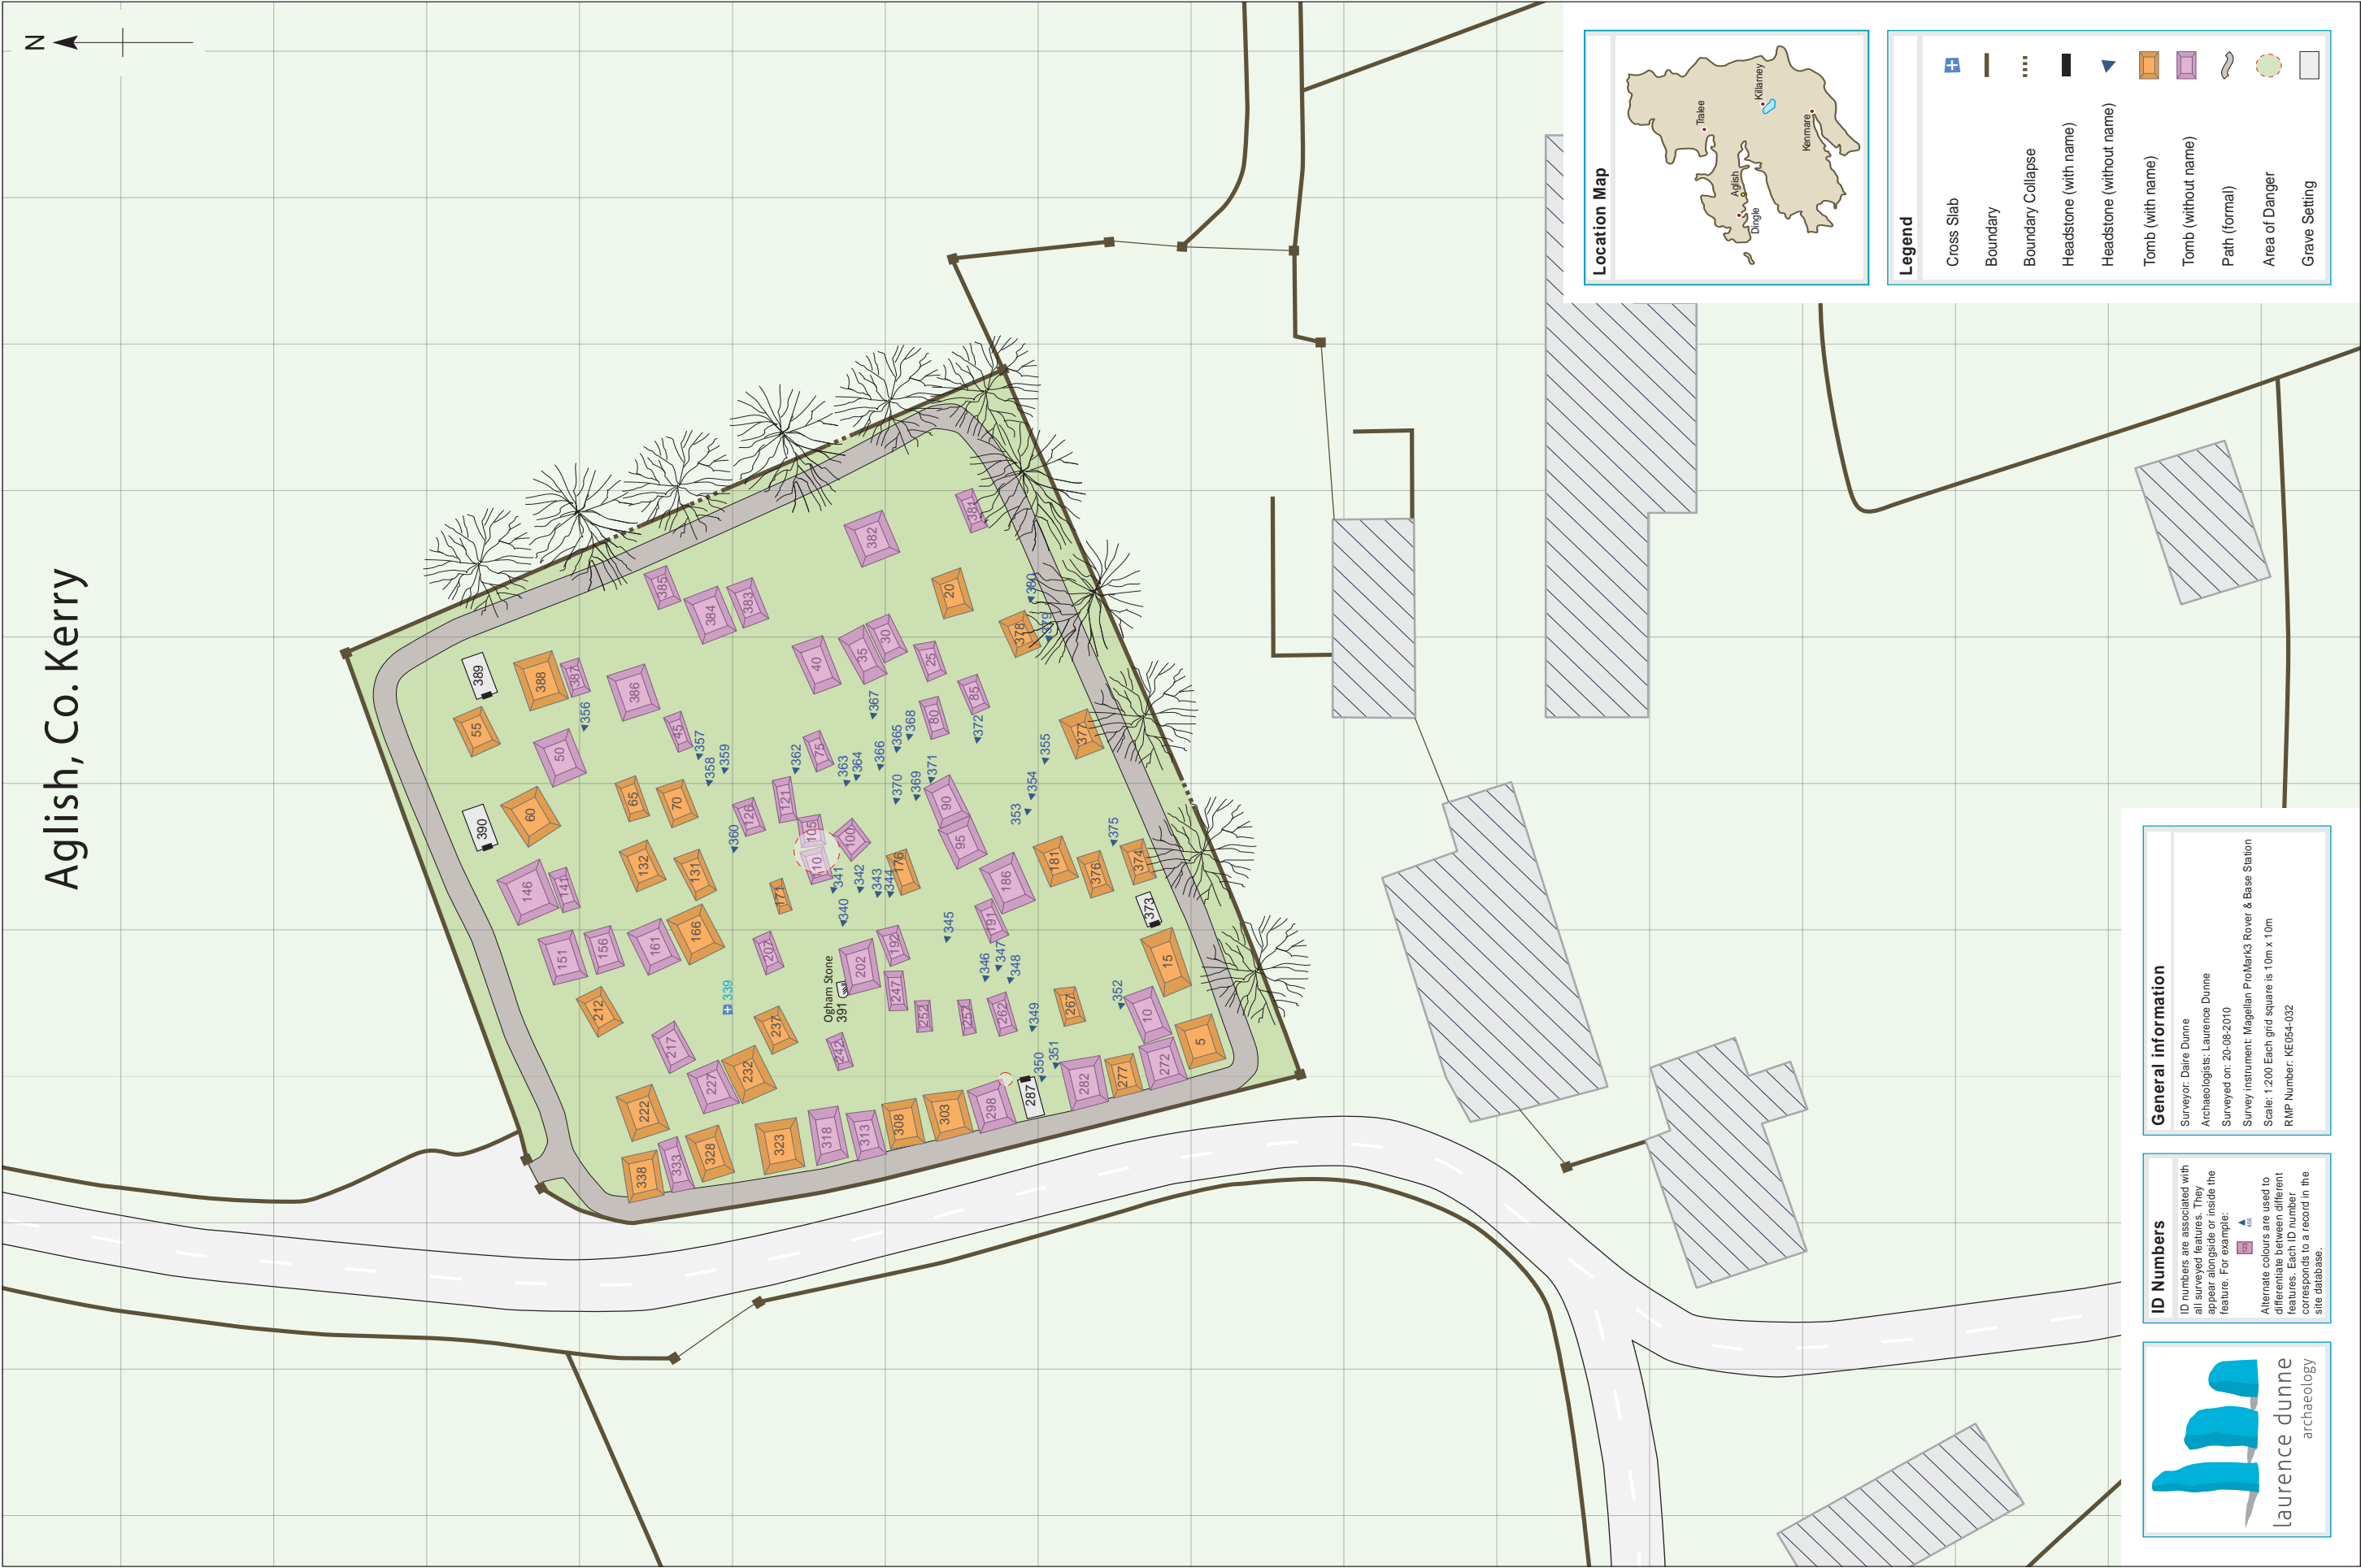
Figure 5: Archaeological survey plan of Aglish Graveyard, 2010.

Aglish Graveyard is little used today and has only three modern formalised grave settings (287, 373, 389, Figure 5). The majority of interments are placed in above ground tombs, seventy six of which were recorded in the course of this survey. Through time many of them have become grassed over and neglected and often lack any named memorial plaque (Plates 2, 3, 7 & 8). There are a few different forms of tomb of which are low 'strong-box' type as well as rectangular, square and house-shaped.

In general the interior of the graveyard is covered bumpy and irregular and difficult to traverse (Plate 10). Indeed one area of ground has collapsed while tomb (105) has partially collapsed (Figure 5).

Aglish graveyard is bounded on three sides (north, east and south) by a low dry stone wall. Mature sycamore trees also run along and beside the interior of the east and south boundary walls (Plate 2, 10, 11 & 12 & Figure 5). In general the low drystone boundary wall is in good order, however, maintenance repairs are required at three areas which have possibly suffered from root action associated with nearby mature sycamore trees (Figure 5 and Plates 10, 11 & 12). The western limits of the graveyard is raised over the roadway that runs north south beside it. This western boundary is protected by a modern galvanised iron fence (Plates 8 & 13).

- Focused archaeological / historic architectural conservation and repairs should be undertaken on the damaged, partially covered and grass covered named and unnamed tombs.

- All vegetation on the tombs should be cut back and removed. The tombs should then be repaired re-pointed, re-rendered and restored sensitive to their original construction. This work should be done under the supervision of an archaeologist qualified in this area or a conservation architect experienced in this field and may require Ministerial Consent.

- Repairs to the dry stone boundary wall should be undertaken by people with a proven track record in repairing dry stone walls.
- The mature sycamore trees should be trimmed or coppiced by a professional tree surgeon.

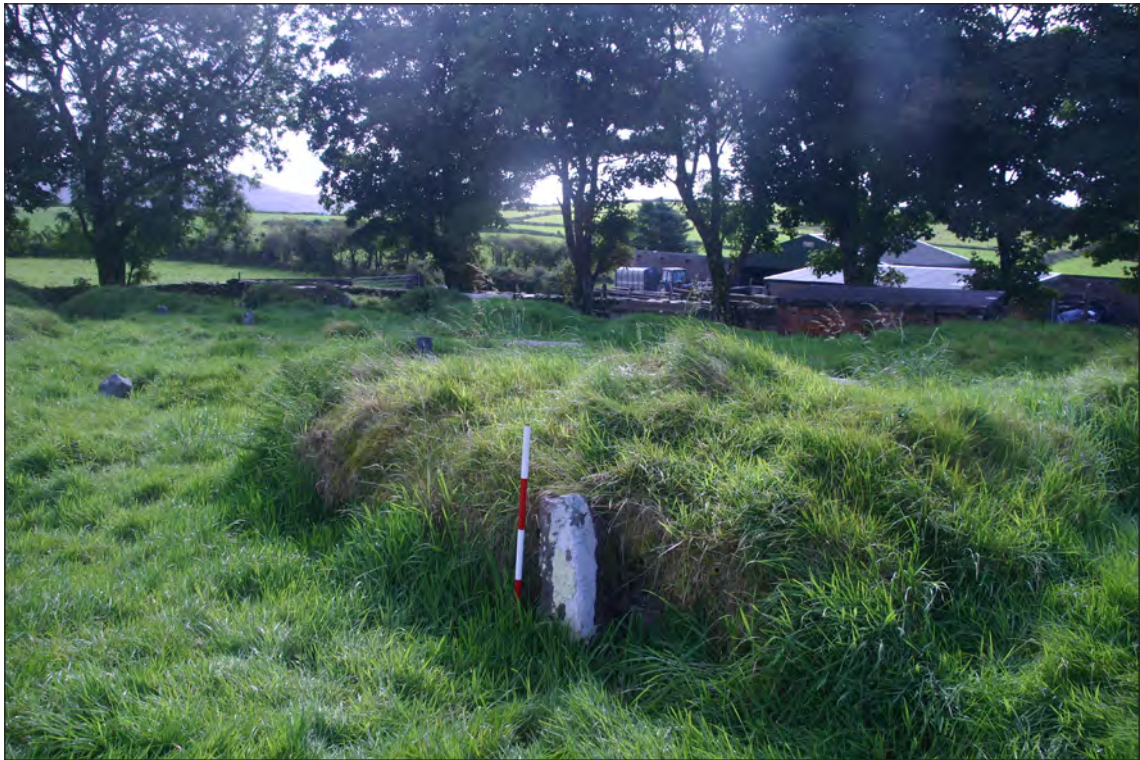
Plate 3: View of ogham stone (391) beside grass covered tomb (202) in Aglish Graveyard

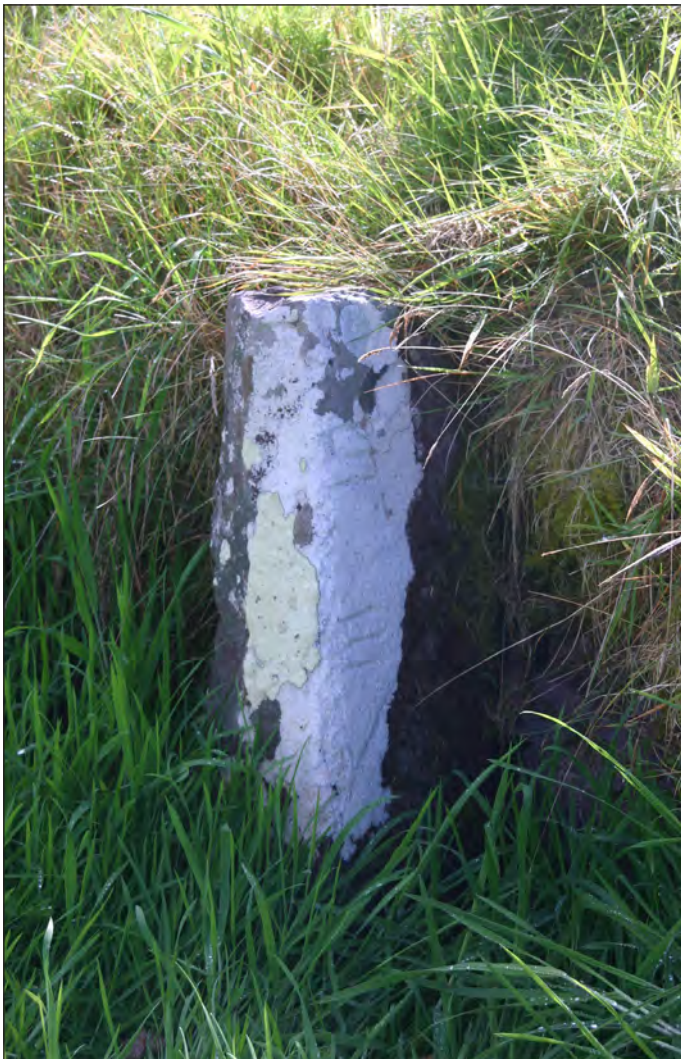
Plate 4: Close-up view of ogham stone (391)

A copy of the cross inscribed ogham stone now on display in the NMI should replace the original at Aglish cemetery.

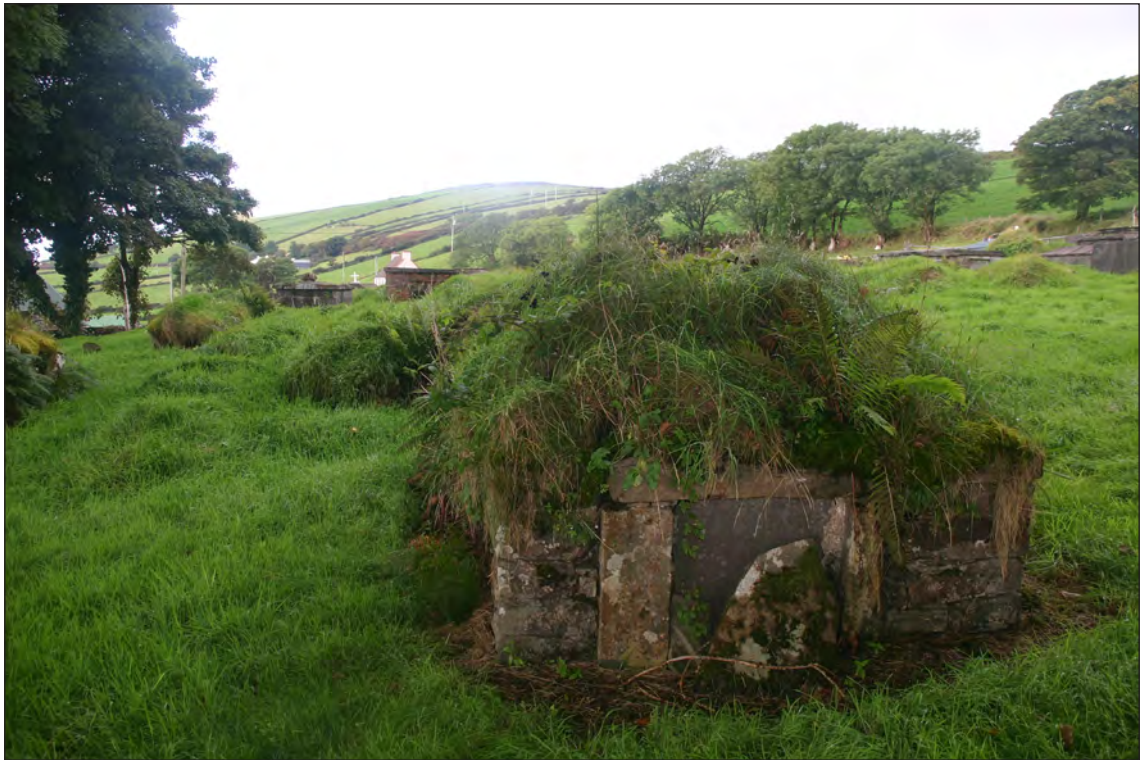
Forty-seven unnamed tombs (Appendix 2 & Figure 5) were recorded in various states of preservation. Many are constructed with rubble sandstone, brick and concrete blocks and are generally rendered or capped with rectangular flag stones. However, there are many more tombs that are partially covered by grass or indeed survive as grass covered mounds (Appendix 2 & Plates 7 & 9-10).

Plate 7: View of partially covered unnamed tomb (382) in south-eastern limits of Aglish Graveyard

The grass partially covering some of the tombs should only be fully removed as the primary element of an agreed inclusive strategy of repairs and other conservation and restoration works. Tombs that are fully covered in grass should be cut back for further evaluation to determine the nature and extent of further conservation / restoration works. This work should be undertaken with expert archaeological advice and guidance.

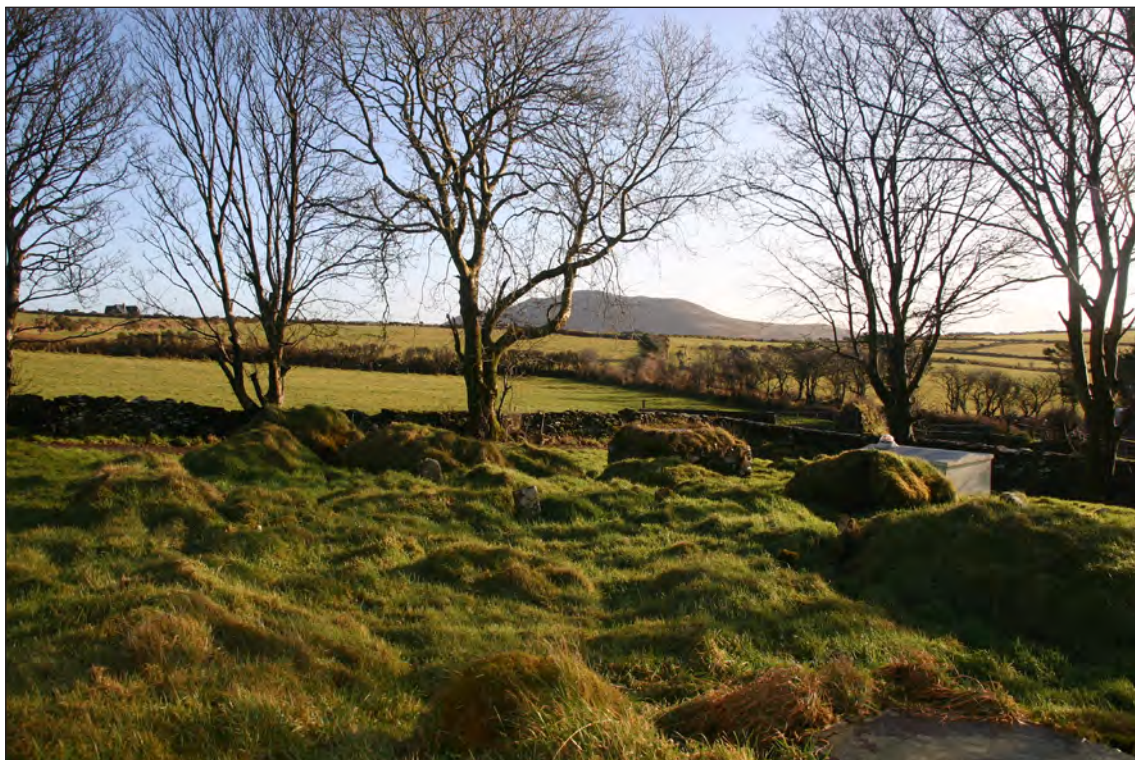
Plate 10: View of the interior of Aglish Graveyard from north-west. Note the very irregular, bumpy ground and grass covered tombs and graves

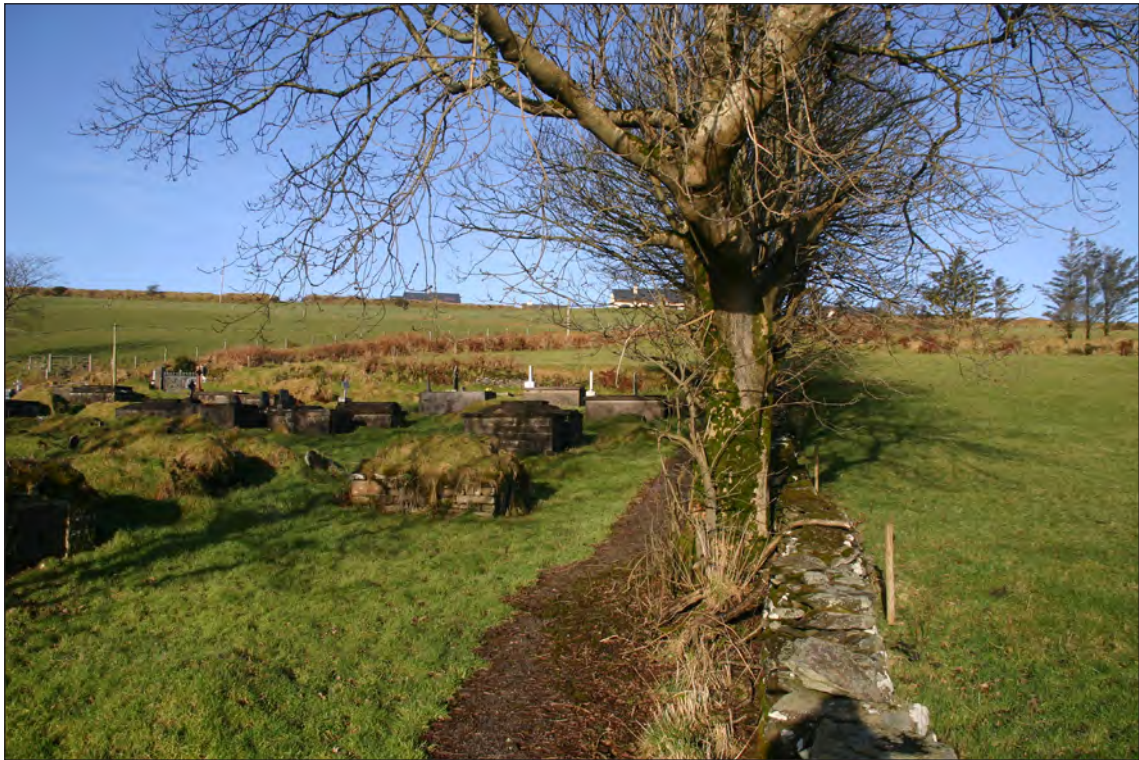
Plate 11: View of eastern boundary wall and interior graveled pathway of Aglish Graveyard. Note the mature sycamore tree abutting the boundary wall

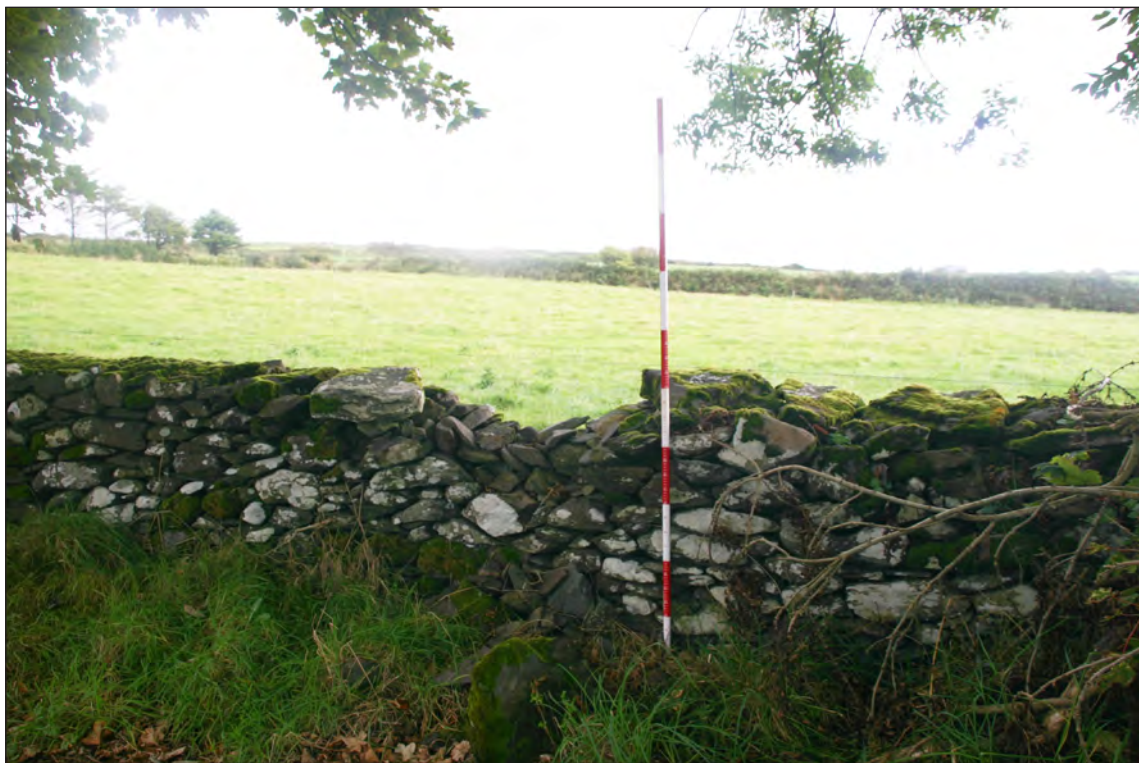
Plate 12: Detail view of damaged and partially breached section of eastern boundary wall

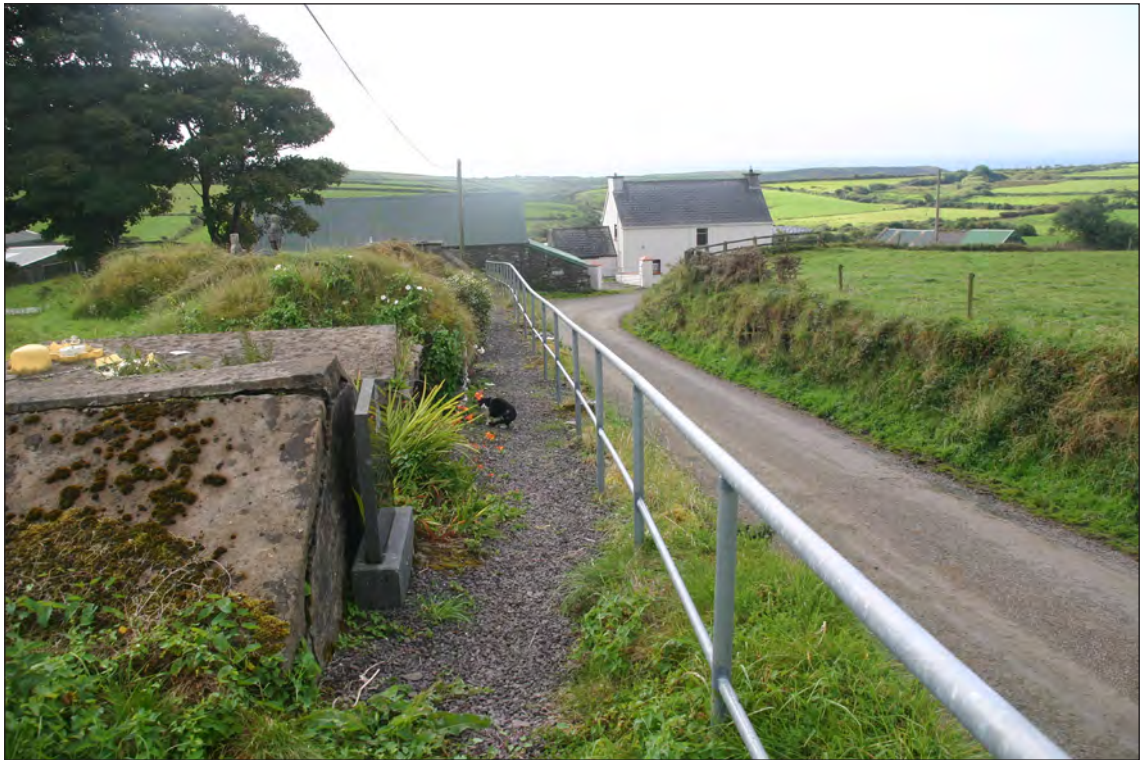
Plate 13: View of western limits of Aglish Graveyard from north. Note gravelled pathway and modern metal protective fence

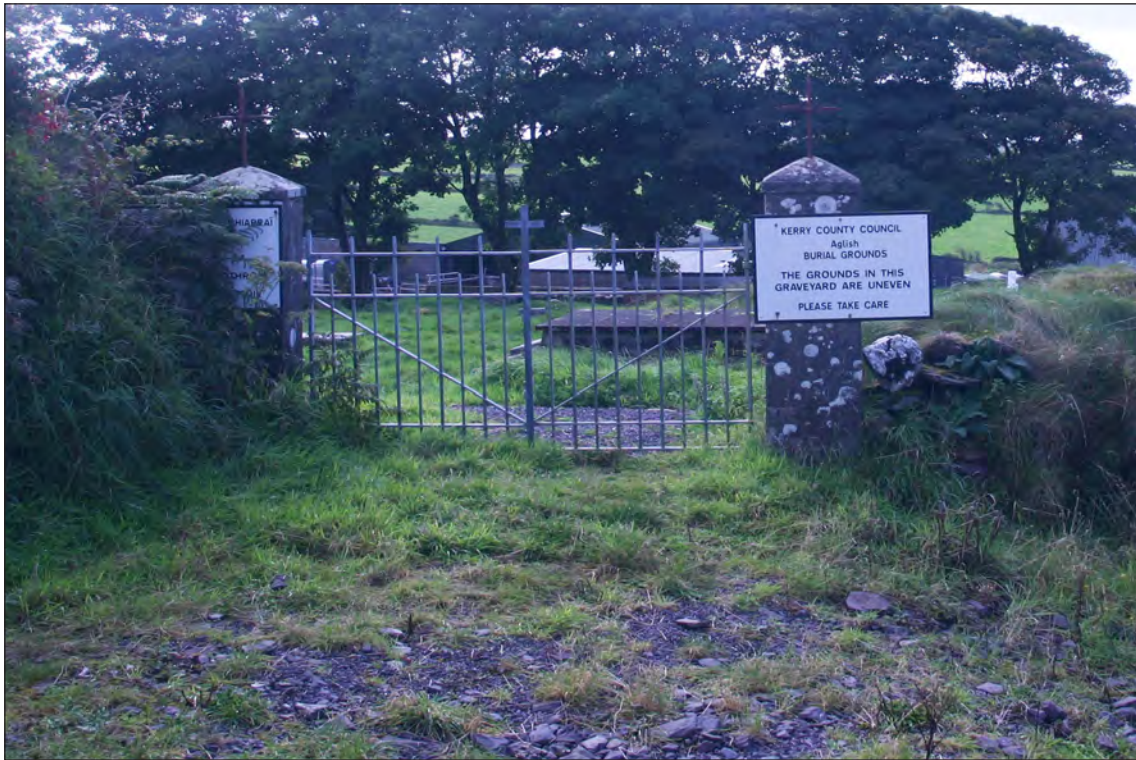
The entrance to Aglish is through a pair of modern galvanised gates that are set between two square, capped and rendered piers (Plate 15). The right or western pier is tilting and part of its render has fallen. There is no stile access into the graveyard.

Plate 15: External view of entrance gates to Aglish Graveyard

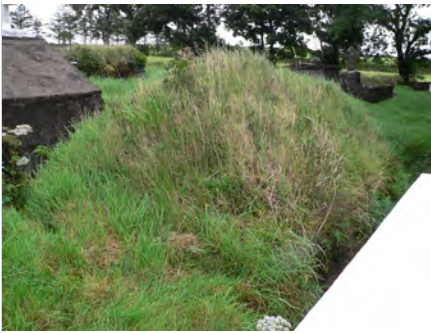
Tomb No:	2
Photo No:	152_0825
Photo:

Notes:	
Collapsed	N
Open	N
Rendered	N
Overgrown	Y

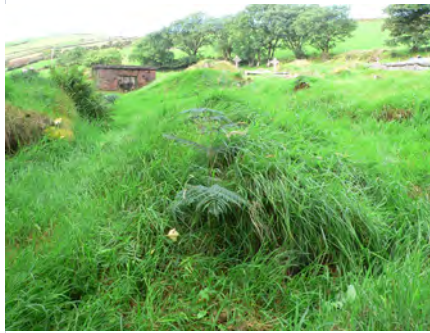
Tomb No:	25
Photo No:	152_0843
Photo:

Notes:	
Collapsed	N
Open	N
Rendered	N
Overgrown	Y

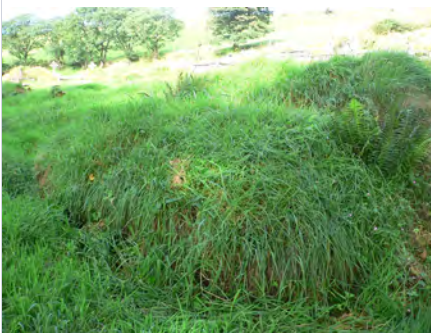
Tomb No:	30
Photo No:	152_0847
Photo:

Notes:	
Collapsed	N
Open	N
Rendered	N
Overgrown	Y

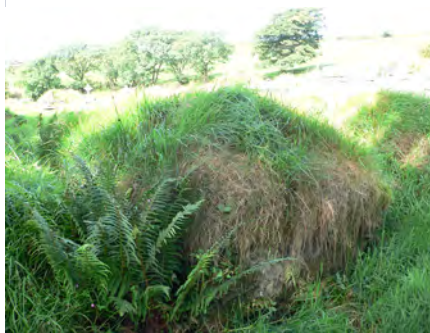
Tomb No:	35
Photo No:	152_0848
Photo:

Notes:	
Collapsed	N
Open	N
Rendered	N
Overgrown	Y

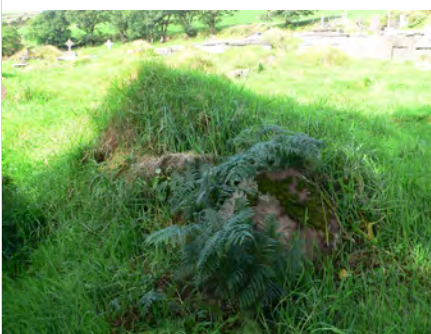
Tomb No:	40
Photo No:	152_0849
Photo:

Notes:	
Collapsed	Y
Open	Y
Rendered	N
Overgrown	Y
