Archaeological Survey,
Annagh Graveyard,
Blennerville,
Co. Kerry.

October 2008

Client: The Heritage Office,
Kerry County Council,
County Buildings,
Ratass,
Tralee,
Co. Kerry.

RMP No.: KE038-003

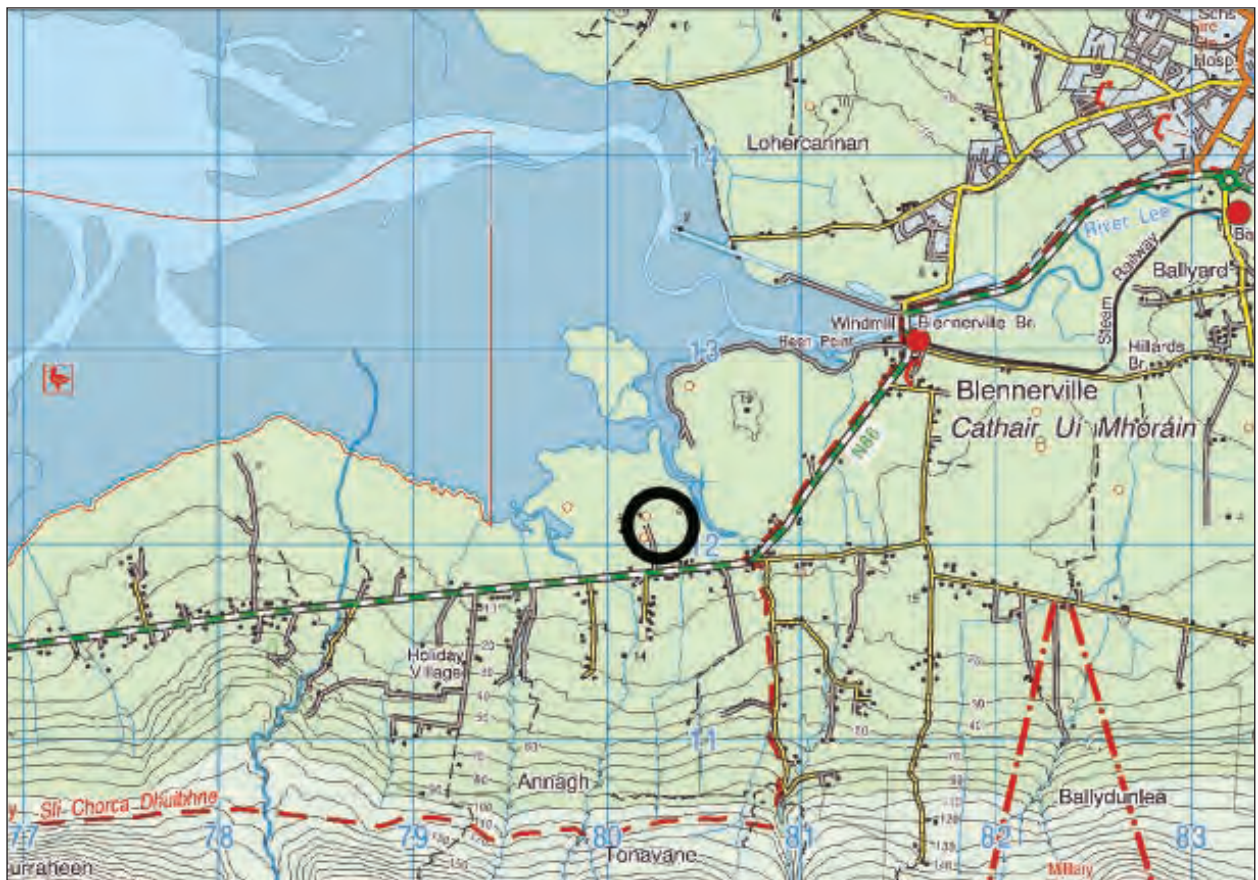
Figure 1: Plan of Annagh graveyard 2008.

Annagh graveyard was surveyed using a Trimble Pro X-H GPS (Figure 1). The survey is linked to GPS and tied into the National Grid. The graveyard plan was produced using Adobe Illustrator. Reference numbers mentioned in the main body of the report relate to the ID point given when the survey was undertaken (see attached A1 plan). A digital photographic record and surname database was also compiled to complement the cartographic survey (Appendices 1 - 7). Photographs of the features within the graveyard are referenced in the appendix and all photographs are provided on the attached disc.

Unnamed headstones are grouped together with the unnamed gravemarkers on the plan of the graveyard (Figure 1).

Gravemarkers are grouped together with the unnamed headstones on the plan of the graveyard (Figure 1)

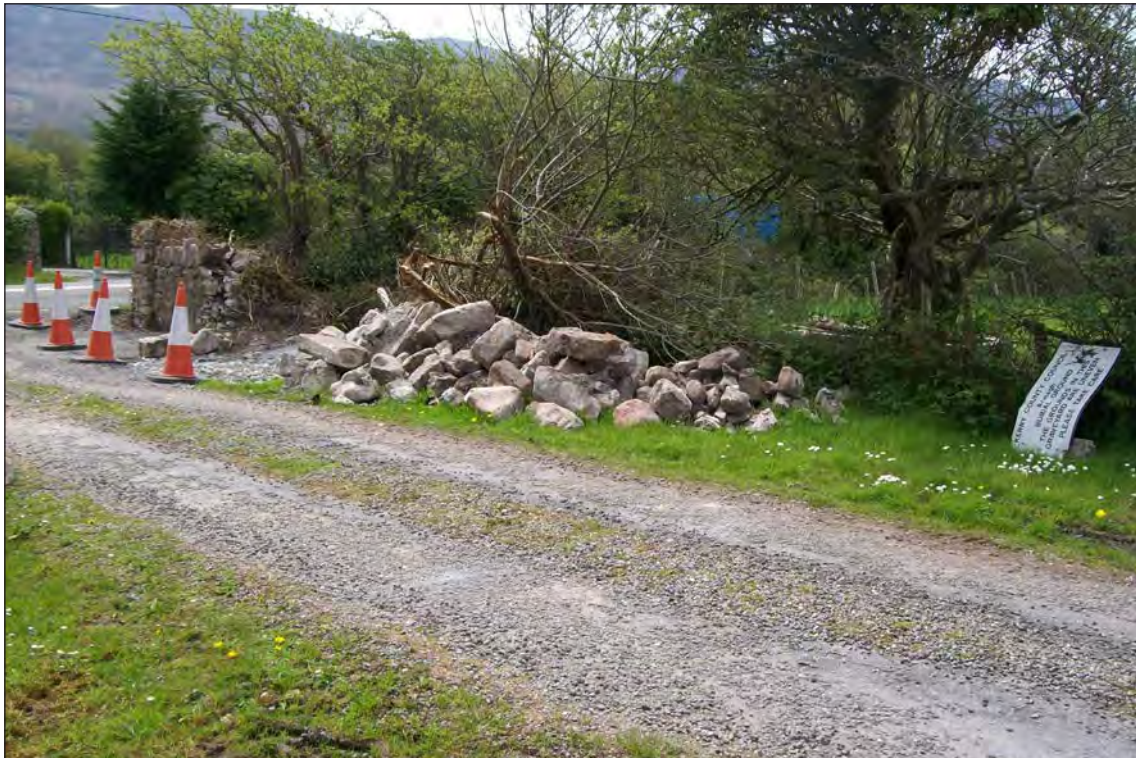
The entrance piers, walls and gates have been recently demolished by workers from Kerry County Council apparently as part of refurbishment works. The rubble stone remains im-

mediately inside the entrance and these walls and piers should be reinstated as soon as possible, with the signage for the graveyard which is currently cast aside by the hedgerow, clearly displayed on the exterior (Plate 3).

Plate 3: View of recently demolished entrance piers adjacent to N86 from northeast

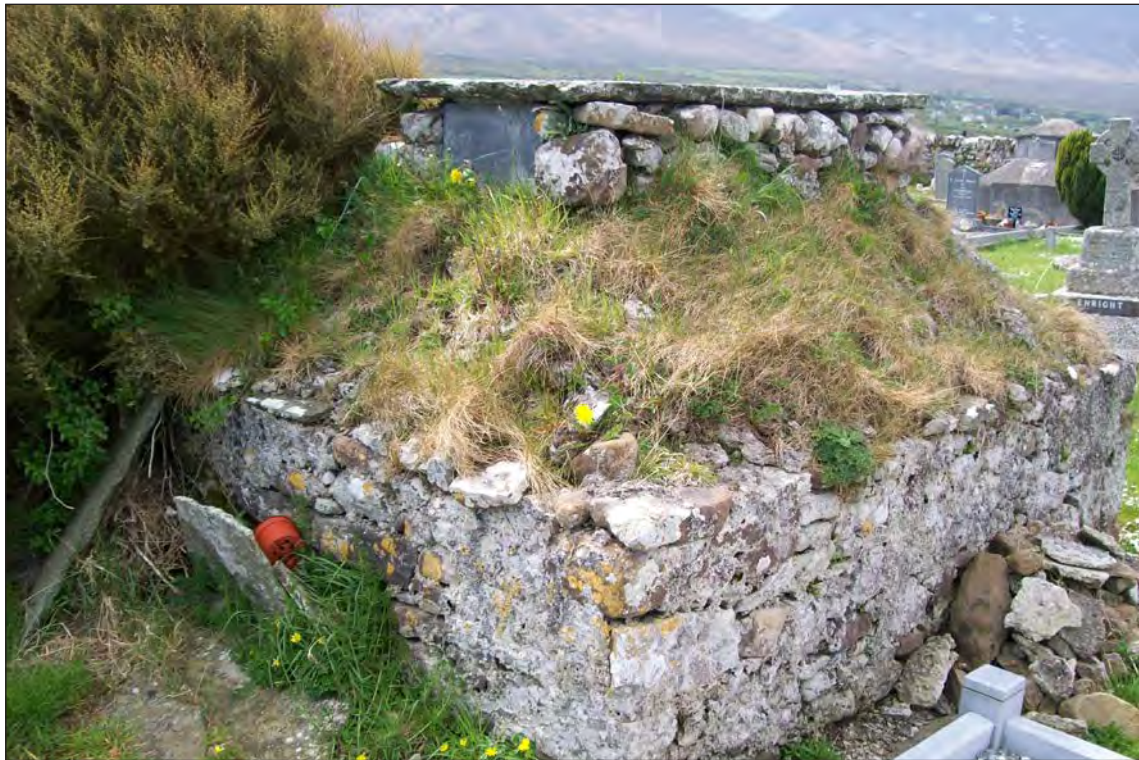
The Gace-Forther tomb (ref. no. 272), located to the southeast of the church and dating from 1825, is very overgrown with grass and part of the rubble stone construction is exposed (Plate 8).

Plate 8: View of Gace-Forthier tomb (ref. no. 272) from northeast

The overgrowth on the Gace-Forther tomb (ref. no. 272) should be removed under archaeological supervision, and the tomb sensitively repaired with matching and appropriate materials by qualified persons.

- The overgrowth on the Gace-Forther tomb (ref. no. 272) should be removed under archaeological supervision, and with the tomb repaired sensitive to its original construction. This work may require Ministerial Consent.

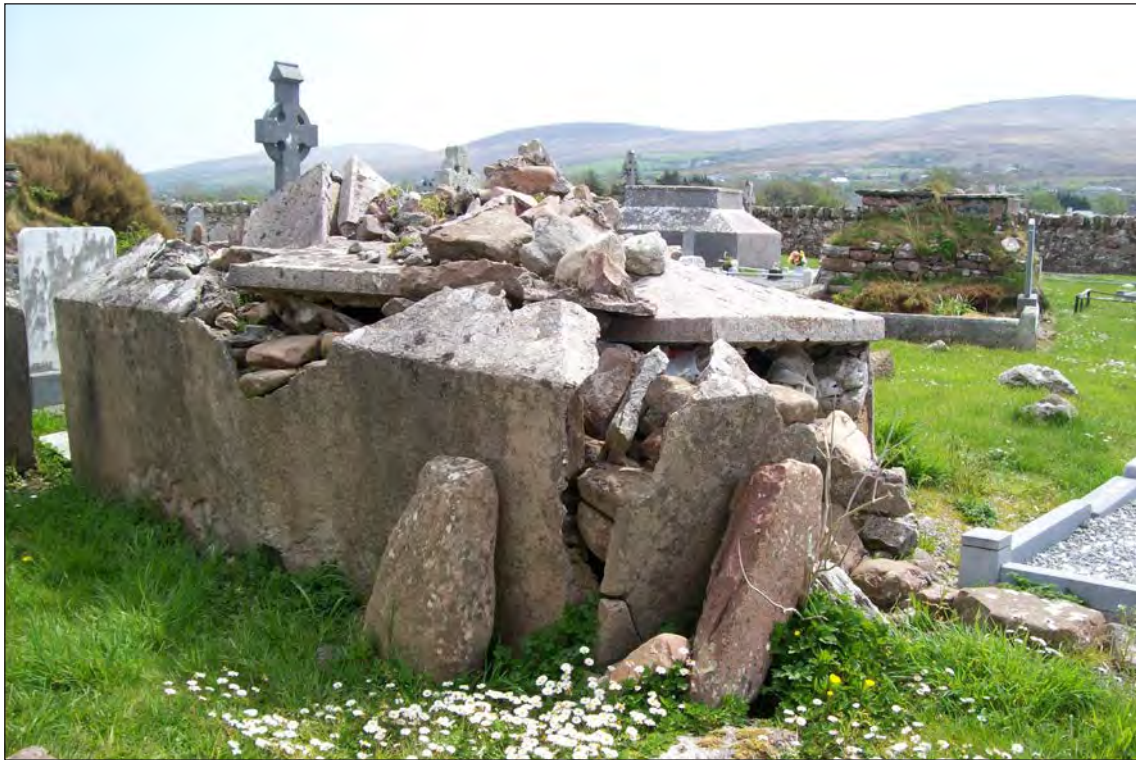
The O' Hanlon tomb (ref. no. 278) is located to the south of the church. This is in an extremely poor condition. Large rubble stones, concrete and other rubble debris have been dumped on top of the tomb contributing to its collapse (Plate 9).

Plate 9: View of the O' Hanlon tomb (ref. no. 278) from northwest

Focused targeted archaeological remedial work possibly associated with limited excavation should be undertaken for the O' Hanlon tomb which is collapsed and buried under rubble stone.

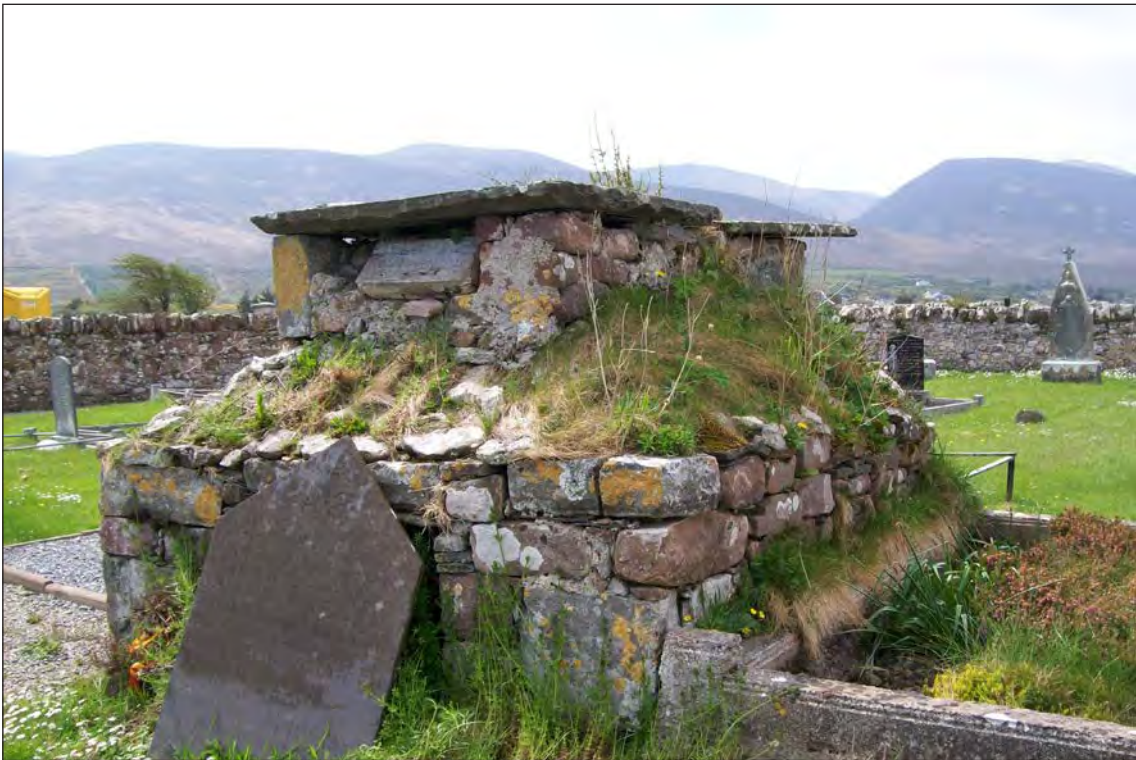
Tomb ref. no. 269 is located to the south of the church and is in poor condition. It is heavily overgrown which has caused some of the stones to loosen. A temporary wooden name plaque is no longer legible (Plate 10).

Plate 10: View of unnamed tomb (ref. no. 269) from northeast

A permanent name plaque should be fixed onto Tomb ref. no. 269 in place of the wooden engraving which is no longer discernible.

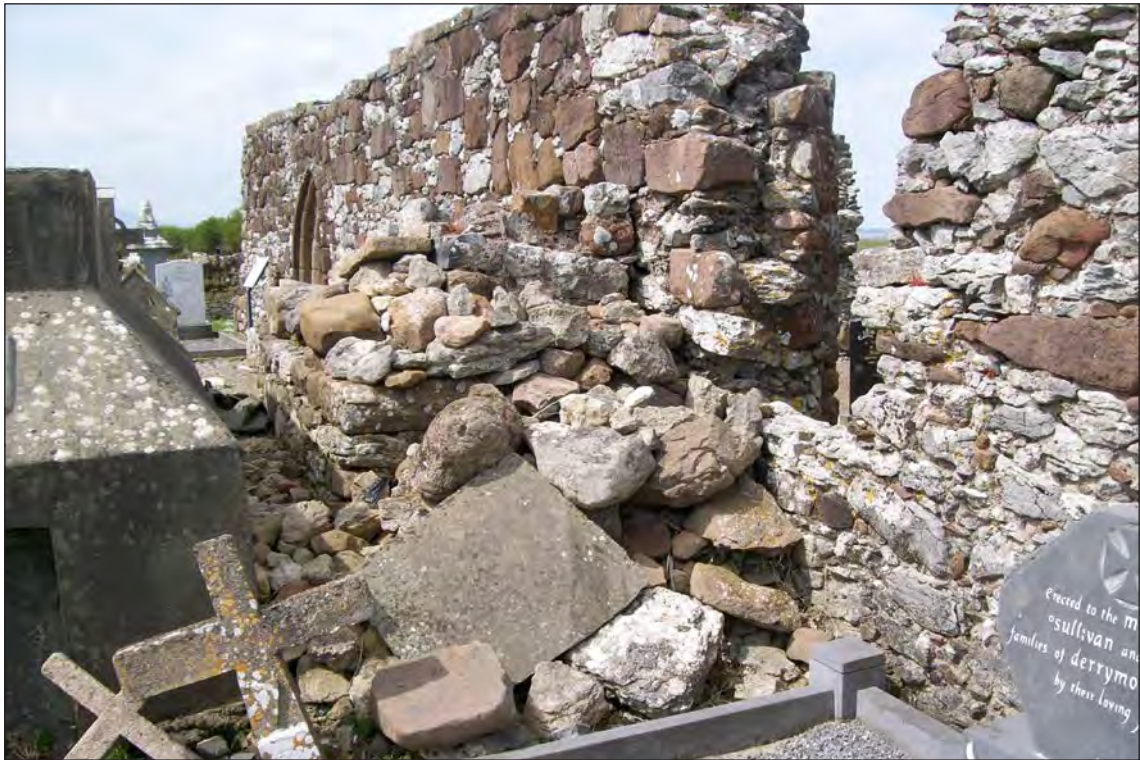
Tomb ref. no. 276 abuts the easternmost window on the southern elevation of the church on its exterior. This is in a poor state of preservation which is further negatively impacted by the dumping or collapse of rubble stone from the relict church and from other areas on top of it (Plate 11).

Plate 11: View of unnamed tomb (ref. no. 276) from east

Focused targeted archaeological remedial work possibly associated with limited excavation should be undertaken where tomb ref. no. 276 is collapsed and buried under rubble stone. This work may require Ministerial Consent.

The tomb can then be reconstructed, repaired and repointed sensitive to their original construction. This work may require Ministerial Consent.

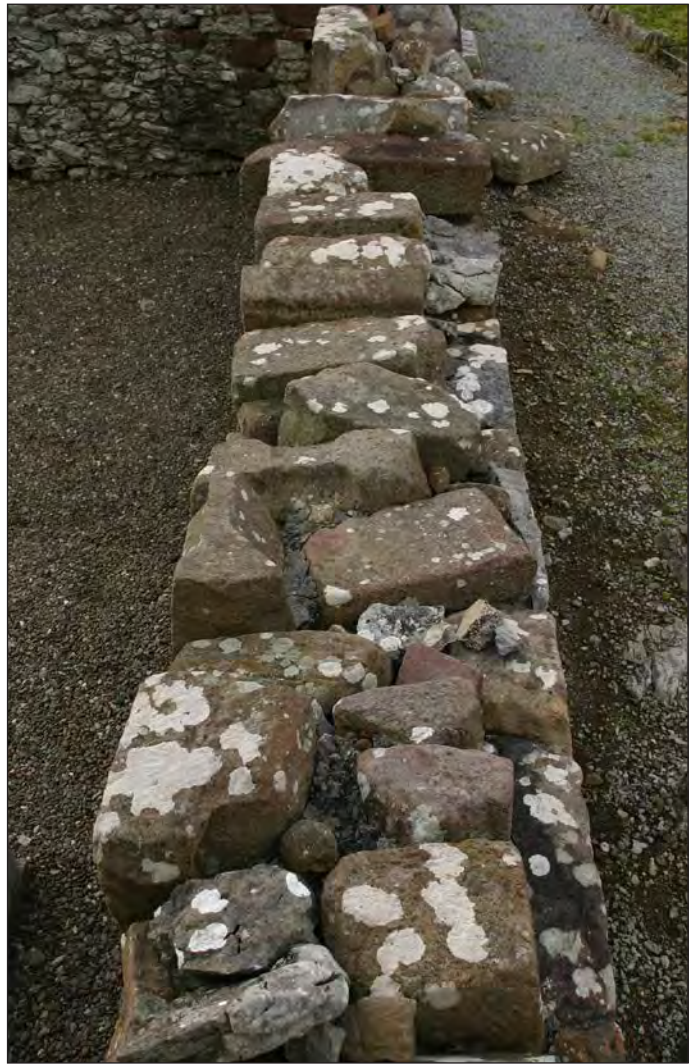
Plate 15: View of architectural fragments
along western elevation from north

There were at least twenty six ex situ architectural fragments noted of which twenty four are currently lying loose on or partially inserted into the partially rebuilt west gable of the medieval church. All of the fragments are dressed structural masonry executed in local red sandstone. Several are quite large and would be difficult to remove, however, others are small and could easily be removed. Several comprise the splayed ingoings of a window embrasure as well as at least one complete cill stone. A broken stoop was also noted partially set within the reduced fabric at the extreme southwest angle of the church (Plate 15 & 16). Another unremarkable fragment was recorded within the church interior painted in white (Plate 17). A further, chamfered piece, possible section of a string course, is set as a grave marker immediately in front of or to the east of the Gace-Forther (ref. no. 272) tomb (Plate 18). It is most likely that several other medieval masonry fragments have been built into nearby tombs and care should be given to the recovery of such pieces if and when these tombs may be refurbished.

The western elevation appears to have been reconstructed in the twentieth century and stands at less than 1m in height at present (Plate 27). The entire upper limits of it comprise at least twenty four ex situ architectural fragments (Plates 15 & 16), some of which are of significant importance to understanding the finer architectural details of this medieval church which appear to be quite early.

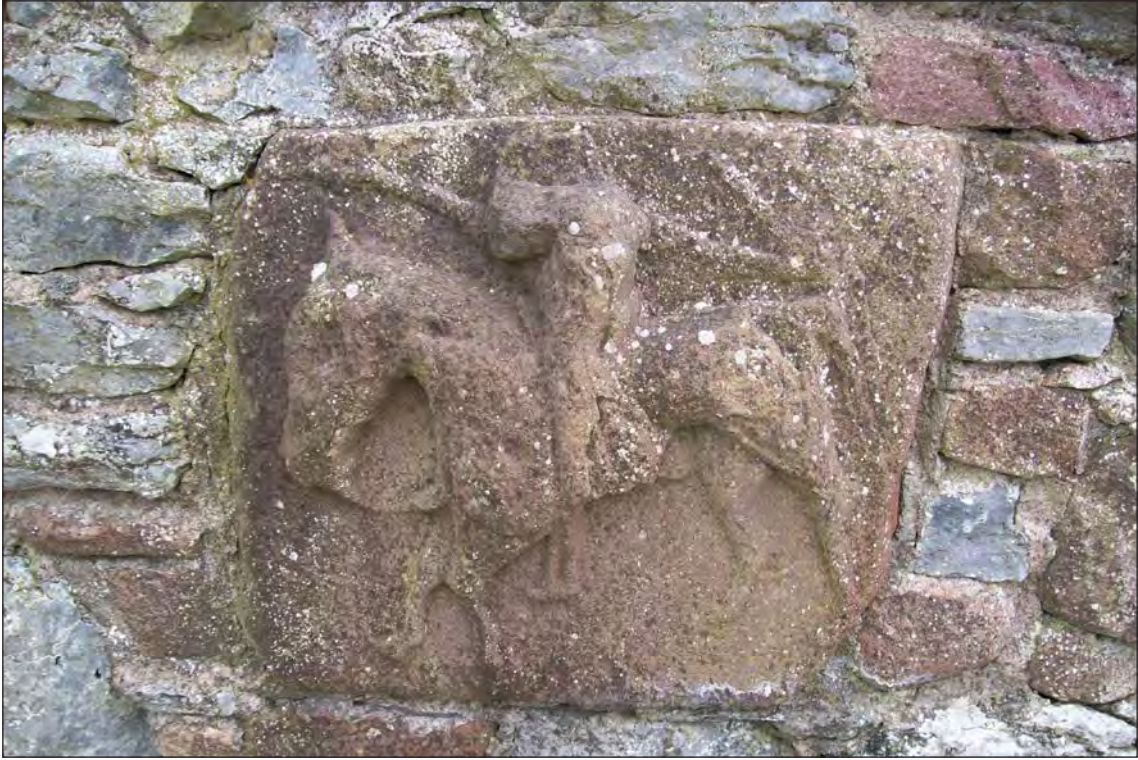
A decorated sandstone has been incorporated into the fabric of the interior southern elevation, to the immediate east of the doorway (Plate 19). The stone, carved in relief, comprises a knight wearing a surcoat with sword scabbard also visible. The knight mounted on a bridled horse with typical high fronted and high backed saddle and stirrup is apparently wielding a spear in his right hand. Peter Harbison (1973, 11) has determined the spear to be a short sword with straight cross, however this is difficult to understand. Hayward interprets the weapon as a scythe and on first impression this looks the case but obviously this cannot be (Hayward, 1970, 271). The carving appears to indicate movement or the commencement of attack, Hayward refers to it as *a lively horse* (ibid). The head and left shoulder of the knight are partially destroyed. The carving possibly dates to the 14th century and likely to be contemporaneous with the medieval parish church.

Plate 19: View of decorated stone on interior southern elevation of church

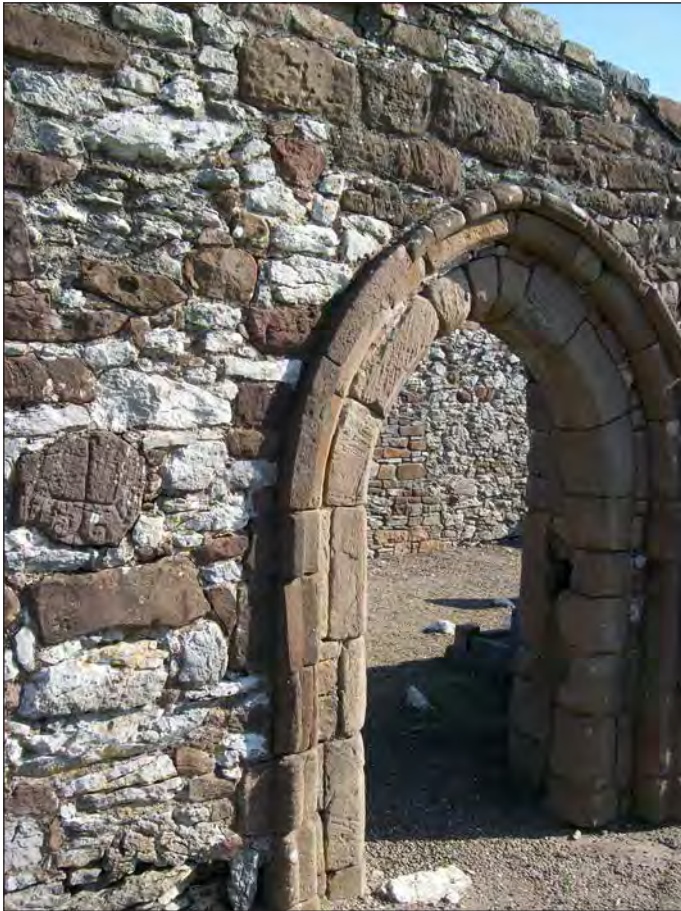
On the exterior southern elevation, to the west of the entrance doorway is an early medieval cross inscribed stone or slab (Plate 20). The sub-circular slab measures 0.30m maximum width which tapers to 0.19m at its western end, and 0.35m in length. The cross slab, which is damaged at the bottom left, comprises an unequal armed cross enclosed within the remains of a circle. It has bifurcated terminals to both side arms. The upper longer arm has a T bar terminal. The bottom of the cross terminates with an attractive outwardly disposed scroll or pelta motif. This type of bottom pelta or scroll is typically found at several locations on the western end of the Dingle Peninsula including Kilshannig, Currauly, Kilmalkedar, Reask etc (Cuppage 1986). The stone was possibly modified before insertion into its current position. The modification impacted on its outer enclosing circle that still survives in part but was retained in principle by its shape. The early medieval carving is undertaken on a much weathered local red sandstone and may date as early as the sixth century AD (*ibid*, 311). The cross slab is the earliest recorded artefact at the site and may reflect an early ecclesiastic foundation there.

Plate 20: View of cross slab in southern elevation

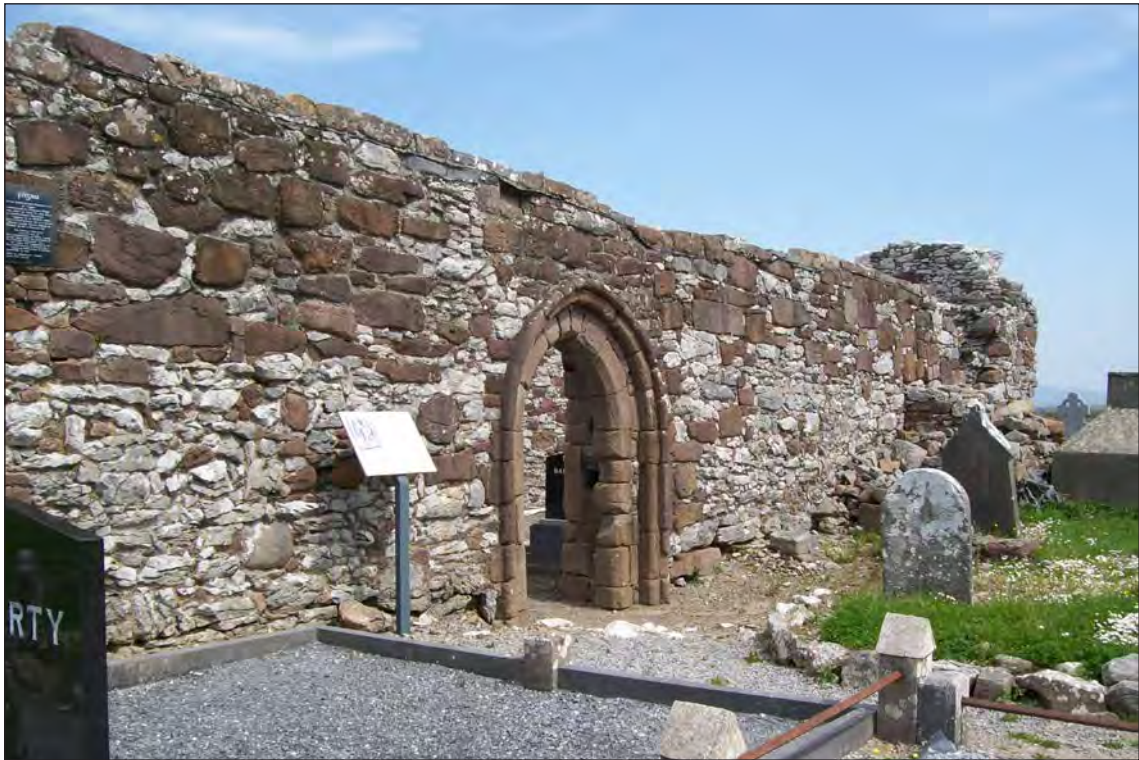
The southern elevation survives more or less to full height but its quoins on both corners are robbed out (Plate 21). A single finely moulded doorway is also located on the south wall and has a pointed arch set in three orders with chamfered edges. The inner door embrasure has a flattened segmental arch in good order with well matched narrow vousoirs. A draw-bar socket is also located at mid height. The sandstones are weathered but still display evidence of punch dressing here and there (Plates 20 & 22). A decorated sandstone carving of a mounted knight is located to the immediate east of the entrance doorway on the interior (see above and Plates 20 & 22).

Plate 21: View of exterior southern elevation

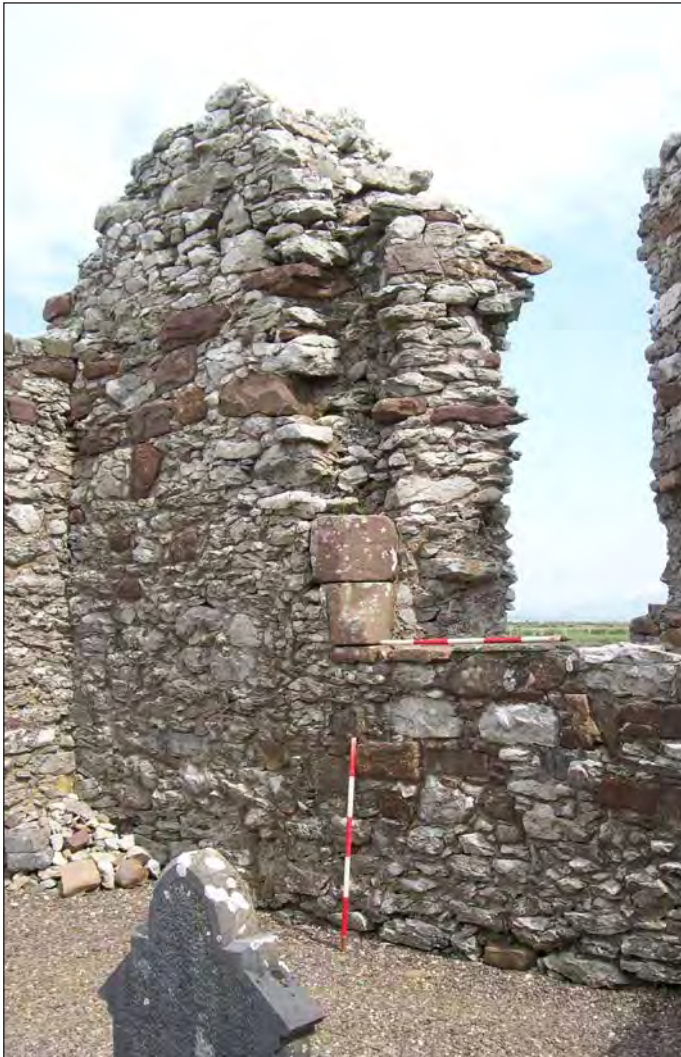
Plate 23: Interior view of window ope in eastern elevation

elevation is lit by a single window ope at its eastern end. Evidence of modern repair work is apparent on the inner window sill (Plate 23).

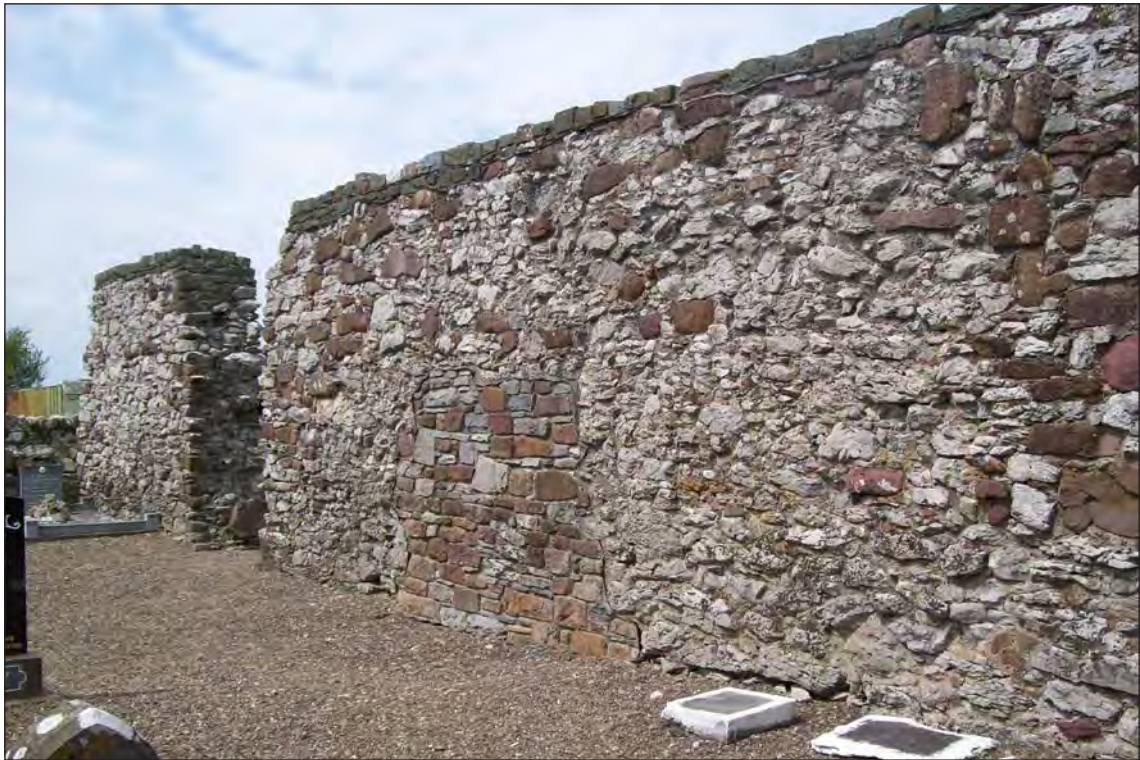
The northern elevation survives to full height although it has a single breach (Plate 25). The western end of the wall survives in poor condition with only three original quoinstones surviving while none survive on the eastern end.

Evidence of modern repair work, in a manner insensitive to the original construction of the building, is apparent to the east of this opening (Plate 25).

Plate 25: View of modern repair work to northern elevation, and large opening of unknown purpose from southeast

Any future repair work on the church should be undertaken with materials and stone sensitive to the original construction of the church.

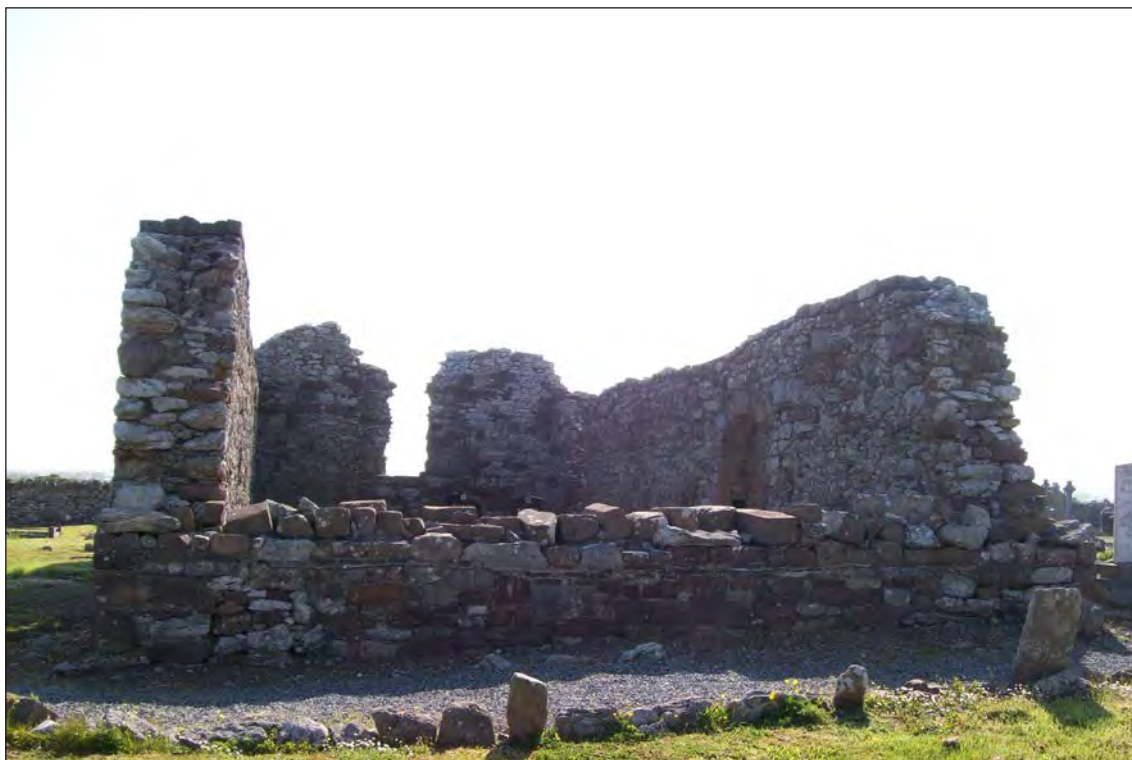
Plate 26: View of blocked up window ope in northern elevation at its eastern end

A possible blocked up window is evident towards the eastern end of this elevation (Plate 26).
