Archaeological Survey,  
Ballynahaglish Church and Graveyard,  
Ankail,  
Co. Kerry

September 2007

Client: The Heritage Office,  
Kerry County Council,  
County Buildings,  
Ratass,  
Tralee,  
Co. Kerry

RMP No.: KE100-015

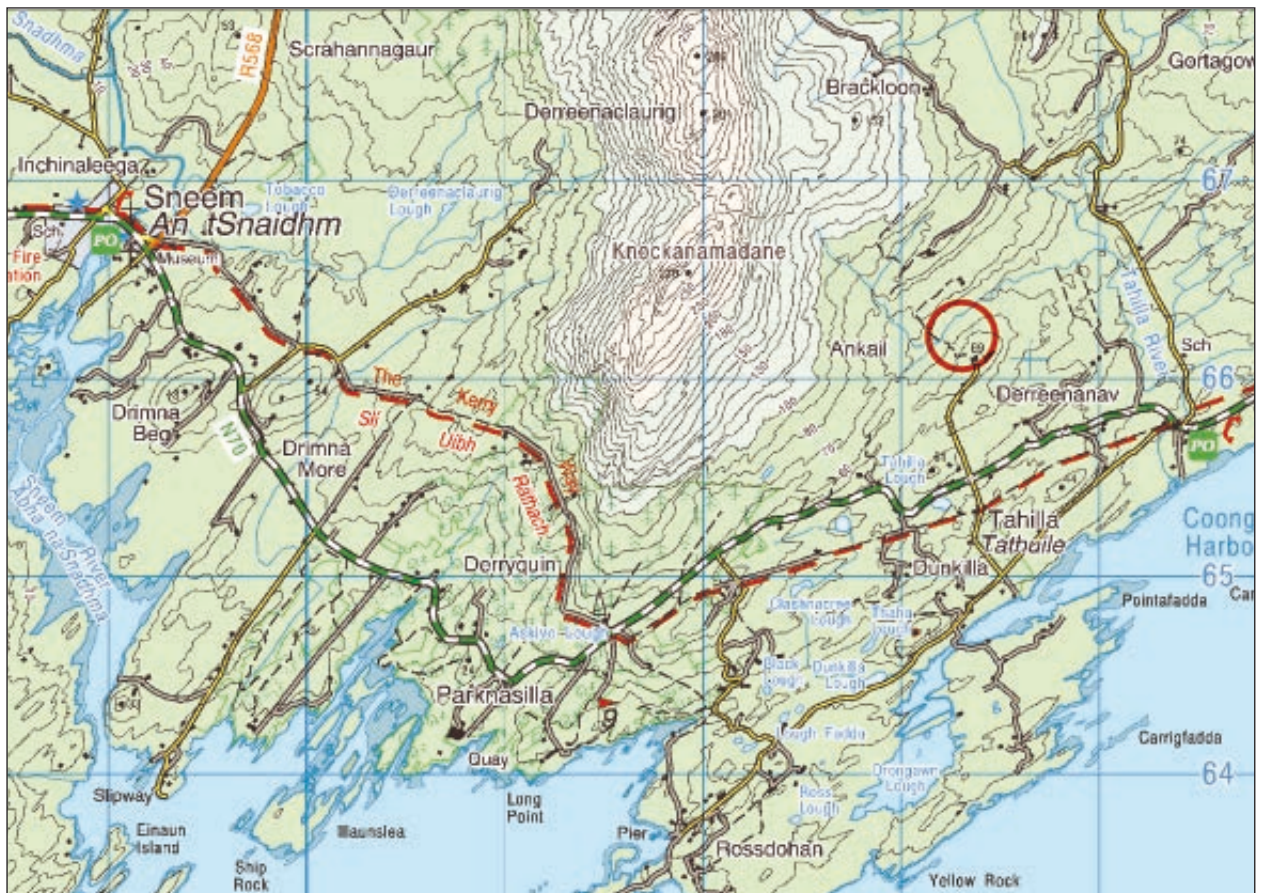
**Figure 1: Plan of Ballynahaglish Graveyard 2007.**

Ballynahaglish graveyard was surveyed using a Trimble Pro X-H GPS (Figure 1). The survey is linked to GPS and tied into the National Grid. The graveyard plan was produced using Adobe Illustrator. Reference numbers mentioned in the main body of the report relate to the ID point given when the survey was undertaken. A digital photographic record and surname database was also compiled to complement the cartographic survey (Appendices 1-5). Photographs of the features within the graveyard are referenced in the appendix and all photographs are provided on the attached disc.

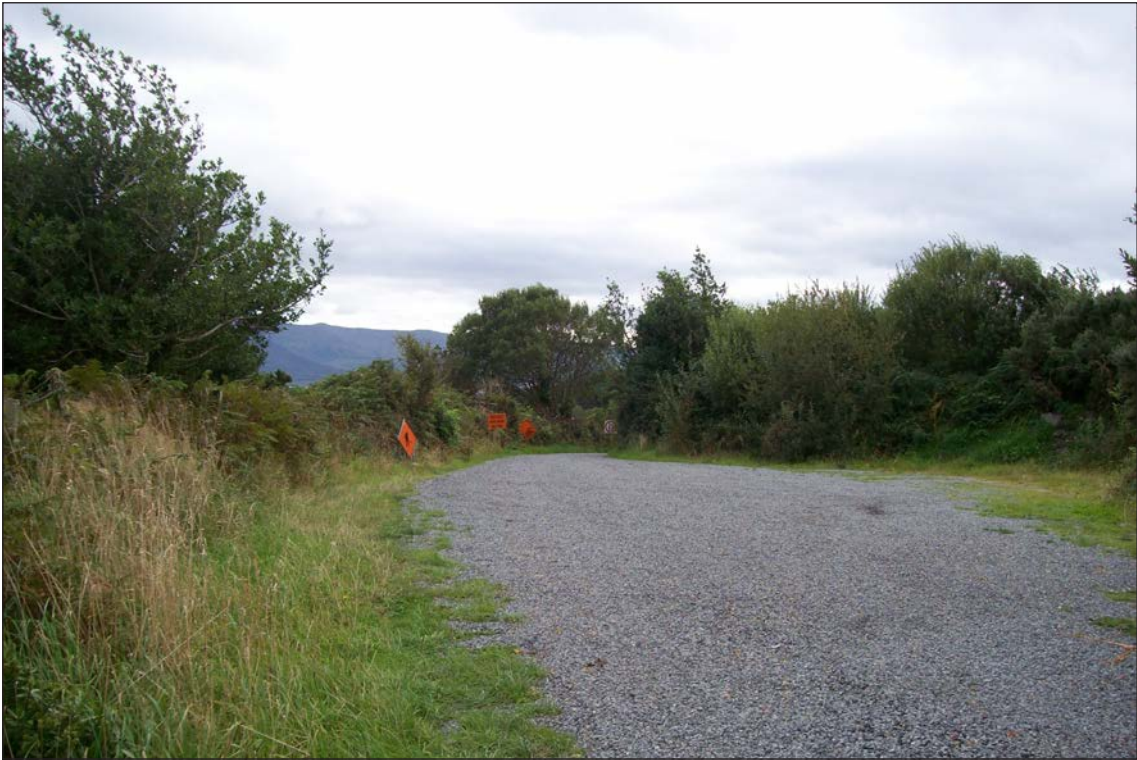
Plate 1: View of approach road to graveyard with parking and turning area for vehicles also visible, taken from north

There is a wide turning area at the graveyard entrance with parking available for a small number of vehicles (Plate 1).

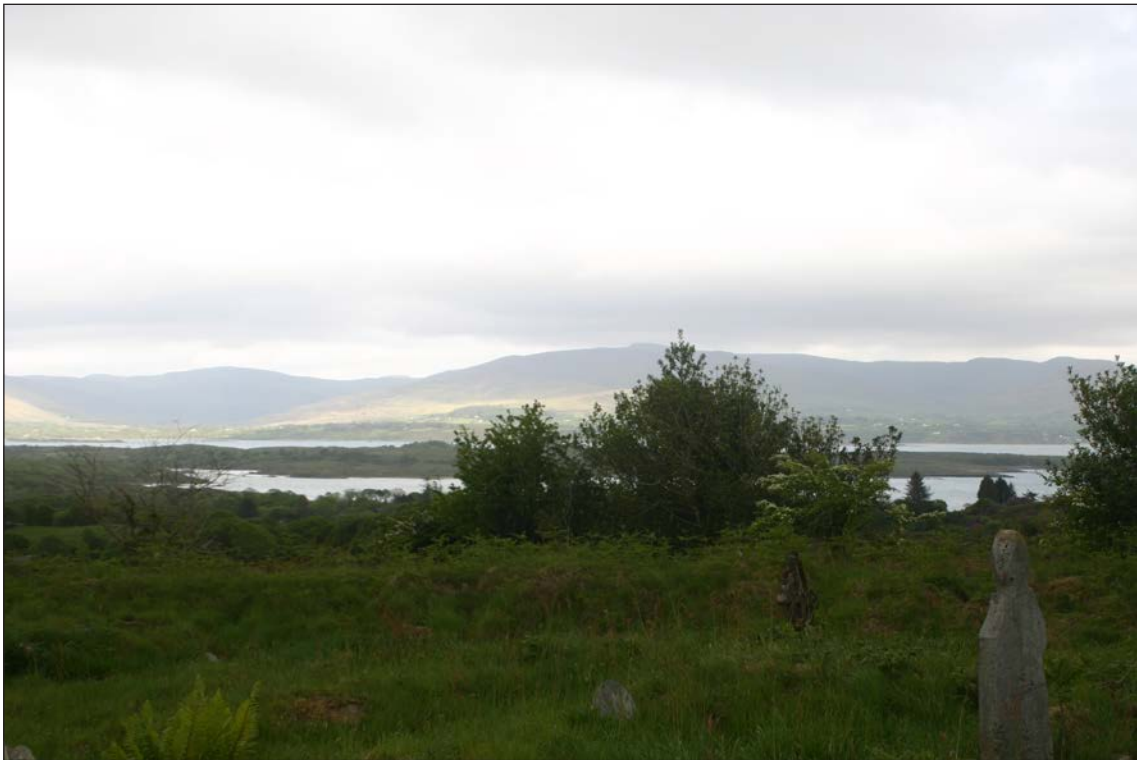
Plate 2: Views to the southeast of the graveyard, taken from northwest

There are extensive views in all directions from the graveyard with the view to the southeast that of Coongar Harbour (Plate 2).

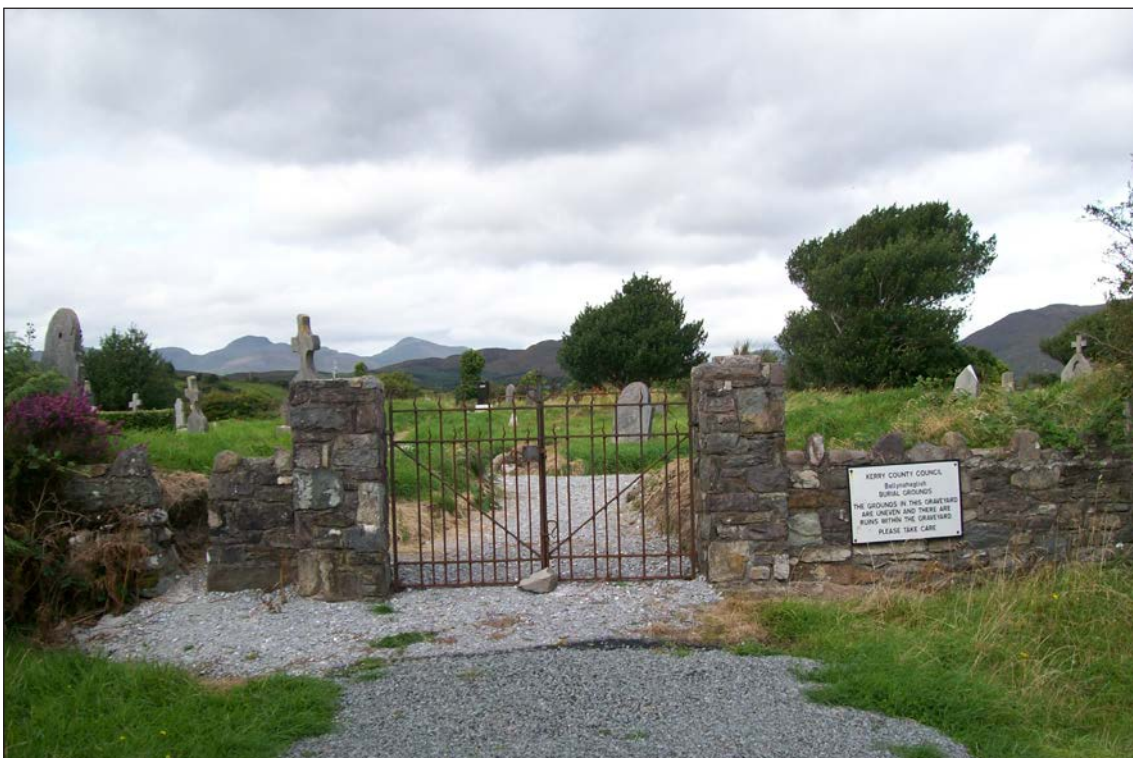
Plate 4: View of southern entrance to graveyard, taken from south

A modern sandstone rubble wall set with a concrete mortar is located on the southwestern side (Plate 4).

The wall is 1m in height and 0.4m in width.

The boundaries are very overgrown on the interior and as such, the dense tree and bramble cover should be cut back and removed on the northern and southern boundaries. The western and eastern boundaries would benefit from regular grass cutting and maintenance.

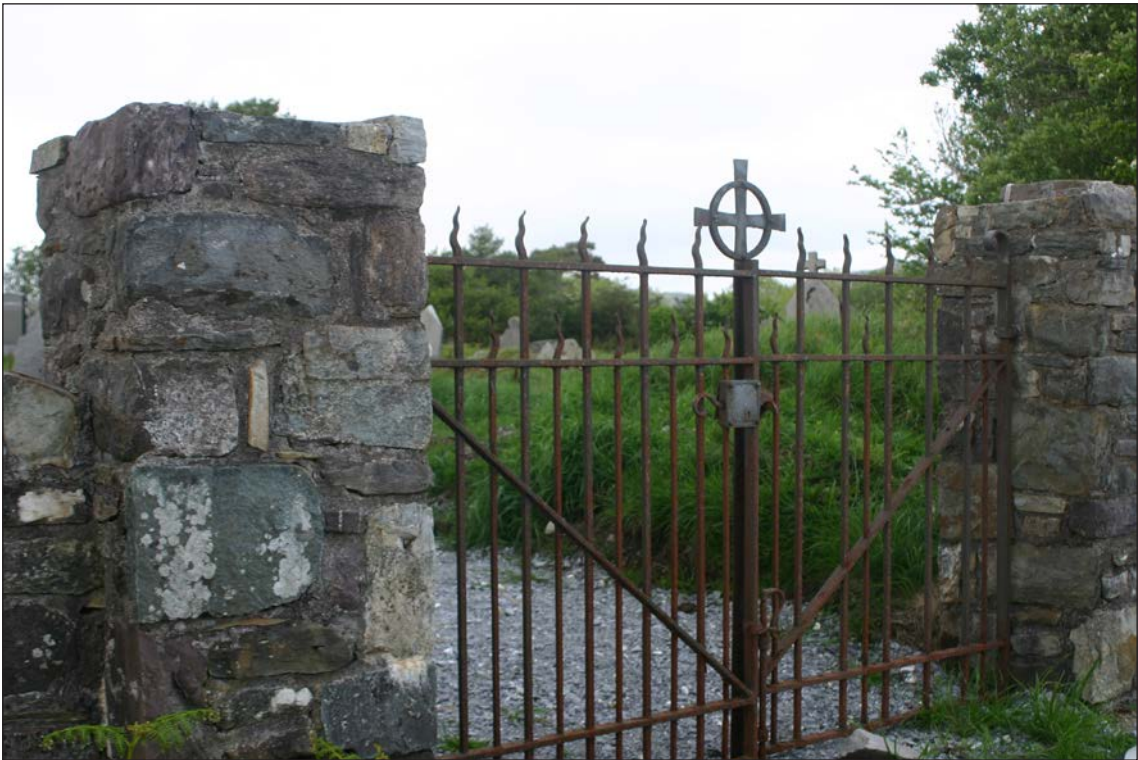
Plate 5: View of entrance gate to graveyard, taken from southwest

The modern iron double entrance gates are set between two sandstone piers with no capping (Plate 5).

A simple metal cross is fixed on the top of one of the entrance gates (Plate 5).

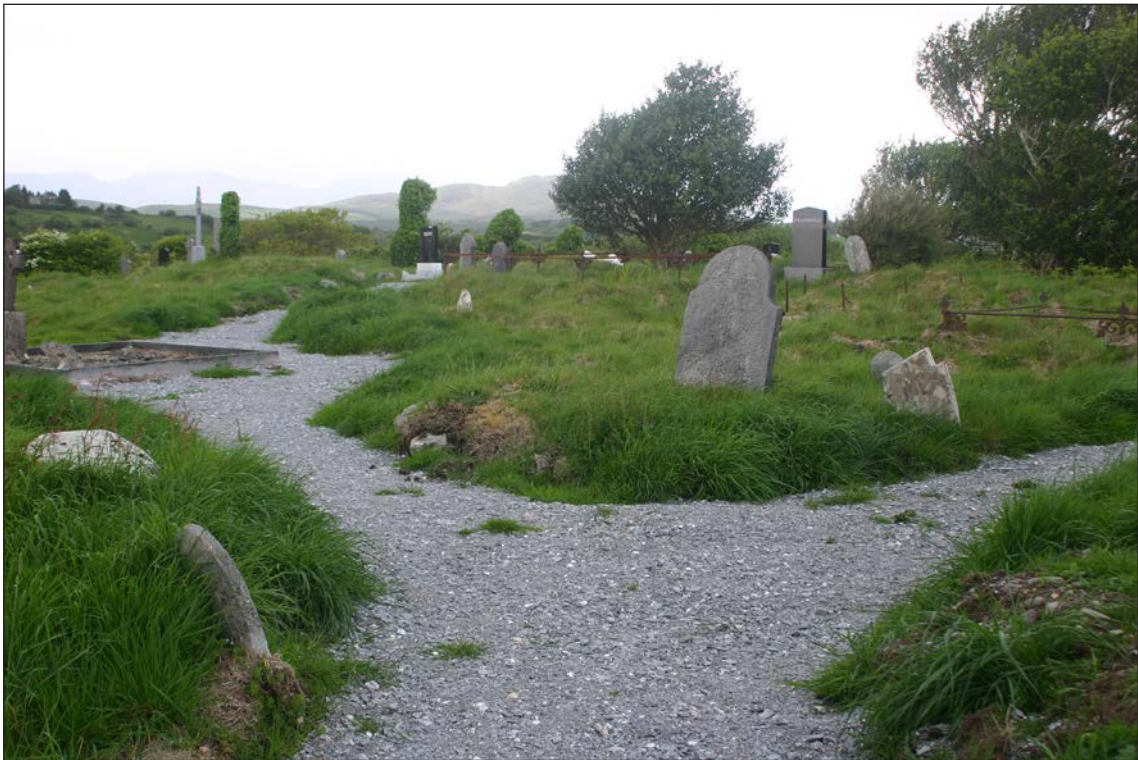
Plate 6: View of formal pathway extending from entrance gate, taken from south

A formal gravel pathway extends northwards and eastwards from the entrance gate where it forms a roughly circular pathway around the centre of the graveyard (Plate 6).

This pathway is occasionally kerbed with sandstone rubble stone.

A number of gravemarkers were also identified forming the boundary of the pathway in places.

The graveyard is almost at full capacity. Should the grounds be regularly maintained, and grass length kept to minimum, the graveyard would be navigable albeit with considerable caution.

Initially, the grass would need to be removed/reduced by hand under archaeological guidance and supervision to fully expose the full extent of the burial markers and nature of collapse. Potential desire lines and safe but meandering pathways could then be designed based on an updated plan. This work may require Ministerial Consent.

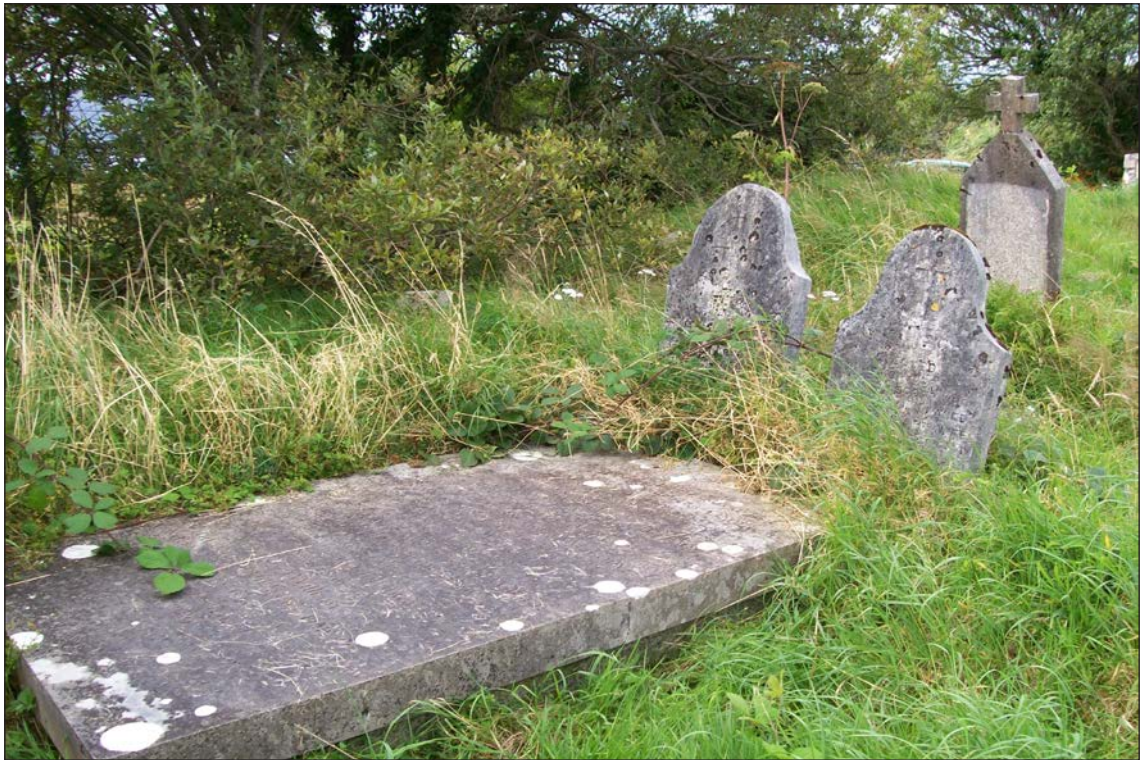
Plate 7: View of Scott family tomb, taken from north

Tomb (ref. no. 37) is an altar type tomb and is located at the southern side of the graveyard. It dates to 1864 and records the death of James Scott and family. A number of adjacent headstones also bear the surname Scott (Plate 7).

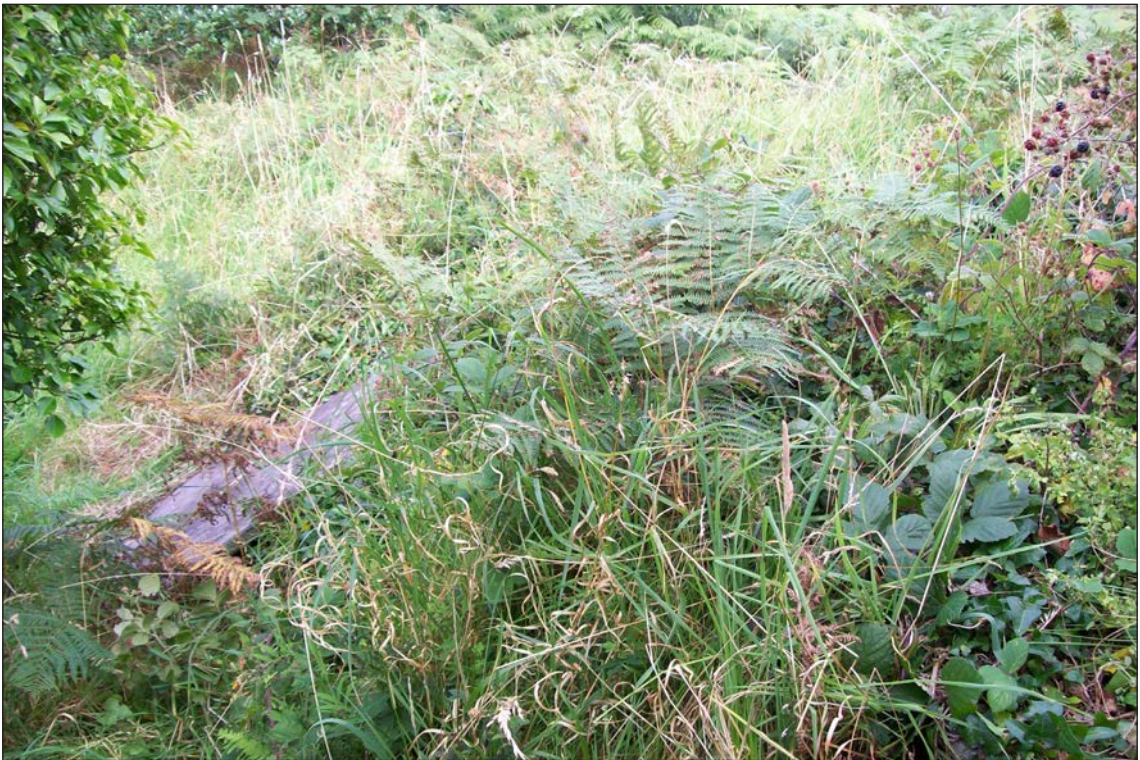
Plate 8: View of very overgrown tomb in northeastern area of graveyard, taken from east

A possible tomb (ref. no. 65) was further identified in the northeastern area of the graveyard (Plate 8). It is extremely overgrown and almost appears to form part of the boundary, given its poor state. A very large grave slab, similar to that forming the cover of the Scott tomb, was lying nearby, having obviously slipped from a height given its position. It recorded the death of Michael Walsh, a Parish Priest, in 1867.

The overgrowth in the northern and northeastern areas of the graveyard should be cut back and removed. This will serve to maintain the boundaries of the graveyard as well as the graves within.

The overgrowth by the possible tomb (ref. no. 65) should be cut back and removed under archaeological supervision. Subsequently, it may be possible to reinstate the name slab on top of the tomb.

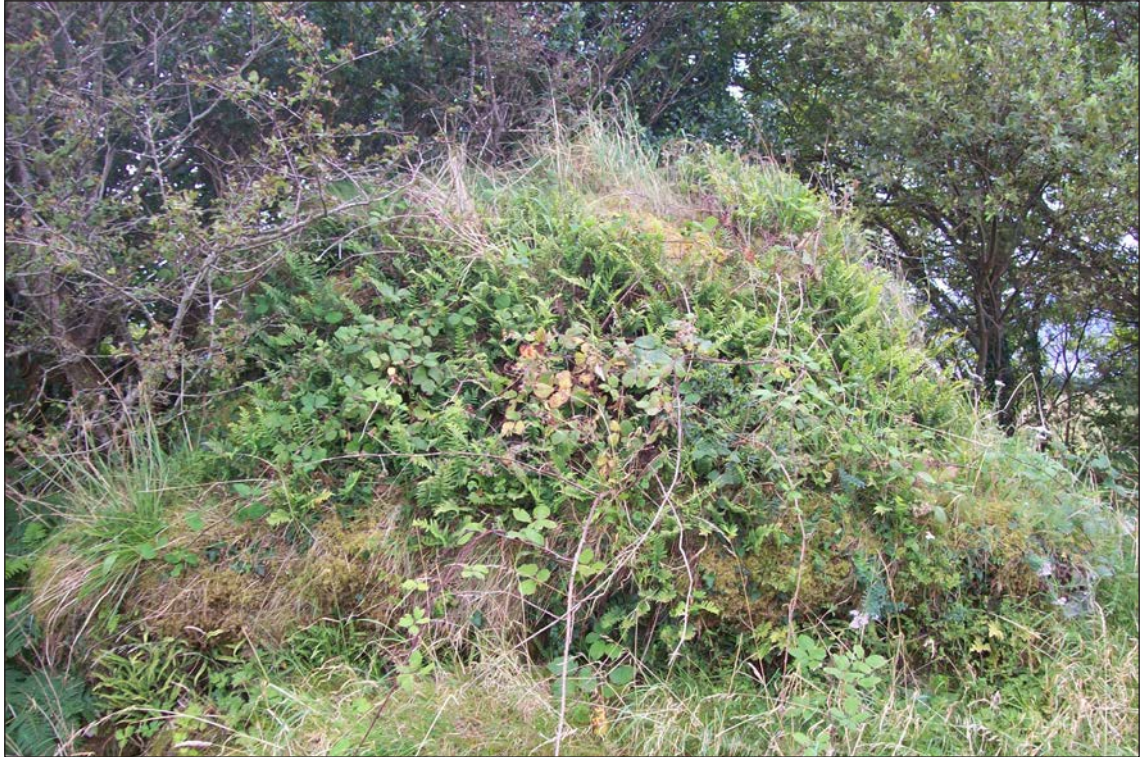
**Plate 9: View of overgrown unnamed tomb at southern extent of graveyard, taken from north**

An unnamed tomb (ref. no. 41) was sited to the east of the Scott tomb mentioned above (Plate 9).

The tomb recorded in the RMP, KE100-015:04 most likely relates to this tomb.

It is in a poor state of preservation and is completely overgrown with grass and brambles. It is also partially obscured by tree cover.

It appears to be constructed of sandstone rubble stone and is unrendered.

The substantial overgrowth on the unnamed tomb (ref. no. 41) should be cut back and removed. The tree cover should also be cut back to allow for greater access to all sides of the tomb.

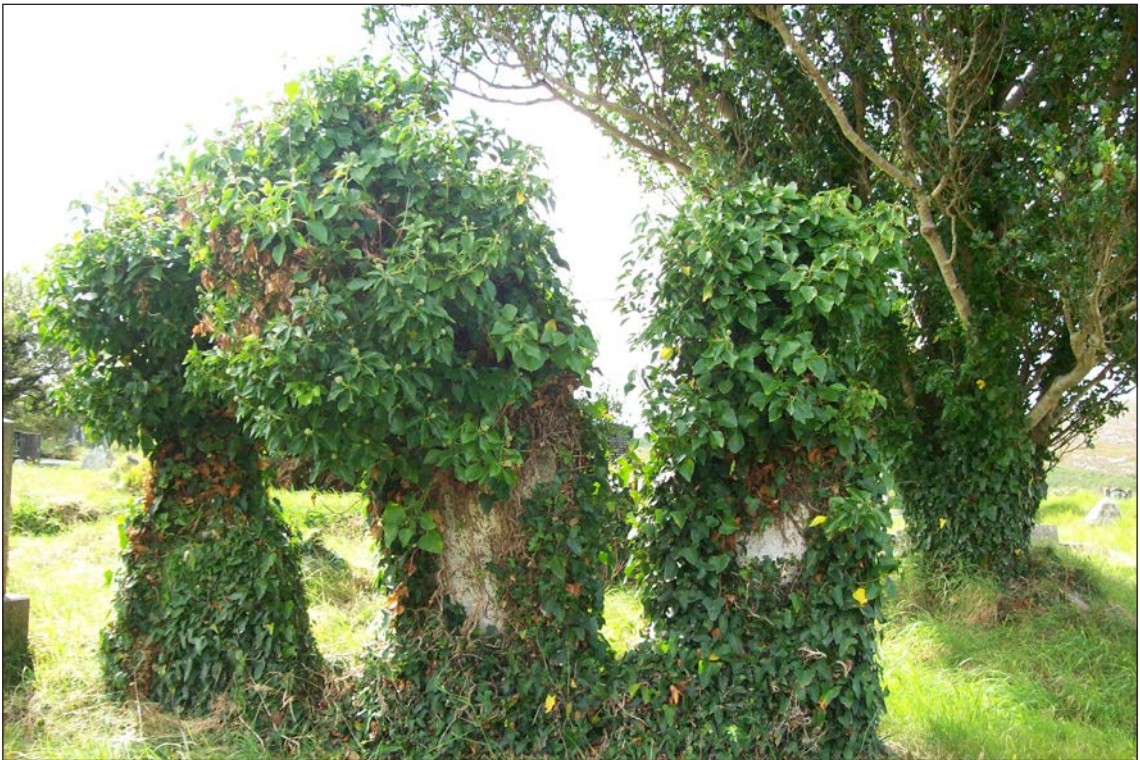
**Plate 10: View of overgrown headstones within the graveyard, taken from northeast**

Many of the inscribed headstones are partially obscured by ivy growth. One such headstone was that recording the death of an unknown person with the surname Sullivan (ref. no. 164, Plate 10).

The ivy growth should be cut back and removed from the ivy covered headstones. The exposed names can then be recorded to provide a complete record for the graveyard.

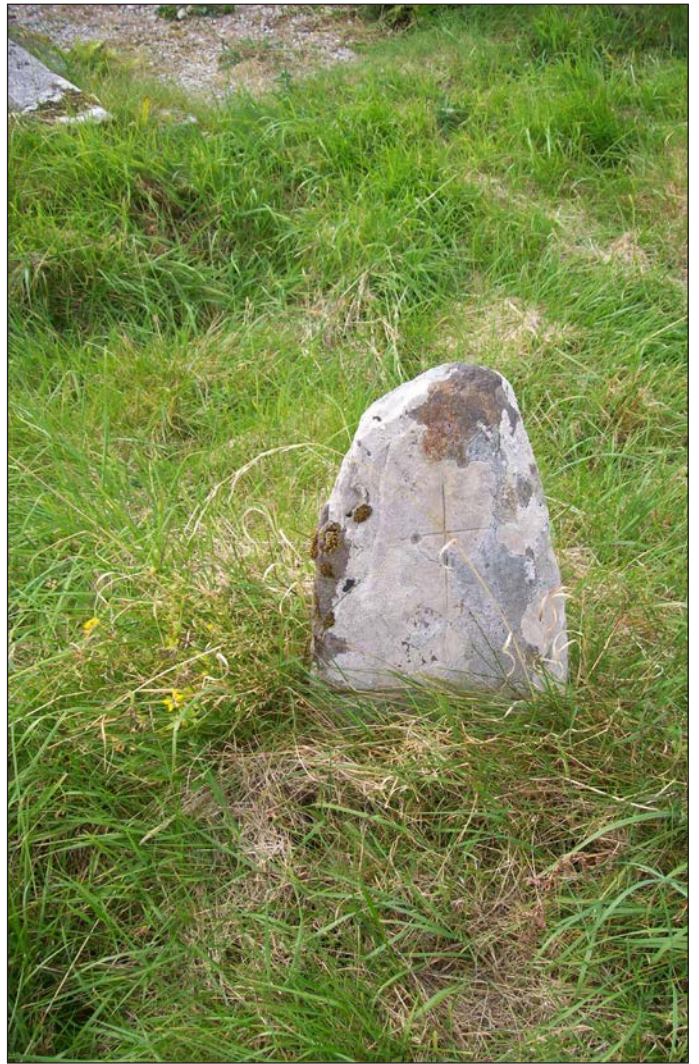
A box-grave (ref. no. 179) was recorded at the northern side of the graveyard and records the death of Alexander Roulston Foster 1890-1972 (Plate 12). It measured *c.* 0.5m by 0.4m. It is possible that it contains a cremation burial given its small size. Internet based research uncovered that Alexander Roulston Foster was born in Derry and was an acclaimed Irish international rugby player, who captained Ireland three times and played for the British and Irish Lions team which toured South Africa in 1910 ([www. ulsterbiography.co.uk](http://www.ulsterbiography.co.uk)).

Plate 12: View of Alexander Roulston Foster box-tomb

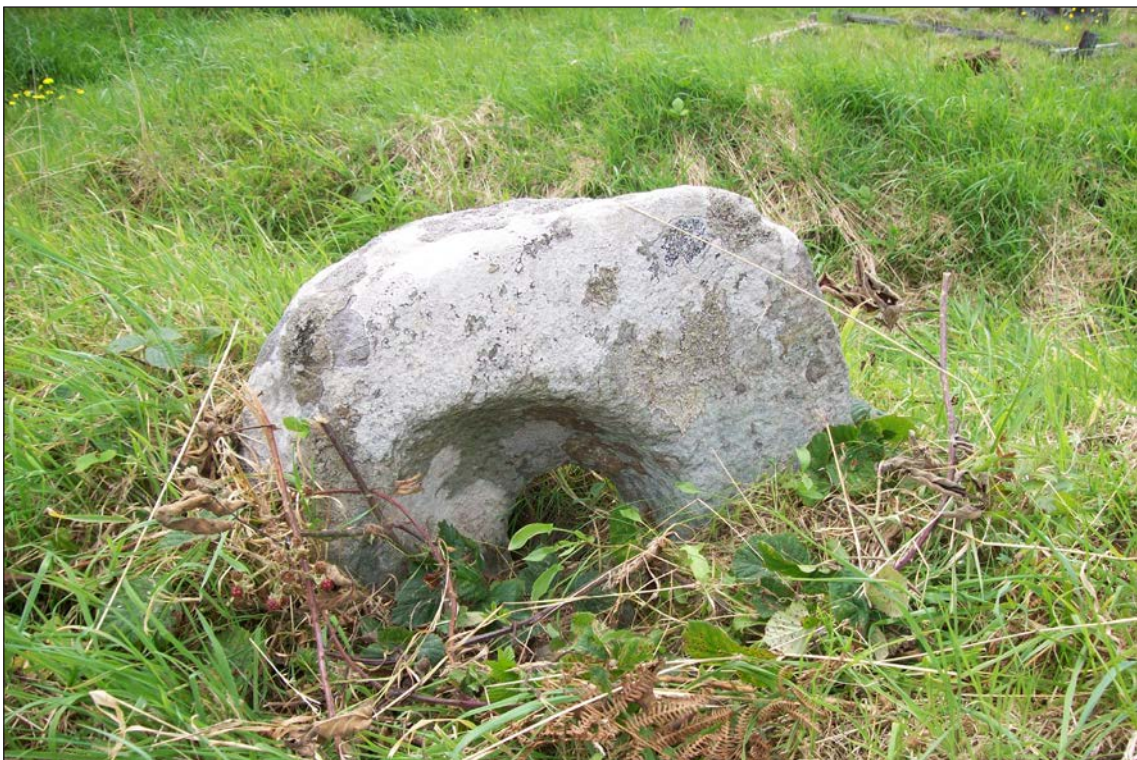
Plate 14: View of circular stone with possible man-made depression, taken from east

An unusual stone (ref. no. 117) which appears to function to as a gravemarker is located in the southeastern area of the graveyard. The large circular stone has a central hollow which has worn through and appears to be man made (Plate 14).

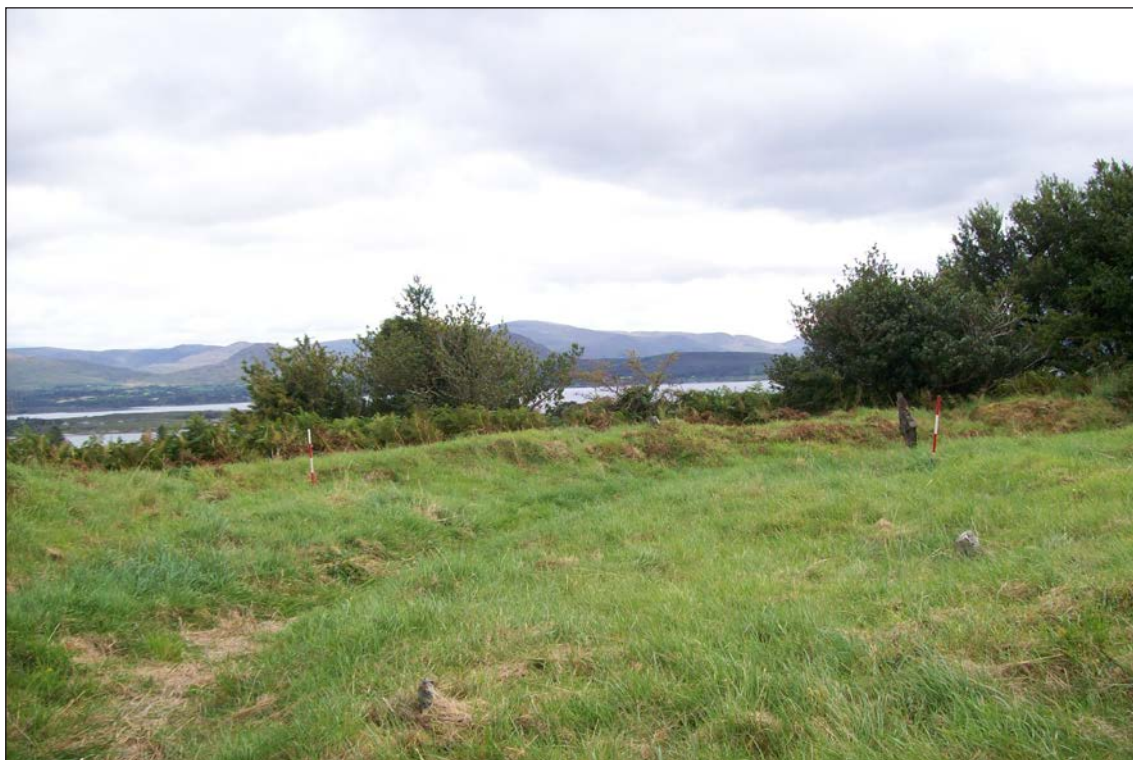
**Plate 15: View of possible location for church visible on 1st edition OS map 1842 (Figure 3), taken from north**

While a roughly rectangular depression could be determined on the ground in 2007, no evidence was seen of a *low stony bank* (Plate 15). However, it may have been levelled in the intervening years.
