Archaeological Survey,  
Ballinskelligs Abbey and Graveyard,  
Ballinskelligs,  
Waterville,  
Co. Kerry.

September 2012

Client: The Heritage Office,  
Kerry County Council,  
County Buildings,  
Ratass,  
Tralee,  
Co. Kerry.

RMP No.: KE097-036

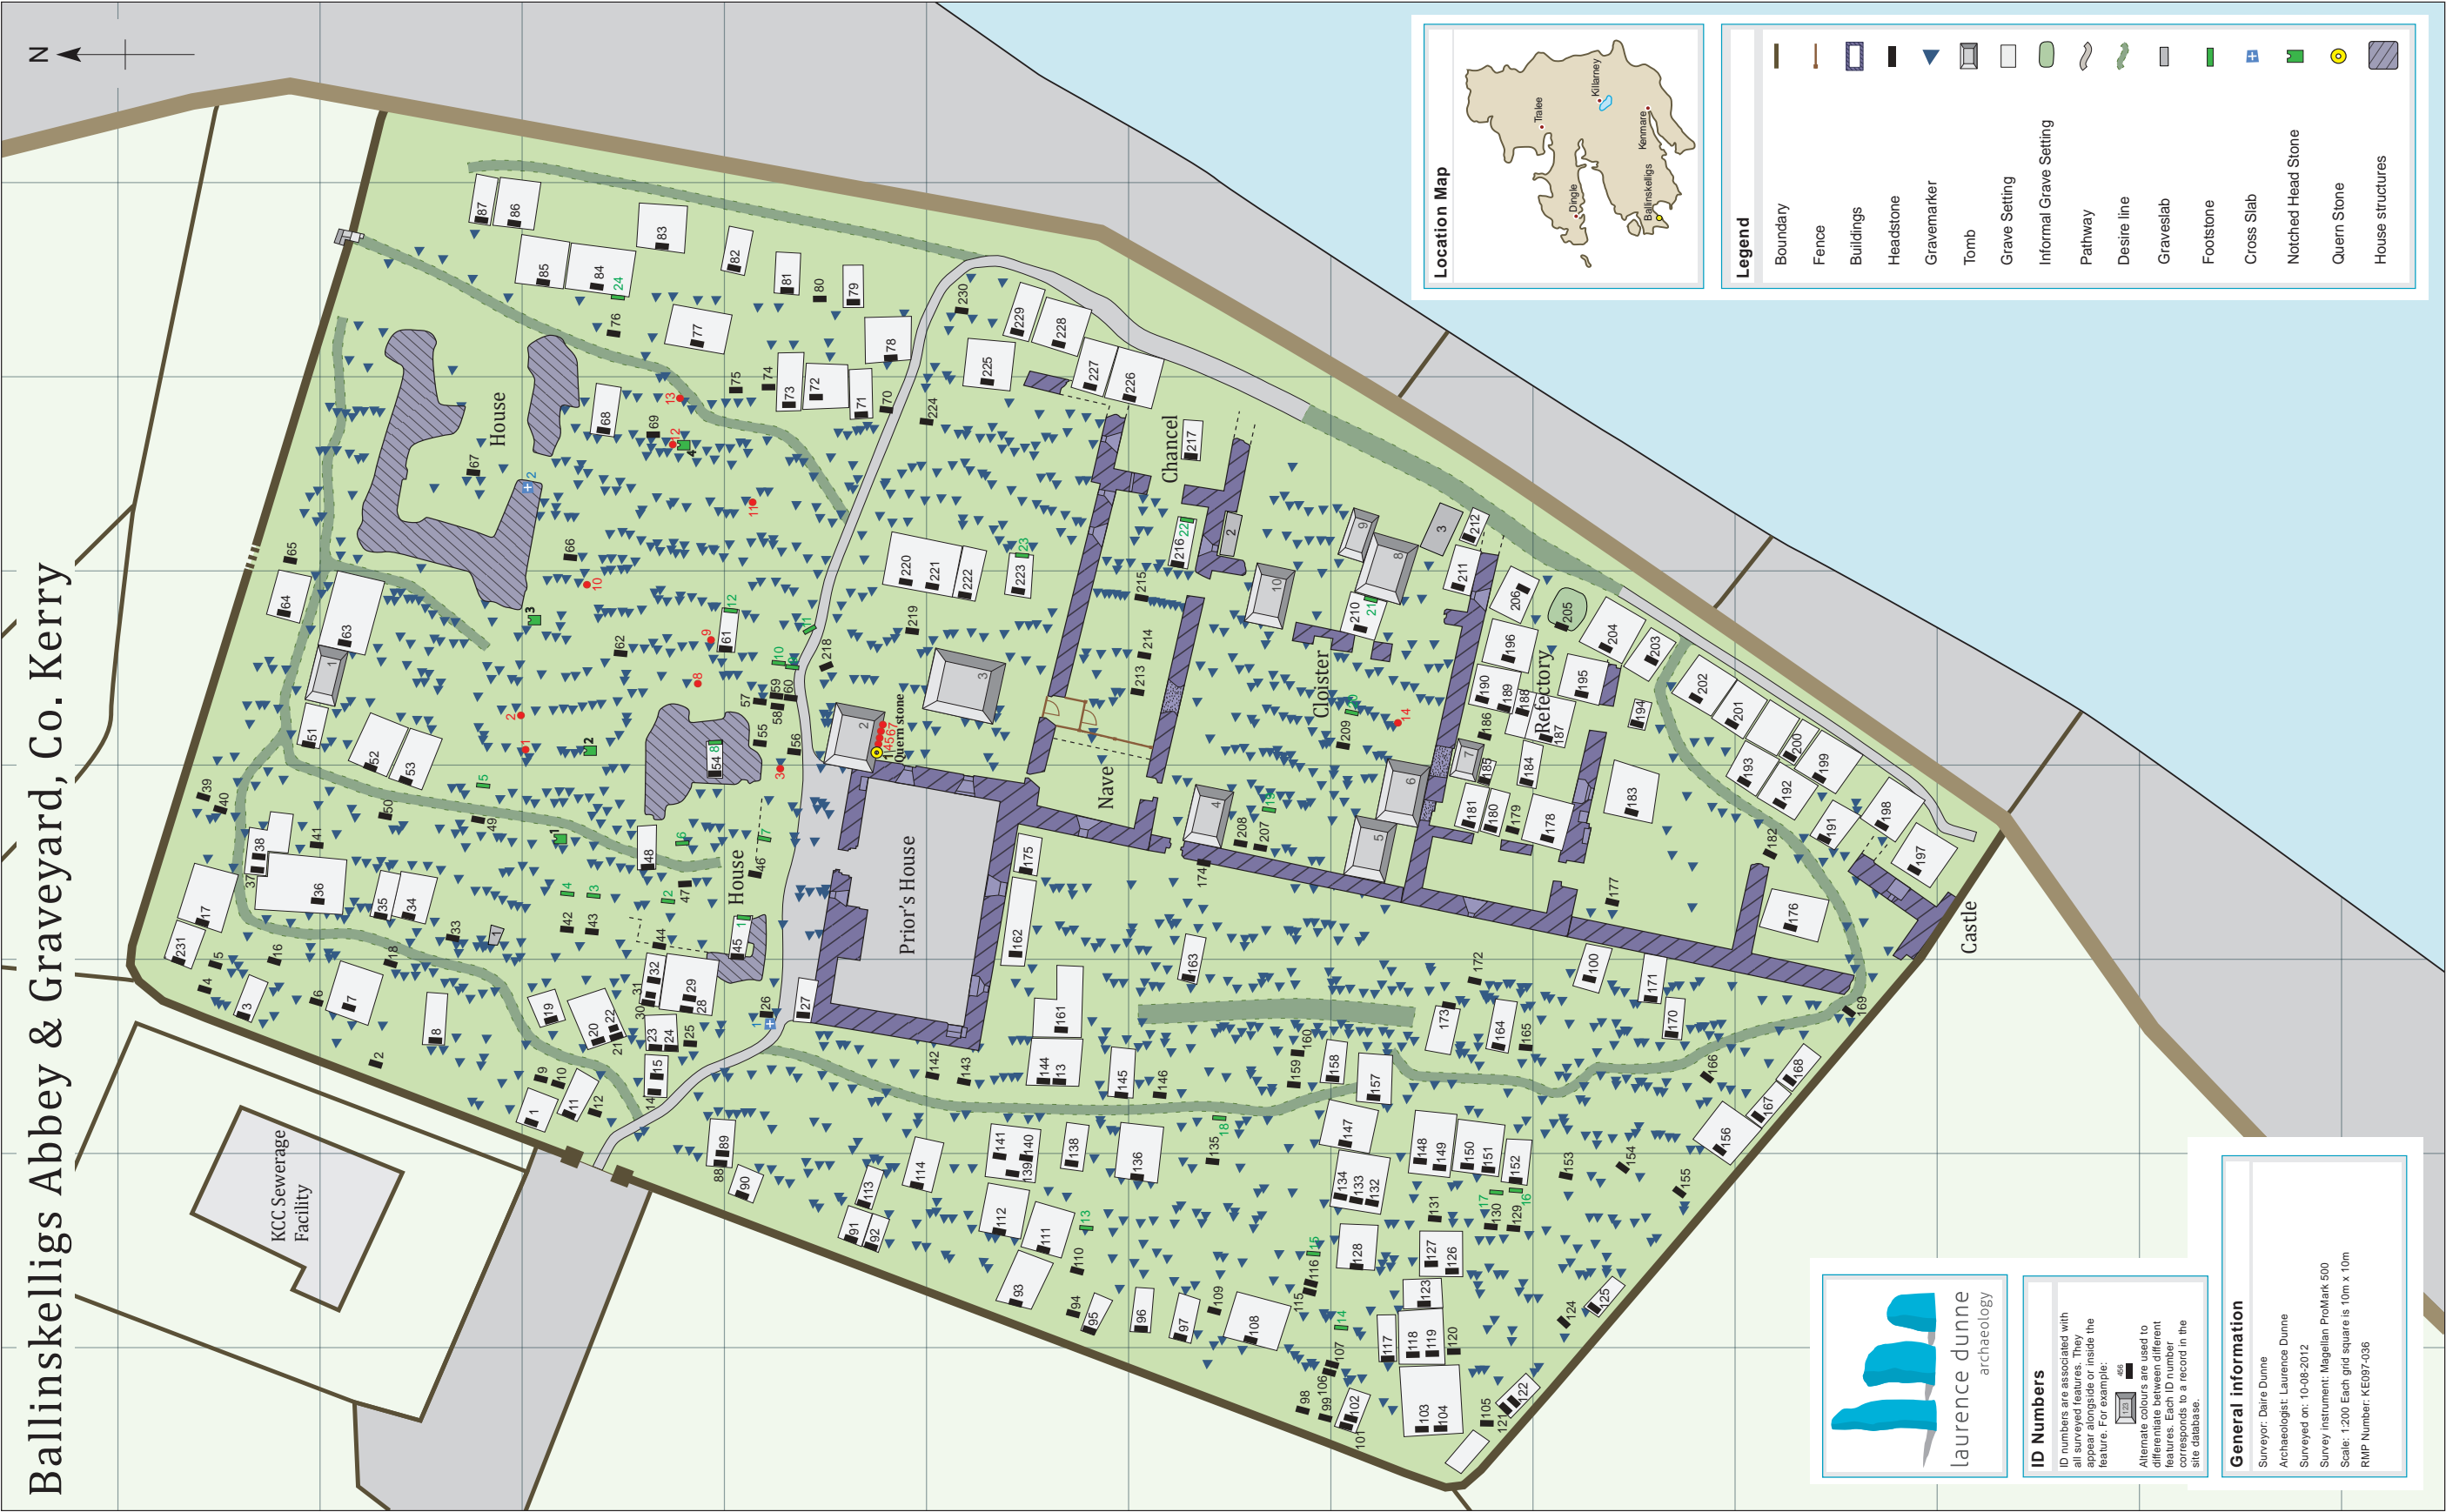
There are one hundred and eighty two (182) unhewn, unnamed gravemarkers in Ballinskelligs graveyard (Figure 2, Plates 1- 2, 6-7 & 28-29). These unnamed gravemarkers are denoted on the plan of the graveyard as blue triangles (Figure 2).

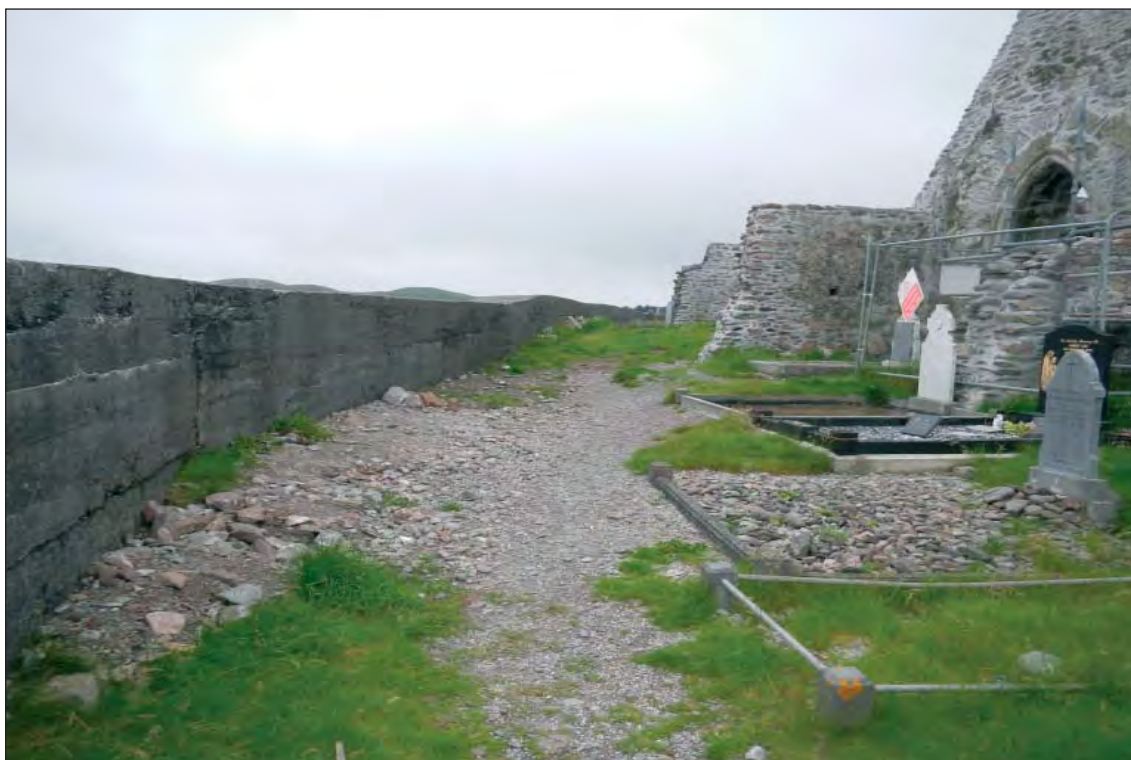
A substantial amount of the E limits of the medieval Augustinian abbey complex has been eroded by the sea in the past. The medieval abbey is now protected by a robust sea-wall

that forms the entirety of the E boundary (Plate 6). The abbey complex of buildings, that are now undergoing conservation by the OPW, dominate the graveyard and effectively divides the burial ground into two areas. The N-NE area slopes to seaward and is bumpy and irregular underfoot. The grass is higher here as it is harder to cut (Plates 4 & 7). The SW area is flatter and the grass cutting easier (Plates 1-2 & 8).

**Plate 6:** View from NE of robust E seawall that forms the E boundary of the graveyard. Note the destroyed remains of the medieval buildings from historic encroachment from the sea. Further note the poor informal pathway

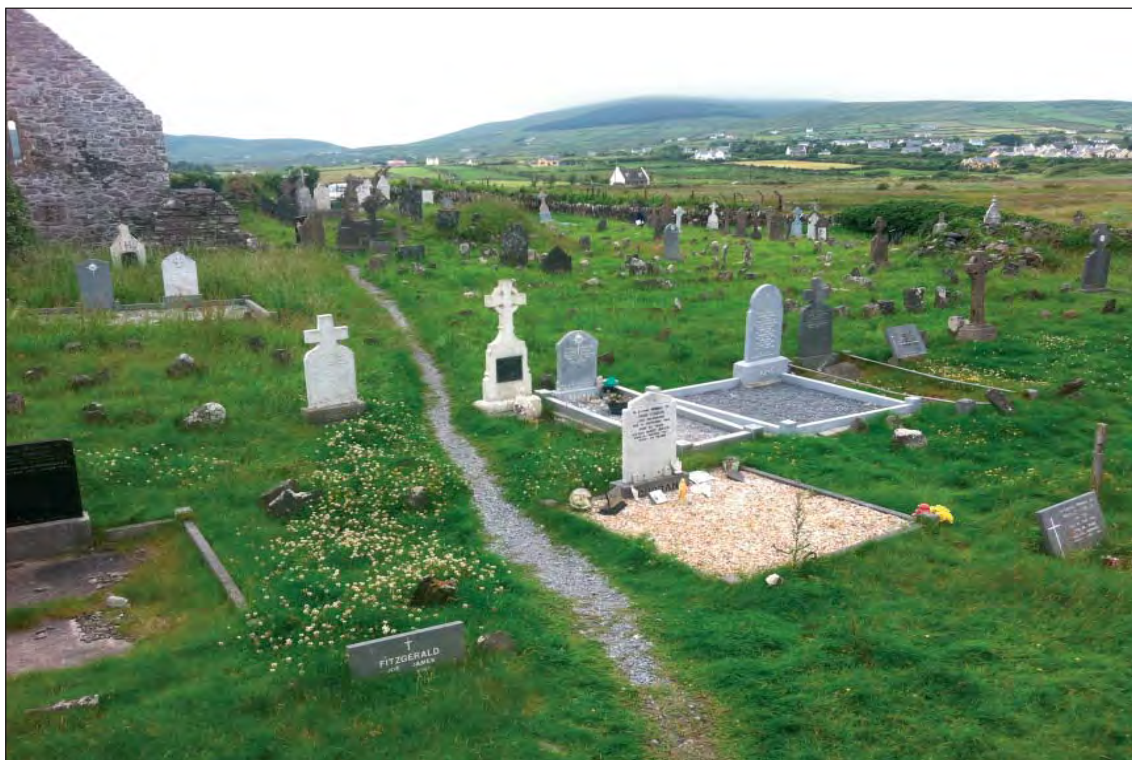
The W & N boundary walls are built of local split sandstone with 'soldier' capping and are very overgrown and encroaching on the graves (Plate 7). While there is a boundary breach mid way along the N wall (Figure 2 & Plate 12). The S boundary is of similar construction but is devoid of ivy and in general good condition (Plate 13). The E or seaward boundary is very robust and constructed of mass-concrete from locally derived gravel (Plate 5). This E boundary also acts as a sea-wall as over the centuries much of the E limits of the medieval complex have been eroded by the sea. Coherent sections of previous destroyed sea-wall lie on the rocky shore.

**Plate 7:** View from E of N limits of graveyard. Note informal gravel path and denuded grass covered remains of two house structures amongst the burial markers. Further note general high grass cover and overgrown ivy-clad N boundary wall

- Adequate official carparking and a turning area should be provided by KCC / OPW.
- The gates should be conserved, re-hung and painted and made fully functional.
- The gate piers should be repaired and cleared of vegetation.
- The boundary walls should be cleared of vegetation and the breach in the N wall repaired. All repairs should be undertaken with local similar material and undertaken by skilled experienced personnel with a proven track record in the construction and maintenance of historic rubblestone walls.
- The KCC facility should be decommissioned and removed including the outfall pipe.
- The construction of any future carparking or other potential construction / deconstruction work above or below the HWM should be archaeologically carried out under Ministerial Consent as the site is a National Monument.

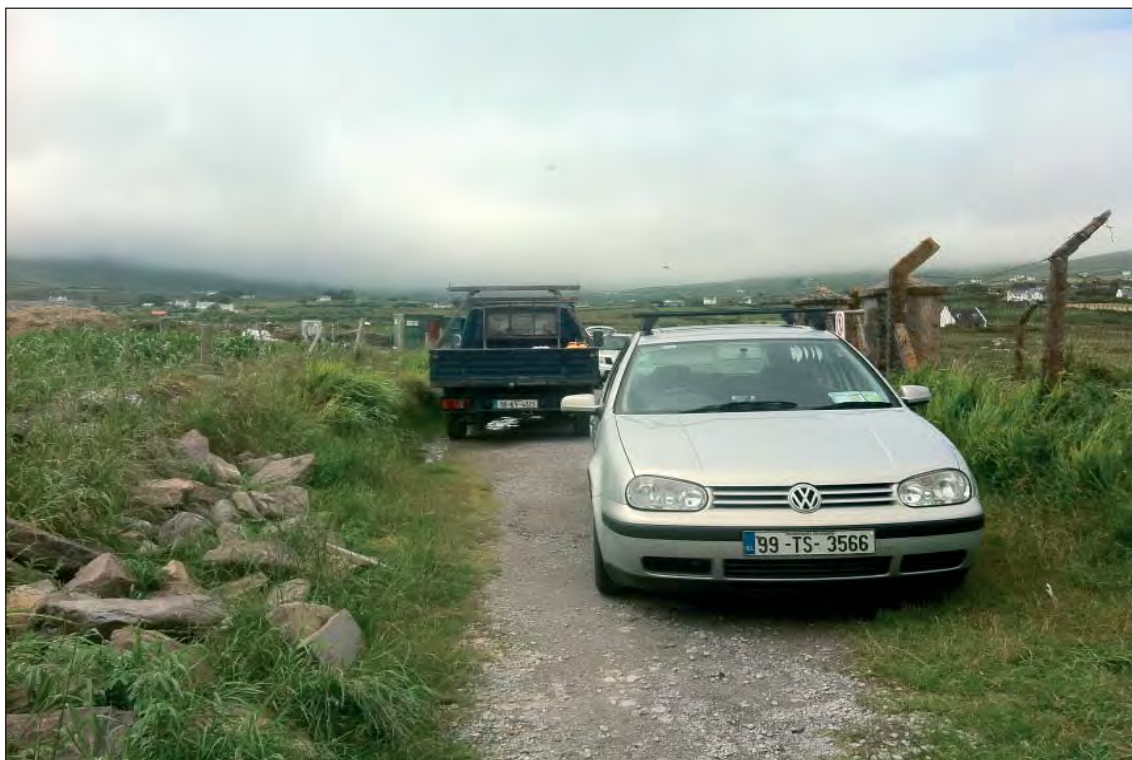
The approach to the graveyard is via a straight narrow cul-de-sac lane accessed from a minor 3rd class road. There is no carparking or turning area provided. Motorised visitors must reverse into a narrow grassy recess to turn (Figure 2 & Plates 9-10 & 19).

**Plate 9:** View W from entrance gates of narrow approach and entire lack of parking that is choked by the presence of only three vehicles. Note the decrepit fence around the KCC sewerage facility on right

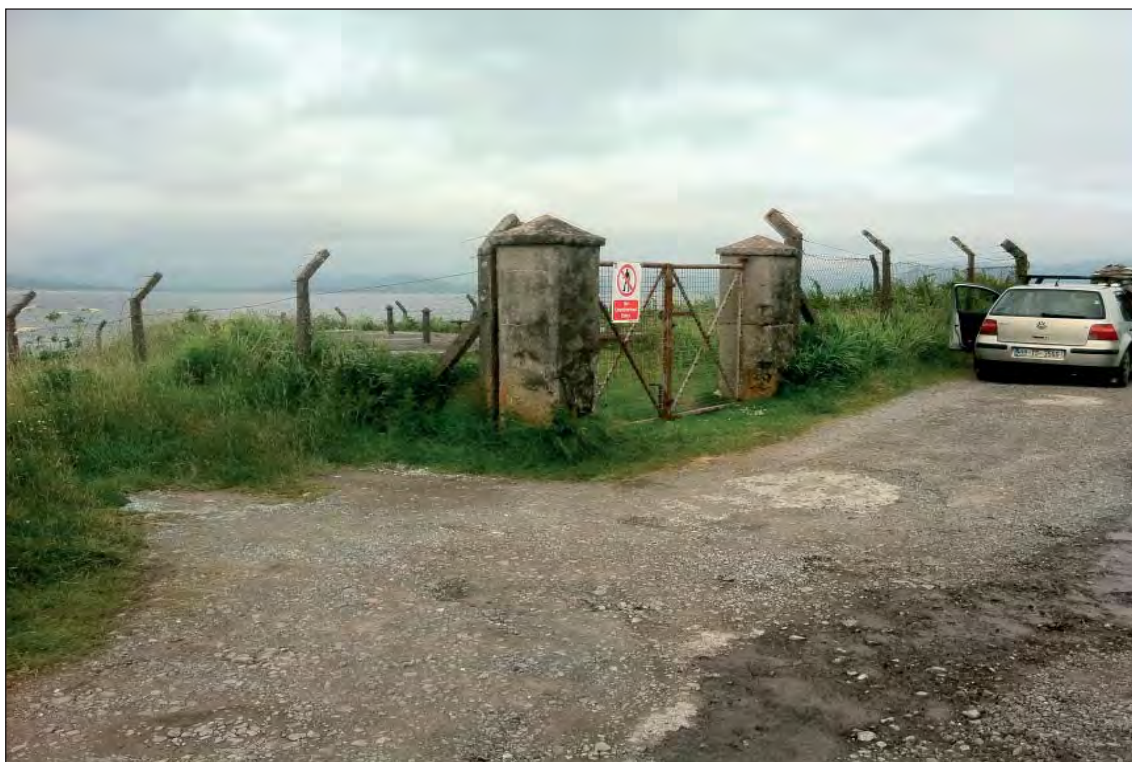
A Kerry County Council (KCC) local sewerage(?) facility inappropriately abuts the graveyard boundary wall at the NE, immediately beside the entrance. It is enclosed by a high decrepit chain-link fence attached to concrete posts (Figure 2 & Plates 10 & 15). The facility is bizarrely and entirely inappropriately built against medieval graveyard encompassing Ballinskelligs Abbey which is a National Monument (No.168) in state ownership. Furthermore it is beside a further recorded monument comprising an ancient settlement site, KE097-035. A concrete encased outfall pipeline runs from the facility immediately eastwards out into the bay. This active outfall pipe is broken in places (Plates 16-17). Digital video imagery of the outfall pipe in operation was also undertaken.

**Plate 10:** View from W of KCC sewerage facility that abuts the NW boundary wall of Ballinskelligs medieval Abbey and Graveyard - a National Monument in State ownership. Further note the absence of any effective dedicated carparking and restricted turning area

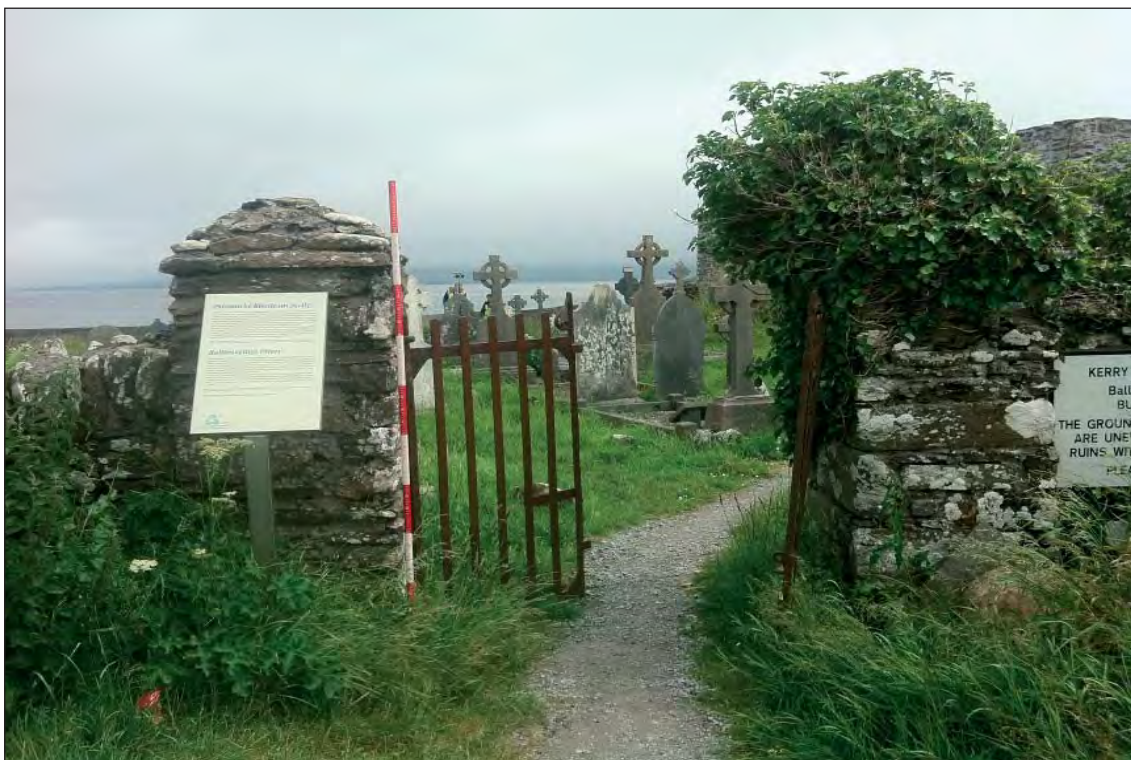
The entrance comprises a pair of locally forged wrought-iron gates, 1.6m wide, set between two square rubblestone piers built to courses. The N gate is not opening and the S gate only partially. The S gate pier is entirely overgrown with ivy (Plate 11). An OPW information sign is provided at the gate.

**Plate 11:** Exterior view from W of the entrance to Ballinskelligs Abbey & Graveyard. Note inability of rusty gate to open fully and further note overgrown pier and general untidy entrance

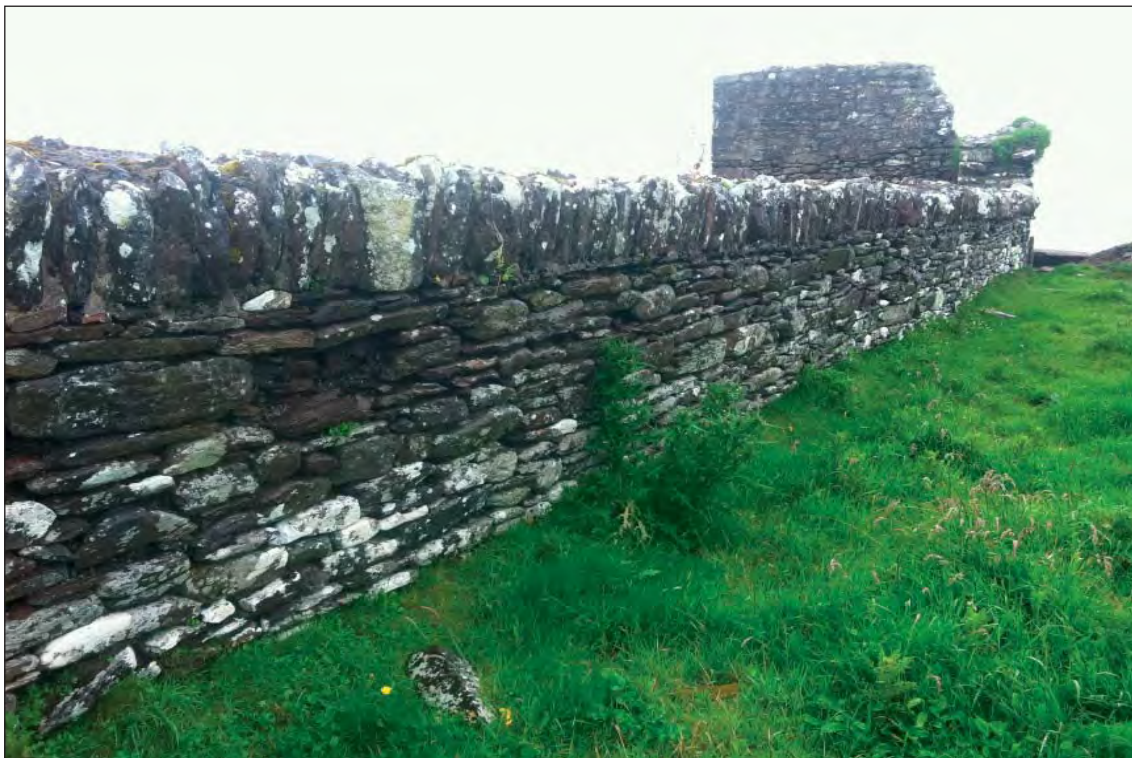
**Plate 13:** View from W of exterior S boundary wall in good order. Note remains of Castle-Casleán Beag, within the SE corner of graveyard

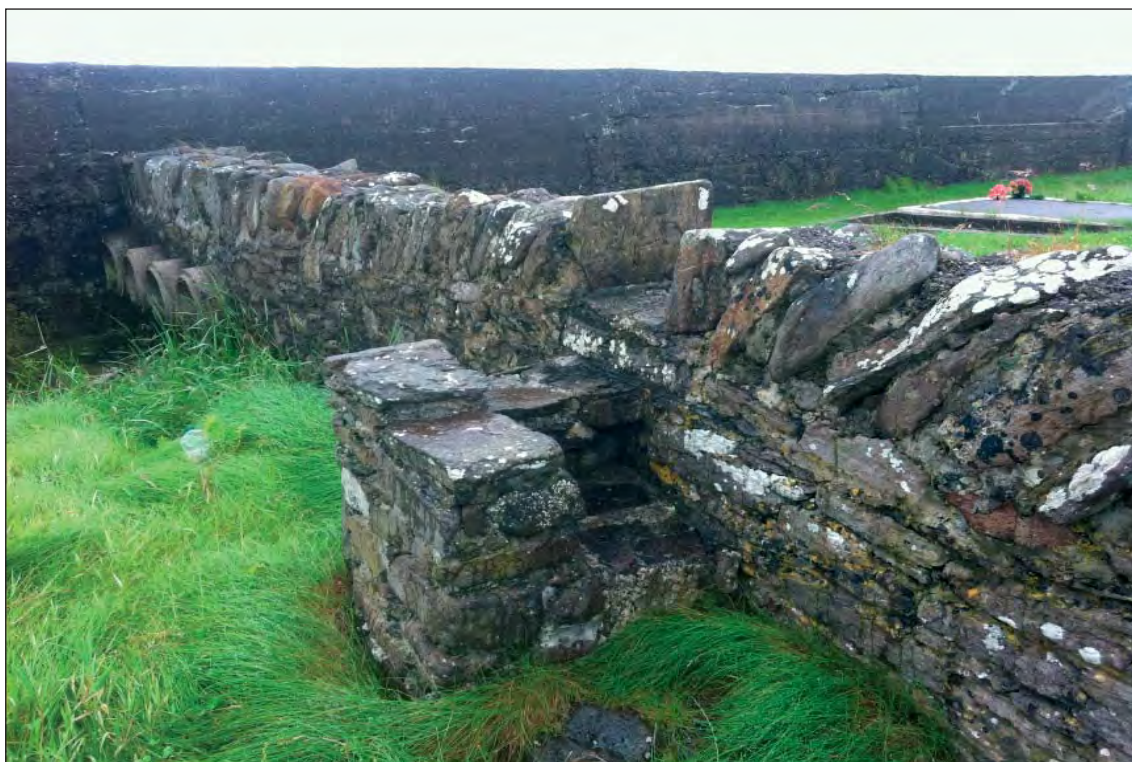
A pedestrian stepped-stile is situated in the ENE limits of boundary wall to accommodate walkers along the beach-front from Ballinskelligs and Ballinskelligs castle (Figure 2 and Plates 4 & 14).

**Plate 14:** View from N of step-stile in NE section of N boundary wall

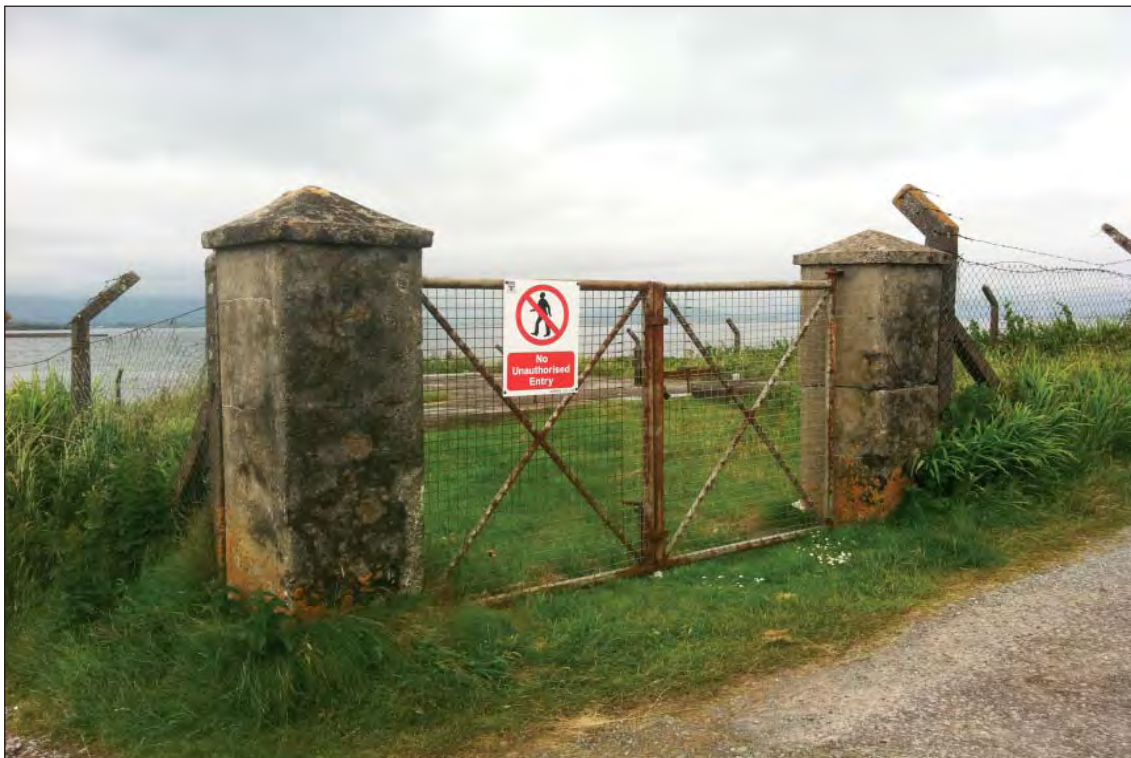
**Plate 15:** Close-up of decrepit run-down entrance to KCC sewerage facility at Ballinskelligs Graveyard

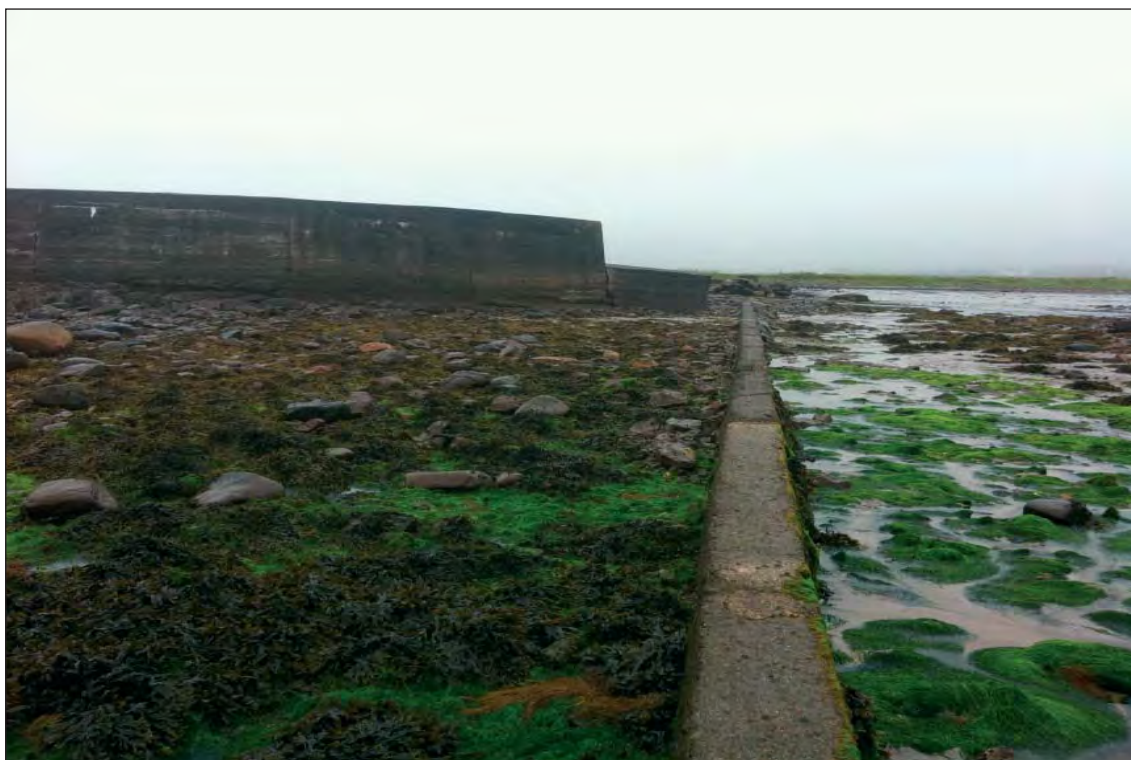
**Plate 16:** View from E at low water of concrete encased sewerage outfall pipe beside the E seawall around Ballinskelligs Abbey & Graveyard

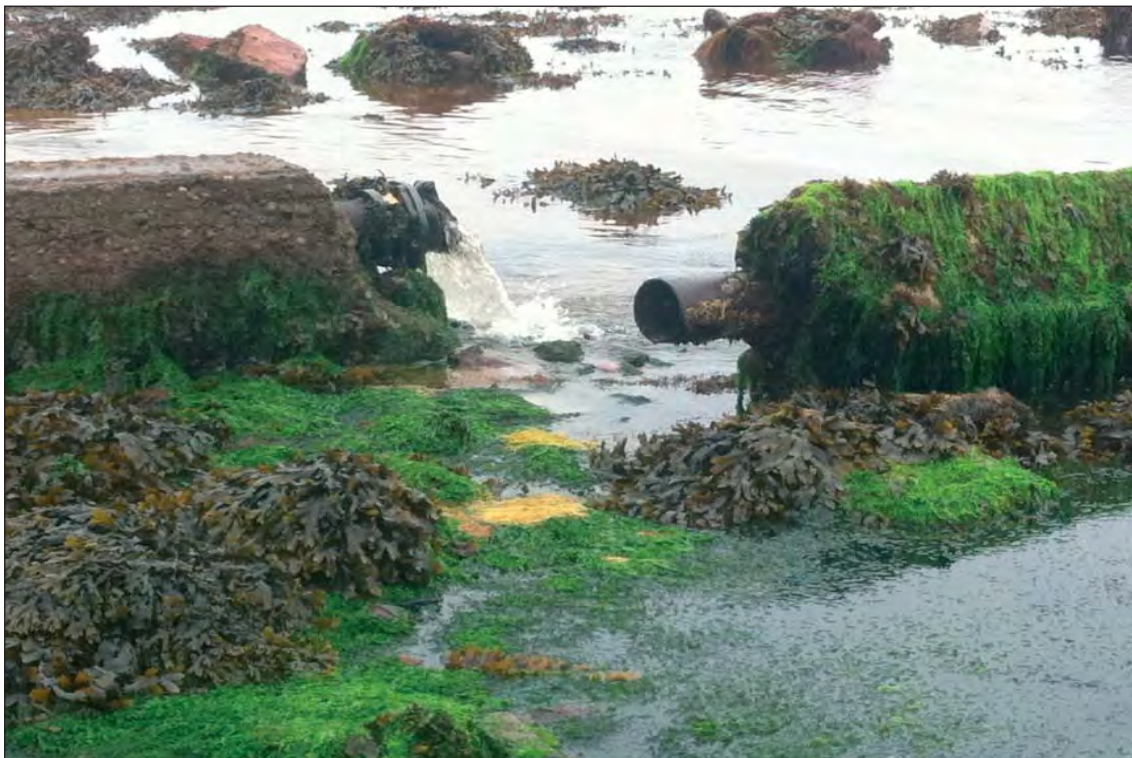
**Plate 17:** View of ruptured and separated active sewerage outfall pipe in foreshore at low water beside Ballinskelligs Abbey & Graveyard

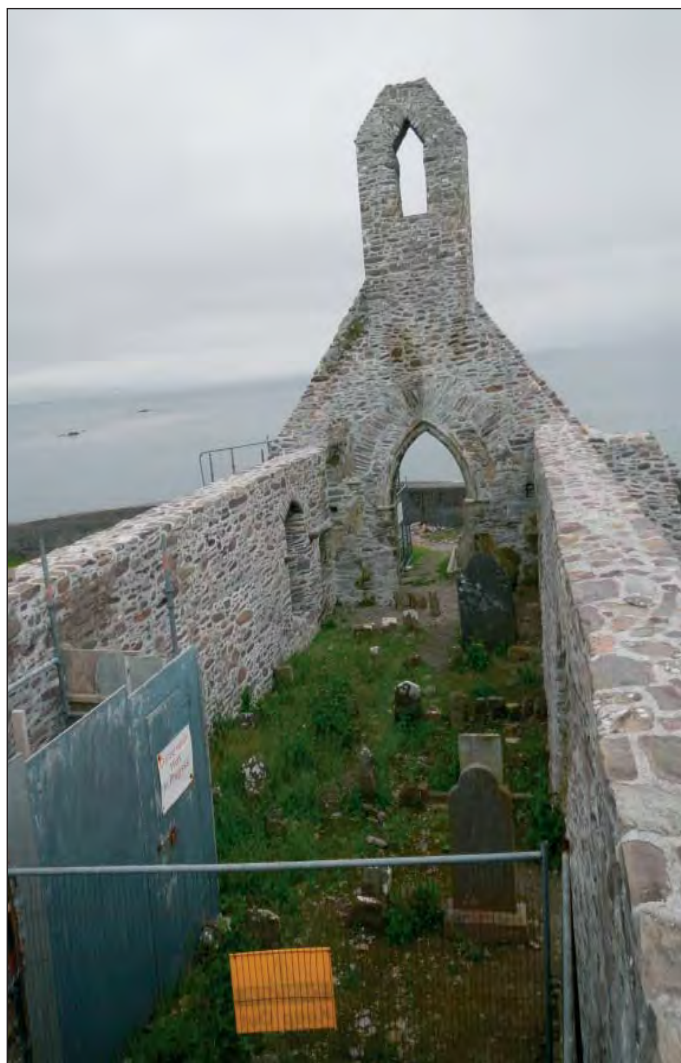
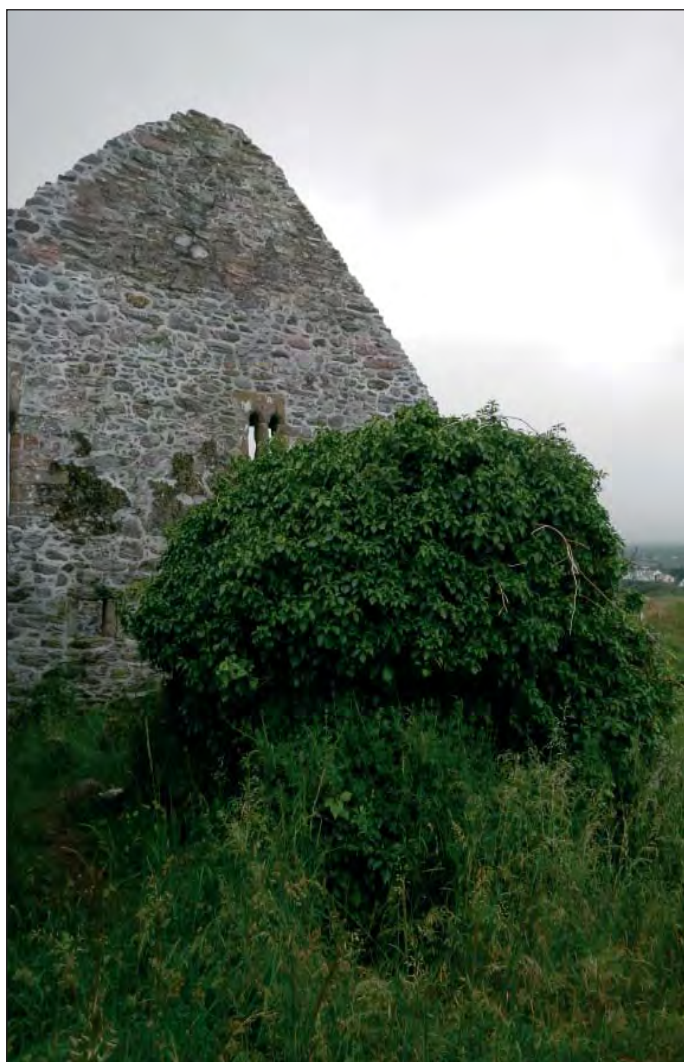
**Plate 22:** View from SE of entirely overgrown tomb at rear of E gable of the conserved Prior's House in Ballinskelligs Graveyard

Grass, ivy & bushes covering some of the tombs should only be fully removed as the primary element of a strategy of repairs and other conservation and restoration works. This work should be undertaken with expert archaeological advice and guidance.

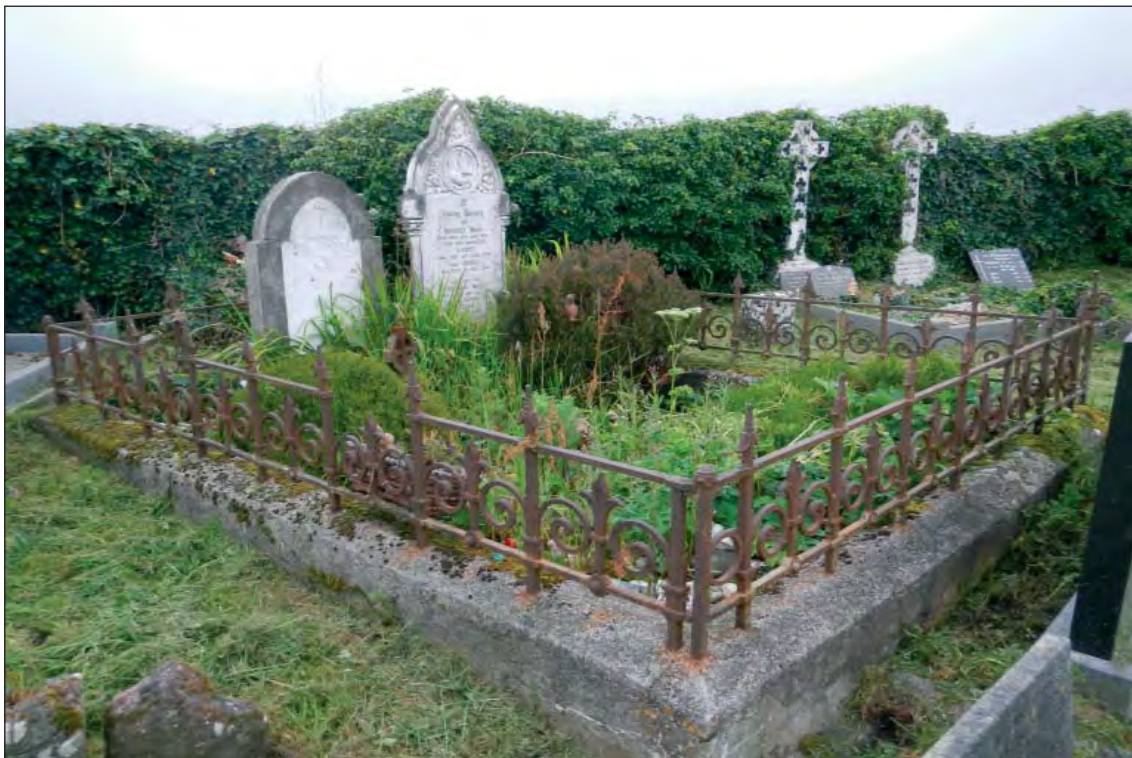
**Plate 25:** View of very fine cast-iron railing around the Main grave-plot at the SW limits of the graveyard. Note again the overgrown boundary wall and encroaching ivy

- The ivy on the many headstones that are being encroached from the extensive growth on the nearby boundary walls should be carefully removed as a matter of urgency.
- Shattered broken headstones should be professionally repaired.
- The wrought and cast iron railings around graves should be professionally conserved, cleaned and painted.
- Local information should be accessed to establish the unknown and illegible names.
- The grass should be kept low.

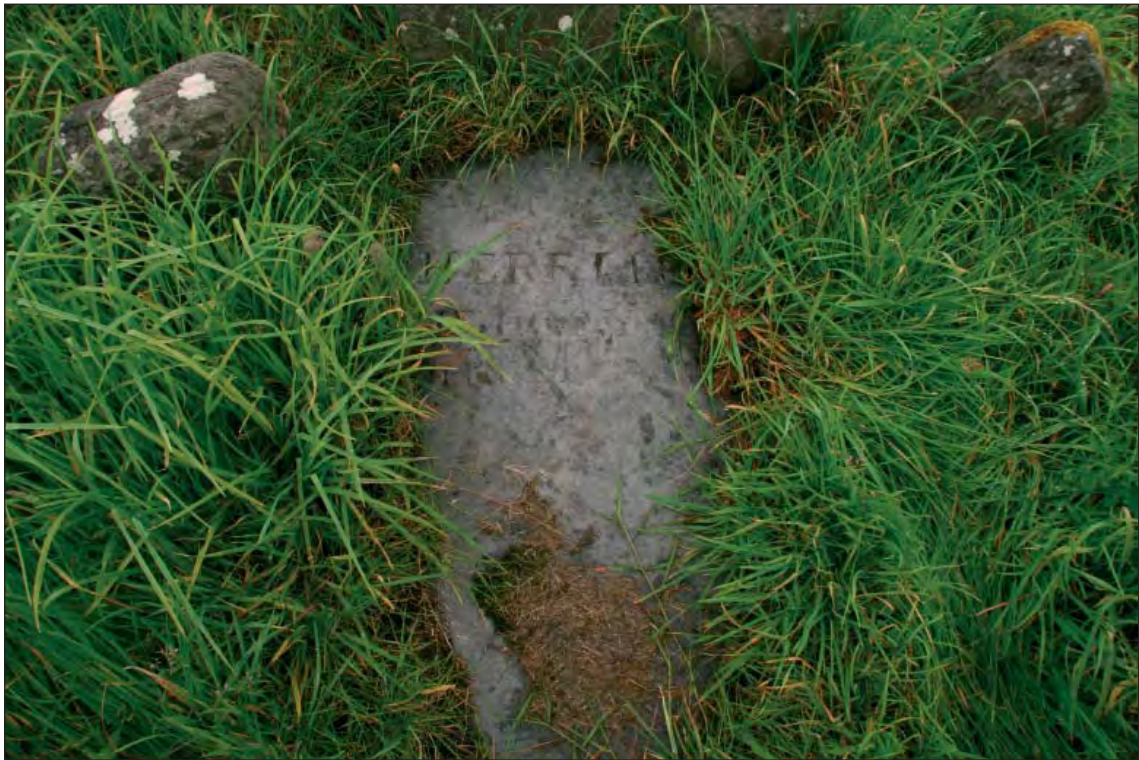
**Plate 27:** View of the partially concealed and grass encroached horizontal McCarthy graveslab

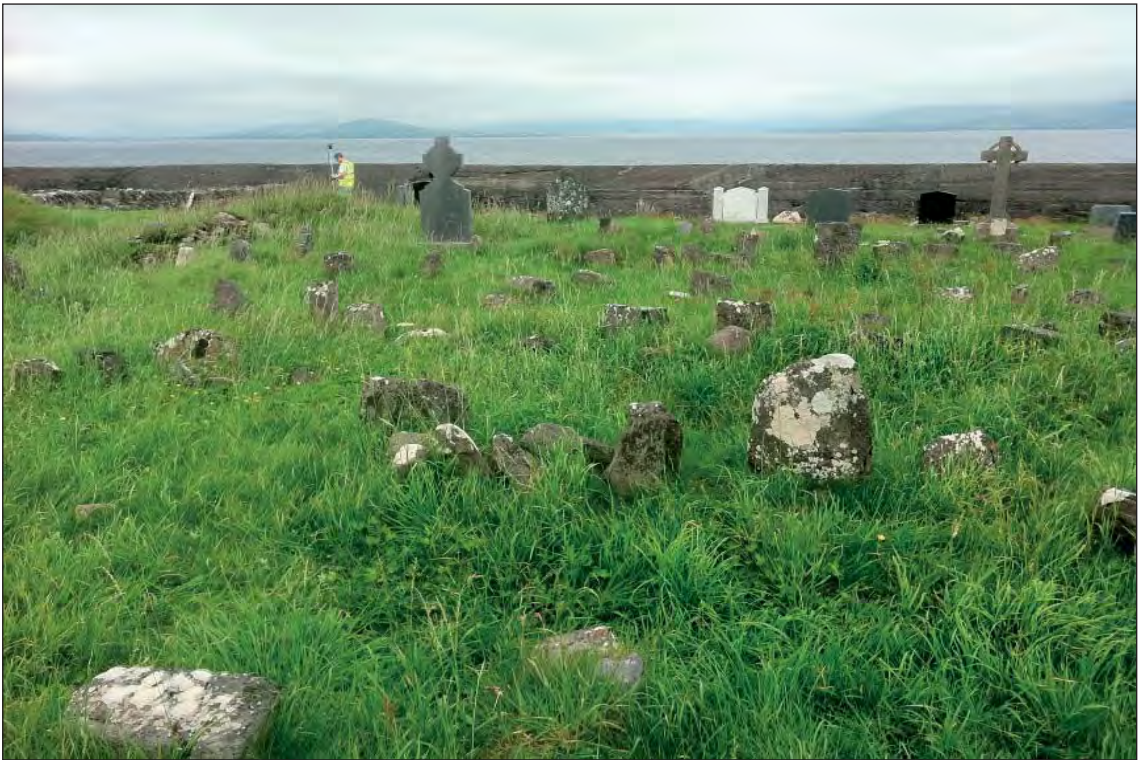
**Plate 28:** View of the interior NE limits of Ballinskelligs Graveyard from SW. Note the high grass that conceals or partially conceals the numerous gravemarkers and other features in the medieval graveyard

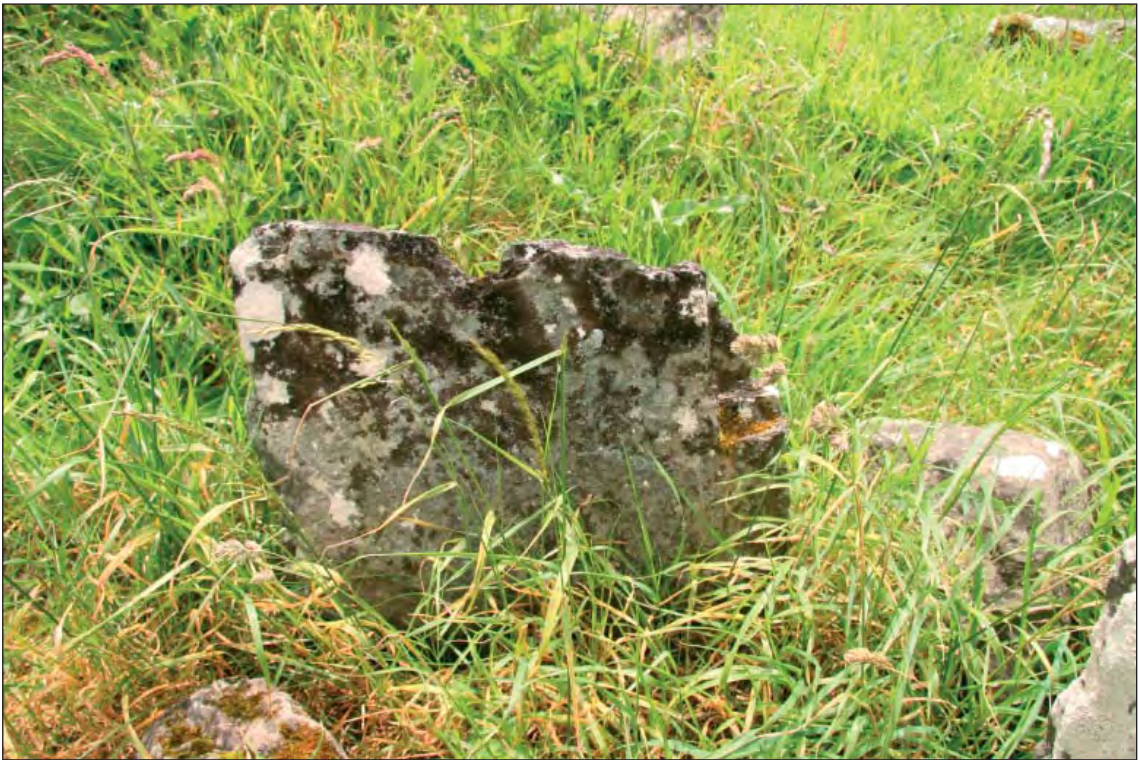
**Plate 30:** View of notched gravemarker in Ballinskelligs graveyard

There were four notched gravemarkers recorded in Ballinskelligs grave yard (Figure 2, Plate 30 & Appendix 5). These unhewn notched gravemarkers form a particular type of medieval grave marker and are relatively unknown and little studied aspect of medieval funerary practice. They are an important element of medieval archaeology that has hitherto been absent from study and recording.

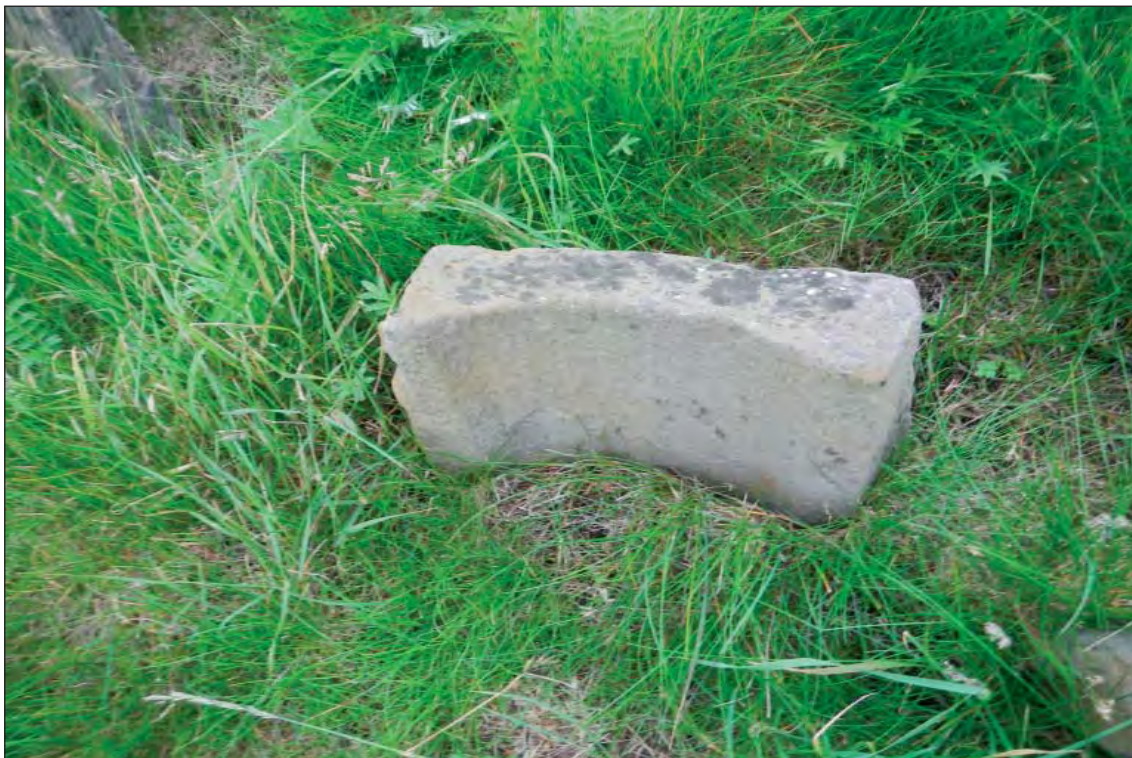
**Plate 31:** View of architectural fragment AF 13 comprising water management slab reused as gravemarker in NE limits of Ballinskelligs Graveyard

- The loose *ex situ* architectural fragments should be secured collected and removed, possibly to the Kerry County Museum or temporarily retained by the OPW for safe keeping storage and individual recording.
- All of the fragments should be archaeologically illustrated.
- The whereabouts of the several other architectural fragments should be determined.
-

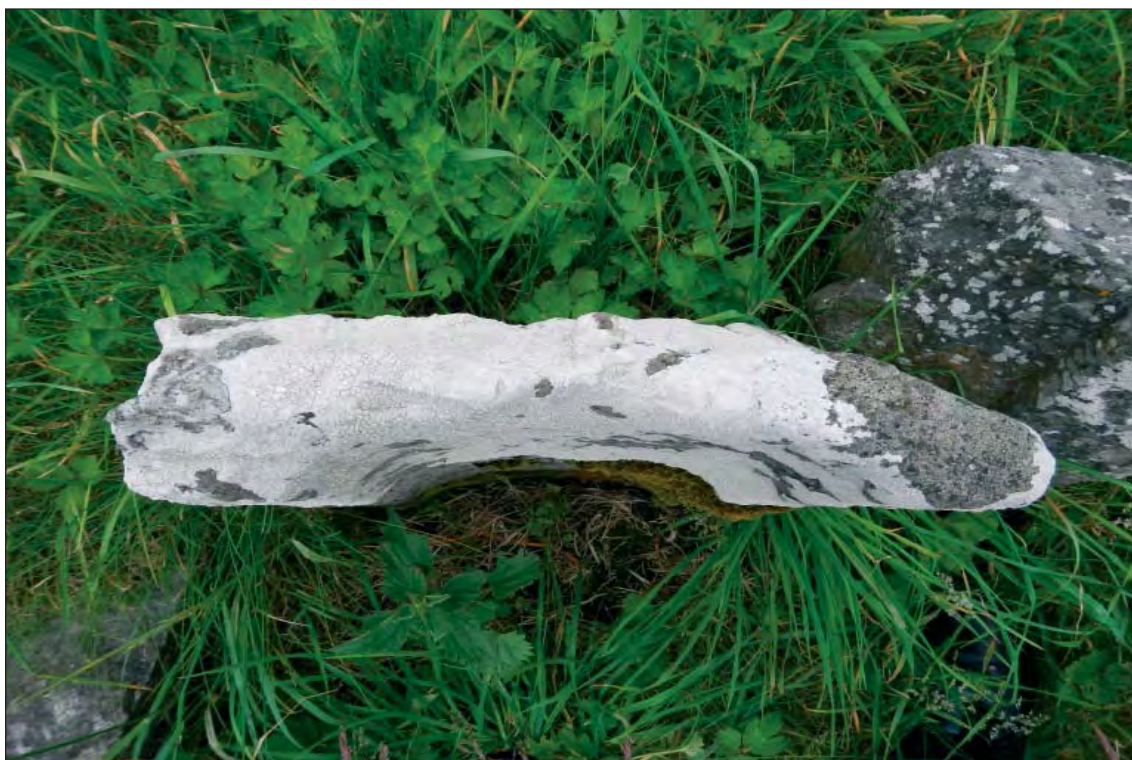
**Plate 32:** View of architectural fragment AF 8 comprising water management slab reused as gravemarker in NE limits of Ballinskelligs Graveyard

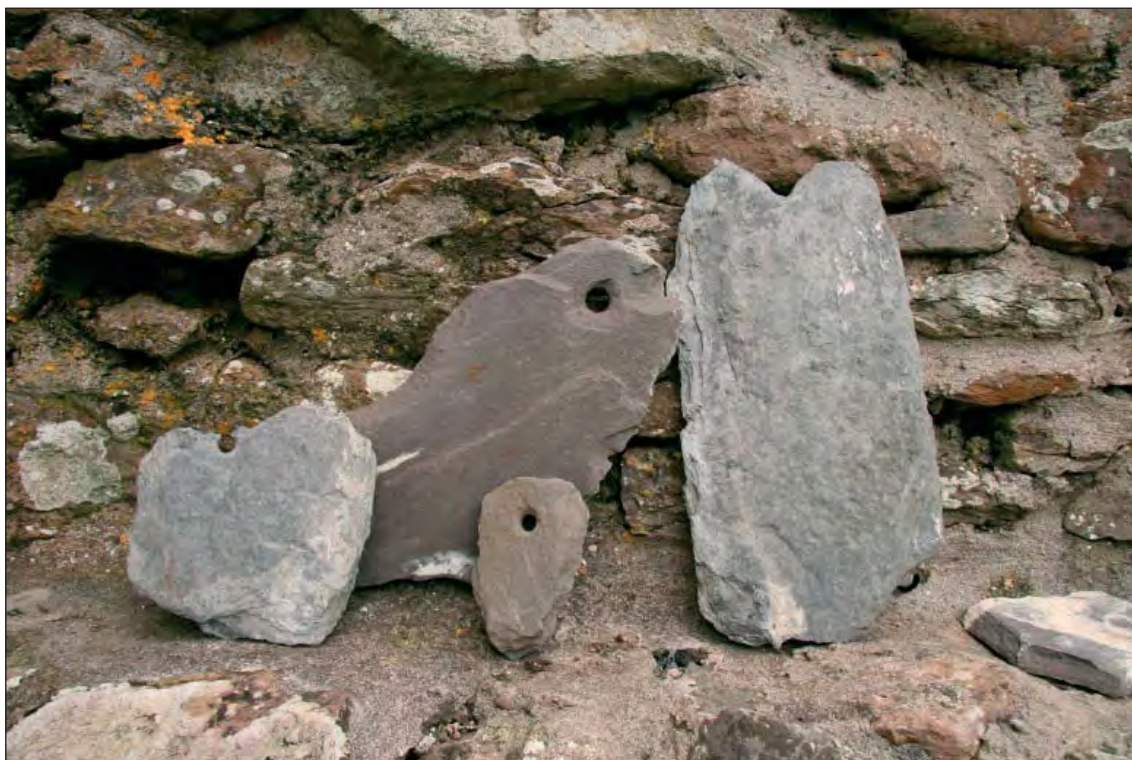
Fourteen (14) architectural fragments (AFs) were recorded in Ballinskelligs abbey and graveyard in the course of this survey (Figure 2 & Appendix 6). Several of these fragments were loose including four medieval perforated roof slates or reused as grave markers (Plates 31-33). Several other fragments were previously recorded at the site (O'Sullivan & Sheehan 1996, 347 & 350). The majority of which were stored in the Prior's House while a font fragment was situated in the abbey church (see General above).

**Plate 33:** View of loose architectural fragments AFs 4,5,6 & 7 comprising four perforated medieval slates loosely placed on Tomb 2 abutting the NE corner of the Prior's House.
