Archaeological Survey,  
Ballinskelligs Abbey and Graveyard,  
Ballinskelligs,  
Waterville,  
Co. Kerry.

September 2012

Client: The Heritage Office,  
Kerry County Council,  
County Buildings,  
Ratass,  
Tralee,  
Co. Kerry.

RMP No.: KE097-036

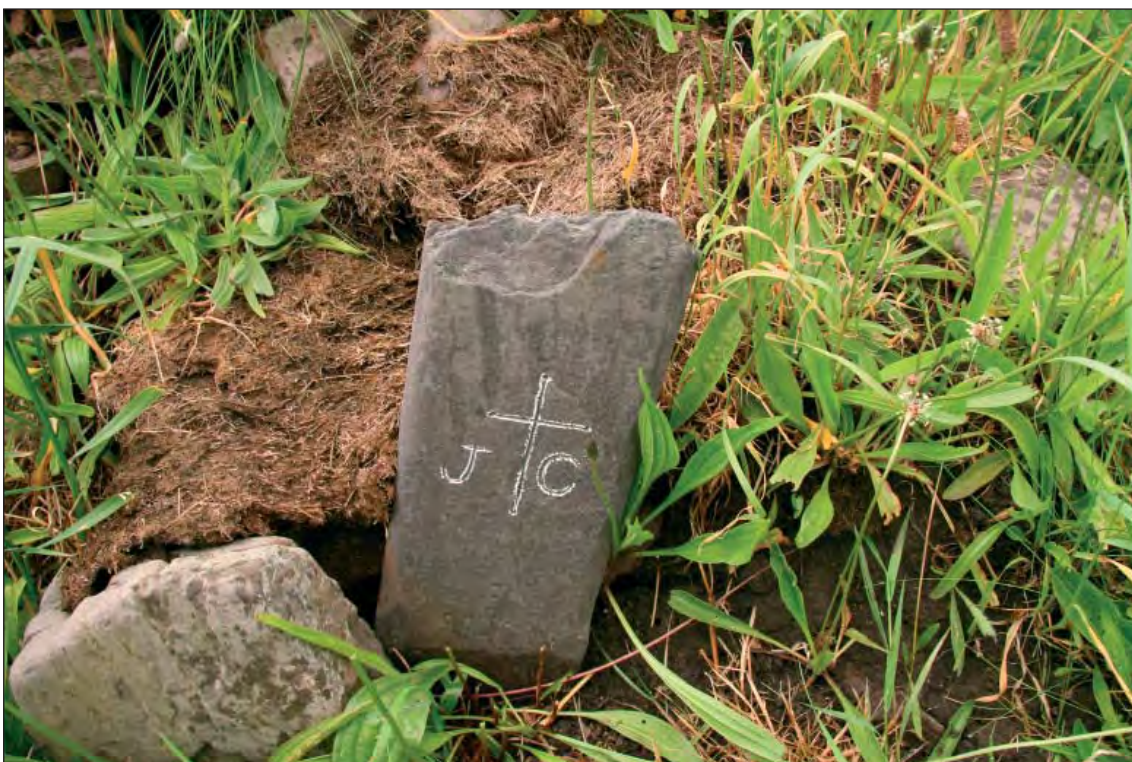
**Plate 34:** View of lightly incised post medieval cross-slab in N section of graveyard.

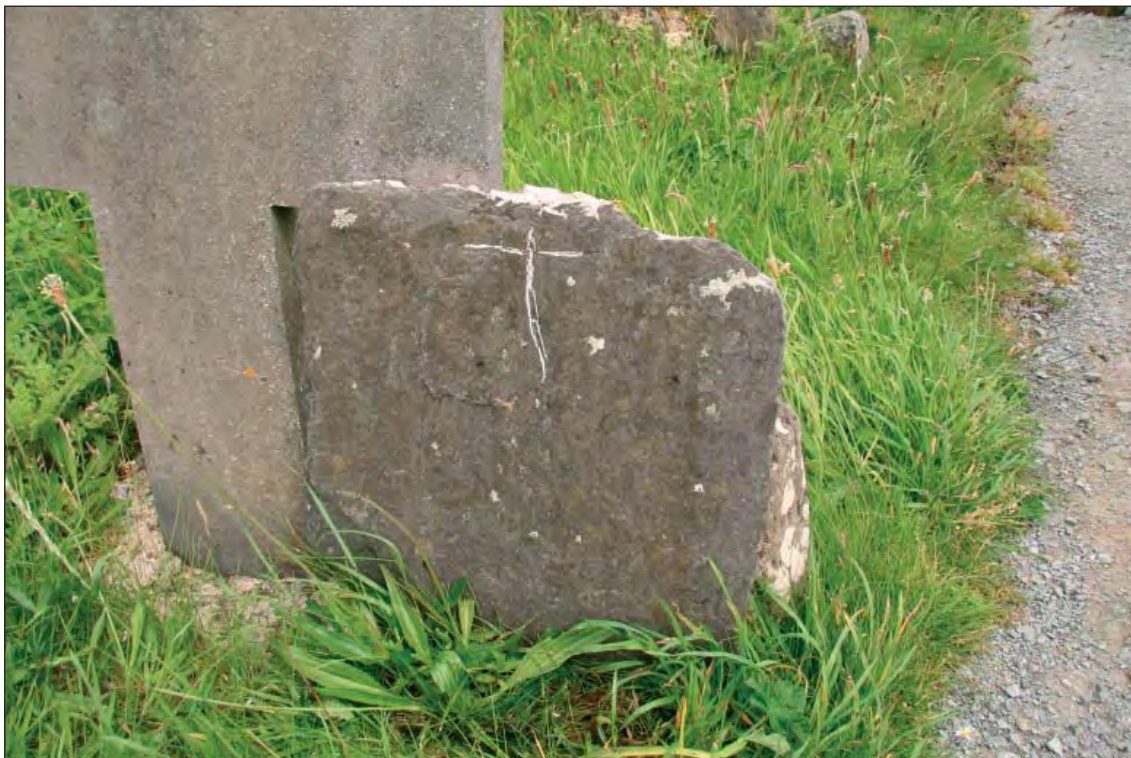
**Plate 35:** View of cross-slab with simple incised small Latin cross situated beside pathway in the N area of Ballinskelligs Graveyard.

The grass around cross-slab CS1 should be kept low to create greater visibility and protection for this thin slab that was spalled at the top in the past.

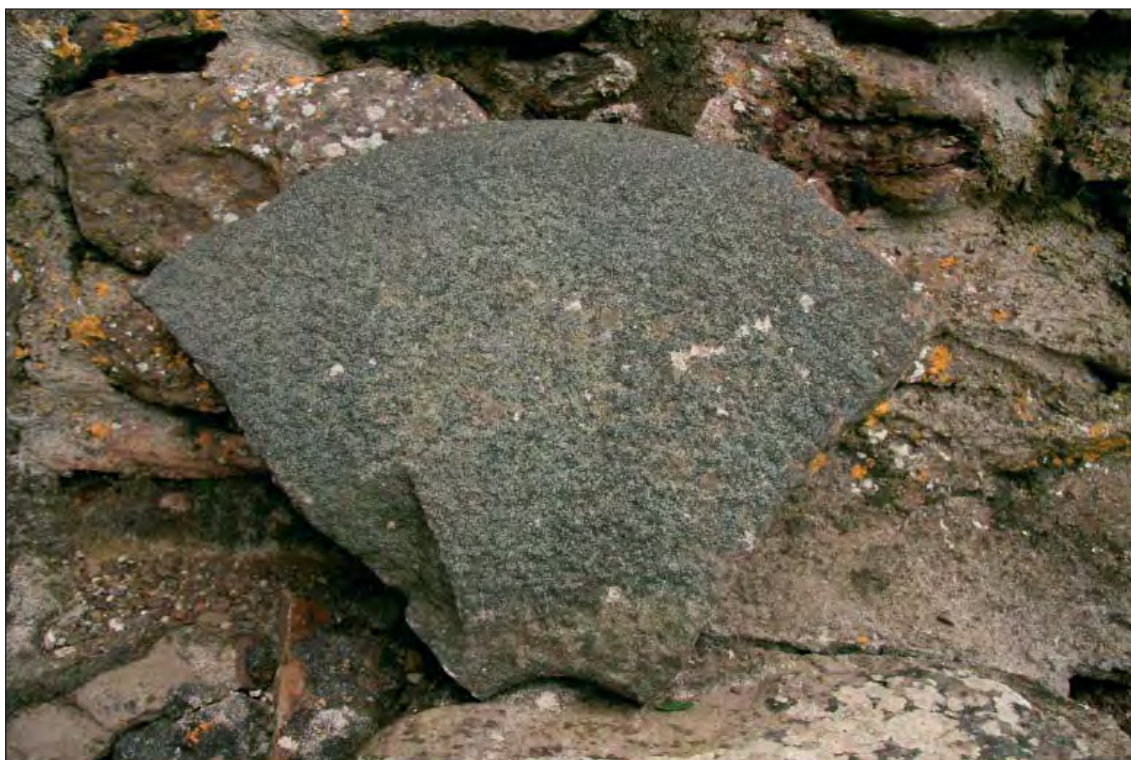
**Plate 36:** View of fragment of rotary quern loosely placed beside other architectural fragments on Tomb 2 abutting the NE corner of the Prior's House.

- The loose quern fragment should be secured collected and removed, possibly to the Kerry County Museum for safe keeping storage and individual recording.
- The quern fragment should be archaeologically illustrated.

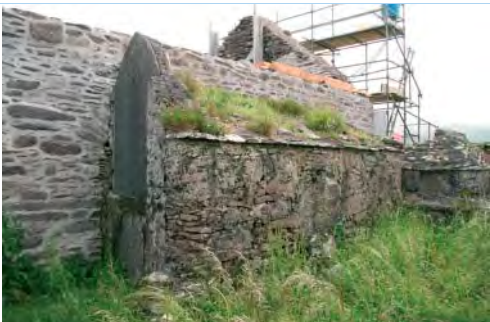
<b>Surname:</b>	O'Sullivan and O'Connell
<b>Tomb No:</b>	6
<b>Photo No:</b>	3356 & 3357

<b>Notes:</b>	
Collapsed	N
Open	N
Rendered	P
Overgrown	P

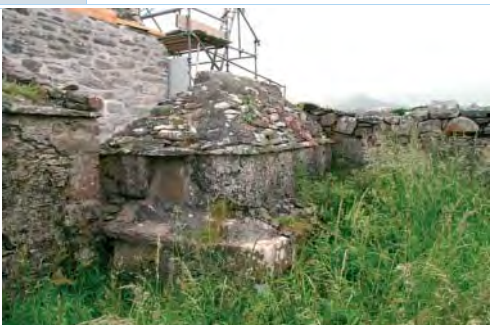
<b>Surname:</b>	Unknown
<b>Tomb No:</b>	5
<b>Photo No:</b>	3358

<b>Notes:</b>	
Collapsed	N
Open	N
Rendered	P
Overgrown	N

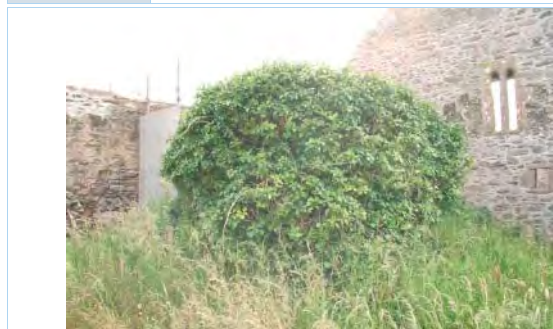
**Surname:** Unknown  
**Tomb No:** 3  
**Photo No:** 3335

Collapsed ☐ Open ☐ Rendered ☐ Overgrown ☒

Grass, ivy & bushes covering some of the tombs should only be fully removed as the primary element of a strategy of repairs and other conservation and restoration works. This work should be undertaken with expert archaeological advice and guidance.

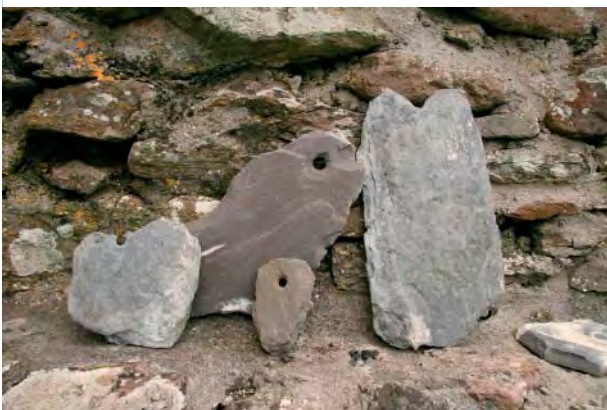
AF No:	5
Photo No:	3334

Notes:	Slate
--------	-------

- The loose *ex situ* architectural fragments should be secured collected and removed, possibly to the Kerry County Museum or temporarily retained by the OPW for safe keeping storage and individual recording.
- All of the fragments should be archaeologically illustrated.
- The whereabouts of the several other architectural fragments should be determined.
-

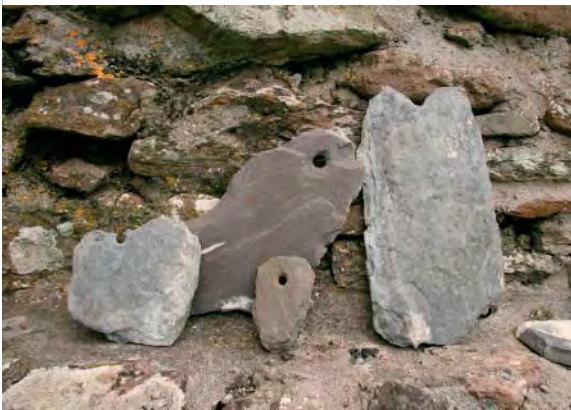
AF No:	4
Photo No:	3334

Notes:	Slate
--------	-------

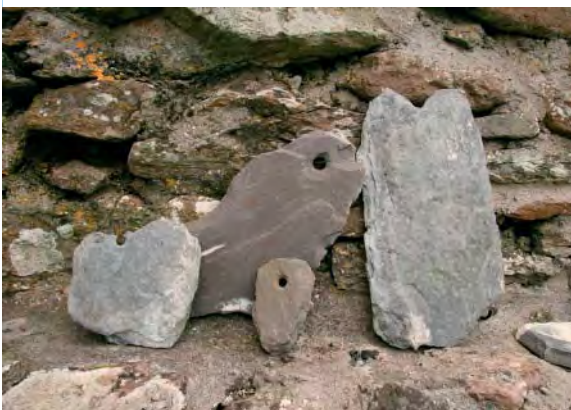
AF No:	6
Photo No:	3334

Notes:	Slate
--------	-------

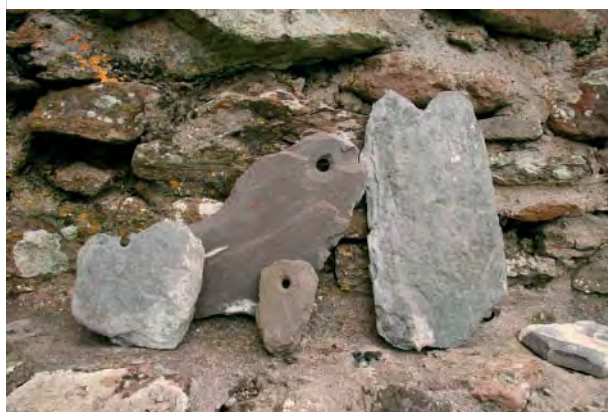
**AF No:** 7  
**Photo No:** 3334

**Notes:** Slate
