Archaeological Survey,
Ballyduff,
Dingle Peninsula,
Co. Kerry.

September 2010

Client: The Heritage Office,
Kerry County Council,
County Buildings,
Ratass,
Tralee,
Co. Kerry.

RMP No.: KE036-066 graveyard

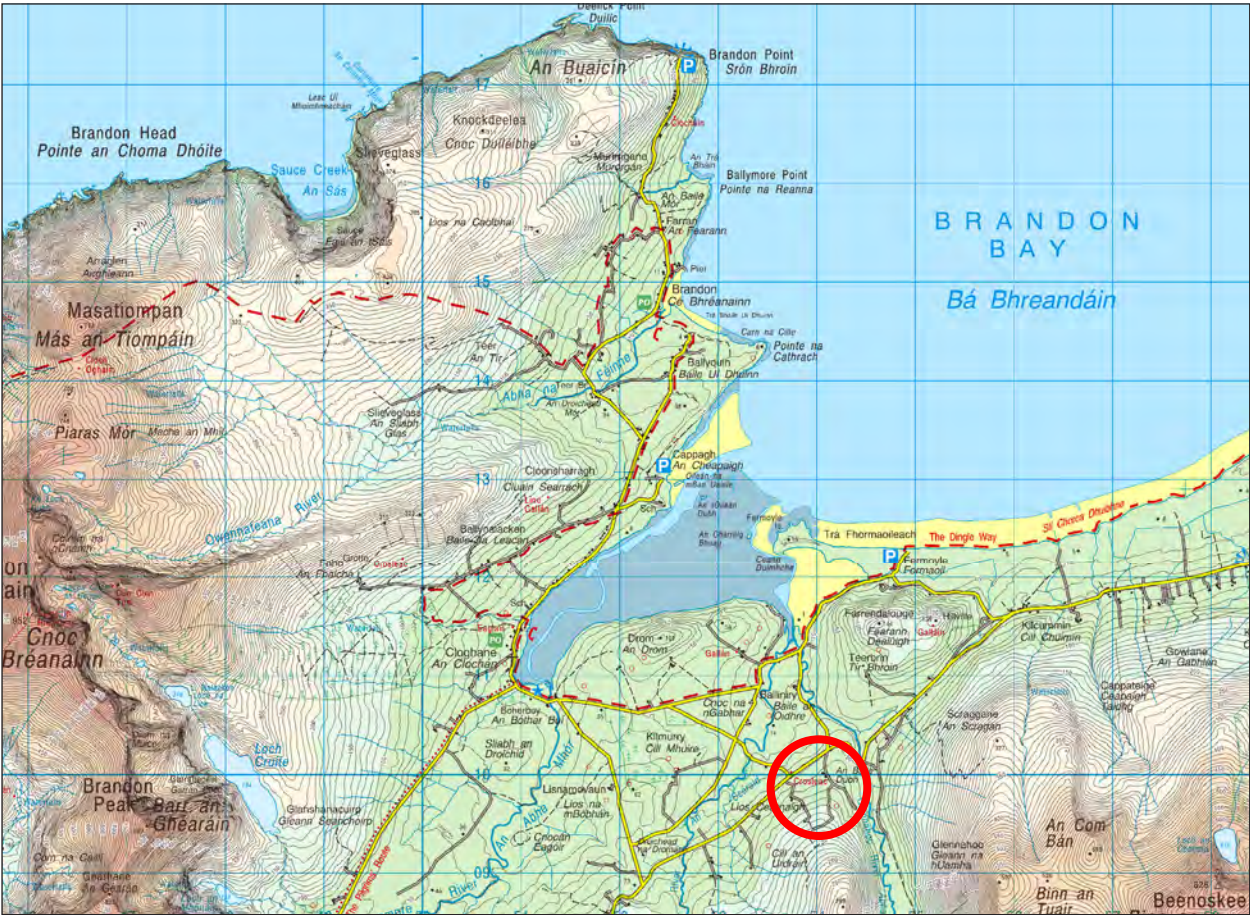
Figure 1: Site location map. Extract from OS Discovery series 1: 50,000, sheet 70.

Ballyduff Church and Graveyard is situated on the N side of the Dingle Peninsula and 10km west of the Castlegregory and 14.5km NE of Dingle (Figure 1 & Plates 1 & 2).

The roadway approach to the graveyard of Ballyduff comprises a short and narrow slip road to S from the R550 Conor Hill road to Dingle (Figure 1).

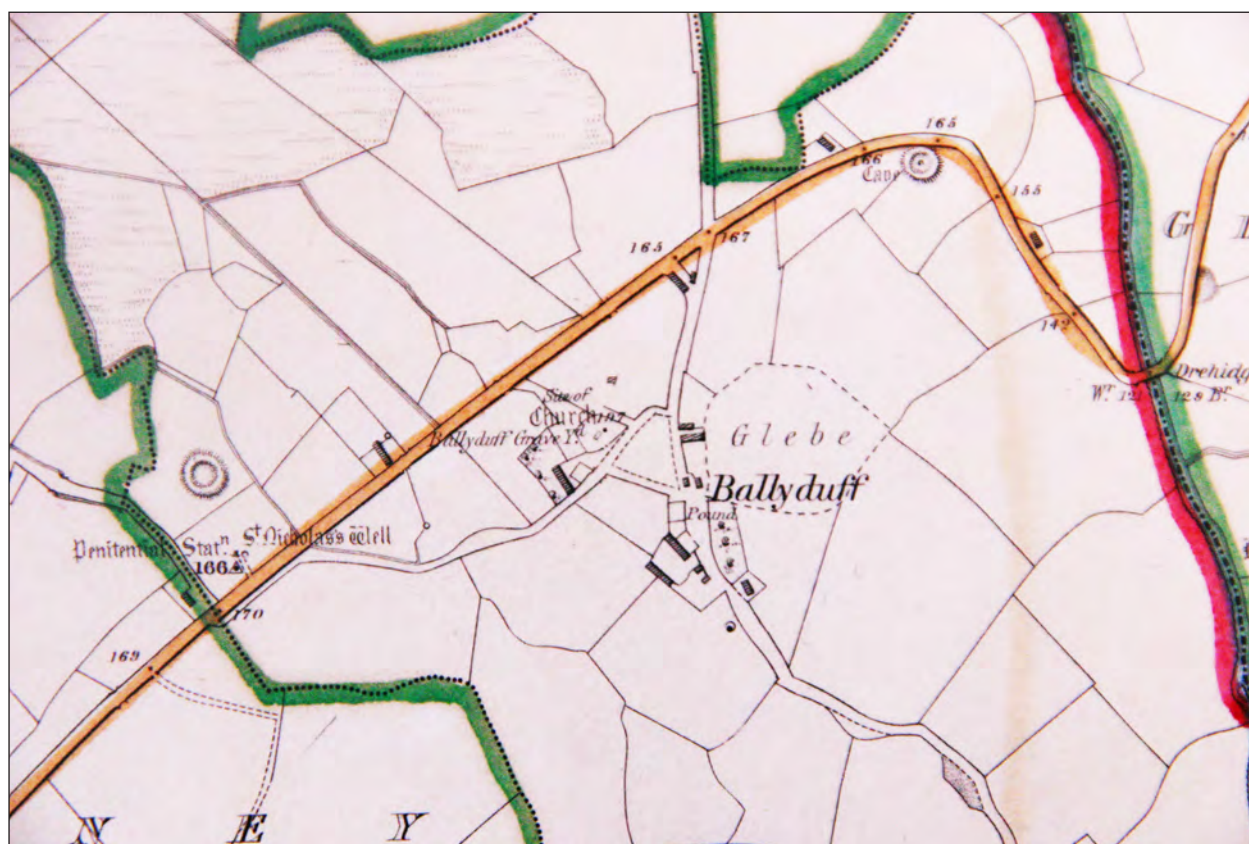
Figure 3: Extract from OS 1st Edition 1841 map, sheet 036.

The tiny sub-circular graveyard of Ballyduff including the site of the rectangular church and its associated glebe land is denoted on the 1st Ed. OS map, sheet 36 of 1841 (Figure 3).

Today, Ballyduff has a new burial ground abutting the old one at the SE. This new section was once the unenclosed triangular village green of Ballyduff (Figure 3).

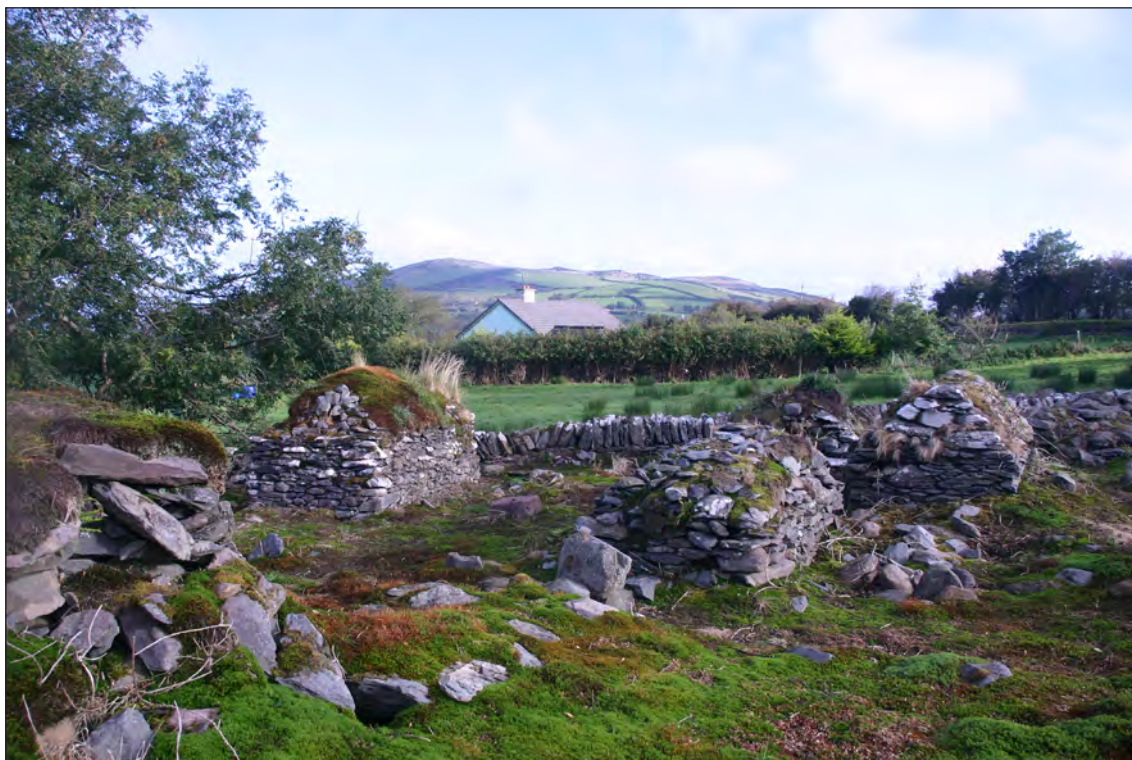
Plate 3: View of eastern limits of the interior of the medieval burial ground at Ballyduff. The varying state of disrepair of the tombs and open lintelled graves

There is an enormous amount of specialist work required to preserve, repair and restore these unnamed tombs at Ballyduff. However, several will require careful rebuilding and important repairs are required of others to close them off. Indeed there is some question as to some tombs if they are viable at all and that maybe they should or could not be refurbished. As these old tomb are built of local red sandstone it will be necessary to repair them with similar material and seal open tombs with sandstone flags.

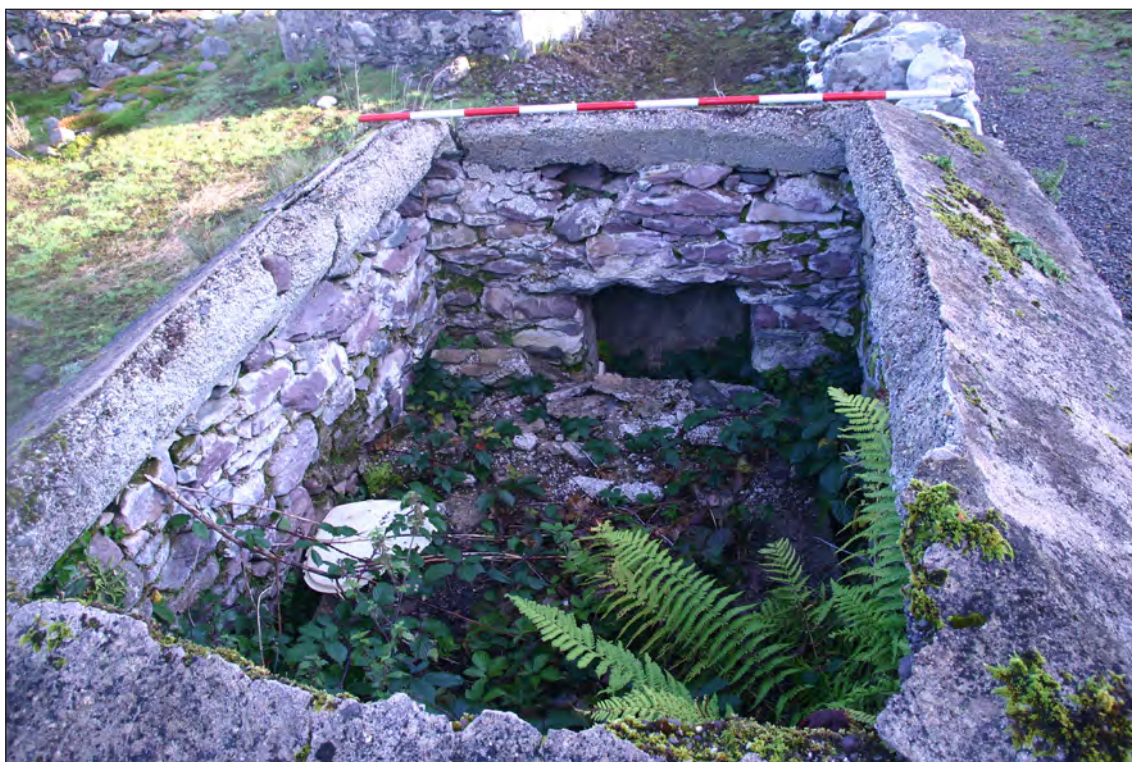
Plate 4: View of collapsed unnamed tomb 10 at Ballyduff Graveyard

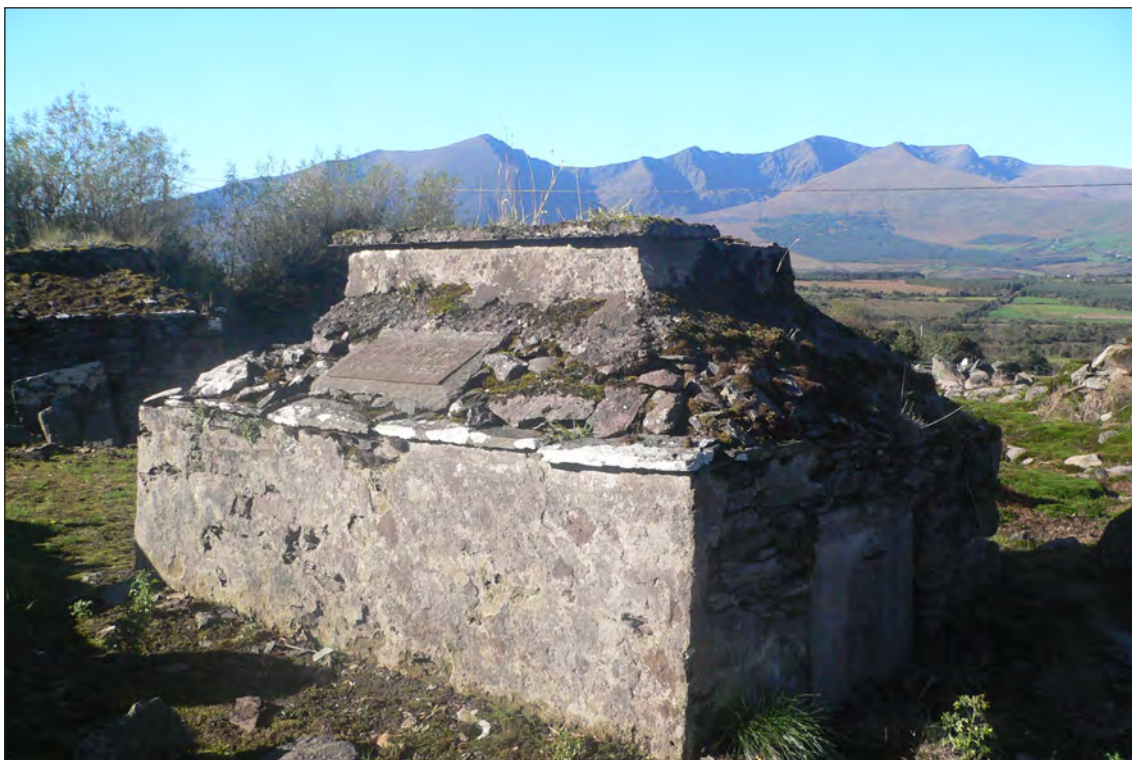
Plate 5: View of the O'Connor tomb 32 at Ballyduff Grave yard

The tombs should be repaired and restored. The O'Connor tomb (32) is in better repair, however, the render on its haunches in particular is in a poor state and needs to be re-rendered. More substantial repairs to the physical fabric of the Moynihan tomb (55) are required and if they are not undertaken soon it is likely to fully collapse. Repairs to both tombs should be undertaken by experienced masons with a proven track record of working on historic structures and in the use of lime mortar etc. This work should only be carried out under expert archaeological advice and supervision as it is most likely that other architectural fragments from the medieval church of Ballyduff are incorporated within the tombs (see Unnamed Tombs section below).

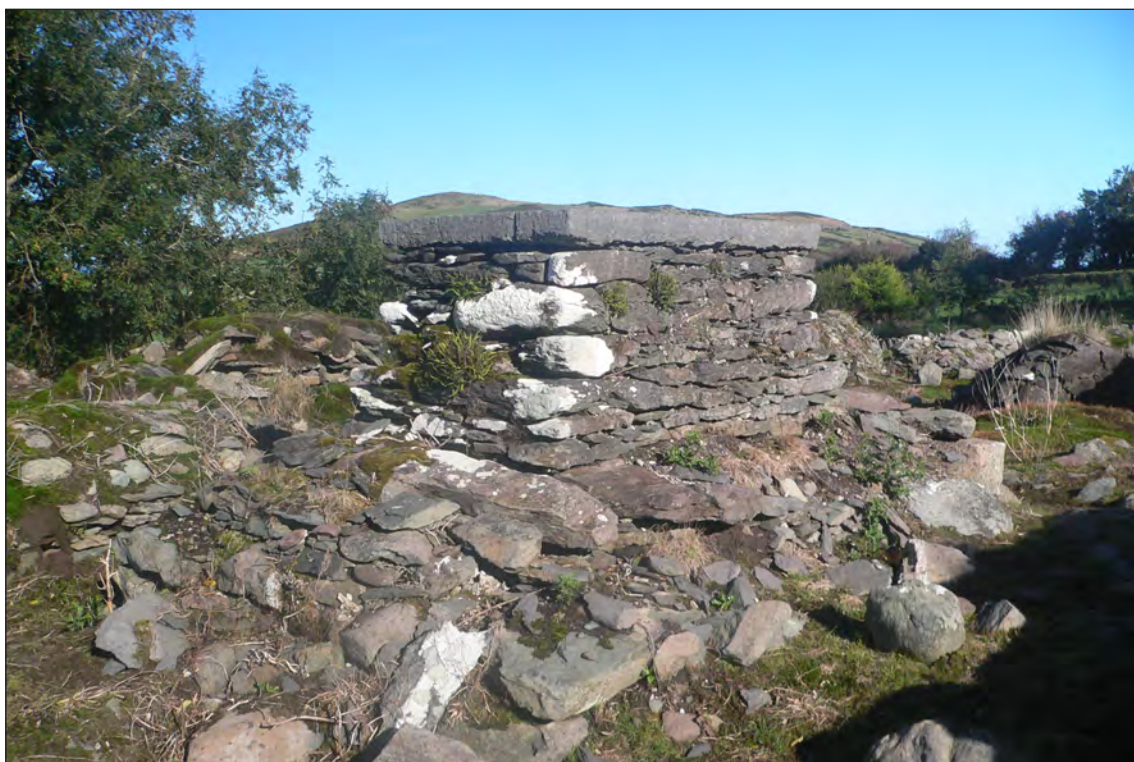
Plate 6: View of the partially collapsed Moynihan tomb 55 in Ballyduff Graveyard

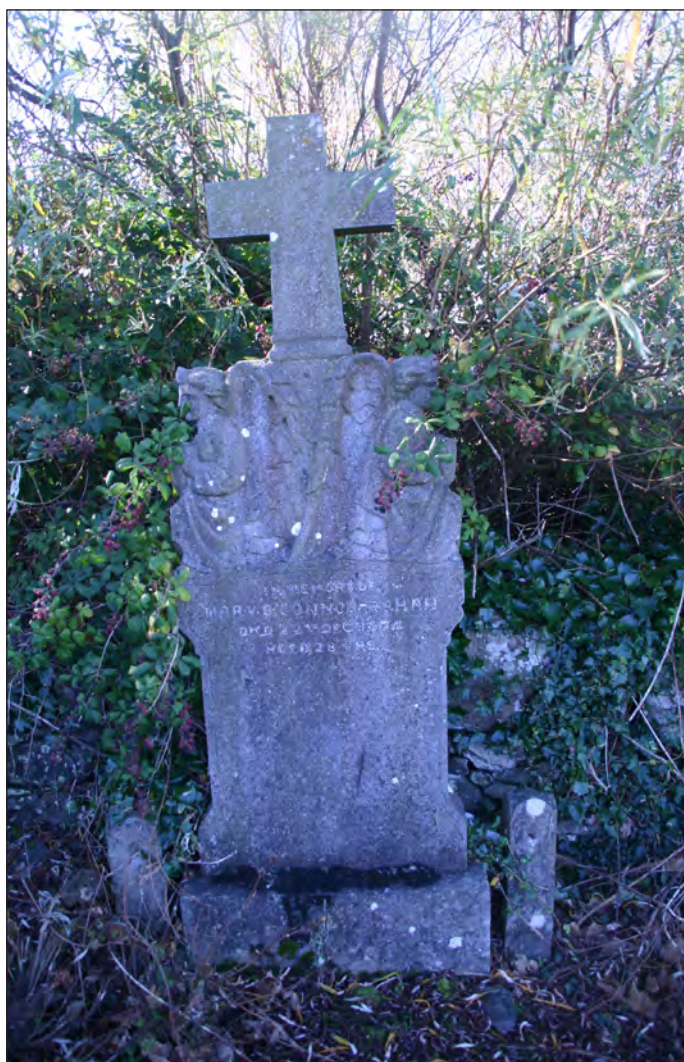
There is only one named headstone with formalised grave setting in the old burial ground at Ballyduff (Plate 8).

There were eighty-nine named and legible headstones recorded at Ballyduff graveyard associated with formal grave settings (Appendix 4, Figure 5 & Plate 1). All the headstones are in good condition and all bar grave 56 (Plate 8) are within the new burial ground.

Plate 8: View of the headstone in memory of Mary O'Connor-Rohan who died on the 22nd December 1874 aged 28. This is the only headstone (56) and modern formalised grave setting in the old section of Ballyduff Graveyard and also the oldest inscribed memorial in Ballyduff

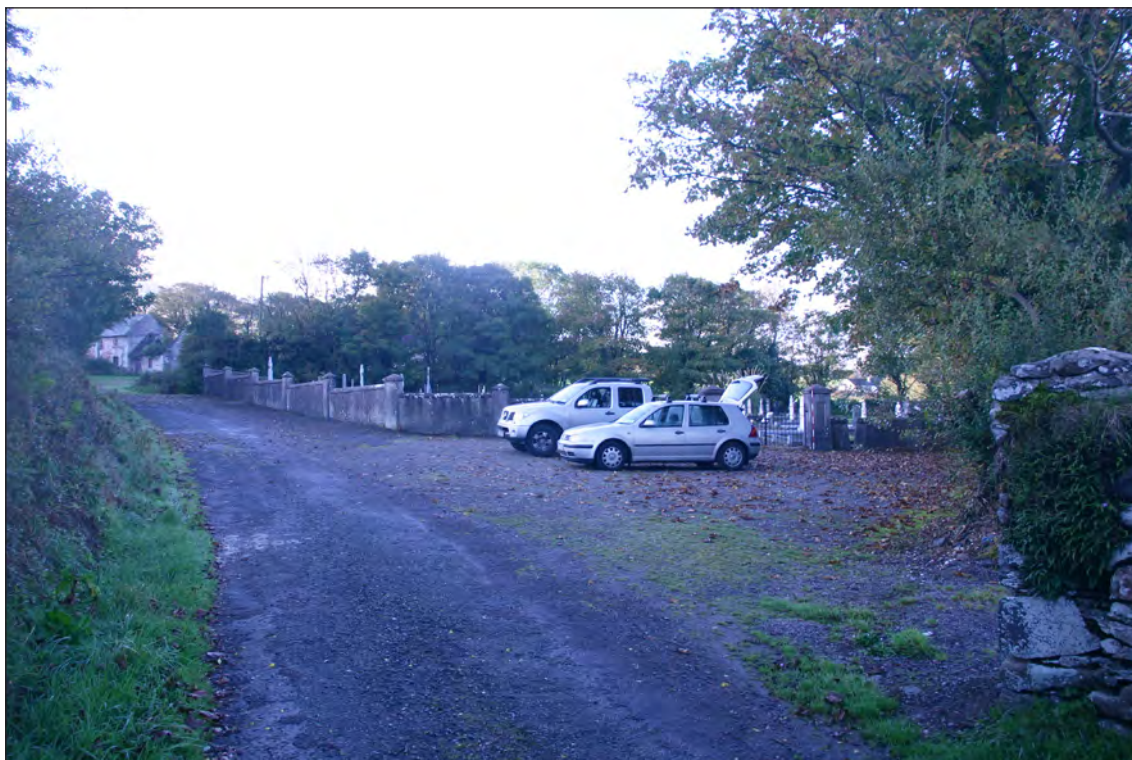
Ample carparking is available immediately in front of the new section of the graveyard (Plate 9). The entrance comprises two modern black painted iron gates set between two square capped and rendered piers in very good order with a simple squeeze-stile immediately beside the right hand or E pier (Plate 10 & Figure 5).

Plate 9: View of the carparking area and approach to the entrance of Ballyduff Graveyard from N

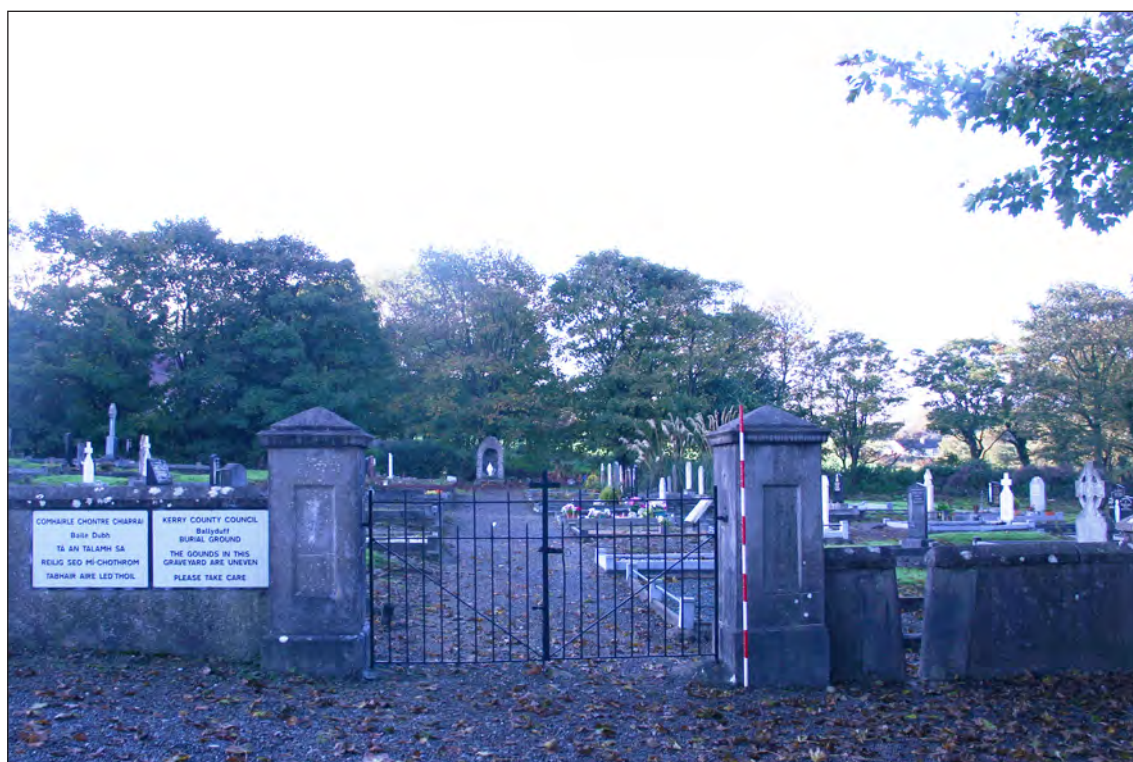
Plate 10: Exterior view of entrance gates, squeeze-stile and walls of modern section of Ballyduff Graveyard

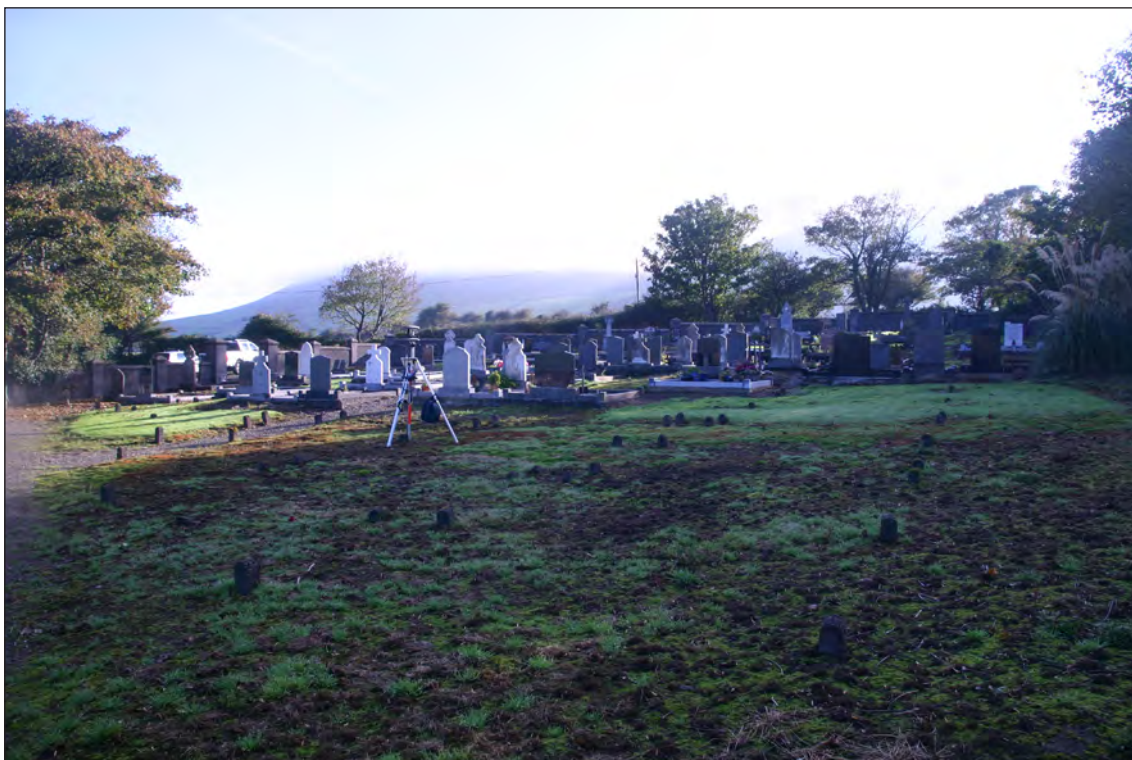
Plate 11: View of unused NW limits of modern section of Ballyduff Church

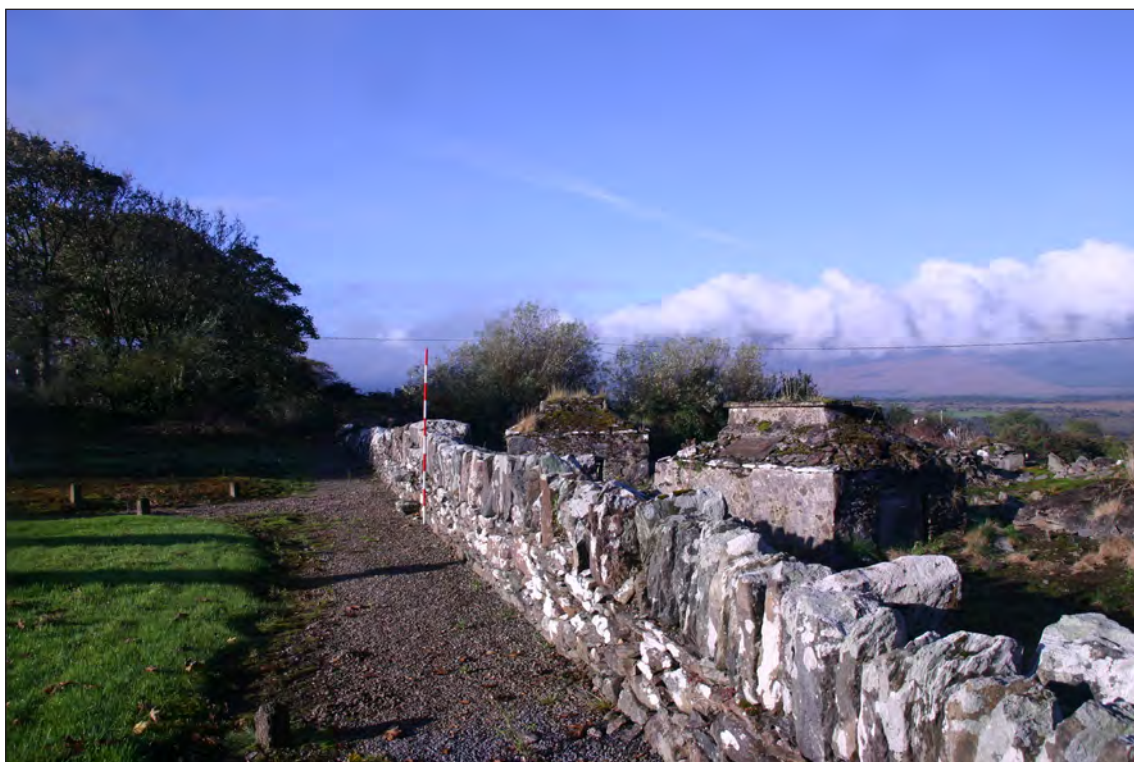
The old medieval section of Ballyduff Graveyard is bounded by a low (0.8m - 1.0m) random rubble wall of local sandstone bedded in mortar and capped with 'soldiers' a NE-SW section of which now separates the old burial ground from the new (Plate 12). A step-stile provides able bodied access into the old burial ground (Plate 13). Otherwise access is gained through a ragged breach at the W end of the separating old boundary wall that is difficult and uneven underfoot (Plate 14). Several sections of the old boundary wall are in rag order especially at the W and NW corner. Several of the capping soldiers along the dividing boundary wall have also been robbed out (Plate 15).

Immediately inside the entrance gates a vehicular gravelled accessway bisects the modern graveyard in an NE-SW direction while a gravelled pathway extends around the internal perimeter (Plates 12 & 16 & Figure 5). The well laid out new graveyard section is amply served with several other spur paths both gravelled and informal throughout its interior.

Plate 12: View from E of graveled pathway and rubble stone wall separating the modern section of Ballyduff Graveyard from the old medieval burial ground

- Repairs to the boundary walls should be undertaken by people with a proven track record in repairing dry stone walls.
- An information booklet on care and maintenance for tombs should be compiled and supplied to the relevant parish church.

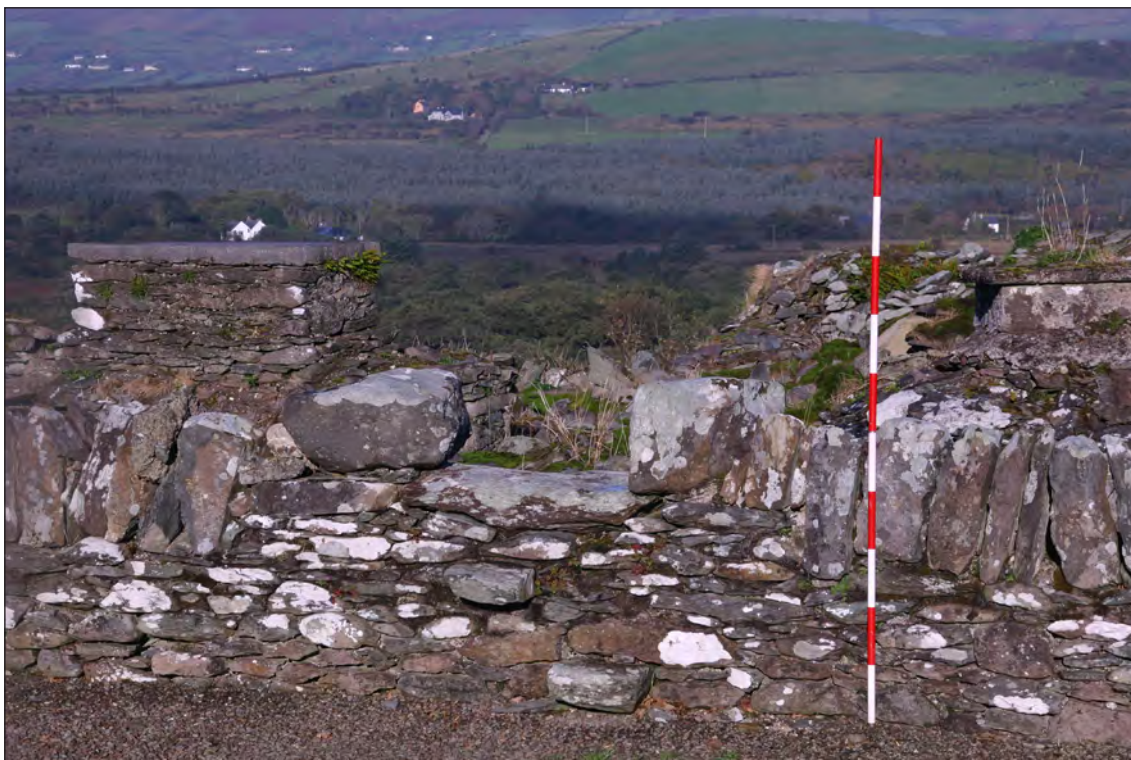
Plate 13: View of step-stile midway along rubble stone wall enclosing old section of Ballyduff Graveyard

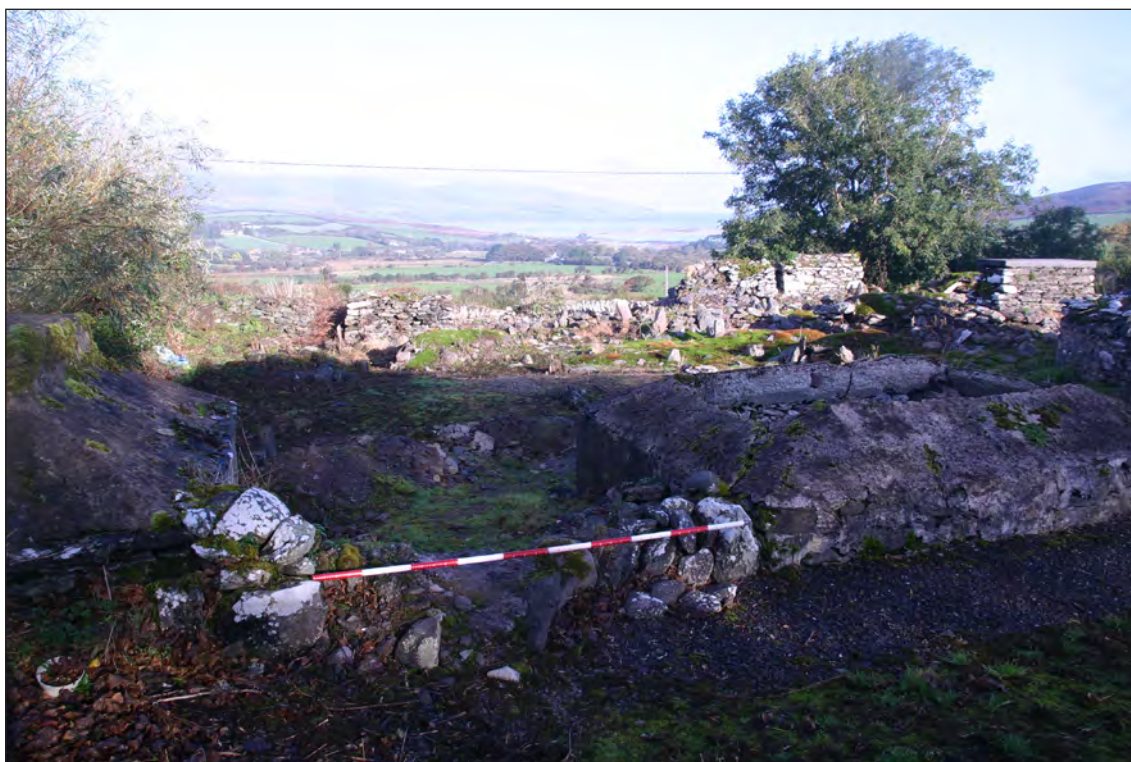
Plate 14: View of breach in W limits of rubble stone wall separating modern burial ground from old. The breach now forms an ad hoc entrance gap

A more efficient simple pedestrian entrance should be inserted in the separating old boundary wall and the current ad hoc breach repaired.

- A proper entrance should be inserted into the boundary wall separating the old burial ground from the new and the current breach properly repaired with local sandstone rubble and lime mortar by masons experienced in historic walls and structures.

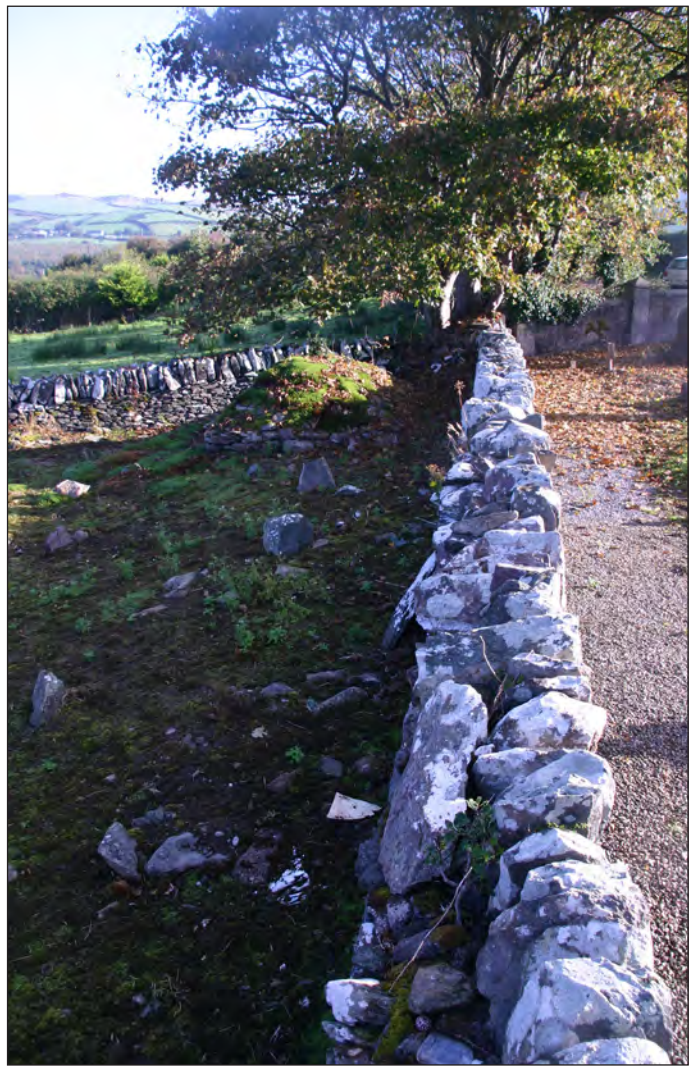
Plate 15: View of E limits of rubble boundary wall at Ballyduff. Note soldier capping, some of which have been robbed out

The old rubble stone boundary wall should be sensitively repaired with similar local sandstone and lime mortar and its soldier capping replaced. This work should only be undertaken under archaeological supervision and by masons with a proven track record of repairing and restoring similar historic walls. A

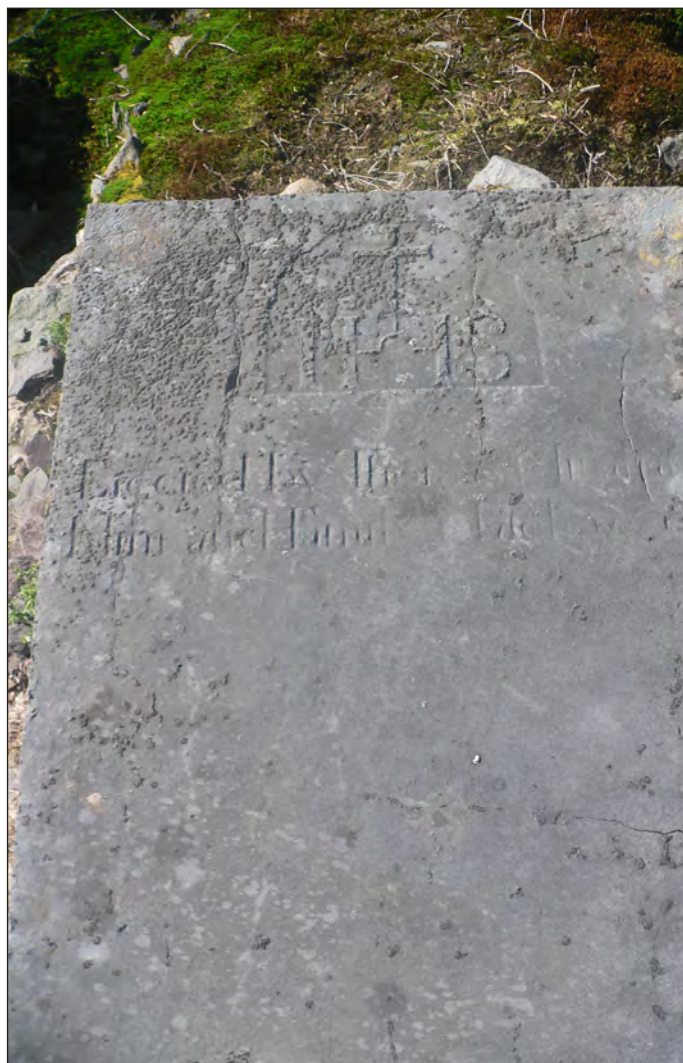
Plate 17: Overview of memorial slab capping partially collapsed tomb 55 in memory of Thomas Moynihan. The 19th century date has disappeared

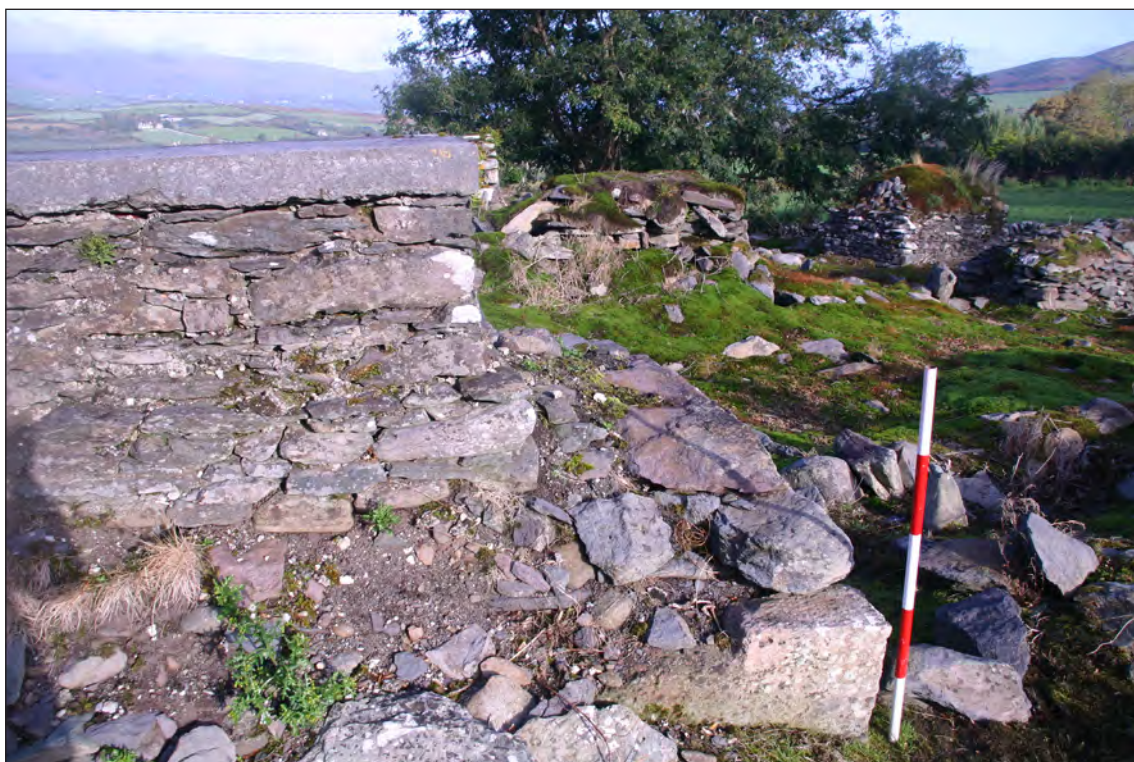
Plate 18: View of SE limits of partially collapsed Moynihan tomb, 55 at Ballyduff. Note reused architectural fragment (291) from medieval church

ID No:	291	Notes Long rectangular punch dressed sandstone block, 0.72 x 0.33m x 0.21m, reused in SE corner of Moynihan tomb 55.
Photo No:	149_1480	
Photo:

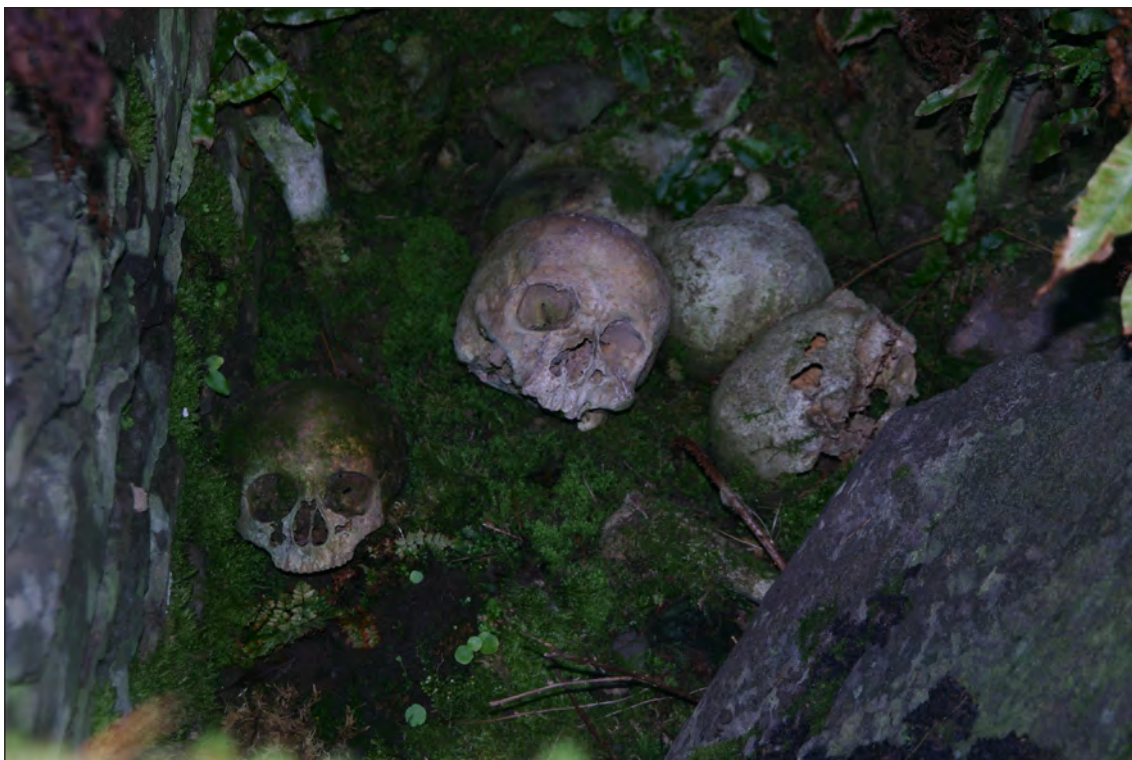
Plate 19: Interior view of open and broken tomb 45 at N limits of the old section of Ballyduff Graveyard

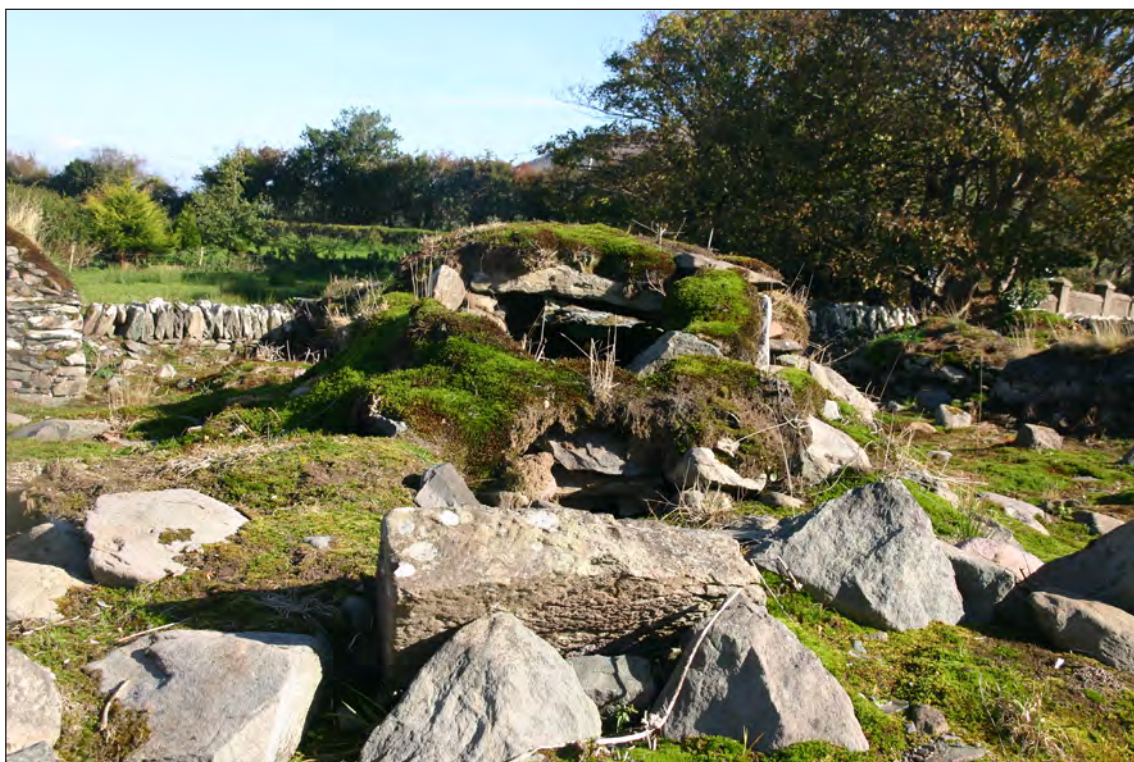
Plate 20: Interior view from W of Ballyduff Graveyard. Note collapsed tombs, open lintelled graves and architectural fragment

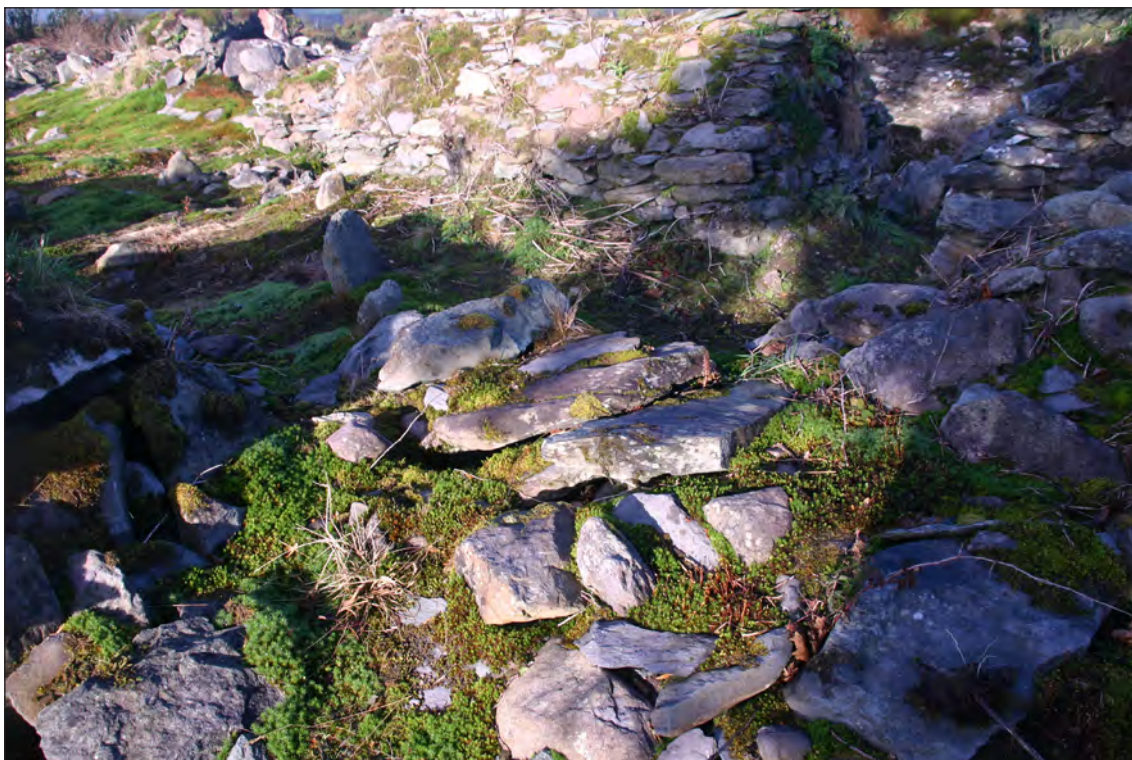
Plate 21: View of partially collapsed lintelled graves 466 & 467 at SE limits of old burial ground.

The exposed lintelled graves should be repaired properly by masons experienced in historic structures under archaeological expert advice and supervision. The graves should then be covered with earth, re-sodded or re-seeded. The unhewn grave markers should be left *in situ*. This will preserve the graves and make the graveyard easier to negotiate.

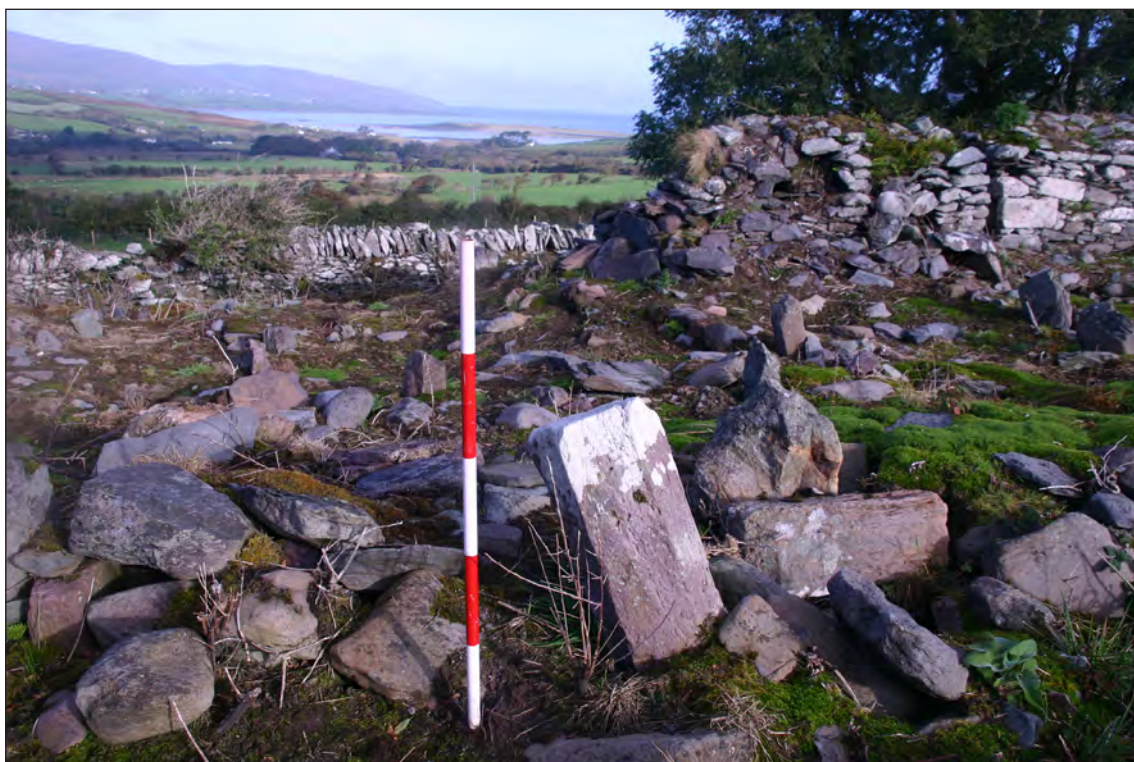
Plate 22: View of interior of old Ballyduff burial ground from S. Note the scattered collapsed remains including upright medieval architectural fragment 281 and horizontal fragment 282.

The collapsed loose *ex situ* architectural fragments should be collected and removed to the Kerry County Museum for safe keeping storage and individual recording.

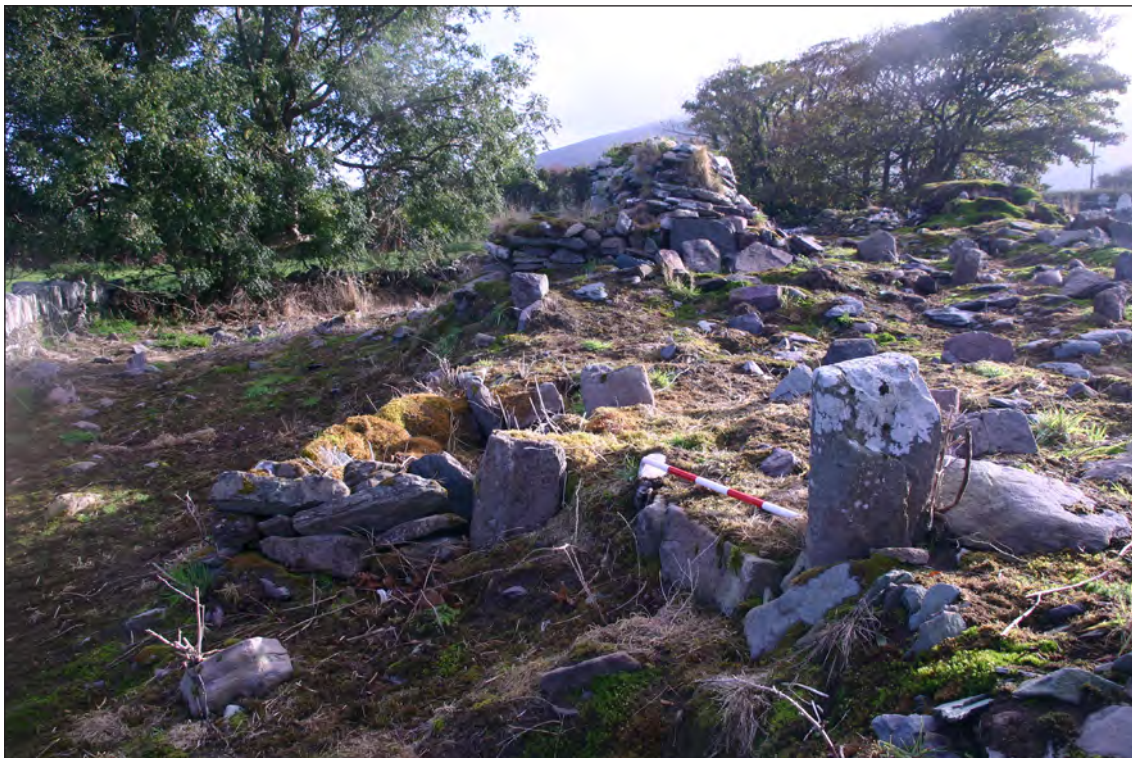
Plate 23: View from W of four architectural fragments (273-275) reused and marking lintelled grave 487 and 456 at NW limits of Ballyduff Church

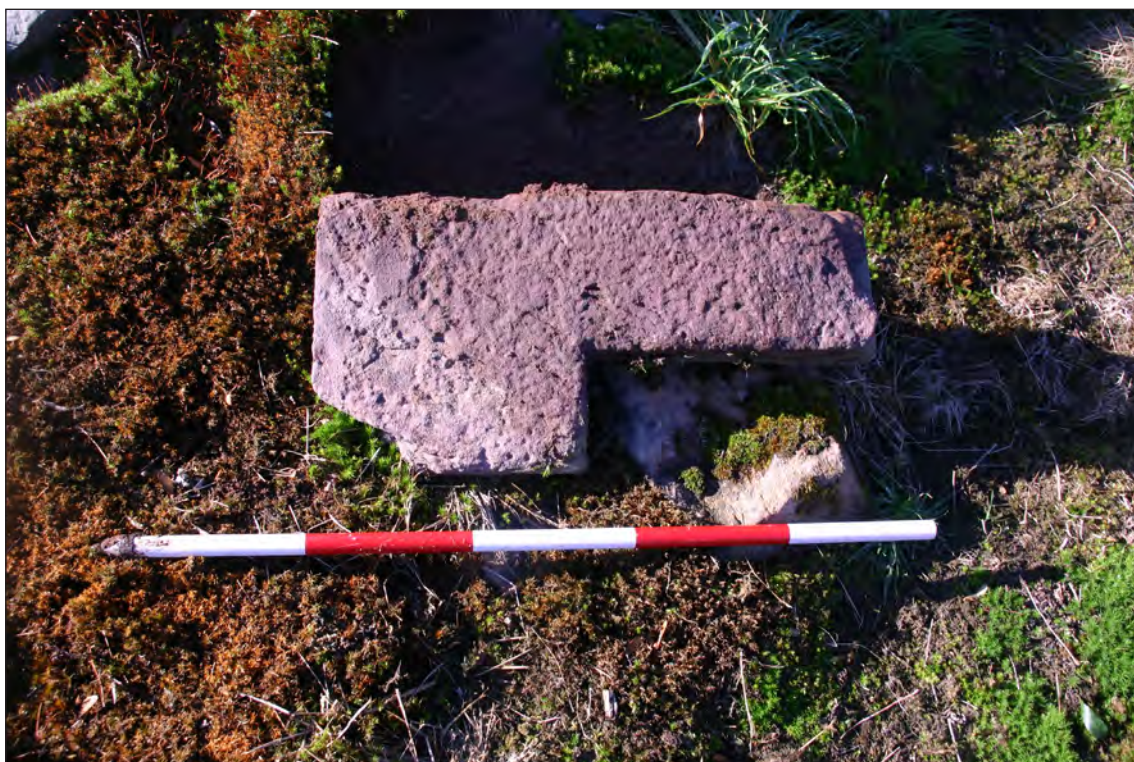
Plate 24: View of easily movable architectural fragment 252 lying loose at E area of Ballyduff Graveyard

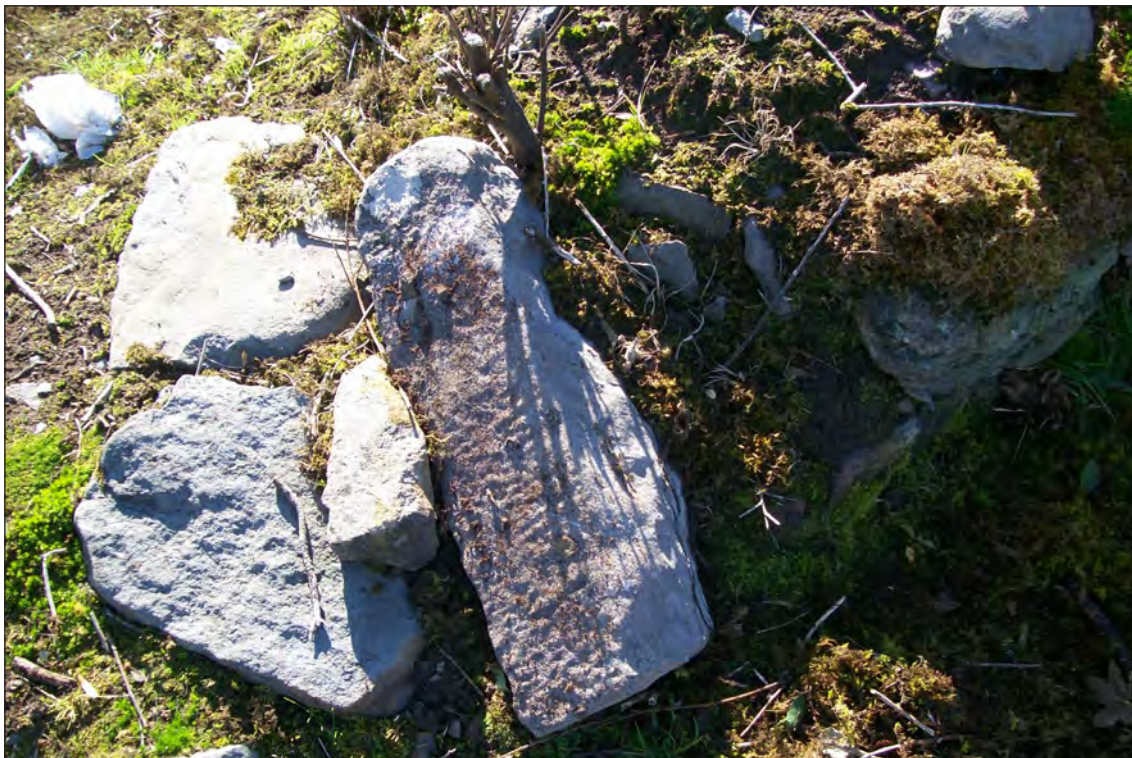
Plate 25: View of architectural fragment 290 at W limits of Ballyduff Graveyard lying loose beside tomb 53

ID No:	290	Notes	Rectangular punch dressed sandstone fragment 0.44m x 0.16m lying in front of tomb 53.
Photo No:	149_1479		
Photo:

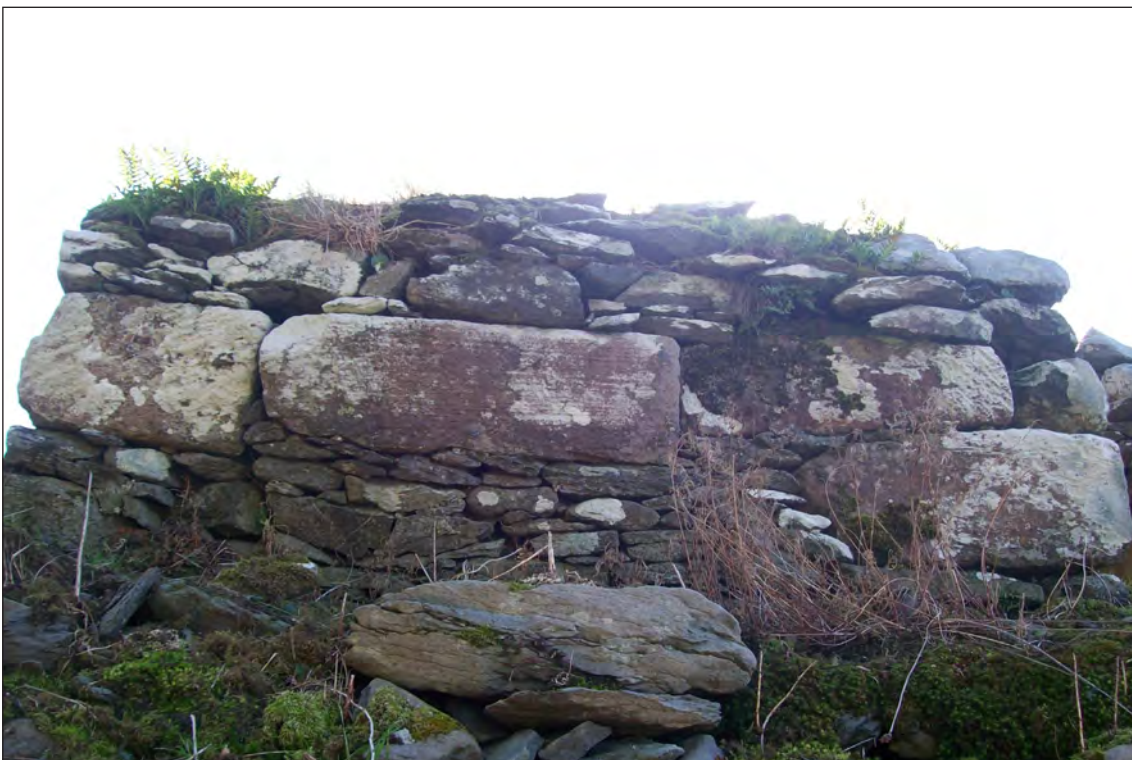
Plate 26: View of N side of tomb 43 in Ballyduff Graveyard. Note reuse of four substantial architectural fragments, (263 a-d), possibly quoins

ID No:	263 A, B, C, D	Notes	Group of four rectangular punch dressed sandstone blocks reused on N side of tomb 43. Specific dimensions not taken due to precarious collapsed nature of tomb 46 beside and below tomb 43.
Photo No:	149_1459		
Photo:
