Archaeological Survey,
Ballyduff,
Dingle Peninsula,
Co. Kerry.

September 2010

Client: The Heritage Office,
Kerry County Council,
County Buildings,
Ratass,
Tralee,
Co. Kerry.

RMP No.: KE036-066 graveyard

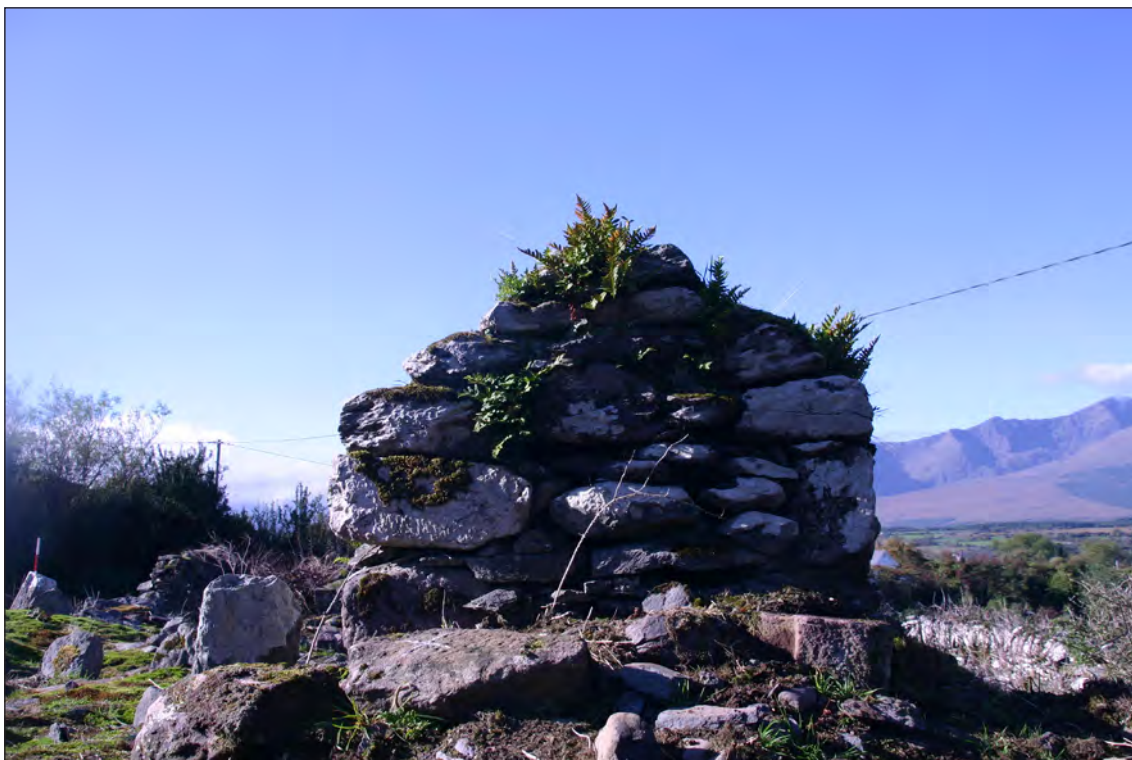
Plate 27: View of east gable of tomb 43. Note architectural fragments 260-263 at base

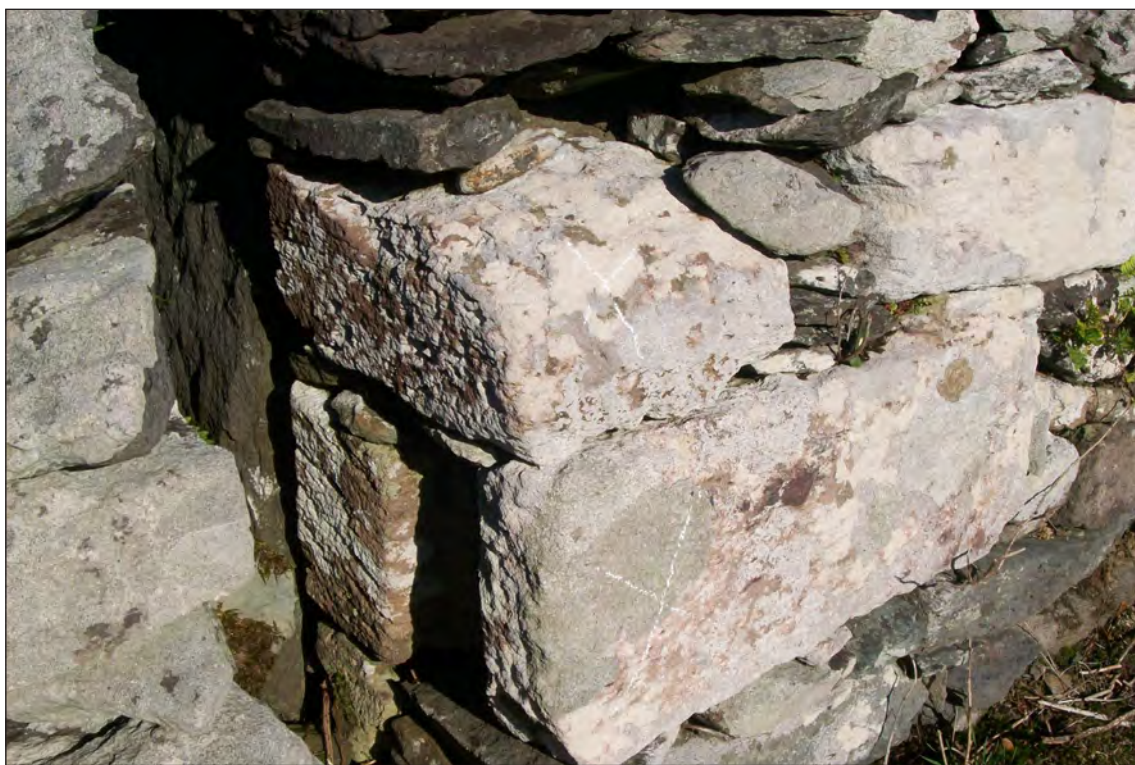
Plate 28: View of SW corner of tomb 43. Note three reused architectural fragments 255, 256 and 257

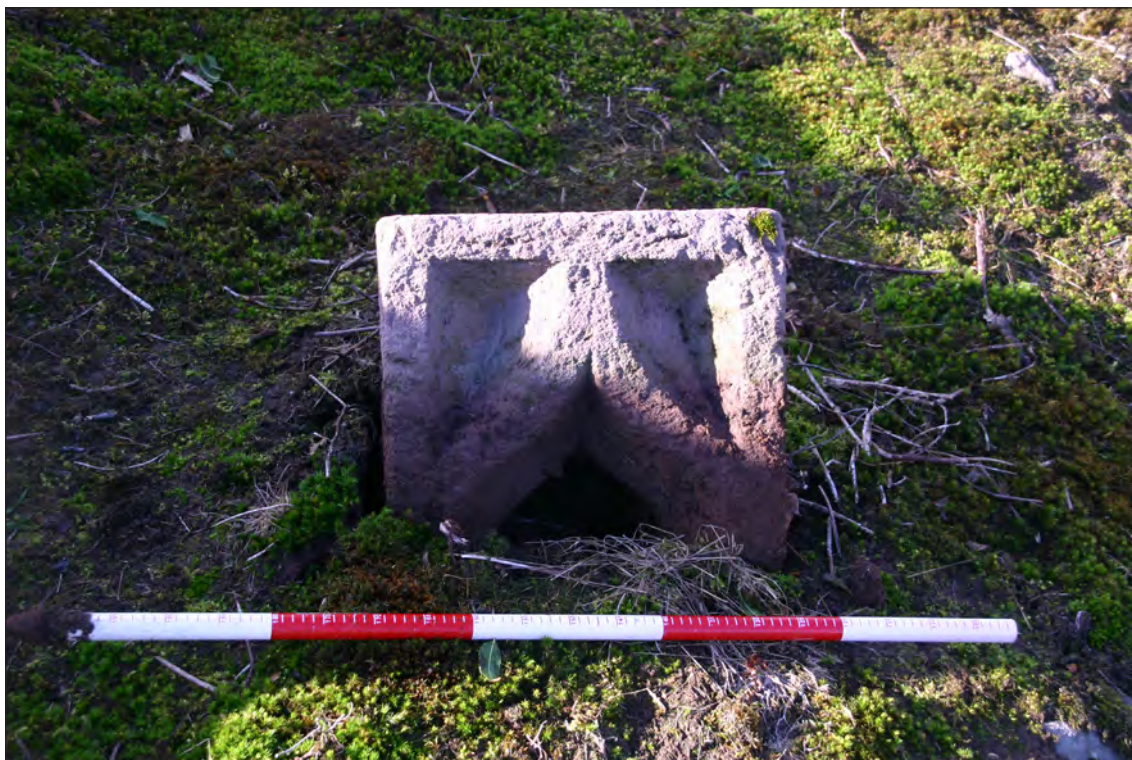
Plate 29: View of architectural fragment (251) comprising ogee head of 15th century window reused as gravemarker in Ballyduff Graveyard

The stoup (254) and the ogee head (251) are barely set in loose earth and easily moved. They should be fully recorded, illustrated and placed in the Kerry County Museum for safe keeping.

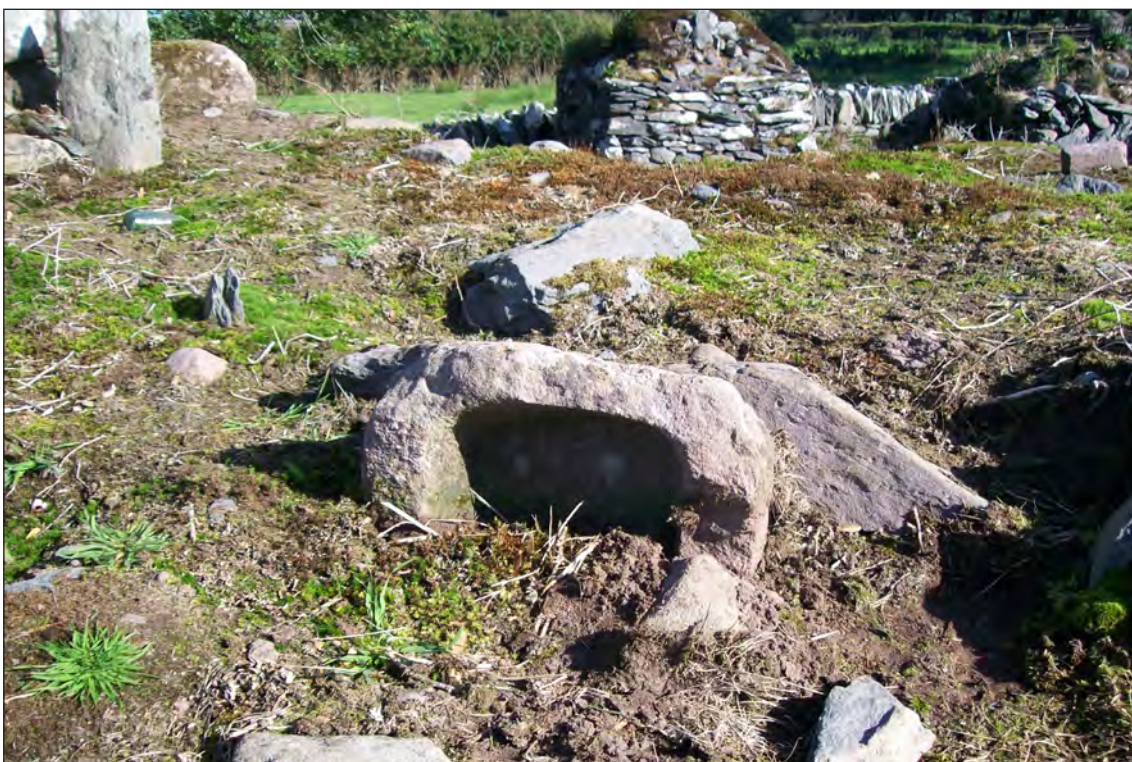
Plate 30: View of Holy Water stoup (254) reused as gravemarker within E limits of Ballyduff Church

ID No:	254	Notes	Sub-rectangular Holy Water stoup with outer corners rounded. Of coarse hewn sandstone situated at eastern limits of interior of church and reused as gravemarker. Dimensions: (Bowl) 0.28m x 0.215m x 0.08m depth; external 0.44m x 0.29m x 0.16m.
Photo No:	149_1452		
Photo:

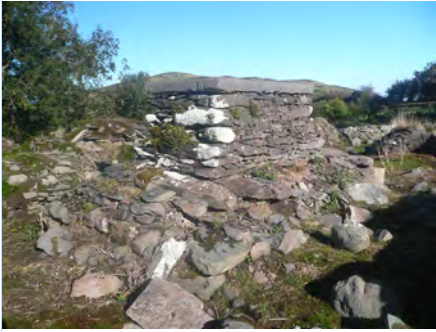
Surname:	MOYNIHAN
Tomb No:	55
Photo No:	159_0028 AND 0029
Photo:

Notes:	
Collapsed	P
Open	N
Rendered	N
Overgrown	P

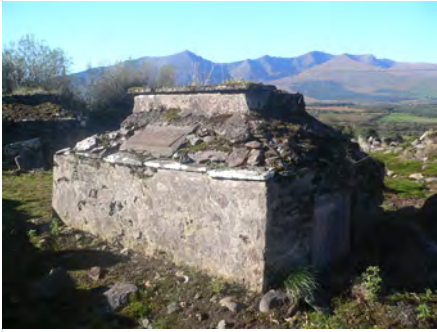
Surname:	O'CONNOR
Tomb No:	32
Photo No:	159_0003 AND 0004
Photo:

Notes:	
Collapsed	N
Open	N
Rendered	Y
Overgrown	N

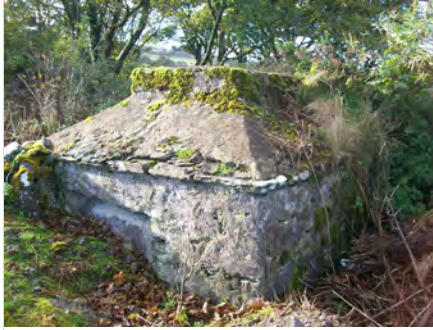
Tomb No:	3
Photo No:	149_1445
Photo:

Notes:	
Collapsed	N
Open	N
Rendered	Y
Overgrown	P

- The tombs should be repaired re-pointed, re-rendered and restored sensitive to their original construction. This work should be done under the supervision of an archaeologist qualified in this area or a conservation architect experienced in this field and may require Ministerial Consent.

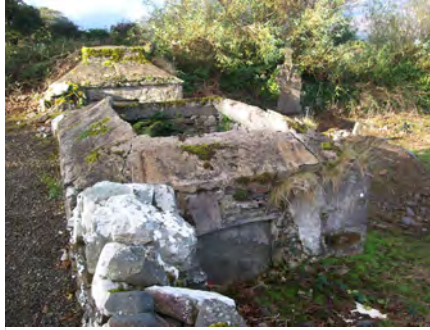
Tomb No:	10
Photo No:	149_1446 447
Photo:

Notes:	
Collapsed	Y
Open	Y
Rendered	Y
Overgrown	N

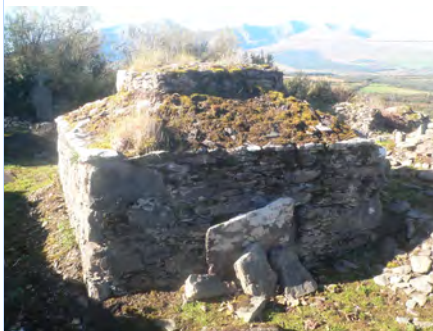
Tomb No:	30
Photo No:	159_0001
Photo:

Notes:	
Collapsed	N
Open	P
Rendered	N
Overgrown	P

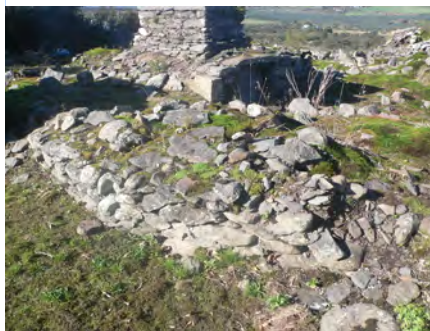
Tomb No:	31
Photo No:	159_0002
Photo:

Notes:	
Collapsed	P
Open	N
Rendered	N
Overgrown	P

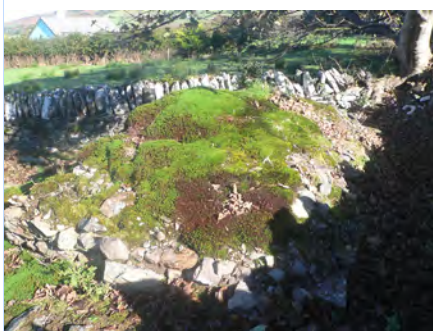
Tomb No:	33
Photo No:	159_0005
Photo:

Notes:	
Collapsed	N
Open	N
Rendered	N
Overgrown	Y

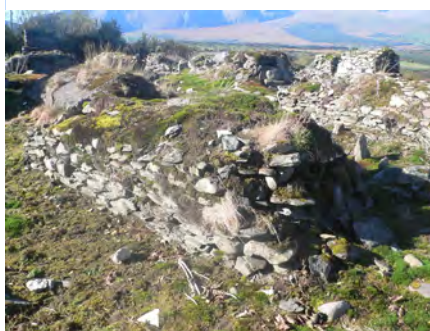
Tomb No:	34
Photo No:	159_0006
Photo:

Notes:	
Collapsed	P
Open	N
Rendered	N
Overgrown	P

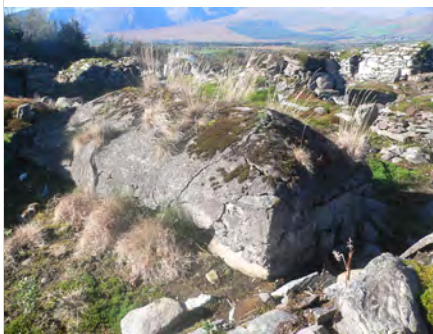
Tomb No:	35
Photo No:	159_0007
Photo:

Notes:	
Collapsed	P
Open	N
Rendered	Y
Overgrown	P

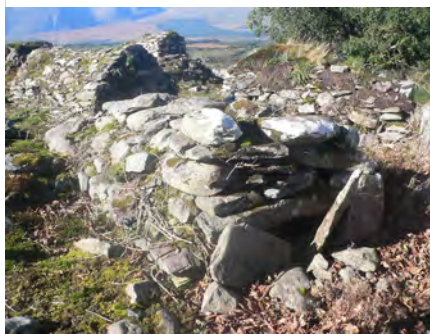
Tomb No:	36
Photo No:	159_0008
Photo:

Notes:	
Collapsed	P
Open	N
Rendered	N
Overgrown	P

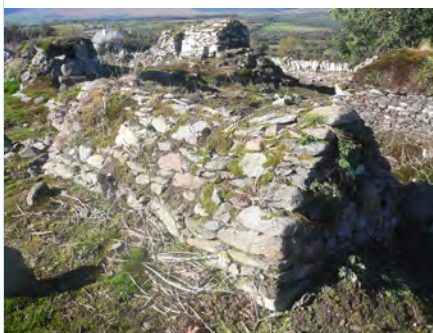
Tomb No:	37
Photo No:	159_0009
Photo:

Notes:	
Collapsed	N
Open	N
Rendered	N
Overgrown	P

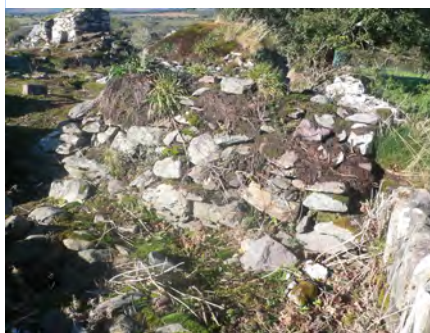
Tomb No:	38
Photo No:	159_0010
Photo:

Notes:	
Collapsed	P
Open	N
Rendered	N
Overgrown	P

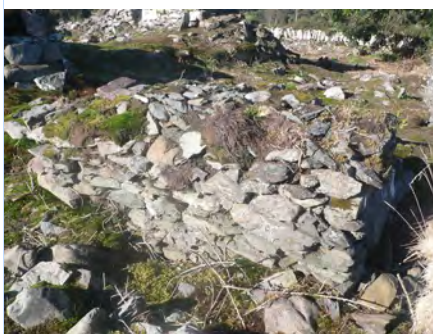
Tomb No:	39
Photo No:	159_0012
Photo:

Notes:	
Collapsed	N
Open	Y
Rendered	N
Overgrown	P

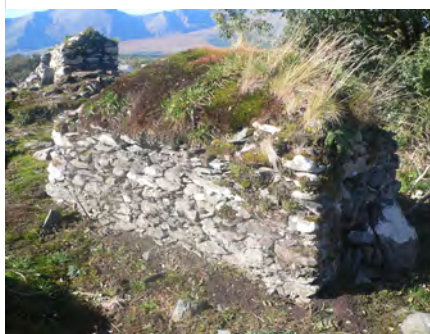
Tomb No:	40
Photo No:	159_0013
Photo:

Notes:	
Collapsed	N
Open	N
Rendered	N
Overgrown	P

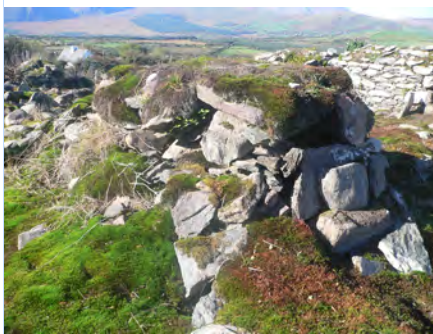
Tomb No:	41
Photo No:	159_0014
Photo:

Notes:	
Collapsed	Y
Open	Y
Rendered	N
Overgrown	P

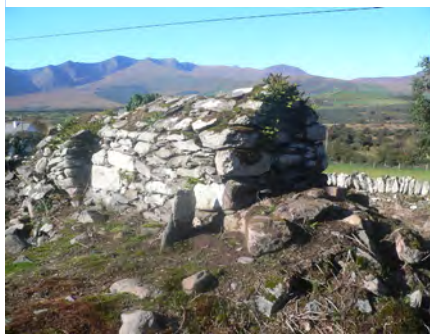
Tomb No:	43
Photo No:	159_0016
Photo:

Notes:	
Collapsed	N
Open	N
Rendered	N
Overgrown	P

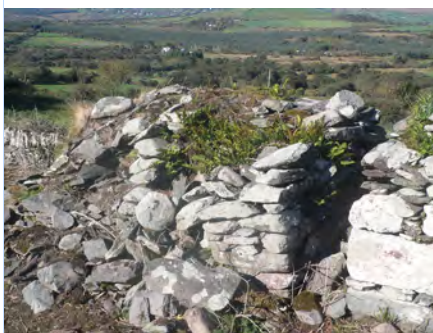
Tomb No:	44
Photo No:	159_0017
Photo:

Notes:	
Collapsed	P
Open	N
Rendered	N
Overgrown	P

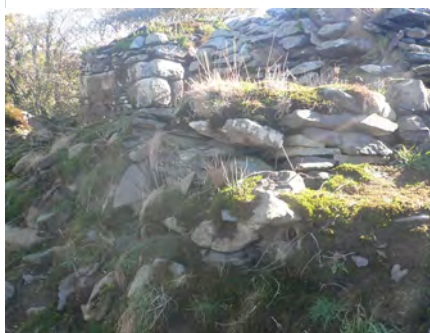
Tomb No:	45
Photo No:	159_0018
Photo:

Plate 19: Interior view of open and broken tomb 45 at N limits of the old section of Ballyduff Graveyard

Notes:	
Collapsed	P
Open	Y
Rendered	N
Overgrown	P

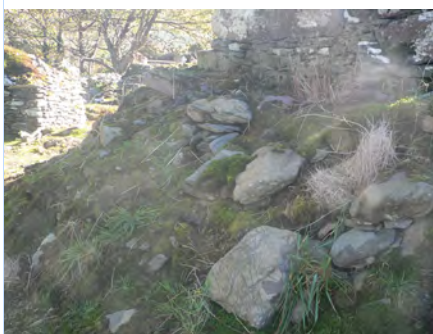
Tomb No:	46
Photo No:	159_0019
Photo:

Notes:	
Collapsed	P
Open	N
Rendered	N
Overgrown	Y

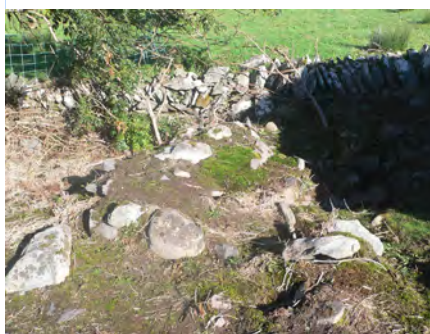
Tomb No:	47
Photo No:	159_0020
Photo:

Notes:	
Collapsed	P
Open	N
Rendered	N
Overgrown	Y

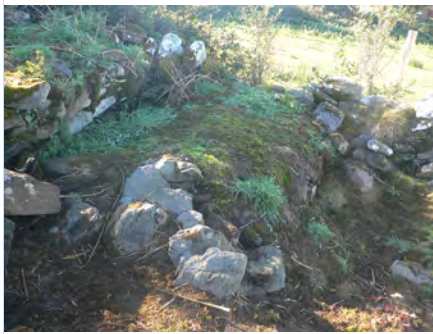
Tomb No:	48
Photo No:	159_0021
Photo:

Notes:	
Collapsed	N
Open	Y
Rendered	N
Overgrown	Y

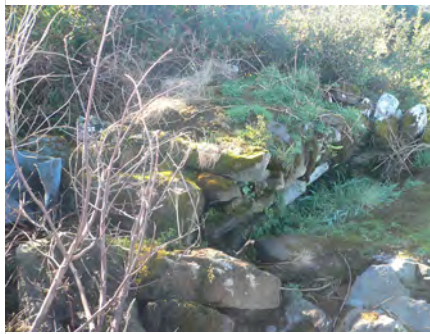
Tomb No:	49
Photo No:	159_0022
Photo:

Notes:	
Collapsed	P
Open	N
Rendered	N
Overgrown	Y

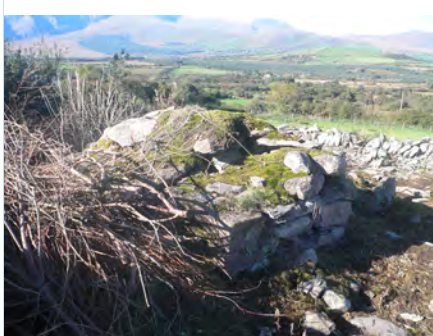
Tomb No:	50
Photo No:	159_0023
Photo:

Notes:	
Collapsed	P
Open	N
Rendered	N
Overgrown	P

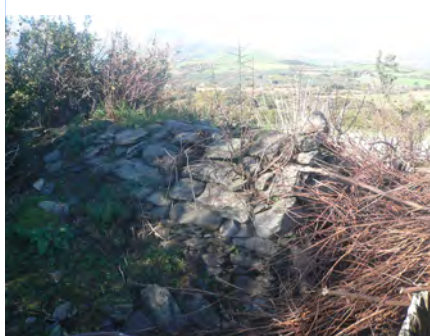
Tomb No:	51
Photo No:	159_0024
Photo:

Notes:	
Collapsed	P
Open	N
Rendered	N
Overgrown	P

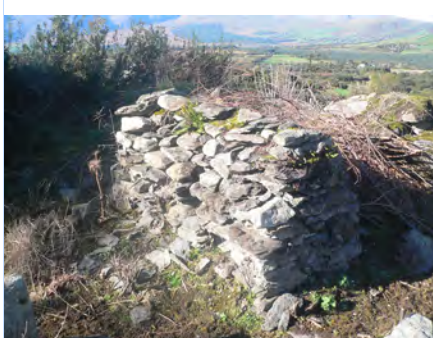
Tomb No:	52
Photo No:	159_0025
Photo:

Notes:	
Collapsed	N
Open	Y
Rendered	N
Overgrown	P

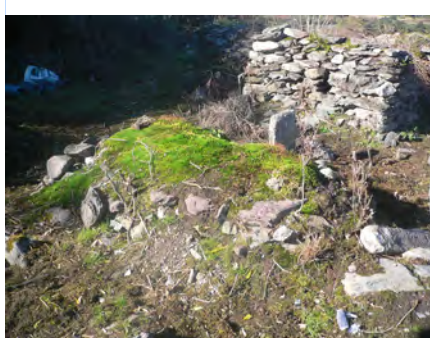
Tomb No:	53
Photo No:	159_0026
Photo:

Notes:	
Collapsed	P
Open	Y
Rendered	N
Overgrown	Y

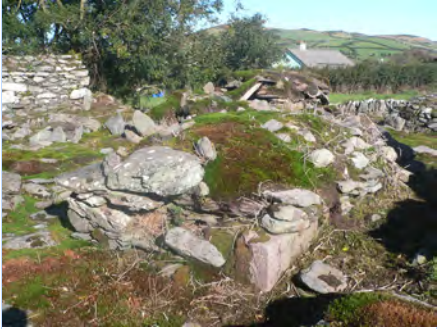
Tomb No:	54
Photo No:	159_0027
Photo:

Notes:	
Collapsed	P
Open	N
Rendered	N
Overgrown	Y

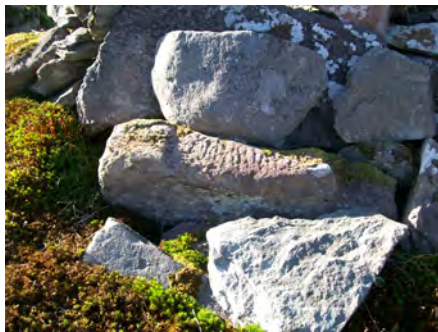
ID No:	253	Notes	Rectangular block of sandstone with linear dressing reused as blocking stone in front of tomb 41, dimensions 0.83m x 0.29m x 0.22m.
Photo No:	149_1451		
Photo:

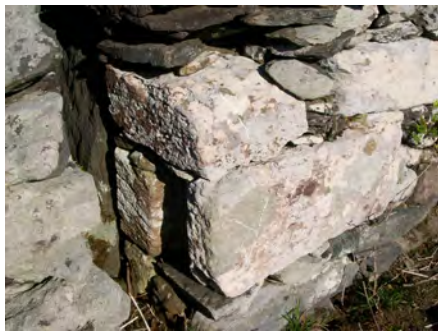
ID No:	255	Notes	Rectangular sandstone punch dressed block with short edge chamfered, 0.68m x 0.29m x 0.15m, built into SW corner of 43.
Photo No:	149_1453		
Photo:

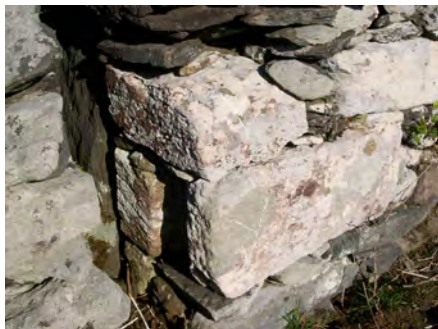
ID No:	256	Notes	Coursed immediately above 255 is another sandstone block. Dims: 0.39m x 0.30m x 0.17m.
Photo No:	149_1453		
Photo:

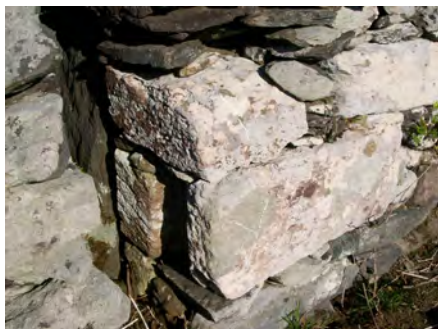
ID No:	257	Notes	Visible in side 255 and beneath 256 one surface of stone visible only with chamfer on one corner and rebate on the other. Dims: 0.245 m x c 0.023m.
Photo No:	149_1453		
Photo:

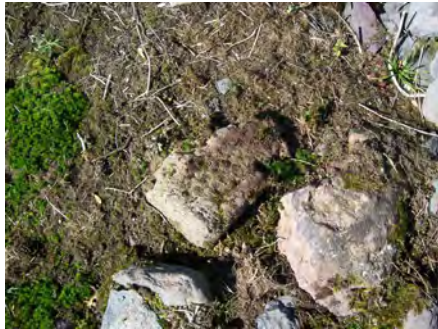
ID No:	259	Notes	Partially visible small architectural fragment, 0.17m x 0.25m in interior of Ballyduff Church.
Photo No:	149_1456		
Photo:

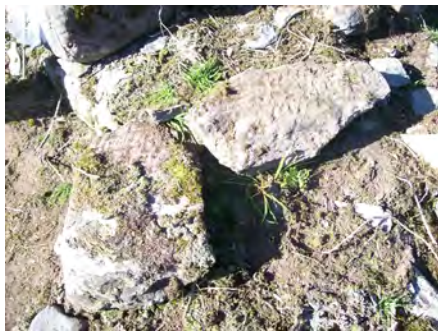
ID No:	261	Notes	Rectangular punch dressed sandstone with broken chamfered edge lying beside AF 260 in front of gable of tomb 43. Dims: 0.52m x 0.26 x 0.11m.
Photo No:	149_1457		
Photo:

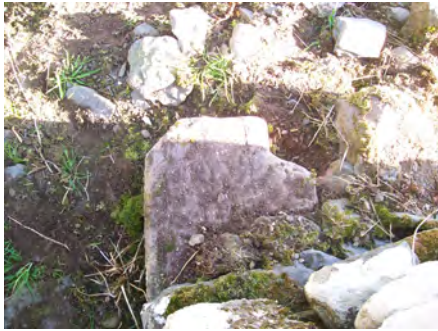
ID No:	262	Notes	Partially visible projecting from base of E gable of tomb 43 is a sandstone block
Photo No:	149_1458		chamfered on one corner and rebated on opposite. Dims: 0.66m x 0.32m x 0.20m.
Photo:

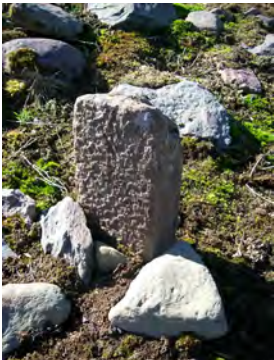
ID No:	264	Notes	Upright rectangular punch dressed sandstone block, 0.45m x 0.21m x 0.13m, reused as gravemarker.
Photo No:	149_1460		
Photo:

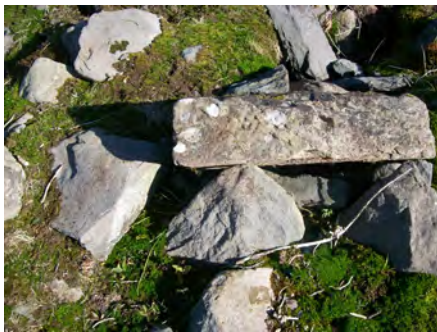
ID No:	265	Notes	Rectangular sandstone architectural fragment, 0.58m x 0.18m lying on lintelled grave 458.
Photo No:	149_1461		
Photo:

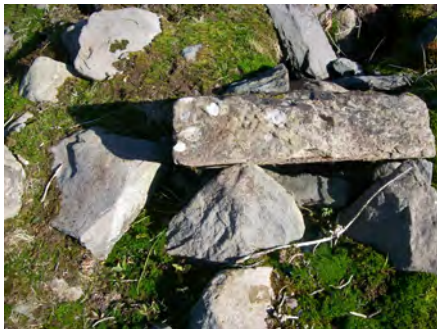
ID No:	266	Notes	Partially concealed architectural fragment in lintelled grave.
Photo No:	149_1461		
Photo:

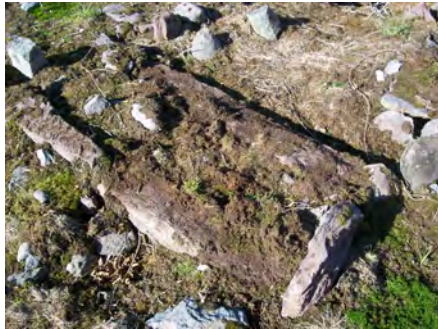
ID No:	268 - 271	Notes	Four rectangular blocks top surface only visible as reused sides of possible lintelled grave at W limits of ruined church.
Photo No:	149_1463		
Photo:

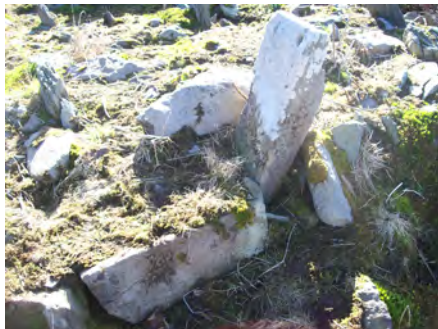
ID No:	272	Notes	Horizontal punch dressed sandstone reused as side of lintelled grave. Dims: 0.64m x 0.23m x 0.11m (exposed).
Photo No:	149_1464		
Photo:

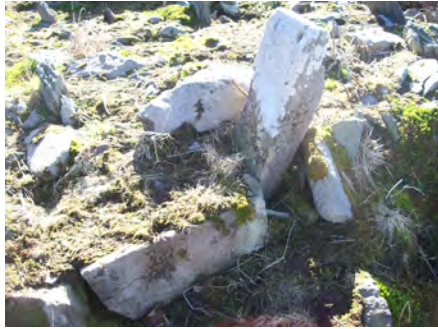
ID No:	273	Notes	Rectangular punch dressed upright sandstone block used as headstone of possible lintelled grave. Dims: 0.71m x 0.25 x 0.17m
Photo No:	149_1464		
Photo:

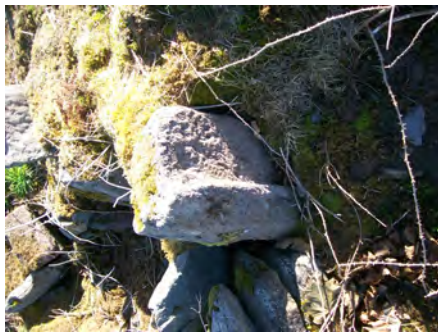
ID No:	274	Notes	Rebated and chamfered dressed sandstone reused as part of corner of lintelled grave. Dims: 0.63m x max 0.35m x 0.22m.
Photo No:	149_1465		
Photo:

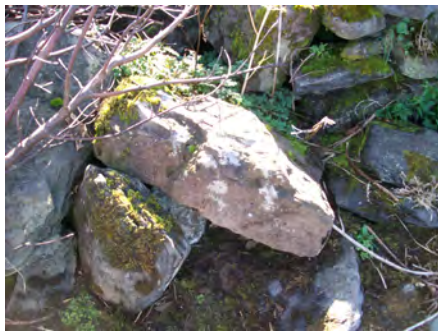
ID No:	277	Notes	Partially accessible beside tomb 48, architectural sandstone fragment 0.45m x 0.24m
Photo No:	149_1468		
Photo:

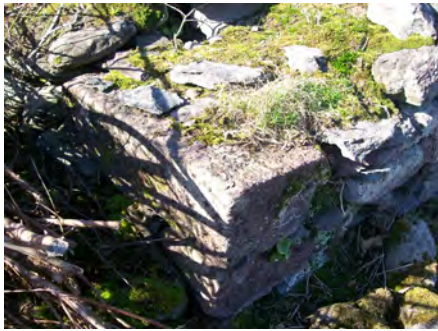
ID No:	280	Notes	Reused squared and punch dressed
Photo No:	149_1471		architectural fragment, 0.46m x 0.22m x 0.19m, at SW corner of tomb 50.
Photo:

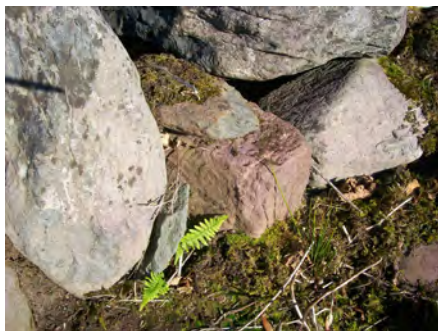
ID No:	282	Notes	Broken rectangular punch dressed sandstone block lying loose on the ground 2m W of AF 282. Dims: 0.56m x 0.32m x 0.15m (exposed).
Photo No:	149_1473		
Photo:

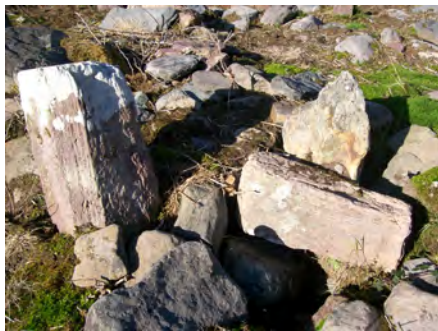
ID No:	283	Notes	Upright large punch dressed sandstone block with chamfered edge down one side. Stone is set as headstone for lintelled grave. Dims: 0.72m (exposed max ht.) x 0.30m x 0.28m.
Photo No:	149_1474		
Photo:

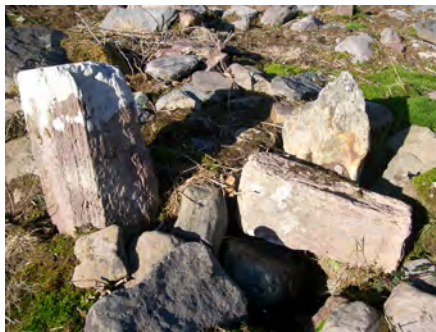
ID No:	284	Notes	Horizontal rectangular punch dressed sandstone block with single chamfer on one short edge. Stone lies beside AF281. Dims: 0.61m x 0.23m x 0.25m.
Photo No:	149_1474		
Photo:

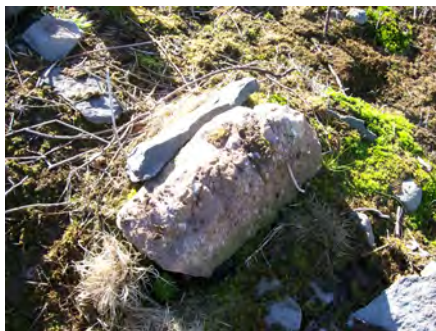
ID No:	285	Notes	Large conglomerate punch dressed in situ block of W limits of S interior wall of medieval church. Dims: 0.73m x. 0.37m x max 0.22m.
Photo No:	149_1475		
Photo:

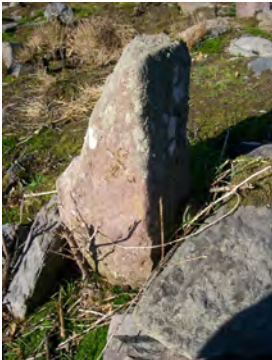
ID No:	286	Notes	Upright rectangular sandstone slab, 0.60m x 0.30m x 0.20m, reused as headstone of lintelled grave.
Photo No:	149_1476		
Photo:

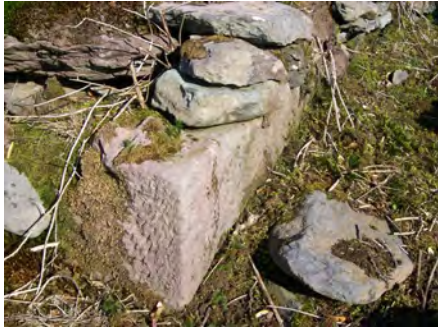
ID No:	289	Notes	Long rectangular punch dressed sandstone
Photo No:	149_1478		block, 0.82m x 0.27m x c 0.31m, reused in
Photo:	SW corner of unnamed tomb 54.
