Archaeological Survey, Ballinakilly Graveyard, Glenbeigh, Co. Kerry.

October 2008

RMP No.: KE063-022

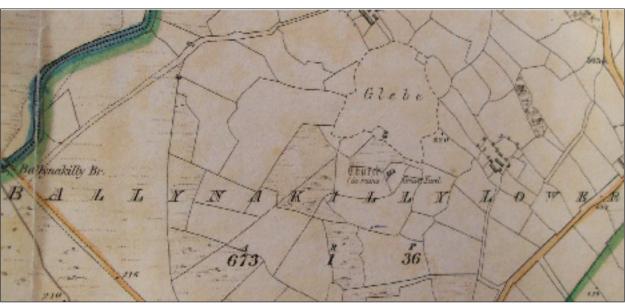
Figure 3: Extract from RMP Sheet 63 with Ballinakilly highlighted in red.

Ballinakilly is recorded in the Record of Monuments and Places (RMP) as KE063-022 classified as a *'church site and graveyard'* with a sub classification of KE063-022:01 a *'grave-marker'* (Figure 3).

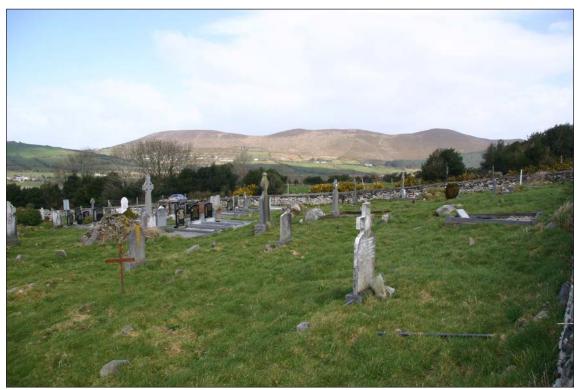
Plate 1: View of older part of Ballinakilly graveyard

Comprising of two sections on either side of the ruined original parish church, the older section is located to the east (Plate 1) and the modern extension to the west (Plate 2).

The older section of the graveyard has reached its capacity while there is ample room in the modern extended area for future burials. The unused space in the extension has not been maintained regularly.

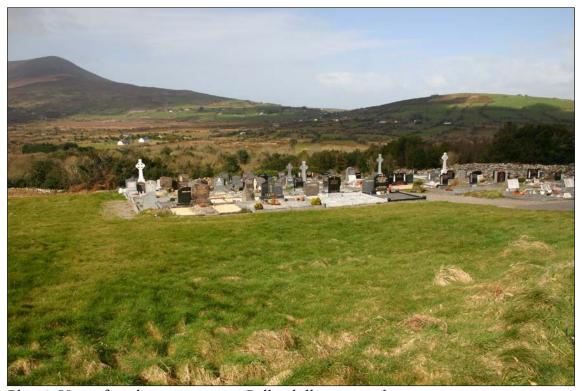
Plate 2: View of modern extension to Ballinakilly graveyard

Formal gravel pathways service the existing burials in the modern section of the graveyard (Plate 2). Some of the pathways have become heavily overgrown with weeds and shrubs from nearby graves.

The formal gravel pathways should be removed of overgrowth to prevent their deterioration.

The formal pathways should be extended into the grassy area where burials have yet to take place to ensure that this area of the grounds will not deteriorate and will aid in the mainte-

nance of the graveyard, as well as ensuring that grave plots will be kept in order.

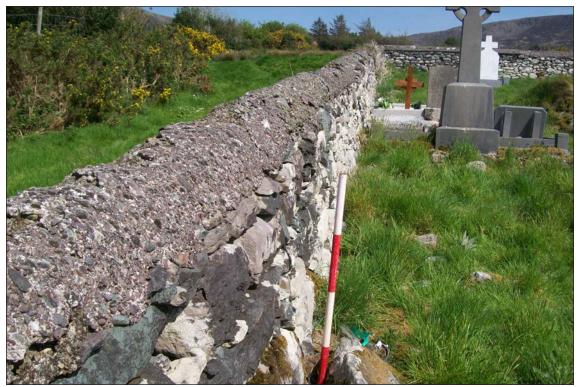
Plate 3: View of northern boundary wall, from west

The graveyard is bounded by a drystone rubble limestone and sandstone wall on the north, east and part of the south (Plate 3) with the remainder of the boundary comprising a mature hedgerow and overgrown drystone wall. The western boundary is composed of an overgrown drystone rubble wall and mature hedgerow. The drystone wall is capped with a layer of cement for the majority of its circumference and is in a poor state. Debris from graves, such as wreaths and plastic containers, is littered along the western and southern boundaries.

The cement capping on the boundary wall should be removed and replaced with coping suitable for its original construction.

Formal refuse facilities should be provided for the two areas of the graveyard, most likely at the two entrance points, to prevent further dumping within the burial ground.

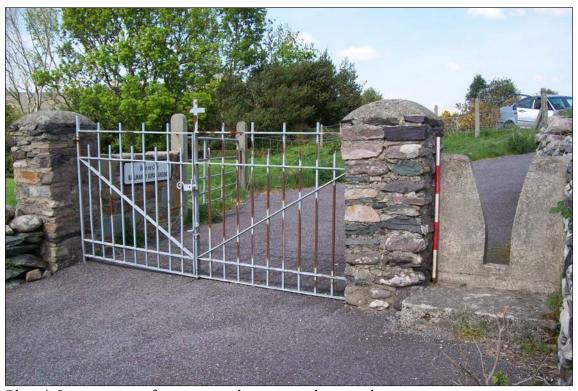
Plate 4: Interior view of entrance and squeeze-stile to modern extension

Access/egress to the modern area is gained through a modern cast iron gate set between two rubble sandstone and shale piers with half barrel capping (Plate 4). The piers measure $1.45m \times 0.57m \times 0.6m$. A concrete squeeze stile is located to the immediate east of the gate.

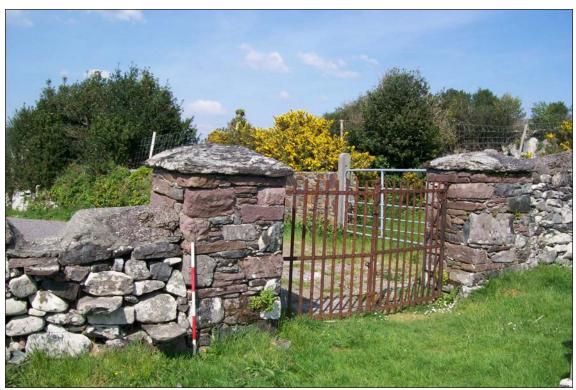
Plate 5: Interior view of entrance and step-stile to old graveyard

Access/egress to the older area is gained through an original rusted iron gate set between two rubble sandstone and limestone piers capped with slate saddle coping (Plate 5). A step-stile is located to the immediate west of this gate and comprises 3 sandstone steps on the exterior and interior.

The original iron entrance gate of the older area should be treated for rust to prevent its further deterioration.

The interior uppermost step of the step-stile is loose and should be fixed as soon as possible to prevent an accident.

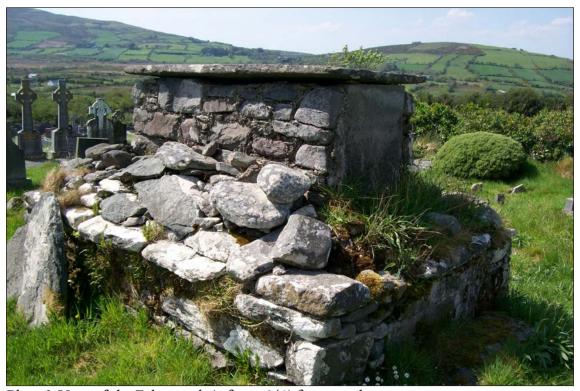
Plate 6: View of the Foley tomb (ref. no. 548) from southeast

One named tomb was recorded within the graveyard (Plate 6).

The Foley tomb (ref. no. 548) dates to 1826 and is almost centrally located in the older part of the burial ground.

It is in a relatively good state of preservation with the exception of its overgrowth in places by grass, which is to be expected considering its antiquity.

Loose rubble stone, which does not appear to originate from the tomb, has been piled on its southern side.

The overgrowth on the Foley tomb should be cut back and removed.

The tomb should then be repaired and repointed sensitive to its original construction.

The overgrowth should only be fully removed as the primary element of an agreed strategy of repairs and other conservation and restoration works. Otherwise ivy and other growth should be simply cut back and maintained at a controllable level.

Restoration works should only be carried out by qualified personnel under supervision.

The loose rubble stone which has been piled on the tomb's southern side should be removed.

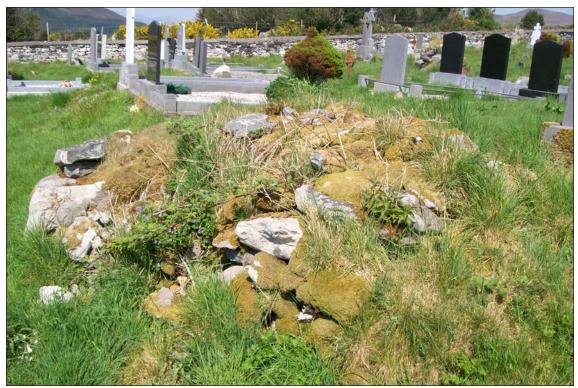
Plate 7: View of unnamed tomb (ref. no. 549) from southwest

The definite tomb (ref. no. 549) was partially concealed and obscured by a mound of rubble stone (Plate 7). It appeared to be constructed of drystone limestone rubble stone.

Focused targeted archaeological excavation should be undertaken where the tombs have been concealed and masked by mounds of rubble stone.

All vegetation on the tombs should be cut back and removed.

The tombs can then be reconstructed and repaired. It is likely that local information would furnish the names associated with these tombs and this information should be collected.

All work on the tombs may require Ministerial Consent.

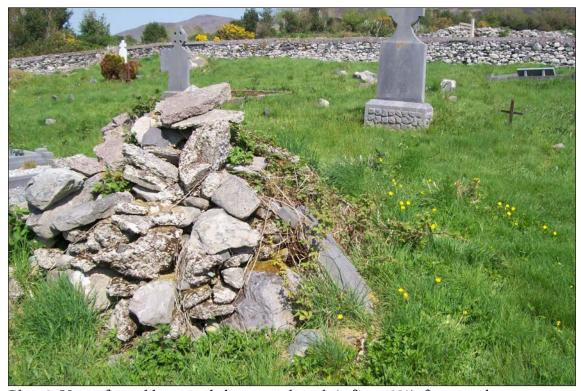
Plate 8: View of possible concealed unnamed tomb (ref. no. 550), from southwest

The second possible tomb (ref. no. 550) was located to the southeast of this tomb, and it was unclear whether a tomb was located beneath the mound of rubble stone (Plate 8).

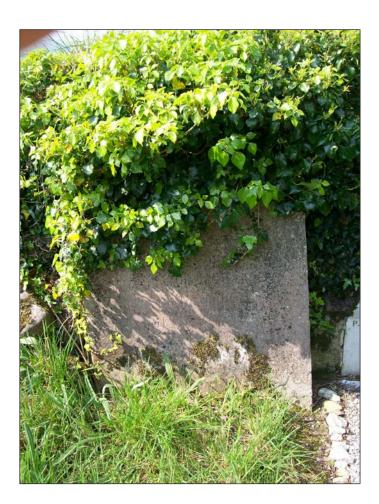
Plate 9: View of earliest dated headstone (ref. no. 152) bearing the name Moriarty and dating to 1782

The oldest named headstone was inscribed with the name of Moriarty (ref. no. 152) and dated to 1782 (Plate 9).

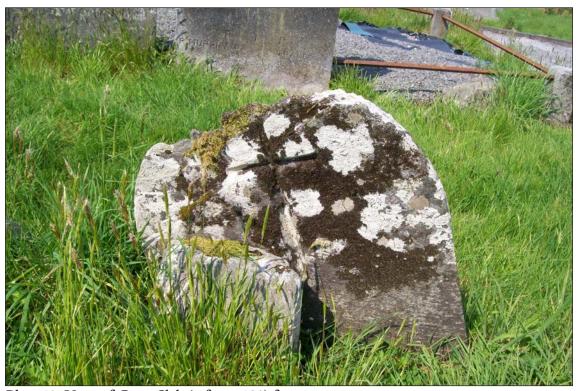
Plate 10: View of Cross Slab (ref. no. 183) from east

Cross slab no. 183 is located to the northeast of the church. Measuring 0.5m x 0.49m x 0.04m, the sandstone slab is listing slightly to the south. A plain Latin cross was inscribed on its eastern face (Plate 10).

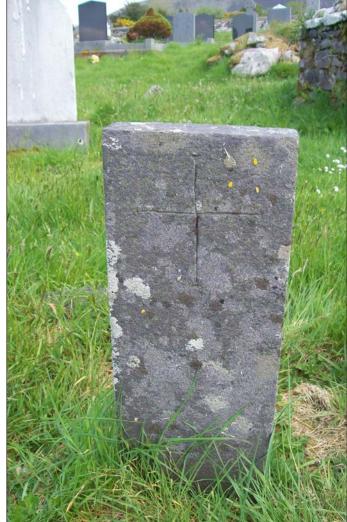
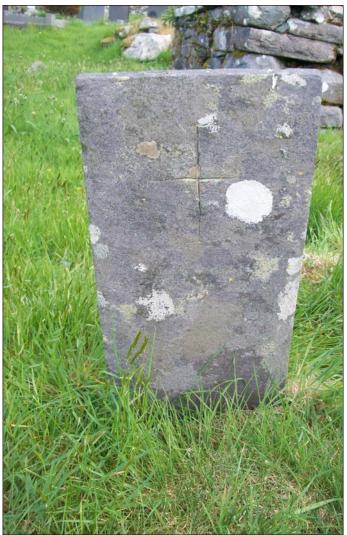
Cross slab no. 429 is located to the south of the church. Measuring $0.56m \times 0.22m \times 0.04m$, the slightly tapering rectangular sandstone slab is inscribed with a lightly inscribed plain latin cross with expanded T bar terminals. This cross may actually be a footer for grave no. 459 as it is not inscribed on a crude rubble stone, which is often the case for cross slabs (Plate 11). Cross slab no. 430 is situated to the immediate south of cross no. 429. Measuring $0.62m \times 0.32m \times 0.035m$, this cross is identical to its neighbour in terms of design and type of stone used (Plate 12). It may act as a footer for grave no. 460.

The lightly inscribed and similar cross motifs and shape and form of the slabs of nos.429 and 430 indicate a rather late date and are unlikely to be early medieval. However, they do reflect a form of vernacular grave slab design by some unknown mason or individual.

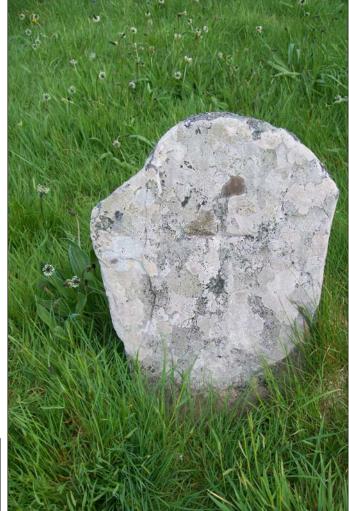
Plate 13: View of Cross Slab (ref. no. 434) from west

Cross no. 434 is located south of crosses 429 and 430. Measuring 0.67m x 0.58m x 0.03m, the slab is inscribed with a small plain cross with expanded terminals on its western side (Plate 13).

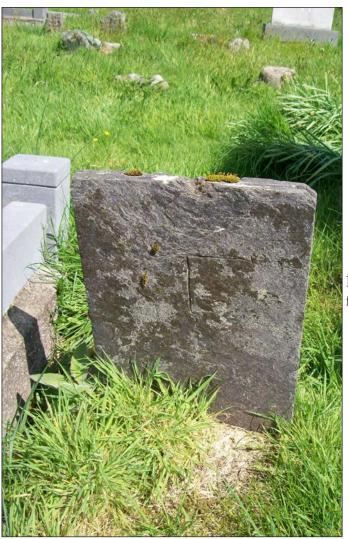
Plate 14: View of Cross Slab (ref. no. 462) from west

Cross slab no. 462 is situated to the south of the church. Measuring $0.4m \times 0.29m \times 0.04m$, the sandstone slab has the partial remains of a simple lightly incised, possibly equal armed, cross with T bat terminals inscribed on its western side (Plate 14). It is similar in style and stone type to crosses 429 and 430.

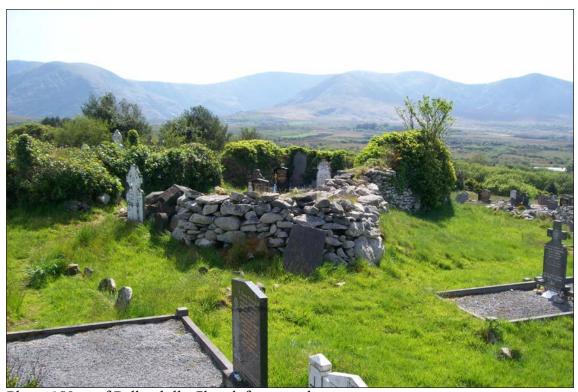
Plate 15 View of Ballinakilly Church from northeast

Ballinakilly parish church (Plate 15) was recorded as part of the Iveragh Peninsula Archaeological Survey (O' Sullivan & Sheehan 1996, 351):

"...The parish church was recorded as being in ruins in 1756 (Smith 1756, 70)...The poorly preserved, rectangular remains of this church stand in a graveyard on the E side of the Behy river, and measure 12.6m x 6.2m internally. The rubble-built, ivy clad walls survive to a maximum height of 1.9m and area 1m thick. There is a 1.2m wide entrance gap towards the W end of the S wall. A large number of burials occupy its interior, while outside are numerous low upright slabs, some of which bear simple crosses. An inscribed grave-marker in the interior of the church carries a date of 1710". The church was also surveyed in 1841 by A. Curry who apart from noting all its relict dimensions states that 'All its features are destroyed' (O'Donovan 1841, 151-2).

The ruined church should be preserved and protected. The building should be securely fenced off during construction works in case of accidental damage.

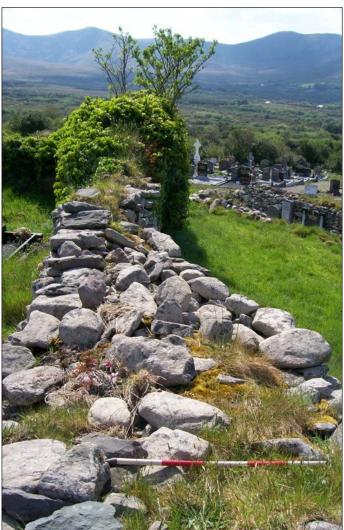
Plate 16: View of northern elevation of church from east

The northern wall of the church, towards its northeastern end, has a dramatic increase in width from 1m to 2m (Plate 16) from the collecting and adding to it of quantities of stone for some unknown purpose. The added stone seems to blend seamlessly into the original construction and masks the earlier fabric.

The dumping or placing of stones on the fabric of the church should be discontinued. Ultimately, if possible, the additional stones should be removed under archaeological supervision. No further burials, except within existing formalised grave-plots, should be permitted within the church interior.

The vegetation cover should be removed under archaeological supervision and the exposed fabric recorded. The structure can then be repaired and made good. Where possible and in principle, all original fabric should be re-used or similar substitutes sourced and matched. The removal of vegetation cover may also help to explain the dramatic width of the eastern end of the northern elevation.

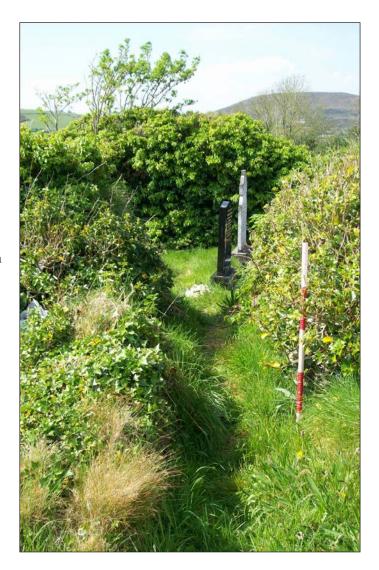
Plate 17: View of small, low-set overgrown walls leading from the entrance to the church in the southern elevation, from south

nal entrance is located in the southern wall. Two small, low-set overgrown stone walls, lead southwards from the entrance creating a hall or porch type aspect to the church entrance (Plate 17). This is not referred to in the survey, nor is it evident in the 1st edition OS map 1842 (Figure 4). The walls are easily missed given their overgrown nature, and their purpose is unclear. However, it may be that upon archaeological investigation these walls may turn out to be unrelated to the church construction.
