Archaeological Survey,
Clogherbrien Graveyard,
Tralee,
Co. Kerry.

October 2008

Client: The Heritage Office,
Kerry County Council,
County Buildings,
Ratass,
Tralee,
Co. Kerry.

RMP No.: KE029-059

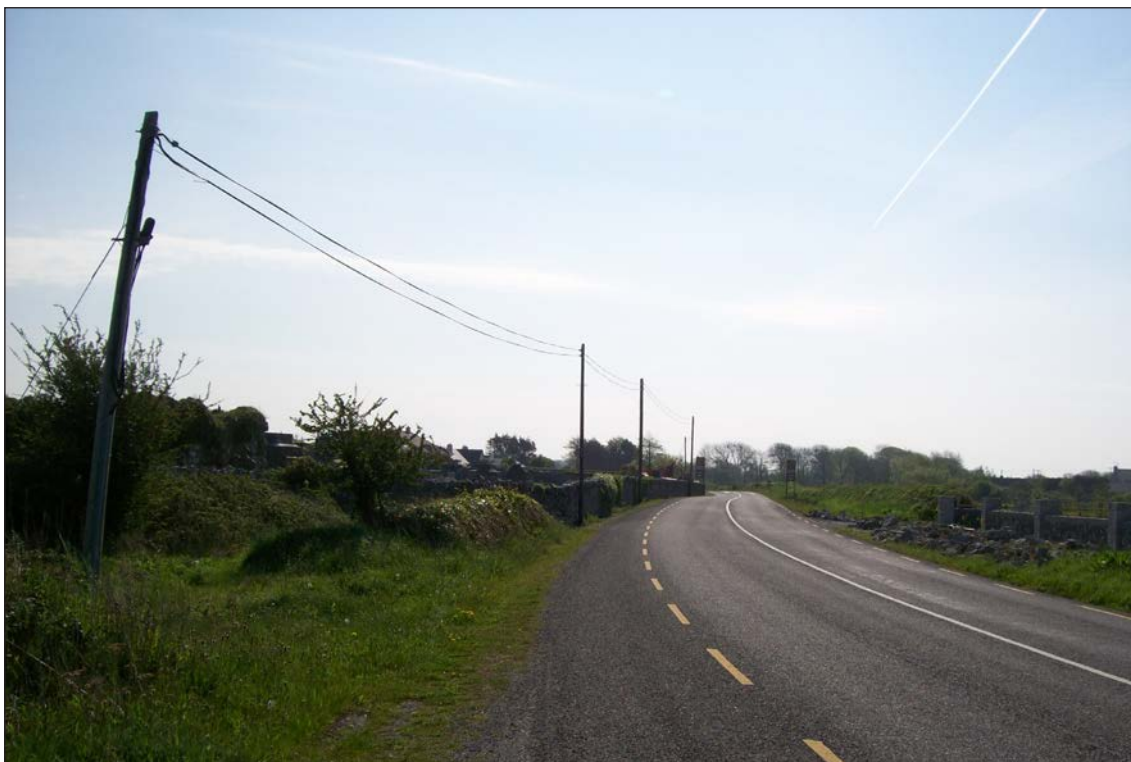
There is no defined space for parking for visitors to the graveyard, nor is there a hard shoulder

present along this road (Plate 1). Therefore, visitors must resort to parking near entrances of existing dwellings nearby which is a dangerous practice.

Plate 1: View of approach road from the west to Clogherbrien Church and Graveyard

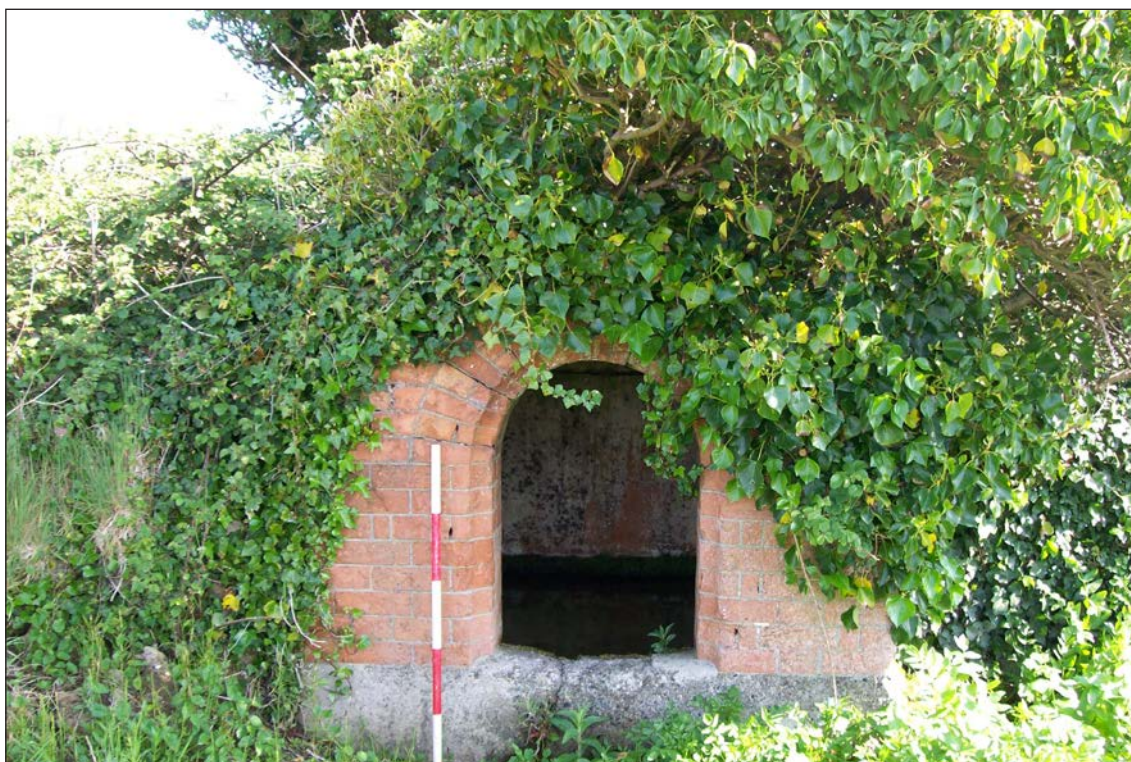
There is no water tap servicing the graveyard. A small formalised built well is located immediately west of the graveyard and it is possible that visitors to the graveyard may source their water here, however, the immediate area of the well is often soft, muddy or waterlogged and would need to be properly ordered and more accessible (Plate 2).

Plate 2: View of well located to the west of Clogherbrien Church & Graveyard

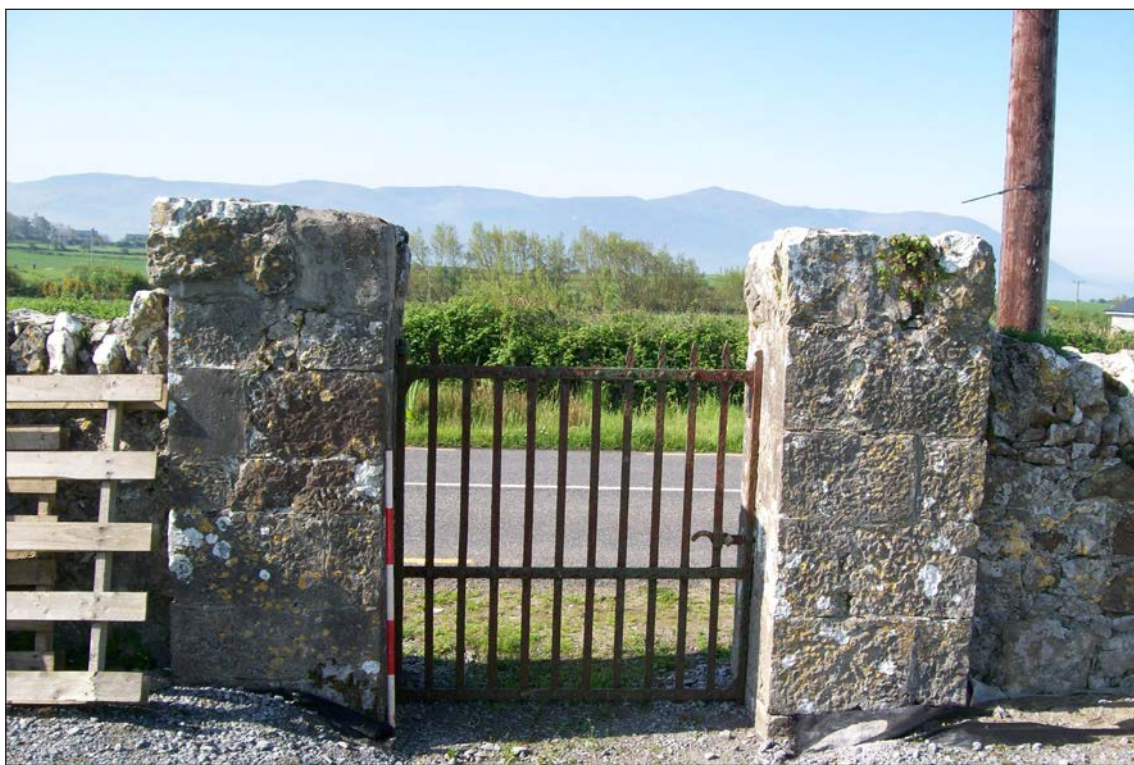
Plate 5: View of southern boundary wall from east

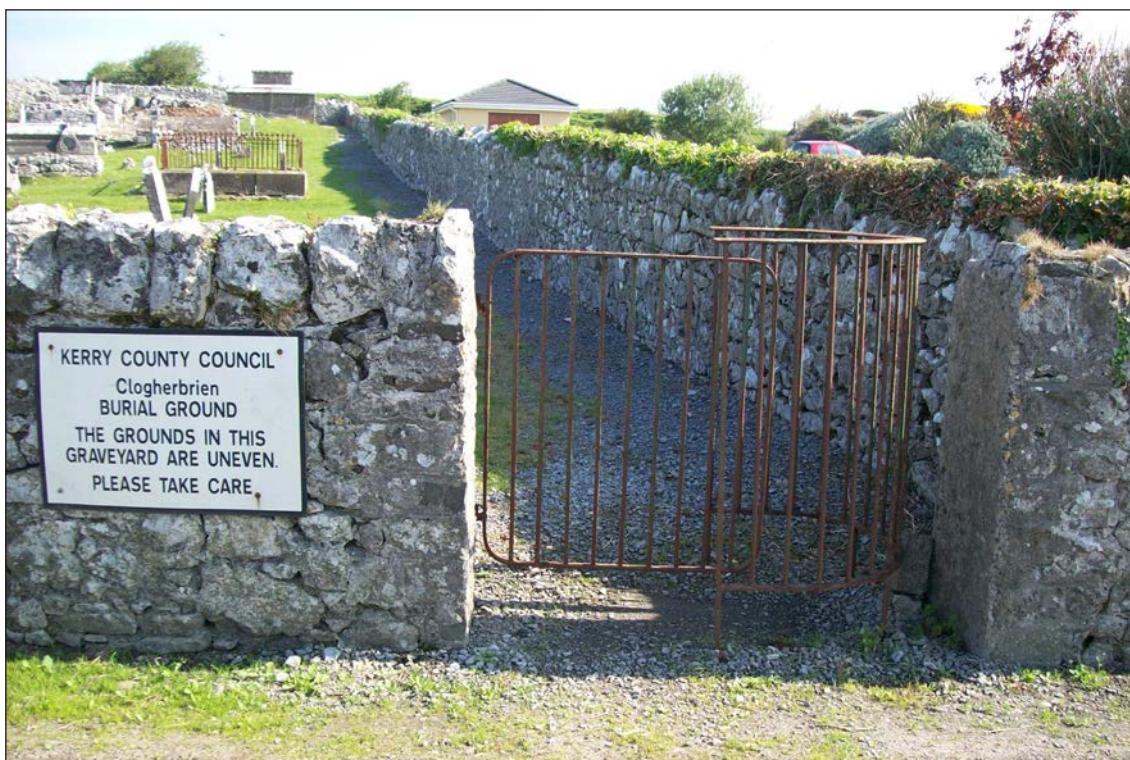
Plate 6: Interior view of pedestrian gate on southern boundary wall

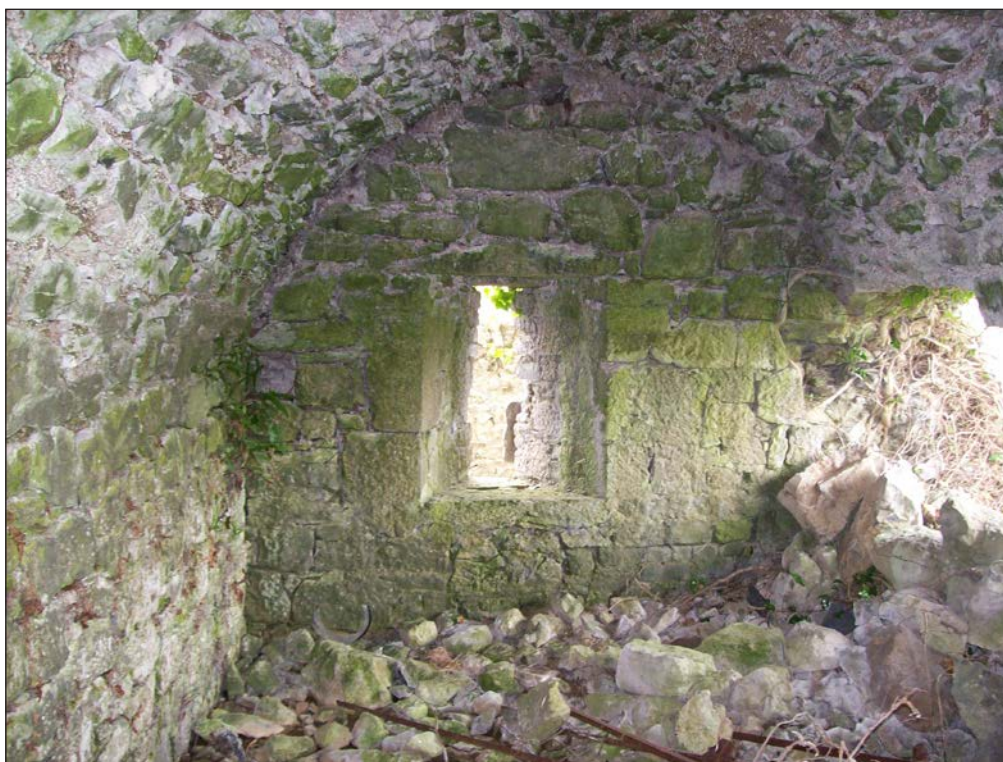
Plate 17: Interior view of southern room from east

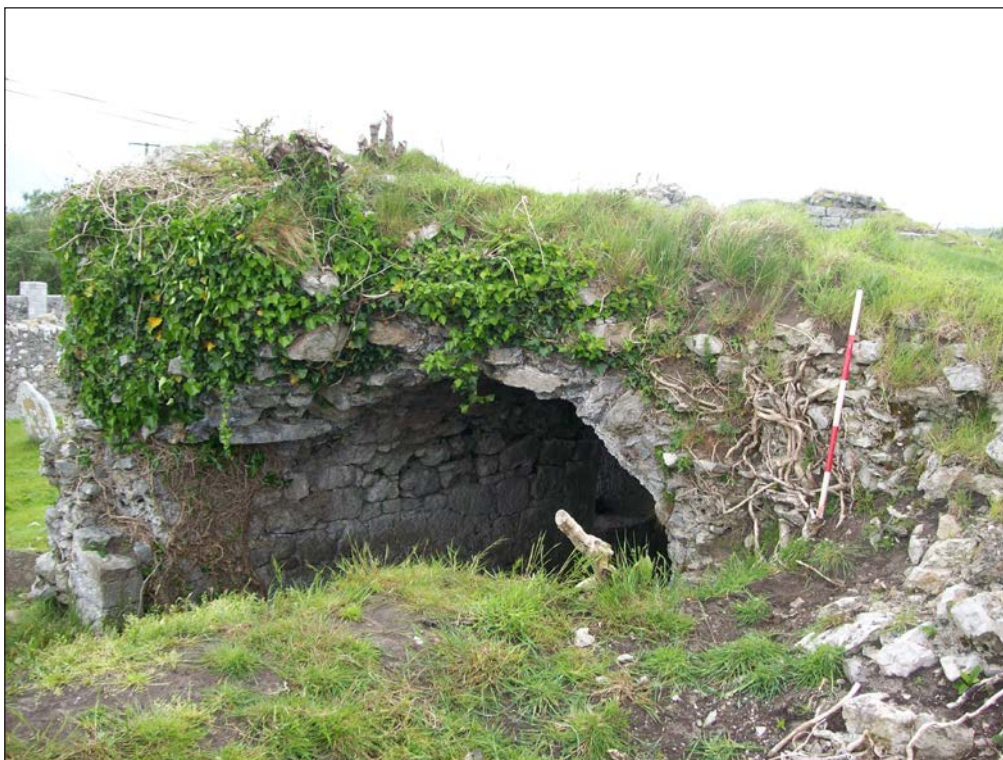
Entrance to the two rooms is gained through the partially missing eastern elevation. The southern room is completely open at this end but remains intact for the northern room.

Plate 19: View of large opening in eastern elevation allowing access/egress to the two rooms

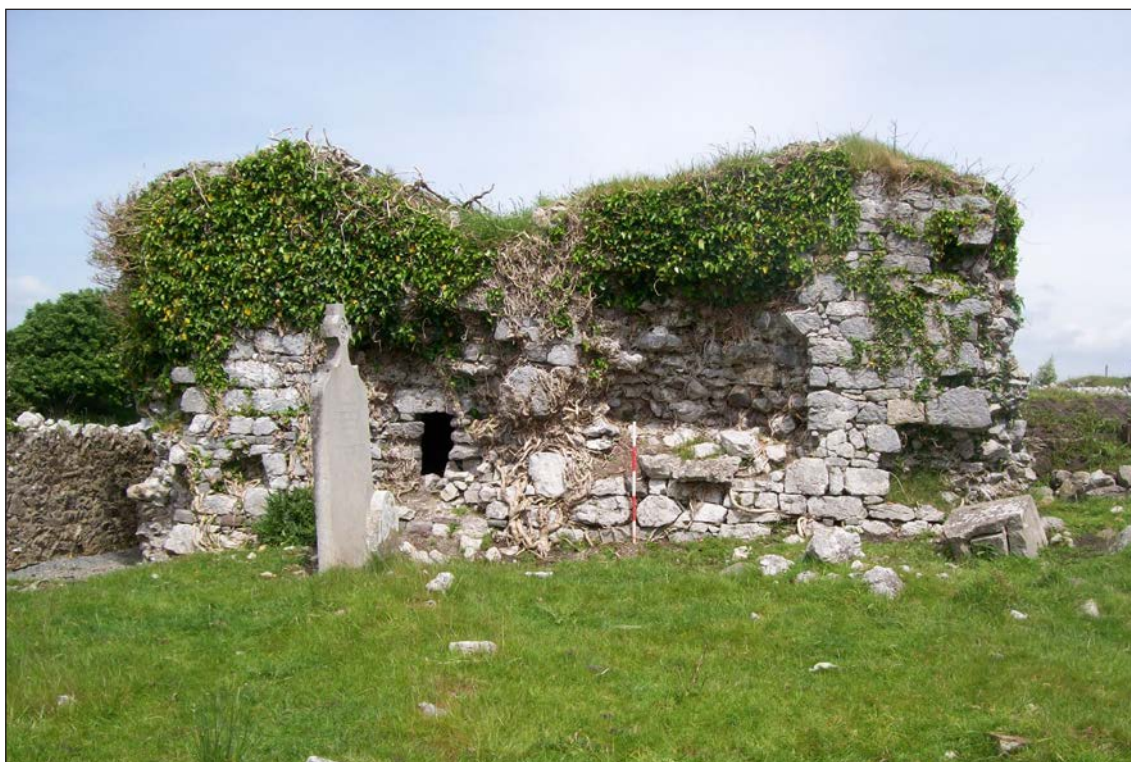
The southern elevation does not survive to full height and is in a poor state of preservation (Plate 20). The quoinstones are missing from both corners while a large void is apparent towards the centre of the elevation; to the immediate east of the window ope. The elevation is heavily overgrown with well established ivy.

Plate 20: View of southern elevation

The ruined church should be preserved and protected. The building should be securely fenced off during construction works in case of accidental damage.

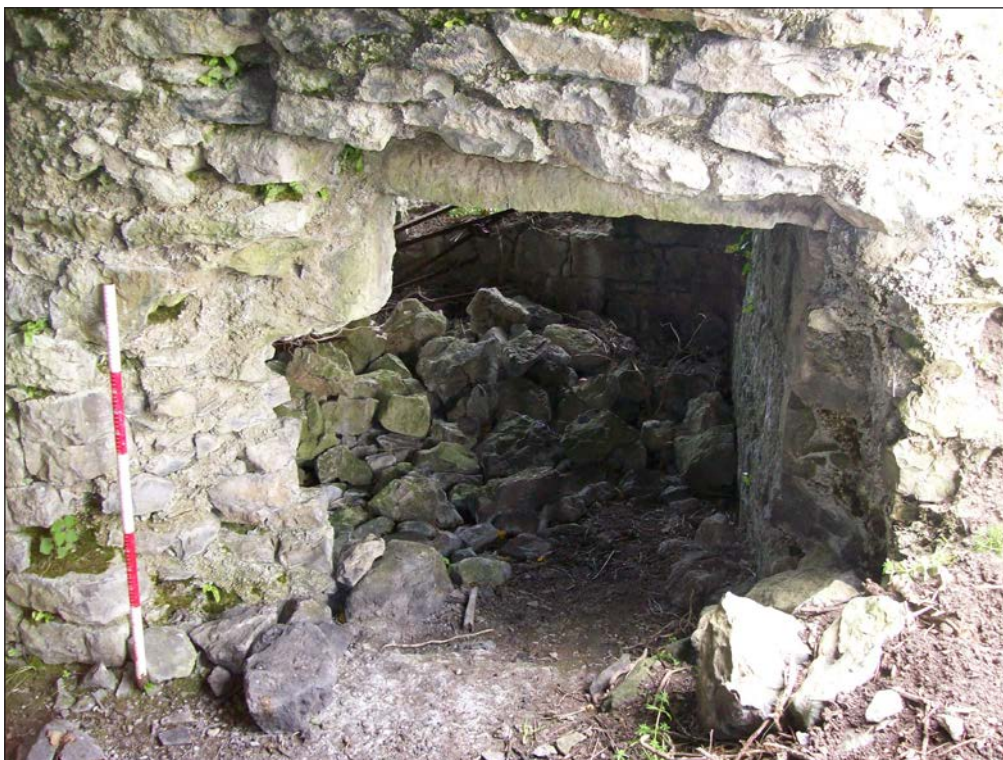
While the sides of the opening are ragged, a flat lintel is evident over the opening suggesting it was a formal entranceway but the exact nature cannot be determined due to the build-up of soil and poor ragged condition of the opening (Plate 25).

Plate 25: View of possible formal entrance way between northern and southern rooms

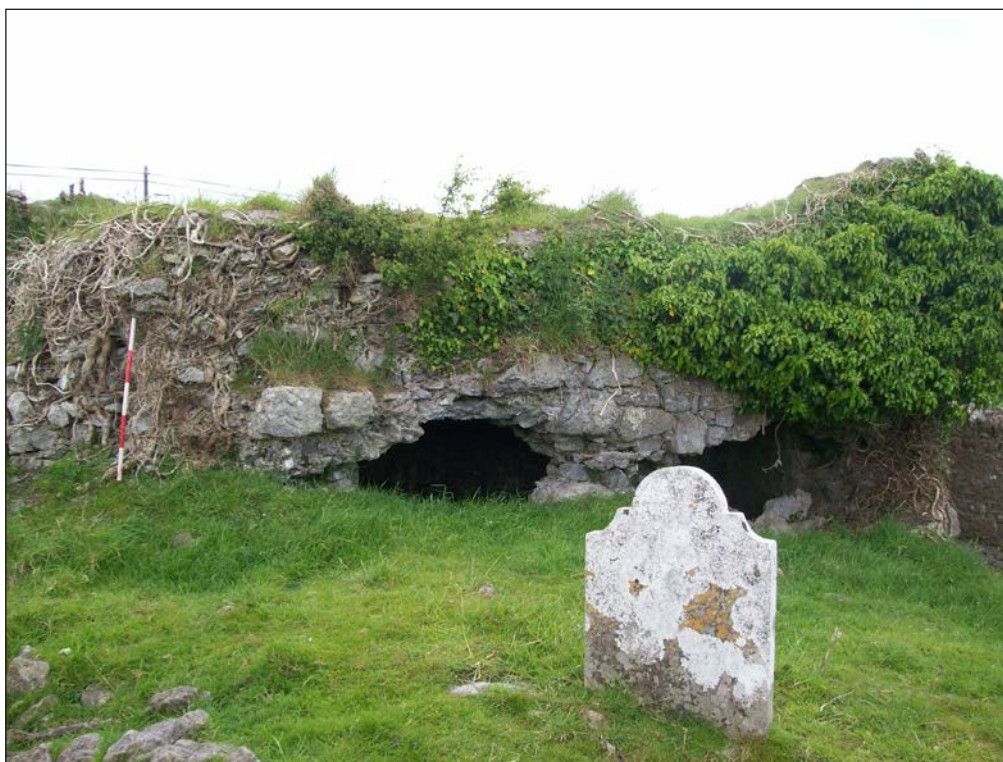
It is mainly featureless but an opening is present towards its eastern end which allows access to the northern room (Plate 25).

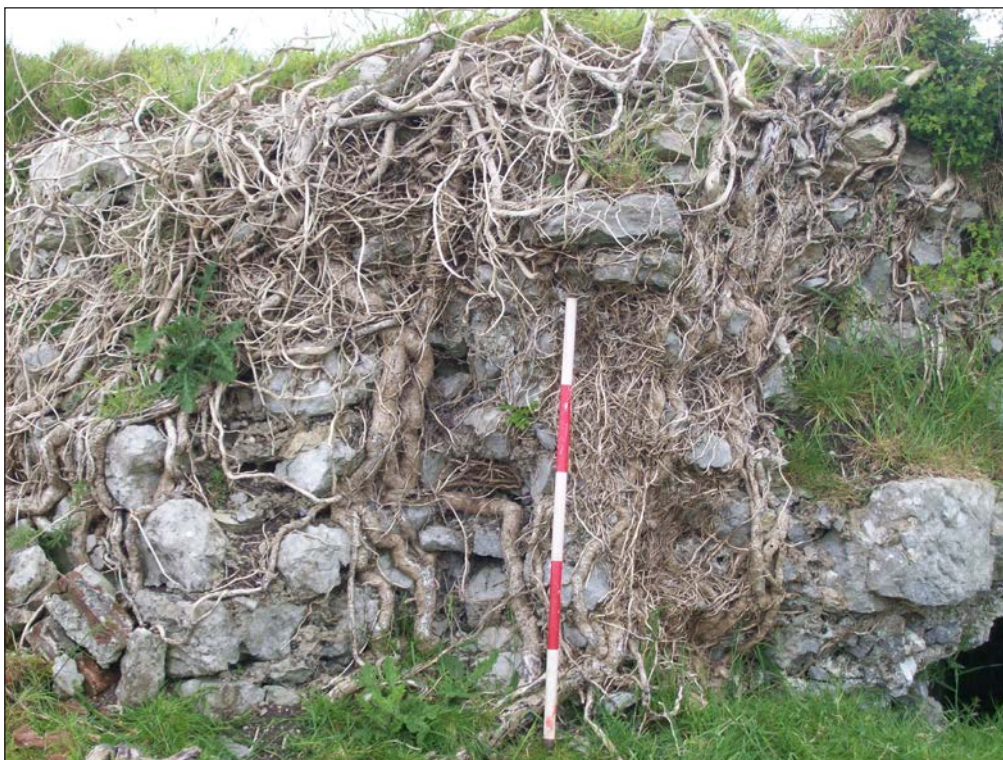
Plate 27: View of well established ivy on northeastern corner of northern elevation

- The ivy and other growth should only be fully removed as the primary element of an agreed strategy of repairs and other conservation and restoration works. Otherwise ivy and other growth should be simply cut back and maintained at a controllable level.

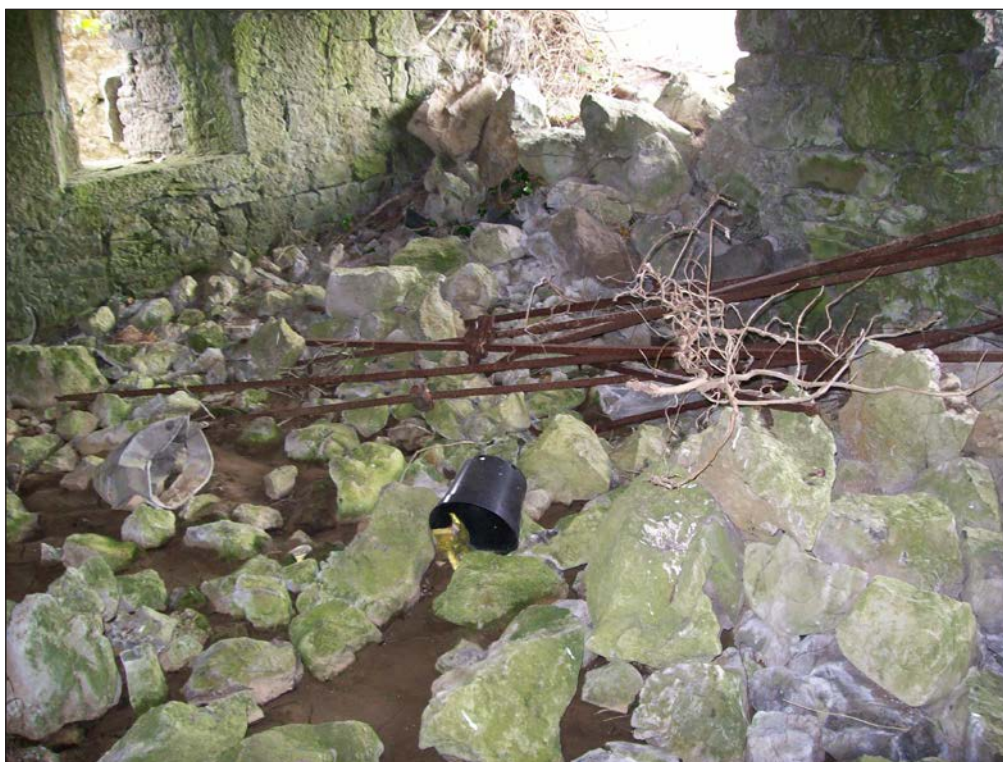
Plate 28: View of rubble stone and debris in northern room, from southeast

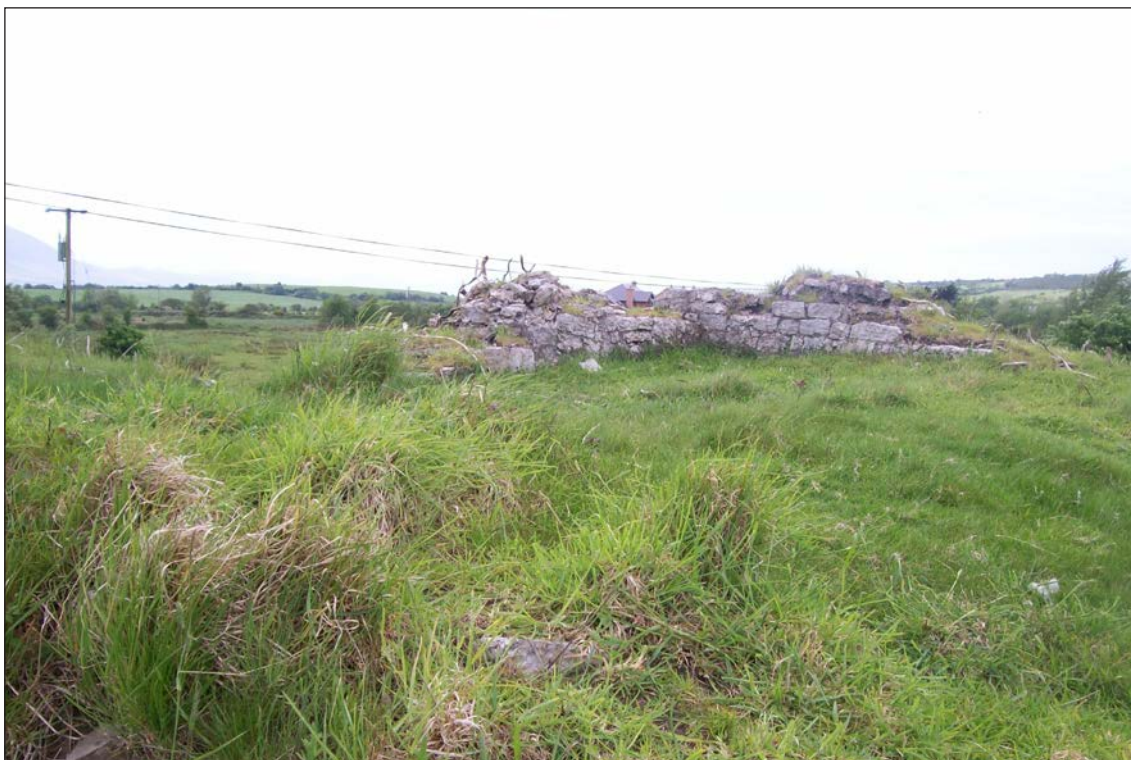
A visual inspection of the exterior possible upper level discovered the continuation of the southern and western elevations with the remains evident on the southwestern corner of the building (Plate 29), with similar results recorded on the northwestern corner (Plate 30).

Plate 29: View of remain of walls on possible upper level southwestern corner

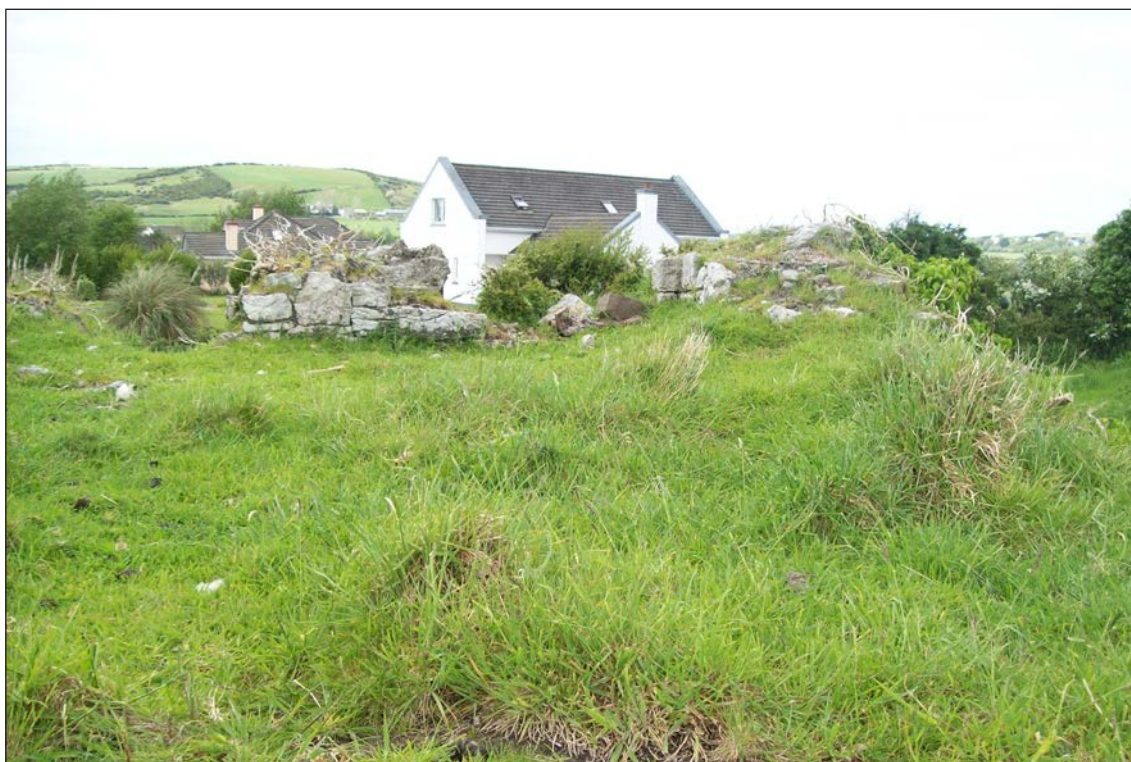
Plate 30: View of remains of walls on possible upper level northwestern corner

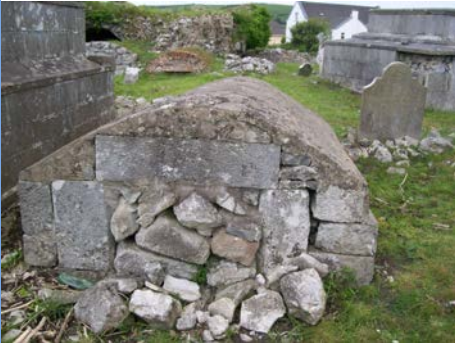
Tomb ID	225
Collapsed	<input type="checkbox"/>
Open	<input type="checkbox"/>
Rendered	<input checked="" type="checkbox"/>
Notes	
Photo No	100-5342
Photo

- All vegetation on the tombs should be cut back and removed. The tombs can then be reconstructed, repaired and repointed sensitive to their original construction. The render should be replaced sensitive to the original construction. This work may require Ministerial Consent.

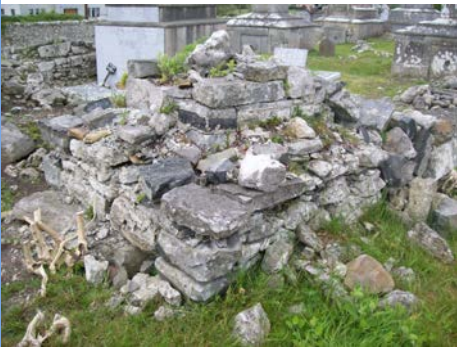
Tomb ID	242
Collapsed	<input checked="" type="checkbox"/>
Open	<input type="checkbox"/>
Rendered	<input type="checkbox"/>
Notes	
Photo No	100-5360
Photo

- The loose rubble stone on the upper slopes of the graveyard should be tidied up under archaeological supervision.
- Focused targeted archaeological conservation and reconstruction should be undertaken where the named and unnamed tombs are collapsed. This work may require Ministerial Consent.

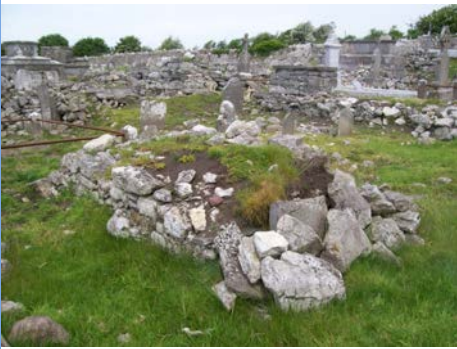
Tomb ID	248
Collapsed	<input type="checkbox"/>
Open	<input checked="" type="checkbox"/>
Rendered	<input type="checkbox"/>
Notes	
Photo No	100-5367
Photo

- All open and exposed tombs should be fully repaired and sealed. This work may require Ministerial Consent.
- A tidy up of the rubble stone in the areas of the tombs should be undertaken under archaeological supervision in order to define the exact extent of some of the tombs and to better safeguard them .

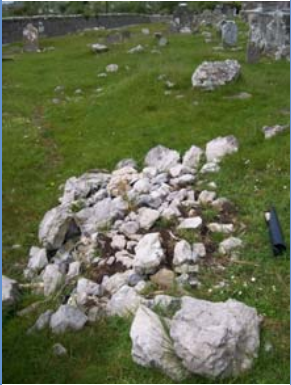
ID No.	278
Photo No.	100-5398
Photo

Notes	Rubble
