Archaeological Survey, Brosna Church and Graveyard, Brosna, Co. Kerry

September 2007

RMP No.: KE032-008

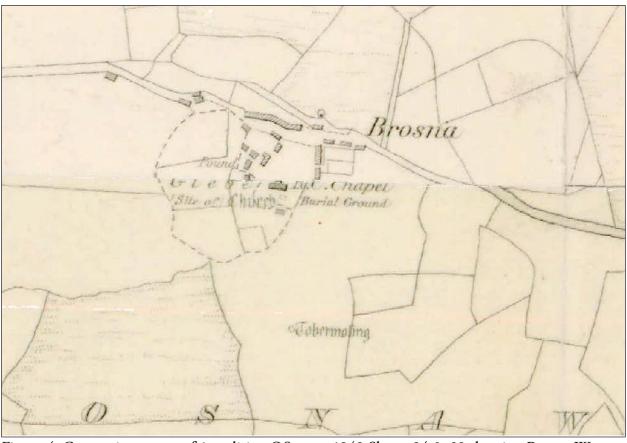
Figure 4: Composite extract of 1st edition OS maps 1842 Sheets 24 & 32 showing Brosna West graveyard.

The 1st edition OS map 1842 (Figure 4) illustrates the site of a ruined church while also denoting the location of the RC Church existing at the time. The latter church was replaced St. Moling's Catholic Church c. 1868 which is the existing church in Brosna today.

The boundary walls of the graveyard reflect the circularity of the original boundary KE032-008:03 which is evident on the 1st edition OS map 1842 (Figure 4, Plate 2).

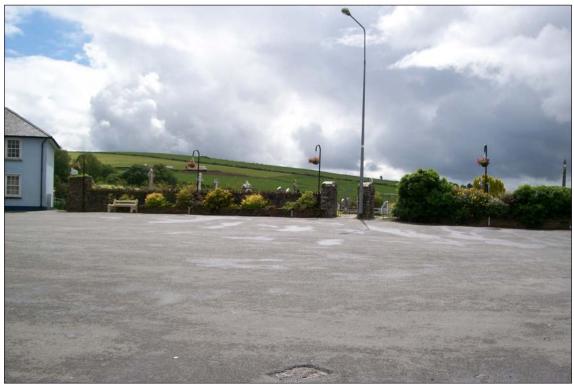
Plate 1: View of Brosna West graveyard, taken from north

Brosna West graveyard is located at the centre of Brosna village (Plate 1), immediately south of the square and southeast of the existing church, St Moling's Catholic Church.

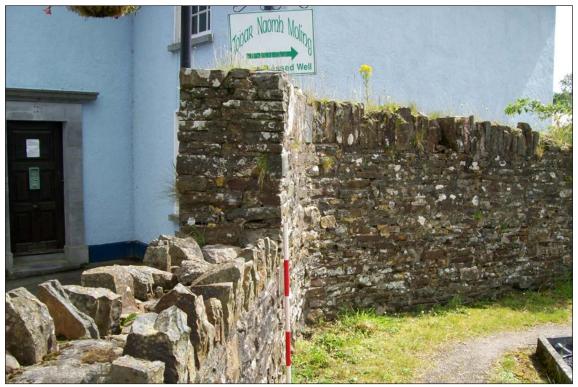
Plate 2: View of northeastern and eastern boundary wall which reflects the curvilinear nature of the original boundary, taken from northeast

The graveyard is bounded by a sandstone and shale wall with irregular coping.

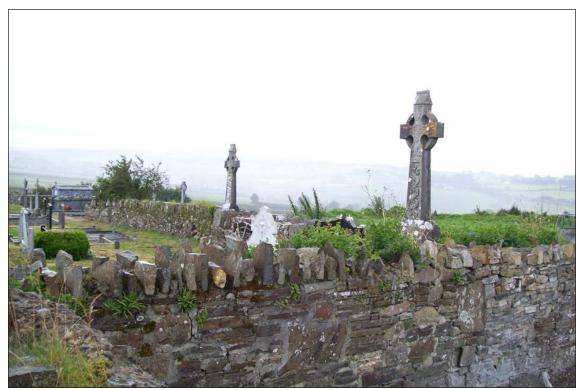
Plate 3: View of phases of repair in northern boundary wall, taken from northeast

The boundary wall is generally in good condition but several phases of repair are evident along the northwestern section which faces onto the Square (Plate 3).

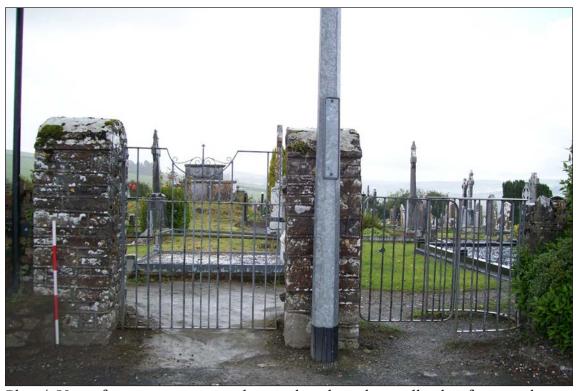
Plate 4: View of entrance to graveyard in northern boundary wall, taken from north

Access and egress to the graveyard is gained through two sandstone piers with forward pointed render (Plate 4).

A modern cast iron gate is set between the piers while a modern turnstile gate is located to the immediate west of the entrance.

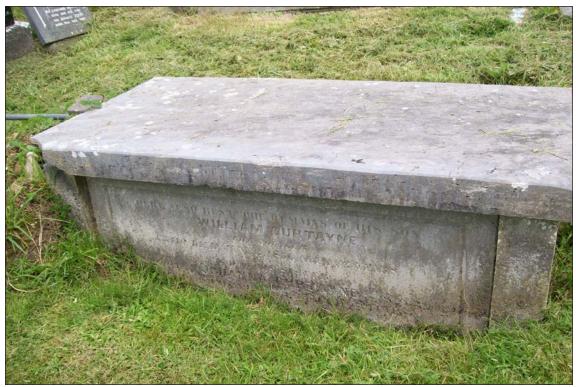
Plate 5: View of tomb for William Curtayne 1856, taken from southeast

All except one had modern commemorative plaques. The exception was tomb ref.no 101 which had its inscription on the southern side panel of the tomb. It commemorates the death of William Curtayne in 1856 (Plate 5), (the death of his sister Johanna is also recorded) and the modern grave setting for the Curtin family plot partially encloses this tomb.

Any inscription that may have existed on the covering slab has long since eroded though it can be deducted from the surviving inscription mentioned above that the father of William Curtayne is also buried in the tomb.

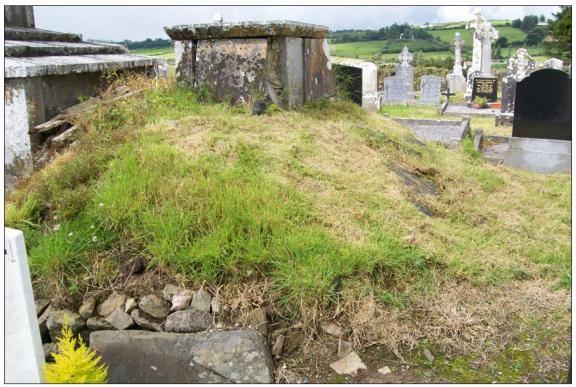
Plate 6: View of best surviving unnamed tomb which seems to be situated atop a tomb of extended length

The best surviving unnamed tomb (ref. no. 99) is situated atop a large mound which may represent a grass covered extended length tomb (Plate 6). Although being the best preserved unnamed tomb, its side panels especially on the eastern side, are loose as the mortar has weathered away.

The side panels on the best surviving unnamed tomb above should be repointed to prevent further erosion and damage.

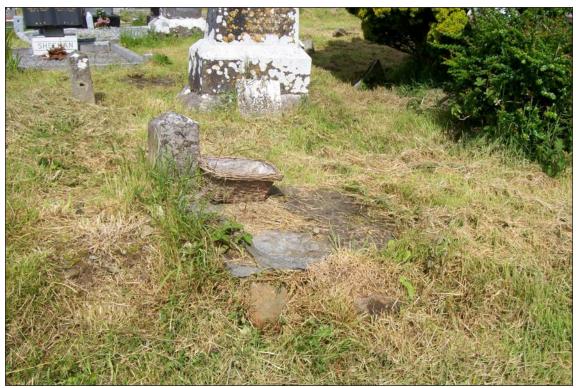
Plate 7: View of small unnamed tomb, taken from east

A very simple tomb is located close to the yew trees in the graveyard (Plate 7). It is almost overgrown with grass and is barely noticeable. It is unrendered and is constructed of sandstone rubble stone with a large slate slab forming its roof.

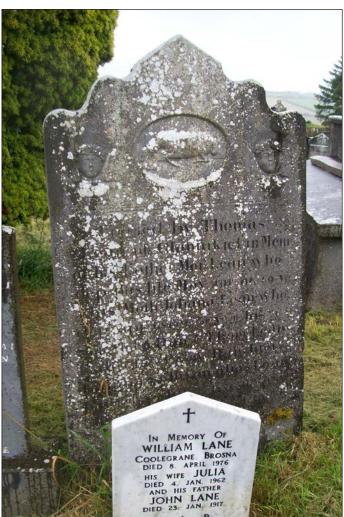
Plate 8: View of earliest named headstone, dated to 1771 and recording the death of Mai Lean

The earliest date was 1771 and recorded the death of Mai Lean (Plate 8). The inscription is in a very good sate of preservation.

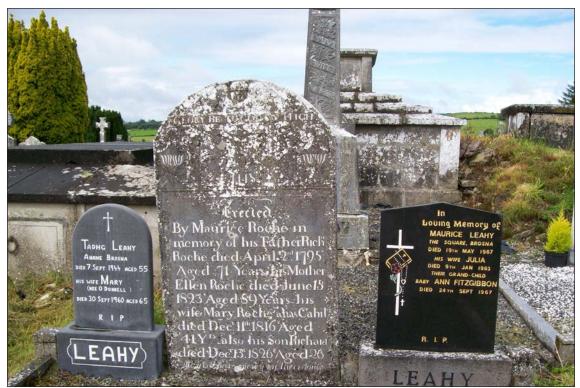
Plate 9: View of headstone dating to 1795 and recording the death of Richard Boyle

Two further headstones, no. 499 and no. 427 can be attributed to the 1700's though the remaining two digits for determining the exact year were illegible on the former headstone. The latter dates to 1795 and commemorates the death of Richard Roche (Plate 9).

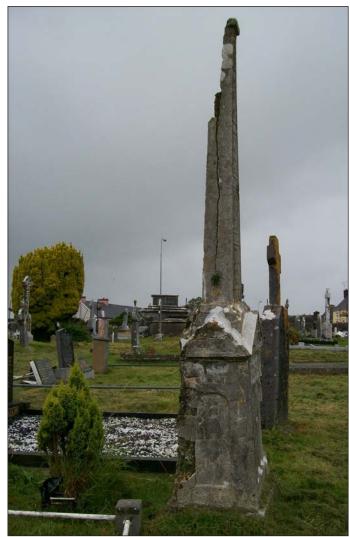
Plate 10: View of dangerous headstone (ref. no. 617) close to collapse, taken from south

Inscribed headstone no. 617 which records the death of Denis Murphy in 1917 is badly fractured and is in need of urgent repair to prevent its collapse. The render is also disintegrating and is no longer remaining on the rear of the headstone (Plate 10).

The headstones (ref. no's 531, 557 and 617) need to be reinforced and repaired to prevent them from collapsing.

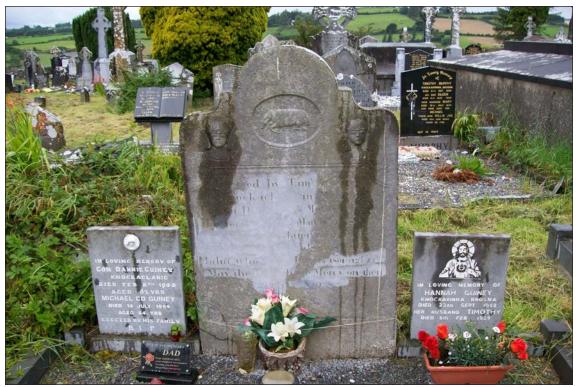
Plate 11: View of damage caused by recent attempts at cleaning the headstone

Another inscribed headstone, (ref. no. 22) that of Margaret Guiney dates to the 19th century displays evidence of a poor attempt at cleaning the headstone, the consequence of which has badly eroded the inscription on one side of the headstone so that it no longer survives (Plate 11).

An informative notice should be erected in the graveyard or on the notice board of the existing church stating that cleaning of 18th and 19th century headstones should not be attempted within professional consultation.

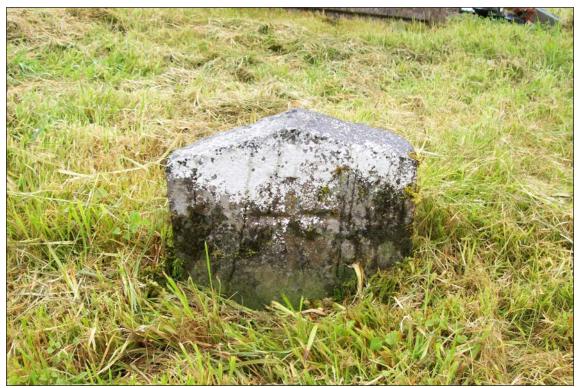
Plate 13: View of cross slab, taken from east

A single cross slab was recorded (Plate 13).

A simple cross is engraved on a piece of worked sandstone.

This was located in the northeastern area of the graveyard and may be related to the early phases of the Brosna Church and Graveyard.

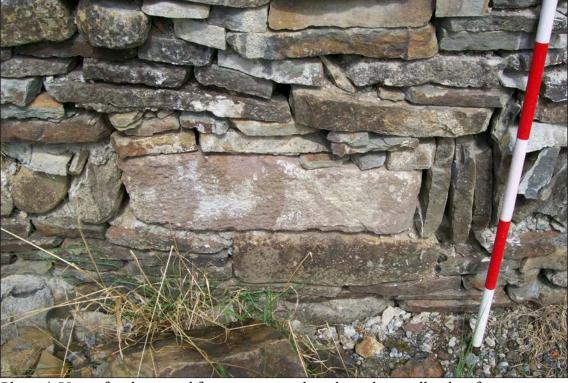
Plate 14: View of architectural fragment in southern boundary wall, taken from east

This was identified on the exterior of the southern boundary wall (Plate 14).

It comprises of a punch dressed, rectangular shaped fragment of sandstone.

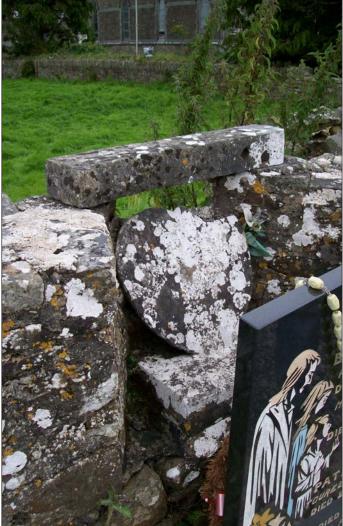
Plate 15: View of window ope in northwestern corner of boundary wall, taken from south

However, evidence of two other structures was recorded within the boundary wall. At the northwestern corner of the graveyard, behind the Walsh grave plot, the remains of an inwardly splayed window embrasure can be seen (Plate 15). It is partially obscured by another much smaller heart-shaped headstone which originally served the Walsh burial plot.

The window embrasure measures 0.9m in width and survives in height to 0.45m.

The window ope has been blocked up on the exterior.

This building is evident on the 2nd edition OS map 1897 as partially extending into the northwestern corner of the graveyard from the adjoining field to the west.

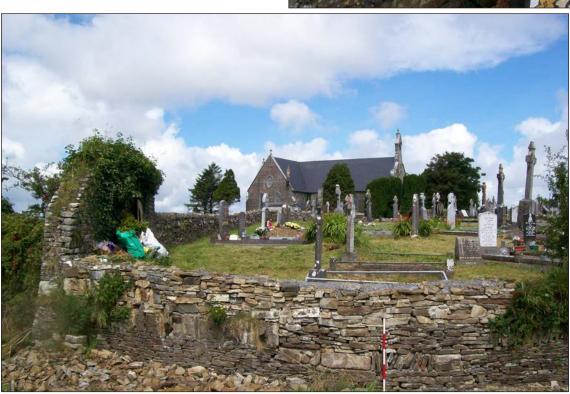
Plate 16: View of gable wall within boundary wall at southwestern corner of graveyard. Architectural fragment also visible. Note evidence of repair of boundary wall and mound of associated rubble stone

A gable wall survives within the boundary at the southwestern corner of the graveyard (Plate 16).

This area has become a dumping ground for plant cuttings and other debris associated with the grave plots.

The wall is partially overgrown with ivy and the existence of window opes could not be determined.

The wall survives in height to 2m on the interior of the graveyard and to over 3m when

viewed on the exterior.

A batter is evident on the southern side of the gable wall.
