Date: October 2009

Project code: TGSK09

Archaeological Survey, Ballynacourty Graveyard, Ballynacourty, Co. Kerry.

RMP Number: KE044 063

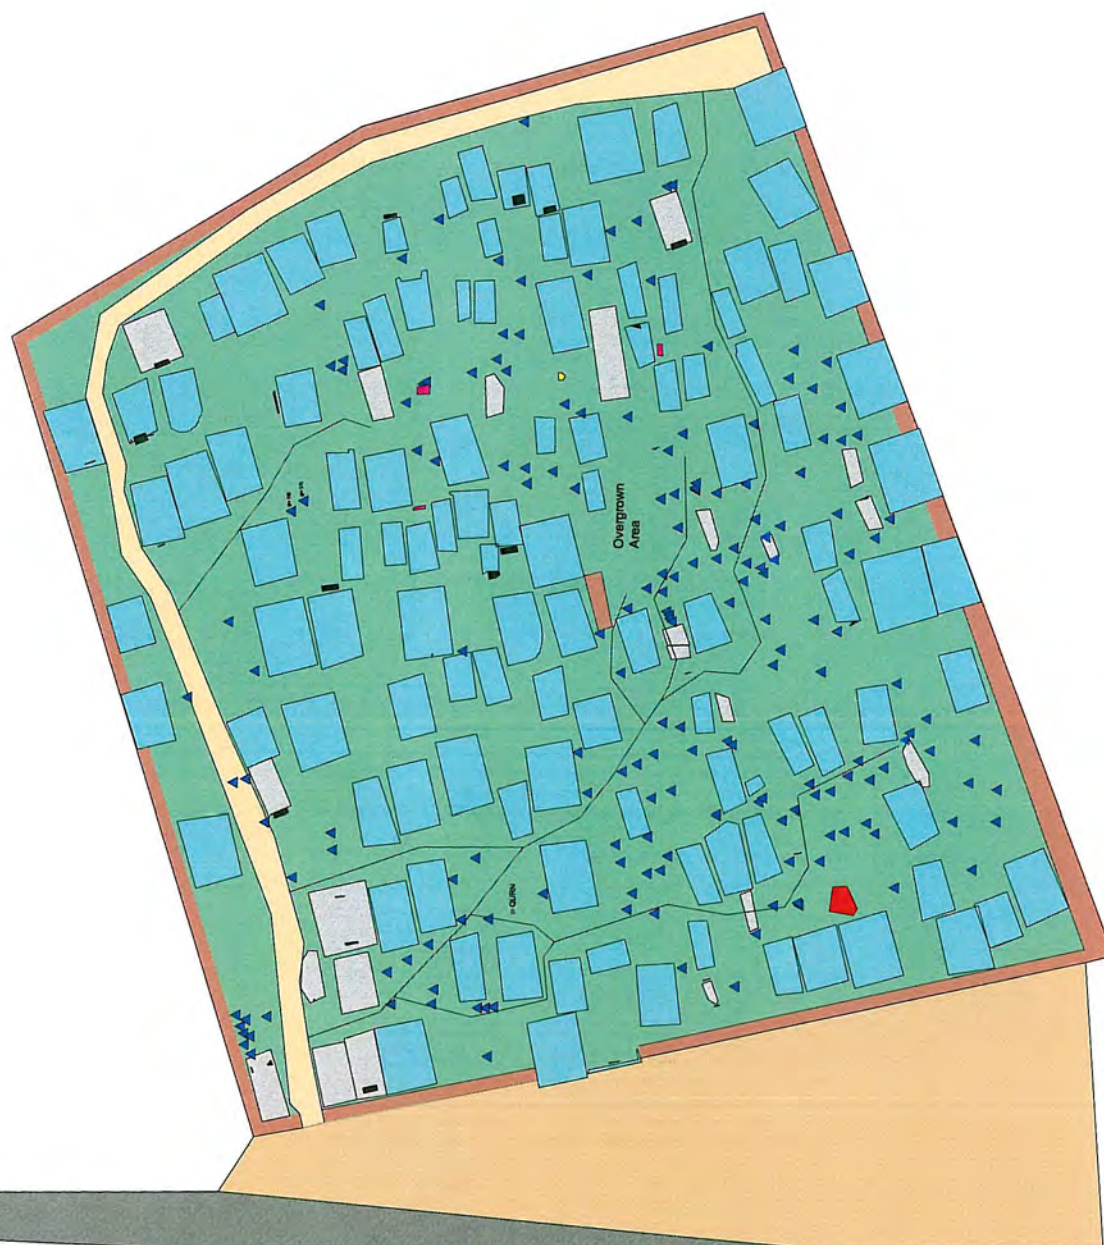
Figure 3: Archaeological Survey, Ballynacourty Graveyard, Co. Kerry.

The graveyard is surrounded by a partially mortared rubble stone wall. The western wall is the highest part measuring approximately 1.5 m. There are different phases of construction evident. The lowest portion of the wall is to the east measuring approximately 0.5 m. A number of tombs are built into and truncating the graveyard walls to the south (grave no's.

137, 139, 141, 142), to the west (grave no's. 005, 012) and to the north (grave no. 111), (figure 3, Plate 17).

Prevent further building of tombs and graves close to the graveyard walls.

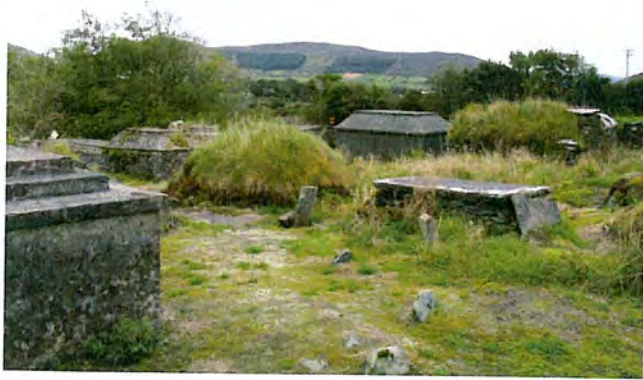
Plate 01 General View.jpg

It appears that broad spectrum weed killer was used in the past. The lack of ground vegetation within the graveyard gives it a neglected and abandoned appearance (Plate 1). A number of desire lines were identified crisscrossing the graveyard. The majority of the graves and tombs are broken and/ or crumbling, (plate 2).

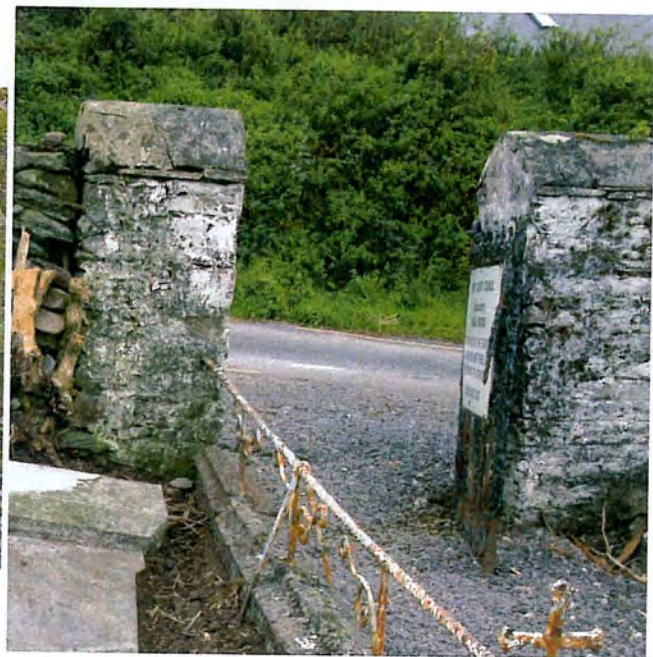
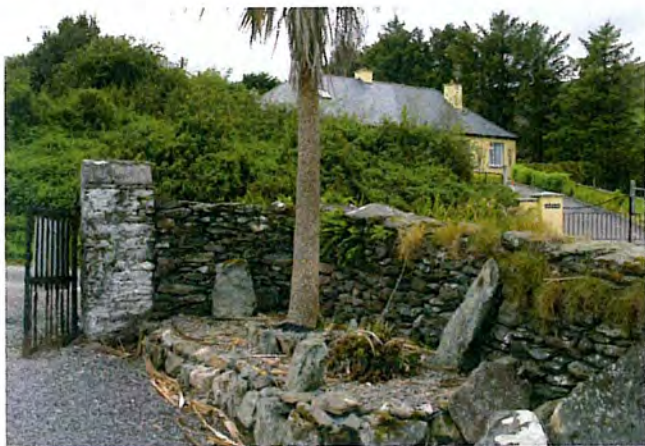
Plate 04 Entrance Gate, from the interior.jpg

A single entrance on the north end of the west wall leads into the graveyard. The wrought-iron gate does not close properly and has partially fallen off its hinges. The rust has eaten away at the iron bars in the gate (plates 4 and 5). Exposed rubble stone piers flank the entrance.

As the gate is probably beyond restoration it is recommended that it is replaced.

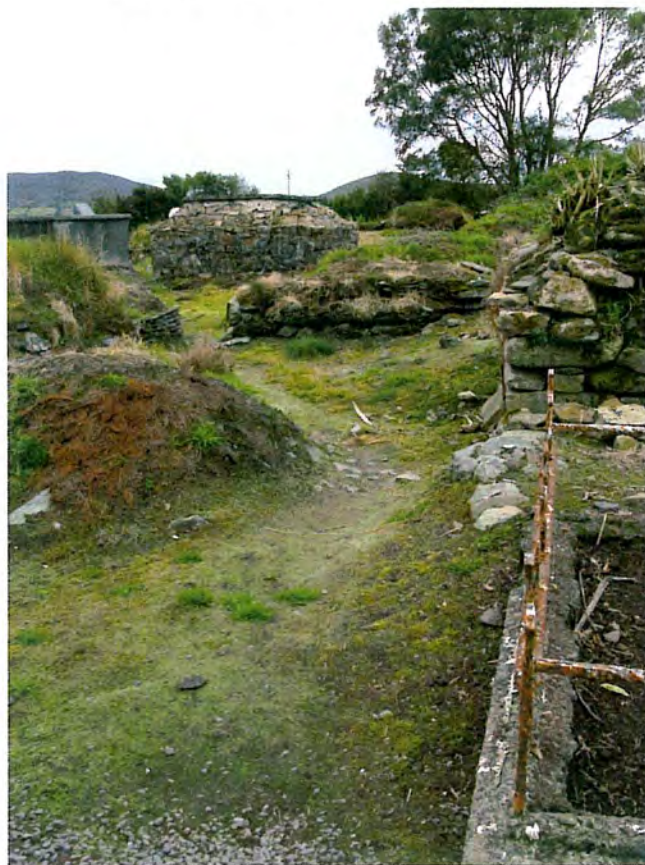
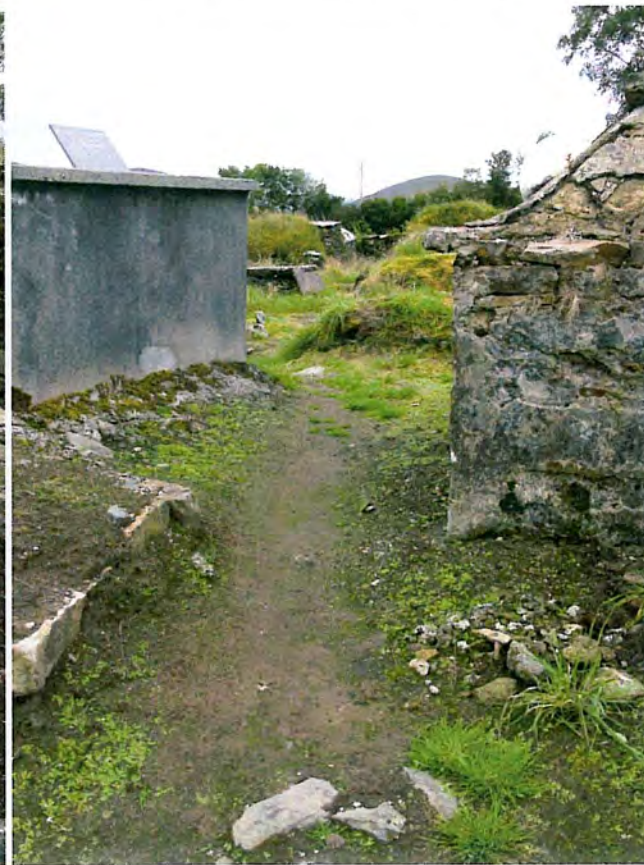
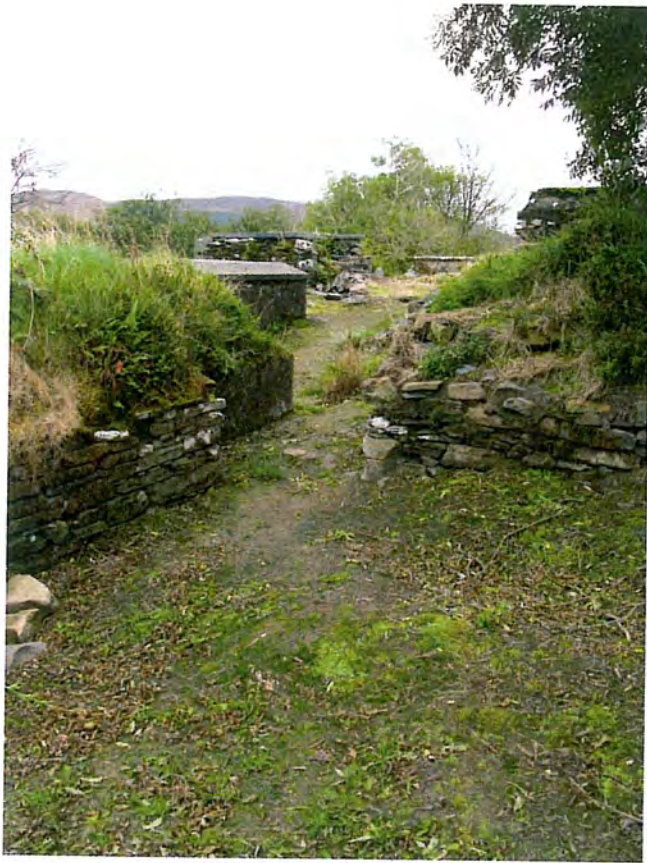
Plate 07 Desire Lines.jpg

There are a large number of desire lines crossing all over the graveyard. A lot of them are traversing graves and low overgrown tombs. They are easy to detect due to the nature of the soil within the graveyard, which is of a very soft and silty consistency (plate 7-9).

Add gravel paths to a selection of desire lines to minimize the destructive impact of associated pedestrian traffic.

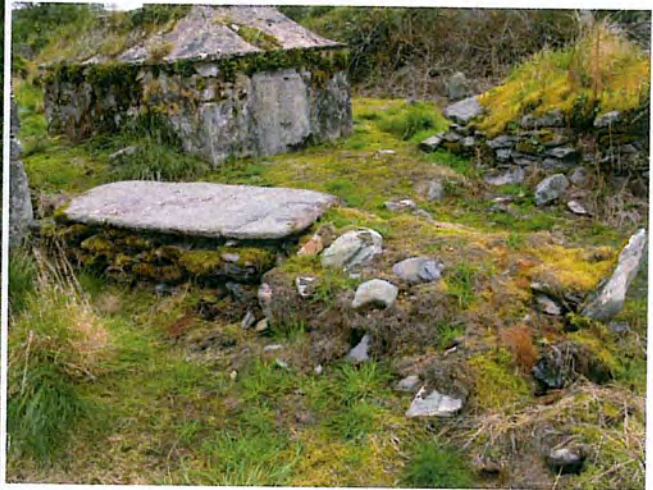
Plate 10 Grv 261.jpg

There are 112 tombs within the graveyard, 88 of which are unnamed with 2 of the remaining 24 found to be illegible. The oldest burial in Ballynacourty graveyard is the tomb (grave no. 261) of Benjamin Webb, who was laid to rest in 1775, however the capstone looks to have been relocated to this tomb at a later stage (plate 10).

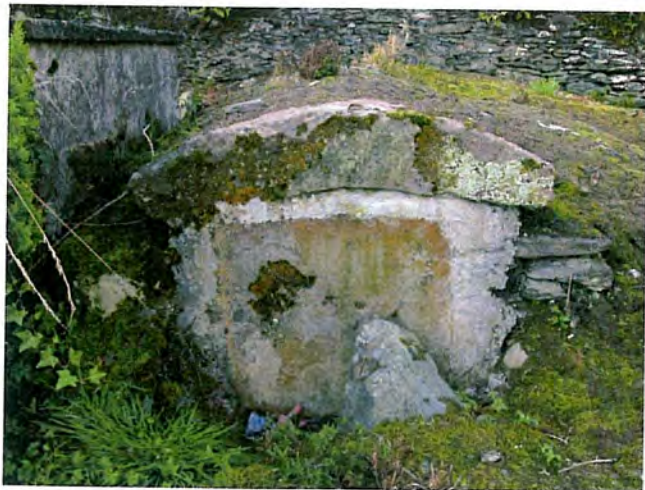
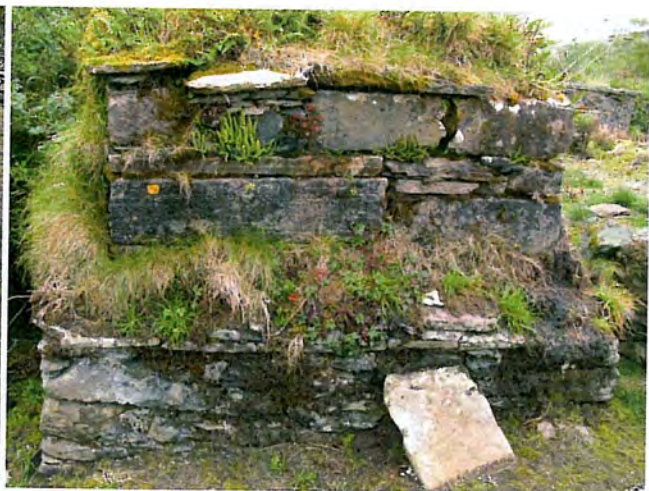
Plate 11 Grv 013.jpg

Tombs are the most common grave type after unmarked graves and are scattered throughout the graveyard. There are a small number of tombs (grave no's. 013, 069 and 302, plates 11-13) that seem to have been built with architectural fragments, that may have come from the church ruin of which there are no visible remains.

Reconstruct broken tombs and graves; also remove any inappropriate concrete that may have been previously used. Any collapsed tombs should be assessed and structural repairs made where necessary. Good conservation practices should be followed using the principle of repair rather than replacement. However, additional material can be used where necessary to reinforce or support the existing material. If repairs are deemed necessary in the future then appropriate materials should be used, i.e. lime mortars and not hard cement.

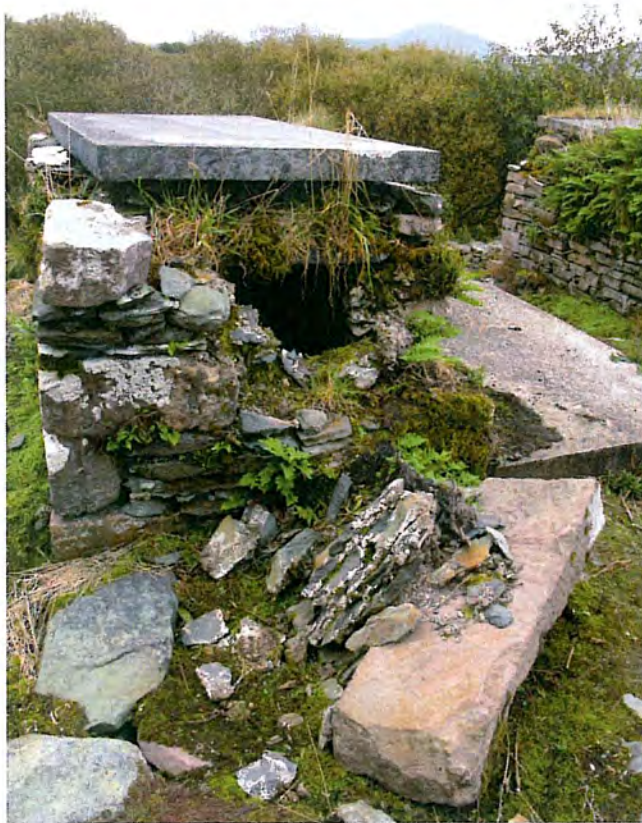
Plate 13 Grv 302.jpg

There appears to have been some recent restoration work done to some of the tombs, mainly comprising the application of cement to gaps and covering collapses in tombs. These measures are now becoming undone, with subsequent collapse evident (grave no's. 075, 179 and 302, Plate 15, 16 and 13).

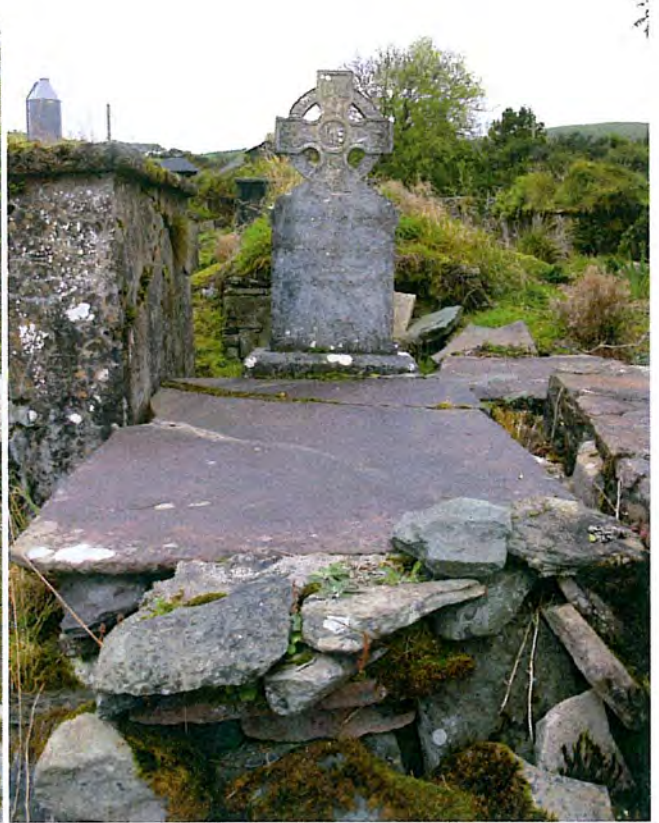
Plate 14 Grv 217.jpg

Grave no. 217 is one of the finest tombs within the graveyard although it is partially collapsed. It was erected for Thomas Benjamin Bowler, Lord Mayor 1947 and a member of 'old' IRA (plate 14).

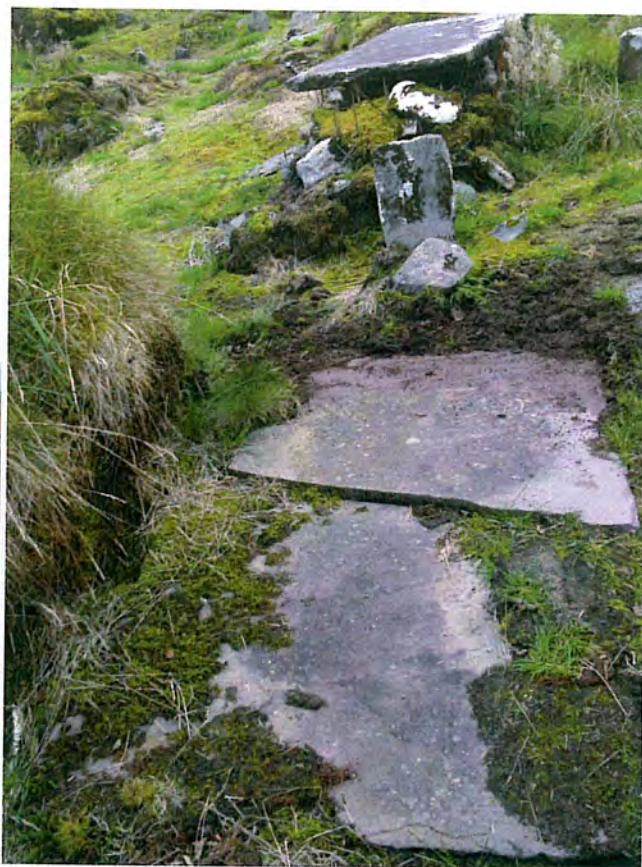
Plate 18 Grv 184.jpg

Grave no. 184 comprises a large capstone placed on the ground over a hollow that could possibly be a stone lined grave. The slab is broken in two and unfortunately a desire line leads you across the plot. The grave is for the O'Sullivan family and was erected 1809 (Plate 18).

Prevent further deterioration of grave no. 184, through renovation. Appropriate materials should be used, i.e. lime mortars and not hard cement. The wooden cross at grave no. 85 should be painted regularly to ensure its survival.

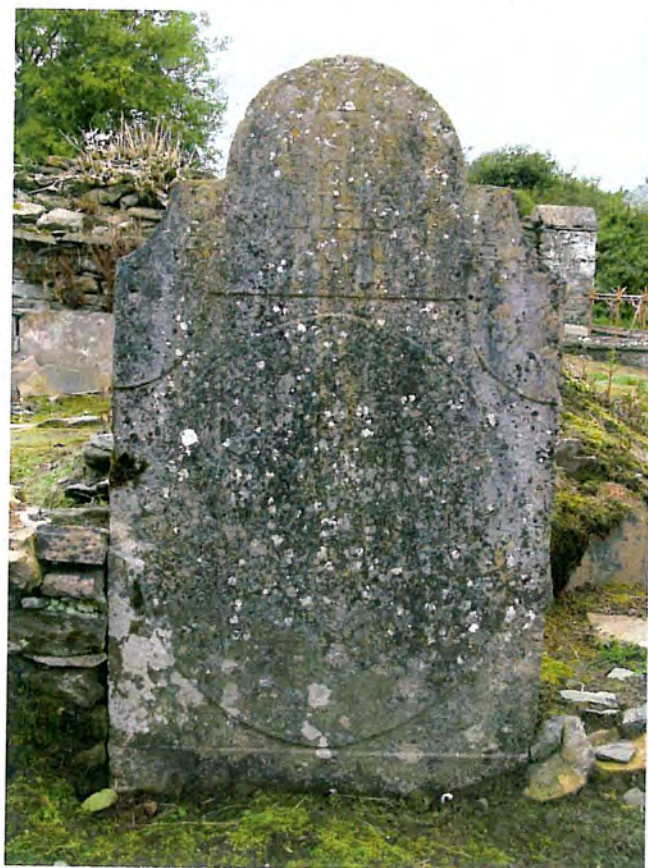
Plate 19 Grv 084.jpg

Grave no. 084, erected in 1847 for the O'Connor family, comprises a beautifully carved headstone and cross footstone (plate 19).

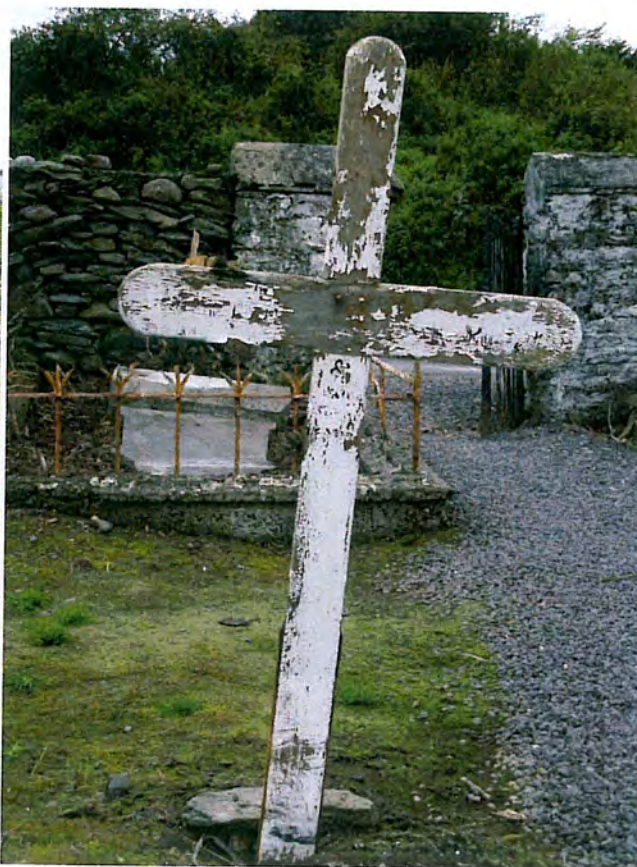
Plate 20 Grv 085.jpg

There are also more simple headstones such as grave no. 085 (plate 20) which comprises a painted wooden cross that is fast deteriorating and becoming illegible. Grave no. 031 has a simple but effective headstone, carved and filled in with black paint to highlight the inscription and set in mortar on the ground (plate 21).

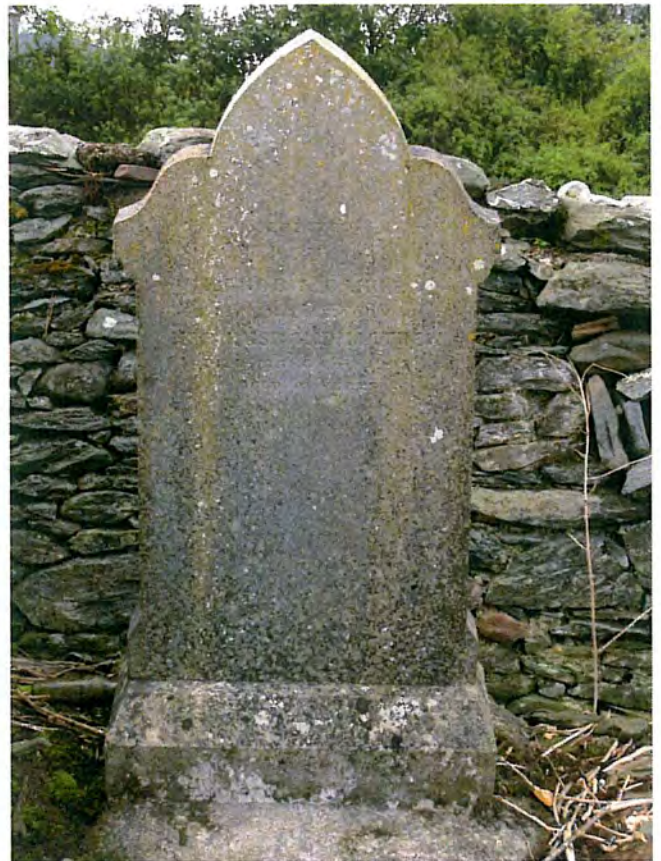
Plate 22 Grv 002.jpg

One of the graves from the 20th century, grave no. 002, was erected in 1905 for the Cahill family (plate 22).

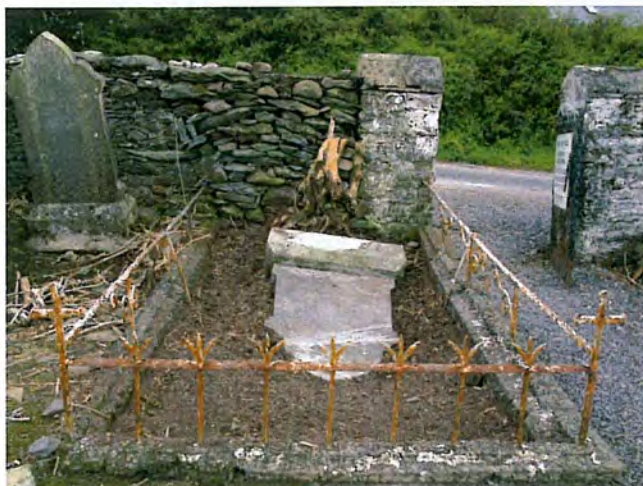
Plate 23 Grv 001.jpg

There are seven illegible/unnamed headstones within the graveyard. Grave no. 001 is the most obvious example that needs attending to as the headstone has fallen over face down. This was most likely caused by a tree growing from within the west graveyard wall pushing out from the wall and forcing the headstone to fall over. The remains of the tree are still visible, but the headstone has not been placed back in its original position (plate 23).

Reinstate the fallen headstone for grave no. 001 and clear the area surrounding grave no. 012, to facilitate the identification of the family buried there but also for the appearance and general maintenance of the graveyard. Remove inappropriate concrete on graves.

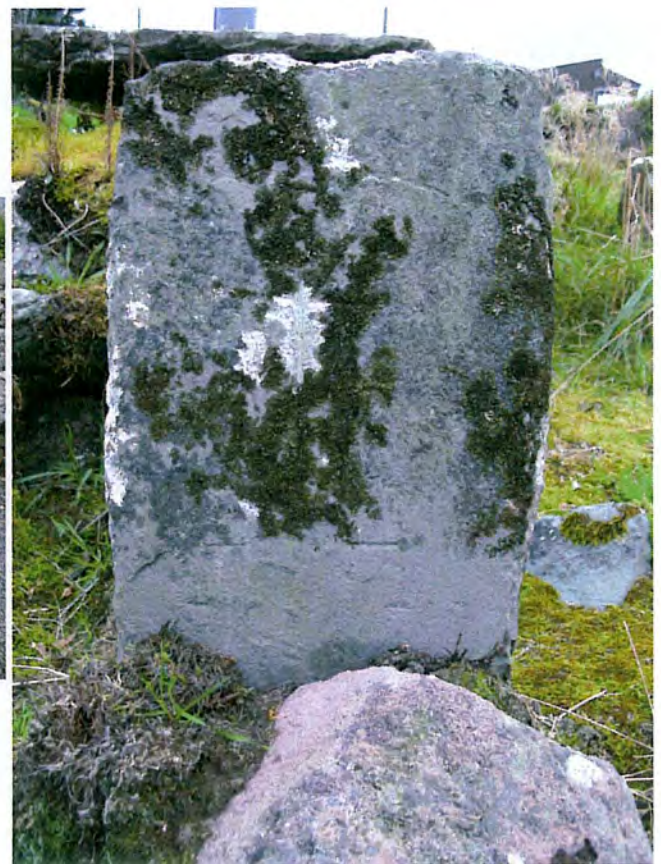
Plate 24 Grv 183.jpg

Some of the unnamed grave markers comprise simple headstones carved with a cross (Grave no's. 183, 244 and 247, plate 24). One stone cross, grave no. 012, which is hidden between the west graveyard wall and grave no. 010, overgrown.

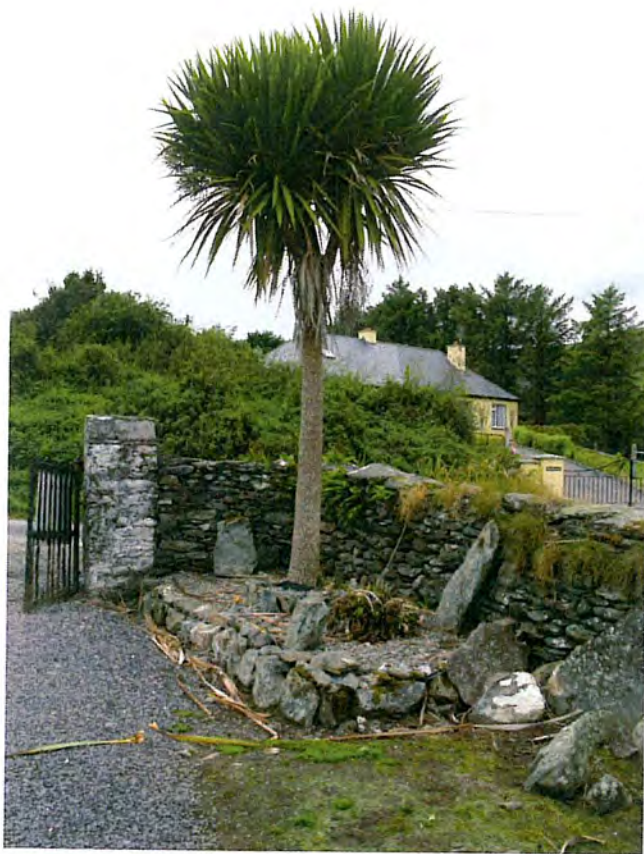
Plate 25 Grv 099.jpg

There is one empty grave setting, grave no. 099, just inside the entrance in the northwest corner. The plot is well maintained and has a palm tree growing in the centre of it. On the western edge of the plot there is a loose unmarked headstone and two additional loose unmarked headstones, one leaning on the south wall and the second placed in the southeast corner of the plot (plate 25).

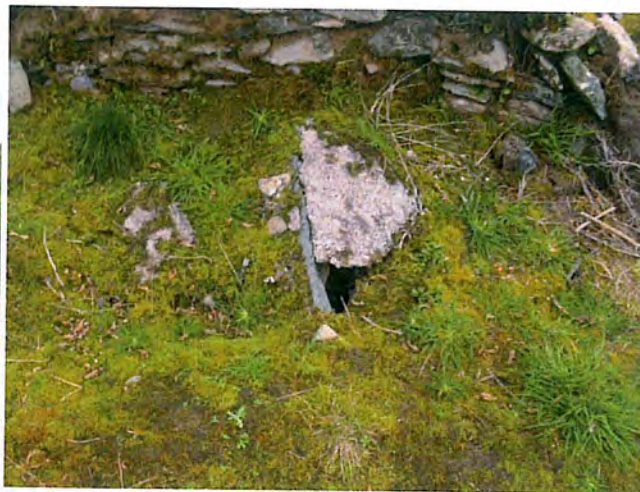
Plate 26 Grv 214.jpg

There are also six unnamed stone lined graves present. Grave no. 214 (plate 26) has at one point broken/collapsed and was repaired by using cement. This material has now given way and there is an opening straight in to the grave.

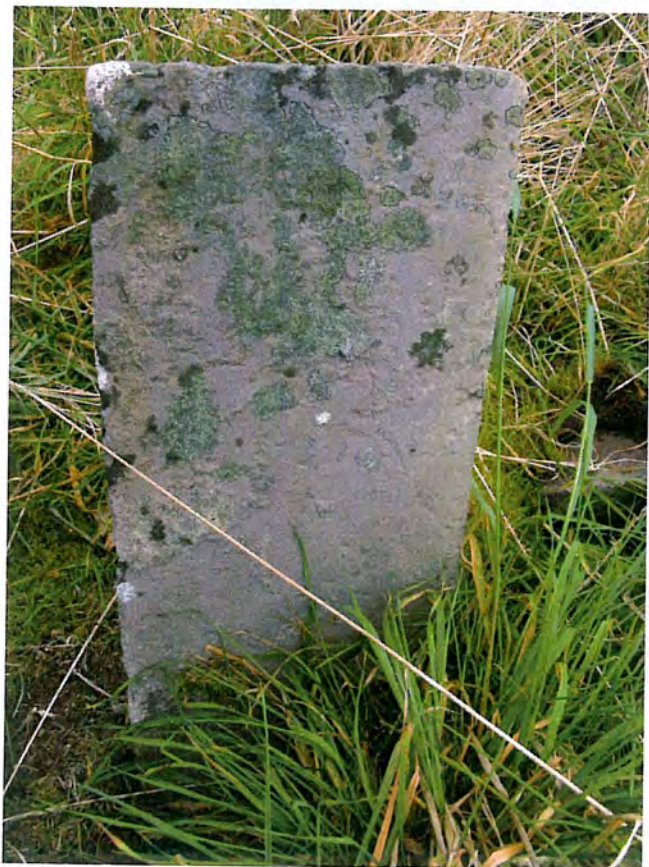
Plate 27 Grv 206.jpg

Most of the graves (176) in Ballynacourty graveyard are unmarked and vary type. Some comprise an uncarved low stone placed into the ground, whilst others have both a head and footstone each having been shaped into grave markers (plate 27).

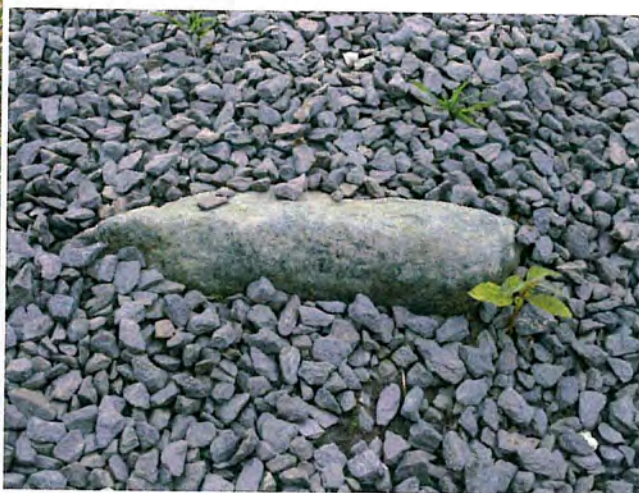
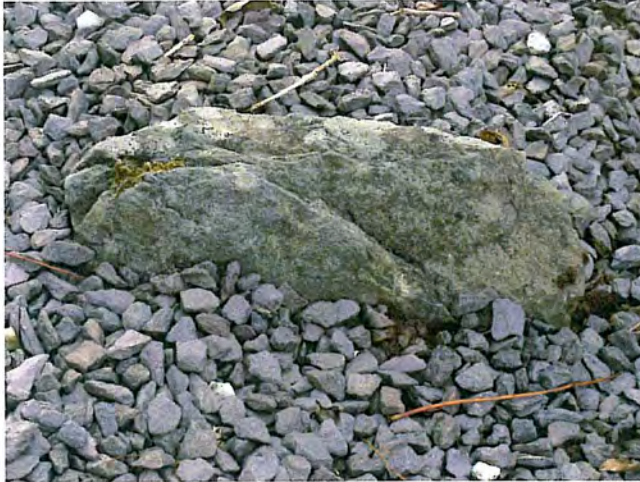
Plate 28 Grv 107.jpg

Both the path and a number of desire lines are placed on top of and truncating the unmarked graves e.g. grave no. 106 -109 (plates 28 and 29).

Cut grass and remove vegetation around the unmarked graves.

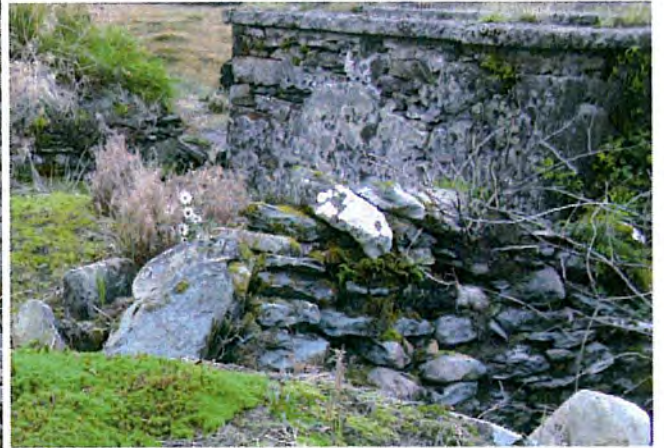
Plate 30 Showing Wall, possible remains of Church.jpg

There are no obvious visible remains of the church within the graveyard, however there are tombs that include architectural fragments within their fabric. There are also three stray architectural fragments strewn about and a quern stone. There is a low wall (plate 30), in the area of where the church ruin is evident on the OS First Edition Map of 1846. On inspection of the Os 25 inch Map of 1896 the church remains are no longer visible and the site of the church is marked with a cross. This wall is not convincing as a part of a church wall as there is no mortar or a build up of soil, moss and grass etc which suggests that this wall is most likely a collection of rubble from the surrounding area or a wall marking the area where the church once stood. A lack of diagnostic architectural fragments supports this theory.
