Date: October 2009

Archaeological Survey, Churchtown Graveyard, Churchtown, Co. Kerry.

RMP No.: KE065 012003

Headland Archaeology (Ireland) Ltd,

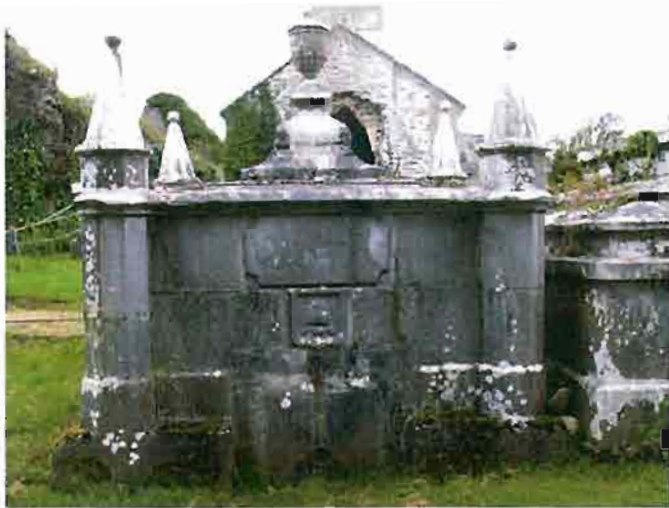
Plate 01-Grave no.467 MacGilly Cuddy's Tomb.jpg

decorative carved limestone commemorative plaque to front (The McGillicuddy Tomb AD MDCCCXX) above a carved limestone shield having family crest and motto (plates 1 and 12).

The overgrowth of vegetation on a majority of the tombs should be monitored and controlled, as for the other better kept tombs this standard of maintenance should be maintained.

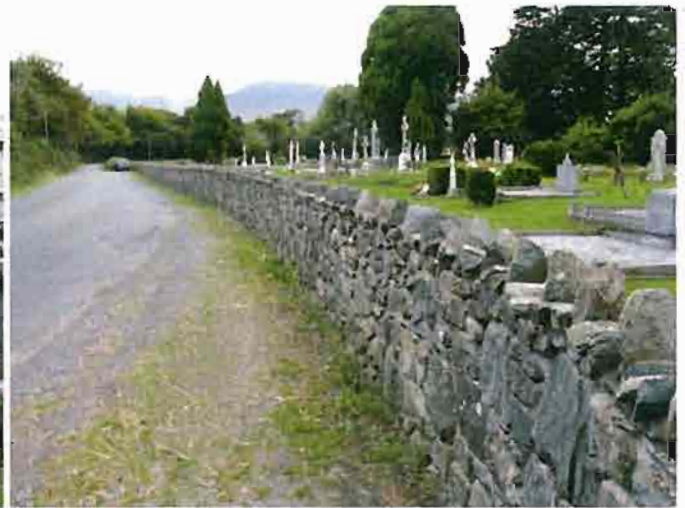
Plate 02-View of exterior of east boundary wall, facing s...

The boundary around the graveyard is a coursed mortared rubble stone wall with a render capping and rubble stone crenulations. The eastern wall by the road is well maintained and free of any vegetation or collapse (plate 2); whereas the north and south walls are very overgrown (plate 3). The west wall is almost level with the ground on the interior of the old graveyard but is approximately a metre high from the exterior (plate 4). No areas of collapse or breaches within the boundary were visible. The walls to the recent burial ground are of rendered concrete, having chamfered render coping and square-profile piers with render caps.

The walls appear to be stable and periodic monitoring should be carried out to ensure that this remains the case. The encroaching vegetation should also be monitored and controlled, preferably in such a way as to preserve the natural habitats that this vegetation provides for local wildlife.

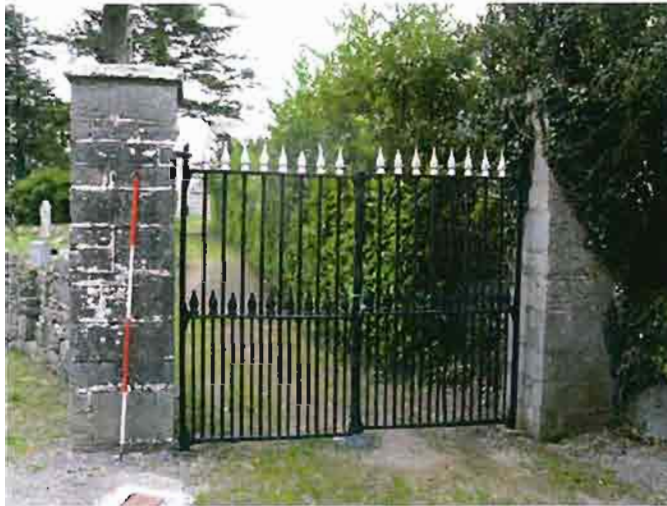
Plate 05-View of gate and pathway (from outside) at no...

There are 3 main entrances to the graveyard. One gated entrance in the north end of the east wall (plate 5), with a now disused stone stile located next to the gate (plate 6). Another entrance in the same wall, at the southern end, is a modern wrought iron removable stile with a cross motif (plate 7). The third main entrance is located in the south-west corner, where an older entrance may have existed, as is evidenced by the breach in the wall and as shown in the OS Historic Maps a road led up to this point. A more recent construction of concrete steps and walls seems to have replaced the original entrance (plate 8). The only other entrance/exit to the original graveyard is what seems to be a deliberate breach in the wall in the north-west corner to link the original graveyard with the more recent extension (plate 9). The entrance to the recent burial grounds consists of a gateway in the south-east corner, having rendered square-profile piers and a metal gate, with a narrow stile to its right as you enter (plate 10).

The only pathway in the original graveyard leads from the main gate at the north-west corner to the more recent derelict church where it ends (plate 5). It is being slightly encroached from the north by vegetation growing out from the north wall.

The entrances to the graveyard are in good condition. The gates should be treated for rust and painted as and when such measures are needed, and continued to be kept clear of vegetation and debris.

Clearing of encroaching vegetation to the path could be carried out by hand and without the use of broad spectrum weed killers.

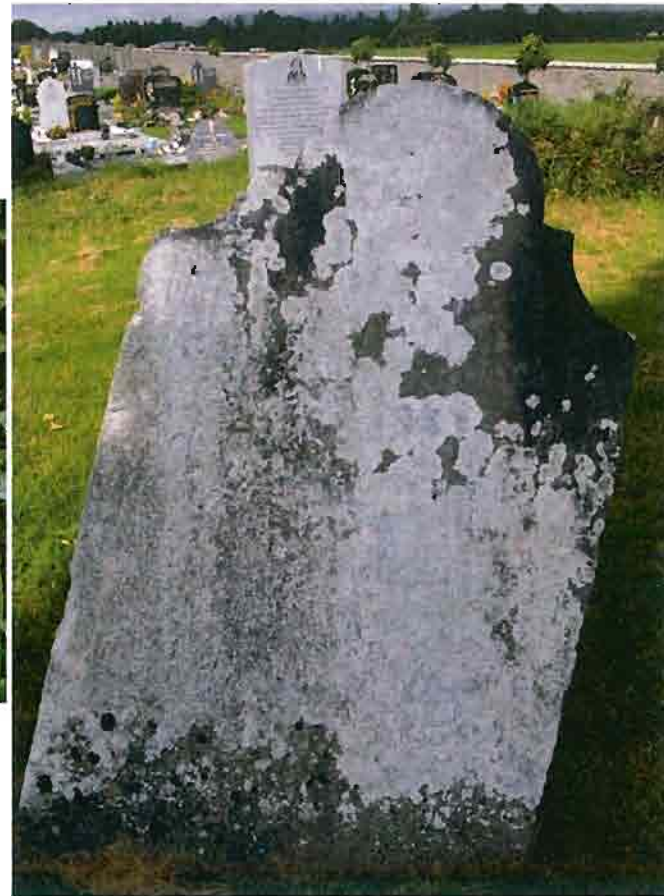
Plate 14- Grave no.306, illegible due to erosion.jpg

The detail on most of these has been eroded away over time (plate 14), and in some cases the headstones themselves are broken as is the case with Grave no. 381 (plate 15). There are also a number of plots which no longer have headstones within the plot-markers or are still empty plots (plate 16).

In general the headstones and grave plots around the graveyard are in good condition and as such should not be interfered with. Continued close monitoring and upkeep of the grounds should ensure that this continues.

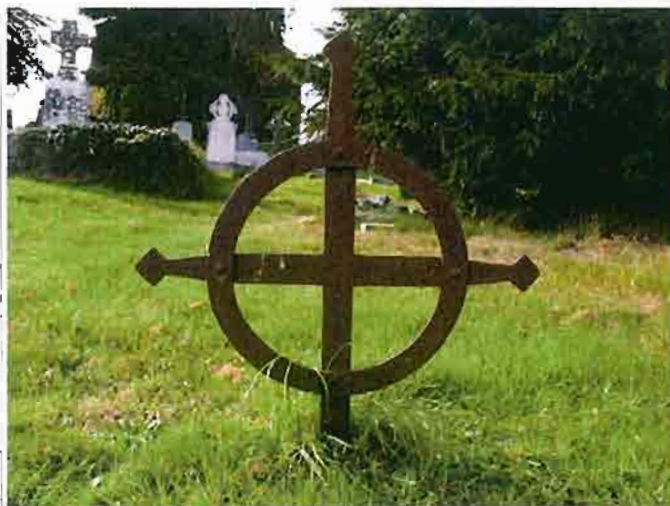
Plate 17-Grave no.420, iron cross.jpg

The majority of gravemarkers are rubble stones indicating the place of a burial. The graves are often placed in seemingly random locations and in some cases have a large amount of vegetation growing on and around them, sometimes to the point of obscuring them completely. These gravemarkers indicate a lower class status and were particularly prevalent during the Famine period. Also included are three unnamed iron crosses, grave nos. 048, 063 and 420 (plate 17).

These gravemarkers should be cleared of vegetation and the grounds routinely mowed in order to improve the visibility of the obscured stones. The iron crosses are in good condition, should be kept clear of vegetation and debris and could be treated to prevent further rusting and deterioration.

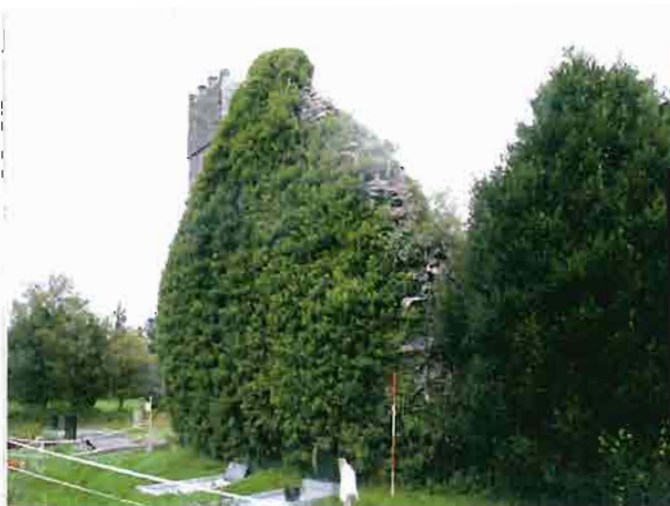
Plate 18-View of east elevation of church, facing south-...

The earlier church is a single cell double-height church surviving to a maximum height of approximately 6-8m, with the gables to the east and west elevations with vegetation throughout (plates 18 and 19). In the south wall there is a pointed arch door opening with dressed rubble stone surround and voussoirs, having a cumberhead (plates 20 and 21). The east elevation of the church contains a narrow square-headed window opening with a stone sill and lintel, surmounted by a possible oculus window having a dressed rubble stone surround above (plate 22). There are three other visible window openings, one on the south elevation (plate 23) and two on the north elevation (plates 24 and 25). There are also three square headed recesses within the church, one in north of the east elevation (plate 26) and two in the east of the south elevation (plate 27). Also in the north elevation we find a rounded arch recess with dressed stone voussoirs (plate 28), as well as a stoup located at the east end of the aforementioned wall (plate 29).

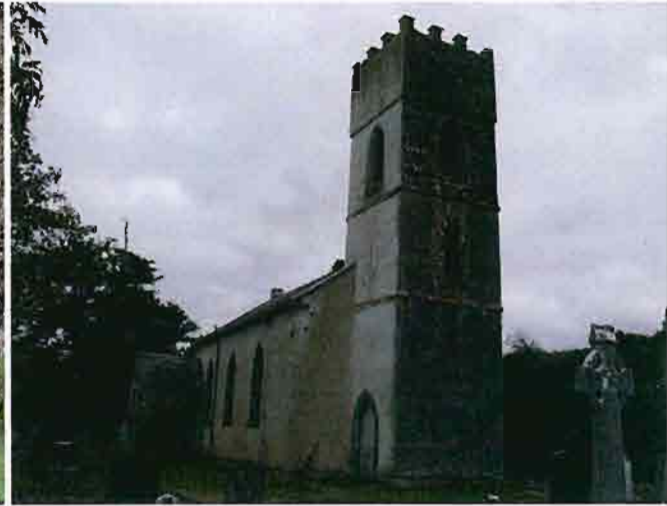
Plate 30- View of Church of Ireland church, facing south...

The more recent church, located 3m to the north and running parallel to the older church, is a free standing double-height Church of Ireland church, built c.1812 (plate 30). It comprises of a 3-bay nave with a 4-stage bell tower to the west elevation and a single-bay, single storey porch to the north elevation. It has a pitched slate roof to nave and porch having corbelled tooled limestone gable copings and the remains of cast-iron rainwater goods. It has rendered rubble stone parapet to bell tower with rudimentary crenellations and a roughcast render over rubble stone walls, having rendered banding between stages of the tower. It has pointed arch window openings with chamfered ashlar limestone sills and block-and-start surrounds to the nave. Having six-over-six pane timber sliding sash windows surmounted by intersecting timber traceried overlights. The window to the east elevation has been removed with the interior red brick surround and voussoirs visible (plate 31). There are also pointed arch door openings throughout having tooled limestone or red brick surrounds and voussoirs.

The later Church of Ireland church should be cleared of any hazards and the open door in the porch should be repaired and locked. Also the opening in the east elevation, where the window used to be, should be closed up to prevent any more damage to the interior like wind and water damage.

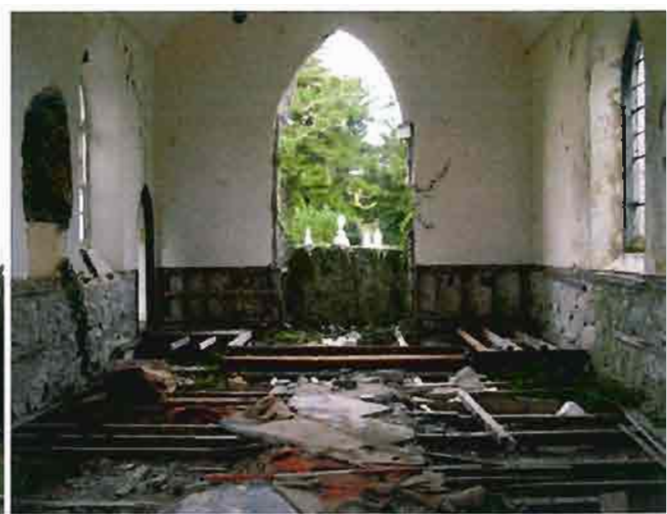
Plate 32- View of inside of Church of Ireland church, fa...

In general the exterior of the more recent church is in good condition, but the interior has exposed beams on the floor from floorboards being removed as well as a large amount of rubble and other building material scattered about the floor (plate 32), which is a health and safety issue that should be dealt with.

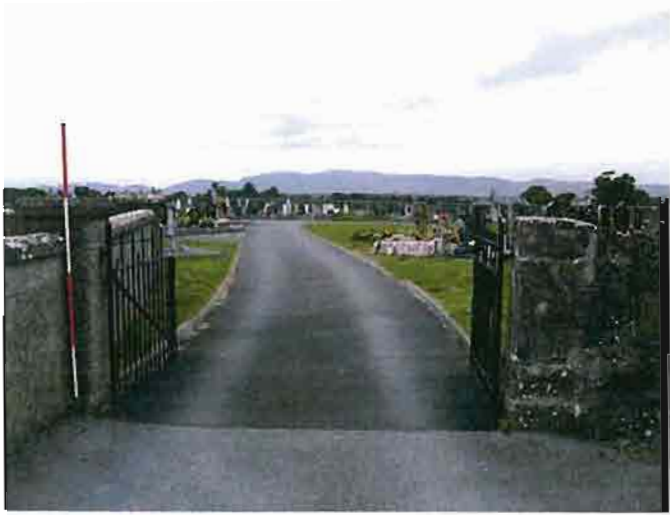
Plate 33-View of Tarmacadam paths in modern gravey...

Tar macadam lined pathways run around the periphery of the modern graveyard and also transects the centre running east-west and north-south (plate 33).
