Archaeological Survey,
Cloghane,
Dingle Peninsula,
Co. Kerry.

October 2010

RMP No.: KE035-025 Cloghane Church &
Graveyard

Written by: Laurence Dunne

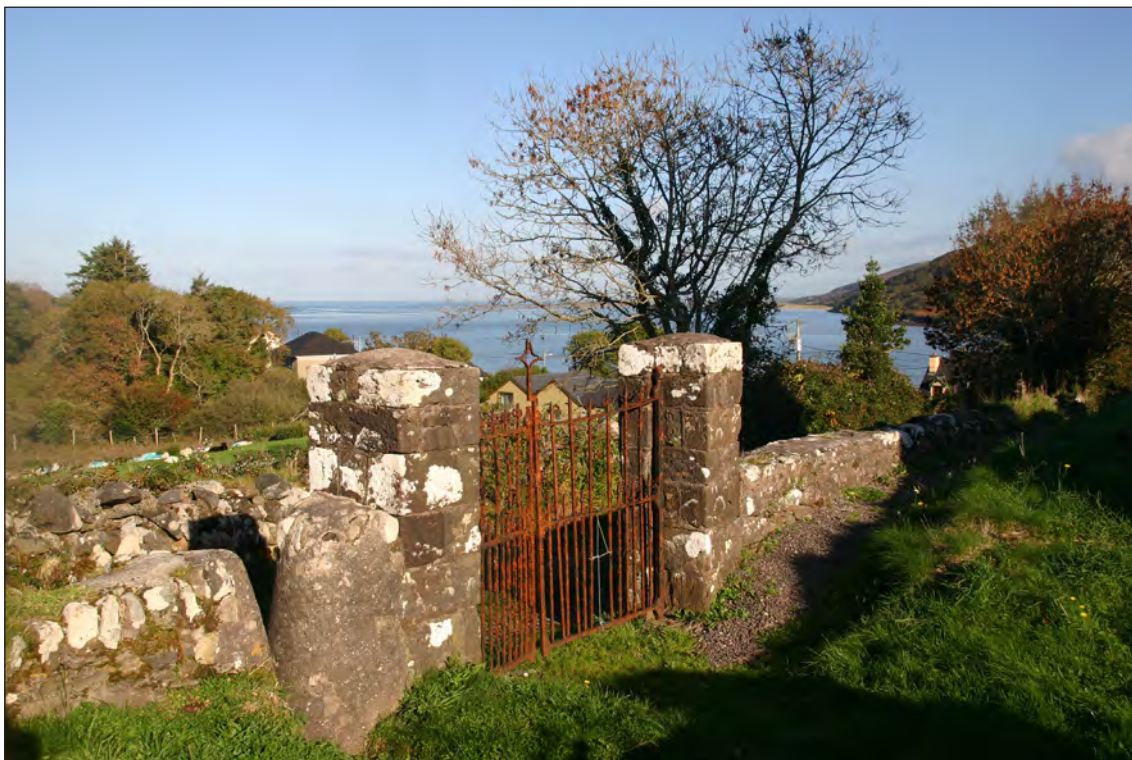
The entrance comprises two neglected rusty iron gates set between two square capped and rendered piers of squared rubble sandstone built to courses. The piers are in very good order with a simple squeeze-stile situated immediately beside the right hand or NW pier (Plate 1 & Figure 5).

Plate 1: View of interior of the entrance area of the old medieval burial ground at Cloghane from south-east. Note Brandon Bay in background

The gates should be professionally cleaned, repaired and painted.

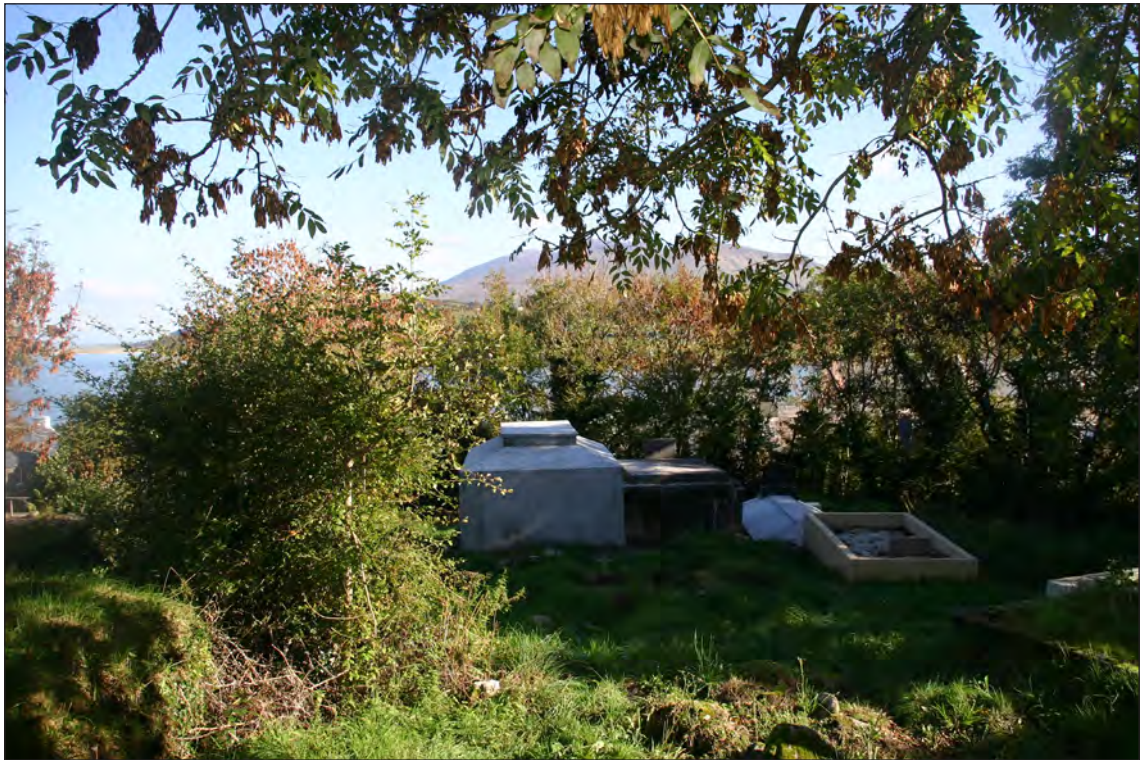
The medieval section of the old burial ground at Cloghane is very difficult to traverse due to the density of tombs and their dilapidated state of repair combined with the sloping topography, and the overgrown nature of the ground (Plates 7-8). The medieval graveyard section is also very narrow and physically dominated by the extant relict remains of the medieval church ruins that are in turn further supplanted by the larger ruinous 19th century Church of Ireland making the burial ground extremely congested (Figure 5).

Plate 7: View from west of the overgrown sloping interior of the old medieval burial ground at Cloghane

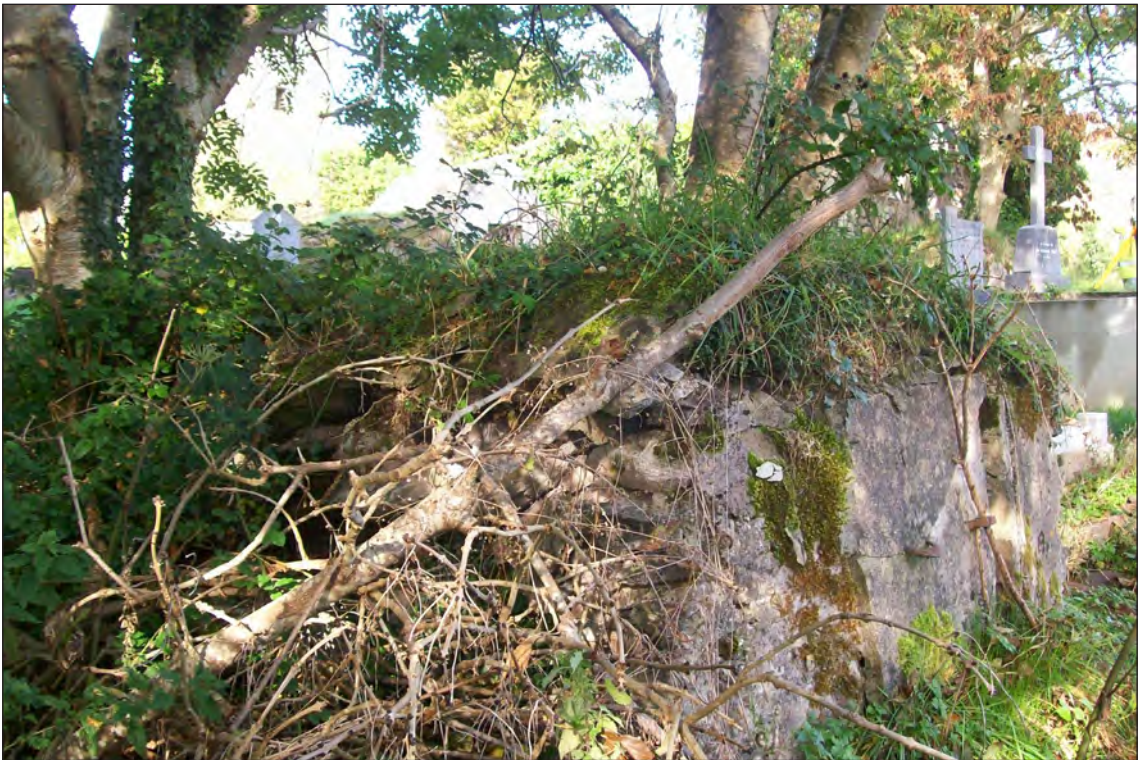
Cloghane contains a massive 92 tombs of which 64 are within the medieval area with another 27 situated in the 19th century section. House shaped and strong-box tombs are the dominant tomb types with many of them in the 19th century area built in contiguous rows of terraced houses of the dead (Plates 11-12). Several of the tombs are in a poor dilapidated state of repair either collapsed or partially collapsed (Plates 8 & 13).

Plate 8: View of grass and tree covered tombs in the eastern limits of Cloghane Graveyard

Neglected, overgrown and partially collapsed tombs should be repaired and restored. Growth on tombs should be cut back tight to determine the extent of the repairs required. Repairs to tombs should be undertaken by experienced masons with a proven track record of working on historic structures and in the use of lime mortar etc. This work should only be carried out under expert archaeological advice and supervision as it is most likely that architectural fragments from the medieval church of Cloghane may be incorporated within the tombs.

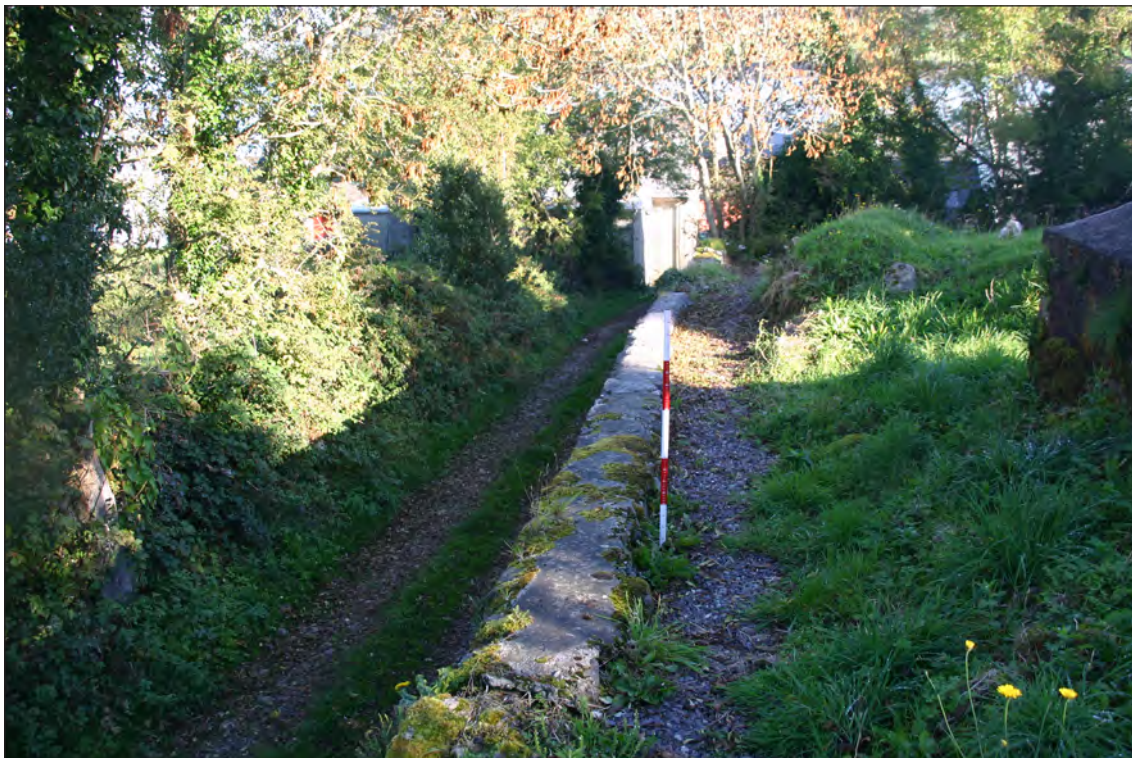
Plate 9: View of the narrow graveled pathway along the northern boundary running downslope east towards the village. Note unprotected very low boundary wall and 2m high fall off to the trackway beside

The interior height of the boundary wall along the N limits of the medieval burial ground is totally inadequate and a danger to visitors. A protective railing should be erected. The vegetation on the walls should be removed and its re-growth managed and curtailed by regular trimming.

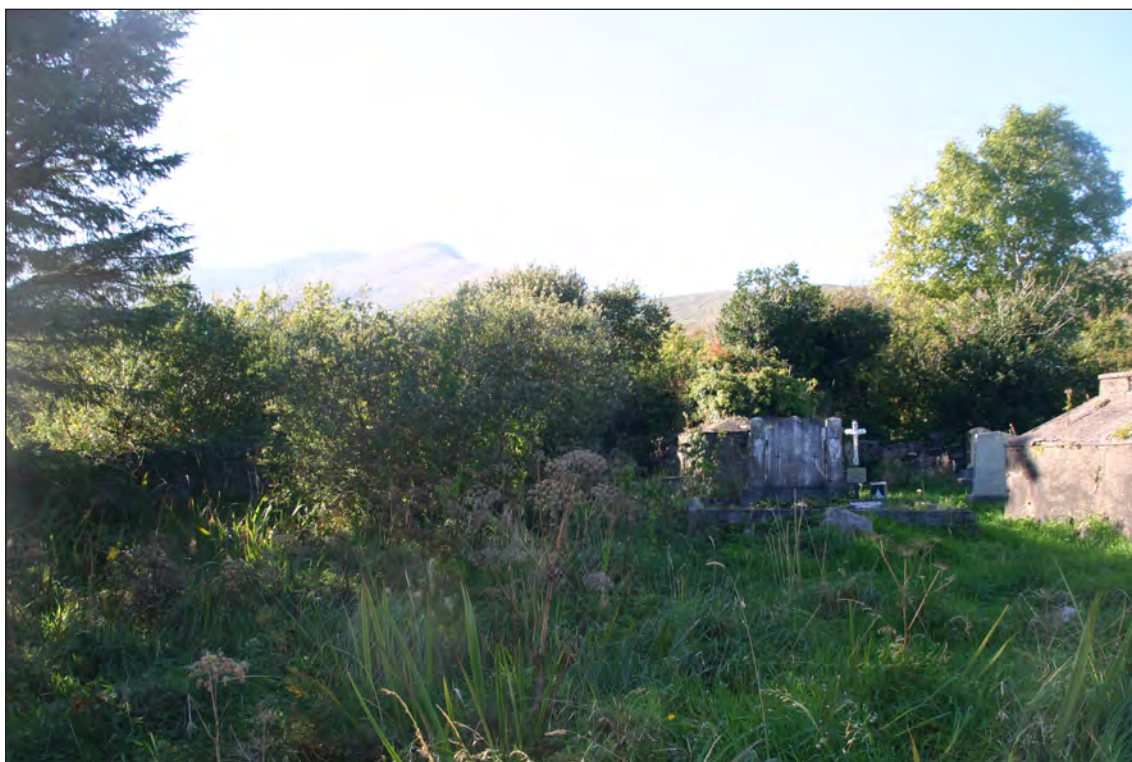
Plate 10: View of the overgrown wet area of the southern limits of the late 19th century section of Cloghane Graveyard from east

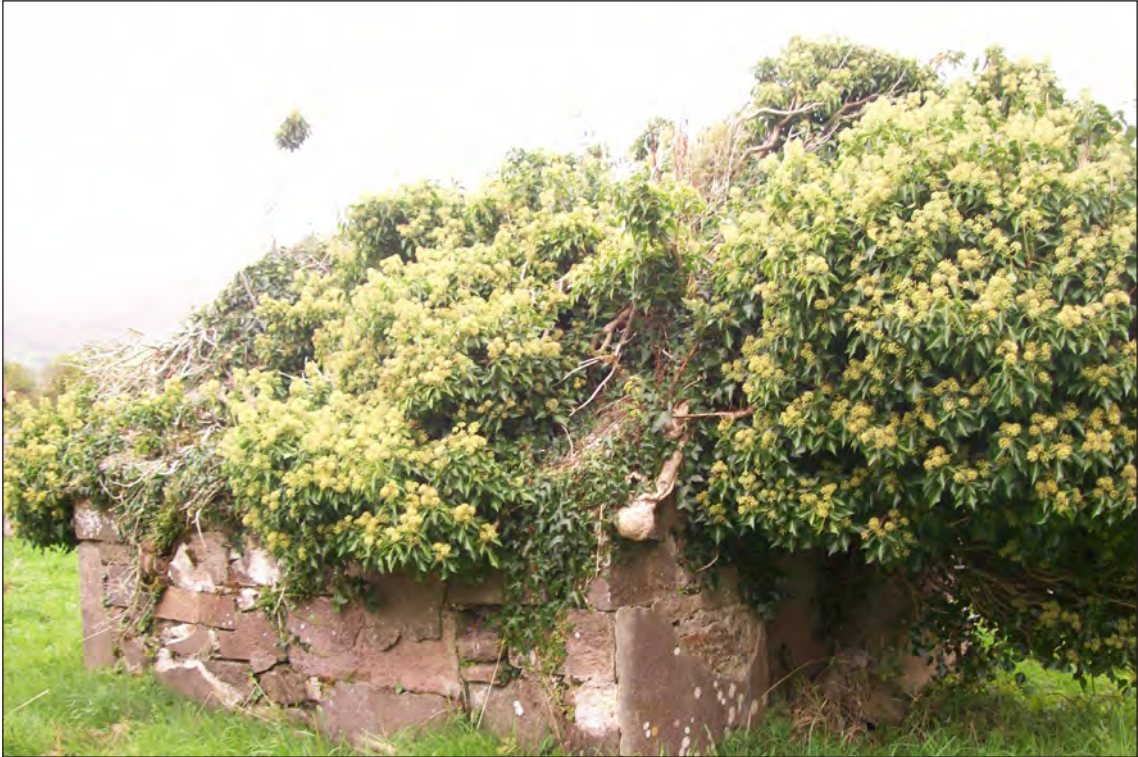
Plate 13: View of completely overgrown tomb (162) in Cloghane Graveyard

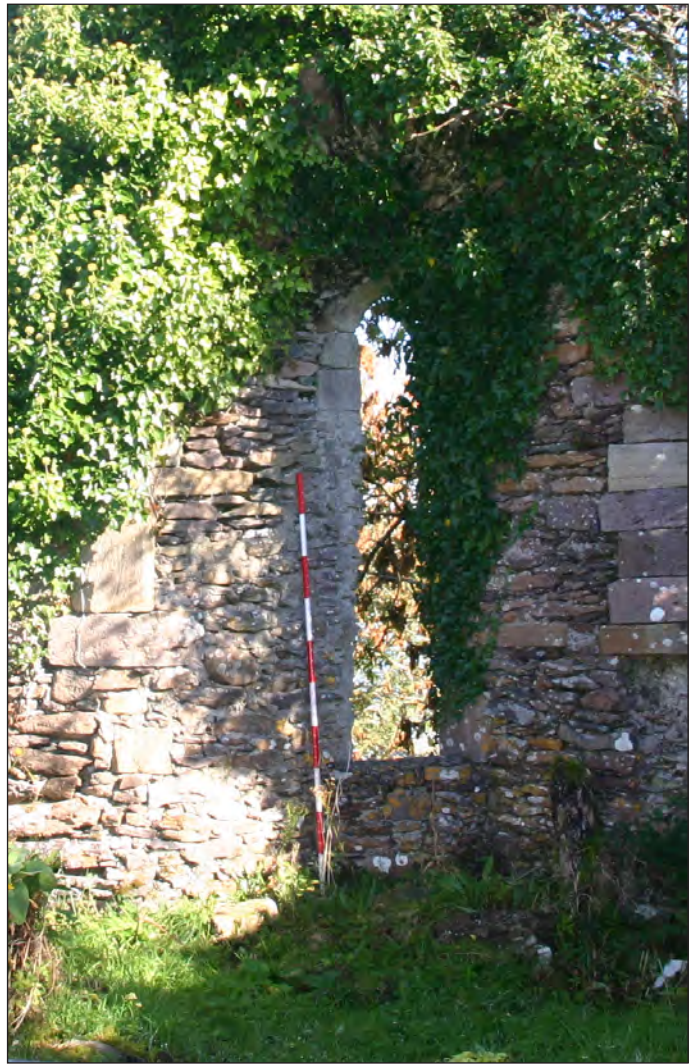
Plate 17: View of east window of 13th century church of Cloghane

The east gable is lit by a tall central round headed window, 2.8m high set within a widely splayed embrasure (Plate 17 & Figure 5). It slightly tapers in width from 0.36m at the top to 0.42m at the bottom. The majority of the dressed stone from the embrasure has been robbed out while other voussoir fragments lie partially hidden on the ground. Several of the cut-stones of the light have also gone and replaced by modern poor cement work. Several of the narrow 'V' profile side-stones of the window have window-bar sockets to receive the metal rods that would have supported the glass. The uppermost section of the embrasure has severely cracked and partially separated and immanently about to collapse and is possibly only being retained by the ivy growth.

The ivy, trees and other growth should be cut back short and a costed conservation assessment of the building undertaken. The remaining vegetation should then be judiciously fully removed and the walls and openings should be repaired and re-pointed. The collapsed medieval masonry in the interior should be collected, recorded and stored in the Kerry County Museum and re-used during any future conservation works at the church. The grass in the interior of the church should be cut low with non-bladed strimmers. Open or partially open graves should be repaired and the interior levelled off. No burials should take place in the inside or against the exterior of the church.

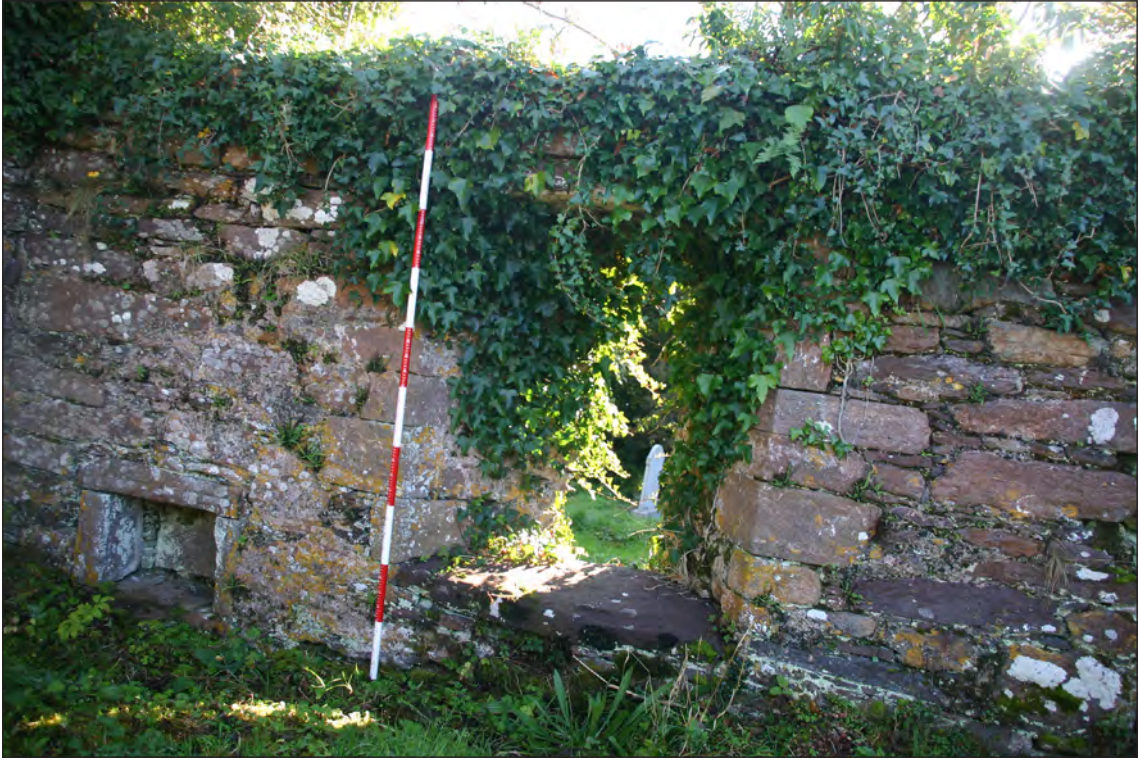
The south elevation survives to a height of 2.1m. It is lit by a single window 1.9m from the SE corner. The flat lintelled window is 1.22m wide and 1.37m high and has a widely splayed embrasure (Plate 19). Between the window and the SE corner is a piscina set within a rectangular recess, 0.8m x 0.66m, that has a nice roll moulding around its outer edge. The damaged piscina bowl projects slightly from the recess while a clearly visible curving water channel leads into its drain plug (Plate 20).

Plate 19: Interior view of south window embrasure. Note piscina on left

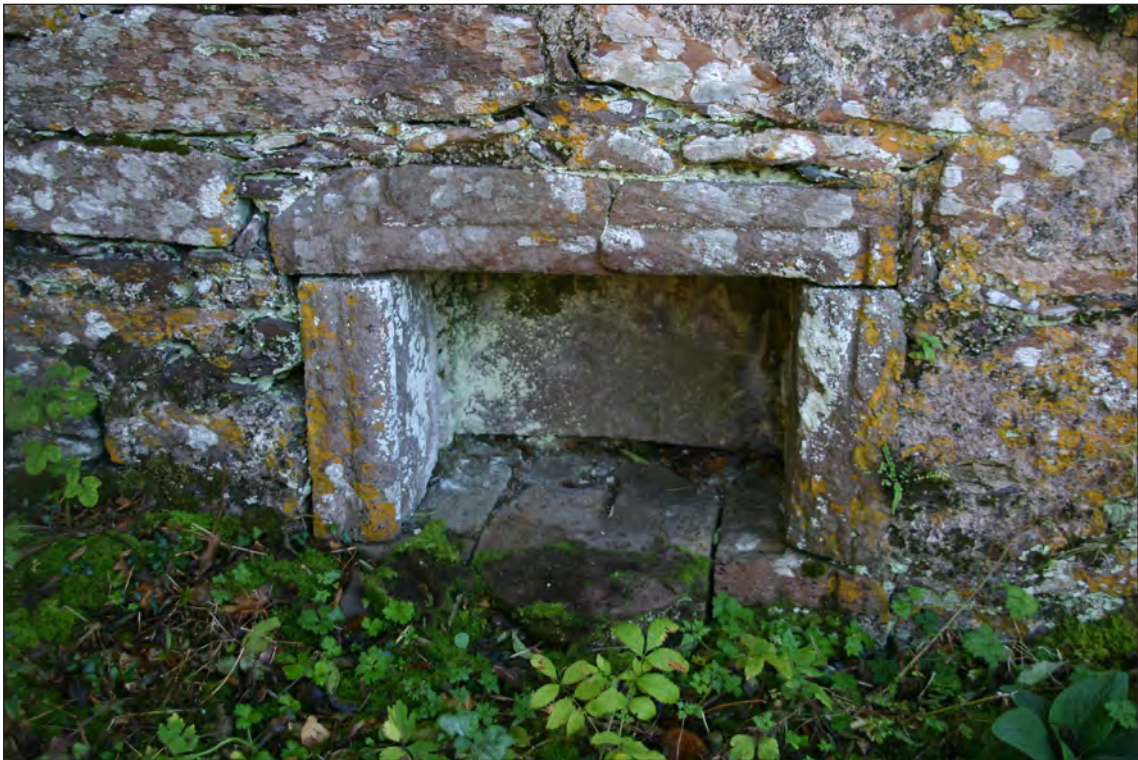
Plate 20: View of piscina in eastern end of south elevation

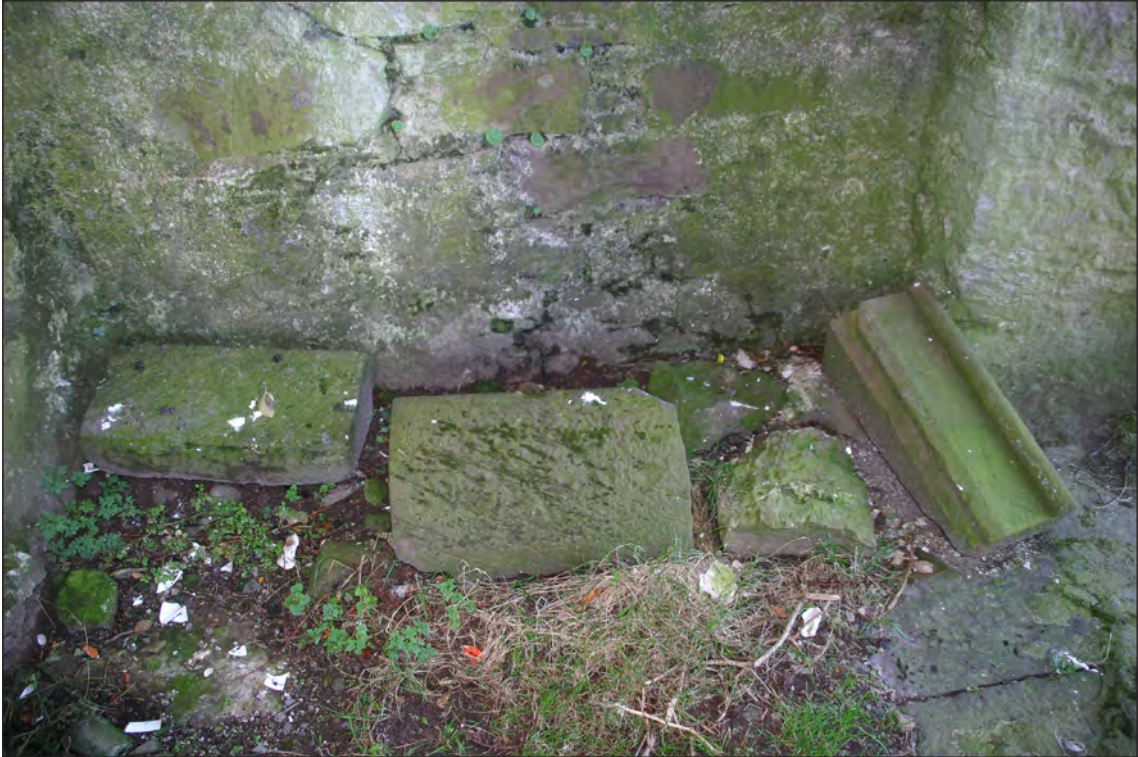
Plate 23: View of architectural fragments in tower-space of ruined Church of Ireland

The trees and ivy adhering to the interior of the structure should be removed. All architectural fragments should be gathered up and placed in safe storage for possible future repairs or conservation work to the church. The plaque commemorating the drowned Port Yarrock sailors should be replaced with a more long lasting one.

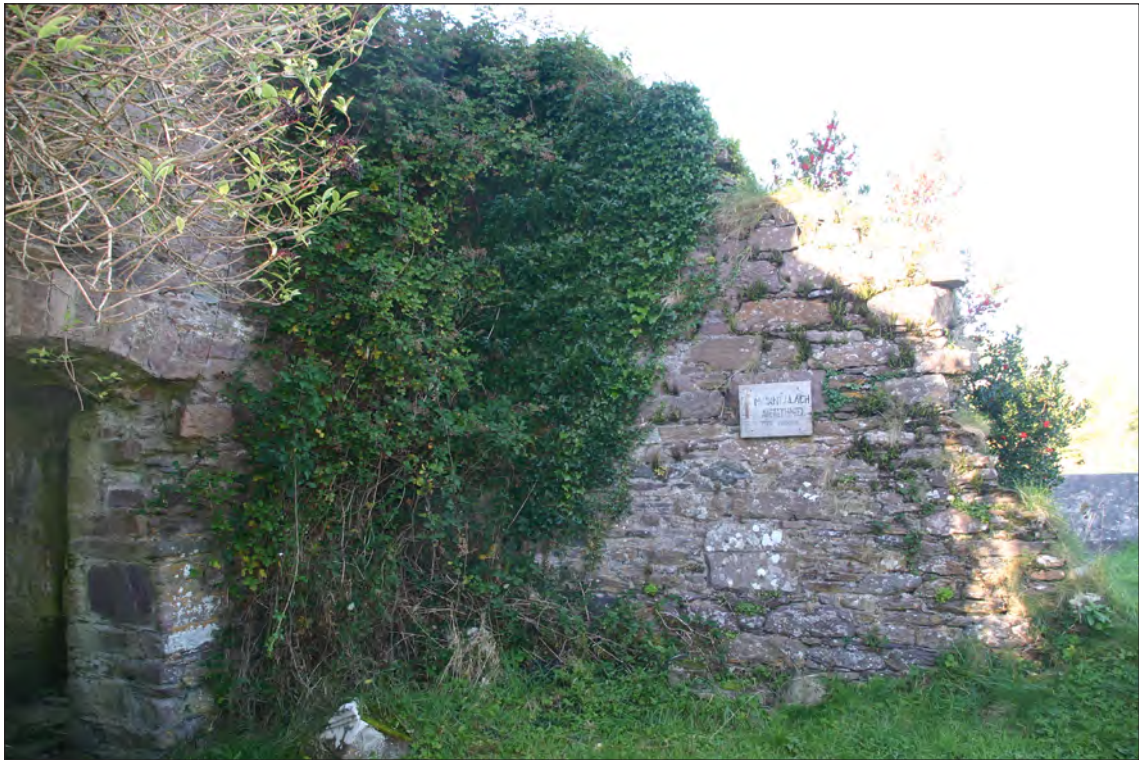
A worn and weathered wooden plaque (748) is situated on the north elevation commemorating the interment of drowned sailors from the ill-fated barque the Port Yarrock

Plate 25: View of interior of ruined Church of Ireland at Cloghane from SE. Note plaque commemorating Port Yarrock shipwreck victims

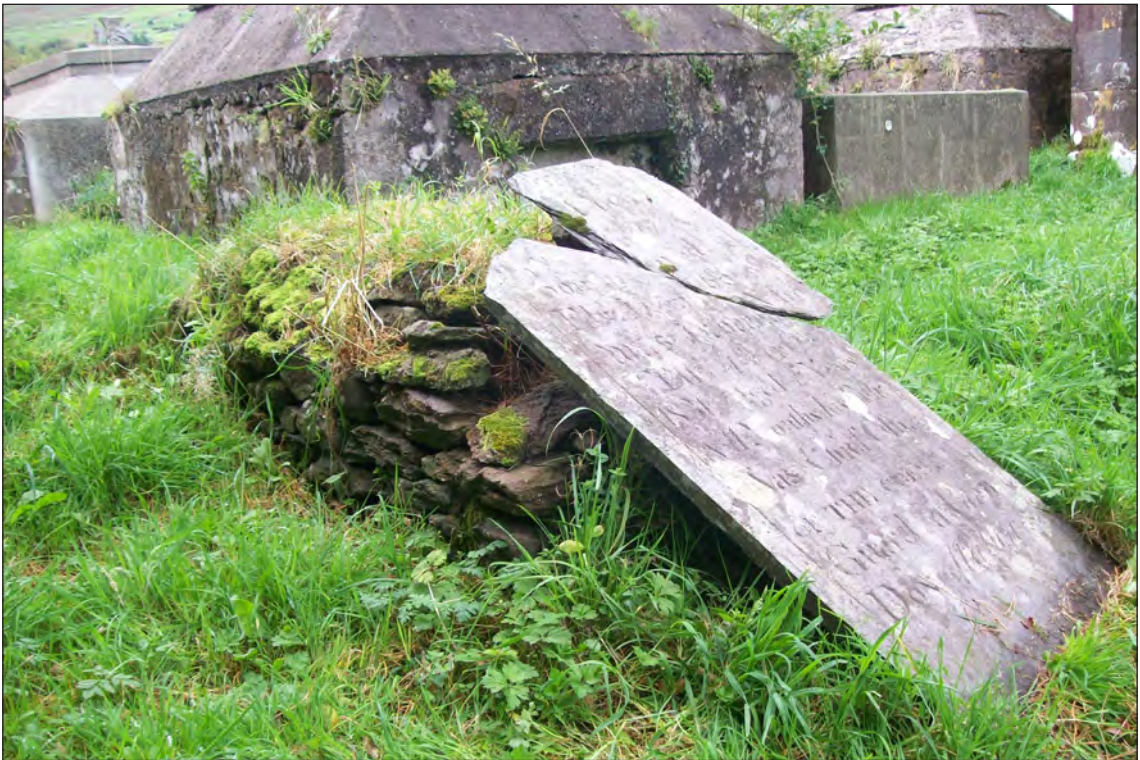
One particularly poignant tomb (727) records the drowning of a youth in 1831. The tomb is partially collapsed and its rectangular memorial flag has slipped and a large portion broken off. The memorial inscription is damaged and reads in serif letters: *...Memory... Son of Eliz Dyer who was drowned The 4th of Oct 1831 aged 15 years & 11 months his father Was Chief Officer Of the Coast Guard at Bran - Don station* (Plates 36-37). Thomas Dyer was the Chief Coast Guard Officer in Brandon and an references of him are to be found in the Reports from the Commissioners into the fishing industry in the Brandon area in 1836, five years after the drowning of his son.

Plate 36: View of broken and slipped of Dyer tomb slab (727)in Cloghane Graveyard

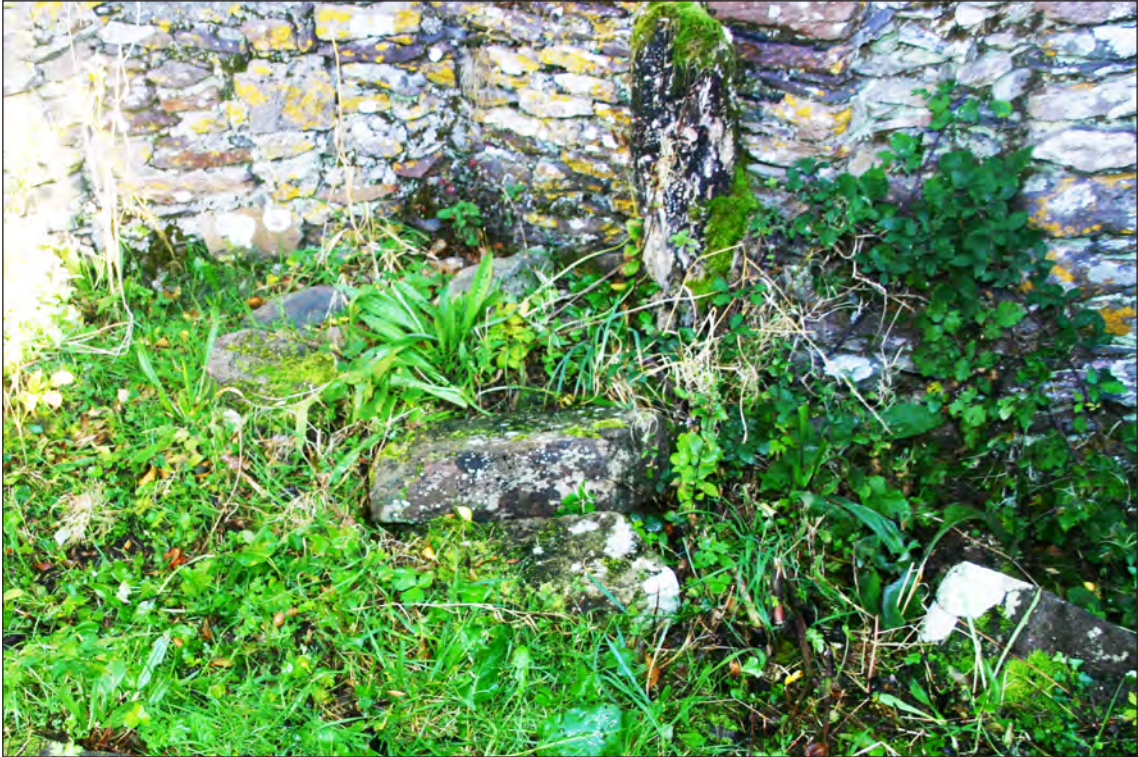
There are at least three medieval architectural fragments lying loose on the grassy ground in front of the E window of the medieval church (Plate 39). These cut and dressed stones are from the RH side of the window embrasure (Plate 40). Other possible fragments from the E window lie concealed in the grass. No effort was made to try and remove the architectural fragments as it was deemed likely that others lay beneath and this would constitute licensed archaeological work. Furthermore, the arch of the window is fractured and bulging and in a very poor state. It is immanently about to collapse which will bring down the gable as well.

Plate 39: View of collapsed medieval architectural fragments from east window embrasure of 13th century church in Cloghane

The collapsed loose *ex situ* medieval architectural fragments should be collected and removed to the Kerry County Museum for temporary safe keeping, storage and individual recording. They should be replaced during any future repairs or conservation work to the E window.

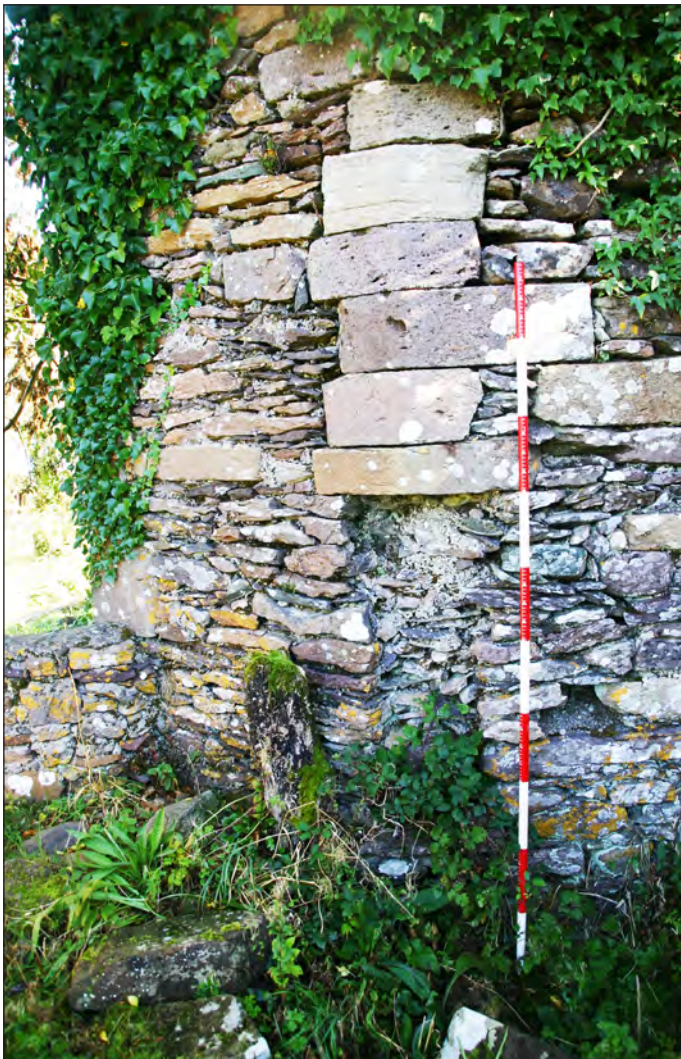
Plate 40: View of collapsing or partially robbed out south angle of embrasure of east window in the medieval church in Cloghane
