Archaeological Survey,  
Cummer Graveyard,  
Ahane,  
Glencar,  
Co. Kerry.

October 2008

Client: The Heritage Office,  
Kerry County Council,  
County Buildings,  
Ratass,  
Tralee,  
Co. Kerry.

RMP No.: KE064-014

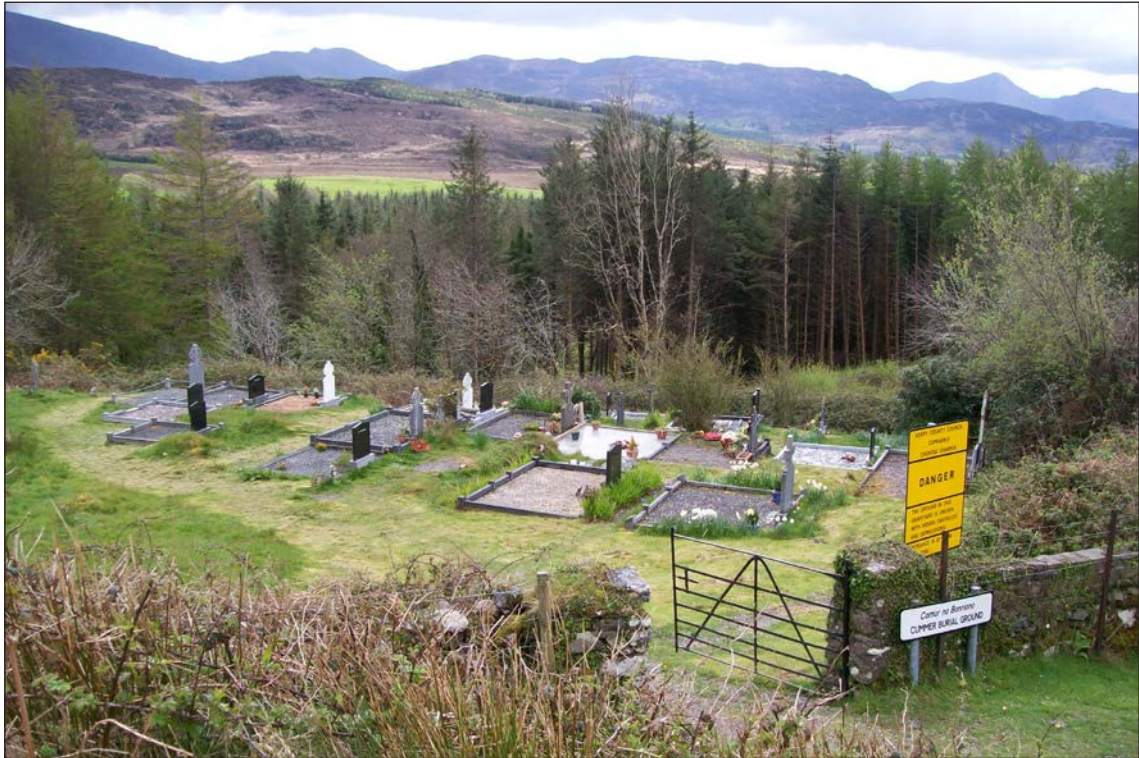
Sited close to Lough Caragh, the graveyard is positioned south of a third class road and gently slopes from north to south while the ground surface is irregular and undulating in places (Plate 1).

A steep grassed over gravel path extends south, southwest-wards and southeast-wards from immediately inside the entrance gate (Plate 1).

Plate 1: View of Cummer graveyard, from north

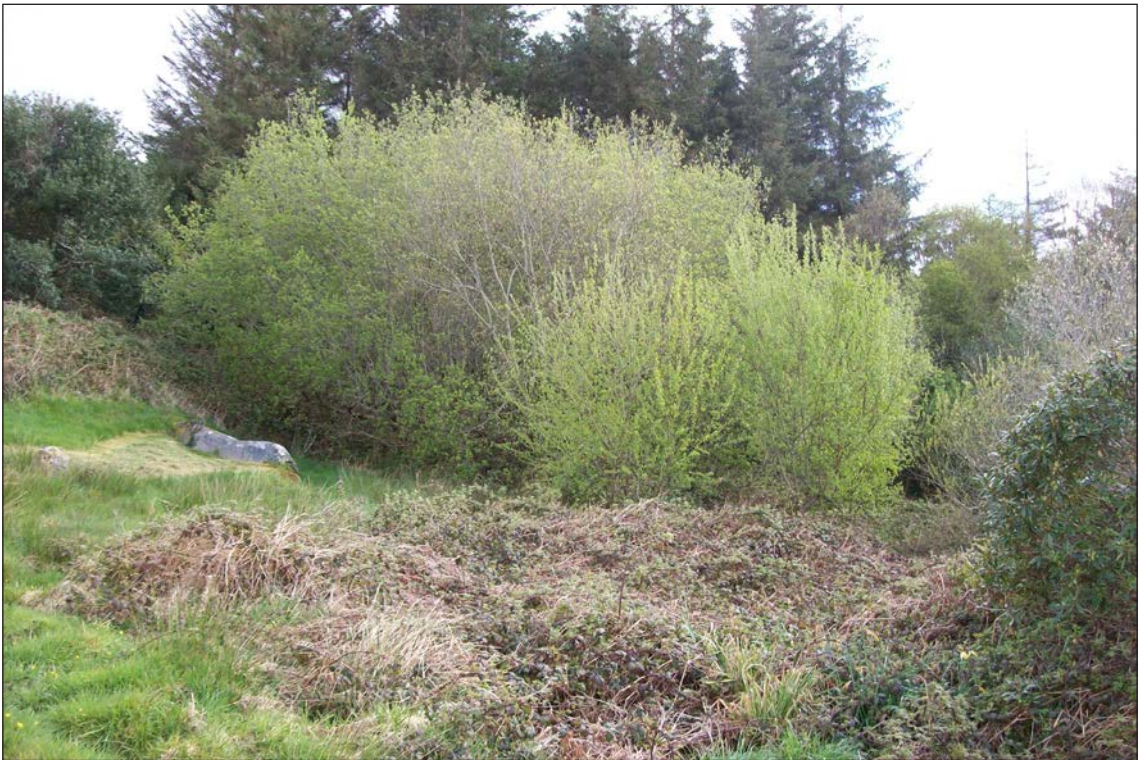
The boundaries in general are in a poor state of repair. The best preserved section is in the immediate vicinity of the entrance gate where the drystone construction of local sandstone is apparent. The remainder of the boundaries are extremely overgrown with brambles and trees, with the southern and eastern boundaries in particular being almost inaccessible (Plate 2). The western boundary is mature hedgerow and earthen bank which is not in such an overgrown state as the rest of the enclosure. Some small-scale dumping of waste has taken place near the eastern boundary (Plate 3).

Plate 2: View of eastern boundary, from south

The overgrowth of brambles on all boundaries but especially the northern, eastern and southern boundaries should be cut back.

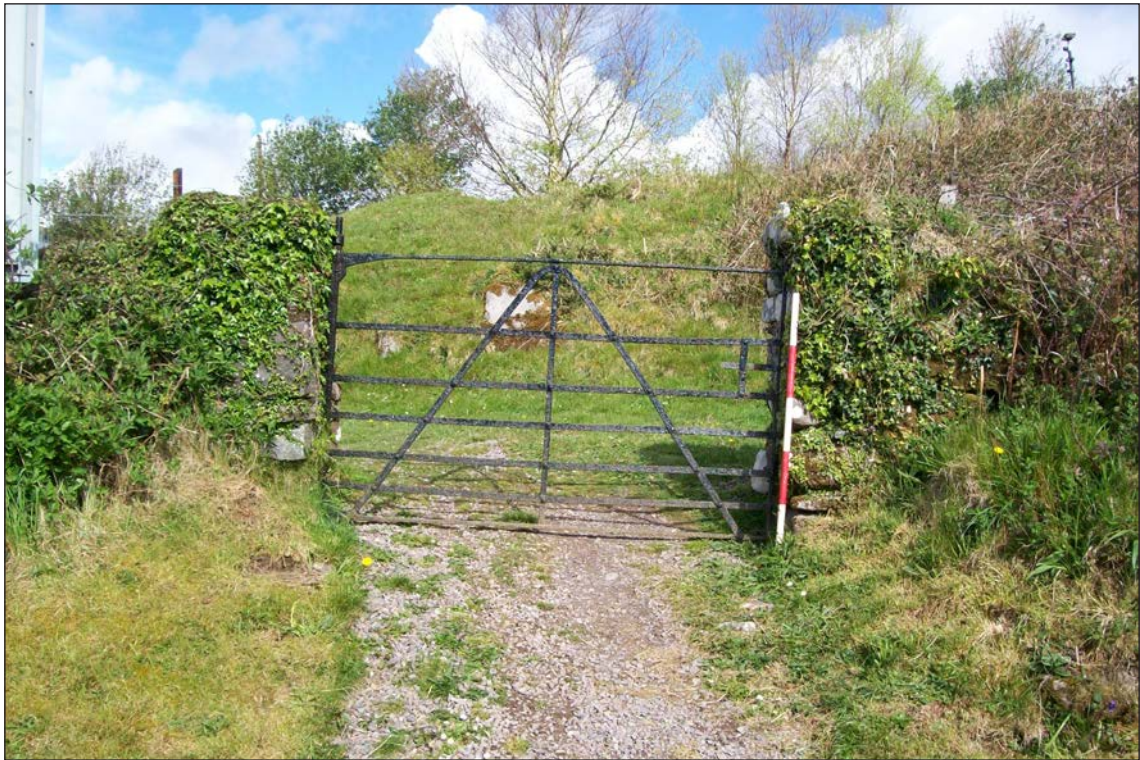
The entrance is located towards the northwestern end of the northern boundary wall (Plates 1 & 3).

The locally forged gate is set between two squat square sandstone piers which are in a good state of repair.

**Plate 3: Interior view of entrance, from south**

The interior immediately inside the entrance gate should be stepped or graded to provide safer access/egress for visitors, especially for the elderly. A handrail would also be a suitable addition.

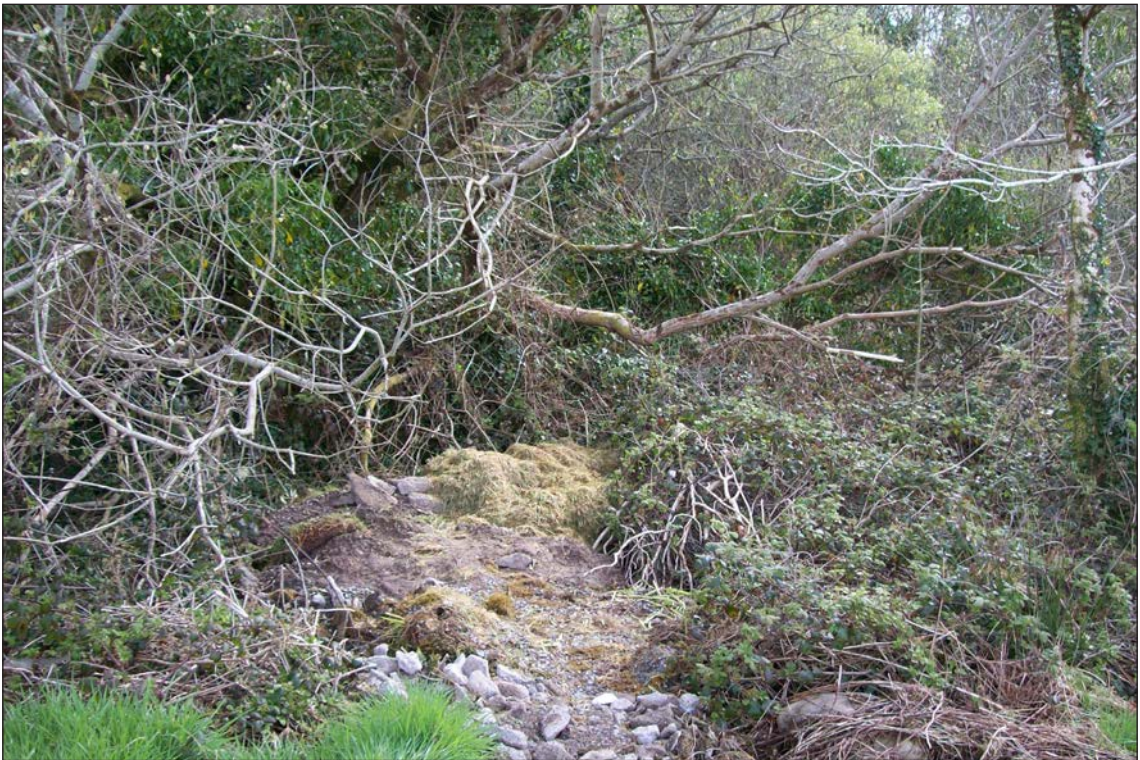
**Plate 4: View of dumping from recent grave-digging along eastern boundary, from west**

Refuse facilities should be provided for the graveyard.

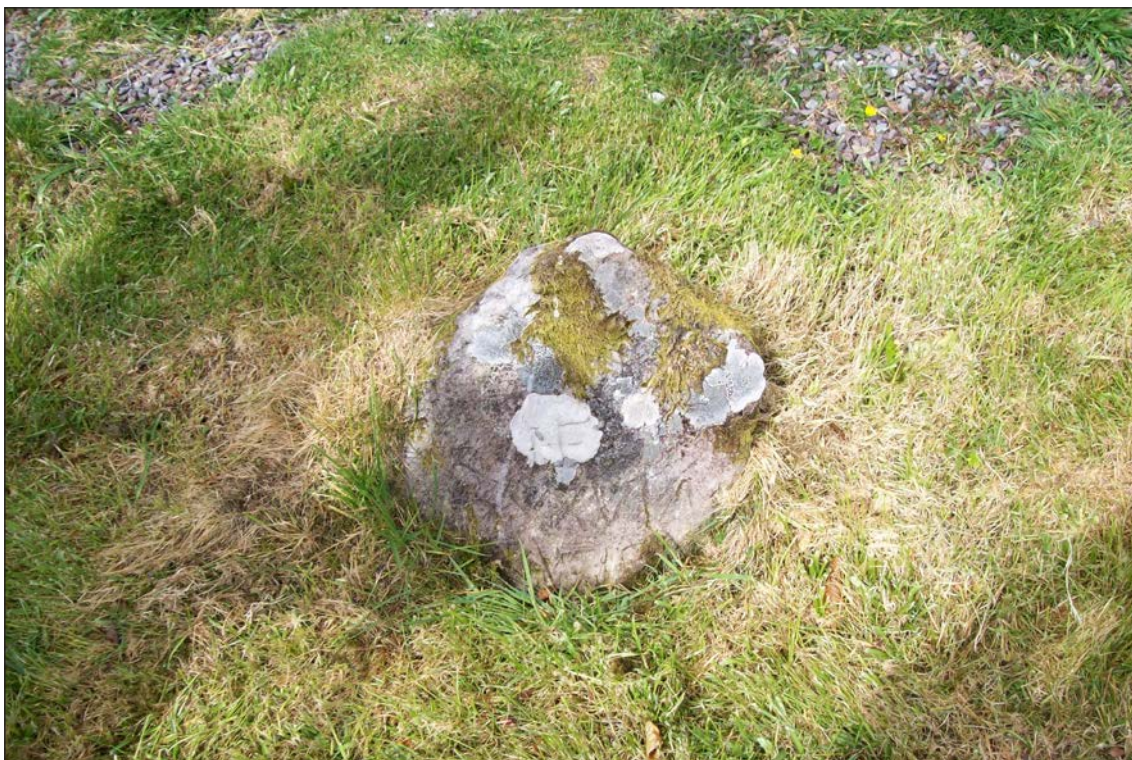
no. 8 & 9), with the former inscribed with 'BXXWM 1719' and the latter with 'A.S. 1796(?)' (Plates 5 & 6, respectively). The third stone dates from 1819 (ref. no. 2) and was inscribed with letters which made no obvious sense; 'HLRCDE 1819' (Plate 7).

Plate 5: View of inscribed stone dating from 1719, ref. no. 8, from east

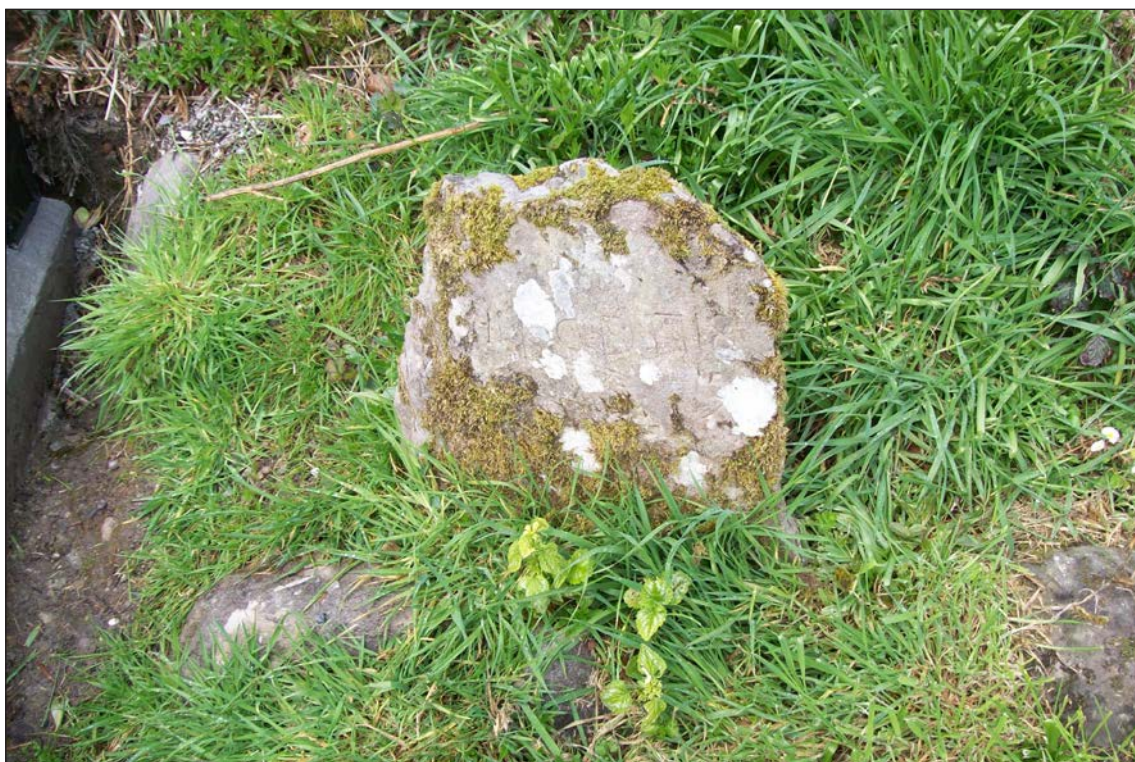
Plate 6: View of inscribed stone dating from 1796, ref. no. 9, from southeast

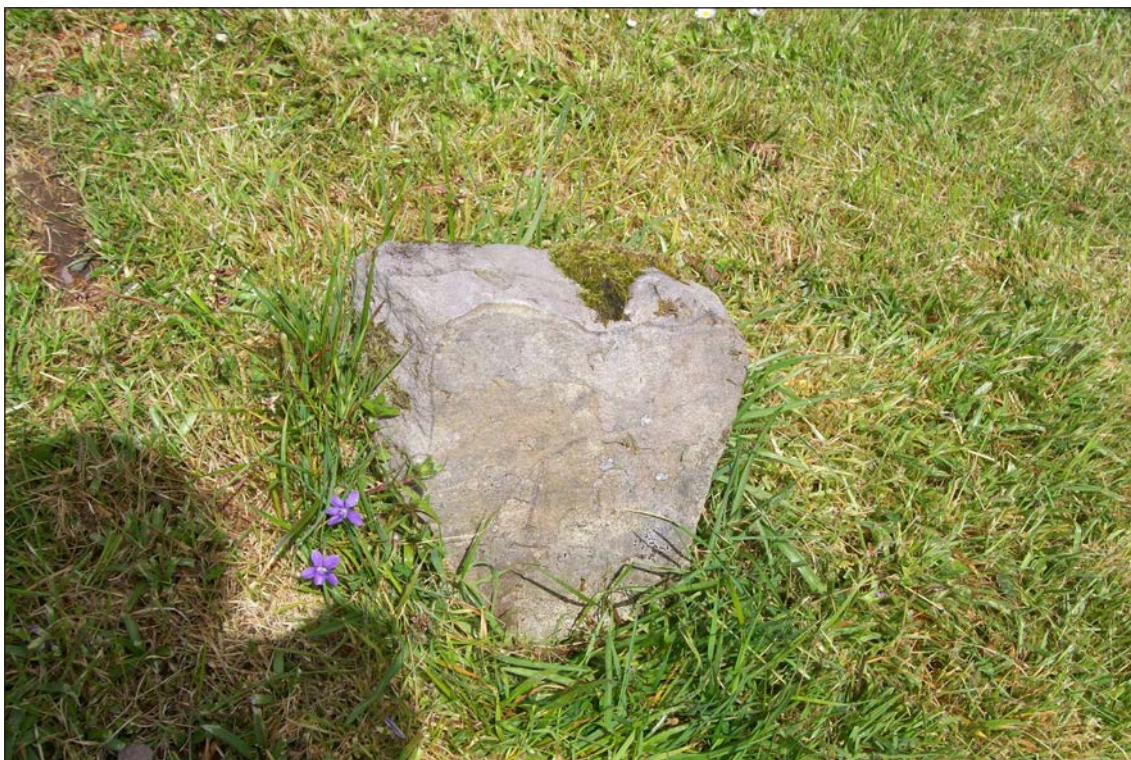
Plate 7: View of inscribed stone dating from 1819, ref. no. 2, from east

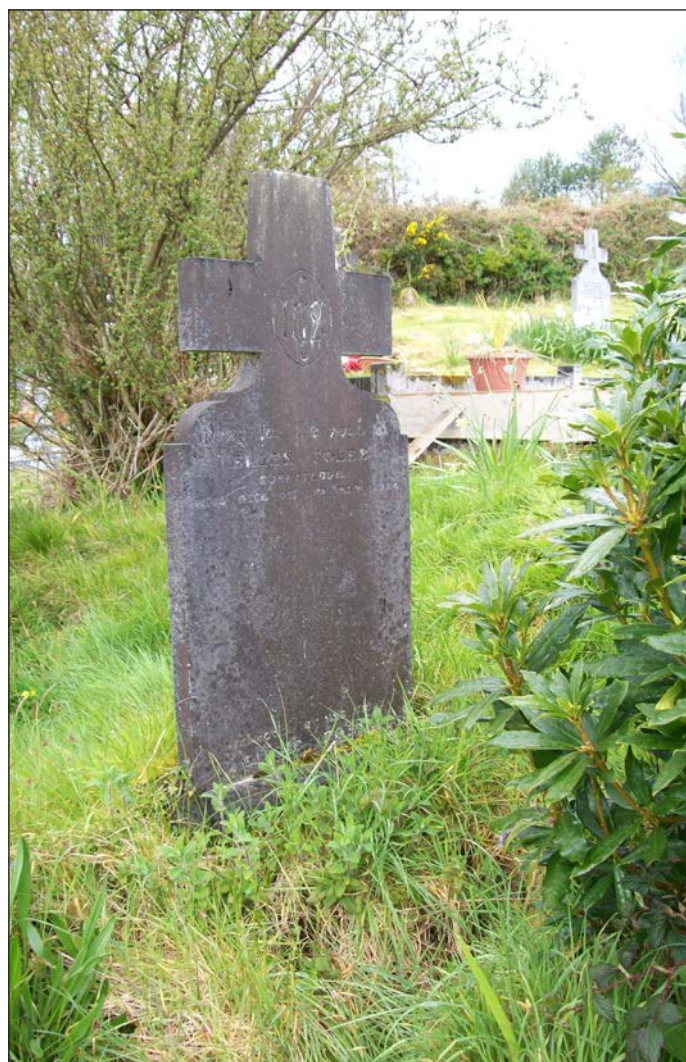
One named headstone, Foley, (ref. no. 42), is becoming overgrown by shrubs and planting by the grave plot and the railing which formalises the plot is sunken and obscured by this overgrowth (Plate 8).

Plate 8: View of Foley headstone (ref. no. 42) which has a sunken and overgrown railing from south

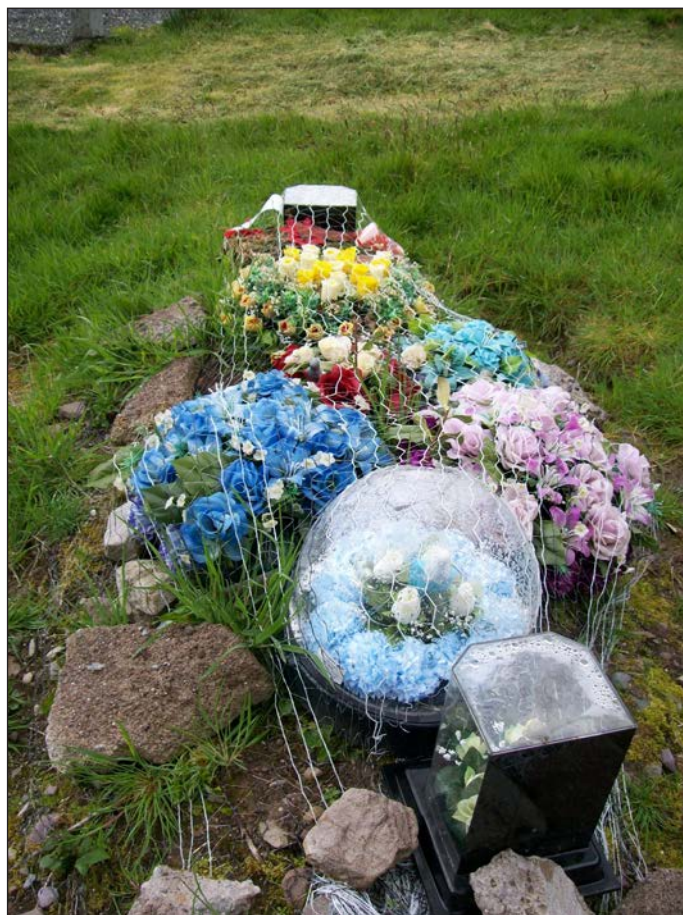
1 unnamed grave (ref. no. 110) was recorded within the graveyard (Plate 9).

This was a recently dug grave for which no temporary plaque was established at the time of the survey.

**Plate 9: View of recent unnamed grave (ref. 110) in southeast corner of graveyard, from east**

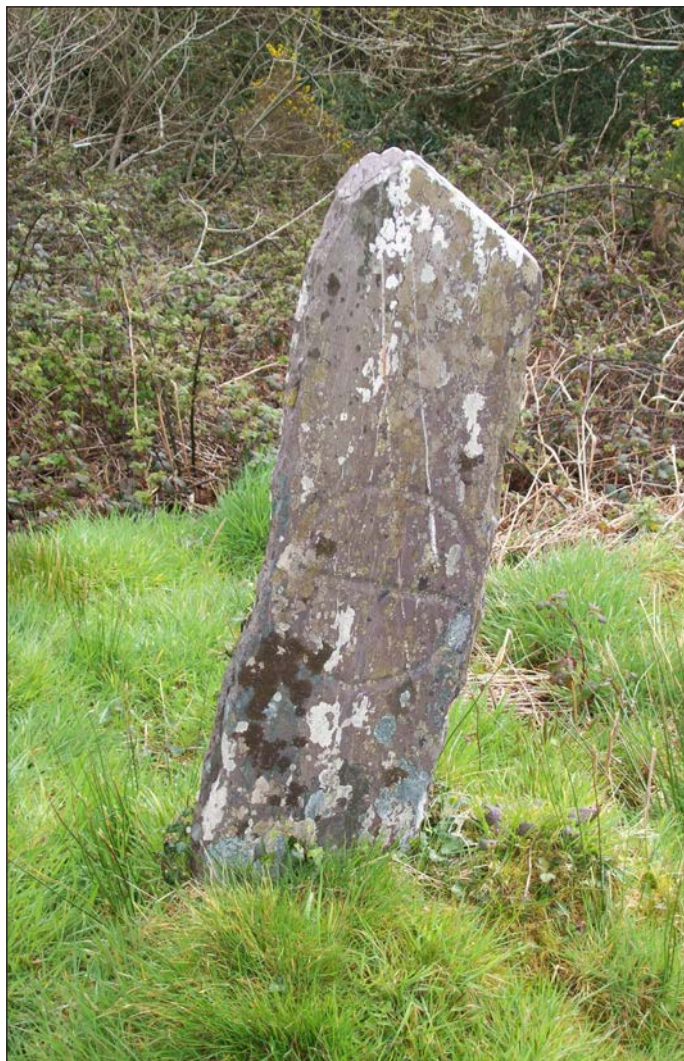
The cross slab (ref. no. 56) was recorded as part of the Iveragh Peninsula Archaeological Survey (ibid, 251 & 252): "*This slab is located in the site's SE quadrant and stands 1.2m high.*"

*It is orientated N-S, measures .36m x 1m at base and inclines slightly towards SE. On its W face is a large, encircled, linear cross. Its arms terminate just short of the circle, while its shaft extends beyond it and features a T-shaped terminal”.*

The cross slab today stands in the same location as recorded above and its inscribed cross is still easily visible (Plate 10).

**Plate 10: View of Cross Slab, KE064-014:03, from west**

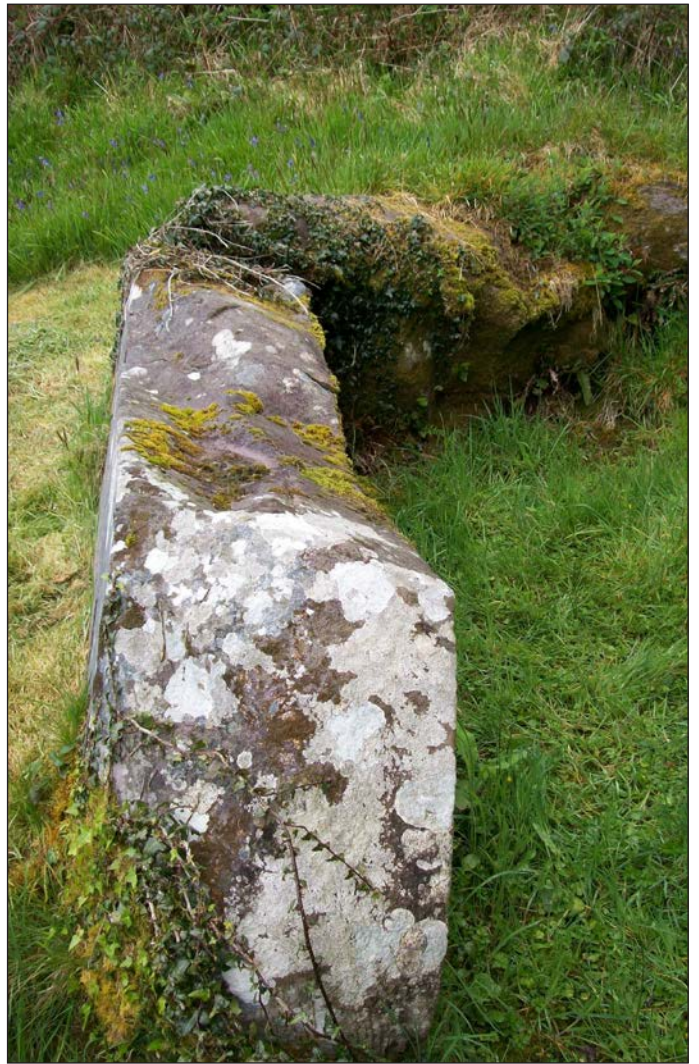
The mass rock today is largely unchanged since being recorded above (Plates 11 & 12). However, the *irregularly shaped stone* described above is no longer present and a search of the graveyard proved fruitless. A chance encounter with the ex-caretaker, Dan Foley, while on site provided a little information as to its disappearance, largely that it vanished over night several years ago and has not been seen since.

**Plate 11: View of Mass Rock, KE064-014:04, from south**

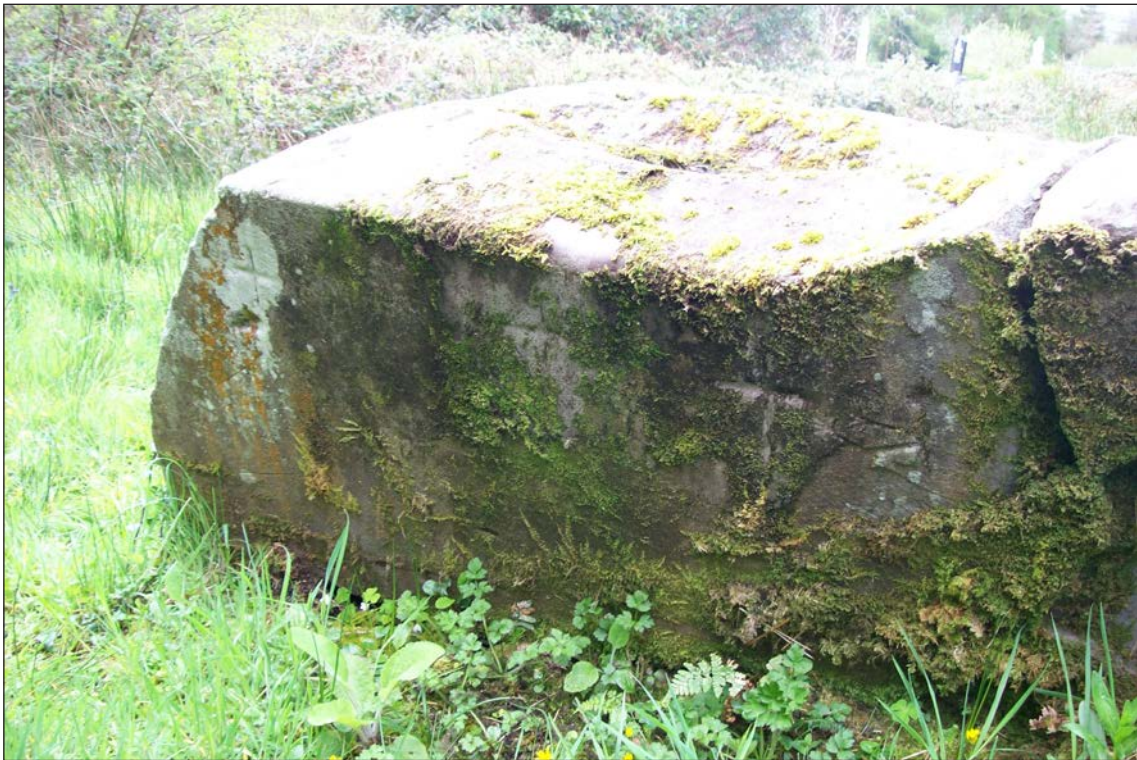
**Plate 12: View of Mass Rock, KE064-014:04, from northeast**
