Archaeological Survey, Curra Graveyard, Glenbeigh, Co. Kerry.

October 2008

RMP No.: KE063-008

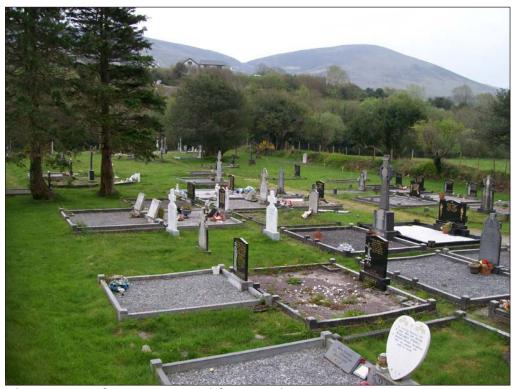
Plate 1: View of Curra graveyard from northeast

Curra graveyard is located in the townland of Curra, located less than 1km southwest of Glenbeigh village (Figure 2, Plate 1).

The graveyard is positioned south of a third class road and gently slopes from north to south.

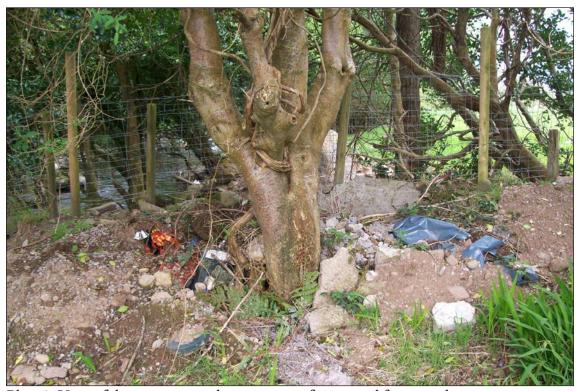
Plate 2: View of dumping in southwest corner of graveyard from southeast

There are no formal refuse facilities for the graveyard and consequently there are two areas of dumping; one in the extreme southwest corner (Plate 2) and the other immediately to the west inside the entrance gate.

Formal refuse facilities should be provided as soon as possible.

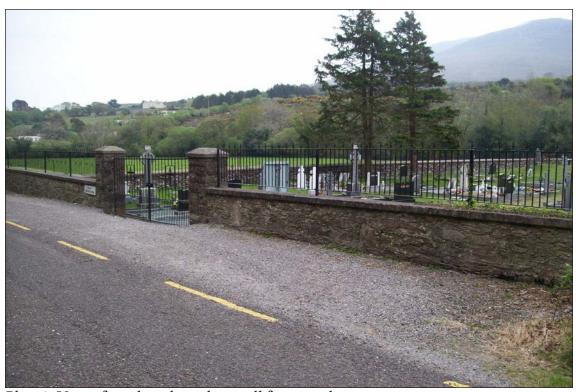
Plate 3: View of northern boundary wall from northwest

The northern boundary comprises a modern rubble sandstone wall mortared with cement with concrete capping atop which is a modern cast iron railing, and the boundary contains a centrally disposed entrance (Plate 3). The wall has a maximum exterior height of 0.75m and an interior height of 1.58m, and a width of 0.65m. The eastern boundary is a drystone rubble sandstone wall with concrete capping atop which is a sheep wire fence. This wall measures 1m in height and 0.7m in width.

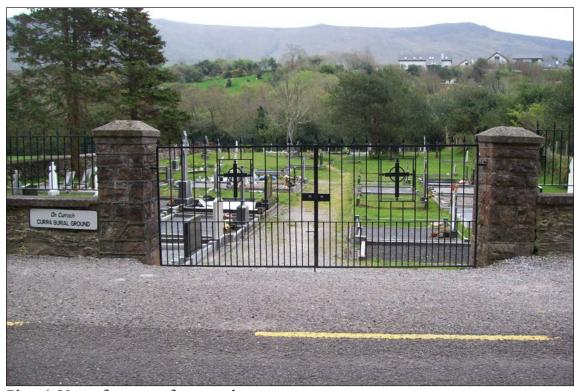
Plate 4: View of entrance from north

The entrance is centrally disposed in the northern boundary and comprises a modern castiron entrance gate, 4m in width, set between two rubble sandstone piers with forward pointing which have an exterior height of 1.8m and interior height of 2.2m, and are 0.6m in width (Plate 4).

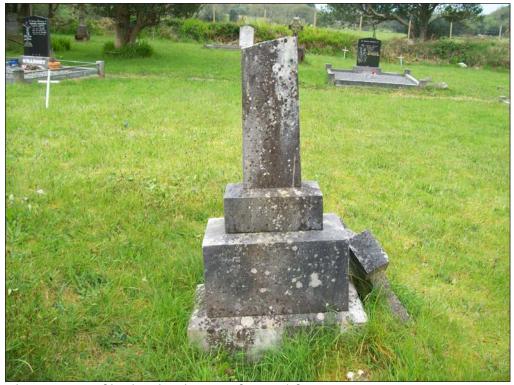
Plate 5: View of broken headstone ref. no. 94 from east

The headstone is broken for grave no. 94 (Plate 5).

The headstone for grave no. 94 should be repaired and made good.

This work may require Ministerial Consent.

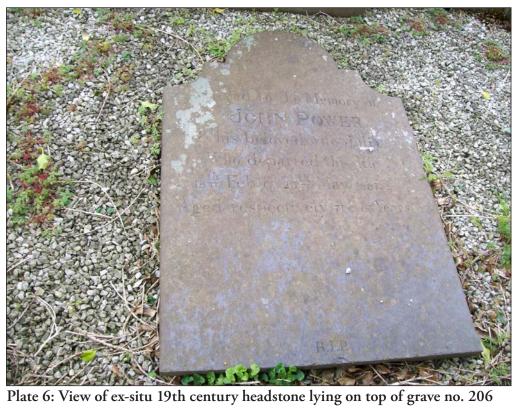
Two ex-situ 19th century headstones are lying on top of grave no. 206 with the uppermost headstone recording the deaths of John and Julia Power in 1867 (Plate 6).

The two *ex-situ* 19th century headstones lying on top of grave no. 206, should be removed from this grave and placed somewhere secure within the graveyard to prevent possible damage in the future.

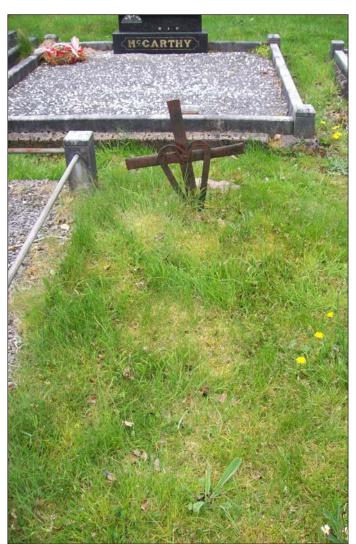
Plate 7: View of unnamed headstone (ref. no. 27) from east

1 unnamed headstone was recorded within the graveyard (Plate 7).

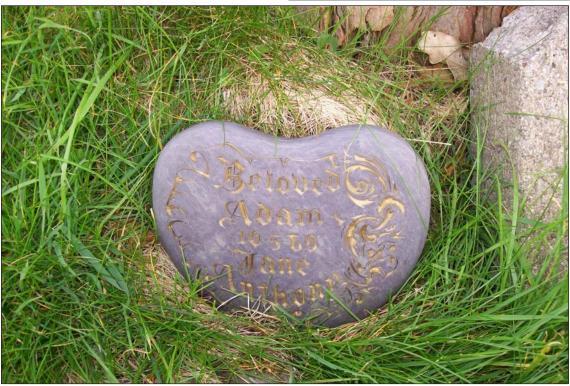
Plate 8: View of memorial plaque for a child's burial underneath an evergreen tree towards the eastern side of the graveyard, from south

A memorial plaque, possibly for the previous anonymous burials of three children, was recorded beneath one of the evergreen trees on the eastern side of the graveyard (Plate 8). Alternatively, it may record the death of the Adam commemorated by his parents Jane and

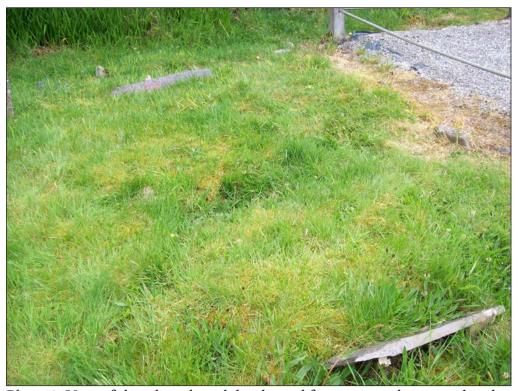
Plate 10: View of three burials with header and footer stones demarcated with slates painted with the name O' Shea, from north

The Iveragh Peninsula Survey (ibid) further recorded similar grave markers in the S portion of the graveyard but these appear to be of a more recent date. These are most likely the burials denoted with both a header and footer stone. Three such burials have been demarcated by two slates with one painted with the name O' Shea (Plate 10).

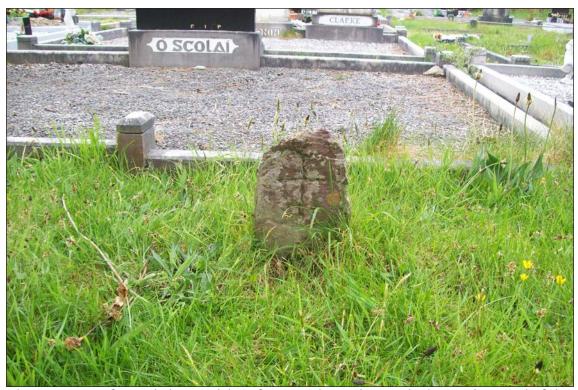
Plate 11: View of recorded cross slab (ref. no. 88) located towards the northern end of the graveyard

The Iveragh Peninsula Archaeological survey recorded the presence of a cross slab at the northern end of the burial ground bearing a plain Latin cross. This purple sandstone stone (ref. no. 88) measures 0.32m x 0.18m x 0.04m max (average) (Plate 11).

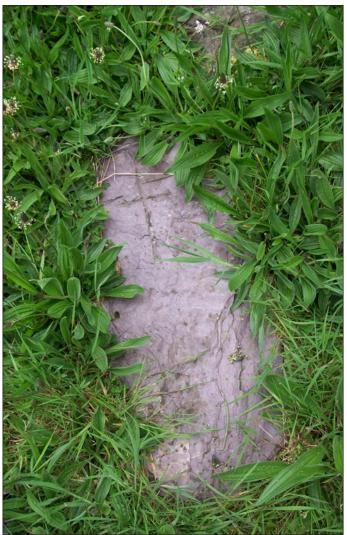
Plate 12: View of previously unrecorded cross slab (ref. 93) found along the eastern boundary wall from south

On the day of the survey, another cross slab (ref. no. 93) was recorded almost concealed and overgrown with grass lying face up along the eastern boundary (Plate 12). Its original location is not known. This previously unrecorded purple sandstone cross slab measures 0.62m x 0.28m x 0.04m (average). It bears a simple Latin cross in the same style as the cross slab recorded by The Iveragh Peninsula survey.

The previously unrecorded cross slab should be fixed in a secure position along the boundary wall as soon as possible to prevent possible future damage or indeed its possible theft from the graveyard.
