Archaeological Survey,
Dunquin Graveyard,
Dingle,
Co. Kerry.

October 2010

Client: The Heritage Office,
Kerry County Council,
County Buildings,
Ratass,
Tralee,
Co. Kerry.

RMP No: KE052-014 church and graveyard

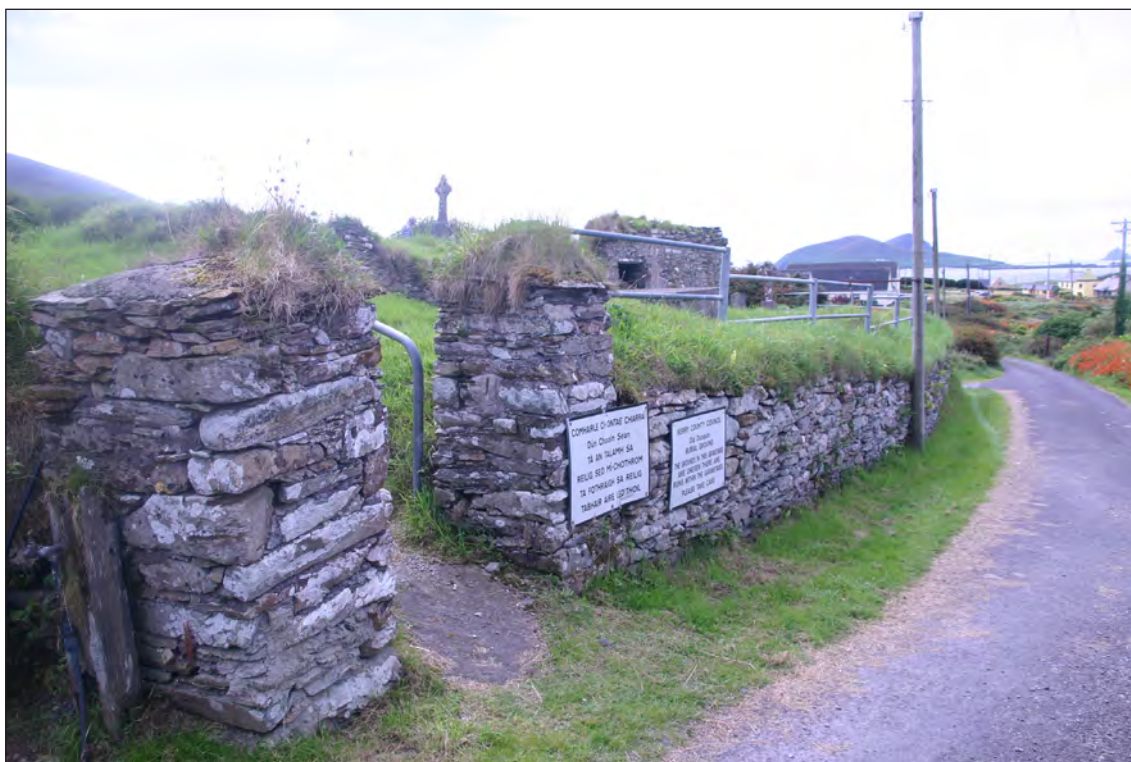
Plate 2: View of entrance to Dunquin Graveyard from NE

Dunquin Graveyard is raised above the laneway to the church that runs alongside its northern limits by 1.5m and *circa* 2m outside its western end (Plate 2). The graveyard is enclosed by a random rubble drystone wall of local sandstone. A modern galvanised metal railing protects visitors along the exposed and open northern and western limits of the graveyard. A small recessed parking / turning area is situated outside and below the western boundary of the graveyard delimited on its southern side by dense fuchsia (Plates 2 & 11). The eastern boundary of earth and some stone that separates the burial ground from the carpark between the modern church is completely covered in dense vegetation mostly of fuchsia and other hedging. The southern boundary which has a wide open drain running downslope beside, is similarly covered with dense vegetation. The graveyard along its shorter western limits rises to almost 2m over the exterior ground and is protected by dense vegetation that is largely gone wild and un-managed (Plate 12).

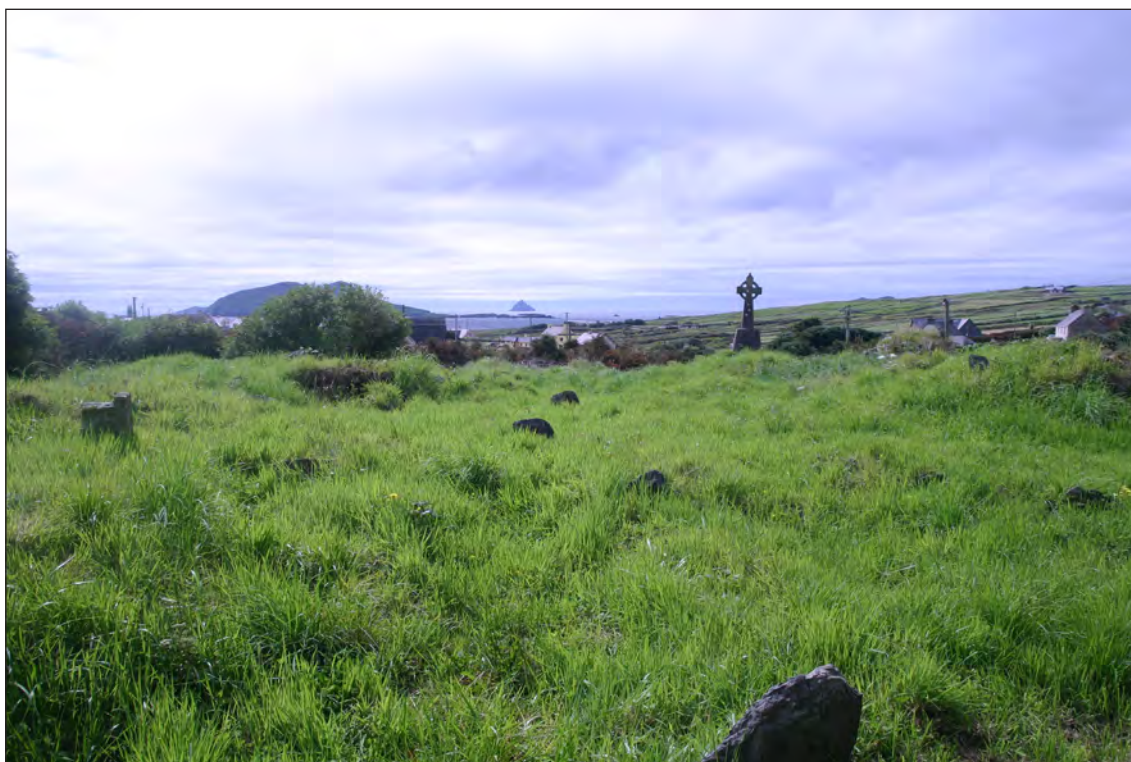
Plate 4: View of interior of graveyard from E

There were thirty-six unnamed headstones (HWN & Appendix 4) in total recorded in the course of this survey. All of the unnamed headstones are simple grave markers of unhewn local sandstone and are disposed around the graveyard (Plate 4 & Figure 5). Some of them mark a number of lintelled graves that are partially exposed on the surface especially around the remains of the ruined church and centre of the graveyard.

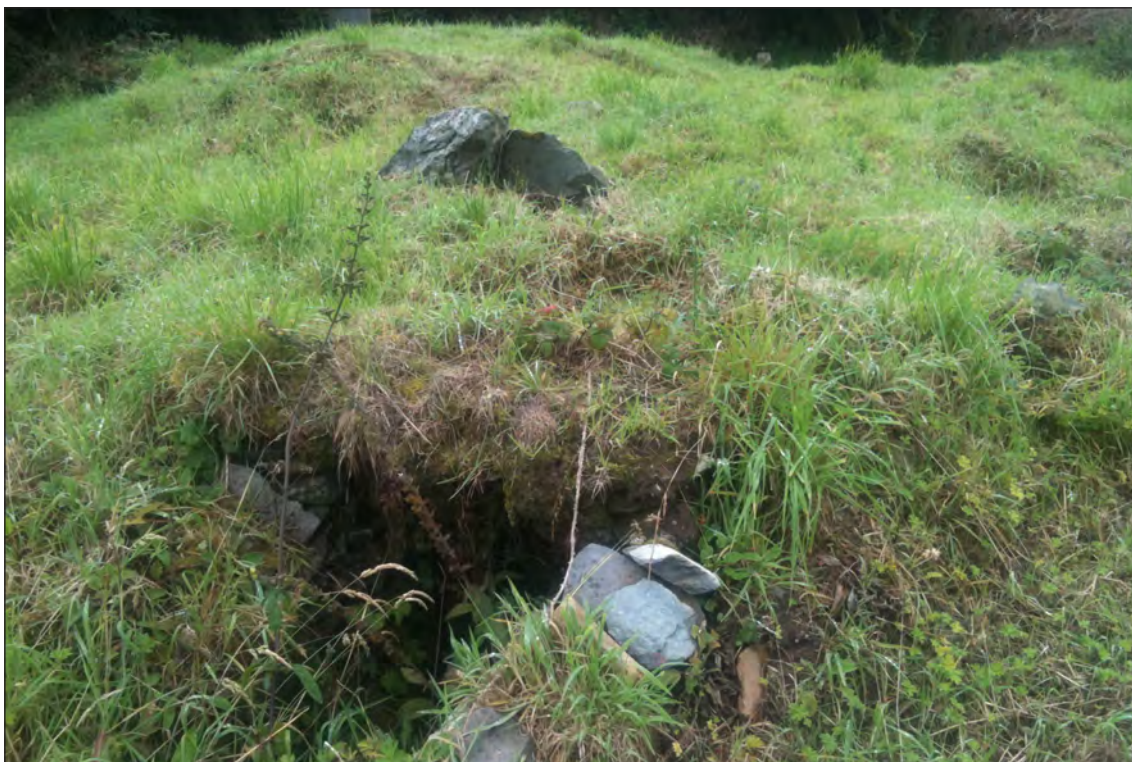
There are twelve grass covered unnamed lintelled type mounded graves dispersed around the interior of the graveyard (Appendix 4). Many of them are partially collapsed, open and dangerous (Plates 5 & 21 and Figure 5).

Plate 5: Close up view of partially collapsed lintelled grave

The exposed lintelled graves should be repaired properly under archaeological expert advice and supervision. The graves should then be covered with earth and re-sodded or re-seeded. The grass should be cut and kept low.

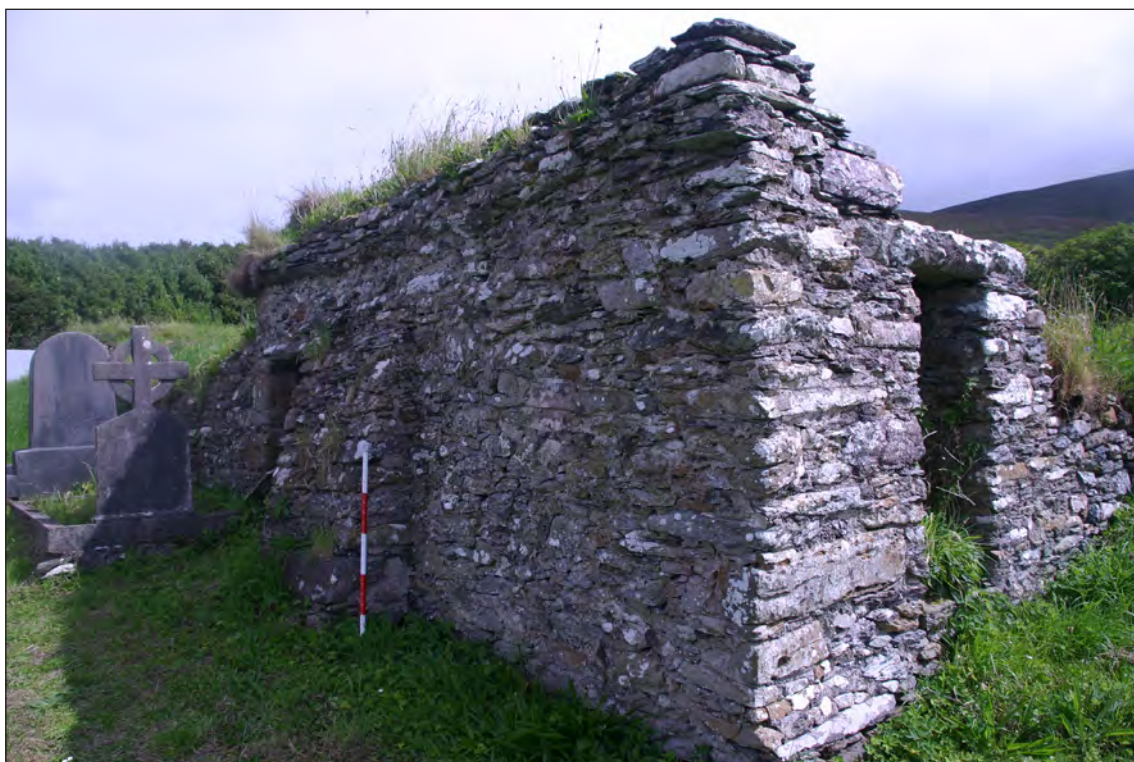
A substantial section of the north wall and part of the west gable of the medieval church survive (Plate 6) and see below).

The north elevation is pierced by a single doorway that is more or less entirely blocked up on the interior by burials. The 0.90m wide doorway is flat lintelled and 1.2m high and is supported by a wide buttress feature on its west side that was no doubt added to support the surviving wall from the outward weight of the much higher interior (Plate 6).

Plate 6: View of NW limits of ruined medieval church of Dunquin from W

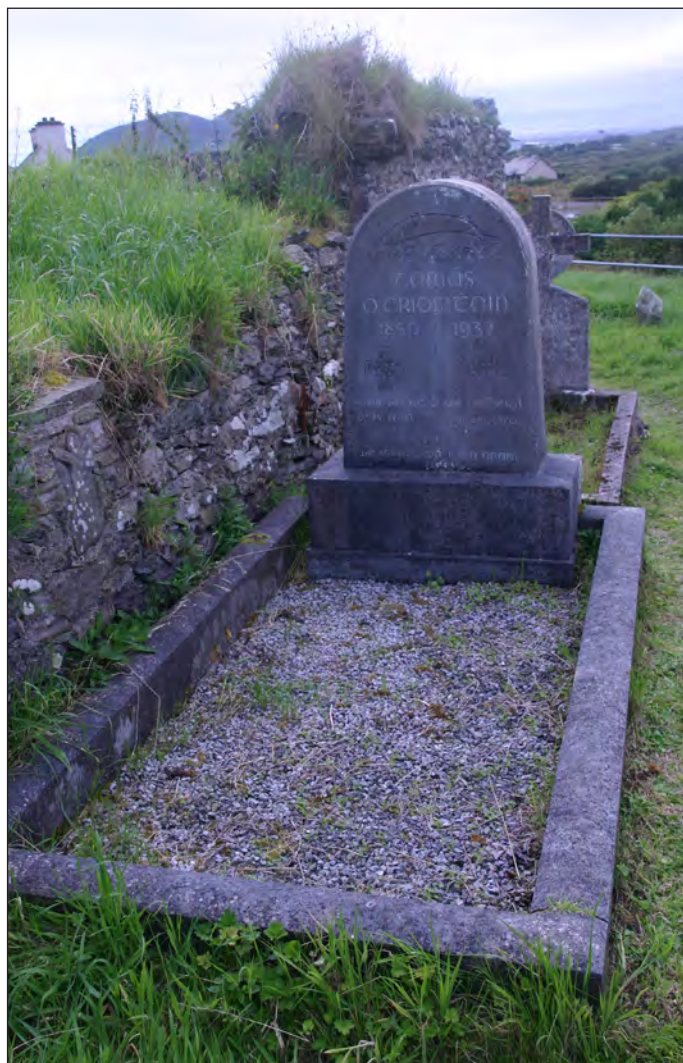
Plate 7: View of Tomás Ó Criomhthain's grave in Dunquin Graveyard

Of wider cultural interest is that Dunquin graveyard was also the traditional burial ground for many of the Blasket Islanders including the writer Tomás Ó Criomhthain who died in 1937, (176, Figure 5 & Plate 7). However, Peig Sayers, who lived in the nearby townland of Vicarstown after she along with the other islanders were evacuated in 1953, is buried in the new Dunquin cemetery at Ballyickeen 2km to the south. Peig Sayers died in 1958. The maritime life and fishing context of the islanders is reflected on the headstone of Tomás Ó Criomhthain (176) by wonderful decoration depicting four islanders with their backs bent rowing their naomhóg while a leaping fish is carved above his name (Plates 8 & 9). Another headstone, (175), marking the grave of Máirtín Ó Catháin also has a naomhóg on it (Plate 10) & Figure 5).

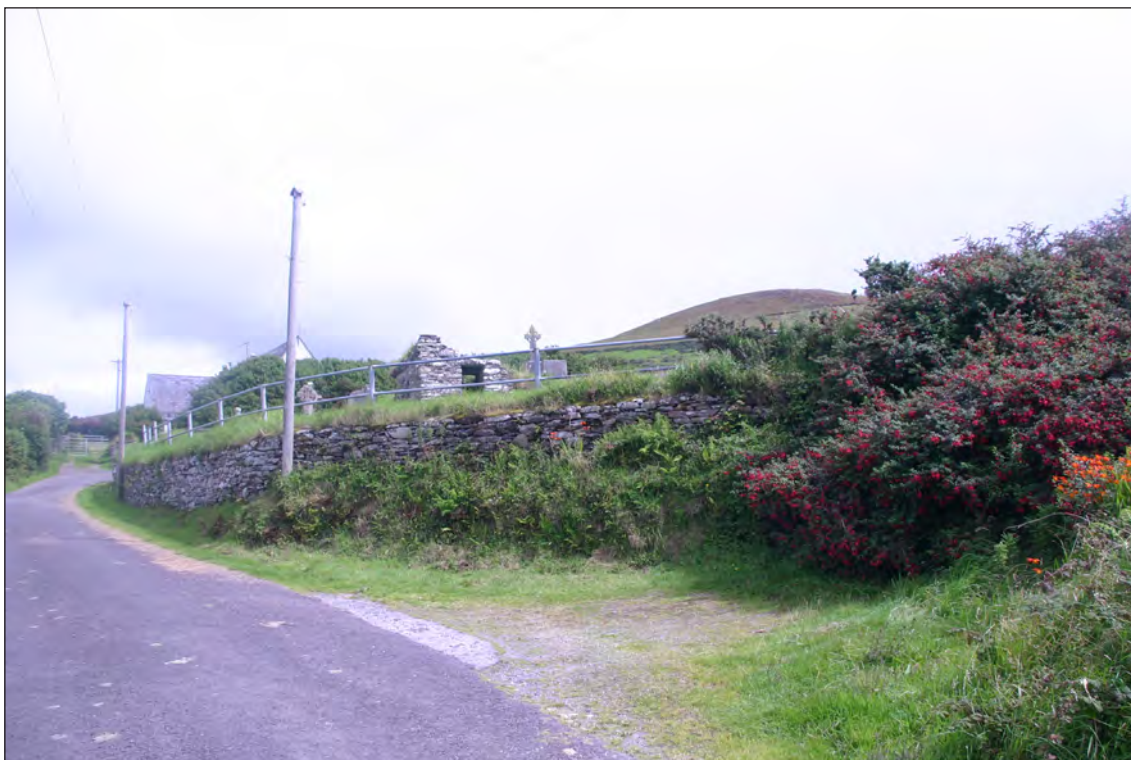
Plate 11: View of western limits of Dunquin Graveyard boundary wall

The outer peripheral limit of the graveyard surrounding the old church central area is serviced by the pathway and is not easily traversed in places. The majority of the modern graves are dispersed around this outer band of ground. The extreme western limits of the interior is rough and overgrown and used for the collection of fuchsia and other scrub cuttings etc (Plates 11 & 12 & Figure 5).

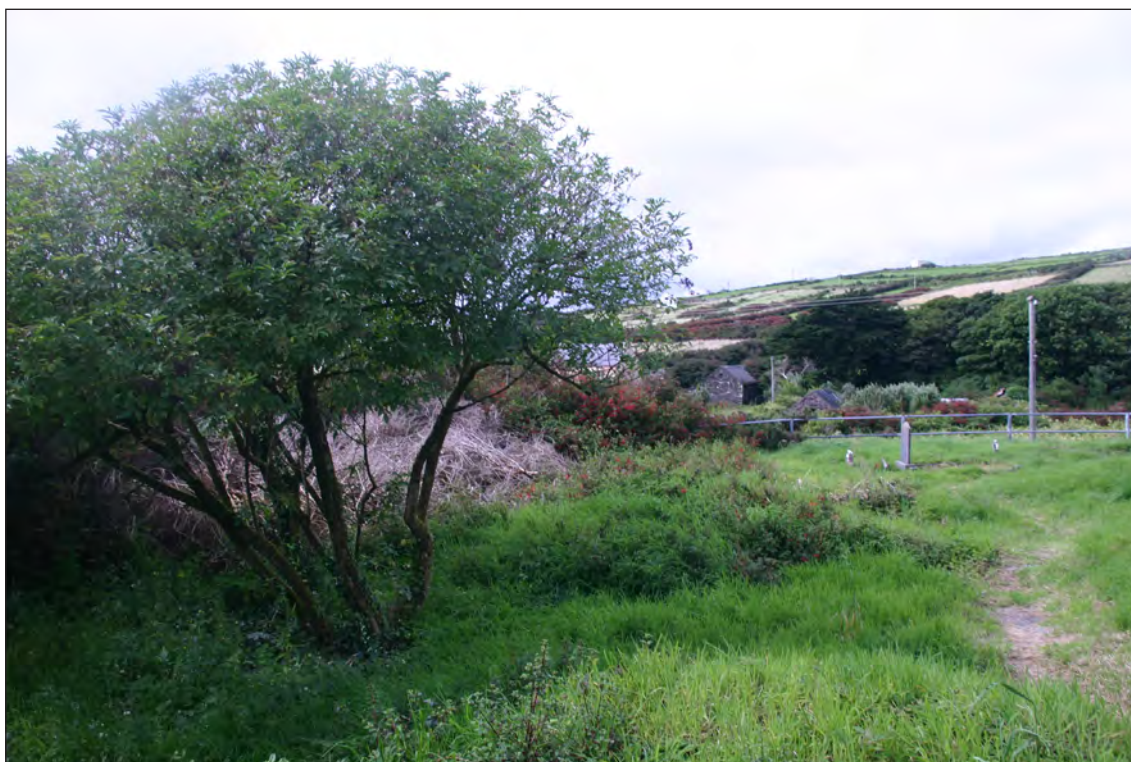
Plate 12: View of overgrown western limits of graveyard. Note dumped mound of fuchsia etc

- All future cuttings should be removed from the graveyard.
- The overgrown area at the west end should be tidied up and properly managed.
- A program of focussed archaeological conservation and repairs should be undertaken on the collapsed, partially collapsed, damaged, partially covered and grass covered lintelled graves.

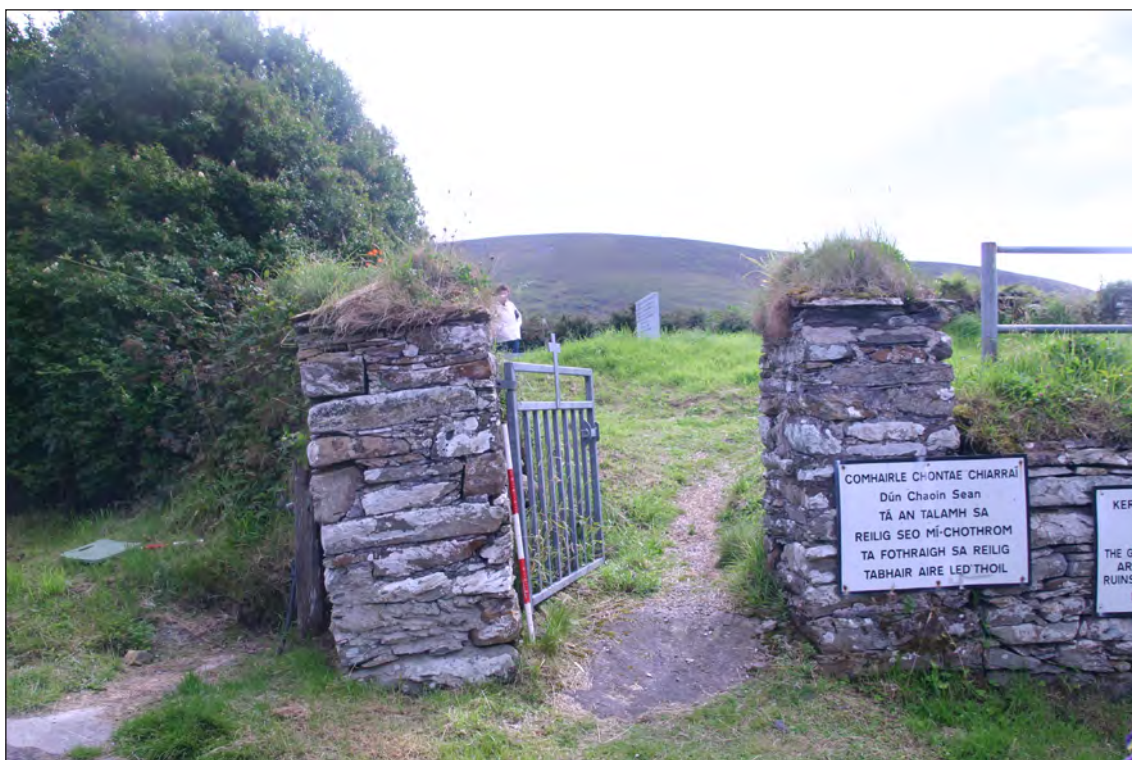
There is only pedestrian access only into the graveyard through a modern galvanised gate. The approach comprises sharply rising ground over loose gravel that is partly encroached with grass. The gate hangs between two robust square piers of local rubble sandstone bedded in cement and soft capped with sod. The left or eastern pier inclines steeply to the east and against which, also on the east side, is modern water tap. The gate does not open fully due to the upslope nature of the grassy interior, however a modern galvanised handrail is provided to aid visitors up the interior slope into the graveyard proper (Plates 13-14). There is no stile or no waste collection area or bins provided.

Plate 13: Exterior view of entrance into Dunquin Graveyard. Note sharp incline to left pier and further not that gate does not open fully

The entrance should be improved. This will require the levelling of the internal swing-area of the gate and possibly minor expansion also. The gate requires adjustment in order to open freely. This will necessitate ideally the rebuilding of the inclining pier and or in the short term a compensation adjustment to the gate hinges. A more defined possibly stepped access up into the graveyard should be provided as the ground is steep and slippery underfoot.

- The existing entrance gate need to be re-aligned and the east pier repaired or re-built.
- The immediate area inside the gate need to be levelled off and steps inserted for ease

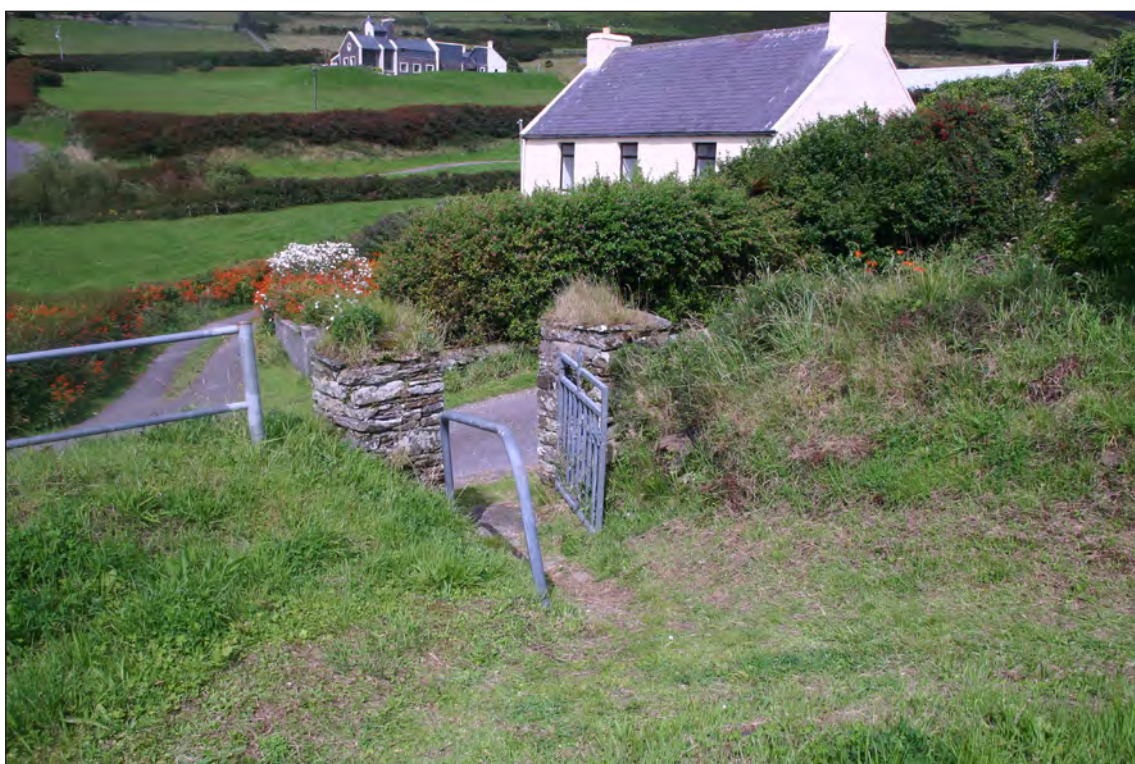
Plate 14: View from south of steep grassy entrance up into Dunquin Graveyard

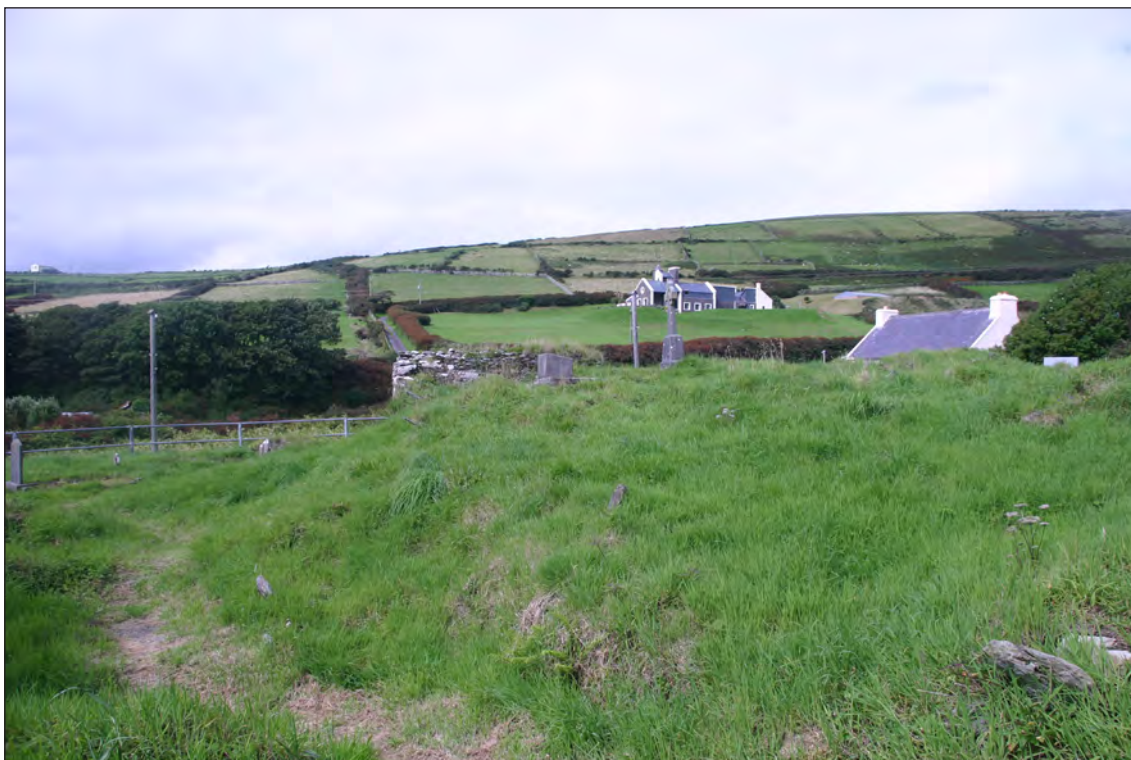
An overgrown partially gravelled and poorly defined path extends around the interior perimeter of the graveyard (Plates 15-16).

Plate 15: View from S of western limits of raised interior of Dunquin Graveyard. Note top of 2.5m high ruined church barely visible due to burials. Note graveled pathway on left

The partially gravelled path should be extended, properly maintained and the verges more defined. The work should be carried out under archaeological supervision and advice.

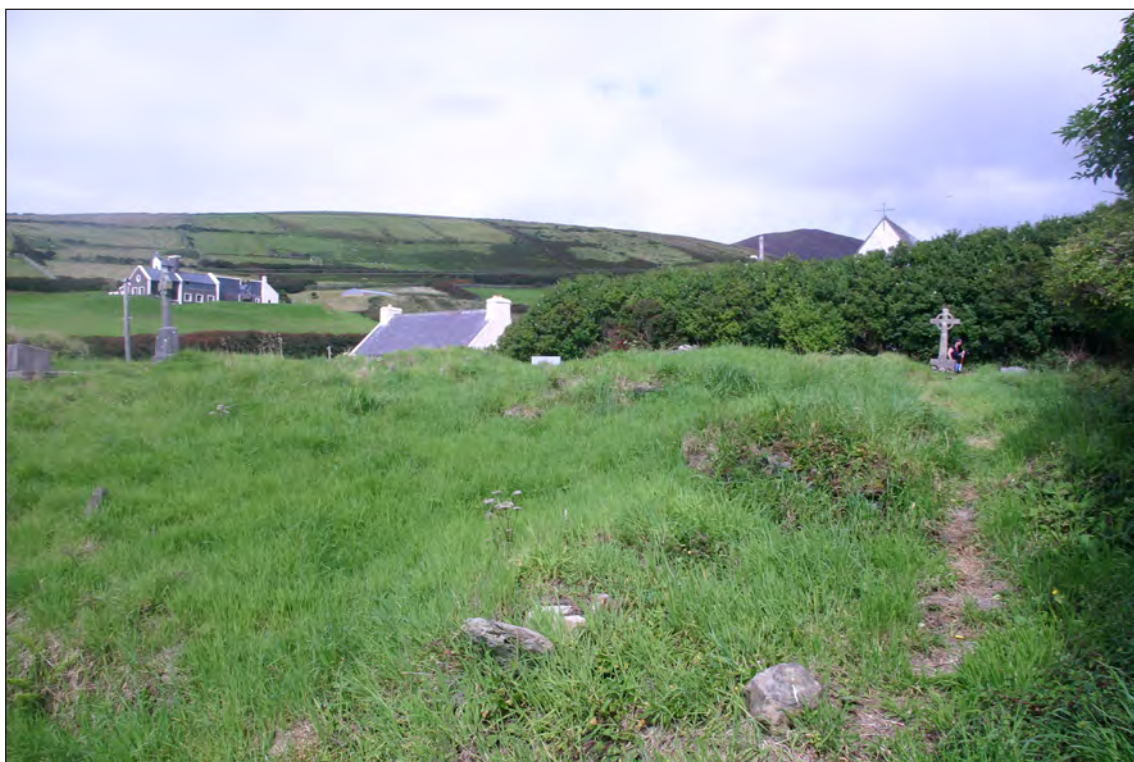
Plate 16: View of interior southern limits of Dunquin Graveyard. Note partially covered graveled pathway. Note proximity of modern church of Dunquin

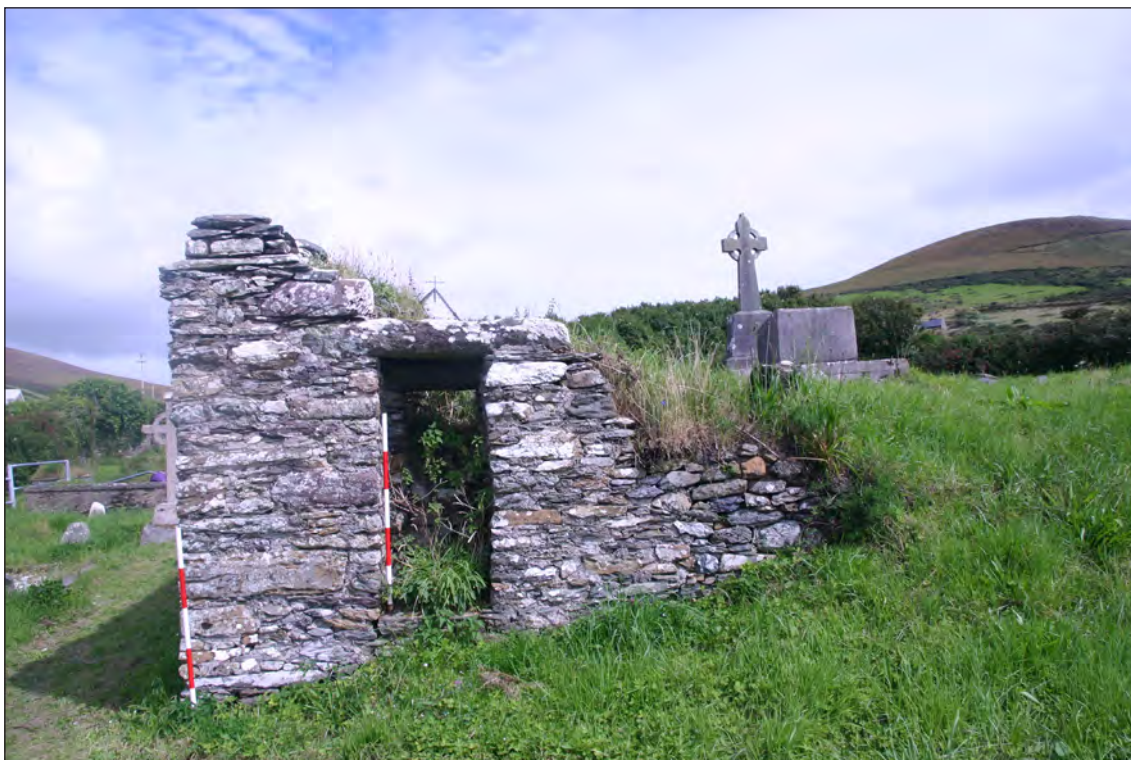
A little over 4m survives of the west gable and is pierced by a single flat lintelled window with stepped ingoings. The window, 0.58m wide x 1.32m high, is eccentrically positioned at the north side of the west gable and indeed looks more like a door than a window. This opening is also filled up on the inside (Plate 18).

Plate 17: View of west gable of ruined medieval church of Dunquin. Note unusual eccentric positioned window (?) on left

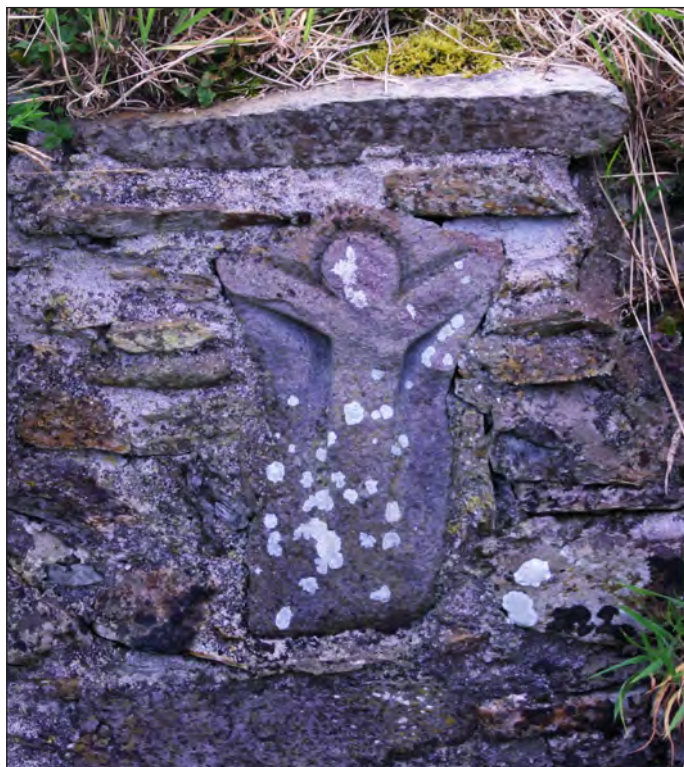
On the exterior at the eastern end of the north elevation is a small carved stone of an emerging figure with raised arms-possibly depicting the crucifixion (Plate 18 & Figure 5). It is most likely modern.

Plate 18: View of modern depiction of emerging crucifixion on stone on N elevation of ruined church.

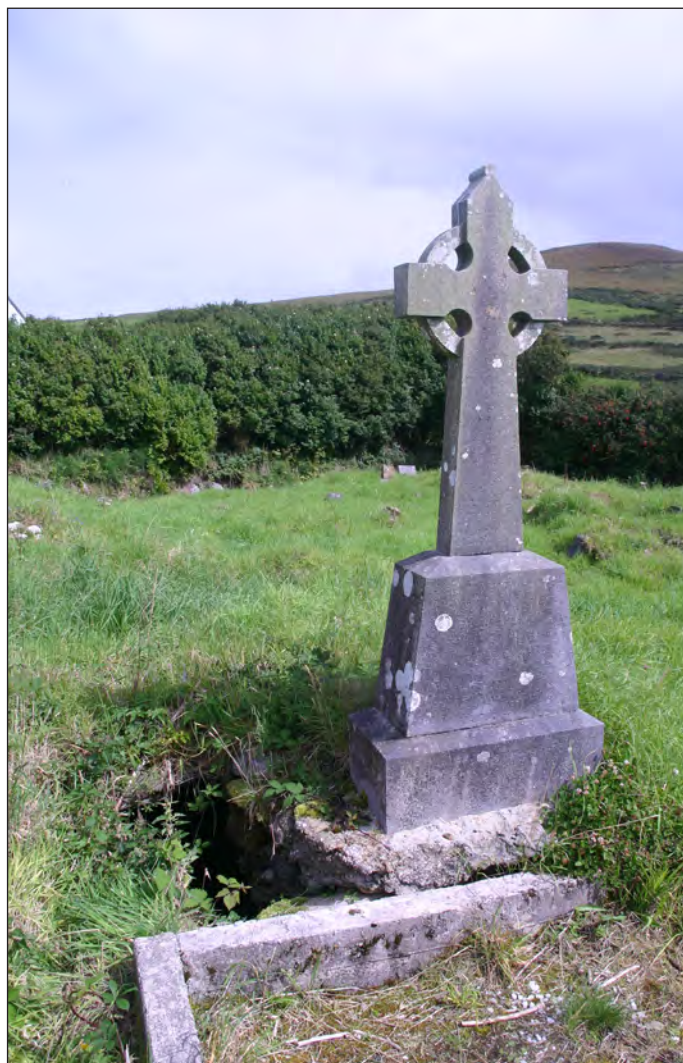
There are two prominent modern graves within the limits of the church, (182 and 183), as well as numerous unnamed headstones. The burials, the majority of which appear to be grass covered lintelled graves within the church are more or less up to the full height of the surviving 2.6m high walls. A prominent 'High Cross' type modern headstone (183) is precariously set alongside a partially collapsed grave within the old church (Plates 17 & 19 and Figure 5).

Plate 19: View of high-cross type headstone (183) in ruined medieval church. Note partially collapsed grave beside it

The open grave beside the modern High Cross in the limits of the old church should be repaired. The ground here is not suitable for the erection of heavy headstones or indeed modern formalised graves.

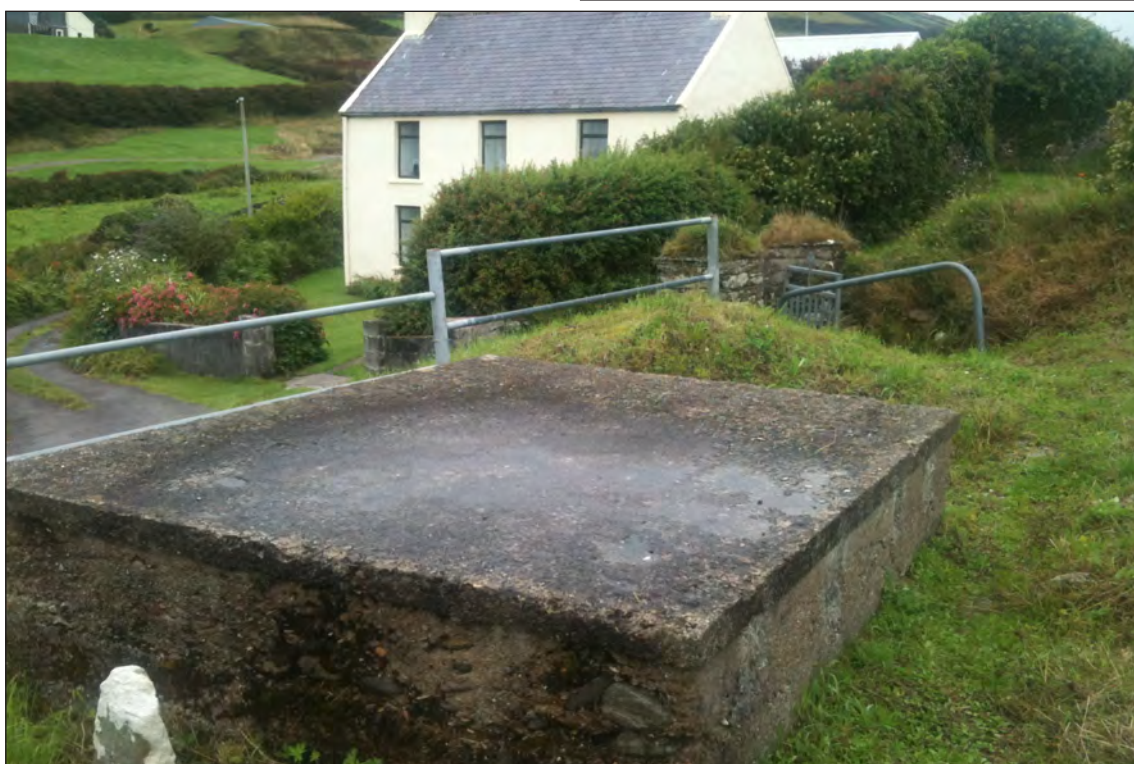
It is a low rectangular flat tomb rendered with coarse cement (Plate 20 & Figure 5).

Plate 20: View of unnamed tomb in Dunquin Graveyard (160)

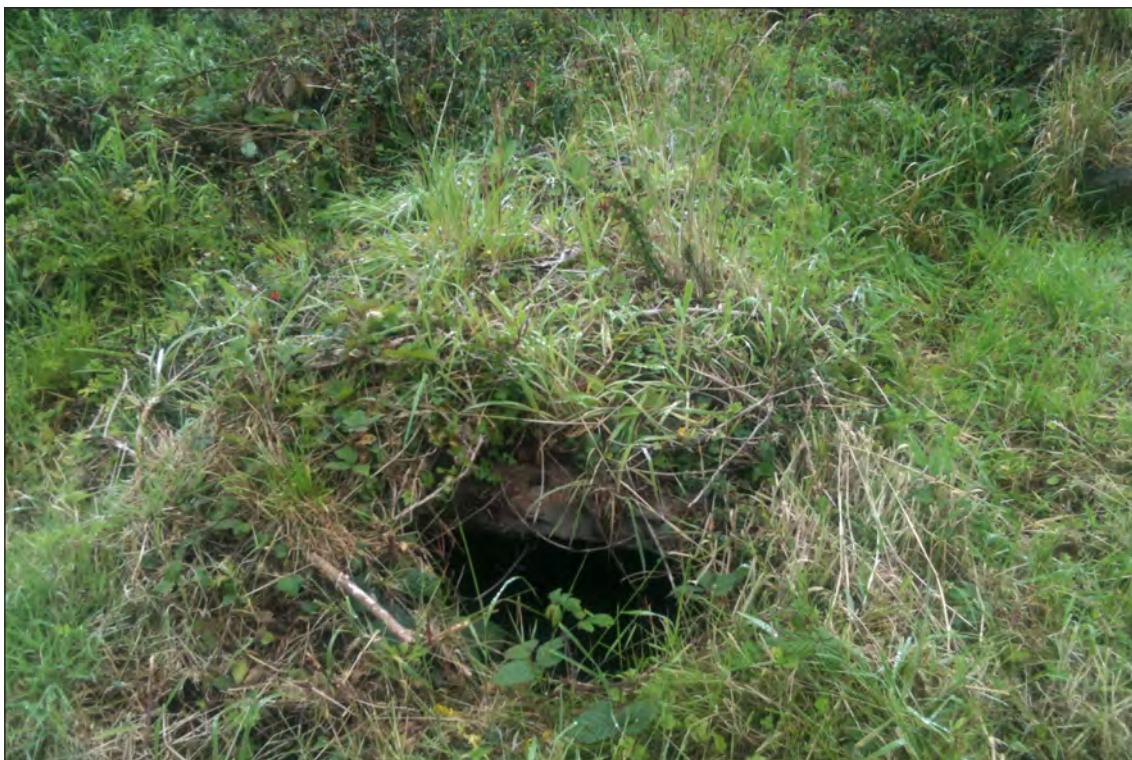
Plate 21: Close up view of partially collapsed lintelled grave

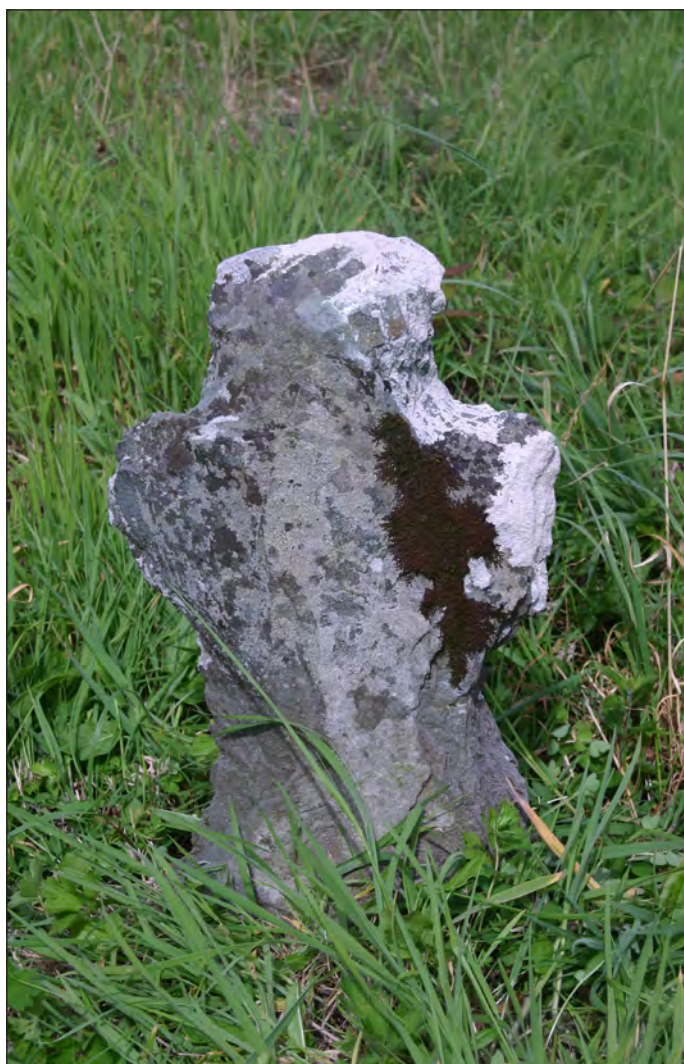
There were four cross slabs recorded in Dunquin in the course of this survey, two of which were recorded in the Dingle Archaeological Survey as ‘...2 *grave-markers in the form of rough stone crosses*’ (Cuppige 1984, 366). The two stones correspond with crosses 180 and 184 in this survey (Plates 22 & 23 and Figure 5).

Plate 22: View of stone cross (180) at NW limits of graveyard

The cross-slabs should be archaeologically illustrated.

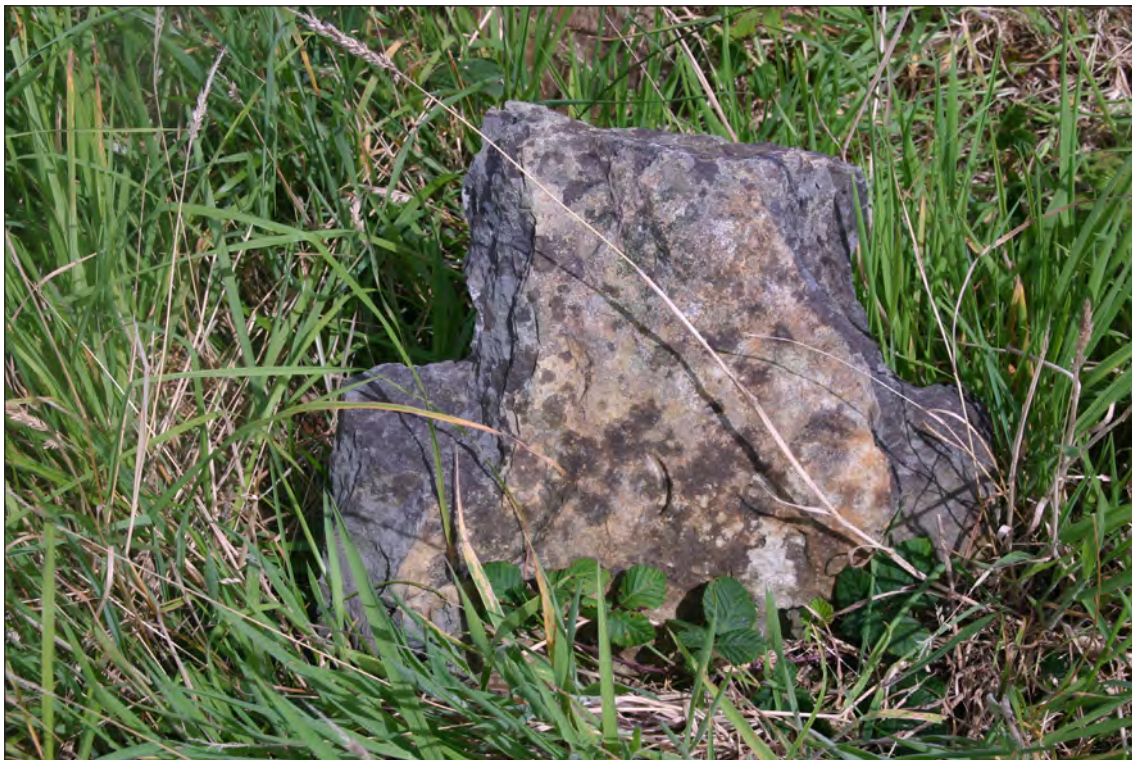
Plate 23: View of stone cross (184) at NW limits of graveyard

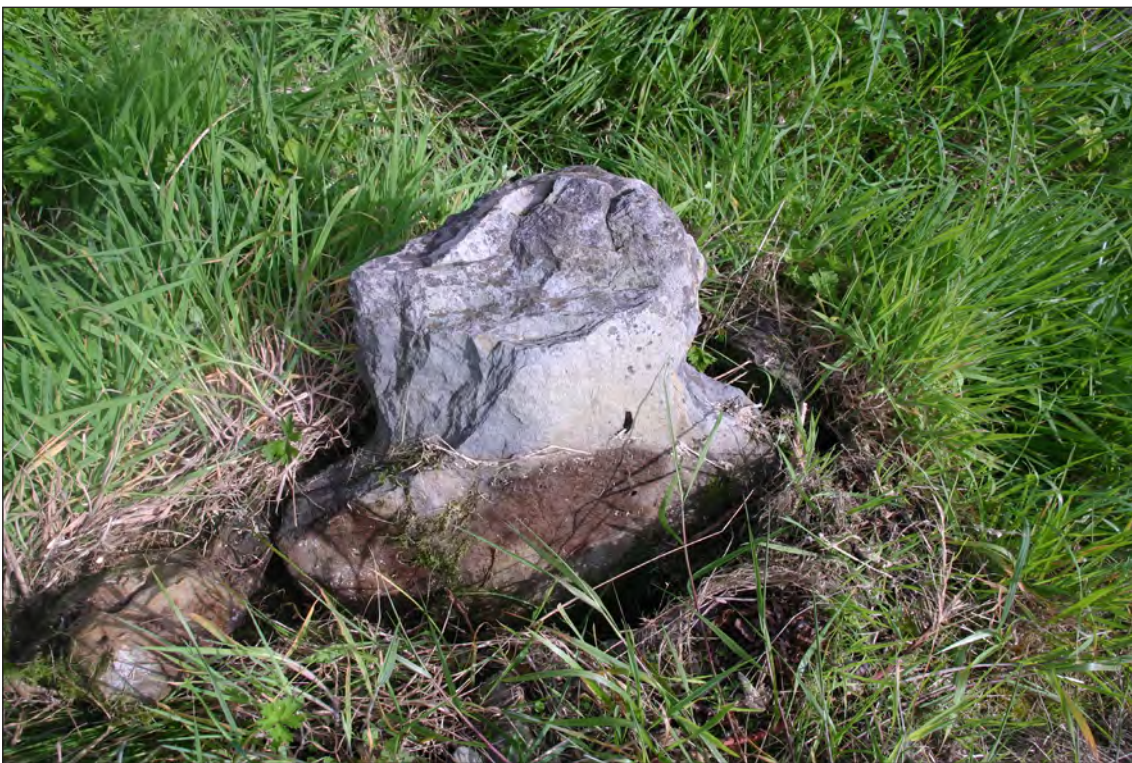
A third similar roughly hewn anthropomorphic type cross (44) of local green siltstone was also recorded partially exposed and askew, abutting a lintelled grave in the interior of the graveyard (Plate 24 & Figure 5).

Plate 24: Partial view of anthropomorphic stone cross (44) at centre of ruined medieval church

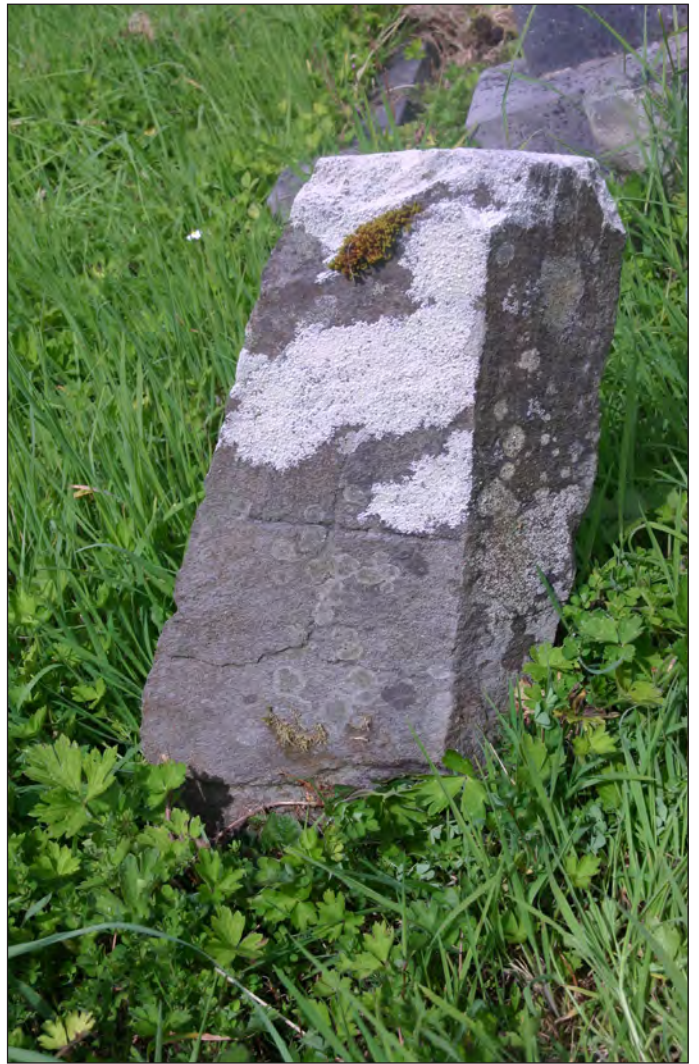
The fourth cross-slab (30) comprises a small rectangular sandstone situated in the north-western limits of the graveyard, *circa* 3.5m from cross-slab (180). The gravemarker is lightly incised with an equal armed cross whose arms extend across the full width of the stone (Plate 25 & Figure 5).

Plate 25: View of cross-slab (30) at NW limits of Dunquin Graveyard
