Archaeological Survey,
Garfinny,
Dingle,
Co. Kerry.

November 2010

RMP No.: KE043-228 church and graveyard

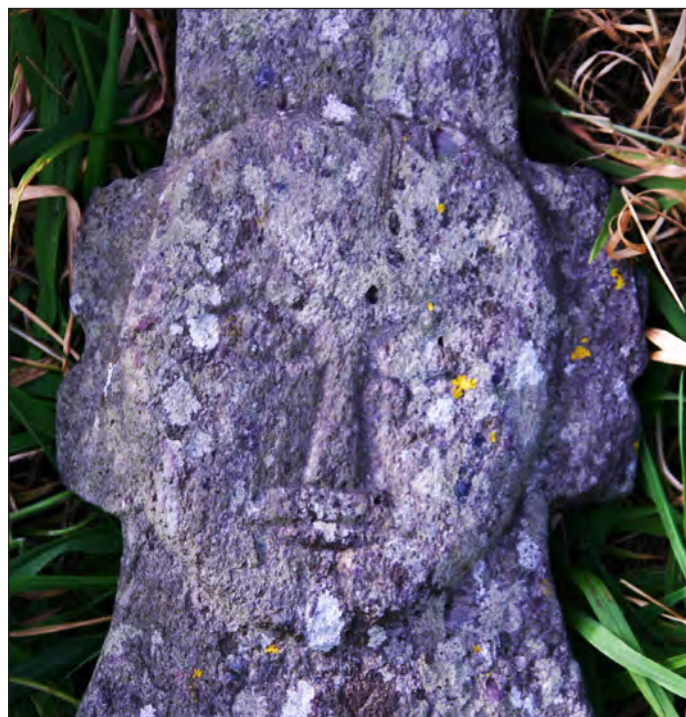
Plate 6: Close up view of carved face on back of headstone 153

On the back of the headstone at the crossing of the arms of the cross is an oval face with lentoid eyes, flattened nose and closed lips or moustache (Plate 6). There are four lines inscribed but are very worn and indistinct and very difficult to decipher as the stone is coarser here (Plate 5). The letters also travel across onto the edge of the stone. A brave attempt at the inscription possibly reads:

- All the cross-slabs, a representative few of the notched stones and holed stone should be archaeologically illustrated and researched.
- The unusual and loose illegible headstone (153) should be temporarily removed, fully recorded, archaeologically illustrated and researched.

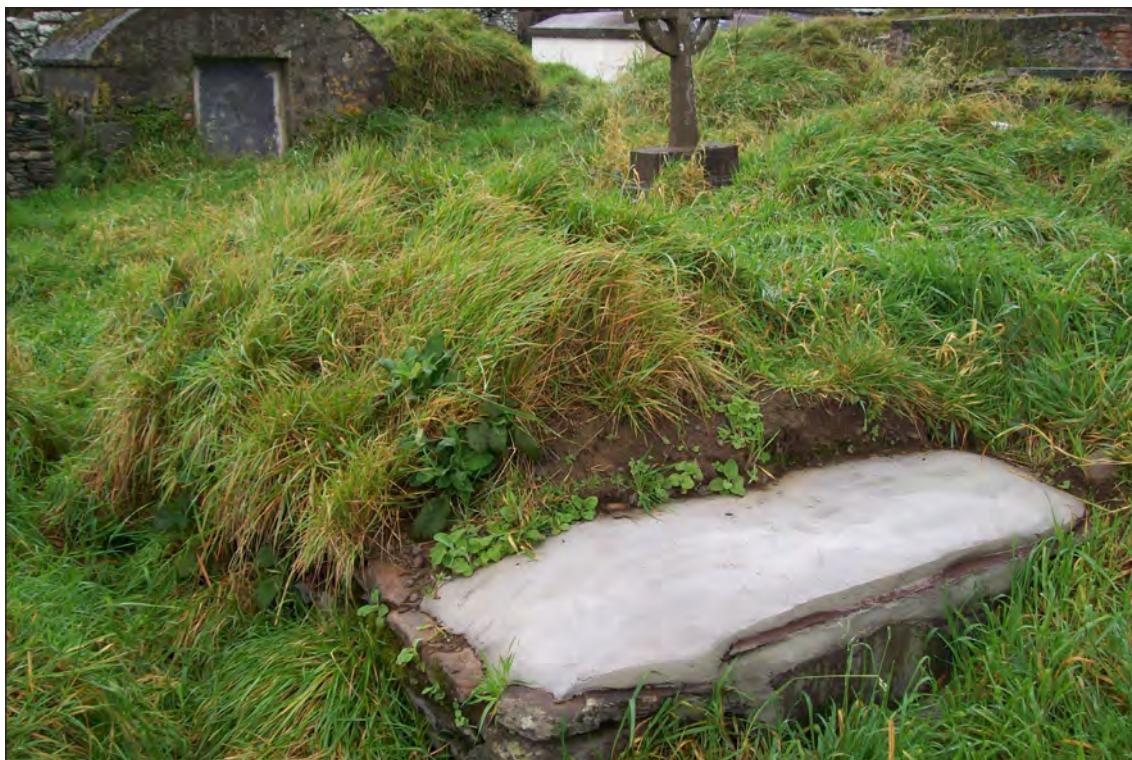
Plate 7: View of recent poorly repaired unnamed tomb (69) at Garfinny

It was obvious, in the course of this survey, that substantial works have been undertaken Garfinny Graveyard in the recent past including the covering of graves, repairs to some tombs etc (Plates 7- 8). It is possible that the internal gravelled pathway was also revamped. However, this work, much of it amateurishly undertaken, is now largely undone.

- The tombs should be repaired re-pointed, re-rendered and restored sensitive to their original construction. This work should be done under the supervision of an archaeologist qualified in this area or a conservation architect experienced in this field and will require Ministerial Consent as Garfinny is a National Monument.

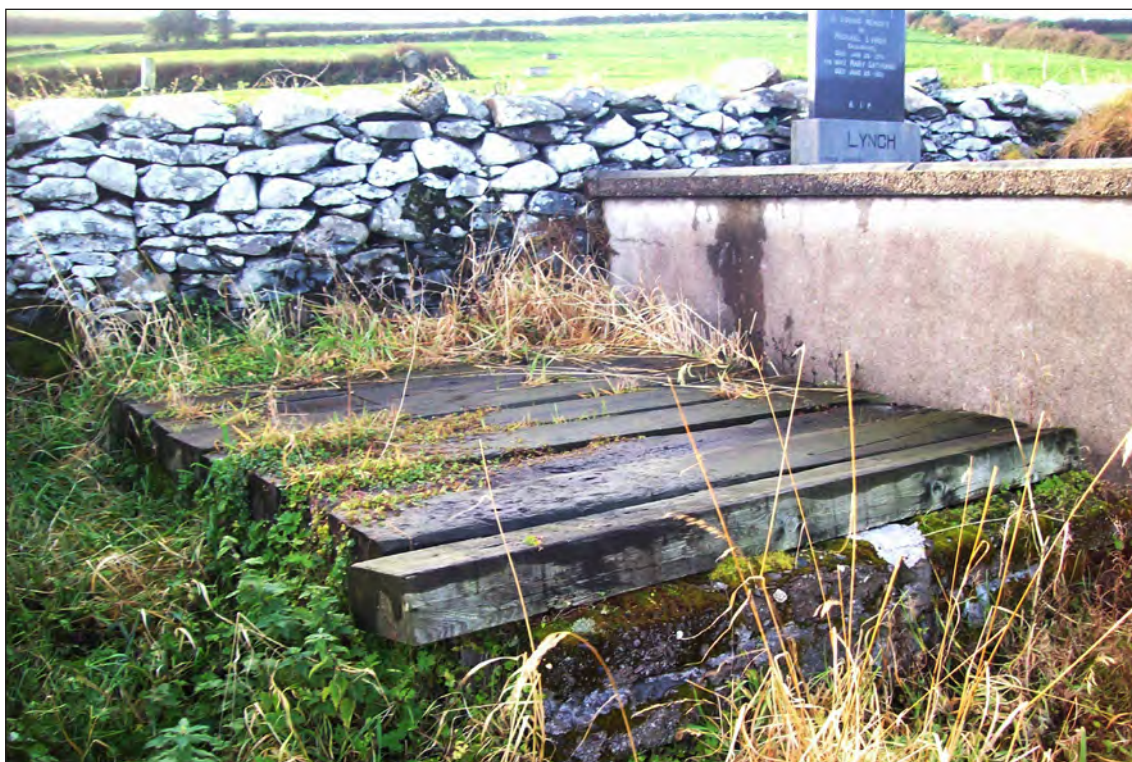
Plate 8: View of old railway sleepers recently reused to cover collapsed unnamed tomb (704) Garfinny Graveyard

Forty-eight unnamed tombs were recorded in the Garfinny (Appendix 2 & Figure 5). Thirty-six of which are manifest as low grass covered mounds. Tomb 704 has been inappropriately recovered with old railway sleepers while tombs 29, 69 and 317 have been partially and amateurishly repaired with cement (Plates 7-8). There is only one, (475), of the forty-nine unnamed tombs that doesn't require remedial works to some degree as it is only recently built and unused.

Specialist work is required to preserve, repair and restore fifty of the unnamed tombs at Garfinny. Several will require careful rebuilding while others will have to be assessed to determine if they are viable to be repaired at all.

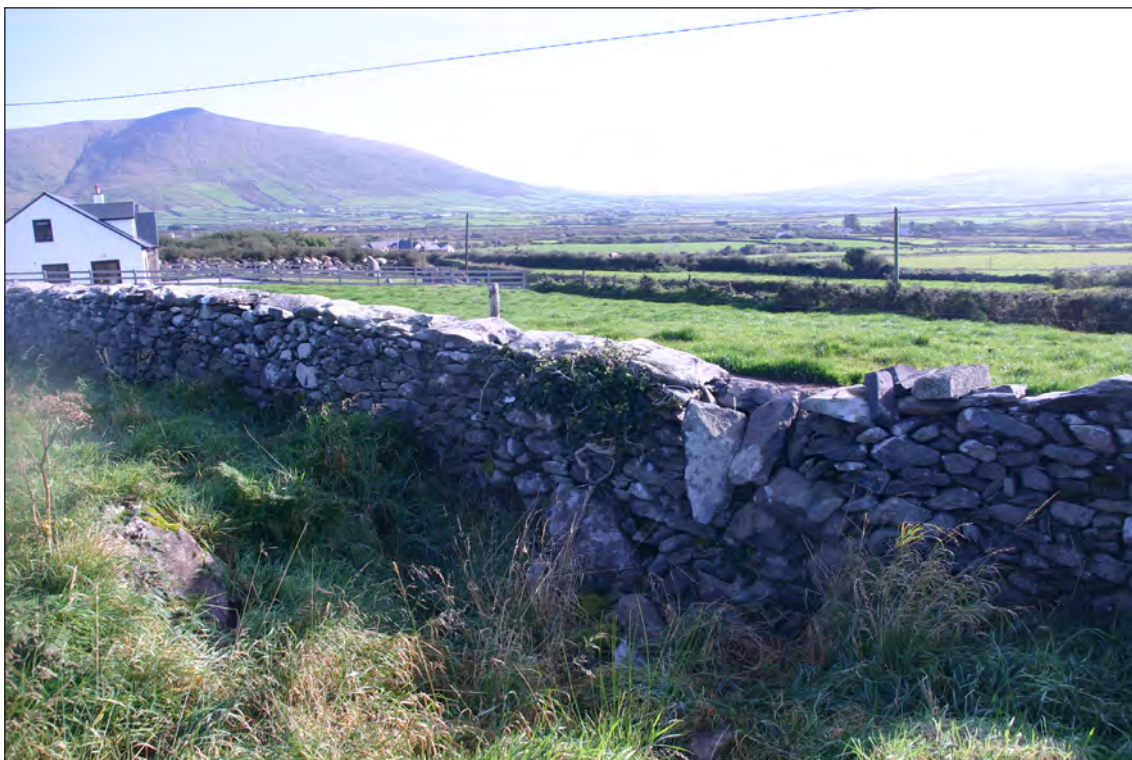
Plate 23: View of damaged section of drystone boundary wall at southern limits of Garfinny Graveyard

The graveyard at Garfinny is enclosed by a drystone wall capped with large flagstones laid flat. The boundary wall is in good order for the most part however there are sections that are partially collapsed and in need of repair (Plates 22-24).

The boundary wall should be repaired and a sheep-wire fence established along its exterior limits that border pasture.

- Repairs to the boundary walls should be undertaken by people with a proven track record in repairing dry stone walls.
- An information booklet on care and maintenance for tombs should be compiled and supplied to the relevant parish church.
