Date: October 2009

Project code: TGSK09

Archaeological Survey, Inch Graveyard, Inch East, Co. Kerry.

RMP Number: KE045 089

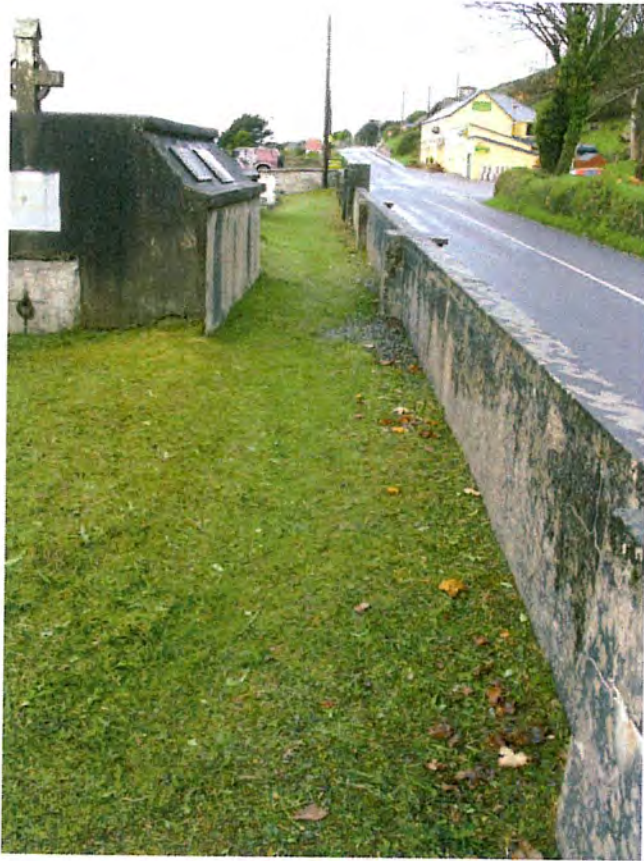
Plate 01 - Enclosing wall from northeast.jpg

The burial ground is sub-rectangular in plan and enclosed by a linear mortared rubble stone boundary wall with rendered coping, having recently rendered sections to northwest (Plate 1). Access to the interior is granted via a double-leaf wrought-iron gate and rendered V-profile stile located to the north-western enclosing wall that fronts directly onto the roadside (Plate 2, 3). Located to the south-east is a second rectangular area that contains a collection of recent graves.

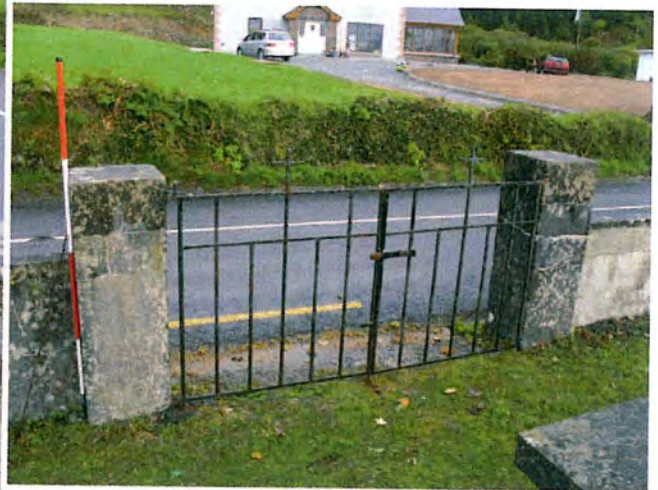
Plate 02 - Gates from south.jpg

There is a gated pedestrian entrance to the burial grounds, located to the northwest wall, comprising rendered square-profile gate piers carrying double-leaf wrought-iron gates which open directly onto

the roadside. The entrance gate is in good condition with the exception of some minor rusting to the gate itself. Located to the west of the main gate is a rendered V-profile stile.

A simple rust treatment and fresh coat of paint should be applied to the gates to prevent further degradation.

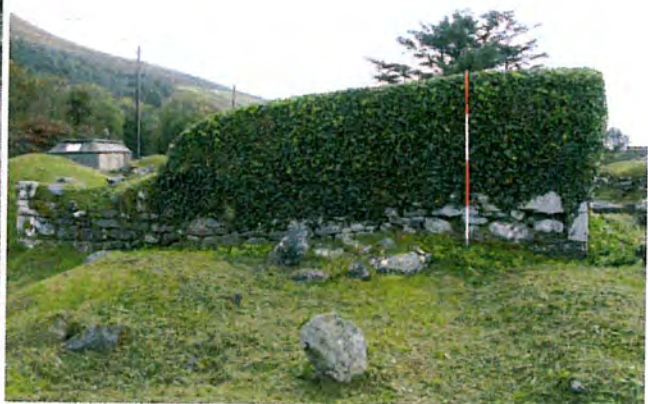
Plate 04 - Church ruin from west.jpg

To the interior of the burial ground, which is itself recorded in the Record of Monuments and places (RMP) as KE045-089002, there is a single recorded monument this being the ruinous remains of a medieval church (Plate 4), recorded as (RMP) KE0589-078001.

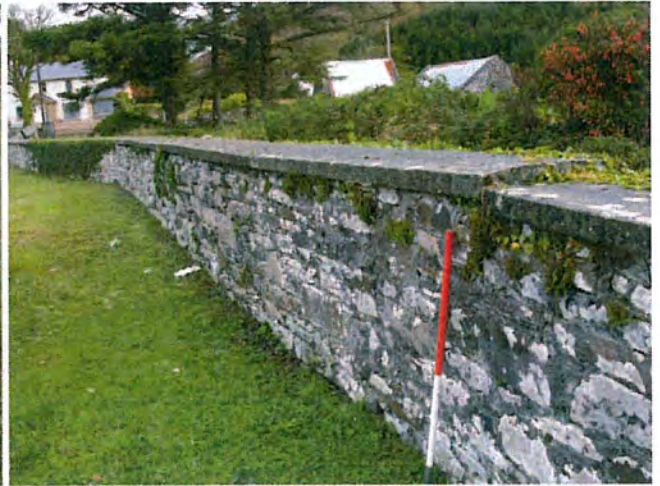
Plate 06 - Enclosing wall from south.jpg

The boundary walls surrounding the burial grounds are of mortared rubble stone with recent render coping, (Plate 6) the north-western section of which fronts directly onto a road. No breaches or areas of collapse were observed within the boundary walls. There were several short lengths of wall that displays minor amounts of Ivy growth, brambles and various ferns though these areas are small.

The vegetation should be managed rather than removed in order to prevent any degradation of the walls whilst still preserving the natural habitats that this vegetation provides for local wildlife.

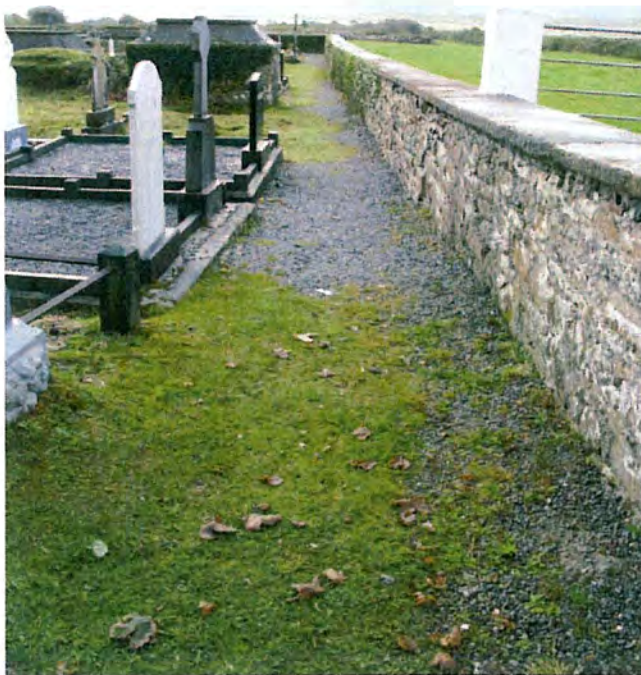
Plate 07 - Path from northwest.jpg

The pathways identified during the survey were of recent origin and located surrounding the site within the enclosing walls, composed of closely cropped grass (Plate 7). These paths also continue through the recent graveyard to the south-east.

Control of the vegetation should be the primary concern, however the paths appear to be in good condition and should be maintained in their current state.

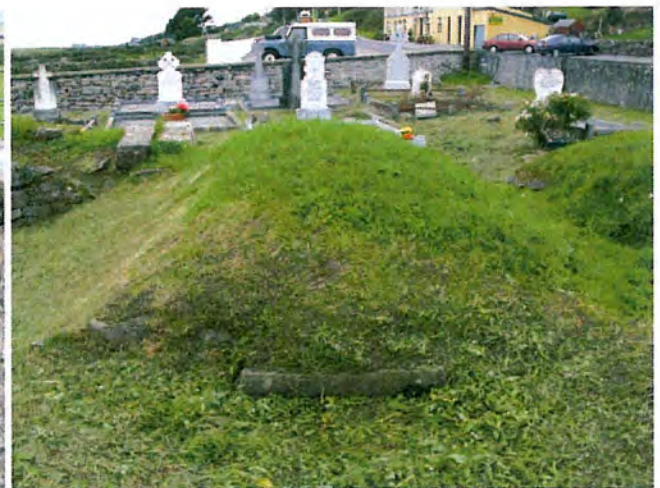
Plate 08 - Mound type tomb from east.jpg

There are fifty-eight tombs located within the burial grounds, concentrated around the foot print of the ruinous church, which is consistent with their associated higher status. The tombs have survived in varying states of repair with the majority of the tombs surviving as raised mounds covered by closely cut grass, for example grave nos. 070, 080 (Plate 8) and 214.

The continued control of all vegetation attached to the tombs should be the primary aim to prevent any further degradation of these features. Steps should also be taken to stabilise some of the less well preserved rubble stone examples, in particular grave nos. 134, 089, 101 and 102. The advice of a conservation architect should be sought in order to determine how best to achieve this.

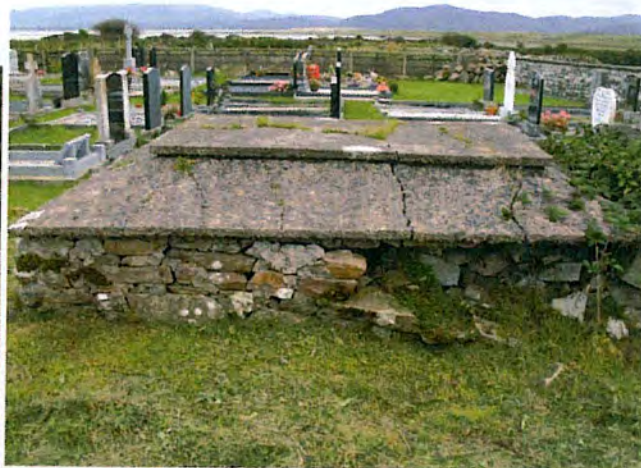
Plate 10 - Grave no. 134 from north.jpg

Of the unnamed examples, of particular note are grave nos. 012, 134 (Plate 10) and 278. These are of varying form and have survived in good states of repair with the exception of grave no. 134 which has suffered some damage to its northern side. Of the numerous other unnamed tombs, grave no. 180 is an excellent example of the less elaborate rubble stone examples that are located throughout the site. Grave no. 212 (Plate 11) is a good example of the mound type tombs, which are by far the most common type in Inch graveyard. These are most likely the collapsed remains of the earliest tombs on the site.

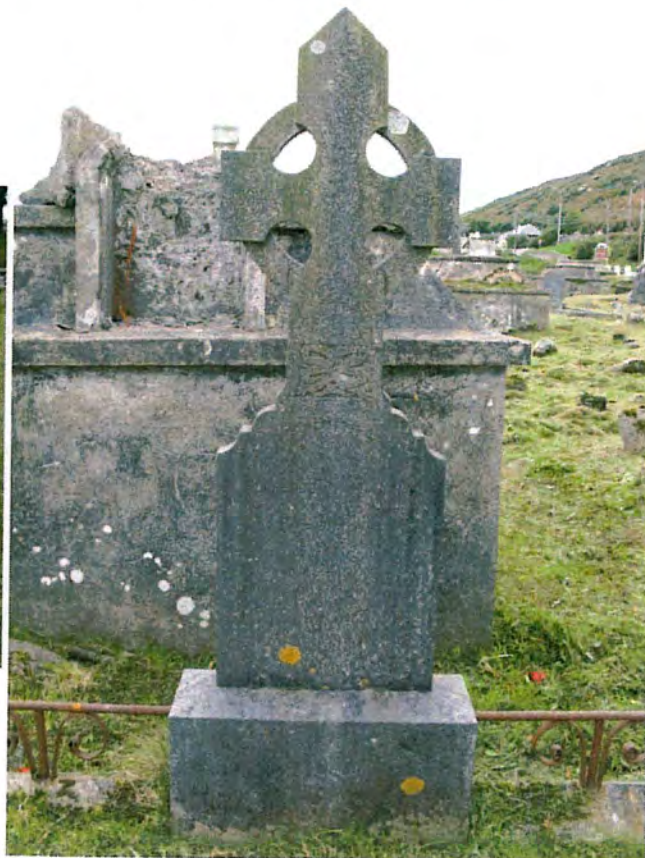
Plate 12 - Grave no. 378.jpg

There were 64 inscribed headstones and grave plots scattered throughout the burial ground at the time of survey, with the majority dating from the early to late 20th century. The most recent stones date from the late 1980's and the earliest, grave no. 378, dates to 1914, (Plate 12). The headstones and grave plots conform to a rough pattern with occasional groupings conforming to informal rows and others placed in relatively random locations. The majority of the extant gravemarkers and headstones face east.

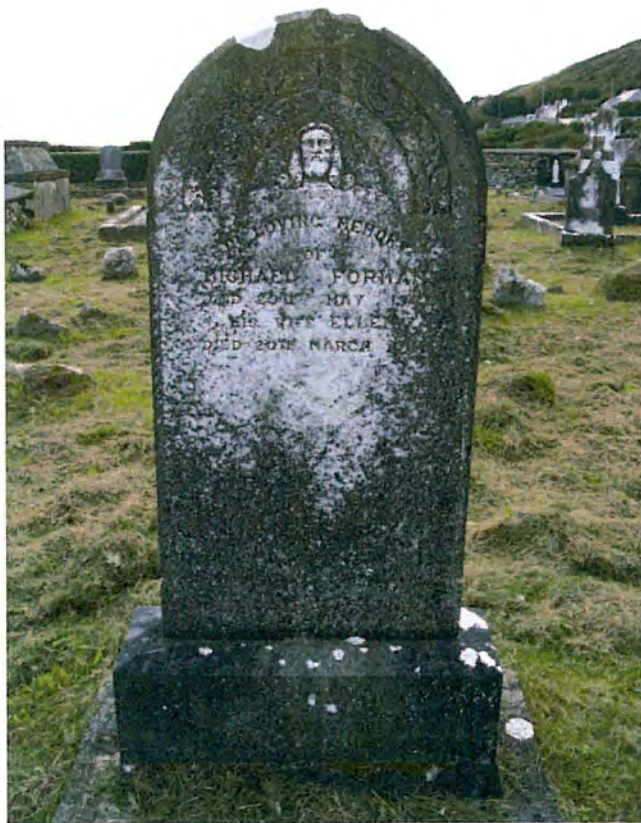
Plate 13 - Grave no. 418.jpg

Several 20th century headstones, namely grave nos. 002, 116 and 411 are of high quality and have retained relatively well preserved elaborate texts and designs. They also appear to have remained in their original locations. Grave no. 418 (Plate 13) displays a particularly elaborate, well executed carving. Also of note are several tooled limestone headstones that are of a high cross style and display elaborate artistic details.

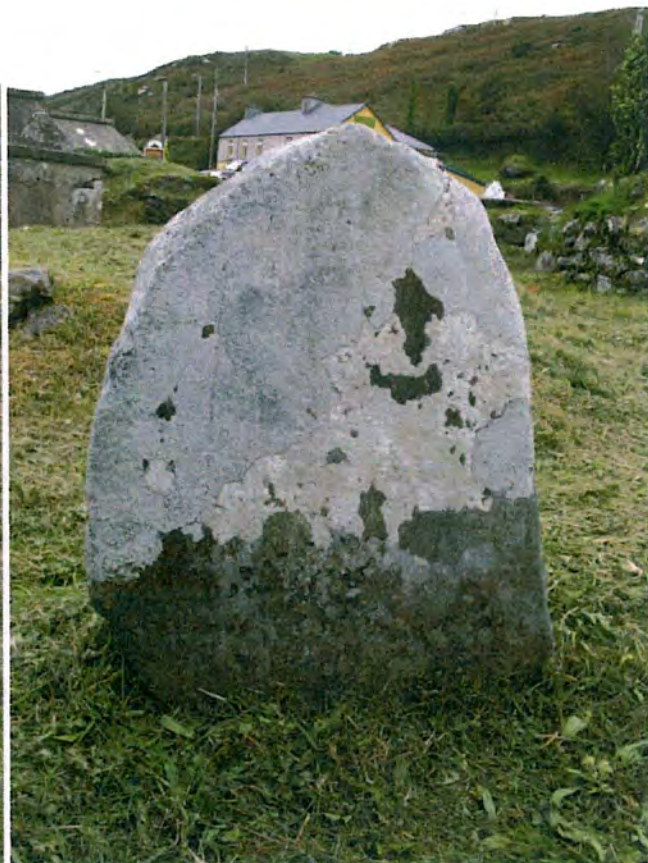
Plate 14 - Grave no. 096.jpg

There were only eleven unnamed headstones and grave plots identified within the burial grounds. Grave nos. 011, 096 (Plate 14) and 125 are particularly note worthy having retained their form despite the loss of their original inscriptions. Grave no. 013 is also of note, although it is not located in its original position.

The unnamed headstones and grave plots remain in relatively good condition despite the deterioration caused by weathering. Where possible, steps should be taken to prevent further degradation of this sort. The continued control of nearby vegetation will benefit the plots and headstones as this will ensure that they remain clearly visible and help prevent accidental damage being caused to them by visitors to the grounds.

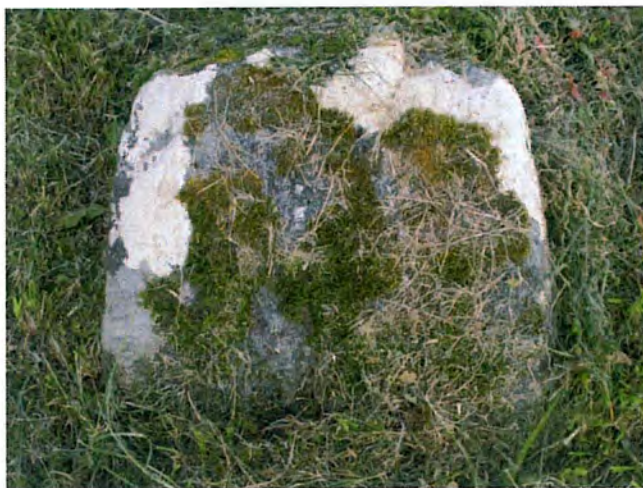
Plate 15 - Grave no. 441.jpg

Unnamed gravemarkers are by far the most common type of gravemarker to be found in Inch graveyard with 309 examples identified at the time of survey. These take the form of simple stone markers, for example those found at grave nos. 005, 317 and 441 (Plate 15).

The unnamed gravemarkers remain in good condition despite the deterioration caused by weathering. Where possible, steps should be taken to prevent further degradation of this sort. The continued control of nearby vegetation will benefit the gravemarkers as this will ensure that they remain clearly visible and help prevent accidental damage being caused to them by visitors to the grounds.

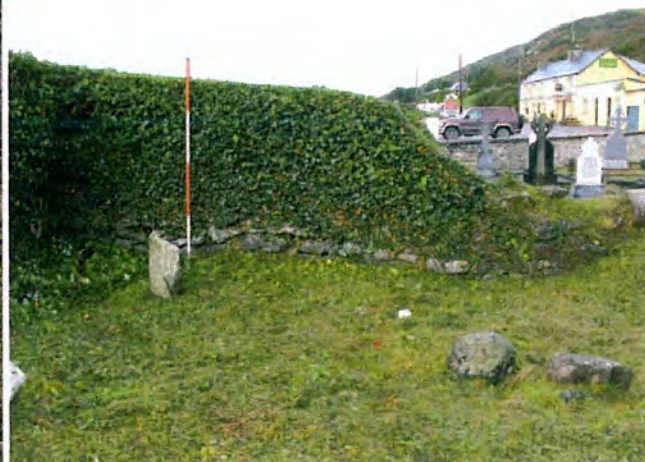
Plate 16 - Ruinous church from north-east.jpg

To the northern portion of the burial grounds stand the ruinous remains of what was presumably single-cell church (Plate 16). The church only survives as a L-plan section of wall, surviving to a maximum height of 2m's, being of a coursed, roughly dressed rubble stone walls (approx 0.7 metres thick). There is a substantial amount of ivy growth to both the interior and exterior elevations of the walls although they appeared stable at the time of survey. According to the first edition OS map the church was already ruinous.

Measures should be taken to secure the existing ruin from any collapse, this could primarily be achieved through the control of the attached vegetation by preventing it from spreading further. The Ivy should not be removed however as this would leave the remains in need of immediate conservation, without which structural collapse may occur. Such work would involve the re-pointing of the walls using correct (lime) mortars with flush or recessed pointing. Ribbon pointing must be avoided as its use would damage the structures historic character. The removal of the Ivy would also result in a loss of habitat and should be avoided.

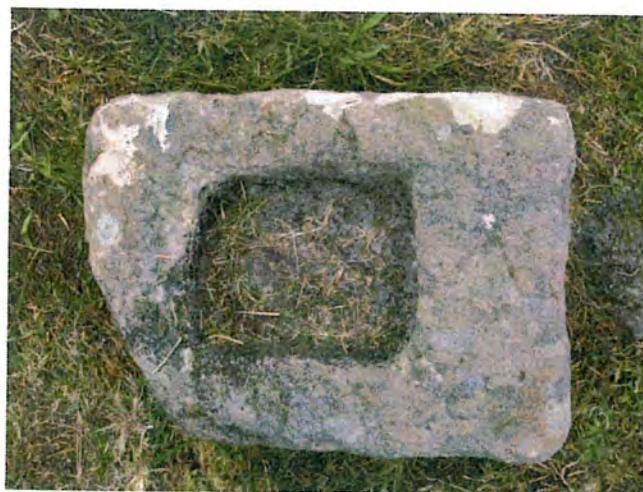
Plate 17 - Architectural fragment grave no. 444.jpg

Several architectural fragments were identified during the survey including what may be the remains of a font or basin grave no. 444 (Plate 17). Also of interest was a fragment of what may have been a door surround, grave no. 445 (Plate 18), although the original purpose of this fragment is somewhat unclear.

The identified architectural fragments should be kept clear of vegetation and left in situ to allow for further examination.
