Archaeological Survey,
Keel,
Boolteens,
Castlemaine,
Co. Kerry.

October 2012

Client: The Heritage Office,
Kerry County Council,
County Buildings,
Ratass,
Tralee,
Co. Kerry.

RMP No.: KE046-021

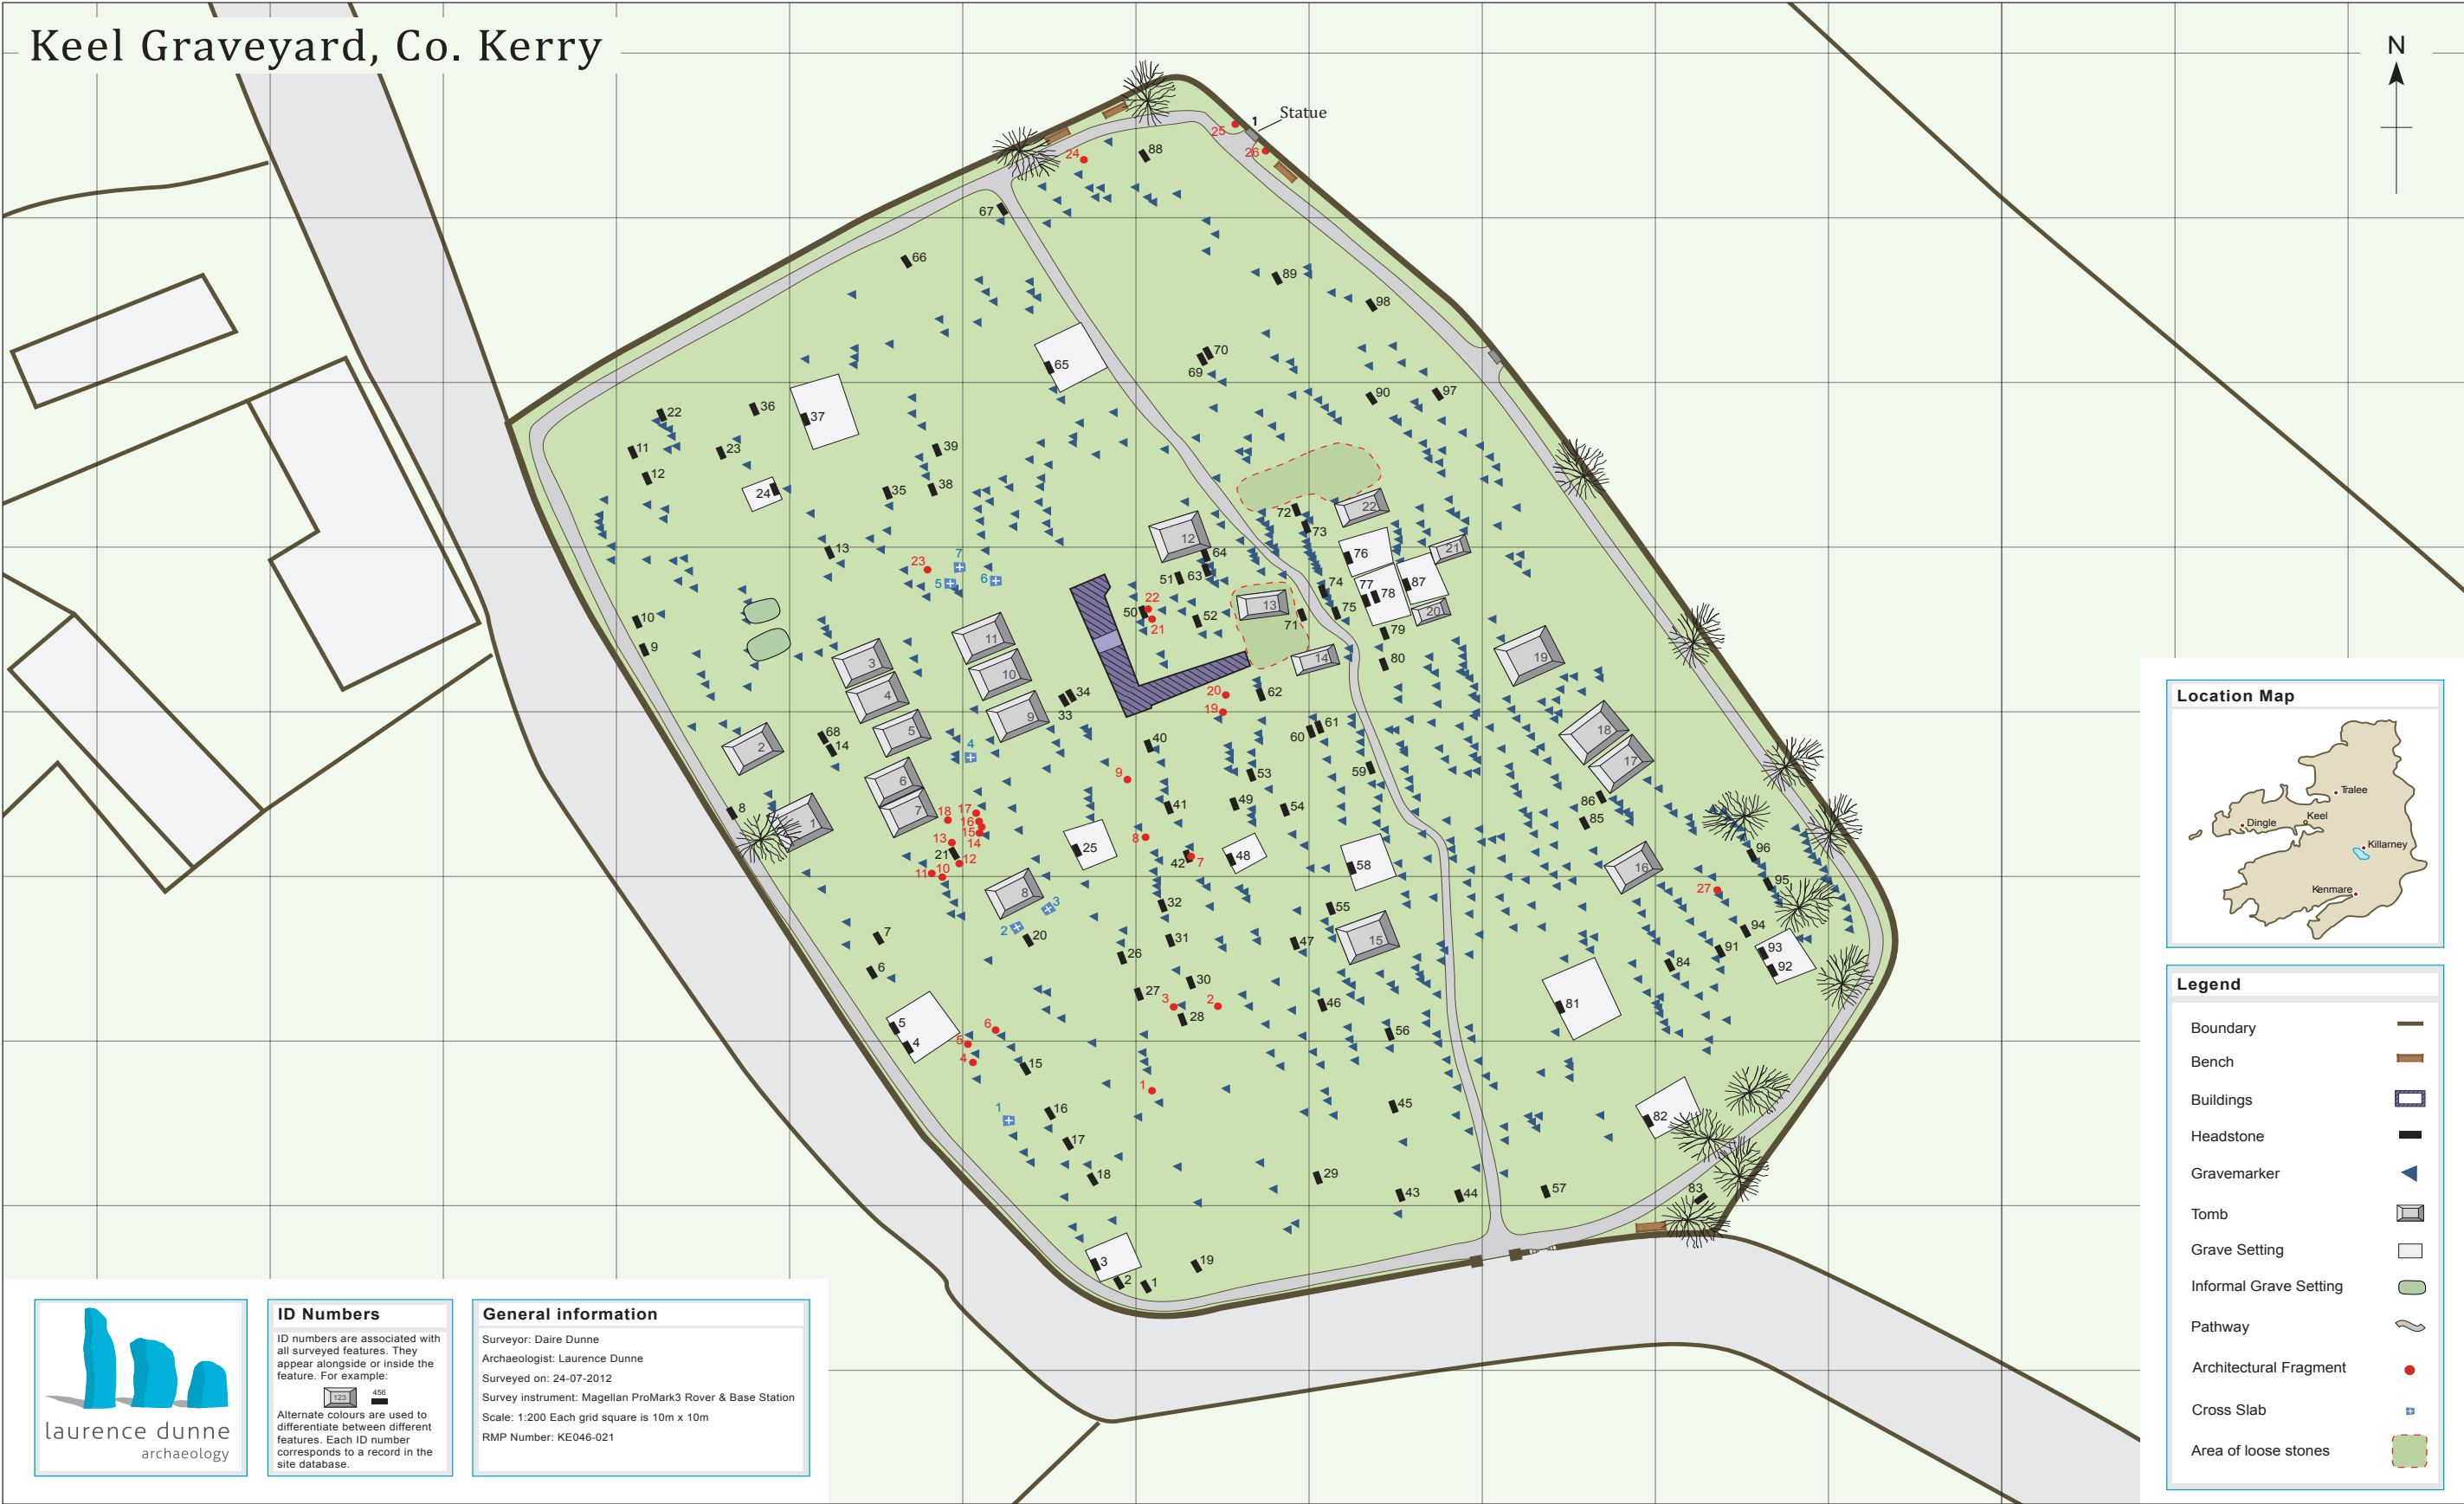
Figure 2: Archaeological survey plan of Keel church and graveyard.

Indeed this is because the-dominant upstanding burial marker is the simple unhewn and uninscribed gravemarker of which six-hundred and sixty nine (669) were recorded in the course of this survey (Figure 2 & Plates 6, 8-9).

There were an incredible six-hundred and sixty-nine unhewn gravemarkers in total recorded in the course of this survey. All comprise simple gravemarkers of unhewn local sandstone and are disposed around the entirety of the burial ground often in rows (Figure 2 & Plates 6 & 8).

Twenty seven (27) architectural fragments were recorded in Keel Graveyard (Figure 2 & Appendix 4). Twenty five of the AFs comprise masonry from the medieval church- the majority of which are chamfered blocks that most likely reflect a string or eaves course of the structure. None of the AFs are decorated.

All but two are situated in various locations in the graveyard with a noted cluster to the W of the church between Tombs 7 & 8. Two lie loose on the ground, AF 22 & 23 (Figure 2). Two others have been recently built into the boundary wall at the N-E corner. One of which, AF25, is a sandstone, 15th century twin light ogee head from the medieval church (Figures 2 -3 & Plate 23). The second, AF 27, appears to have been originally a rotary quern stone that was recently modified and adapted as a pseudo stoup (Plate 24 & Figure 4).

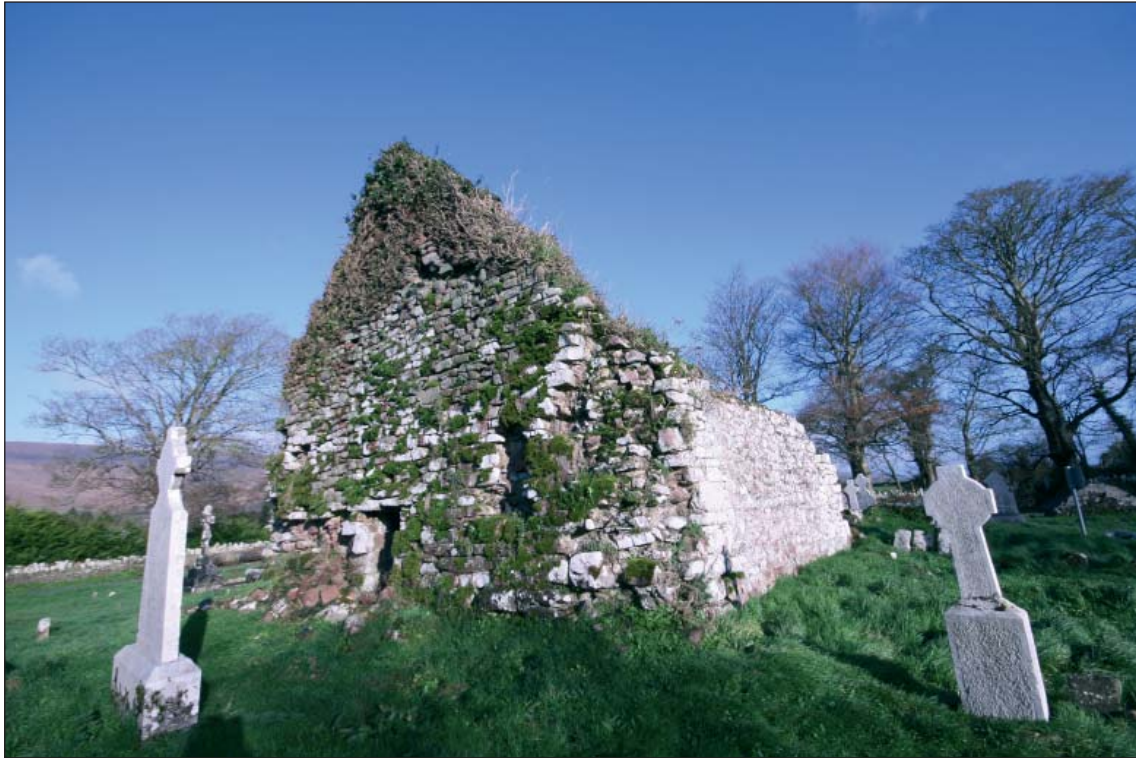
Plate 1: View of Kilgarrylander church from WSW

The upstanding relict remains of the W gable and S wall are all that survives above ground of the parish church of Kilgarrylander (Figure 2 & Plate 1), much as O'Donovan (see above) recorded it in 1841. The W gable is in a poor condition but amazingly still stands to full height even though the outer facing stones have been robbed or tumbled out in several areas. Furthermore, the majority of the pointing has disappeared and there is extensive ivy growth also (Plate 2). There is a large pile of loose stones within and outside the doorway in the W gable which is also in need of much attention (Plate 3).

The surviving section of the S elevation stands to full height and is in a much better condition and well pointed (Plates 1 & 4-5).

The ivy and other growth should be cut back short and a conservation assessment of the upstanding remains of building undertaken. The vegetation should then be judiciously fully removed and the walls and openings should be repaired and re-pointed. The collapsed masonry in the interior should be collected, recorded and stored in the Kerry County Museum and re-used during any future conservation works at the church. No burials should take place in the inside or against the exterior of the church.

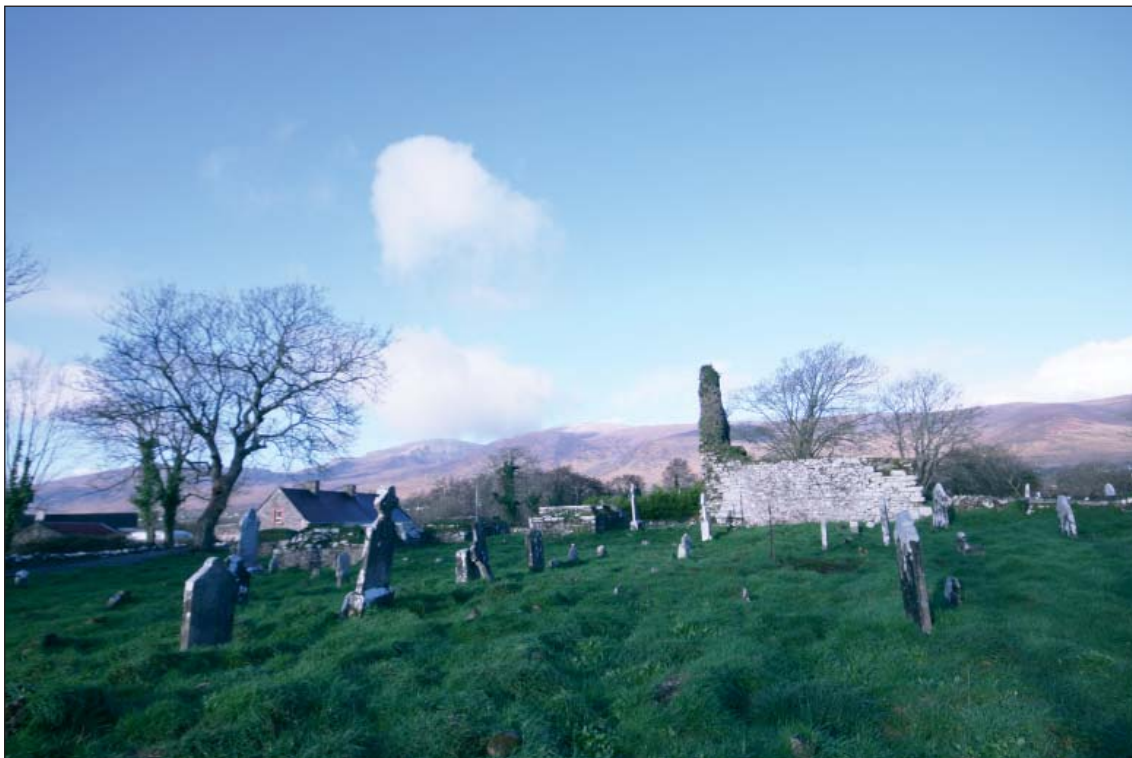
Keel Graveyard is bounded by a random rubble wall of local sandstone bedded in mortar and in general good condition although ivy has established itself on sections here and there. (Plate 12 & 13). The NW limits of the boundary wall is low on the interior and has suffered much in the past from mature trees the stumps of some of which still survive (Plate 13).

Plate 7: View of western limits of Keel graveyard from W. Note very low boundary wall on right.

Impacted and low area of the boundary wall should be repaired and restored by personnel with a proven track record of experience in working with historic walls.

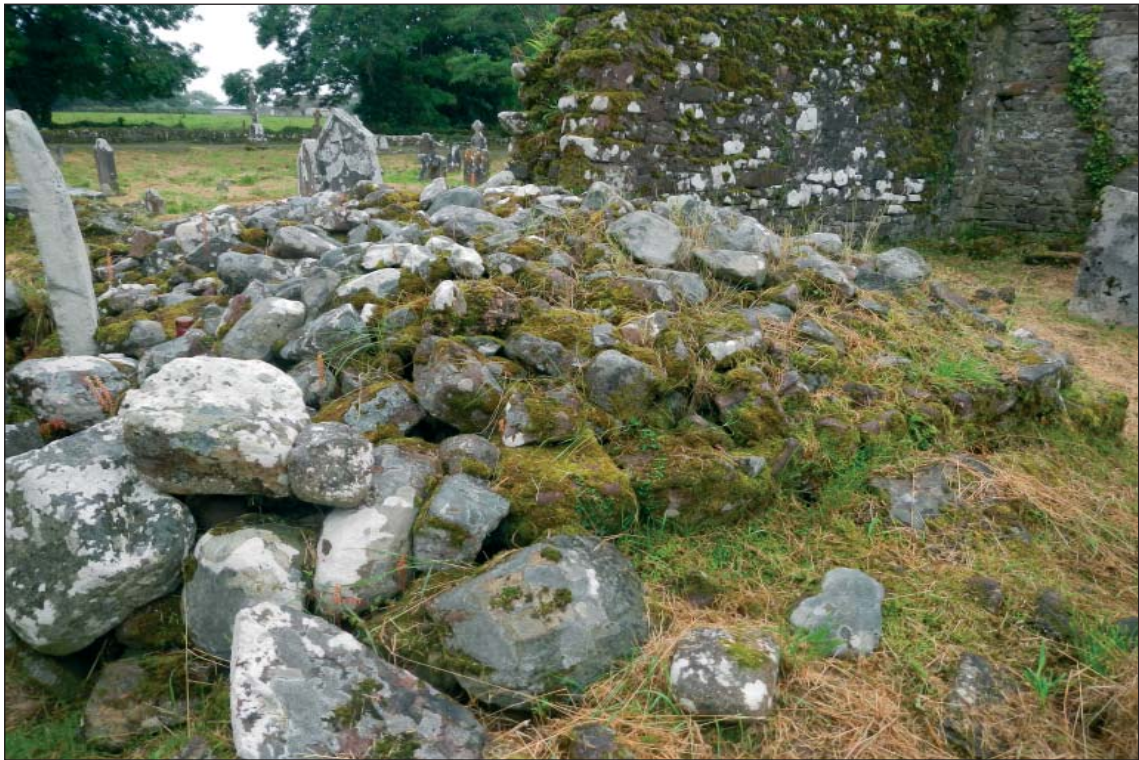
Plate 13: View of NW corner of Keel graveyard. Note (1) the stand alone headstone without formal grave setting; (2) partially blocked up disused entrance; (3) large tree stump situated on very low boundary wall

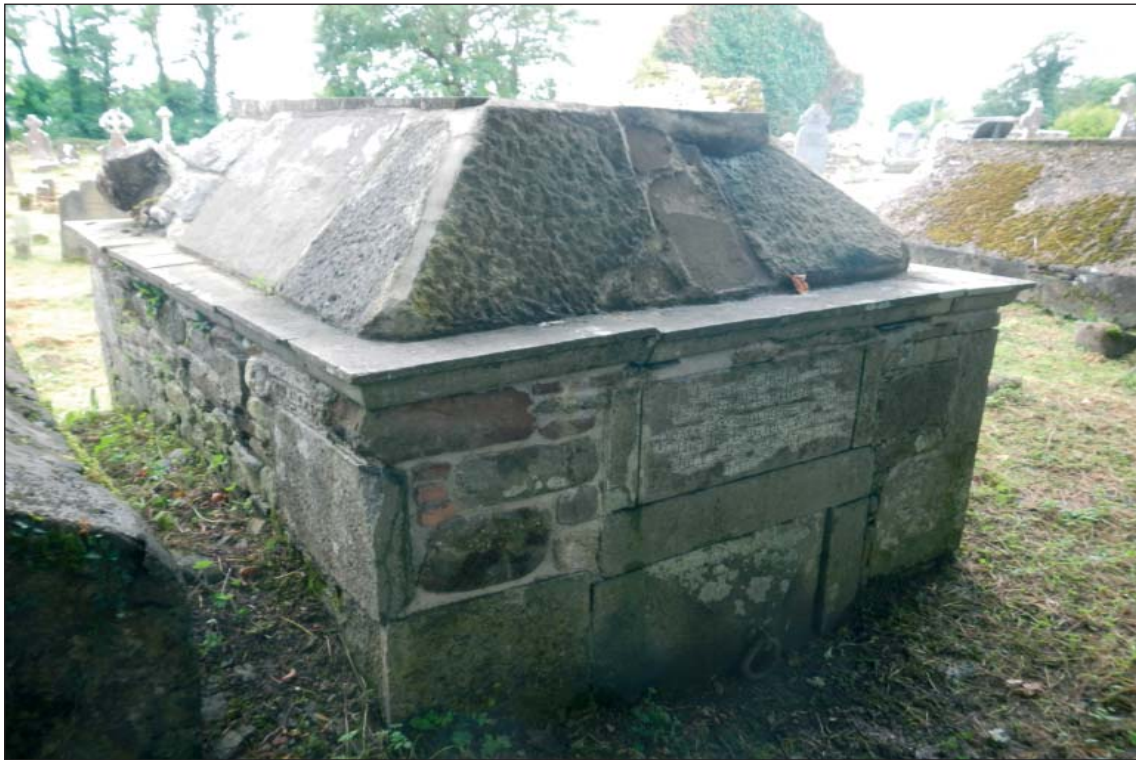
There were twenty-two tombs recorded in Keel Graveyard in the course of this survey (Figure 2 & Appendix 1). Several of the tombs are in various states of disrepair. Many other tombs have lost much of their render exposing a construction fabric of local rubble sandstone. The loss of render permits the growth of grass, briars ivy and other bushes on the tombs and accelerates their demise (Plates 15-16). The names on eight of the tombs are unknown. Of interest are the family tombs of the Langford family (TB 18) who first built Keel House in 1680 and also the Rae family (TB15) who bought Keel House from the Langfords and developed it into a large estate (Plates 17-18). The Rae tomb is in a very poor condition and requires much professional restoration.

Plate 15: View from NE of collapsed Tomb 13 in the interior of Kilgarrylander church

Neglected, overgrown and partially collapsed tombs should be repaired and restored. Growth on tombs should be cut back tight to determine the extent of the repairs required. Repairs to tombs should be undertaken by experienced masons with a proven track record of working on historic structures and in the use of lime mortar etc. This work should only be carried out under expert archaeological advice and supervision as it is most likely that architectural fragments from the medieval church of Keel may be incorporated within the tombs.

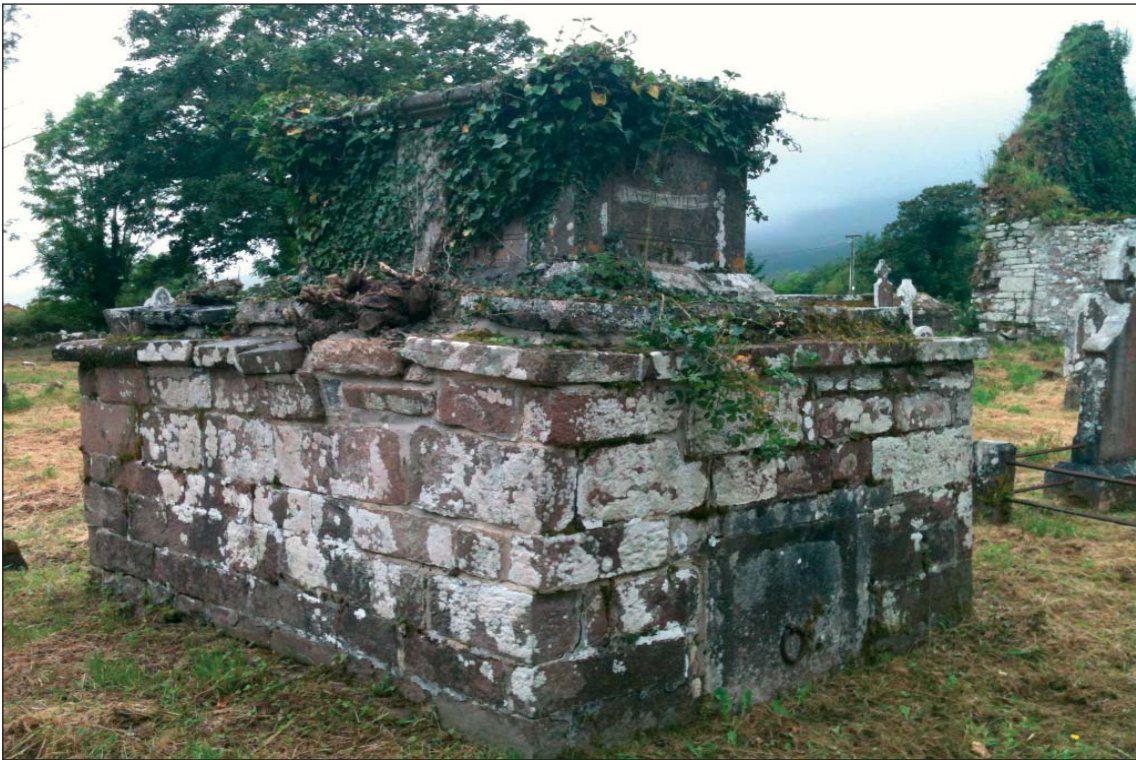
Plate 16: View of eroding and grass covered Tomb 5 from NE

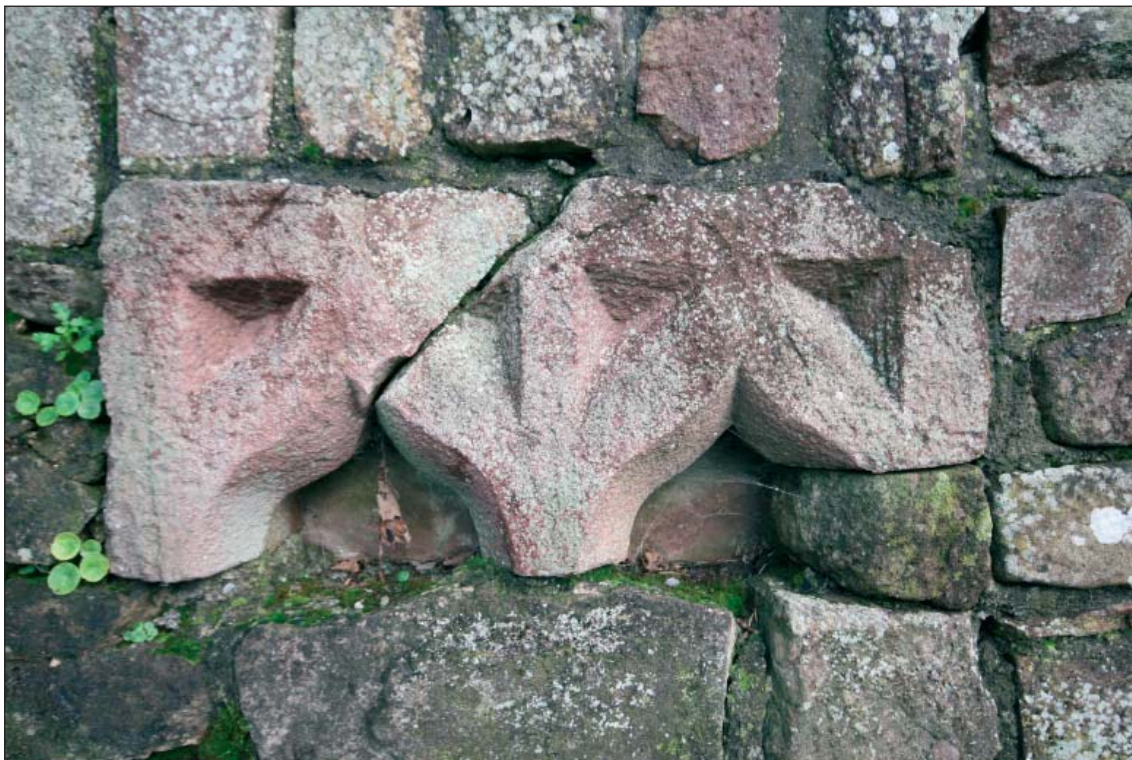
There were seven (7) cross inscribed headstones (CS) recorded in Keel graveyard (Figure 2 & Appendix 3). All but one have Latin crosses some with T-bar terminals. It is likely that two (Nos. 2 & 3) form a head and a footstone of one grave (Plates 21-22). They share the same shape and the design on CS3 faces that of CS2. Both slabs possibly date to the 18th century while the other five most likely date to the 17th or early 19th centuries.

Plate 21: View of unusual anthropomorphic cross-slab, CS2, with deeply carved Latin cross with T-bars to arms and possible alpha symbol over

The cross-slabs should be archaeologically illustrated.

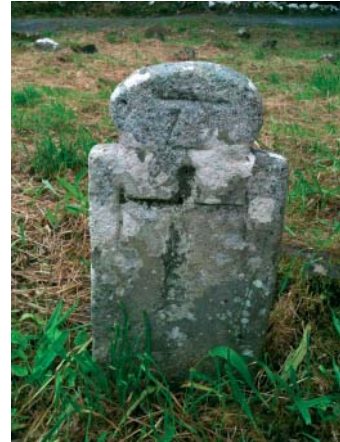
CS No: 2

Notes: Related to CS3

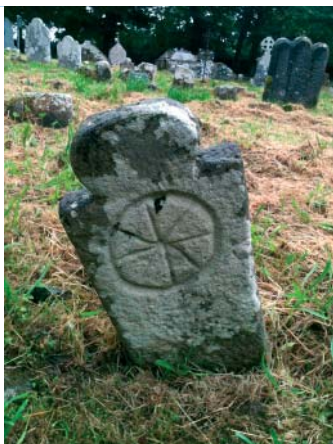
CS No: 3

Notes: Facing CS2

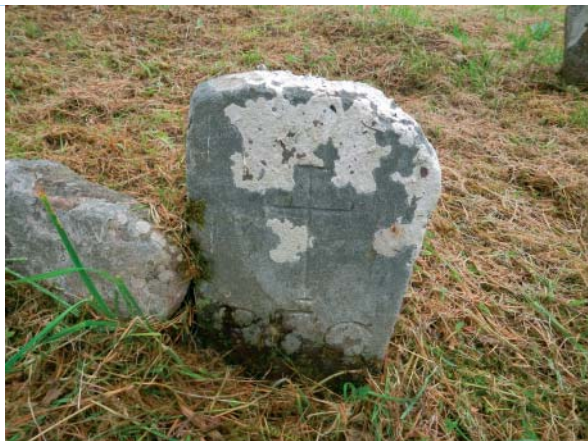
CS No: 5

Notes: Peg

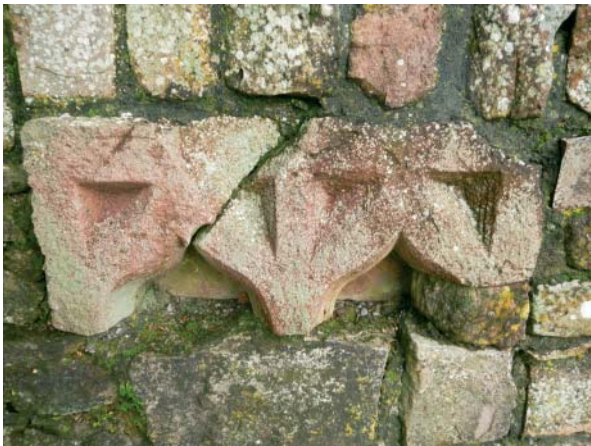
AF No:	25
Photo No:	147

Notes:	Ogee Window
--------	-------------
