Archaeological Survey,
Kilconly Church & Graveyard,
Ballybunnion,
Co. Kerry.

September 2007

RPM No.: KE001-028

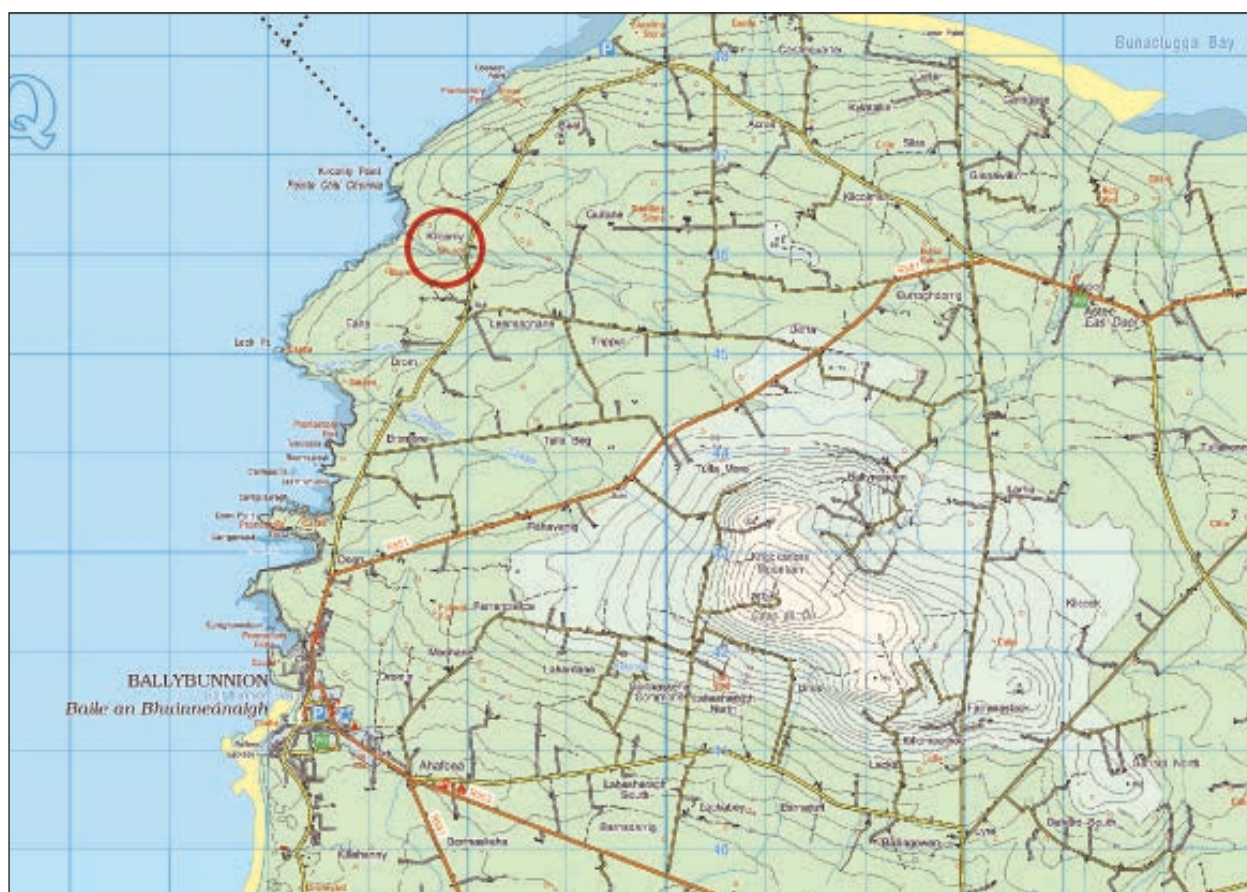
Figure 1: Plan of Kilconly Church and Graveyard 2007.

Kilconly graveyard was surveyed using a Trimble Pro X-H GPS (Figure 1). The survey is linked to GPS and tied into the National Grid. The graveyard plan was produced using Adobe Illustrator. Reference numbers mentioned in the main body of the report relate to the ID point given when the survey was undertaken. These numbers are illustrated on the attached A1 plan. A digital photographic record and surname database was also compiled to complement the cartographic survey (Appendices 1-2). Photographs of the features within the graveyard are referenced in the appendix and all photographs are provided on the attached disc.

The unnamed graves are composed of 18th and 19th century headstones from which the engraving has eroded, and recent graves which are without a headstone or the information card on the temporary metal cross has faded over time and is no longer legible. Unnamed headstones are grouped together with the unnamed gravemarkers on the plan of the graveyard (Figure 1).

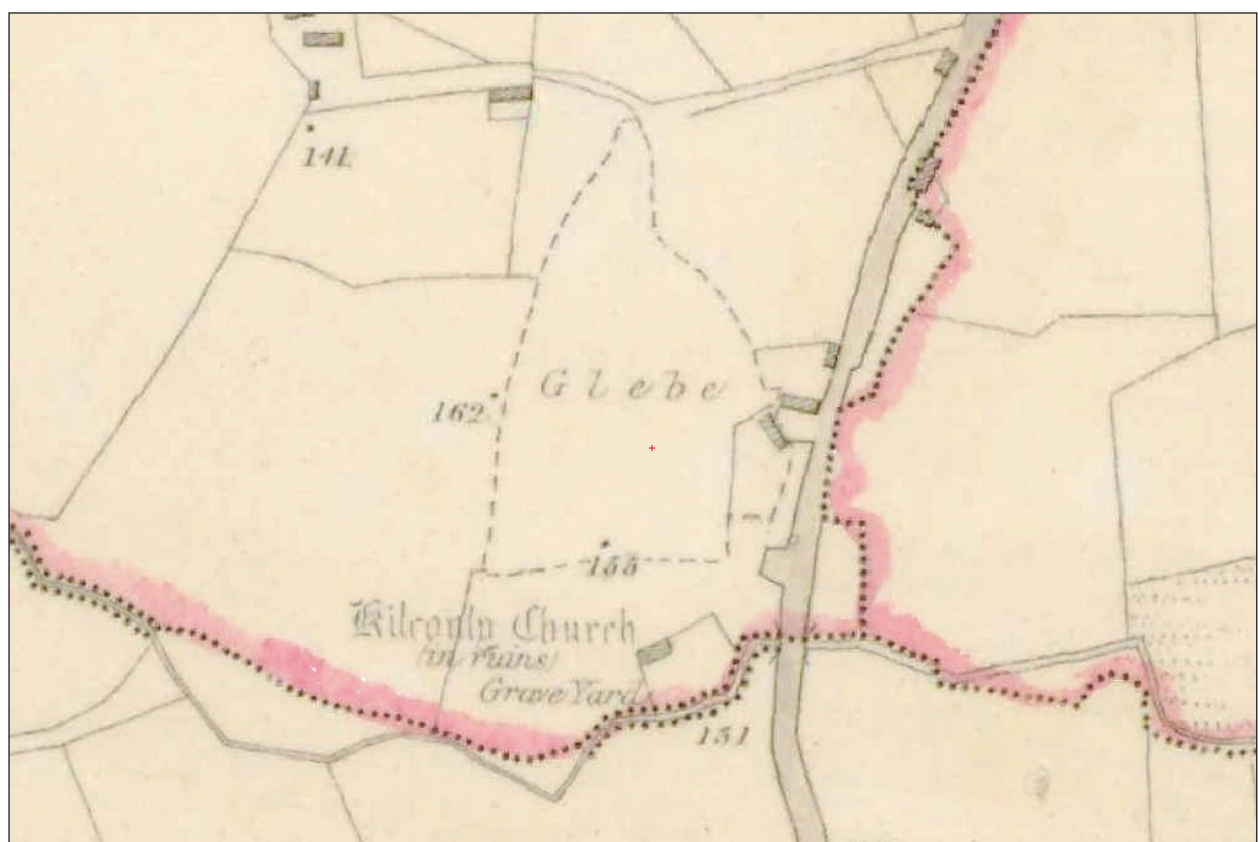
Figure 4: Extract from 1st edition OS map 1842 Sheet 1.

An examination of the 1st edition OS map of 1842 reveals the northern boundary wall originally abutted the northern wall of the church, which was in ruins at this time (Figure 4).

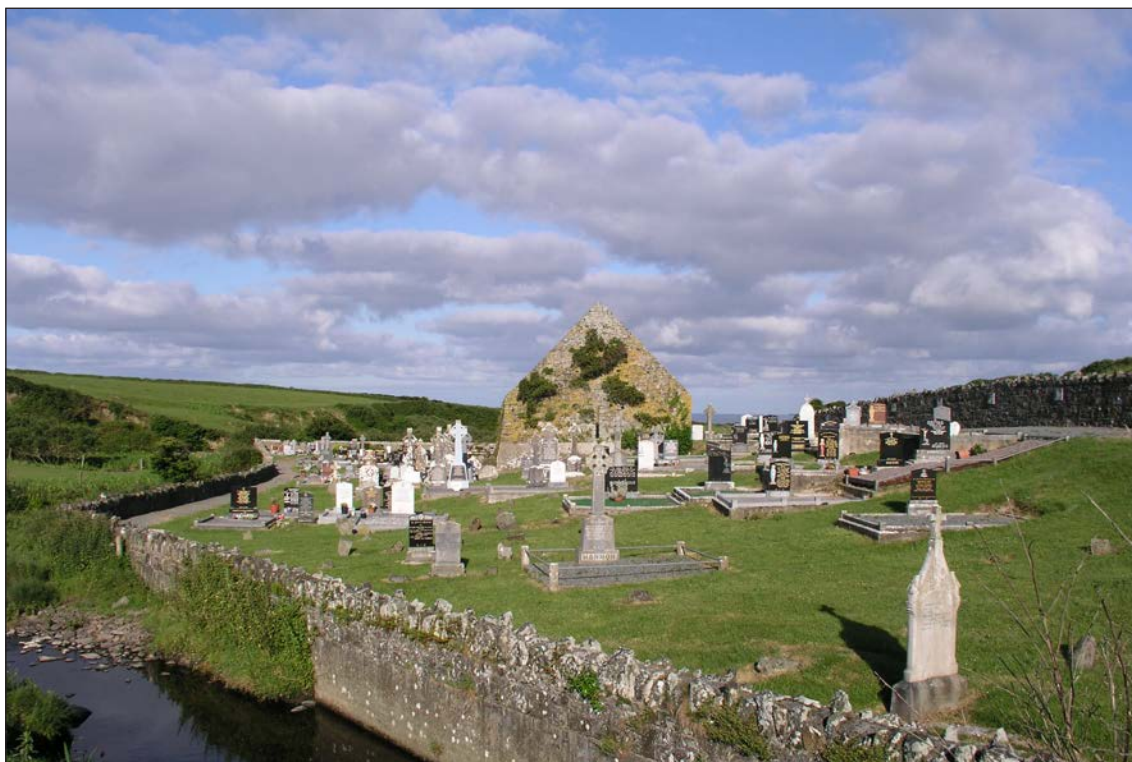
Plate 1: View of Kilconly Church and Graveyard taken from southeast

The boundary walls and interior of the graveyard are well maintained and in a good state of preservation.

The main area of the graveyard is bounded by a rubble sandstone wall with irregular coping with forward pointed sand and cement cap render visible between the stones (Plate 1).

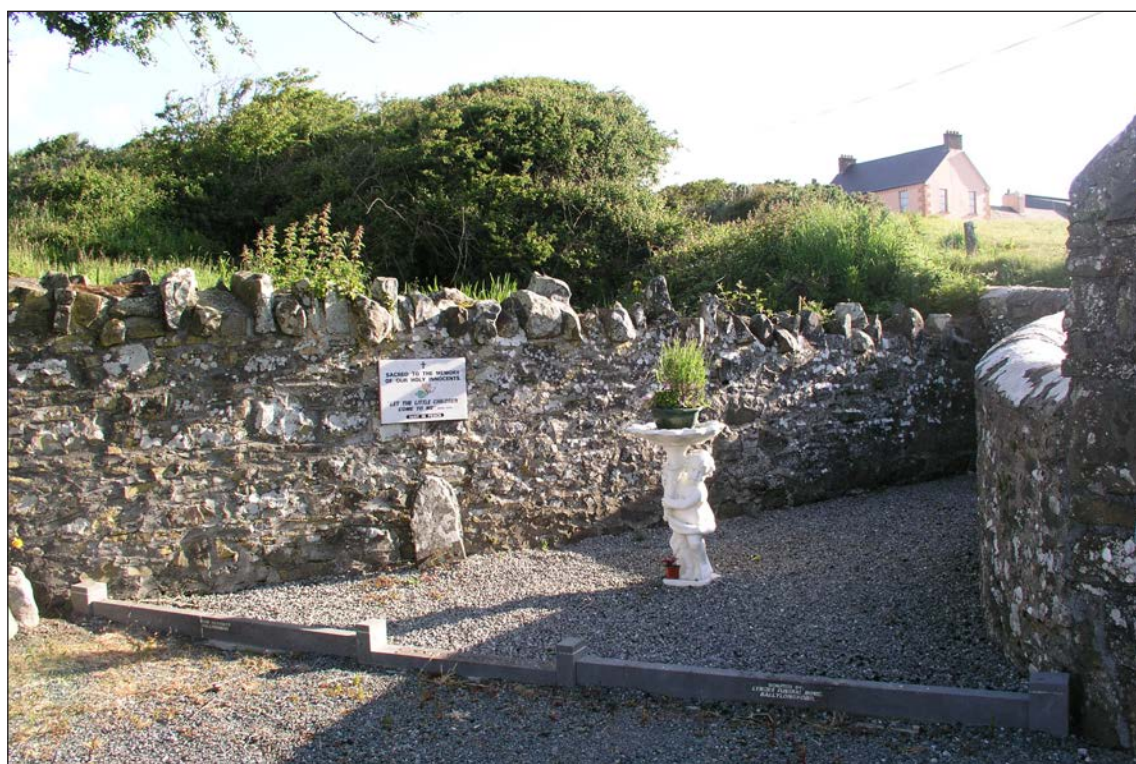
Plate 2: View of set-aside for Children's Burial Ground taken from west

A set-aside for a Children's Burial Ground is located immediately north of the entrance on its interior (Plate 2). The Whitethorn tree is situated adjacent to this set-aside.

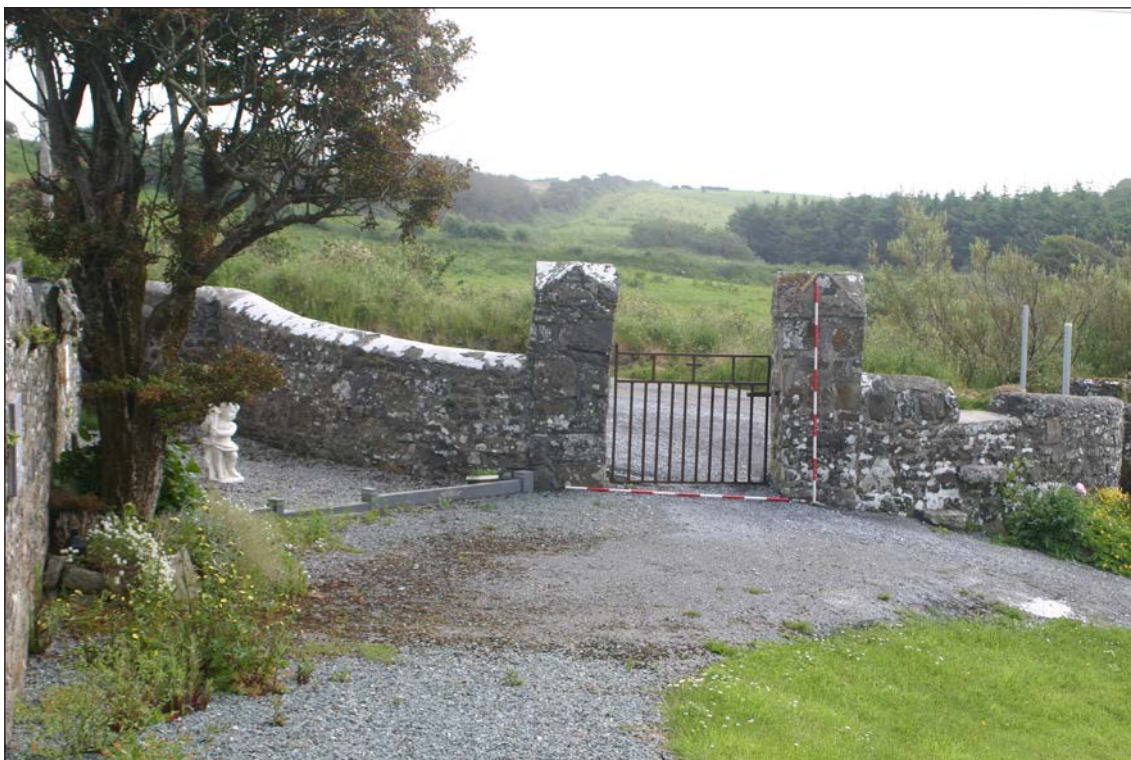
Plate 3: View of entrance to graveyard taken from west

Entrance to the graveyard is through an iron gate set between two gable capped stone piers or via a footstile (a single step on the exterior and two on the exterior) to the immediate south of the gate (Plate 3).

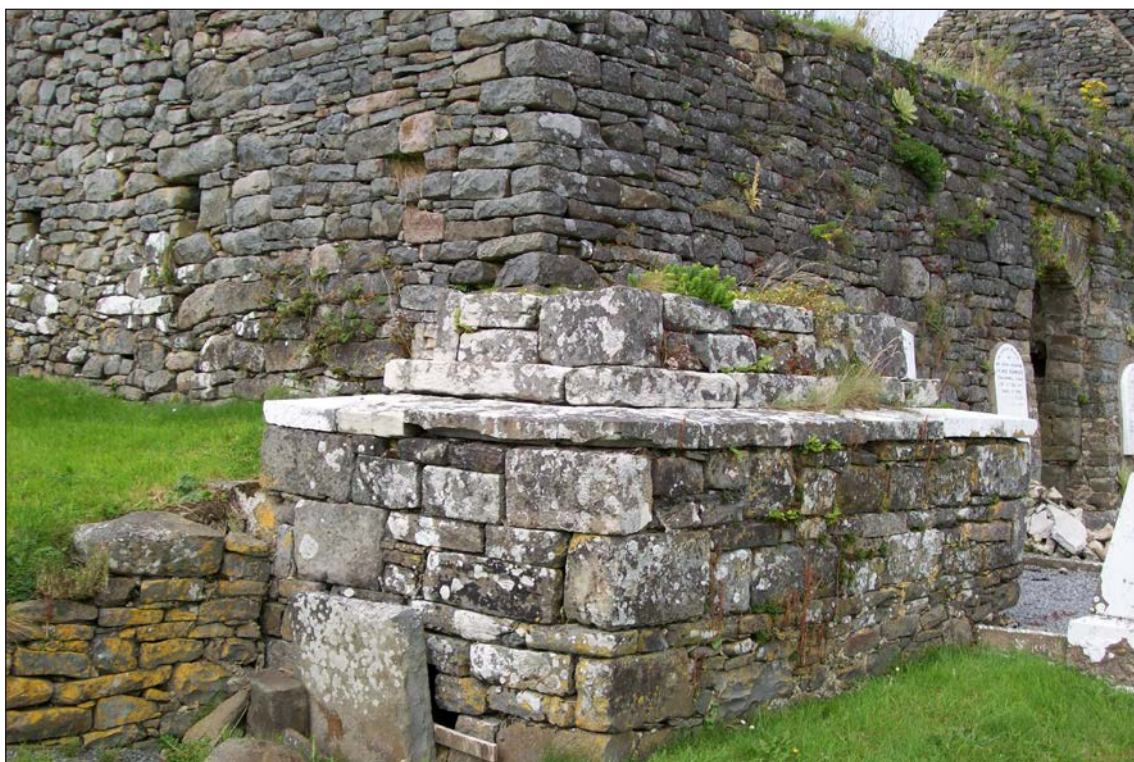
Plate 4: View of unnamed tomb recorded within the graveyard

A single tomb, unnamed, was recorded at Kilconly. This is abutting the southwestern corner of the ruined church (Plate 4).

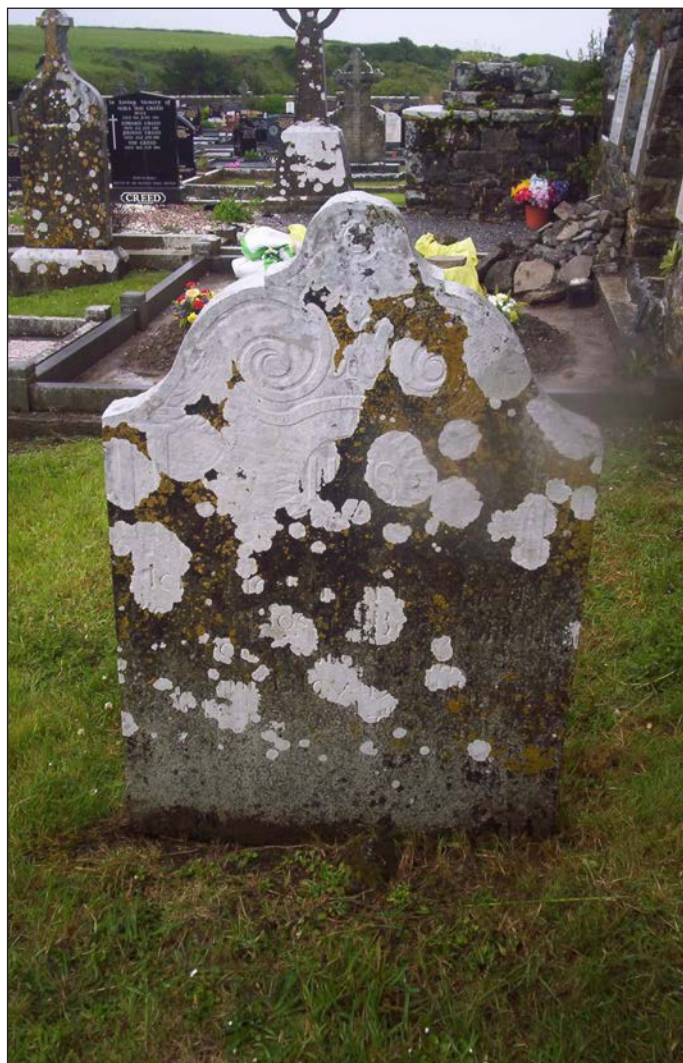
Plate 5: View of earliest recorded named headstone, dating to 1797 and recording the death of Joseph Carmody, taken from east

The earliest named grave recorded (ref. no. 445) is located to the south of the church and marked the burial place of a Joseph Carmody, who died on 30th September 1797 aged 37 years and Iain or Adam Carmody who died on the 7th April 1790 or 1799 aged 69 years (Plate 5). Due to erosion of the headstone, it was not possible to fully determine the exact year that Iain/Adam Carmody died or indeed, his exact name.

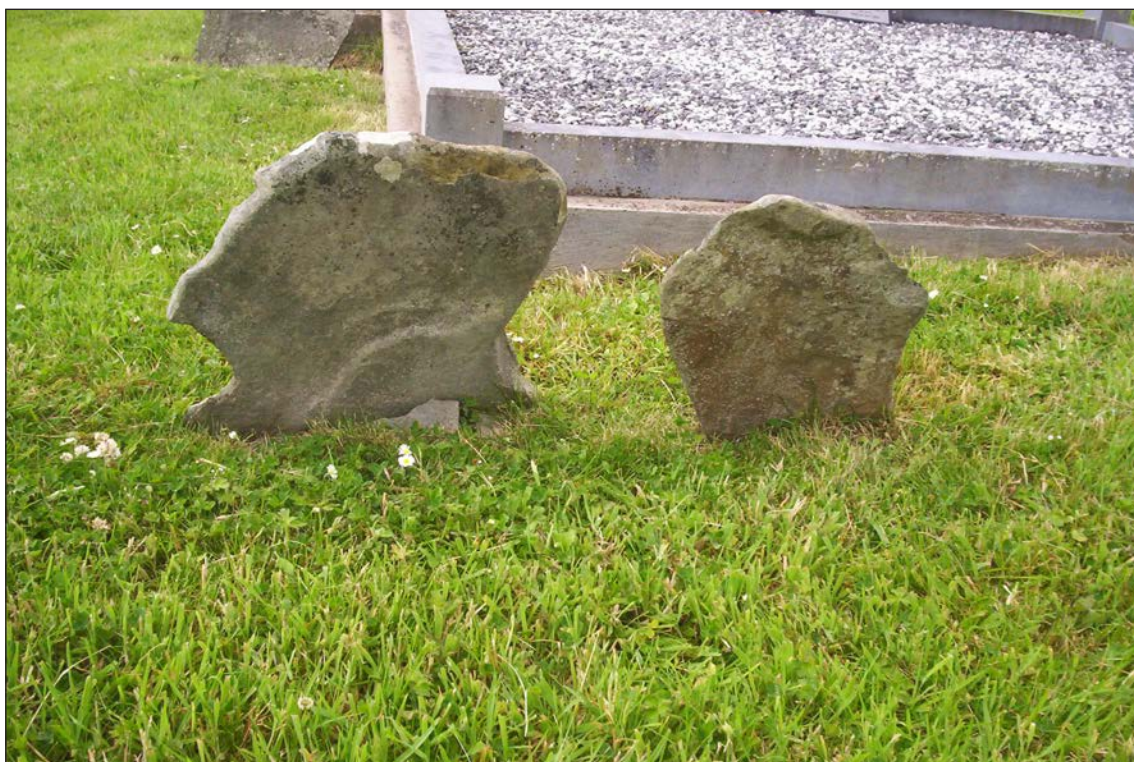
Plate 6: View of unnamed gravemarkers recorded in Kilconly graveyard, taken from east

They are generally low set and rise above the ground surface for an average 0.3m. Occasionally, a distinguishing feature of these stones is a semi-circular concave shape cut into the stone, often at the top of the stone. A number of such distinctive unhewn stone was recorded at Kilconly (Plate 6).

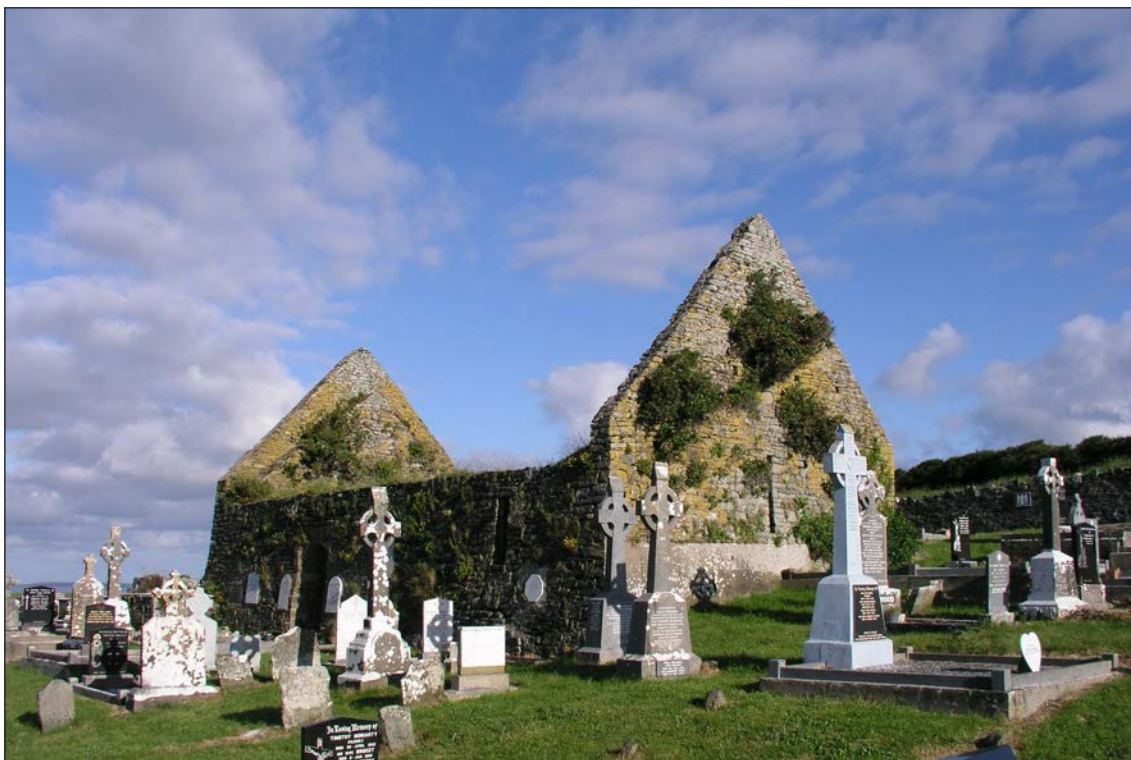
Plate 7: View of Kilconly Church taken from southeast

This current survey, undertaken in 2007, found that the church has remained in a remarkably good state of preservation (Plate 7). However, recent cultivated vegetation has gone wild and has taken hold on several areas of the church exterior and interior.

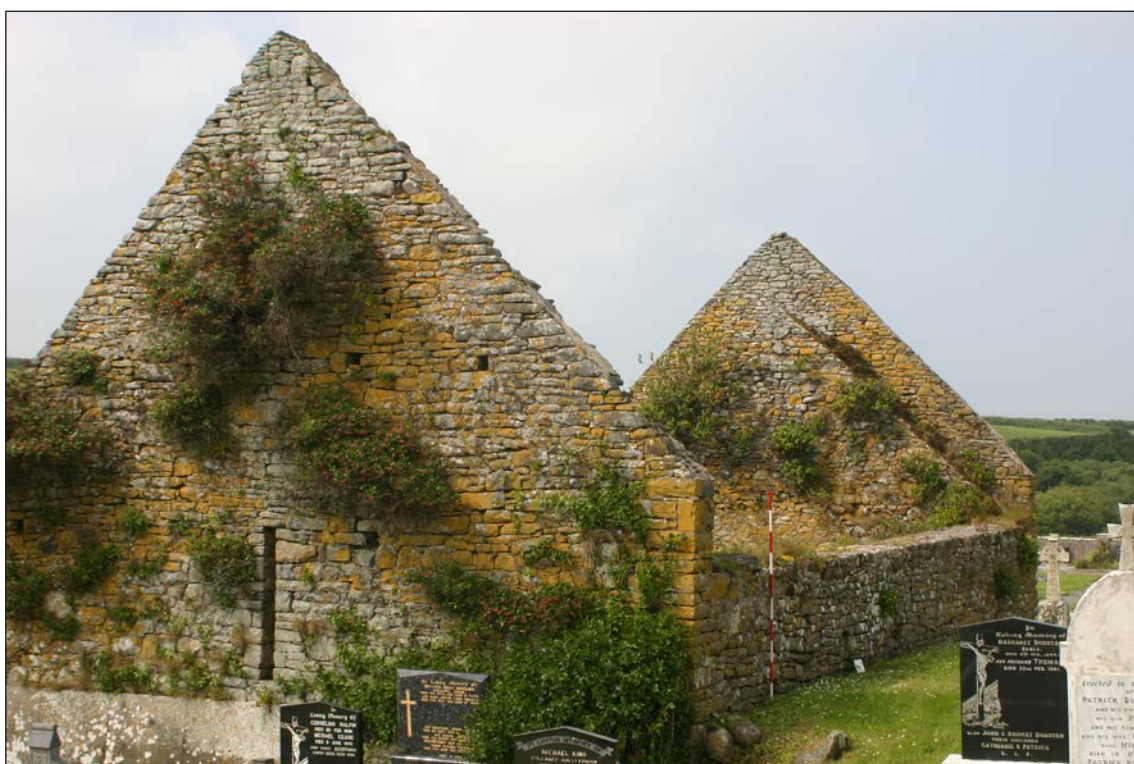
Plate 8: View of northern elevation and east gable, taken from northeast

The northern elevation survives to full height but as the ground rises sharply from west to north, it is only c.1.3m above present ground level (Plate 8).

The upper course of the wall has been tidied with a dressing of mortar.

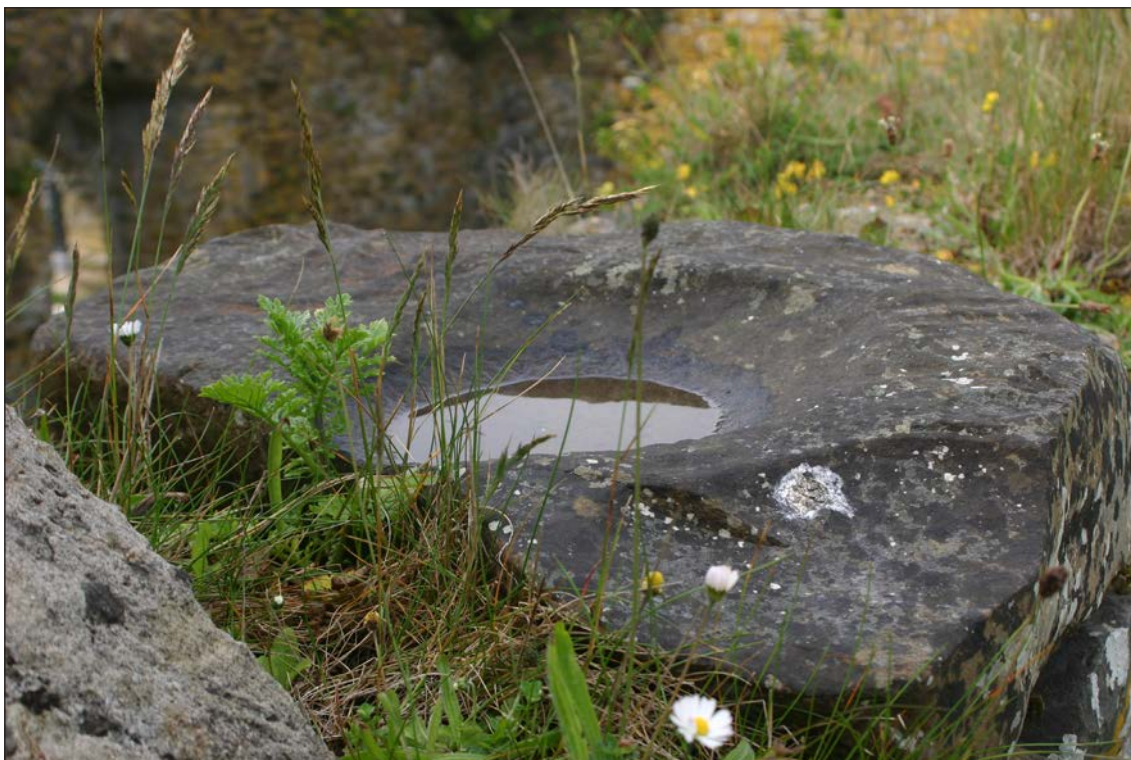
Plate 9: View of possible bullaun stone on top of northern elevation at its northeastern corner, taken from northeast

A possible bullaun stone is located on top of the wall at its eastern end (Plate 9).

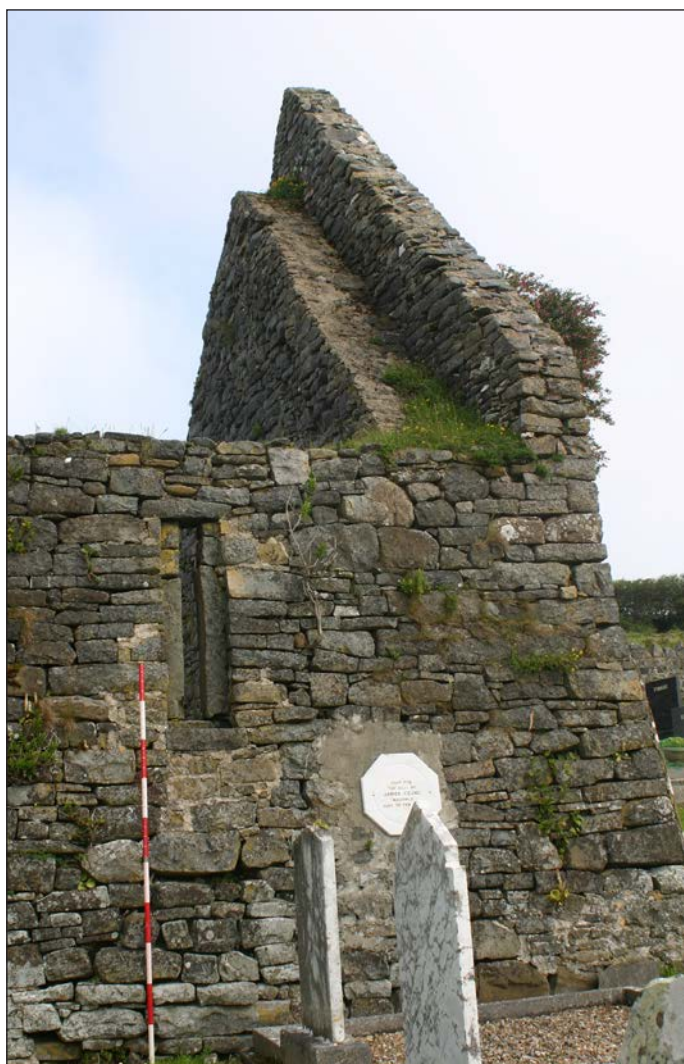
Plate 10: View of eastern extent of southern elevation taken from south

The church is built upon a north-south slope and consequently, the southern elevation is battered from the roofline to the base.

A rectangular slit window ope is located on the southeast corner of the southern elevation. It is comprised of undressed stone with a simple flat lintel and sill. It is slightly set back from the wall.

Six modern memorial plaques are fixed in concrete onto the elevation at varying heights.

The practice of cementing memorial plaques to the walls of the church should not be permitted in the future.

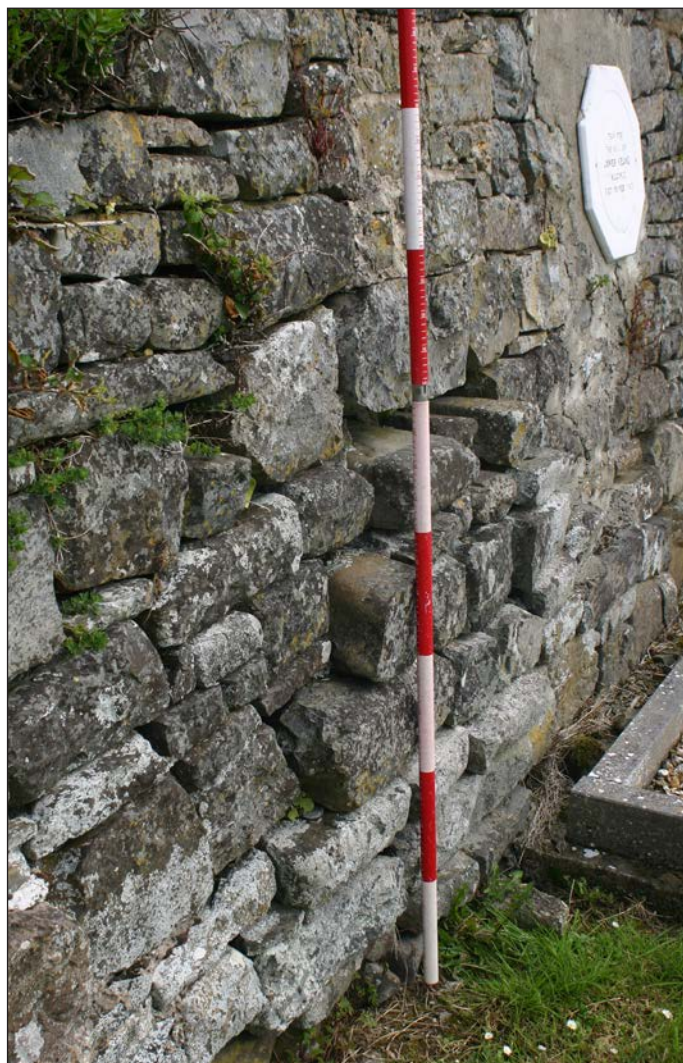
Plate 11: View of noticeable outward bulge directly beneath easternmost window on southern elevation

There is a distinct outward slump directly beneath this window and some modern cement repairs are visible but urgent attention is required (Plate 11).

The adjacent graves on the exterior and interior of the wall are most likely undermining the wall.

Urgent care is needed to prevent the collapse of the window ope on the exterior of the southeastern corner of the southern elevation.

- The practice of setting memorial plaques on the walls of the church, both interior and exterior, should no longer be deemed acceptable.
- The outward slump noted directly beneath the southeastern window on the southern elevation is in need of urgent repair to prevent its total collapse.

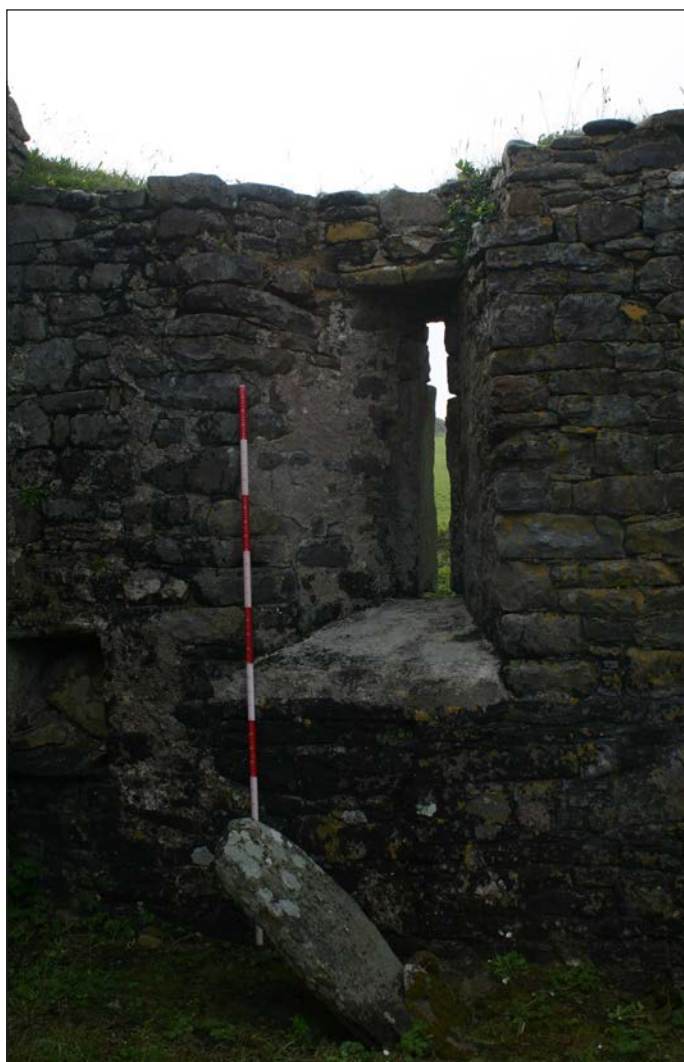
Plate 12: Interior view of easternmost window on southern elevation, taken from north

The south-east window has splayed ingoings with a socket for a shutter visible on the western corner of the split lintel (Plate 12).

There is no evidence for the base of this socket on the window sill as it has been rendered.

The interior lintel of the splayed embrasure is missing and the area of slump visible on the exterior, directly beneath the window, is also visible on the interior. The adjacent graves are most likely undermining the wall.

Urgent care is needed to prevent the collapse of the window ope on the interior of the south-eastern corner of the southern elevation.

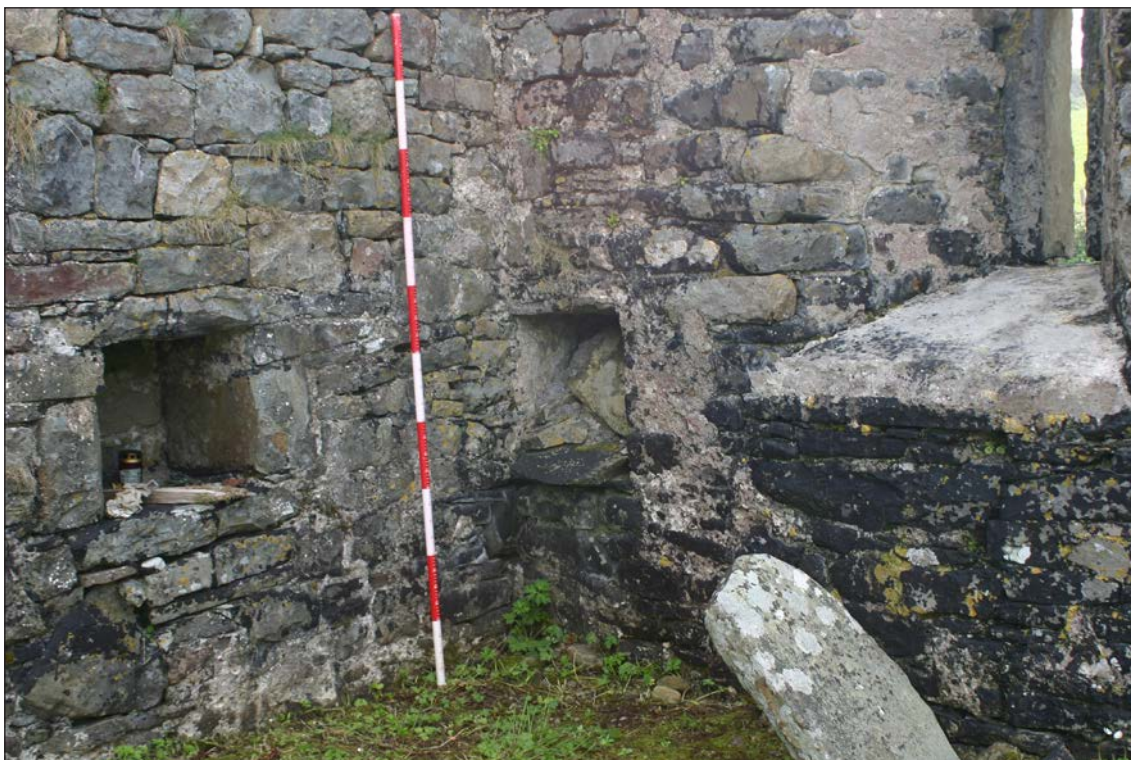
Plate 13: View of possible piscina at interior southeastern corner of southern elevation, taken from northwest

A square recess is located on the corner where the southern wall meets the eastern wall and is located 0.7m above present ground level.

It may have originally functioned as a piscina but rubble stone and waste cement has been dumped within it (Plate 13).

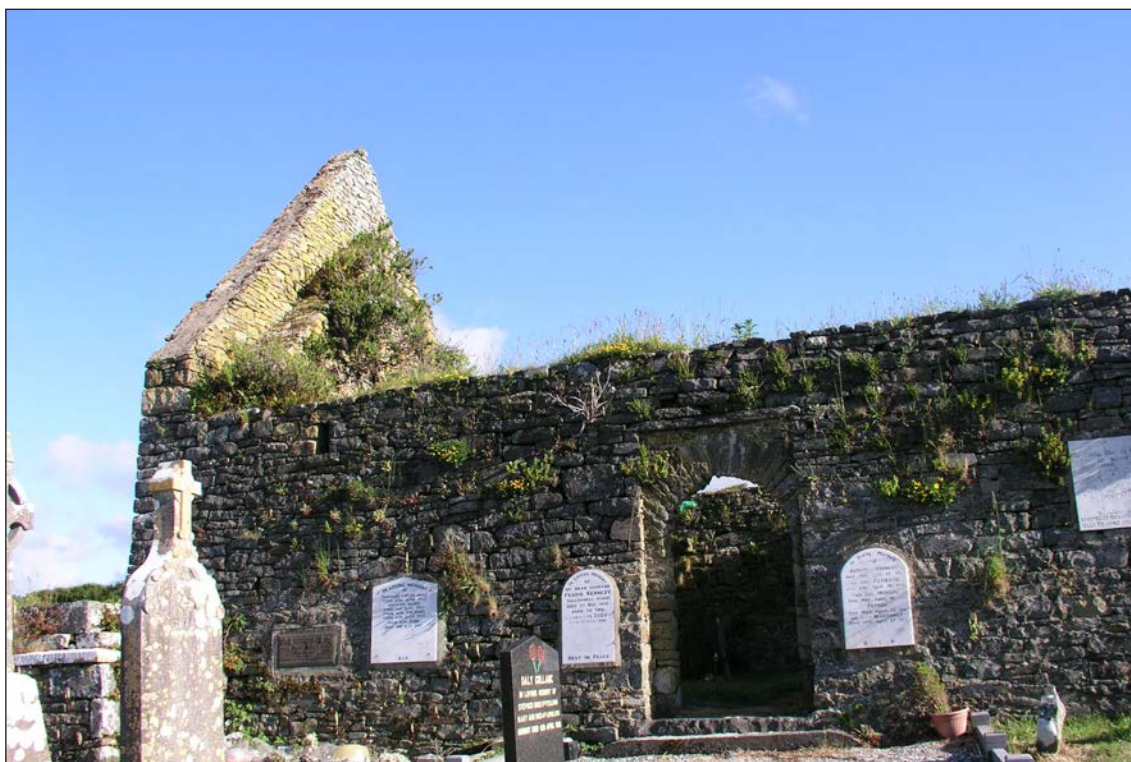
Plate 14: Exterior view of doorway in southern elevation, taken from south

A doorway, comprised of a circular arch of 22 voussoirs, is located towards the western end of the southern elevation (Plate 14).

The arch is slightly recessed from the exterior of the elevation and has slipped slightly on the western side.

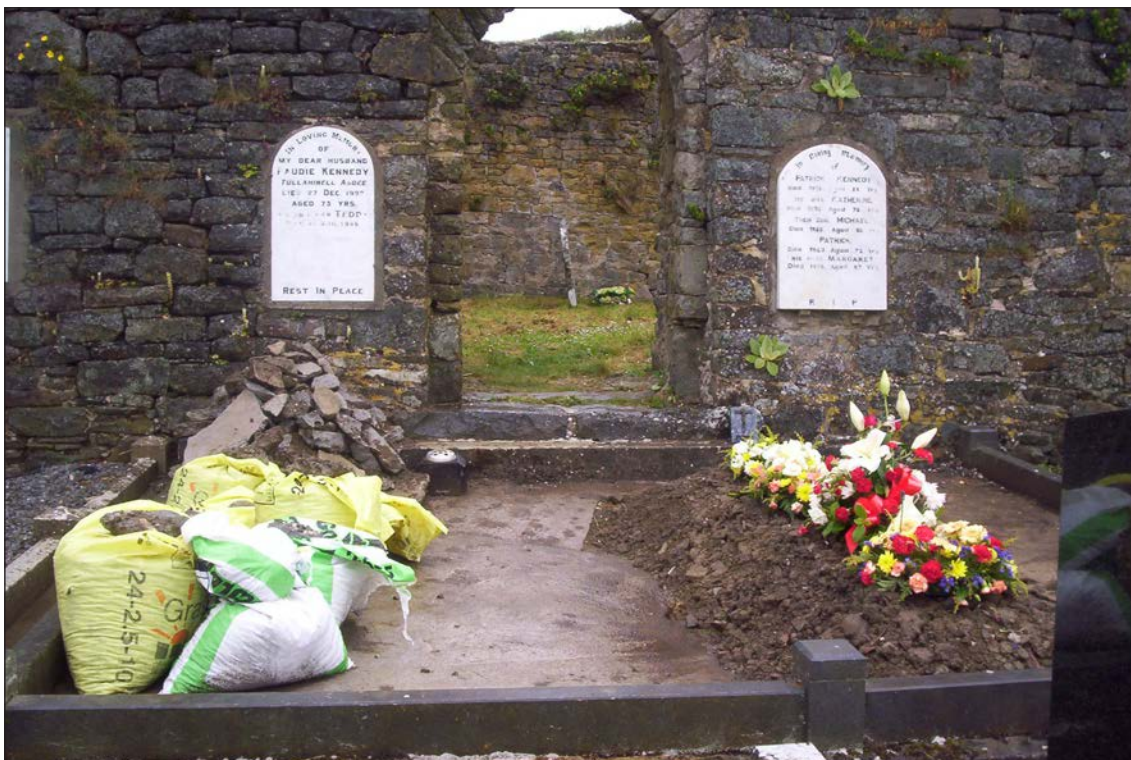
Plate 15: View of doorway showing recent internment in burial plot directly in front of doorway, taken from south

Two sandstone steps lead into the interior of the church, however kerbing from a modern grave surrounds the entranceway and access to the church cannot be gained without walking over the grave-plot which is still in use, as a very recent burial (approximately one to two weeks previous) had taken place prior to undertaking the survey at the site (Plate 15).

No further interments should take place within the burial plot directly in front of the doorway. It may be necessary to divide in two and judiciously reduce the burial plot to allow a direct accessway to the doorway from the existing ground surface. This work may require Ministerial Consent.

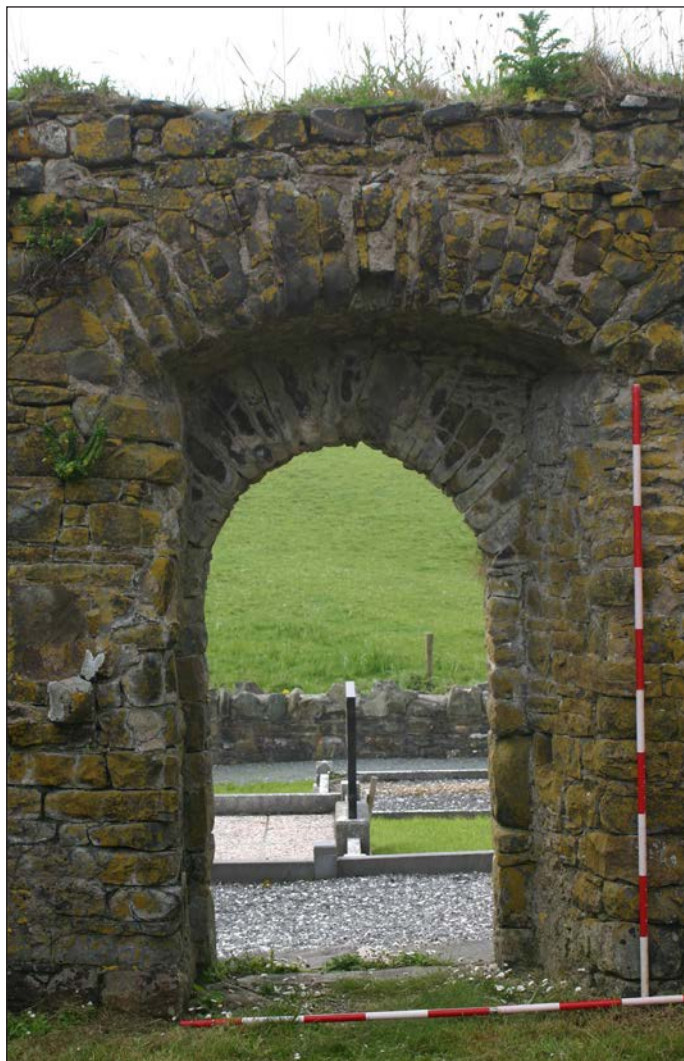
Plate 16: Interior view of doorway in southern elevation, taken from north

The interior arch is a flattened segmental type and the arris of the arch has been removed (Plate 16).

Splayed ingoings are present on the western side of the doorway while the eastern side is composed of straight ingoings.

The socket for the drawbar is situated on the western side of the doorway while it would have extended into the eastern side.

A broken holy water stoop of local sandstone is noticeable to the immediate east of the entrance.

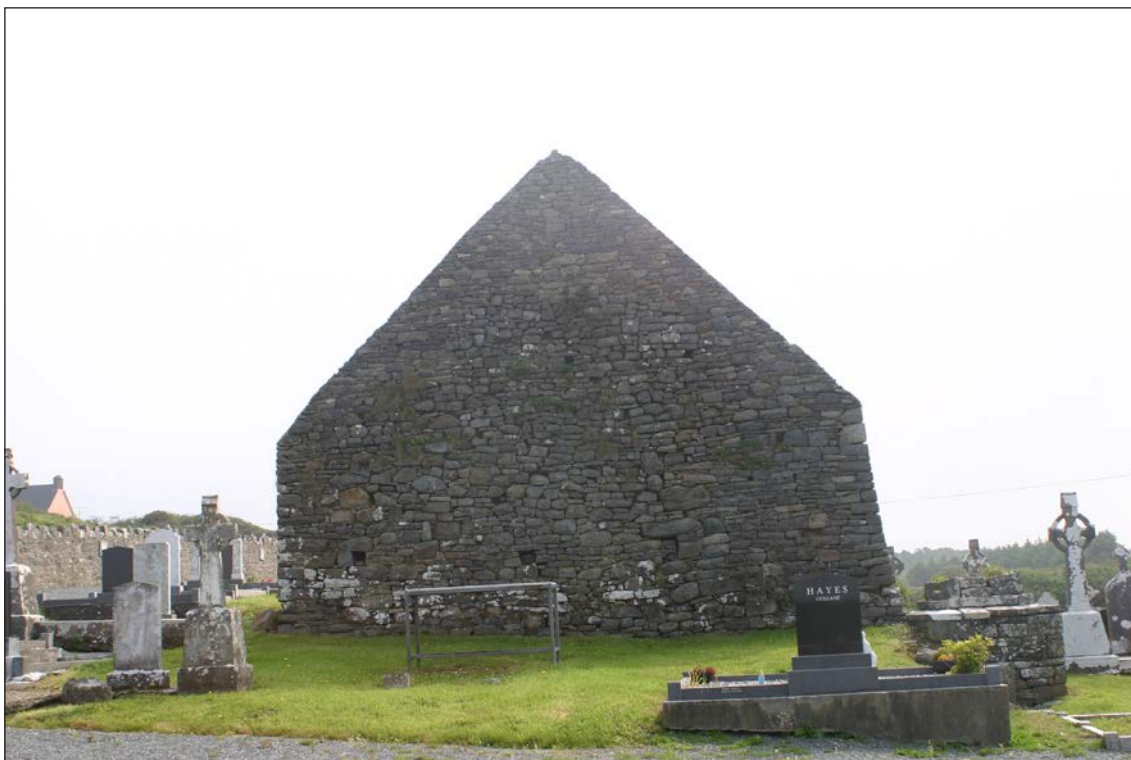
Plate 17: Exterior view of west gable, taken from west

The west gable survives to full height and is in a good state of preservation.

It is composed of well matched, roughly coursed, flat rectangular blocks of sandstone (Plate 17).

Three through apertures are located 1.2m above present ground level and these may have allowed light to penetrate into the church interior or a listening posts for the less well-off parishioners attending mass.

Several put-logs are visible on the upper level of the elevation.

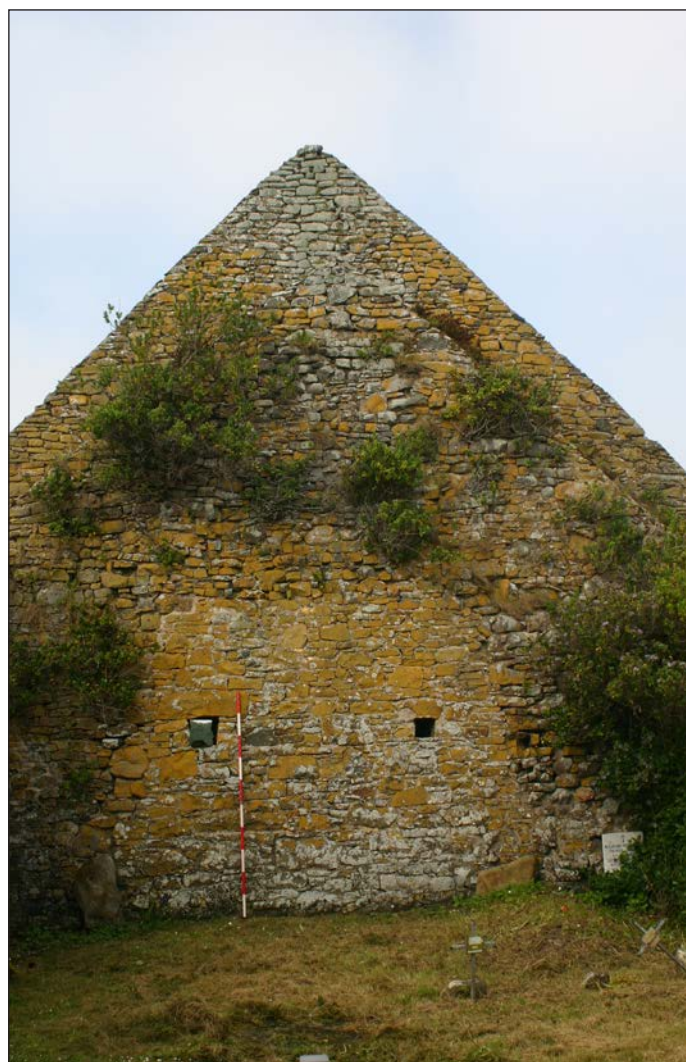
Plate 18: Interior view of west gable, taken from east

The interior of the western elevation is featureless apart from the through apertures that may have allowed light into the church as well as allowing sound to travel outside (Plate 18).

Modern vegetation is well established on wall, especially on its upper levels.

A modern headstone plaque is fixed onto the wall at the northwestern corner and is partially obscured by the overgrowth.

The overgrowth of vegetation should be cut back and removed under archaeological supervision.

The practice of fixing headstone plaques onto the walls of the church should be prevented.

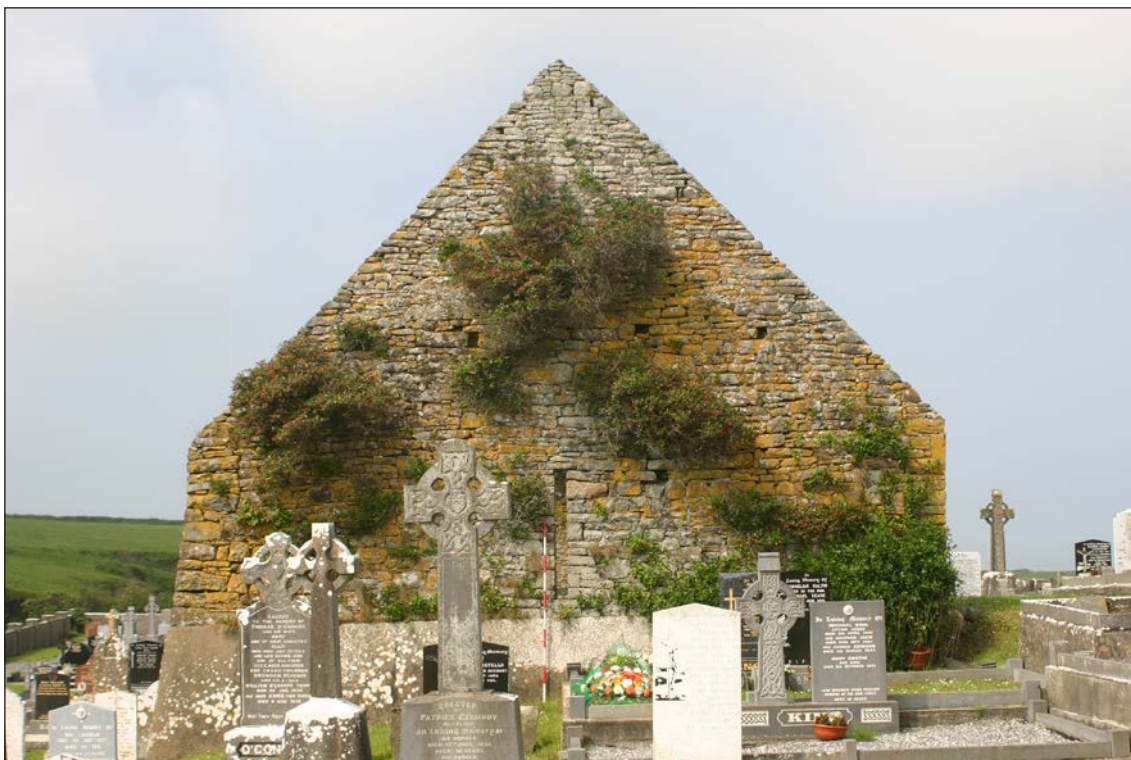
Plate 19: Exterior view of east gable, taken from east

The east gable survives to full height and is in relatively good condition (Plate 19).

The elevation is lit by a centrally disposed single narrow rectangular slit window ope of undressed stone, located 1m above present ground level.

Several put-logs are present on the upper levels of the elevation.

A modern concrete plaster panel is located on approximately 60% of the wall and tapers in height (from south-north) from 1.6m to 0.9m.

There is substantial modern vegetation established on the upper levels of the wall. Several crows' nests are visible within this growth.

The overgrowth of vegetation should be cut back and removed under archaeological supervision.

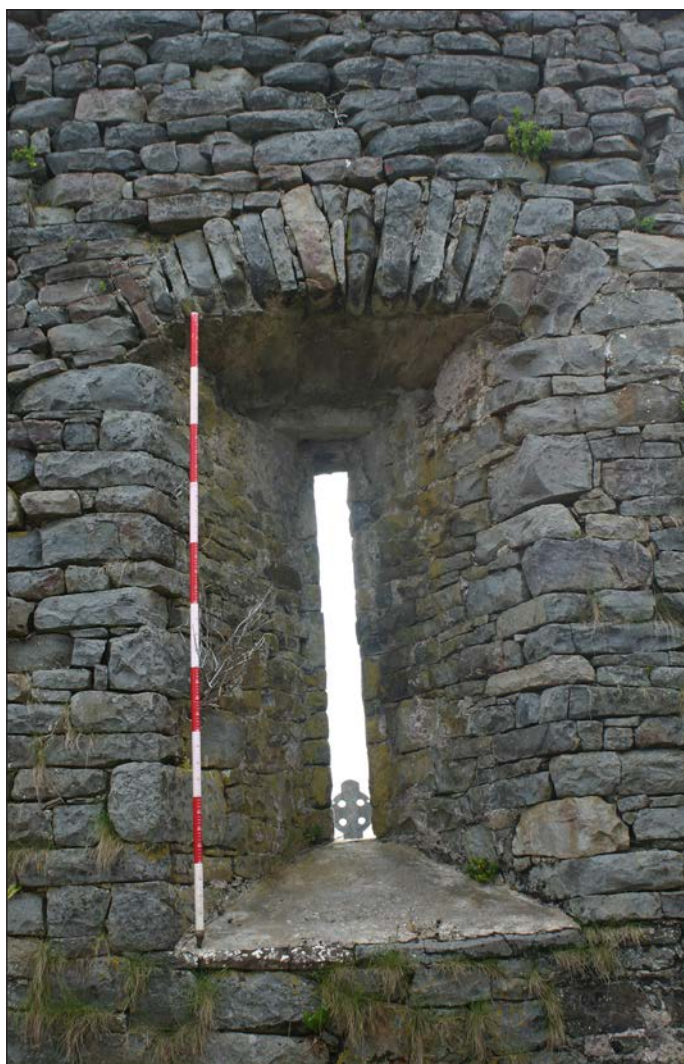
Plate 20: Interior view of window in east gable, taken from west

The window ope on the eastern gable has a splayed embrasure and is composed of well matched sandstone with a flattened segmental arch over (Plate 20).

A shutter socket is also present on the northern side of the window ope but no base socket was visible.

Two intra-mural recesses or aumbrys are located on either side of the window and the northernmost recess has been filled with loose rubble stone.

Recent removal of a course of masonry beneath the arch of the window has taken place and this may undermine the window and cause its eventual collapse.

The arch of the window ope is in need of urgent repair to prevent its total collapse.

- The arch of the window ope on the interior eastern elevation requires urgent attention to prevent its collapse.
- No further interments should take place within the burial plot directly in front of the doorway. It may be necessary to divide in two and judiciously reduce the burial plot to allow a direct accessway to the doorway from the existing ground surface. This work may require Ministerial Consent.
