Date: October 2009

Project code: TGSK09

Archaeological Survey, Kilcummin Graveyard, Kilcummin, Co. Kerry.

RMP No.: KE058 072

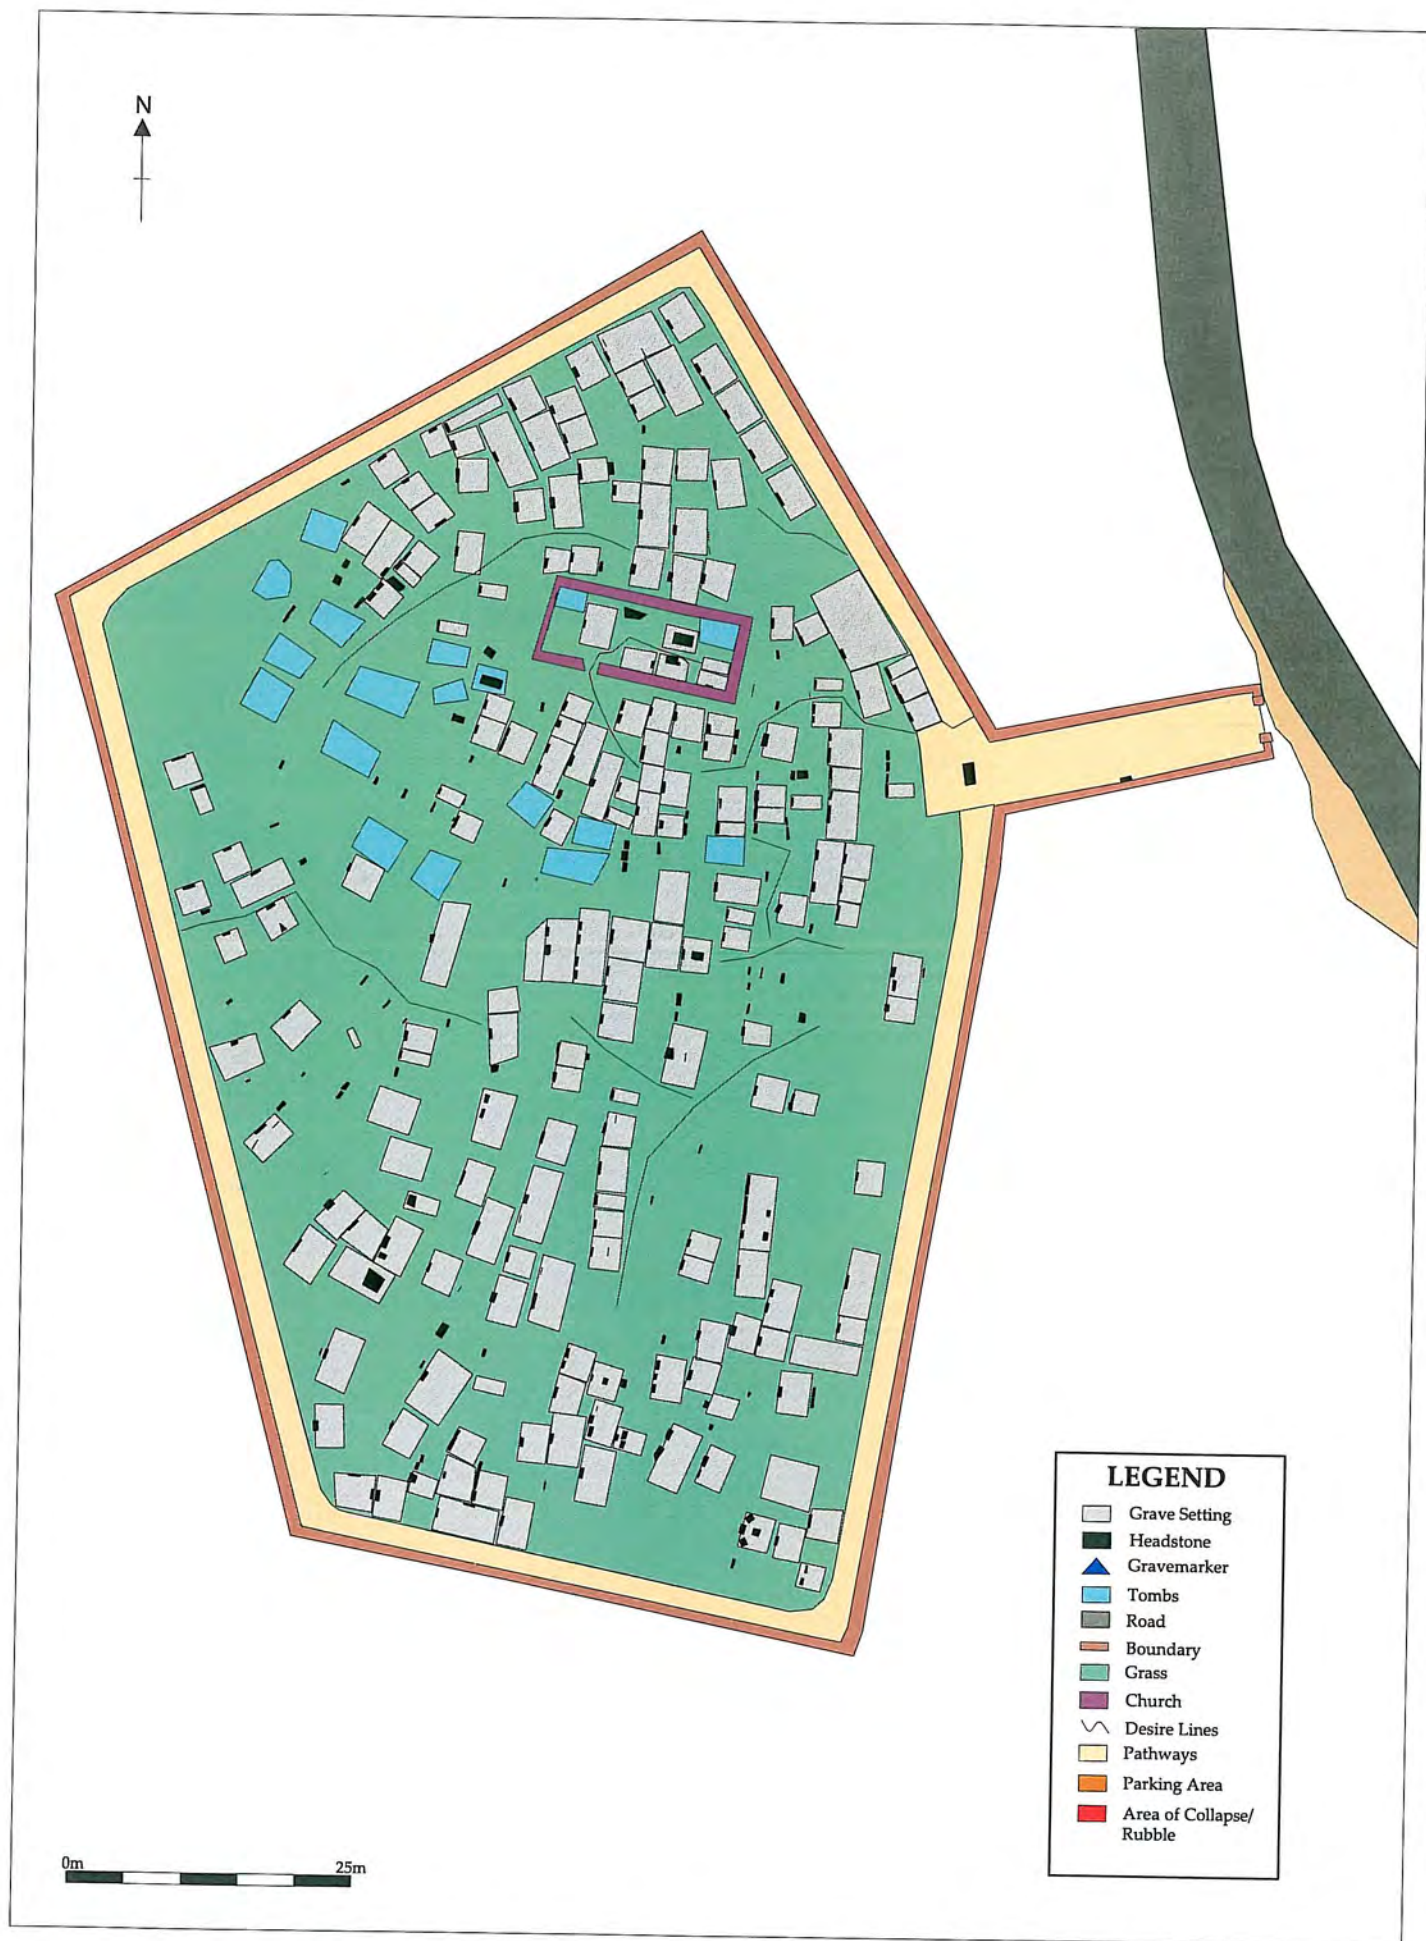
Figure 3 : Archaeological Survey, Abbey Island Church & Graveyard, Co. Kerry.

This report presents the results of an archaeological survey conducted at Kilcummin Graveyard, Kilcummin, Co. Kerry (Figure 3). The work was undertaken in accordance with survey specifications provided by Kerry County Council.

The report comprises an accurate plan showing boundaries, the location of paths and desire lines, gravemarkers, tombs, architectural fragments, extant remains of churches or buildings and dangerous areas of ground collapse. A photographic survey of headstones and gravemarkers is linked back to the survey drawings. Also included in the survey are written descriptions of buildings, cross-slabs and early enclosures; statements on the condition of these buildings; suggested suitable/necessary remedial action that may be needed to secure these structures; breaches of the boundary walls, open or collapsed tombs and the condition of paths and entrance gates. A photographic survey of damaged and dangerous structures or features is also included.

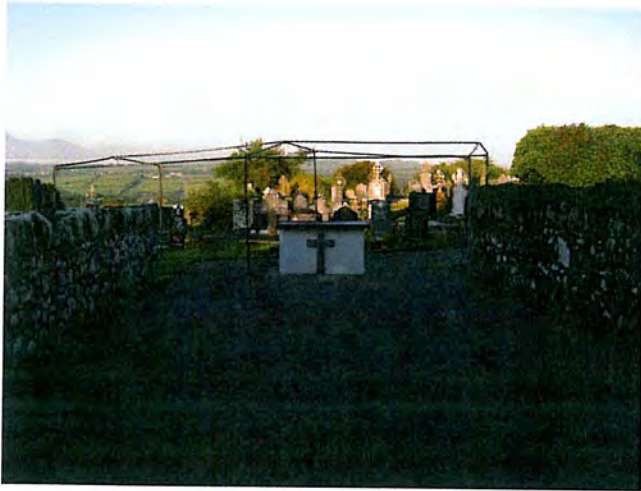
Plate 01 View of alter, facing west.jpg

Before entering the actual burial ground there is an altar, decorated with a cross on the east and west side, around and above it is a frame (plate 1). The entire graveyard is enclosed by a mortared stone wall, with vertical stones on the top. Along the wall runs a gravel pathway, however most visitors seems to use desire lines and these are crossing the graveyard.

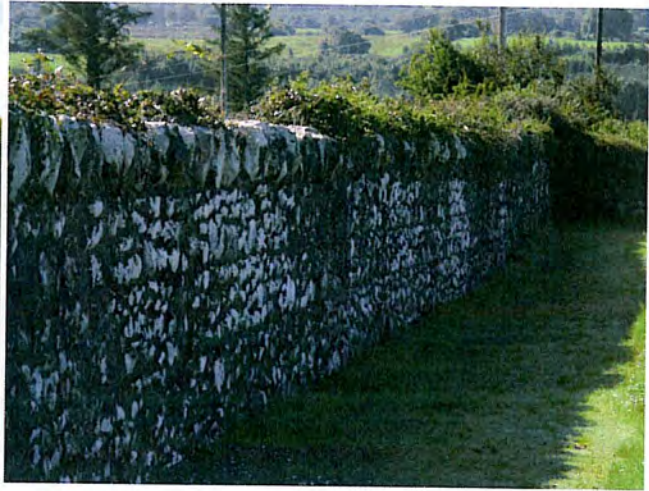
Plate 02- View of boundary wall.jpg

The entire graveyard is enclosed by a mortared rubble stone wall, with vertical coping stones on top, with little or no vegetation present (plate 2).

The walls appear to be stable and free of overgrowth, periodic monitoring should be carried out to ensure that this remains the case.

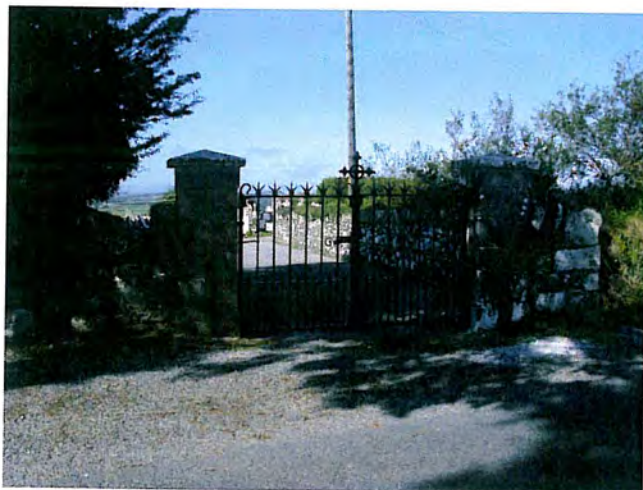
Plate 03- View of gated entrance, with disused stile to ri...

The only entrance is to the east with a cast iron gate, with a disused stile in the wall directly to the south of the gate (plate 3). Inside the gate is located, on the south side, a memorial plaque (plate 4) inscribed;

The entrance to the graveyard is in good condition. The gates should be treated for rust and painted as and when such measures are needed, and continued to be kept clear of vegetation and debris.

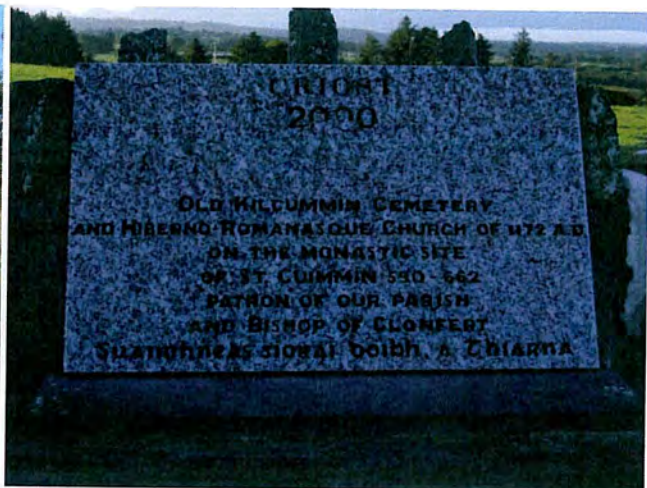
Plate 04-Memorial Plaque.jpg

*Criost 2000
Old Kilcummin Cemetery
and Hiberno Romanesque Church of 1172 AD
On the Monastic site of St Cuimmin 590-662
Patron of our Parish and Bishop of Clonfert
SUAIMHNEAS SIORAI OOIBH, A THIARNA*

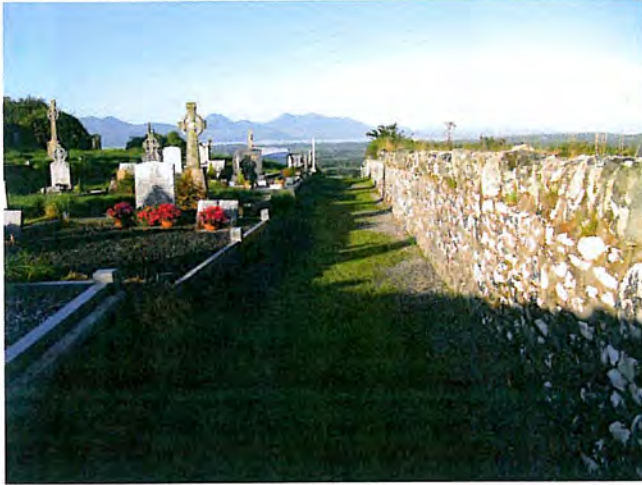
Plate 05- View showing pathway, facing south-west.jpg

There is a pathway which runs along the boundary wall enclosing the graveyard which is in good condition and free of any obstacles (plate 5).

The existing pathways are in good condition and periodic monitoring should ensure that they remain so.

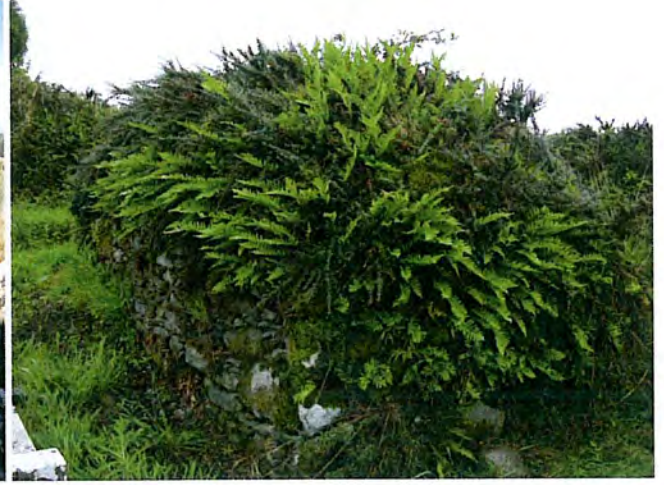
Plate 06- Grave no. 289, overgrown tomb.jpg

Of the 23 tombs that were identified during the survey, only six were named, the remainder had either weathered to the point of illegibility, grave no. 289 for example (plate 6) or were so covered by vegetation that name plaques could not be identified, for example grave no. 312 (plate 7). As is consistent with such high status burials, the tombs are concentrated in an area surrounding the ruinous church.

The control of all vegetation attached to the tombs should be the primary aim, this would help to prevent further degradation of these features. Ivy should not be removed however as to do so would most likely destabilise the more fragile examples. Particular attention should be paid to grave nos. 136, 307 and 315, all of which are suffering badly on account of the encroaching vegetation.

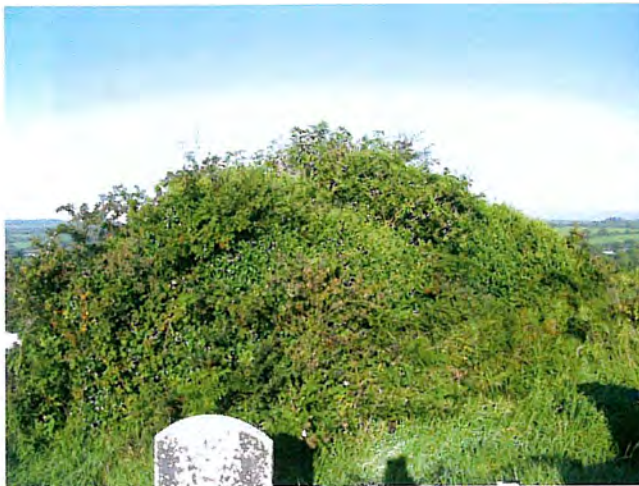
Plate 07- Grave no. 312, overgrown tomb.jpg

Overgrown vegetation was a common problem across the site, with 15 of the tombs being thoroughly overgrown by Ivy, brambles, ferns and other vegetation. Of the remainder, the most common tomb type was of a tooled limestone fabric with chamfered tooled limestone caps, good examples being grave nos. 094 and 095 (plate 8). Grave no. 130 had rendered walls and a rendered cap and so the construction material could not be determined (plate 9). Also of note were two table tombs, grave nos. 289 and 295 which are of tooled limestone fabric (plate 10).

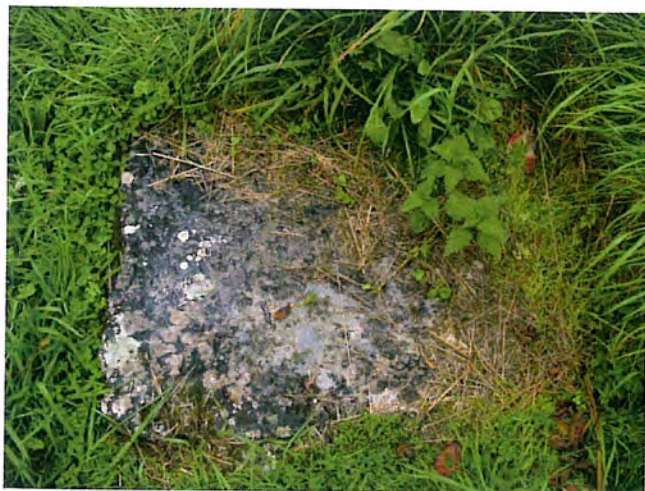
Plate 13- Grave no. 137.jpg

There are 21 unnamed headstones and grave plots throughout the burial grounds, with some that once bore names, now lost due to weathering, e.g. grave no's. 107, 110 and 170 (plate 11). Overgrown vegetation may cause further destabilisation of headstones and plots which may result in occurrences similar to those seen at grave nos. 105 and 137 (plate 12), where the headstones now lie down on the ground.

Where possible, steps should be taken to prevent further degradation of this sort. The control of overgrown vegetation would also be of benefit to the plots and headstones as this would make them more clearly visible and prevent accidental damage being caused to them by visitors to the grounds and also prevent the destabilisation of the headstones.

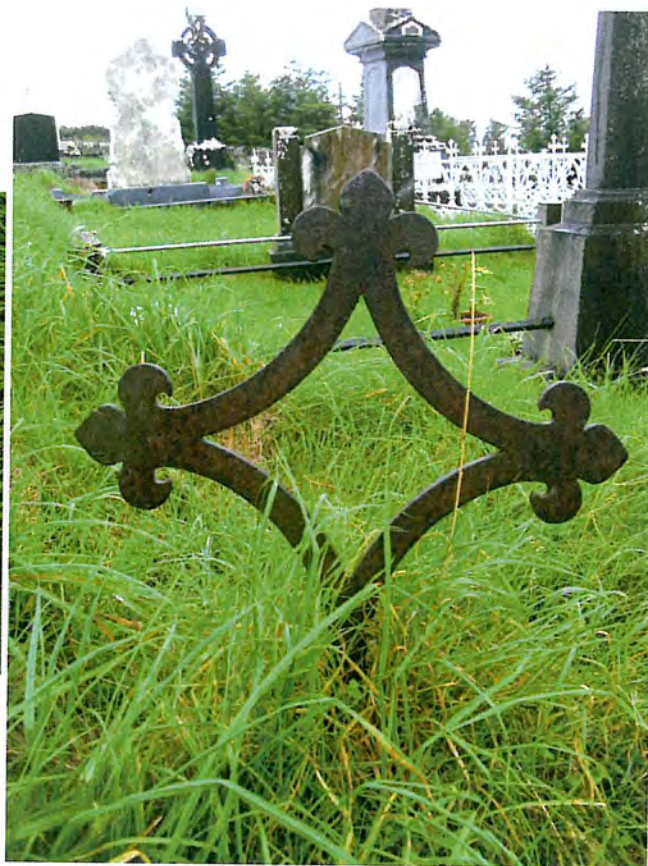
Plate 14- Grave no. 089, iron cross.jpg

Six unnamed gravemarkers were identified during the survey, all of which were of the iron cross type. All of the markers bar one conform to the same standard design, this being that of a simple crucifix with an attached circular band. The exception being grave no. 089 which is of a simple design with inverted bands and trefoil motifs (plate 14). The cross of grave no. 320 is not in situ and is located leaning against the boundary wall to the southwest corner of the site (plate 15). The gravemarkers all appear to be in a stable condition with the obvious exception of grave no. 320.

A simple rust treatment may help prolong the survivability of these interesting features. The cross associated with grave no. 320 should perhaps be secured in its current position to prevent it becoming dislodged and damaged.

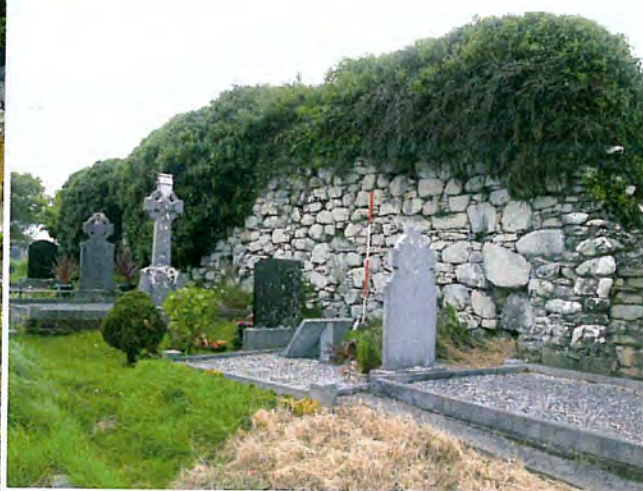
Plate 16- View of north elevation of church, facing sout...

To the northern section of the site stand the ruinous remains of a single-cell, double-height barn style church, which dates to the 16th or 17th century. The building appears on the first edition OS maps as being ruinous at the time of survey. The church is of mortared rubble stone construction, with its walls surviving to a maximum height of approx 3m's. The walls are heavily overgrown by Ivy and other vegetation with the vegetation covering approximately 80% of the surface area (plates 16).

Control of the overgrown vegetation should be of primary concern in order to prevent further deterioration of the ruin. The Ivy should not be removed however, nor should any broad spectrum weed killers be applied as this would most likely destabilise the structure. Areas of exposed wall should be re-pointed using appropriate (lime) mortars with flush or recessed pointing. This would greatly benefit the structure and help secure it from collapse. Ribbon pointing however, must be avoided as its use would damage the structures historic character.

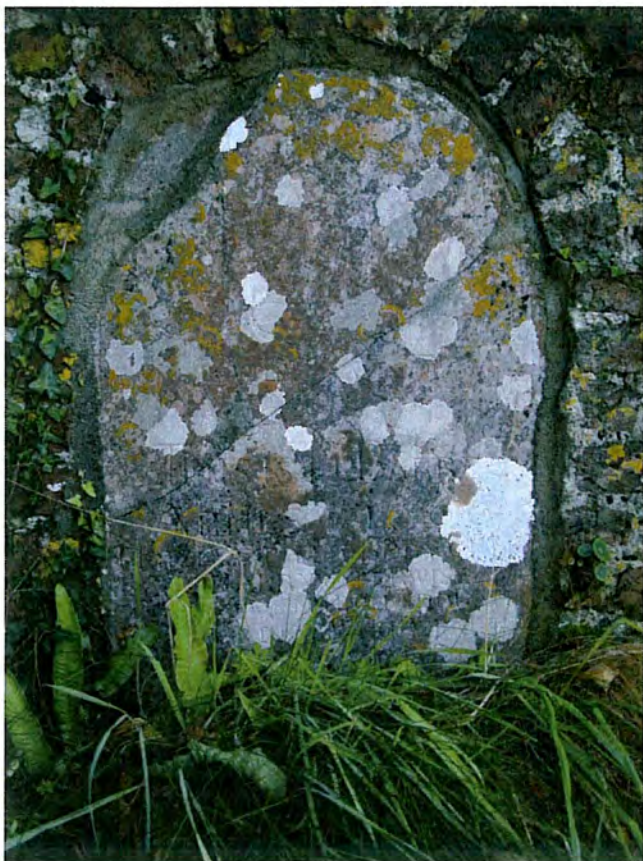
Plate 11- Grave no. 290, oldest determinable headston...

There is a wide variety of headstones and grave plots throughout the graveyard that range in date between the mid 17th century and early 21st century. The latest dates to 2006 and the oldest determinable headstone, Grave no. 290 is erect for Barry and dates to the 1660's (plate 11). The graves conform to a rough plan with the vast majority of the extant headstones facing east. Flemming is the most common name to be found on the marked headstones and plots, with the next most common names being O'Sullivan, McCarthy and O'Connor.

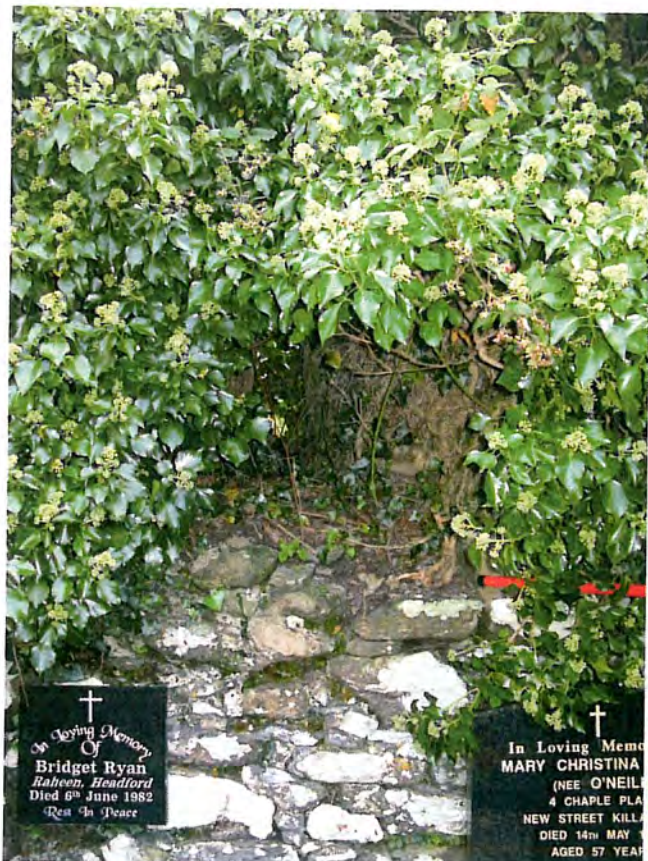
Plate 17-Showing window on eastern wall from the inter...

Two lancet window openings were identified at the time of survey, located to the south and east walls (plate 17). Each opening had deeply recessed, chamfered reveals to the interior elevation with dressed rubble stone surrounds, voussoirs and sills. As a result of extensive Ivy overgrowth the window openings were not visible to the exterior elevations of the church.

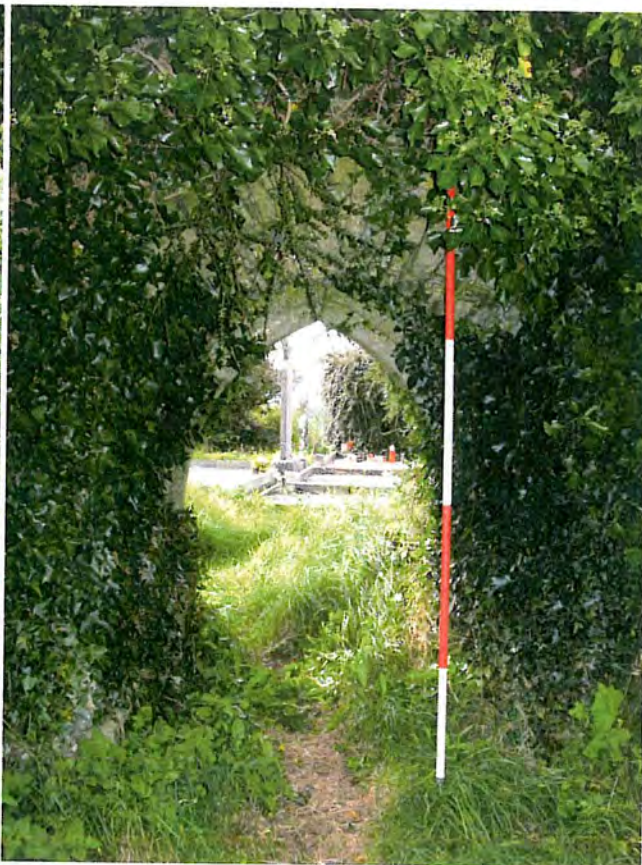
Plate 18- View of church door from interior, facing sout...

A single pointed arch door opening was identified to the south elevation with a tooled limestone surround and voussoirs with chamfered reveals to the exterior elevation. A slightly larger pointed arch chamfered recess is located to the interior elevation, having dressed rubble stone surround and voussoirs (plate 18). To the interior of the church are six grave settings and two tombs (plates 19 and 20).
