Archaeological Survey,
Kildrum,
Dingle,
Co. Kerry.

November 2010

RMP No.: KE043-130 church and graveyard

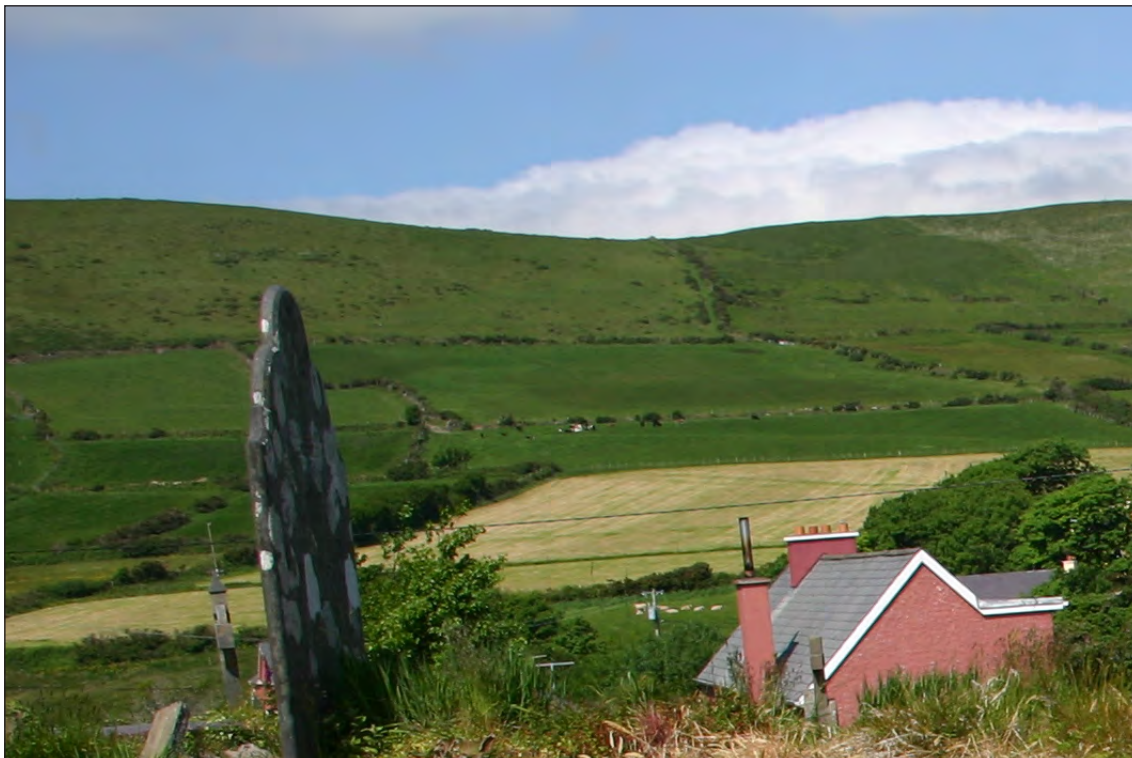
Plate 3: View north-east along the south-east boundary of old medieval burial ground at Kildrum . Note modern railing and extent of scarping-out works. Further note Mount Brandon in background

The old rubble stone boundary wall should be sensitively repaired with similar local sandstone and lime mortar and its capping replaced. This work should only be undertaken under archaeological supervision and by masons with a proven track record of repairing and restoring similar historic walls.

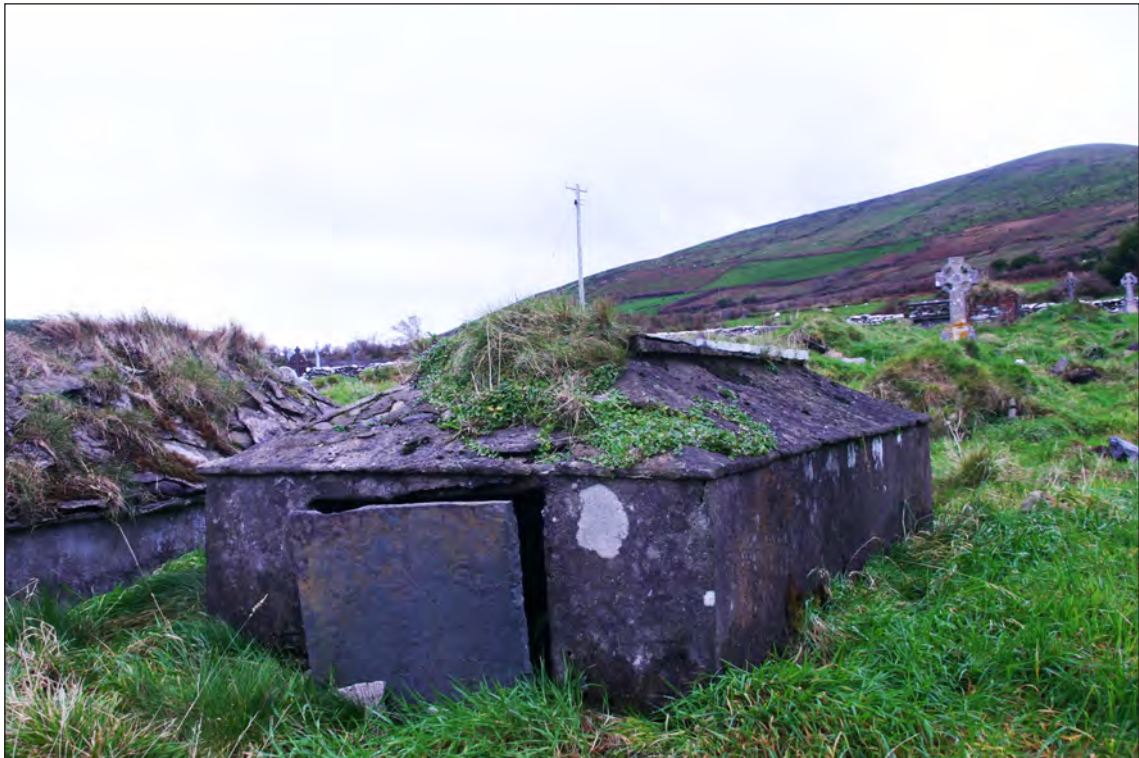
There are eighteen named tombs in the old medieval burial ground (Plates 7 & 23; Appendix 1 & Figure 5). The majority of them are constructed with local rubble stone and rendered and are generally of the simple box and strong-box variety. Six named tombs are heavily or partially grass covered and in need of repairs. The render on others also needs to be repaired while grass is establishing itself on several others. Tomb (1038) records the death of James Devine. The inscription reads: *Sacred to the memory of James Devine Who Departed This Life On The 16 Of March 1892 Aged 70 years R.I.P.* There is a small and unusual cross inscribed at the top of the memorial slab that is integrated into an IHS monogram. Father James Devine was parish priest of Annascaul and was interred

Plate 7: View of the dilapidated, partially open tomb (1038) of James Devine who died in 1892. This is possibly the burial tomb of Father James Devine P.P. Annascaul who was buried beside his brother Father Michael Devine P.P. Dingle

The tombs should be repaired and restored. Repairs to tombs should be undertaken by experienced masons with a proven track record of working on historic structures and in the use of lime mortar etc. This work should only be carried out under expert archaeological advice and supervision as it is most likely that architectural fragments from the medieval church of Kildrum are incorporated within the tombs.

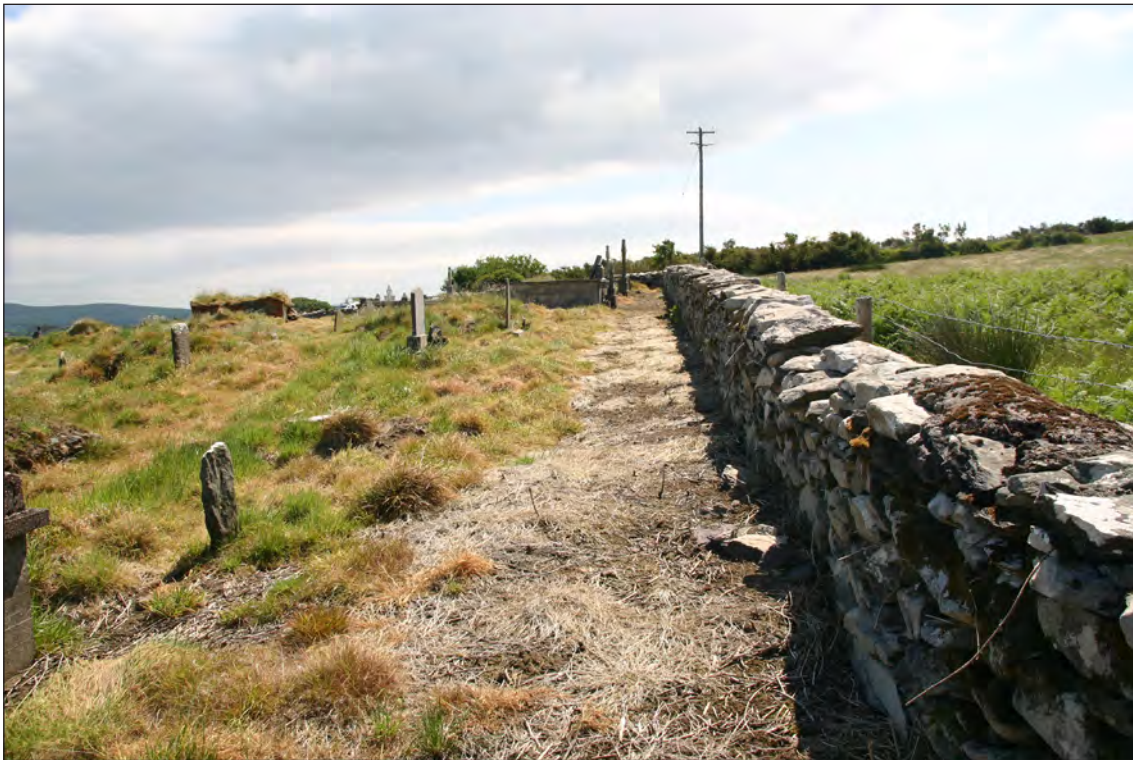
Plate 12: View from north-east corner of old burial ground in Kildrum. Note use of weed killer to try and maintain informal perimeter path

The grass in the old graveyard should be cut low by non-bladed trimmers and kept low by regular cutting especially in the interior of the graveyard as it is studded with low gravemarkers, cross slabs, holed stones and quartz. The use of weed killer should be prohibited. Other recommendations are recorded hereunder in their respective sections.

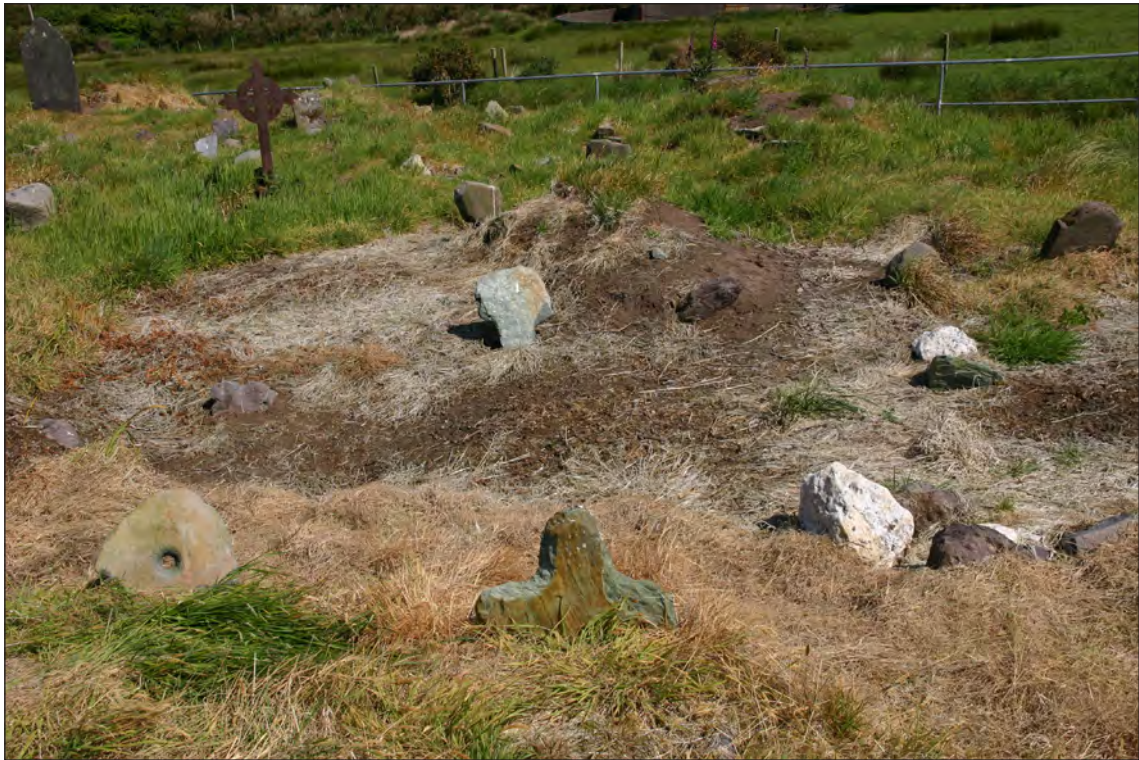
Seventeen white unhewn quartz stones were recorded in the course of this study (Plate 13, Appendix 10 & Figure 5). Quartz has been recorded from many early ecclesiastic sites and have been found on *leachta* often as water rolled pebbles. On Illauntannig and Skellig they were used to make crosses over the entrances to oratories. The use of quartz is also associated with marking the graves of un-baptised children in *ceallúraigh* or Children's Burial Grounds. It is in this context that they have been recorded at Kildrum as there are a number of features that indicate that the interior of Kildrum was re-used as such. Including, several early cross forms, holed stones and notched stones that are clustered together in the interior (Figure 5). Quartz stones are rarely or incidentally recorded on archaeological sites and in general terms only.

Plate 13: View of interior of old burial ground Kildrum, possibly reused as ceallúragh. Note cross-slabs holed stone, notched headstones and quartz. Note the widespread use of weed killer

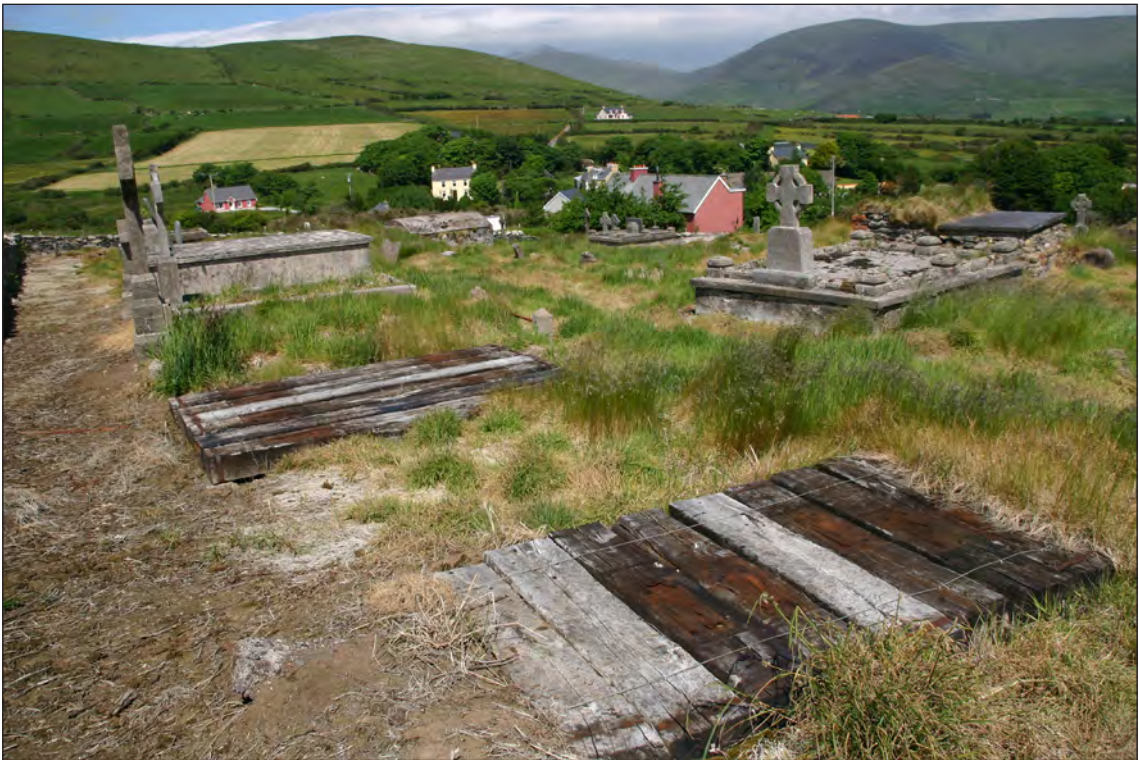
Plate 14: View NE of old burial ground at Kildrum. Note the inappropriate use of old railway sleepers on lintelled graves. Further note the widespread use of weed killer

The exposed lintelled graves should be repaired properly by masons experienced in historic structures under archaeological expert advice and supervision. The use of railway sleepers should be discontinued and existing sleepers replaced with more appropriate materials including local sandstone flagstones or, where appropriate, concrete lintels. The graves should then be covered with earth, re-sodded or re-seeded. The unhewn grave markers should be left *in situ*. This will preserve the graves and make the graveyard easier to negotiate.

- The exposed lintelled graves should be sensitively repaired with matching material and then covered with earth and re-sodded leaving the unhewn unnamed headstones *in situ*. Graves recently covered with inappropriate old railway sleepers should be sensitively replaced with local stone flags or concrete lintel slabs.

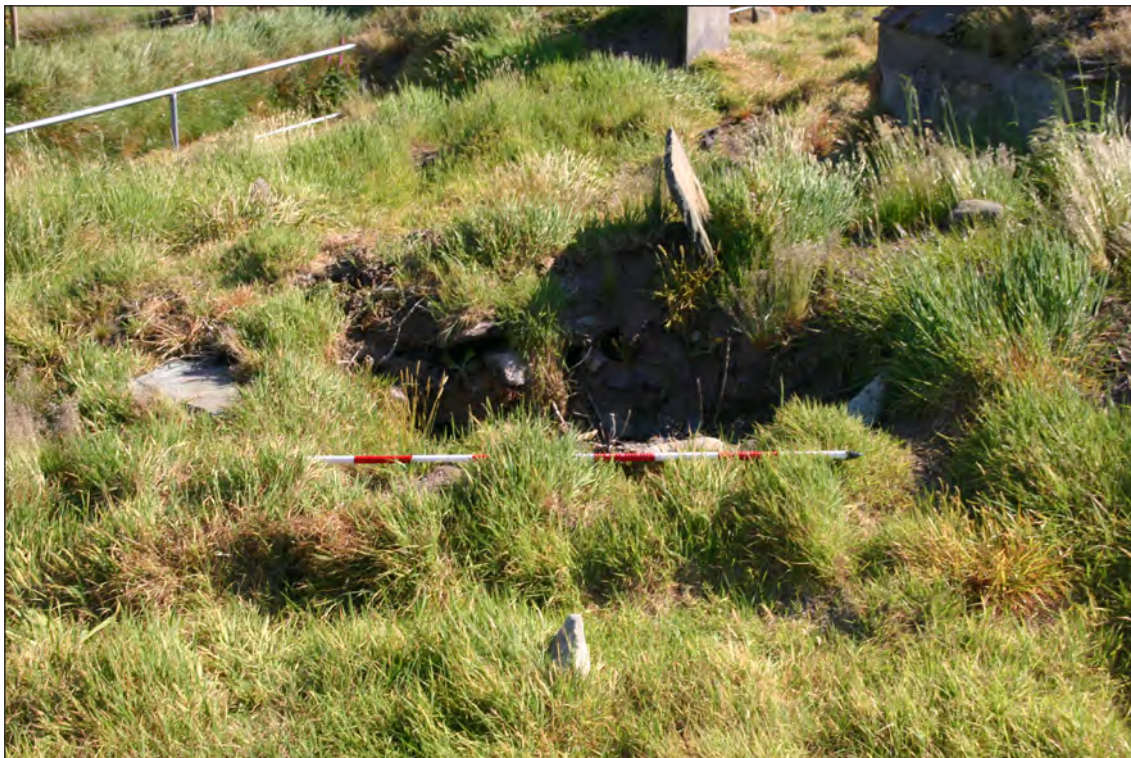
Plate 15: View of collapsed lintelled grave (1033) in the old burial ground at Kildrum

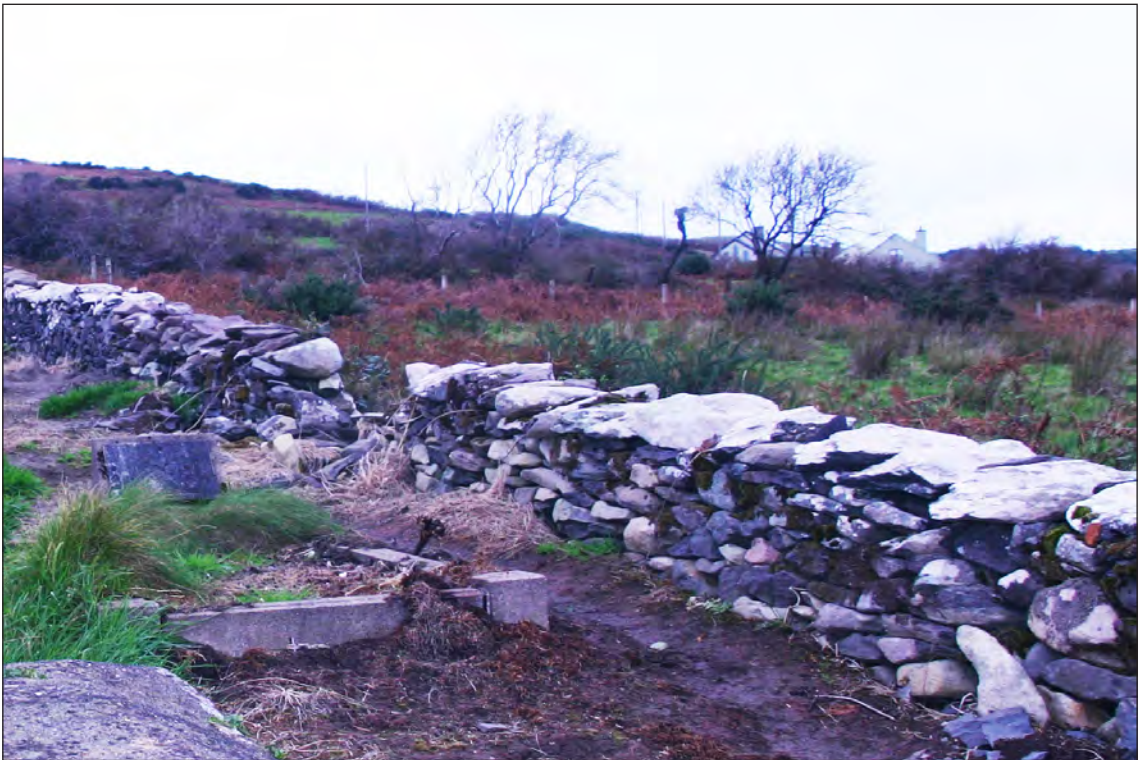
Plate 20: View of breach in drystone wall along the north-east boundary of Kildrum Graveyard

- Repairs to the boundary walls should be undertaken by people with a proven track record in repairing dry stone walls.
- The use of broad-spectrum weed killer should decrease immediately.

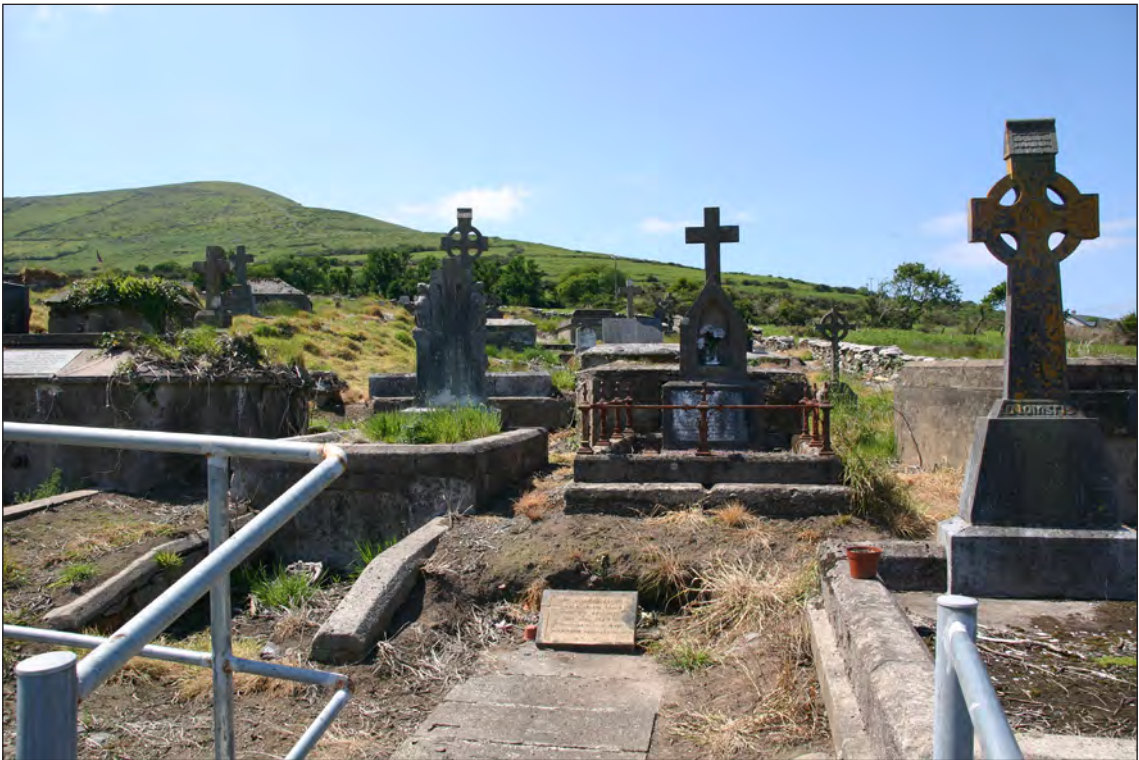
Plate 22: Entrance into old burial ground at Kildrum from recently constructed ramp. Note visitors are channeled directly onto the O'Mahoney family grave (90) and a cul-de-sac of built tombs and graves

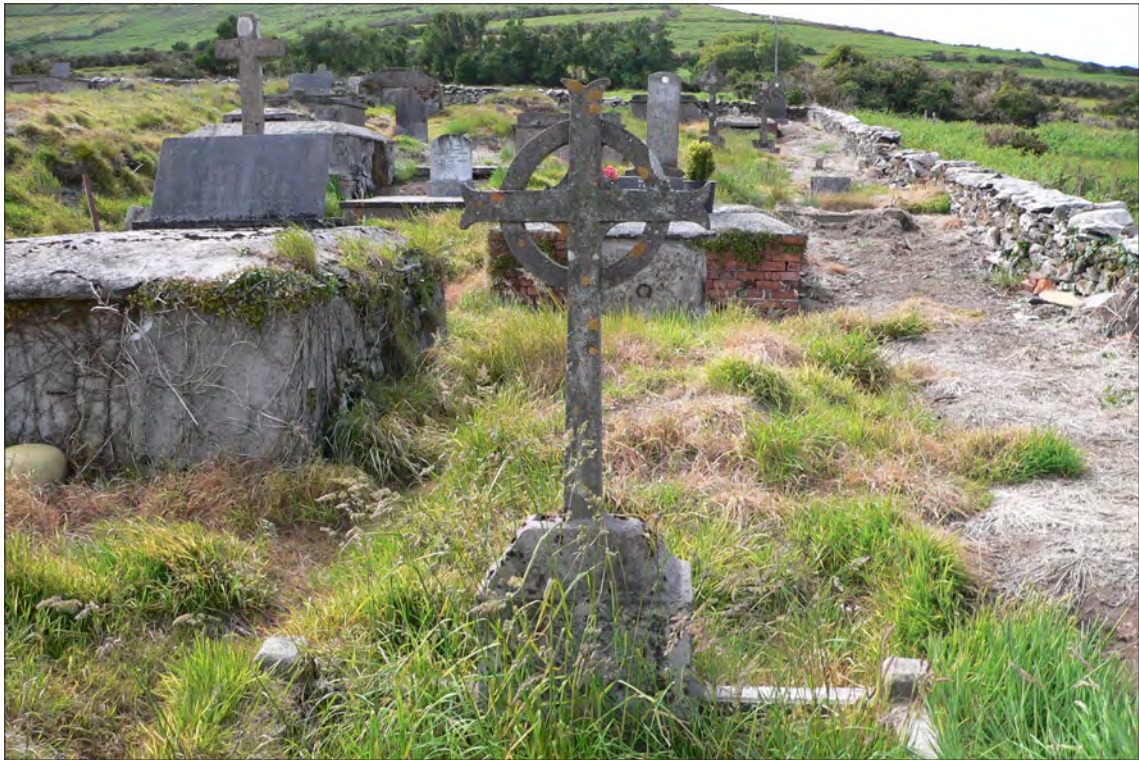
Plate 23: View up along north-east limits of the old burial ground at Kildrum. Note breaches to boundary wall, remains of abandoned unused cement and other builder's rubbish. Further note grass encroachment on modern gravesetting etc

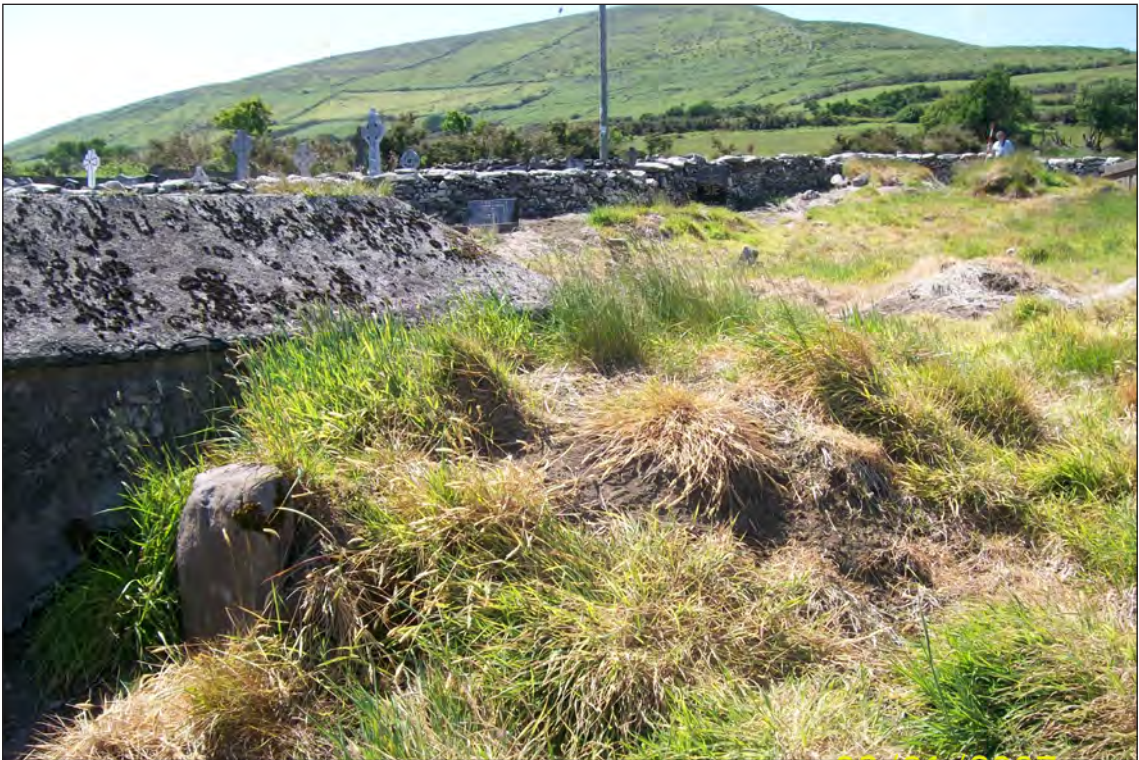
Plate 24: View of grass covered unnamed tomb (48) beside unnamed strong-box tomb (43) in old burial ground at Kildrum

Specialist work is required to preserve, repair and restore many of unnamed tombs at Kildrum. Several will require careful rebuilding.

Grass covering some of the tombs should only be fully removed as the primary element of an agreed inclusive strategy of repairs and other conservation and restoration works. This work should be undertaken with expert archaeological advice and guidance.

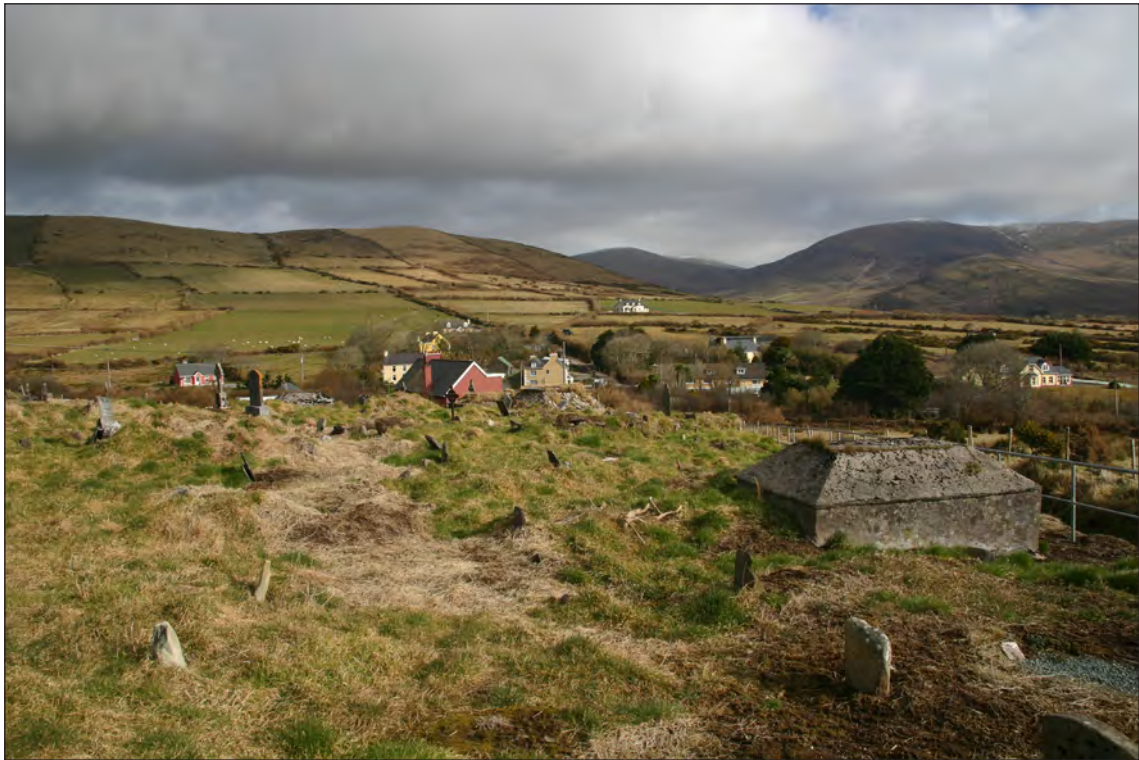
Plate 25: View of interior of old burial ground at Kildrum from SW. Note widespread use of weed killer

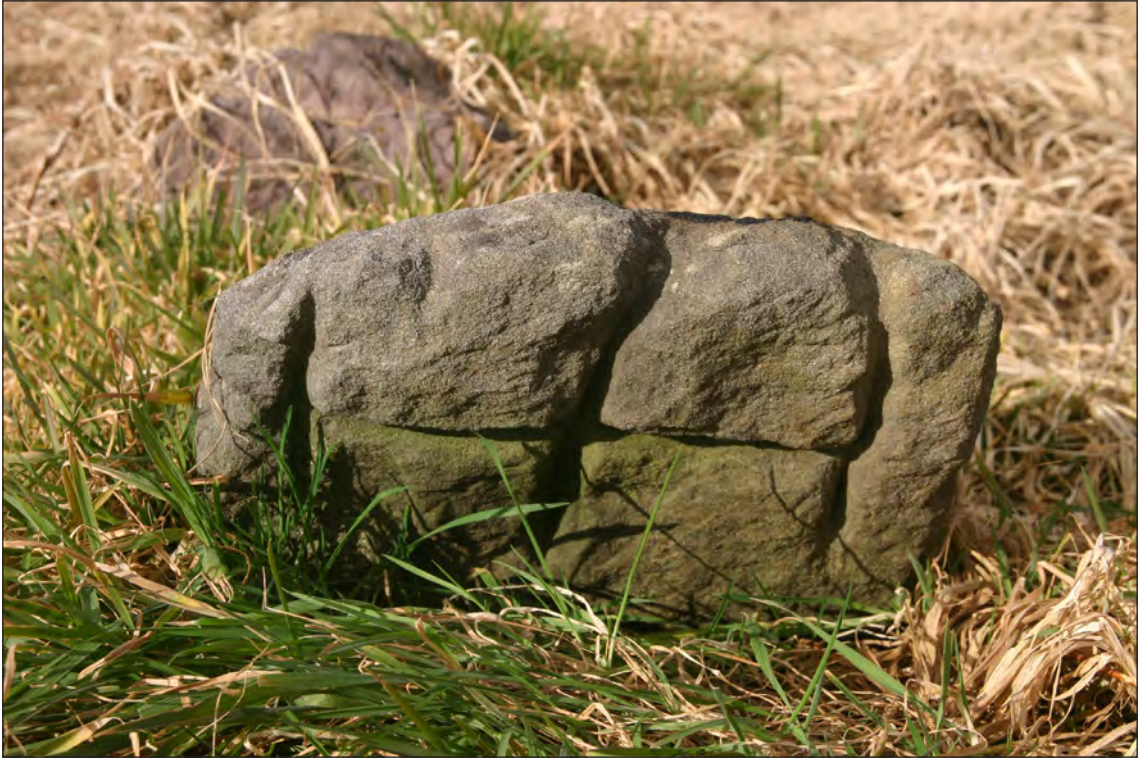
Plate 29: View of unlocated cross-slab in the old burial ground at Kildrum

The grass in the interior of the graveyard around these cross-slabs should be cut low and maintained at a lower level so that they have a greater visibility which will in turn help in greater safety while walking. After the grass is cut the missing cross-slab should be found, recorded, plotted and illustrated.

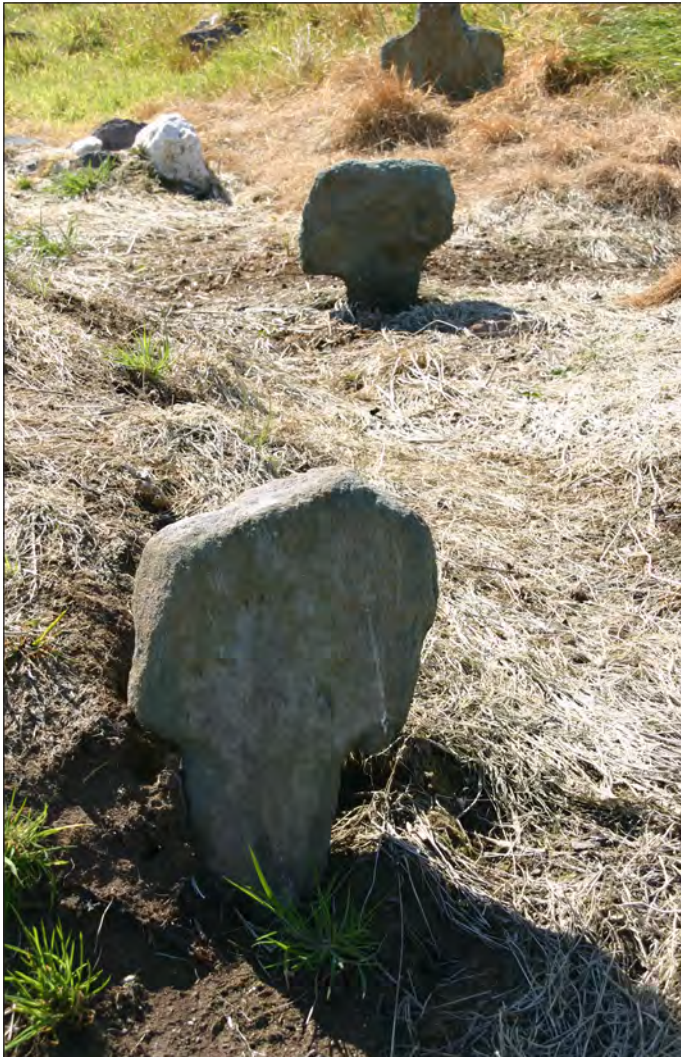
Plate 30: View of 'Tau' cross-slabs (1100 & 1102) in Kildrum Graveyard

Three cross-slabs (1099, 1100 & 1102, Plates 30-32) are 'Tau' cross forms. The crosses are roughly shaped and similar to others at nearby Raheenyhooig and Kilmalkedar and are possibly Early Medieval. Cross-slab 1099 has a pronounced notch at the top as well as distinct curving sides that creates a more finial like resemblance (Plate 32).

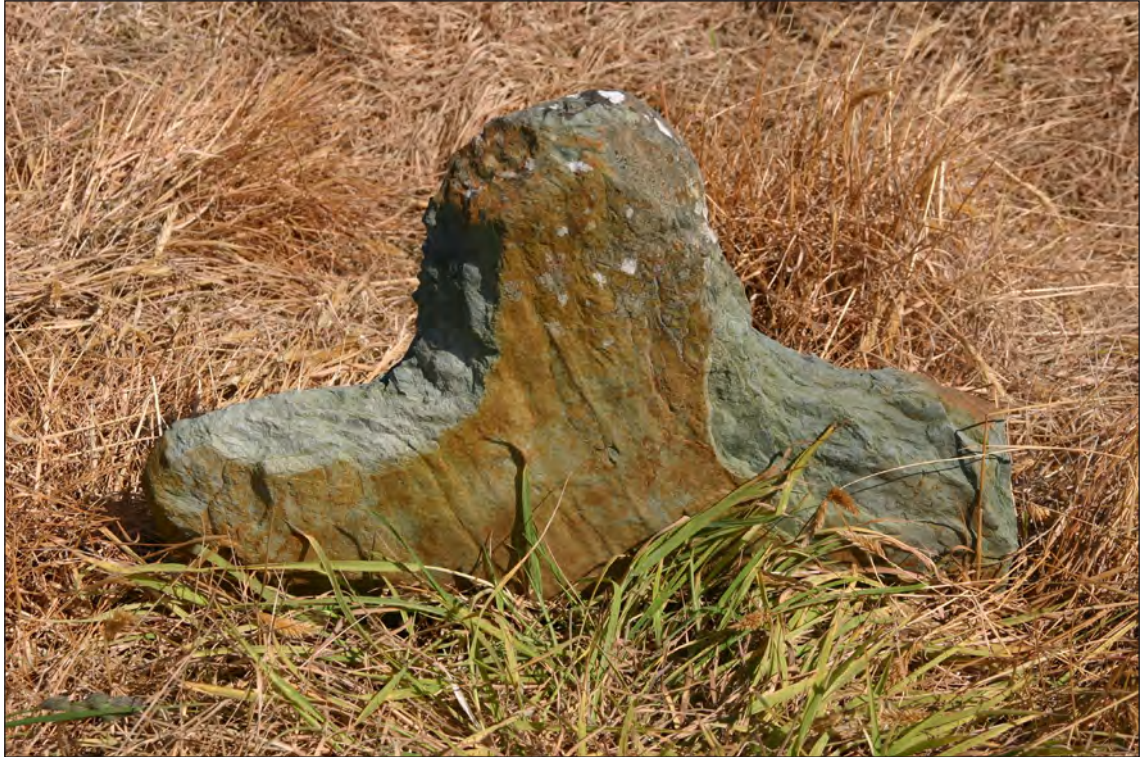
Plate 33: View of anthropomorphic cross-slab (1121) in Kildrum

Cross-slab (1121), of local green sandstone, is anthropomorphic in form with roughly made rounded truncated type arms and head and is also possibly Early Medieval, 0.56m x 0.47m x 0.05m (Plate 33).

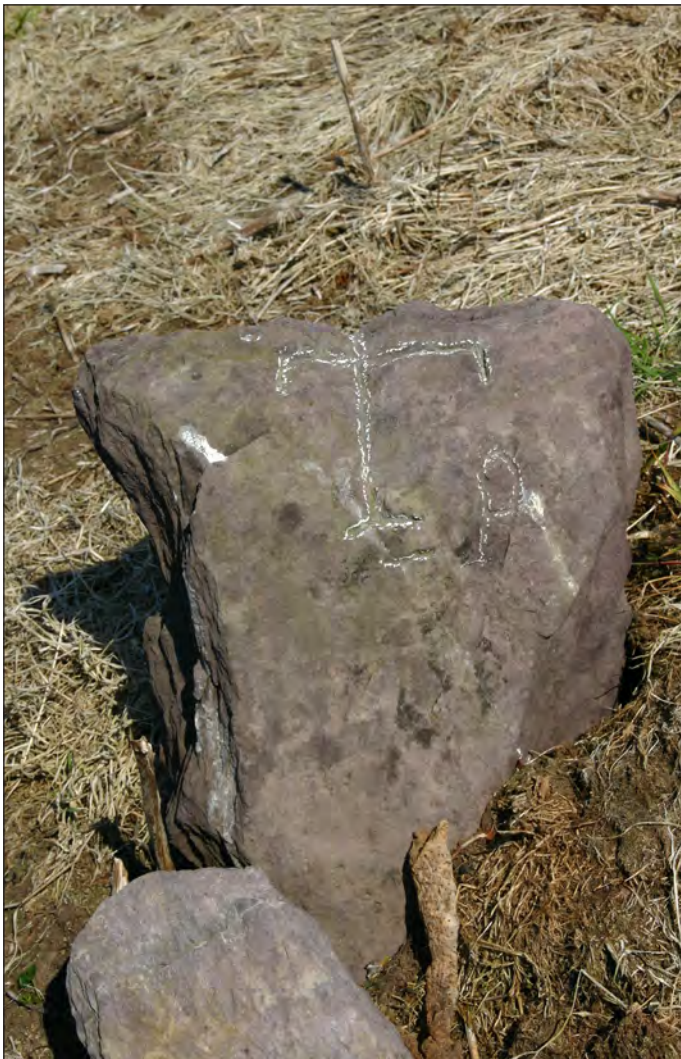
Plate 34: View cross-slab (1124) in Kildrum

Two other cross-slabs (1115 and 1124) have shared characteristics in that they both have crosses that extend up into notches at the top of the stones, a feature that is also noted on the missing cross-slab (Plate 29). Cross-slab 1124 is made from unhewn local red sandstone with an incised Latin cross with a T-bar at the base of the shaft and downturn bars to both arms (Plate 34). Cross-slab 1115 has a simple Latin cross that extends up and incorporates a notch at the top of the stone (Plate 35).

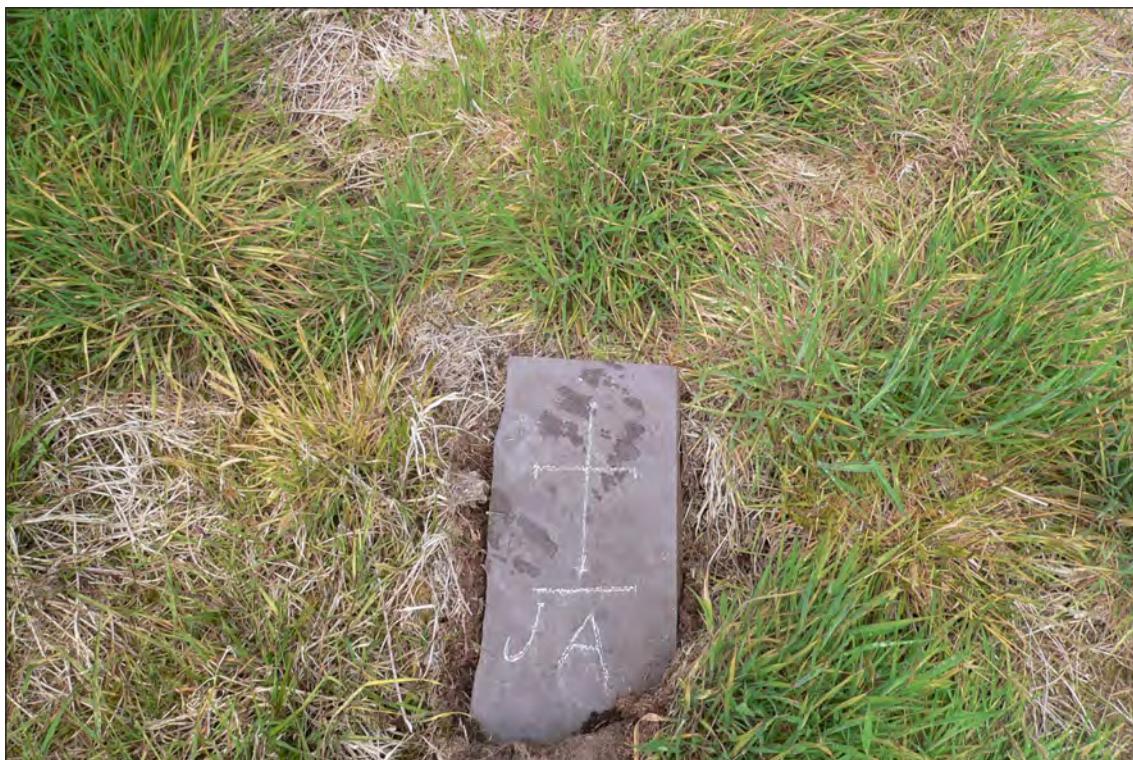
Cross-slab 1130 lies loose on the ground. This uniform, sandstone flag, 0.74m x 0.19m x 0.04m, has a lightly incised Latin cross with T-bar terminals. Under the shaft is a horizontal stroke beneath which are the letters *JA* eccentrically disposed (Plate 39).

Plate 39: View of cross-slab (1130) in Kildrum

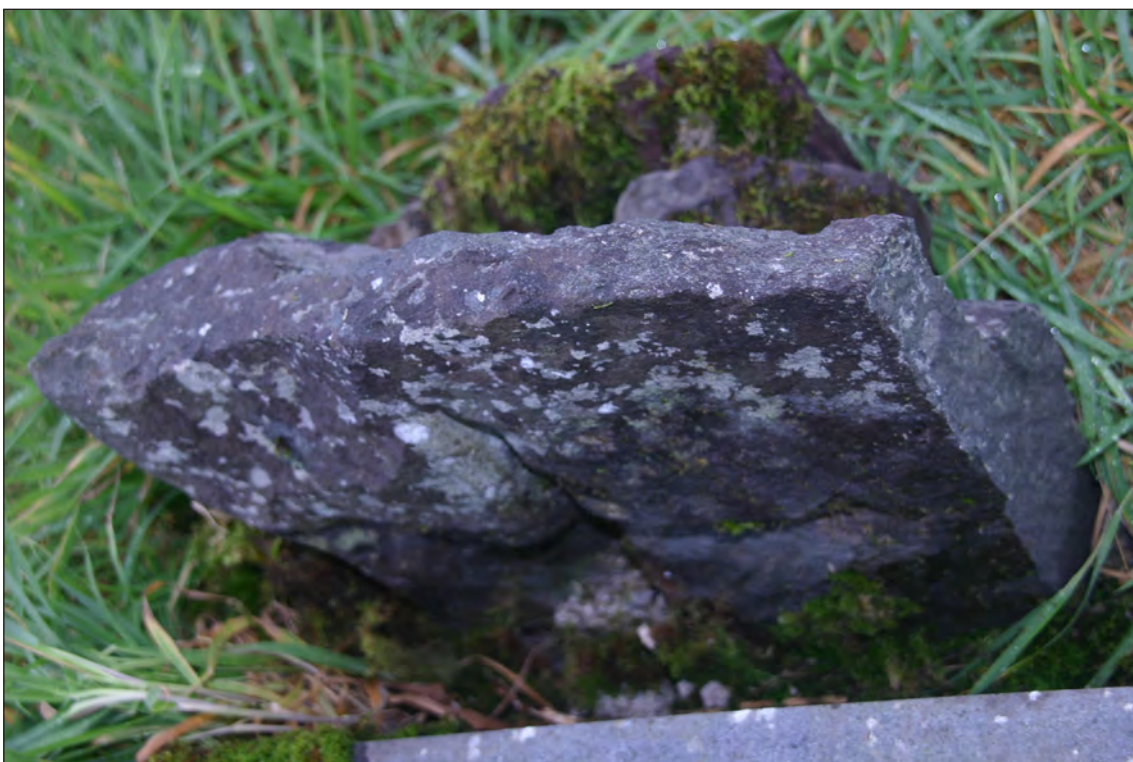
Plate 40: View of cross-slab (1127) in Kildrum

Cross-slab 1127 stands partially obscured beside a modern headstone (1141). It has a Latin cross, partially concealed by moss, deeply incised on a rectangular sandstone slab, 0.60m x 0.41m x 0.10m (Plate 40).

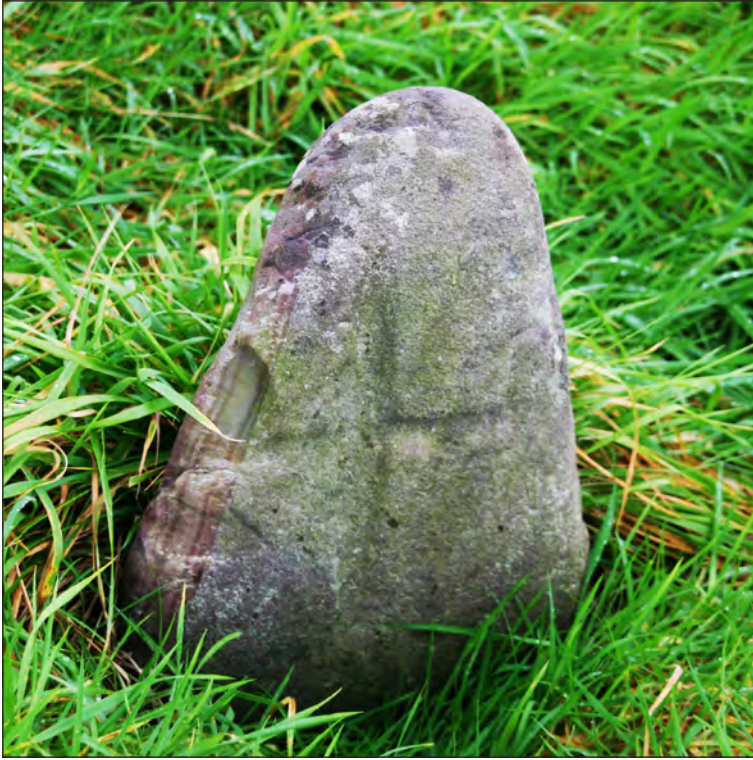
Plate 41: View of cross-slab (92) in Kildrum

Cross-slab 92 situated near the eastern limits of the old burial ground is a triangular sandstone, 0.54m x 0.32 x 0.09m, with a wide incised plain Latin cross (Plate 41).

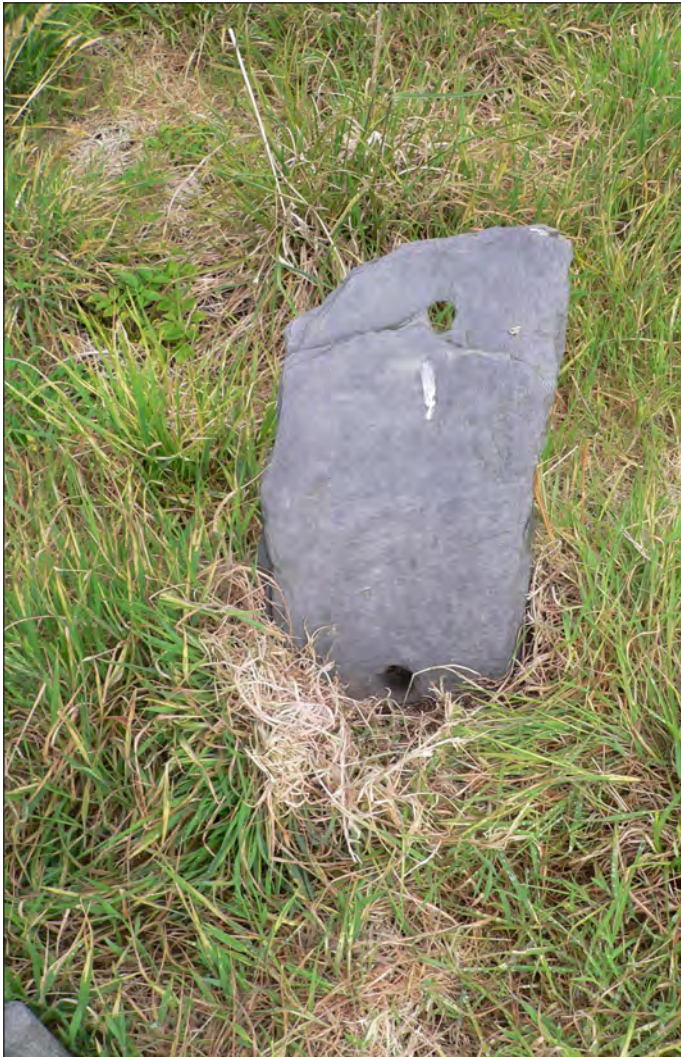
Plate 42: View of holed-stone (1098) in Kildrum

Holed-stone (1098) of slatey-sandstone, 0.43m x 0.23m x 0.065m, has a double perforation, one at the top and the other at the base. Both perforations are small and uniform, diameter of upper perforation 20mm and bottom 28mm (Plate 42).

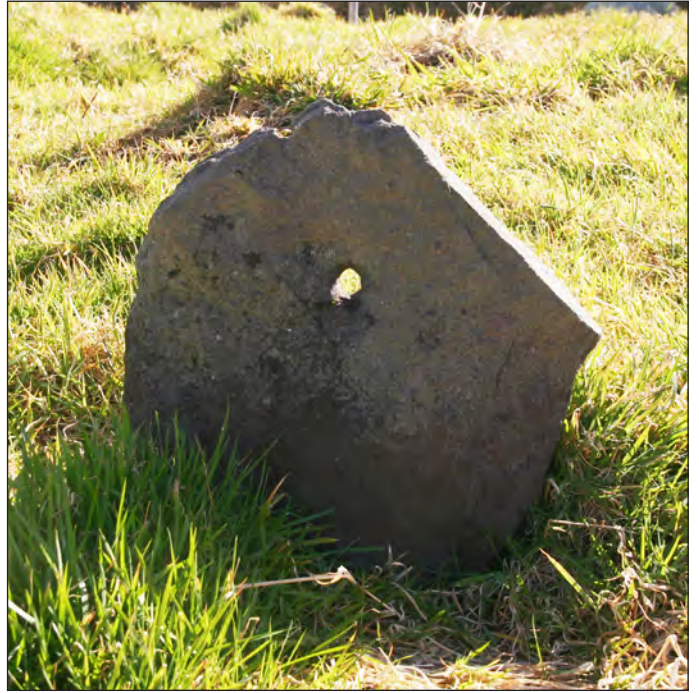
Plate 43: View of holed-stone (1120) in Kildrum

Holed-stone (1120) of local sandstone with a small hour-glass perforation, diameter 25mm, centrally disposed. The stone is somewhat gable shaped of un-dressed sandstone 0.46m x 0.41m x 0.045m (Plate 43 & Figure 5). Interestingly there is a small circular notch at the top of the stone as well that may reflect either a deliberate notch or a broken previous attempt at perforation. This notched section of the slab has also been roughly trimmed.

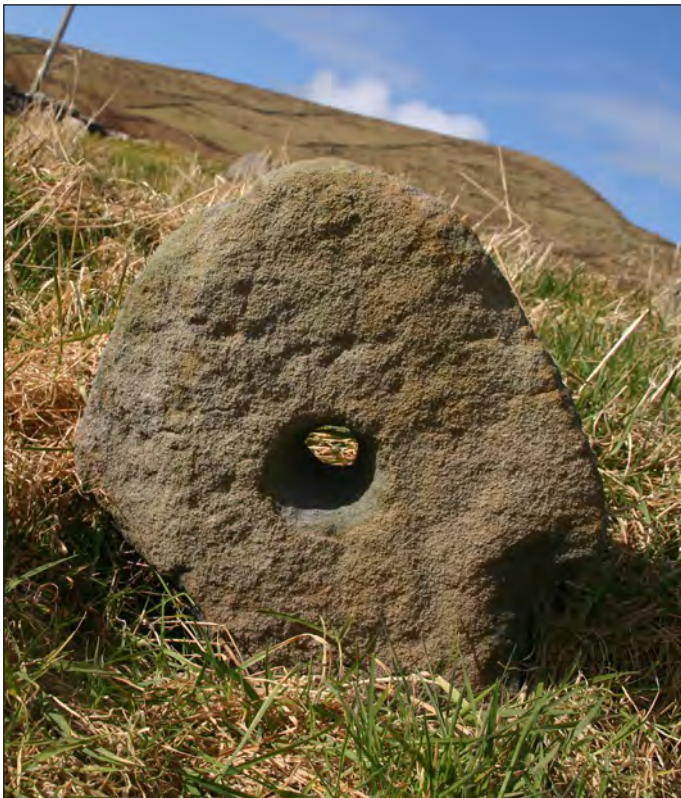
Plate 44: View of holed-stone (1122) in Kildrum

The third holed-stone (1122) is stylistically at variance with the previous two in that it could or should possibly be categorised as a perforated cross-slab? The local sandstone, 0.46m x 0.39m x 0.07m, has a narrow shaft that expands into a somewhat dome shaped head. Centrally disposed is a large hour-glass perforation with an external diameter of 80mm decreasing to 30mm at the centre or narrow neck of the hour-glass (Plate 44). The holed stone (1122 has) been trimmed and shaped into a variant cross-form that may be a skeumorph of the two definitive Tau cross-slabs, both of which are situated beside the holed-stone at Kildrum (Plate 13).

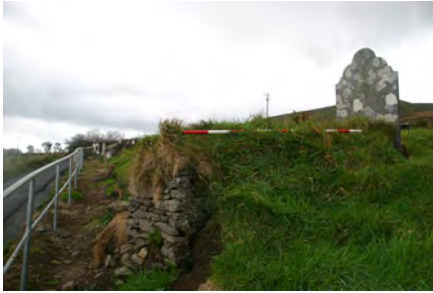
Surname:	MCDONNELL
Tomb No:	94
Photo No:	IMG_4952 AND IMG_4953
Photo:

Notes:	
Collapsed	N
Open	N
Rendered	N
Overgrown	Y

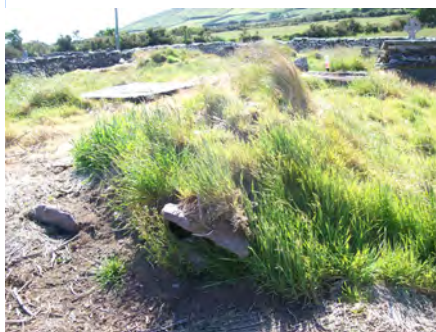
Tomb No:	163
Photo No:	149_0921
Photo:

Notes:	
Collapsed	P
Open	P
Rendered	N
Overgrown	Y

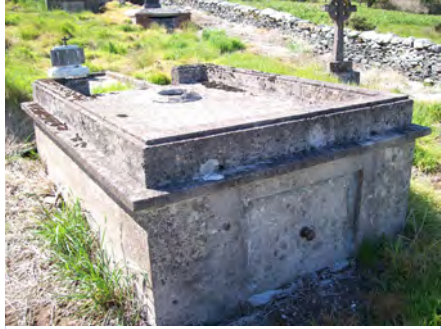
Tomb No:	178
Photo No:	149_0924
Photo:

Notes:	
Collapsed	N
Open	N
Rendered	Y
Overgrown	N

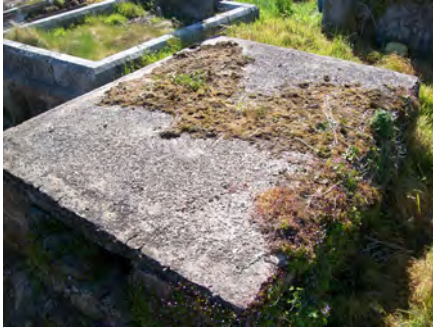
Tomb No:	203
Photo No:	149_0929
Photo:

Notes:	
Collapsed	N
Open	N
Rendered	N
Overgrown	N

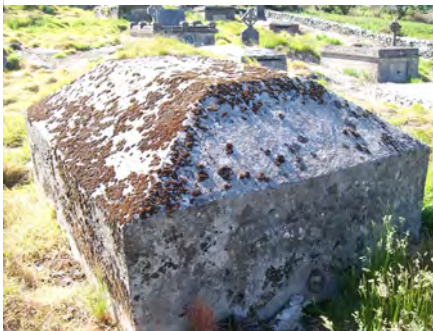
Tomb No:	261
Photo No:	149_0939
Photo:

Notes:	
Collapsed	N
Open	N
Rendered	Y
Overgrown	N

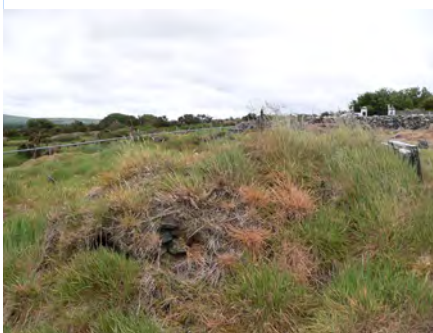
Tomb No:	1064
Photo No:	148_0030
Photo:

Notes:	
Collapsed	N
Open	N
Rendered	N
Overgrown	Y
