Archaeological Survey, Kilflynn Graveyard, Co. Kerry.

September 2012

RMP No.: KE021-142

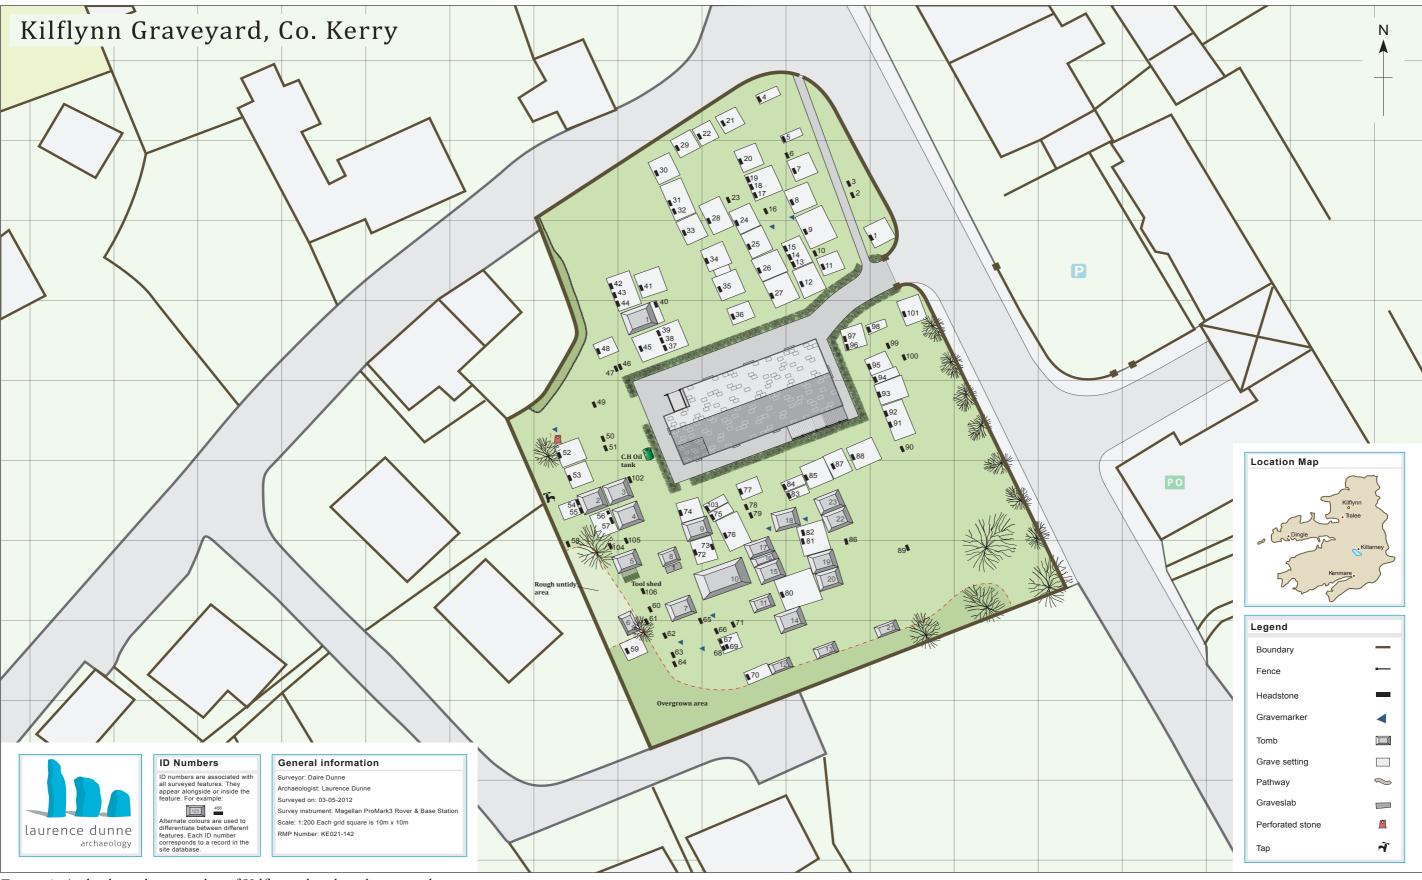
Figure 2: Archeological survey plan of Kilflynn church and graveyard.

There is a formal concrete pedestrian path extending north-south along the NE area of the graveyard (Figure 2).

There are twenty-three, (23), tombs within the old medieval graveyard disposed around outside the south and south-western limits of the graveyard with only the Parkinson family tomb (TB7) situated on the north of the church (Figure 2). The tombs are, for the most part, of the 'strong-box' and gabled style. Two are ashlar or partially ashlar while the remainder are constructed with rubble stone and rendered or partially rendered (Figure 2 & Plates 5-6).

There are eight unhewn gravemarkers in Kilflynn graveyard. Five of which are located to the south of the church where the ground is more irregular and the grass higher. These unnamed gravemarkers are denoted on the plan of the graveyard as blue triangles (Figure 2).

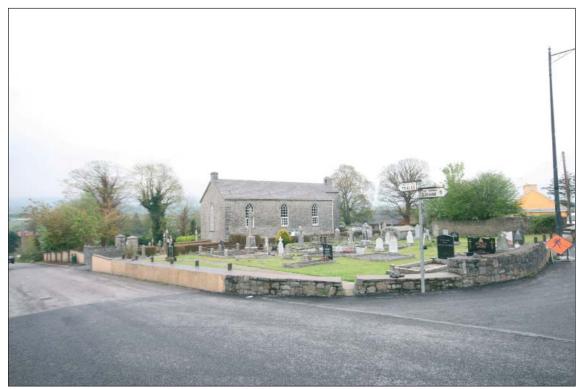
A mixed concrete block and rubble stone wall and flat capping extends north from the entrance and returns west. The wall is very low comprising of only two courses in places and has a pedestrian gapped entrance on the rounded corner (Plates 1-2).

Plate1: View of Kilflynn church and graveyard from north east

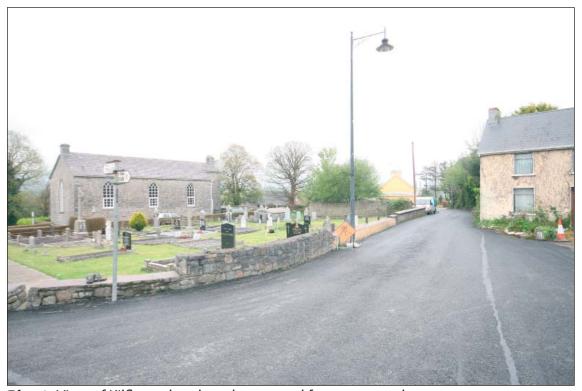
Plate2: View of Kilflynn church and graveyard from east north east

The approach is open and easy in all directions. Carparking is available along the roadway in the village (Plate 2 & Figure 2).

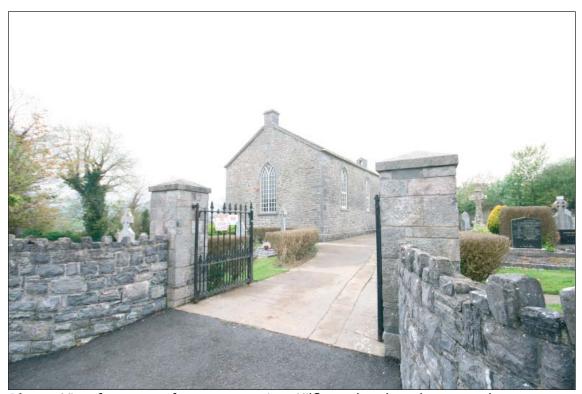
The main entrance into the modern graveyard is via a pair of iron gates between two robust square limestone piers, capped and in good order. The gates are set within a rounded recessed entranceway that provides very limited vehicular access directly beside the church (Figure 2 & Plate 3).

Plate 3: View from east of entranceway into Kilflynn church and graveyard

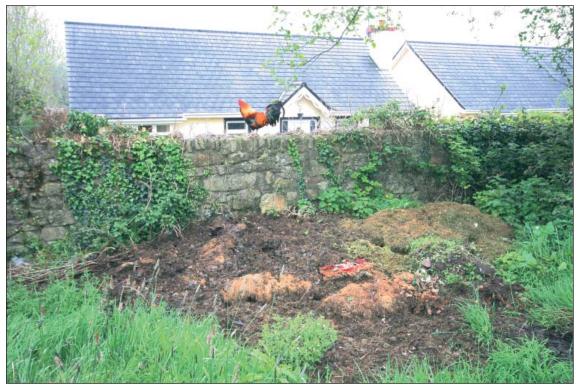
The south boundary wall is constructed with local rubble limestone and is covered in ivy and mature trees. The west boundary comprises a 1.4m high rubble stone capped wall in good condition. Apart from some ivy on the older rubble stone wall there are no breaches and are in general good order, (Plate 4).

Plate 4: View of boundary wall in the south-west limits of the graveyard. Note the dumping of rotted material and grass clippings

The ivy should be kept in check otherwise no further recommendations necessary.

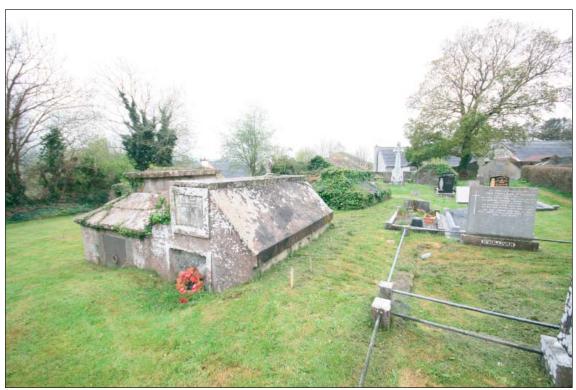
Plate 5: View of tombs in southern limits of graveyard. Tombs 22 & 23 in foreground

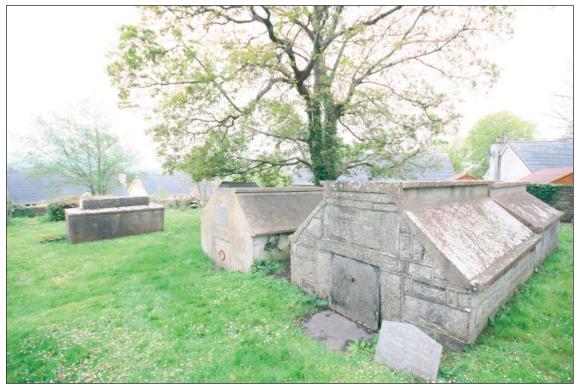
Plate 6: View of tombs in south-west limits of graveyard. Note ashlar tomb (TB3) in foreground

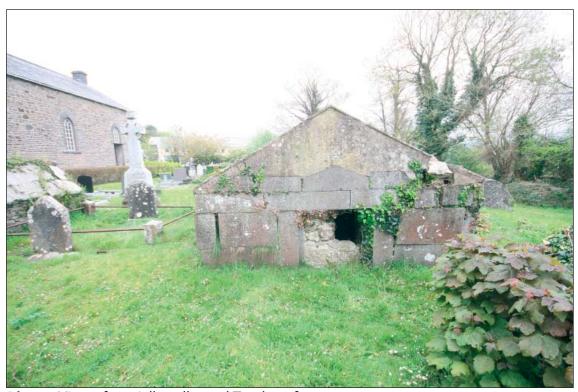
A number of the tombs in Kilflynn are in a very poor state of preservation with many requiring serious attention (Plates 7-8). While other tombs are heavily overgrown partially or totally collapsed and in need of urgent repair and maintenance (Plate 9 & Appendix 1).

Plate 7: View of partially collapsed Tomb 10 from west

Specialist work is required to preserve, repair, clean and restore several of the tombs at Kilflynn. A number will require careful rebuilding. The dense overgrowth on some should be carefully removed and the tombs re-examined by an experienced archaeologist for possible re-used architectural fragments or features.

Work should only be undertaken by skilled masons with a proven track record of working with historic structures, ashlar masonry as well as contemporary materials and lime mortar.

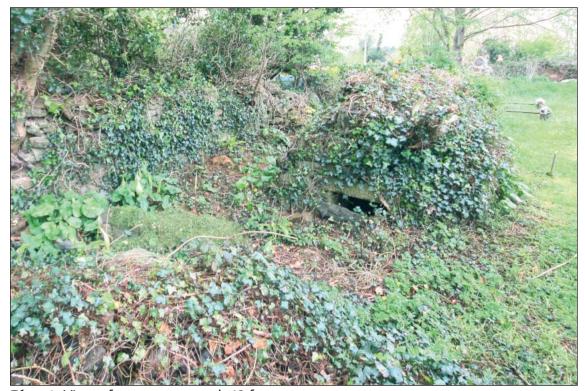
Plate 8: View of overgrown tomb 13 from east

The grass and ivy growth on the tombs should only be fully removed as the primary element of an agreed inclusive strategy of repairs and other conservation and restoration

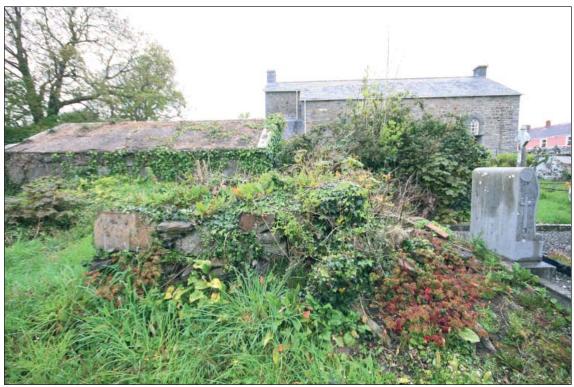
Plate 9: View of collapsed Tomb 11 from south

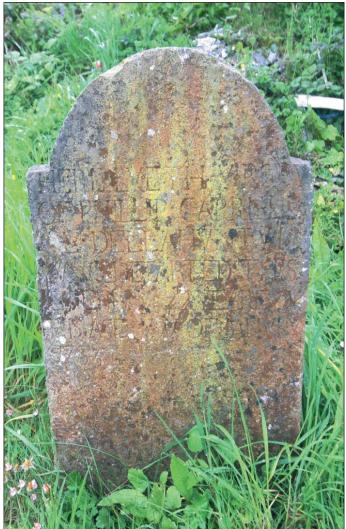
There are 106 recorded named headstones in total at Kilflynn (Figure 2). The earliest headstone recorded in the medieval burial ground (HS 106) records the death of Phillip Carrell who died in 1735, (Plate 10 & see Appendix 2) for images of all named headstones). The headstones are in good order however many require professional cleaning as the lichen has made the inscriptions virtually illegible. There is a Republican grave-plot to the memory of Capt. George O'Shea, Timothy Tuomey and Comdt. Timothy (Aero) Lyons.

Plate 10: Close up view of headstone of Phillip Carrell who died in 1735

The headstones are in a general good state of preservation with only two shattered and should be repaired. White lichen is present and pervasive on some that obscures the memorial inscription. These are few and should be properly cleaned under expert advice only. They should not be cleaned with a power sander or wire brush.

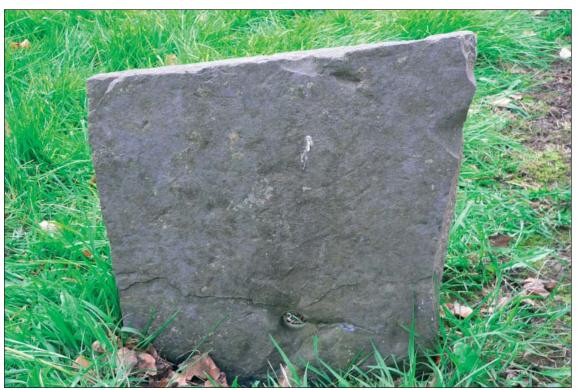
There is a single perforated or holed stone in the western limits of Kilflynn graveyard at the rear of the church (Figure 2 & Plate 11).

Plate 11: View of perforated gravemarker situated in the western limits of the graveyard
