Project code: KCCG11
Client: Kerry County Council
Date: July 2011

Archaeological Survey of Kilgobbin Graveyard, Camp, County Kerry

Surveyors: Ann Frykler & Robert Hanbidge
Report Author: Robert Hanbidge

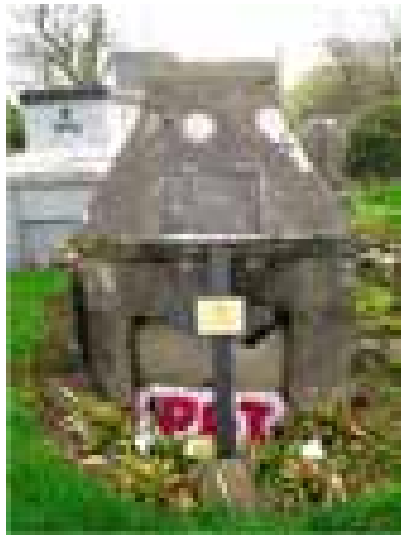
Plate 17-View of tomb
(Grave No. 93), from east

Many of the tombs still remain in use, e.g. Grave No. 93 which contains one of the more recent burials, dating to 2010 (Plate 17).

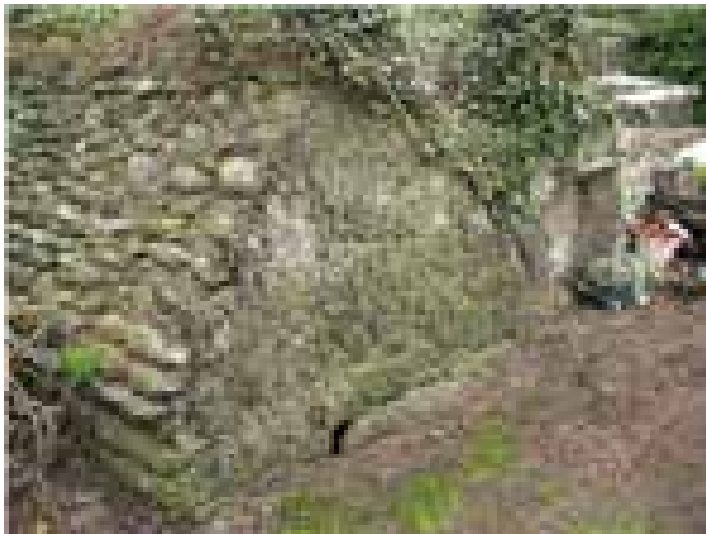
Plate 19-View of tomb (Grave No. 15), from east

During this survey, 55 unnamed tombs were recorded within Kilgobbin Graveyard. Vernacular forms account for a large proportion of the unnamed tombs; e.g. Grave No. 15, an example of a 'leacht' type tomb which features rubblestone construction with a rubblestone corbelled roof; the the entrance is now situated below ground level (Plate 19). Another unnamed tomb at Grave No. 52 features a drystone wall construction with a corbelled roof. The stones of this roof were originally roofing stones, possibly indicating the presence of much earlier stone structures within the graveyard or in the vicinity (Plate 20).

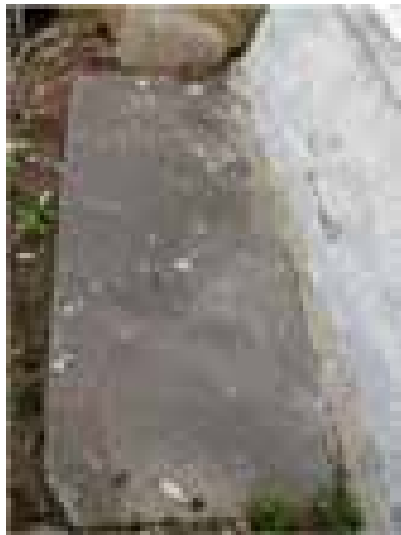
Plate 21-View of slab to
tomb (Grave No. 90)

Other forms of tombs include underground types, which are usually sealed/marked by a large horizontally placed slab that forms the roof/lid of the burial chamber e.g. a large stone slab which forms the capping stone of Grave No. 90. This capping stone was also originally inscribed, however due to erosion the inscription is now mainly illegible except for a possible date of '177_' indicating a possible eighteenth century date for this grave (Plate 21)

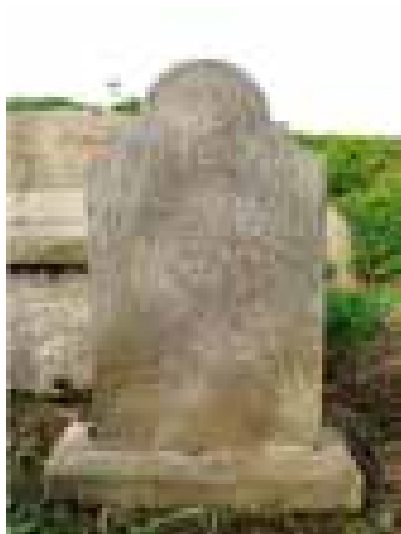
Plate 23-View of Grave No.
119

There are 31 named headstones and plots at Kilgobbin Graveyard. The majority of these are in good condition and mostly date to the nineteenth and twentieth centuries. The oldest inscribed headstone which bears a date of 1816 belongs to Grave No. 119 (Plate 23) and commemorates a member of the Butler Family.

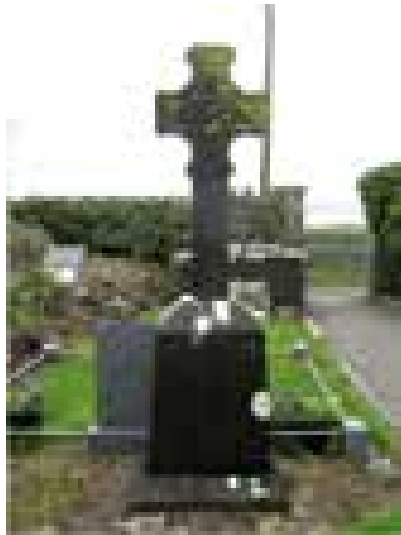
Plate 25-View of Grave No.
21, from east

There is great variety in the forms of headstones found within Kilgobbin Graveyard which include both modest and elaborate examples of limestone slabs, polished stone examples and various forms of plinths which range from cast and wrought-iron to tooled and cut stone. All of the headstones contribute to the historic and artistic importance of the graveyard. The limestone headstone of Grave No. 4 is a quite a substantial example and displays an elaborate finial (Plate 24). In common with most graveyards, there are many variants on the Celtic Cross design e.g. Grave No. 21 (Plate 25).

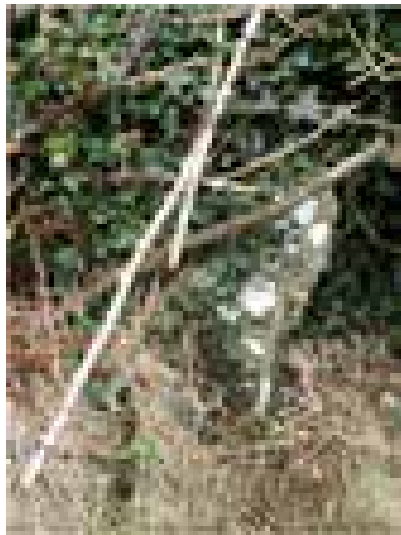
Plate 29-View of headstone to
Grave No. 2, from south

A possible headstone which is in the north-eastern corner of the graveyard adjacent to the northern boundary marks Grave No. 2. However due to excessive overgrowth the headstone is partially hidden and it was not possible to locate an inscription (Plate 29). Inscriptions on some of the headstones could be partially read but no name or date was identifiable, e.g. Grave No. 83 had the inscription 'OSE CLAISN VINCIT VERITAS' (Plate 30). There are some more unusual examples of unnamed plots which feature a substantial enclosing element; e.g. Grave No. 161 which contains no visible headstone but did contain a dated footstone (1866) while the plot is enclosed by a decorative wrought-iron railing (Plate 31).

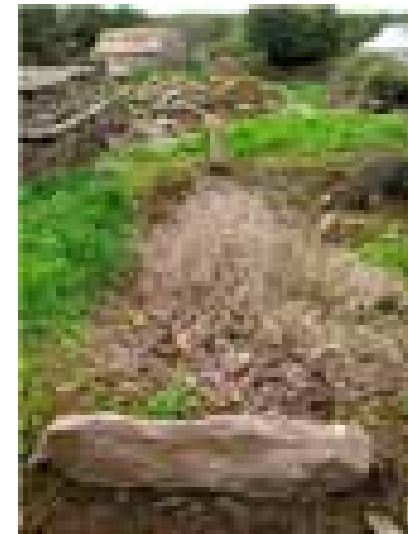
Plate 32-View of plot to
Grave No.74

It was not always possible to clearly define the limits of individual plots. An example of this was Grave No. 74 which appeared to be a plot given that it contained a footstone to the east and the remains of wooden cross at the west (Plate 32).

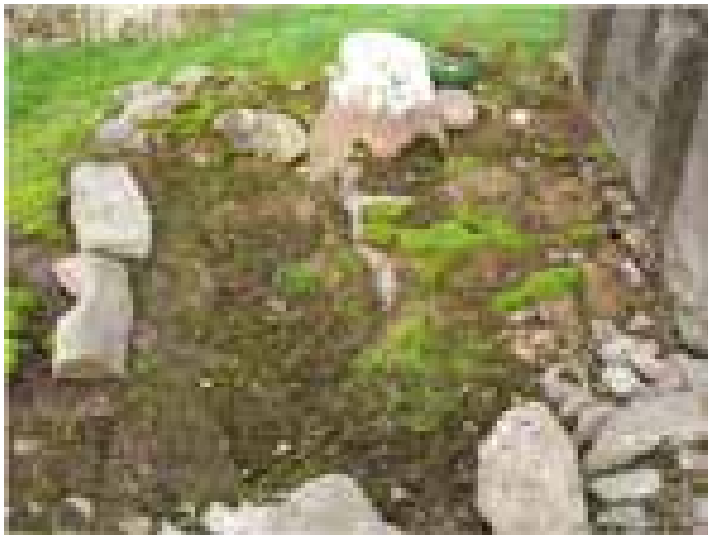
Plate 33-View of plot (Grave No. 92)

Although not common, some evidence for disturbed burials was observed within the graveyard, where fragments of human remains were scattered around certain plots e.g. Grave No. 92 (Plate 33).

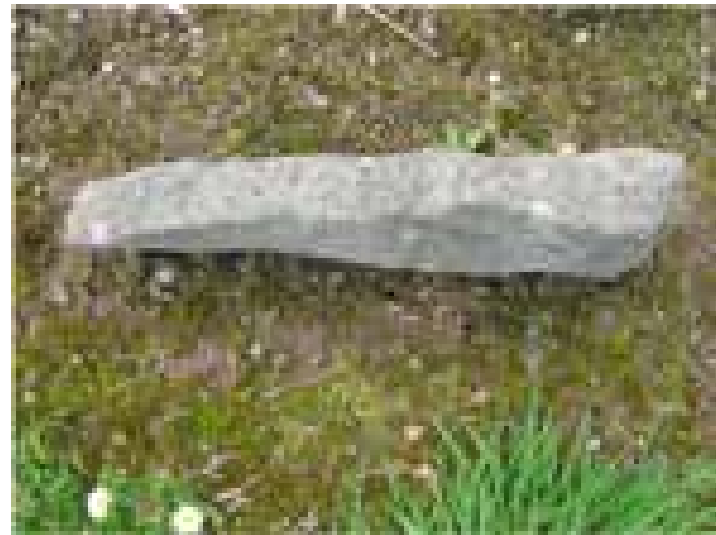
Plate 34-View of gravemarker to Grave No. 198

Only one named gravemarker (Grave No. 198) was recorded in the southern portion of Kilgobbin Graveyard. This consisted of a stone slab which has lightly inscribed letters; 'McCar...' on the upper surface, possibly representing the family named of those interred (Plate 34).

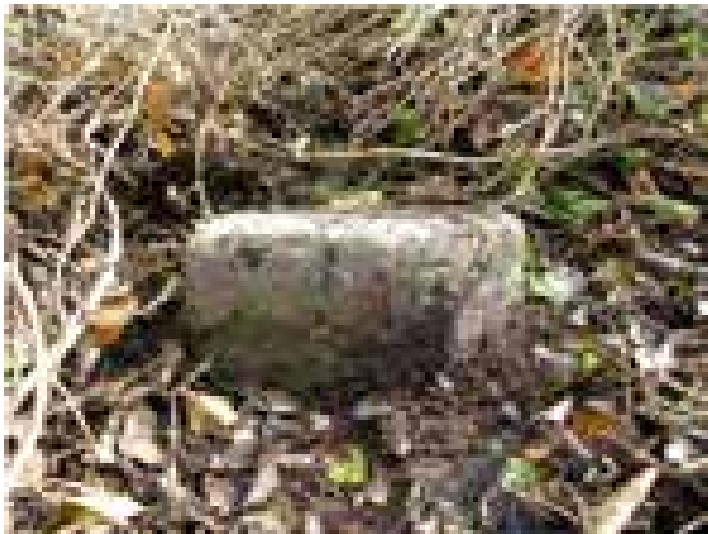
Plate 35-View of gravemarker to Grave No. 127

There are 124 unnamed gravemarkers within Kilgobbin Graveyard. The majority of these are concentrated in the lower southern portion of the graveyard and consist of locally sourced stone, usually thin pieces which are placed upright in the ground e.g. Grave No. 127 (Plate 35). The one

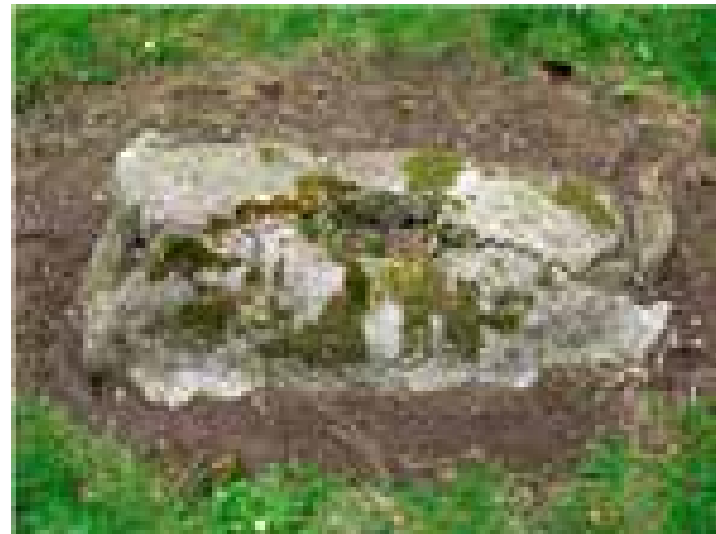
Plate 36-View of plinth block to Grave No. 3

exception is Grave No. 3 which consists of a ruined render plinth block from which the headstone is missing (Plate 36).

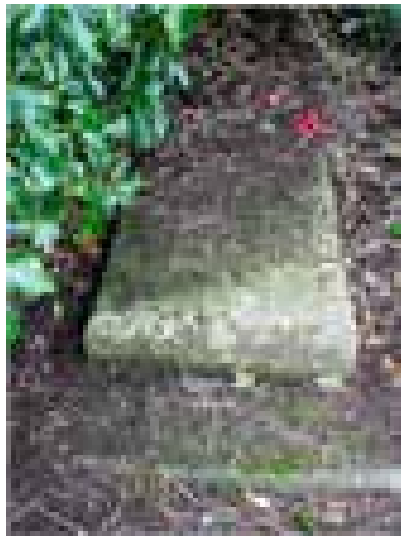
Plate 37-View of lintelled grave (Grave No. 162)

One of these included a named lintelled grave; Grave No. 162. This commemorates a member of the Jackson family who was buried in 1872 (Plate 37). The grave is partially hidden under overgrowth.

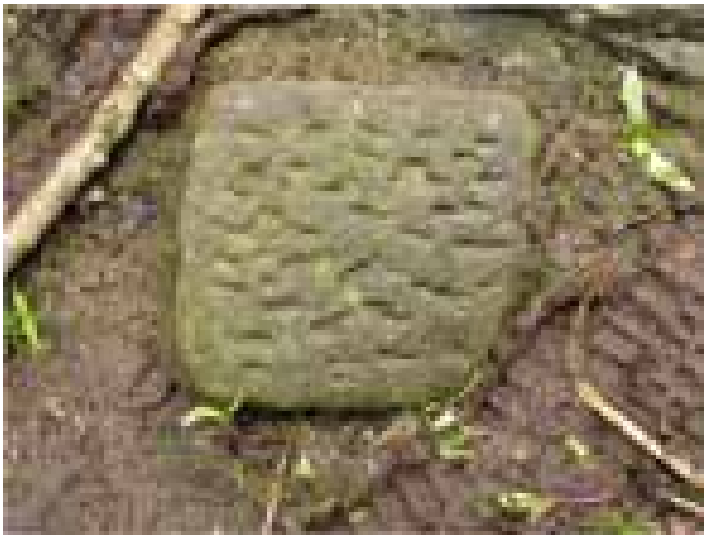
Plate 44-View of Miscellaneous No.01

Miscellaneous No. 01: Octagonal tooled stone block, part of composite column, possibly for a font (Plate 44).

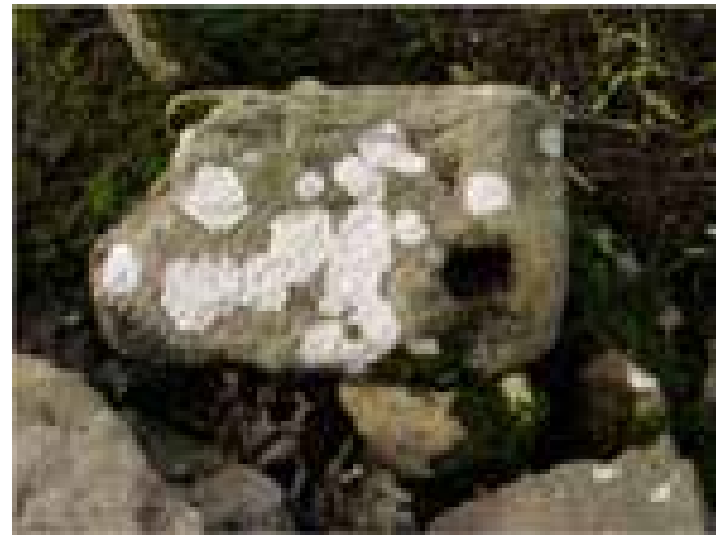
Plate 45-View of tooled stone (Miscellaneous No. 02)

Miscellaneous No. 02: Tooled stone block (Plate 45)

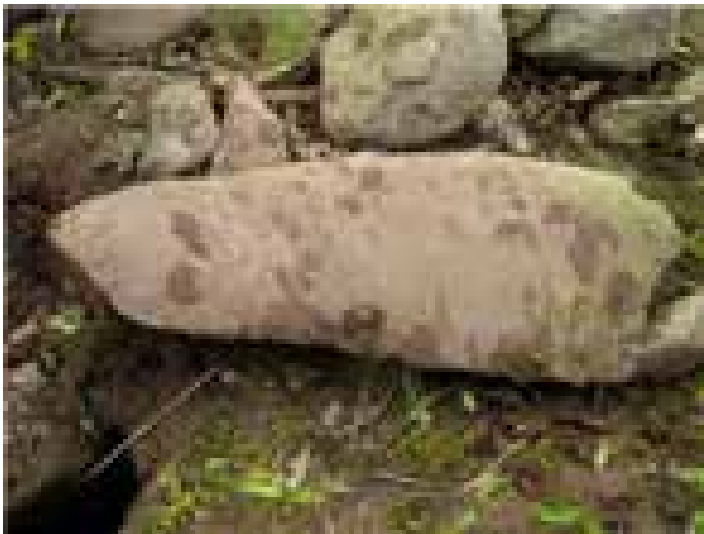
Plate 46-View of possible window/door jamb (Miscellaneous No. 05)

Miscellaneous No. 05: Carved rectangular block of sandstone with mortise carved on upper surface, possibly a window/door jamb with mortise accommodating glazing bars for a window or tracery (Plate 46).

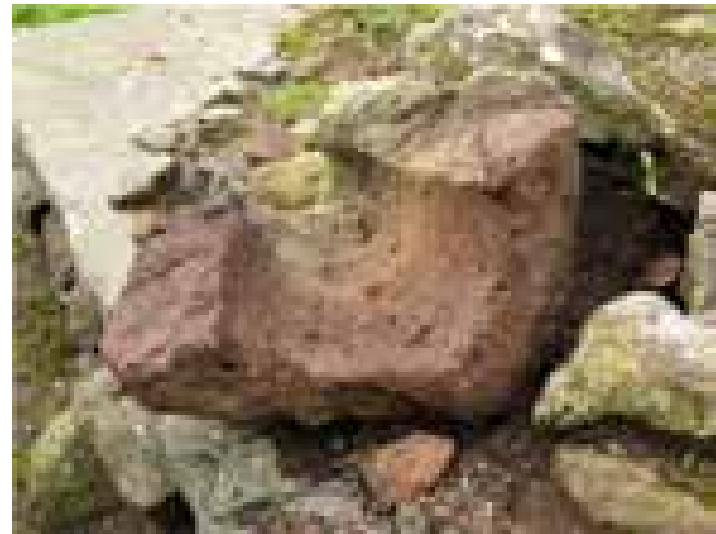
Plate 47-View of possible quern/grinding stone (Miscellaneous No. 03)

Miscellaneous No. 03: Elongated fragment of a possible quern/grinding stone (Plate 47).

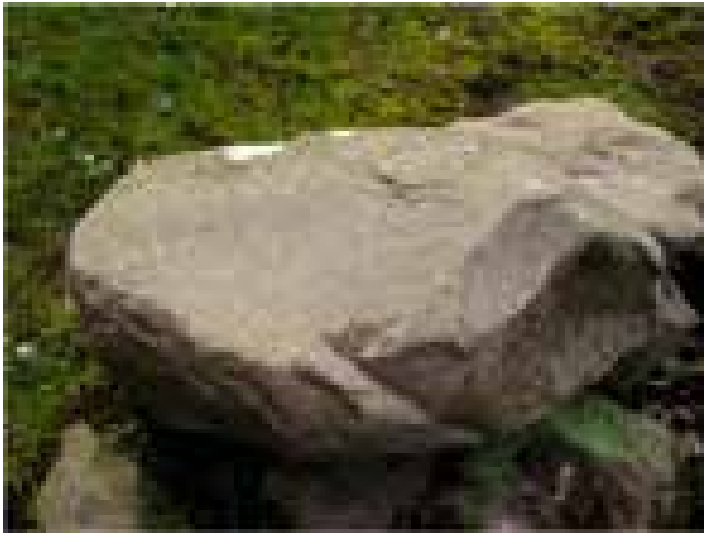
Plate 48-View of possible beehive quern fragment (Miscellaneous No. 04)

Miscellaneous No. 04: Possible fragment of a beehive quern stone with a carved out conical interior (old red sandstone) (Plate 48).

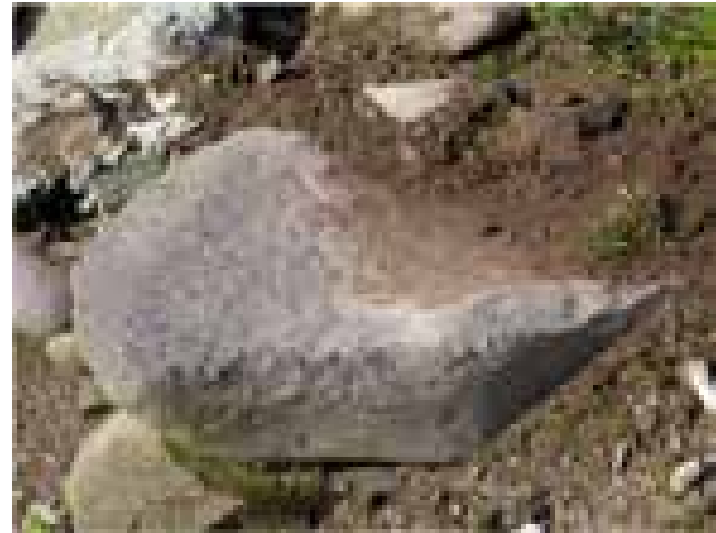
Plate 49-View of possible saddle quern fragment
(Miscellaneous No. 06)

Miscellaneous No. 06: Possible fragment of a saddle quern displaying a smooth concave surface on the upper side (old red sandstone) (Plate 49).

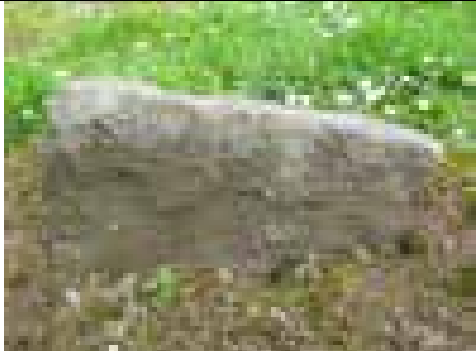
Grave_Type		Gravemarker
Grave_No	Family Name	Photo_Name
198	McCar?	IMG_0479
Notes		
Inscription on top of the gravemarker

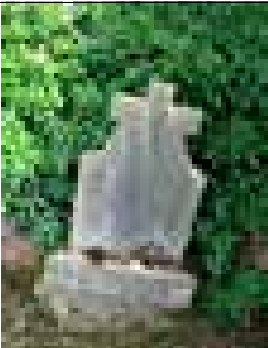
Grave_No	Family Name	Photo_Name
178	McCarthy	IMG_0460
Notes		
Single headstone, has either been moved or somehow disturbed and is now tilting

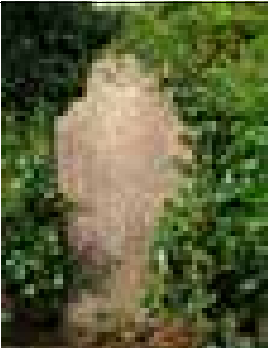
Grave_No	Family Name	Photo_Name
114	Riordan	IMG_0286
Notes		
Headstone in moderate condition, still legible but is eroding, date 1825

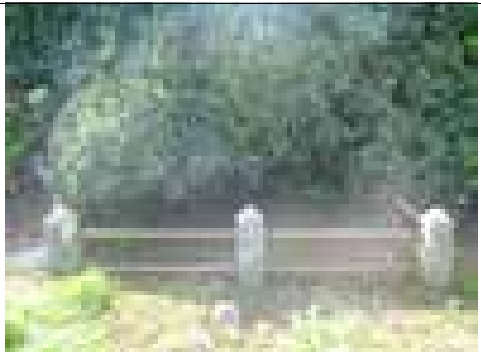
Grave_No	Family Name	Photo_Name
168	Chute	IMG_0438
Notes		
Heavily overgrown from graveyard wall, headstone is not visible

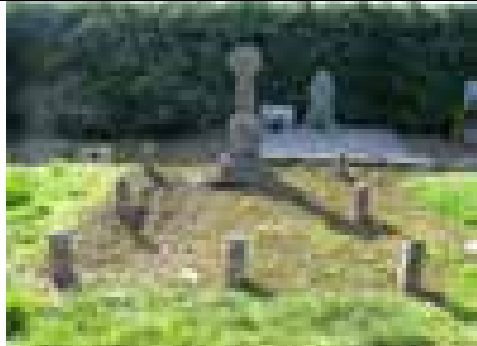
Grave_No	Family Name	Photo_Name
174	Griffin	IMG_0450
Notes		
Family plot in poor condition, high cross inspired headstone

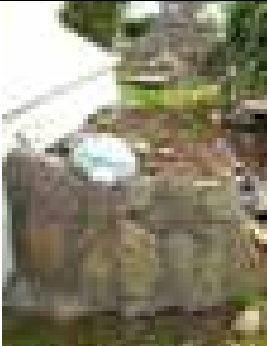
Grave_No	Family Name	Photo_Name
111	Cahillane	IMG_0281
Notes		
Tomb/grave in poor condition, recently de-weeded but structurally collapsing

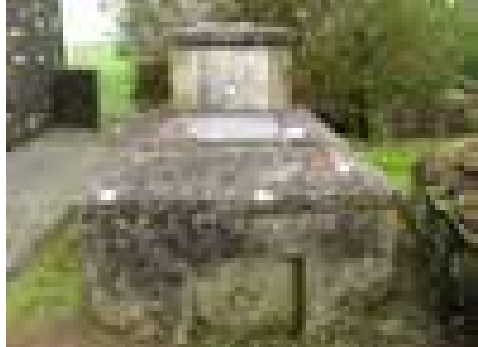
Grave_No	Family Name	Photo_Name
49	Costello	IMG_0151
Notes		
Tidy family tomb, two headstones the primary one is illegible,

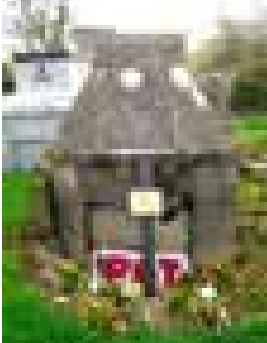
Grave_No	Family Name	Photo_Name
93	Crean	IMG_0241
Notes		
Tidy family tomb most recent burial in October 2010

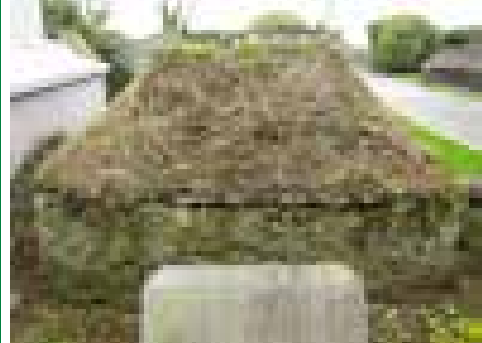
Grave_No	Family Name	Photo_Name
48	Crean	IMG_0148
Notes		
Headstone commemorating two brothers, one mayor of Tralee and one chief boatman in Coad,

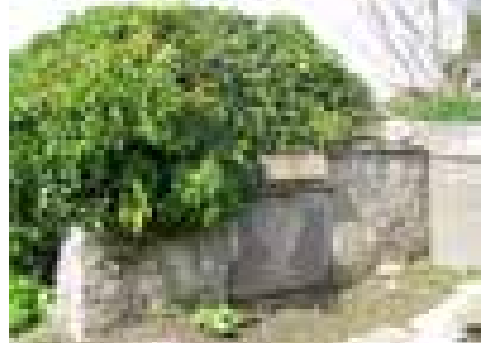
Grave_No	Family Name	Photo_Name
141	Day	IMG_0374
Notes		
Large walled family tomb with some roof overgrowth

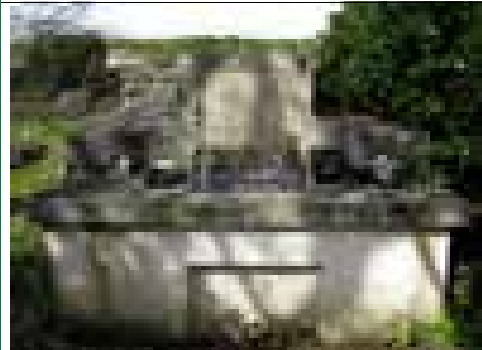
Grave_No	Family Name	Photo_Name
131	Curran	IMG_0332
Notes		
Large family tomb in good condition

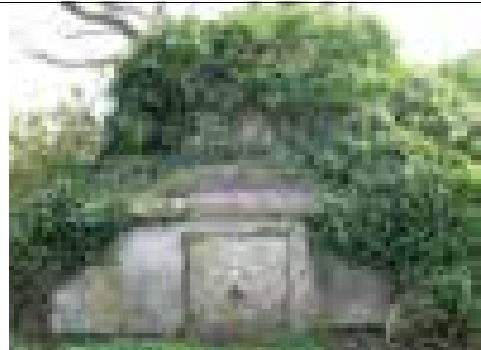
Grave_No	Family Name	Photo_Name
134	Finn	IMG_0342
Notes		
Large family tomb heavily overgrown

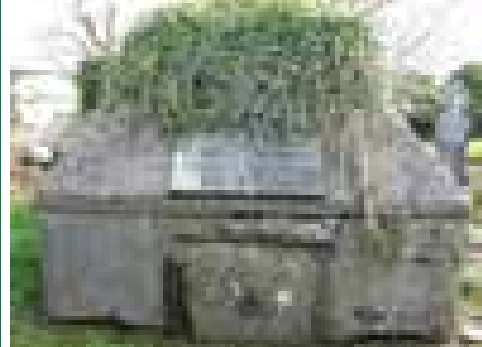
Grave_No	Family Name	Photo_Name
126	Curran/Dunne	IMG_0320
Notes		
Sergt R.I.C Slightly overgrown tomb, in good condition

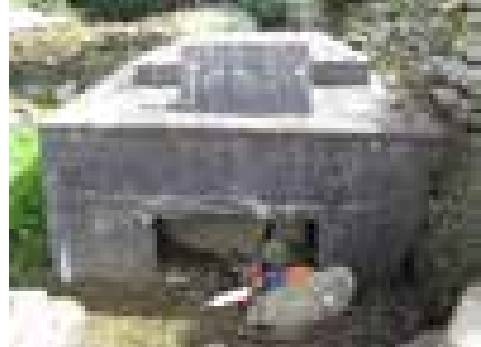
Grave_No	Family Name	Photo_Name
140	Finn	IMG_0370
Notes		
Small family tomb, in good condition

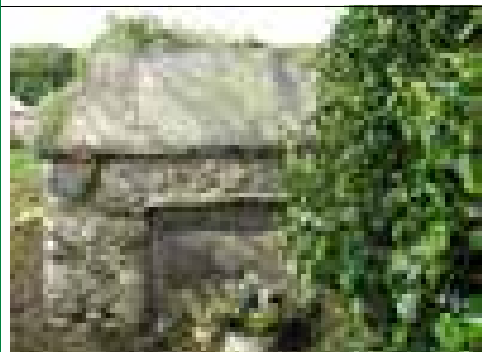
Grave_No	Family Name	Photo_Name
124	Griffin	IMG_0315
Notes		
Slightly overgrown tomb, attempts have been made to remove foliage

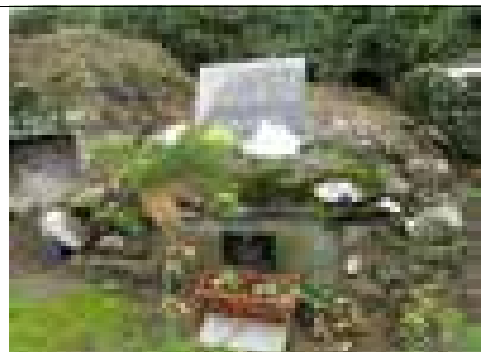
Grave_No	Family Name	Photo_Name
13	Griffin/Fahey	IMG_0043
Notes		
Overgrown, recently de-weeded family tomb

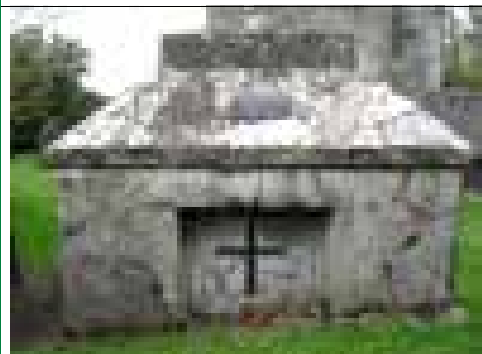
Grave_No	Family Name	Photo_Name
10	Griffin	IMG_0030
Notes		
Well maintained family tomb

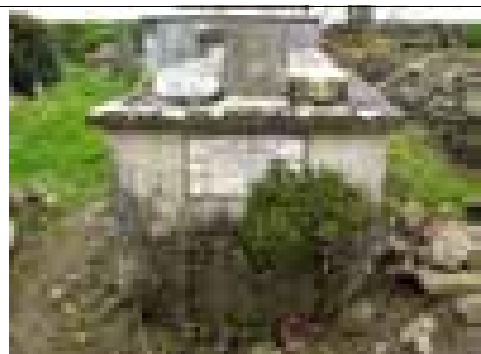
Grave_No	Family Name	Photo_Name
38	Herlihy/McCrohan	IMG_0116
Notes		
Family tomb in good condition, looked after

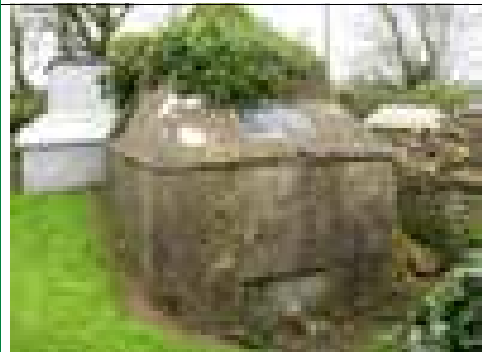
Grave_No	Family Name	Photo_Name
33	Griffin	IMG_0103
Notes		
Slightly overgrown family tomb in moderate condition, concrete is cracked in places

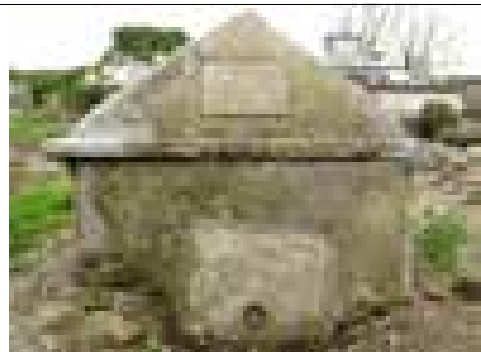
Grave_No	Family Name	Photo_Name
40	Keane	IMG_0125
Notes		
Recently restored with a fresh concrete capping of the roof

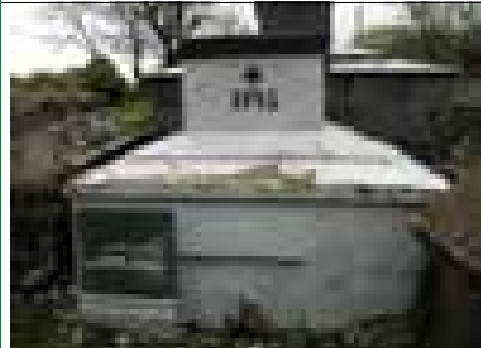
Grave_No	Family Name	Photo_Name
25	Keane	IMG_0078
Notes		
Maintained family tomb. Recent frosts have begun to crack the external rendering.

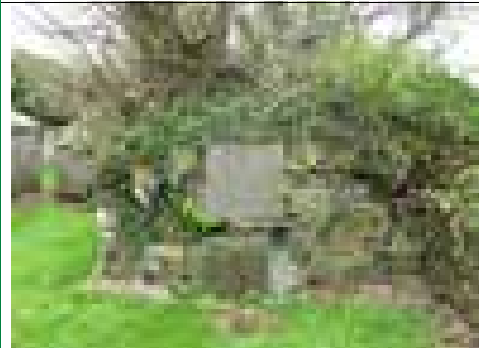
Grave_No	Family Name	Photo_Name
5	McElligott	IMG_0013
Notes		
Overgrown tomb dated 1835, behind tomb is a dump for garden waste

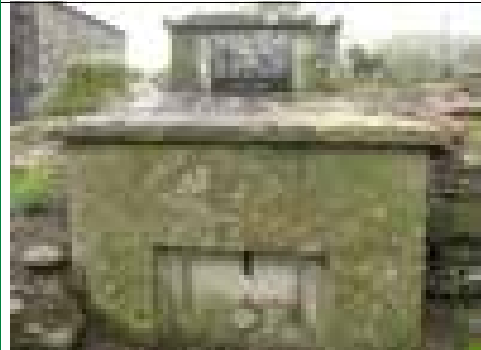
Grave_No	Family Name	Photo_Name
17	Kennedy/Coakley	IMG_0056
Notes		
Family tomb in good condition, small cracks in the upper parts of the concrete roof

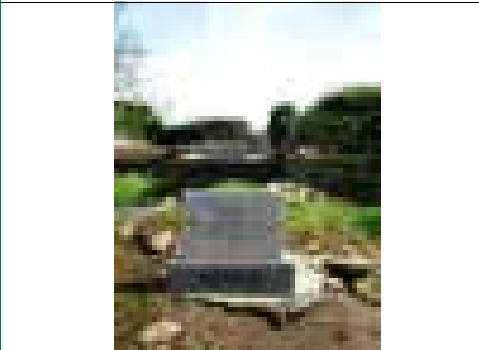
Grave_No	Family Name	Photo_Name
145	Moore	IMG_0390
Notes		
Low underground tomb overgrown by grass and flowers

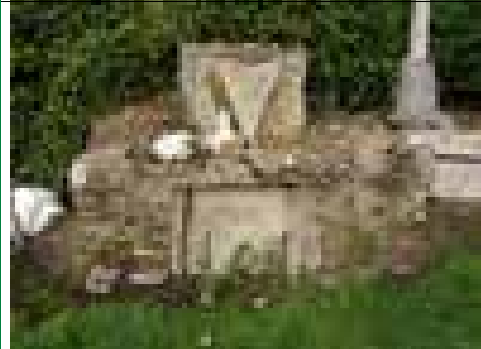
Grave_No	Family Name	Photo_Name
99	McCarthy	IMG_0258
Notes		
Partly overgrown and crumbling tomb in poor to moderate condition,

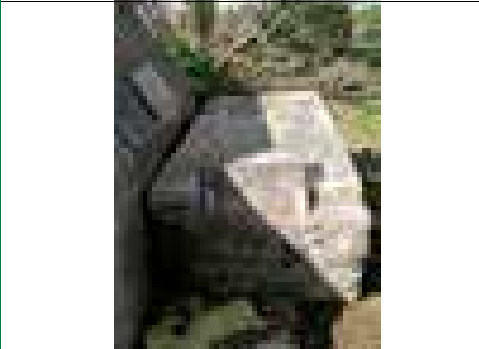
Grave_No	Family Name	Photo_Name
135	Moriarty	IMG_0346
Notes		
Low narrow tomb in good condition

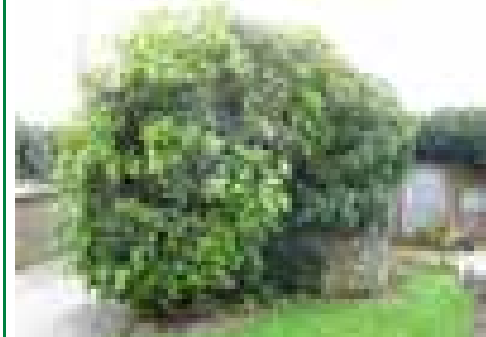
Grave_No	Family Name	Photo_Name
9	Moyinhan	IMG_0027
Notes		
Severely overgrown tomb, positioned next to the entrance of the grave yard

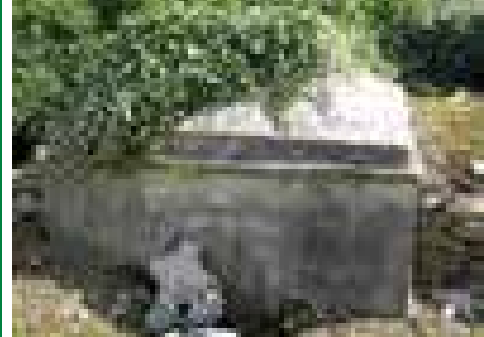
Grave_No	Family Name	Photo_Name
146	Murphy	IMG_0385
Notes		
Tomb in good condition , upper parts are overgrown and headstone is covered in foliage

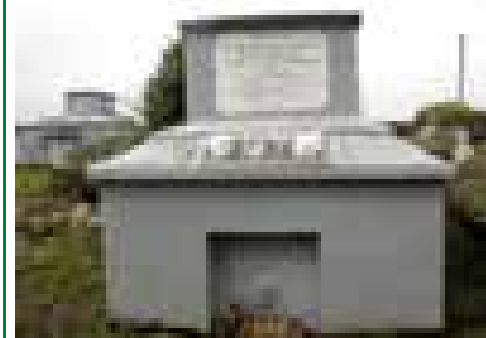
Grave_No	Family Name	Photo_Name
47	Moynihan	IMG_0141
Notes		
Well maintained tomb with two headstones in white marble

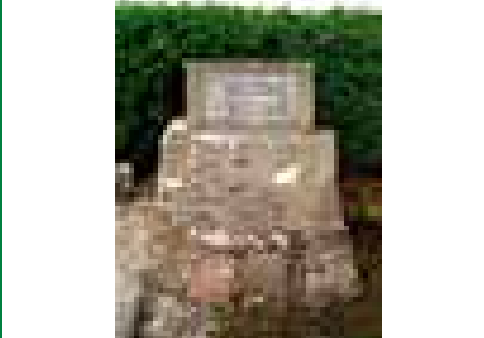
Grave_No	Family Name	Photo_Name
97	O'Connor	IMG_0252
Notes		
Small family tomb, with recesses for flower pots flanking the headstone

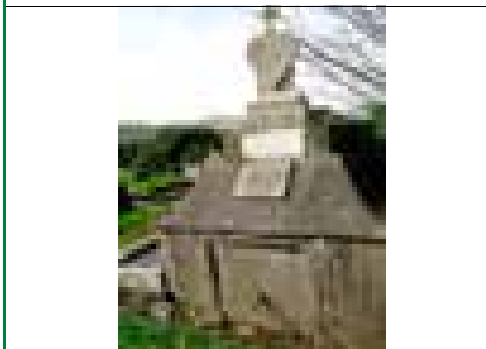
Grave_No	Family Name	Photo_Name
137	Moynihan	IMG_0359
Notes		
Large family tomb in moderate condition

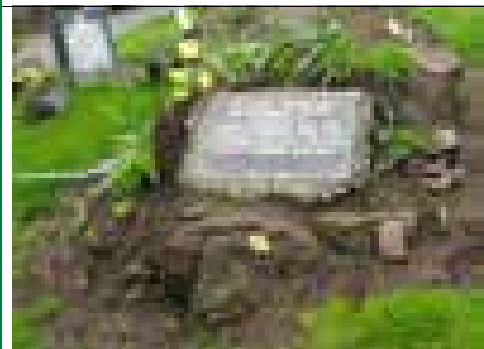
Grave_No	Family Name	Photo_Name
19	O'Connor	IMG_0063
Notes		
Recently de-weeded family tomb, freshly planted daffodils, also in memory of Cathrine Mulcahy

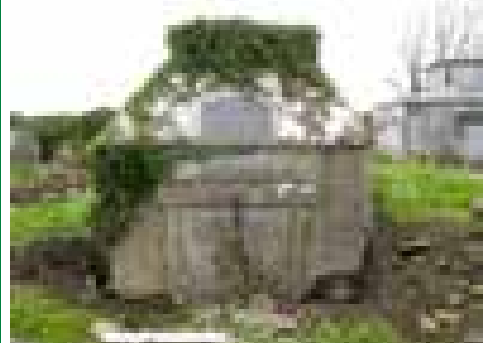
Grave_No	Family Name	Photo_Name
76	O'Donnell	IMG_0200
Notes		
Slightly overgrown large family tomb with two headstones, the primary one from 1871

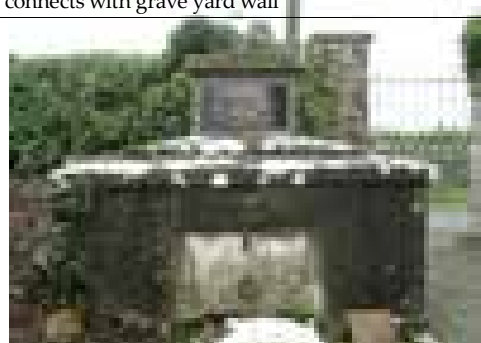
Grave_No	Family Name	Photo_Name
12	O'Donnell	IMG_0039
Notes		
Family tomb, slightly overgrown to the west, also in memory of Hanna Crean, west part of tomb connects with grave yard wall

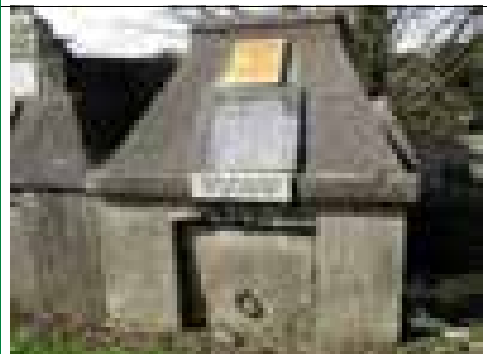
Grave_No	Family Name	Photo_Name
136	O'Donnell	IMG_0350
Notes		
Large family tomb in good condition

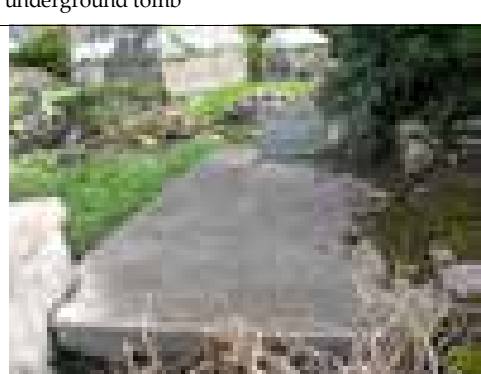
Grave_No	Family Name	Photo_Name
122	O'Donoghue	IMG_0309
Notes		
Concrete slab with headstone possibly covering a underground tomb

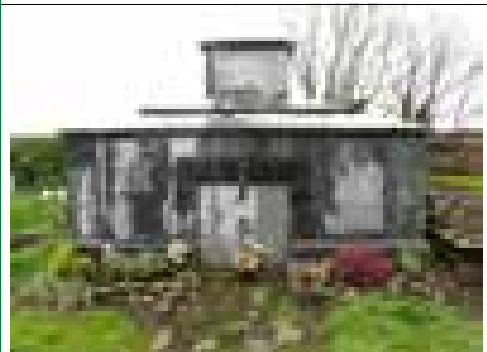
Grave_No	Family Name	Photo_Name
26	O'Donnell	IMG_0081
Notes		
Large well maintained tomb in cut limestone, oldest date 1871, four headstones

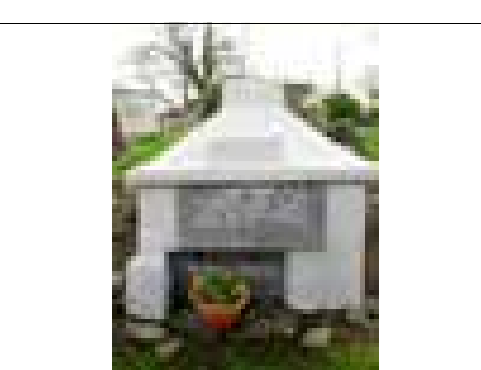
Grave_No	Family Name	Photo_Name
110	O'Gorman/O'Connor	IMG_0275
Notes		
Tidy family tomb in good condition, fresh flowers

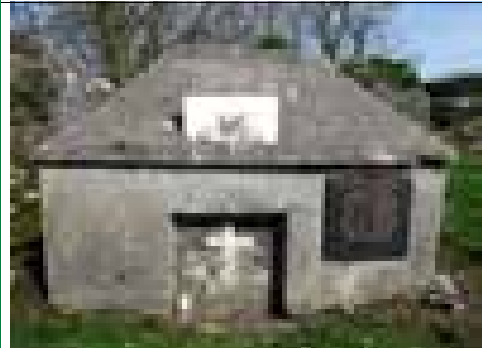
Grave_No	Family Name	Photo_Name
155	O'Shea	IMG_0409
Notes		
WWII headstone 'John O'Shea SGT 26 INF 1 INF DIV WW2 SS-2 PH'

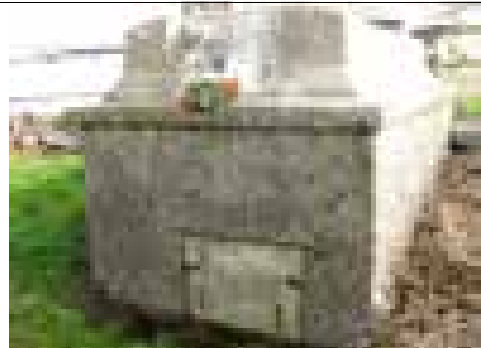
Grave_No	Family Name	Photo_Name
120	Quinlan	IMG_0297
Notes		
Tidy family tomb, possibly flooded

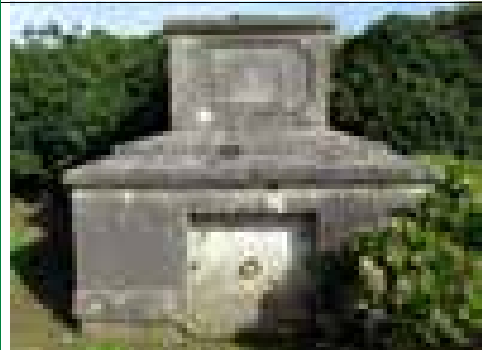
Grave_No	Family Name	Photo_Name
176	O'Sullivan	IMG_0454
Notes		
Large family tomb in good condition some cracks in the concrete

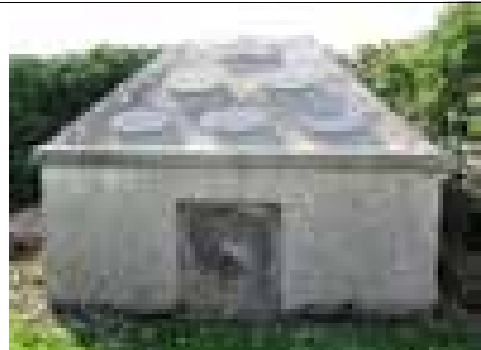
Grave_No	Family Name	Photo_Name
164	Sayers	IMG_0430
Notes		
Family tomb in good condition

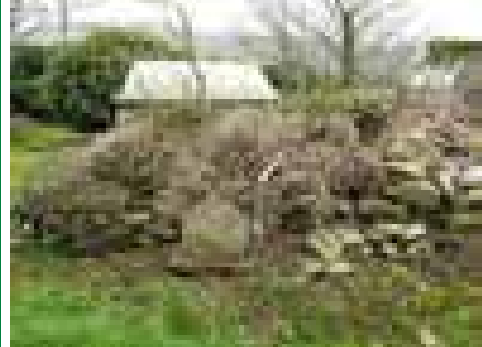
Grave_No	Family Name	Photo_Name
45	O'Sullivan	IMG_0137
Notes		
Narrow low tomb with headstone to the north, overgrown with ivy

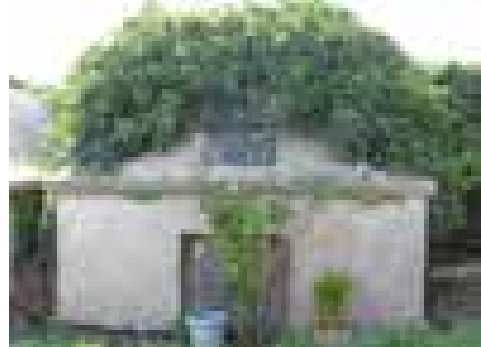
Grave_No	Family Name	Photo_Name
163	Scannell	IMG_0427
Notes		
Large family tomb, with slight overgrowth on the roof

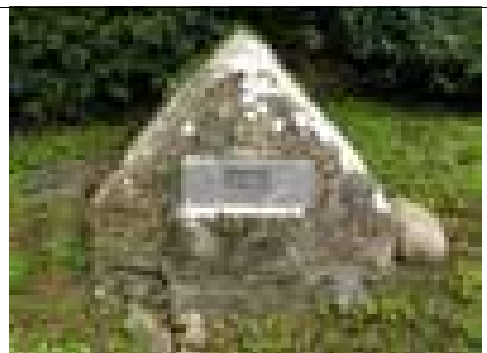
Grave_No	Family Name	Photo_Name
57	Tullig	IMG_0170
Notes		
Well concreted tomb in moderate condition a few cracks in the concrete

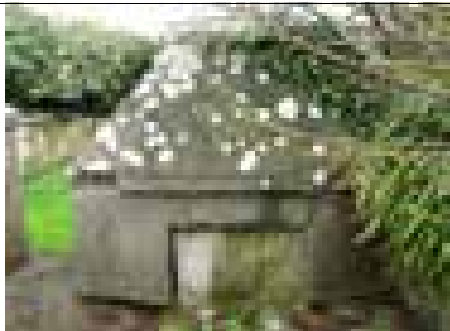
Grave_No		Photo_Name
6		IMG_0017
Notes		
Slightly overgrown with ivy, partly cracked roof, north side of tomb covered by the same garden waste as grave 5

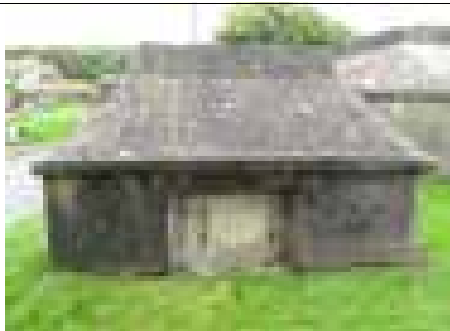
Grave_No		Photo_Name
11		IMG_0035
Notes		
Well maintained tomb,

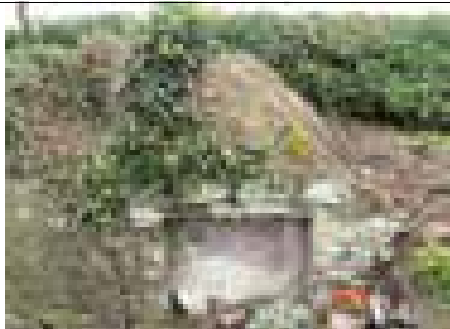
Grave_No		Photo_Name
14		IMG_0048
Notes		
Overgrown tomb possibly partly de-weeded with grave 13, not well maintained,

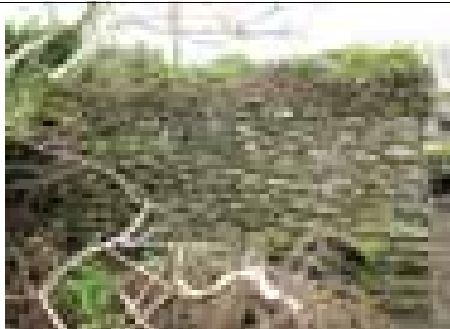
Grave_No		Photo_Name
15		IMG_0052
Notes		
Slightly overgrown with ivy, partly de-weeded revealing a cobbled stone triangular roof,

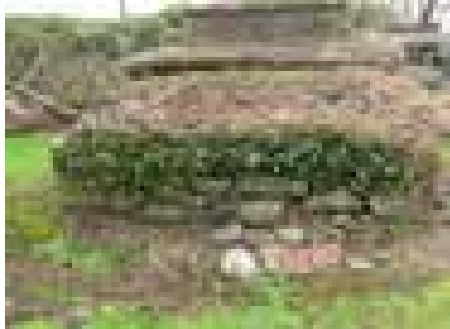
16 Partly overgrown with ivy, in moderate condition

Grave_No		Photo_Name
16		IMG_0054
Notes		
Partly overgrown with ivy, in moderate condition

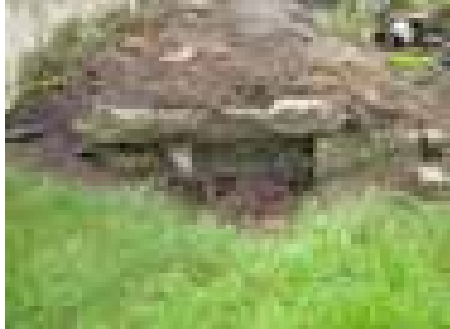
Grave_No		Photo_Name
18		IMG_0060
Notes		
Low overgrown tomb, recently de-weeded

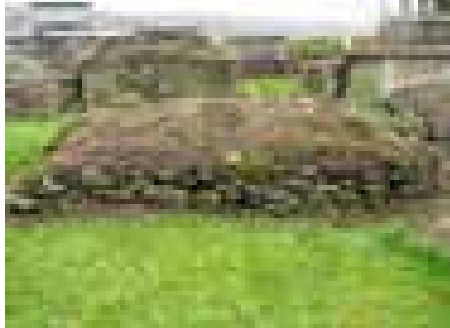
Grave_No		Photo_Name
22		IMG_0074
Notes		
Recently de-weeded tomb

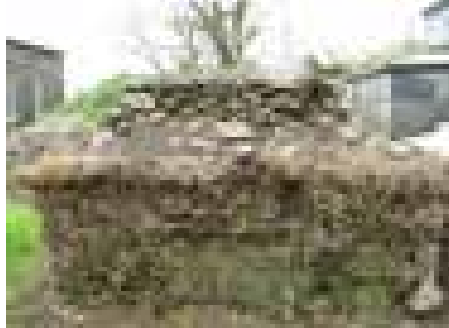
Grave_No		Photo_Name
24		IMG_0076
Notes		
Partly overgrown recently de-weeded

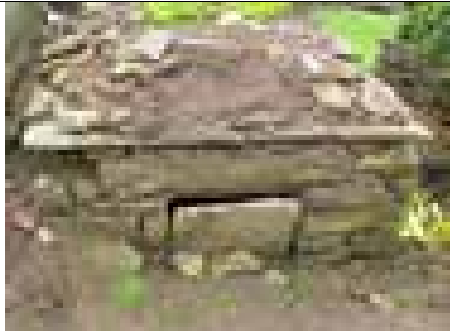
27 Recently de-weeded tomb in moderate condition, to the north a spontaneous compost heap has been created between grave 27 and 28

Grave_No		Photo_Name
27		IMG_0090
Notes		
Recently de-weeded tomb in moderate condition, to the north a spontaneous compost heap has been created between grave 27 and 28

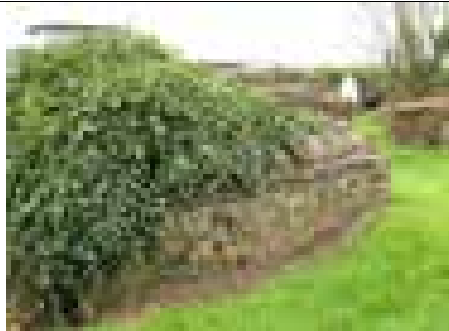
Grave_No		Photo_Name
28		IMG_0093
Notes		
Partly overgrown with ivy, could benefit from de-weeding to prevent structural damage, the tombstone/headstone lays on top and is illegible due to

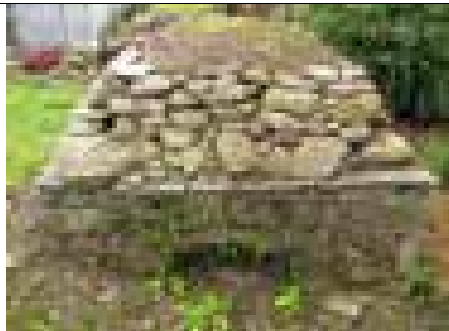
Grave_No		Photo_Name
34		IMG_0109
Notes		
Walled tomb in good condition, recently de-weeded, a number of bone fragments visible on and around this tomb including skull fragments

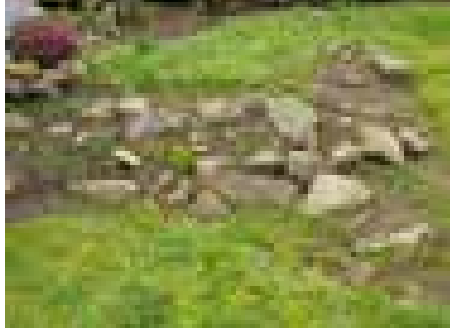
Grave_No		Photo_Name
36		IMG_0114
Notes		
Underground tomb, possibly related to or predating grave 26, several fragments of roofing slate visible as capping of the tomb

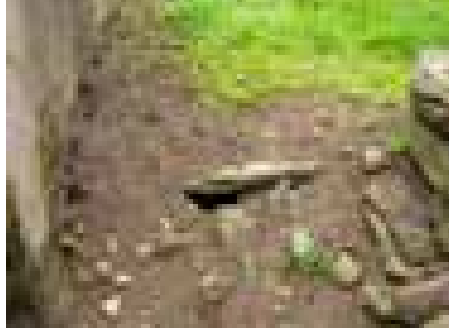
Grave_No		Photo_Name
39		IMG_0122
Notes		
Underground tomb, only visible to the east the rest is covered by grass

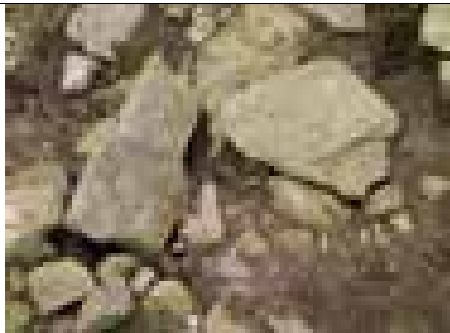
Grave_No		Photo_Name
42		IMG_0131
Notes		
Underground tomb with two headstones to the west, the eastern most one shows sign of being quarried and cut into shape, no visible writing on either of the two stones

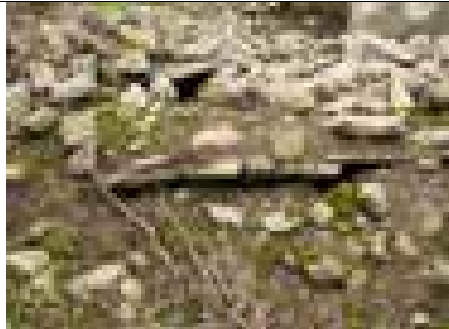
Grave_No		Photo_Name
44		IMG_0135
Notes		
Low, narrow formed partly underground tomb with stone flag lintels visible to the north

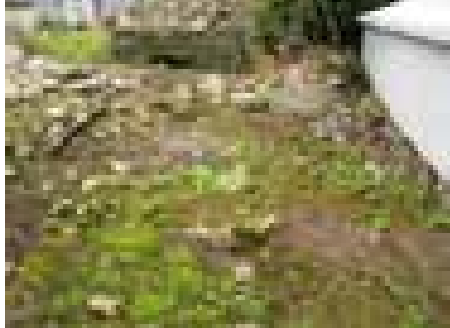
Grave_No		Photo_Name
46		IMG_0140
Notes		
Remains of one or more collapsed/removed tombs

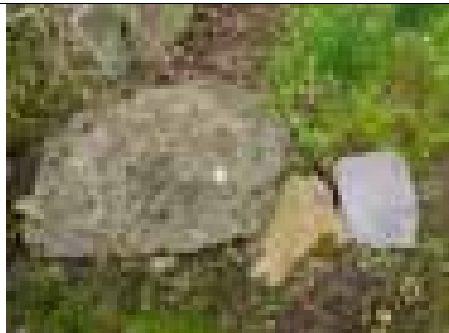
Grave_No		Photo_Name
65		IMG_0180
Notes		
Underground tomb, only visible through the concrete fix and two possible capstones, one of which a roof slate

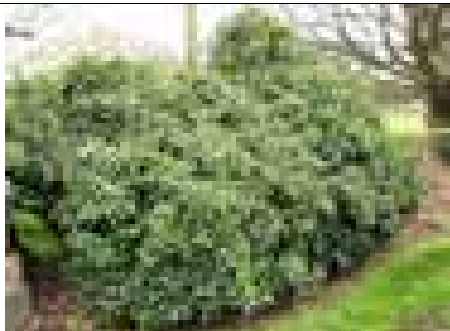
Grave_No		Photo_Name
67		IMG_0184
Notes		
Complete overgrown tomb,

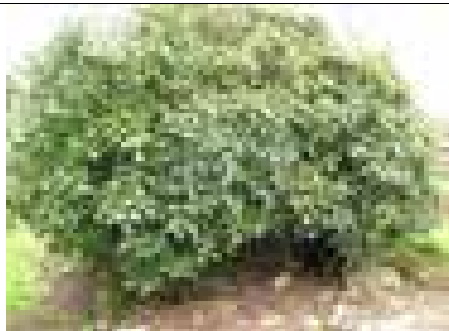
Grave_No		Photo_Name
68		IMG_0187
Notes		
low and narrow formed tomb with heavy overgrowth covering most of the tomb,

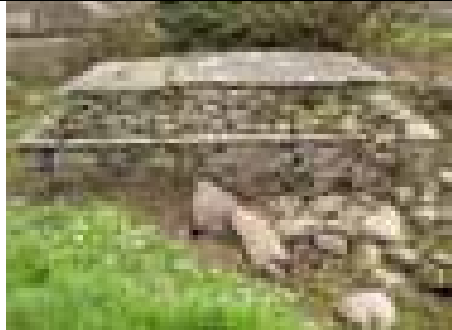
Grave_No		Photo_Name
77		IMG_0210
Notes		
Walled tomb in good condition, however the capstone is fractured in multiple places

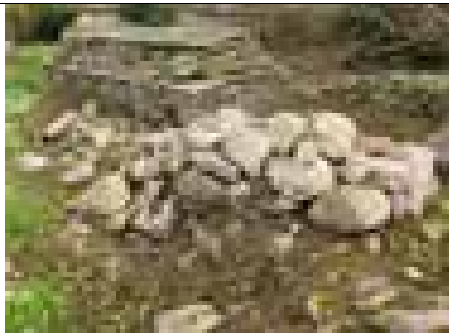
Grave_No		Photo_Name
78		IMG_0211
Notes		
Long narrow tom partly collapsed in the east

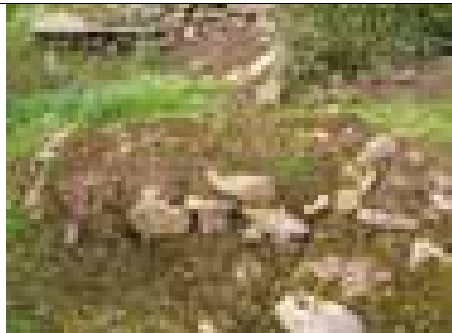
Grave_No		Photo_Name
80		IMG_0218
Notes		
Low underground tomb freshly de-weeded

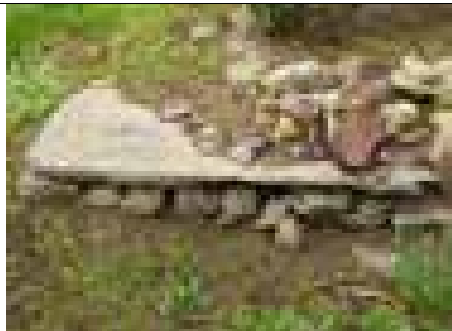
Grave_No		Photo_Name
85		IMG_0228
Notes		
Low tomb consisting of a large capstone covering a low stone wall

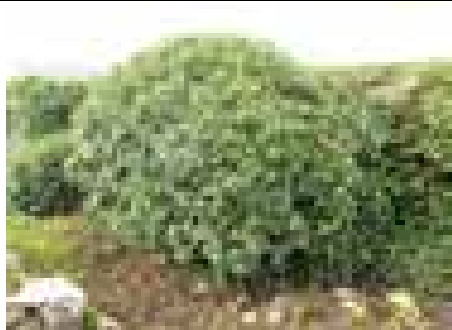
Grave_No		Photo_Name
106		IMG_0270
Notes		
Severely overgrown tomb, if named impossible to see due to foliage

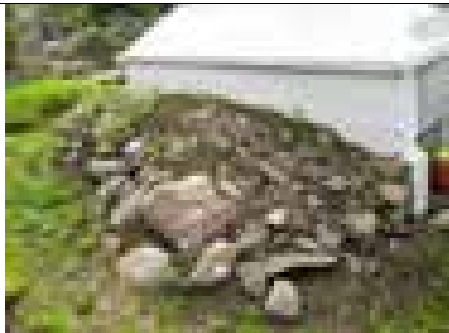
Grave_No		Photo_Name
108		IMG_0273
Notes		
Low narrow tomb, close to complete collapse, recently de-weeded

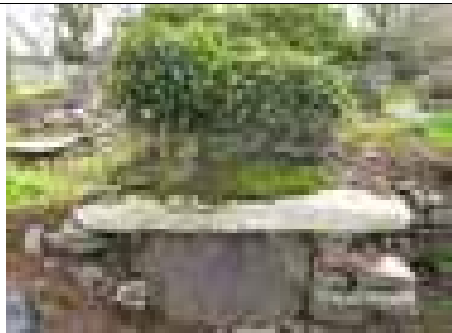
Grave_No		Photo_Name
116		IMG_0288
Notes		
Tomb in poor to moderate condition, upper parts heavily overgrown which have caused damage to the structure

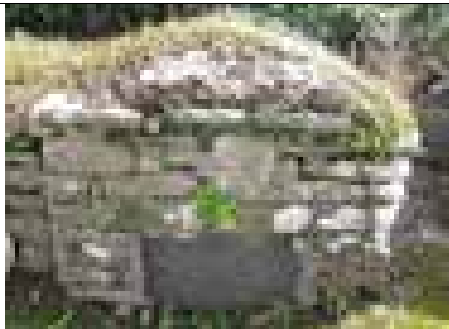
Grave_No		Photo_Name
143		IMG_0381
Notes		
Small tomb in good condition, slight overgrowth seem to have been partly cleared from the structure

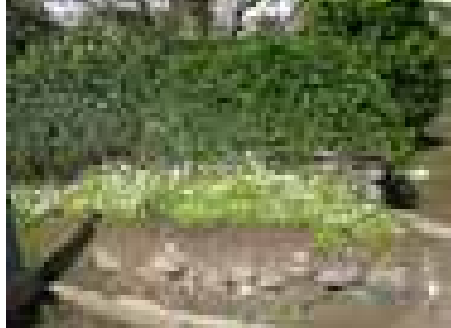
Grave_No		Photo_Name
149		IMG_0399
Notes		
Low narrow underground tomb overgrown by grass and flowers

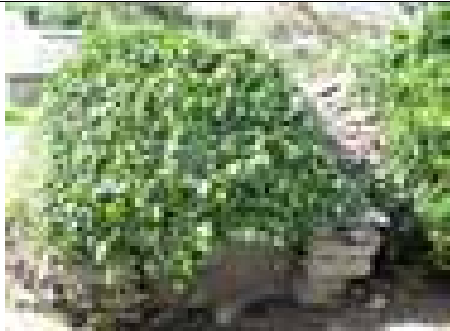
Grave_No		Photo_Name
150		IMG_0401
Notes		
small tomb in moderate condition heavily overgrown by ivy which could have compromised the structure

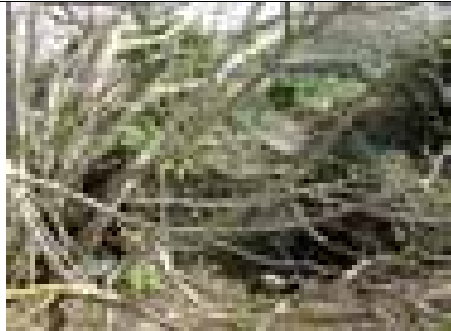
Grave_No		Photo_Name
151		IMG_0405
Notes		
small tomb in moderate condition heavily overgrown by ivy which could have compromised the structure

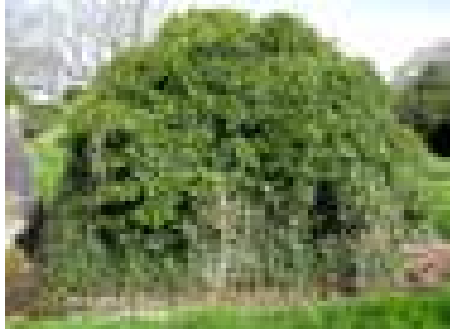
Grave_No		Photo_Name
160		IMG_0423
Notes		
Heavily overgrown tomb(s), due to overgrowth impossible to say if its one or two tomb present underneath foliage, size would suggest two

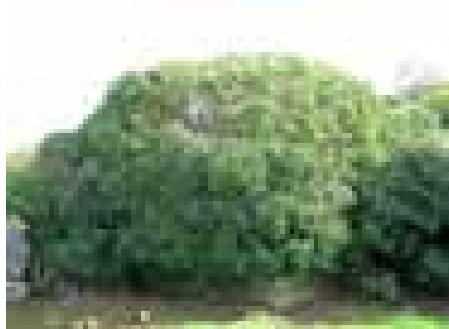
Grave_No		Photo_Name
179		IMG_0461
Notes		
Heavily overgrown tomb,
