Archaeological Survey,
Killagha Abbey and Graveyard,
Milltown,
Co. Kerry.

October 2012

RMP No.: KE047-047-Killagha Abbey & graveyard

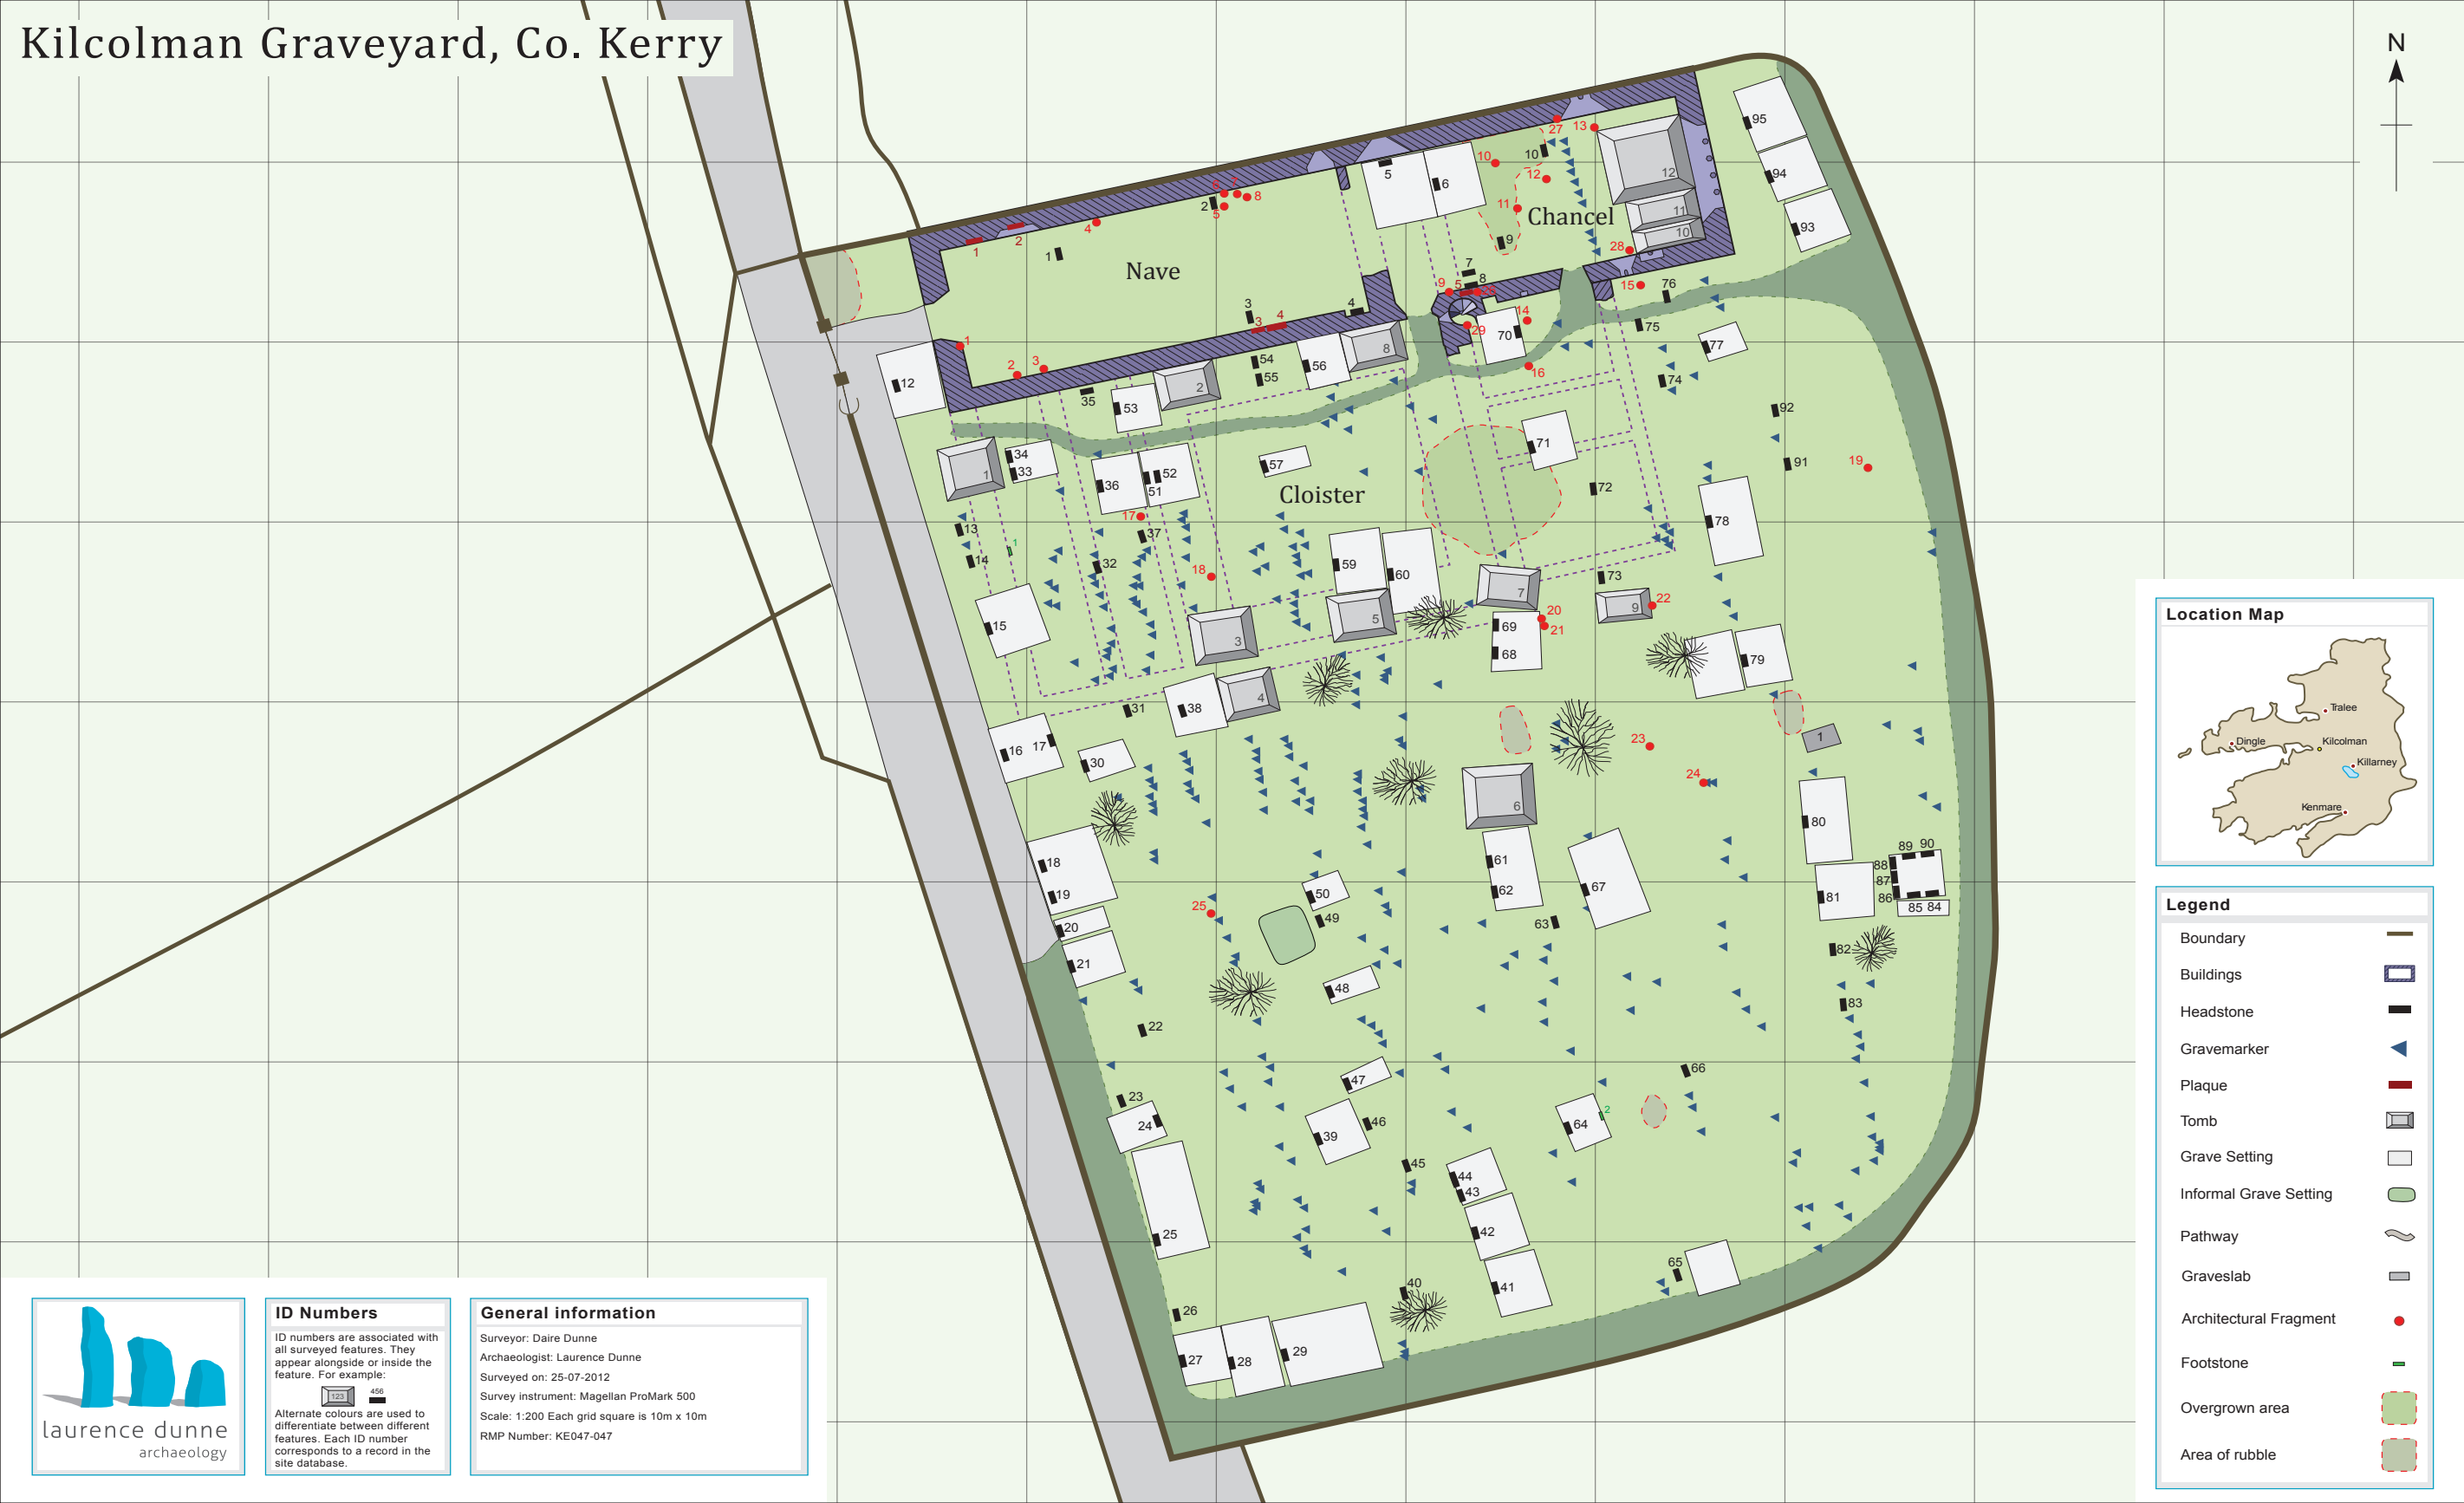
Figure 2: Archaeological survey plan of Killagha abbey and graveyard.

The extant, rectangular abbey occupies the northernmost limits of the graveyard with its N elevation forming most of the N boundary (Figure 2). Traces of its wider associated medieval complex of buildings are discernible abutting and protruding from the S elevation in particular the sacristy (Figure 2 & Plates 2-3). While a coherent horizontal slot mid way along the S elevation accommodated the mono-pitched ambulatory around the cloister (Plates 1-2)

There are only twelve tombs and sixty modern formal grave settings associated with headstones in the cemetery. Thirty three modern headstones have no formal grave plot. Otherwise the dominant headstone (83) is the simple ubiquitous, unhewn and un-inscribed gravemarker many of which are arranged in loose rows in the graveyard and indeed in the chancel of the abbey (Figure 2).

Dispersed around the old medieval abbey and graveyard are many loose medieval architectural fragments some of which were reused as gravemarkers while others lie loose on the ground (Figure 2, Appendix 6).

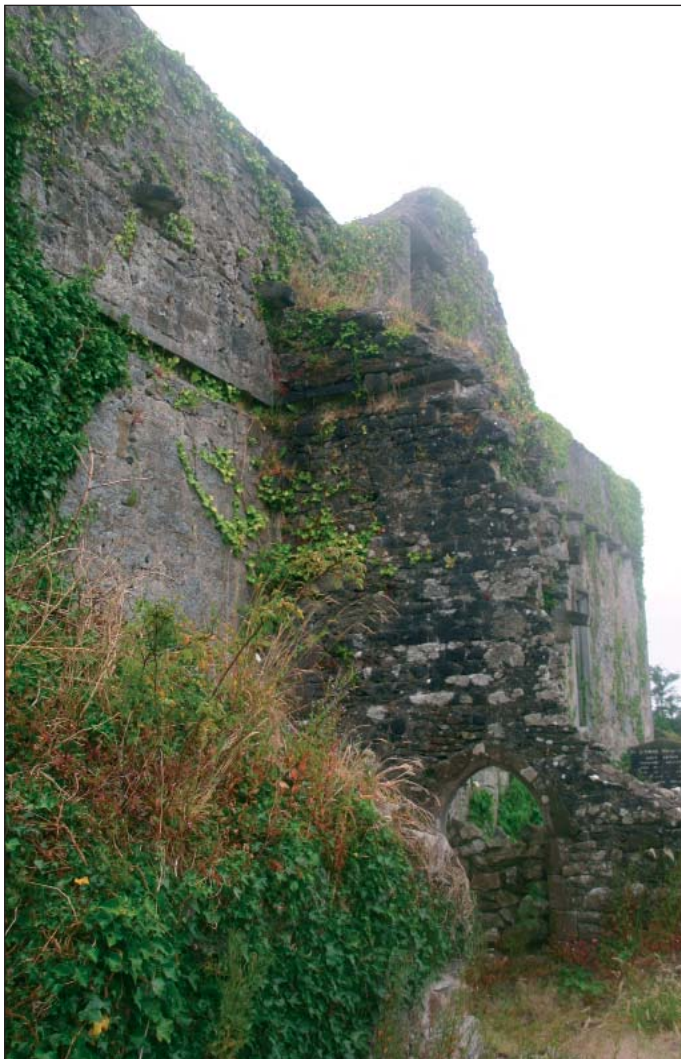
Plate 2: View from W of partial remains of wider Augustinian monastery buildings abutting the S elevation of the abbey church. Note the horizontal slot to accommodate the cloister ambulatory building

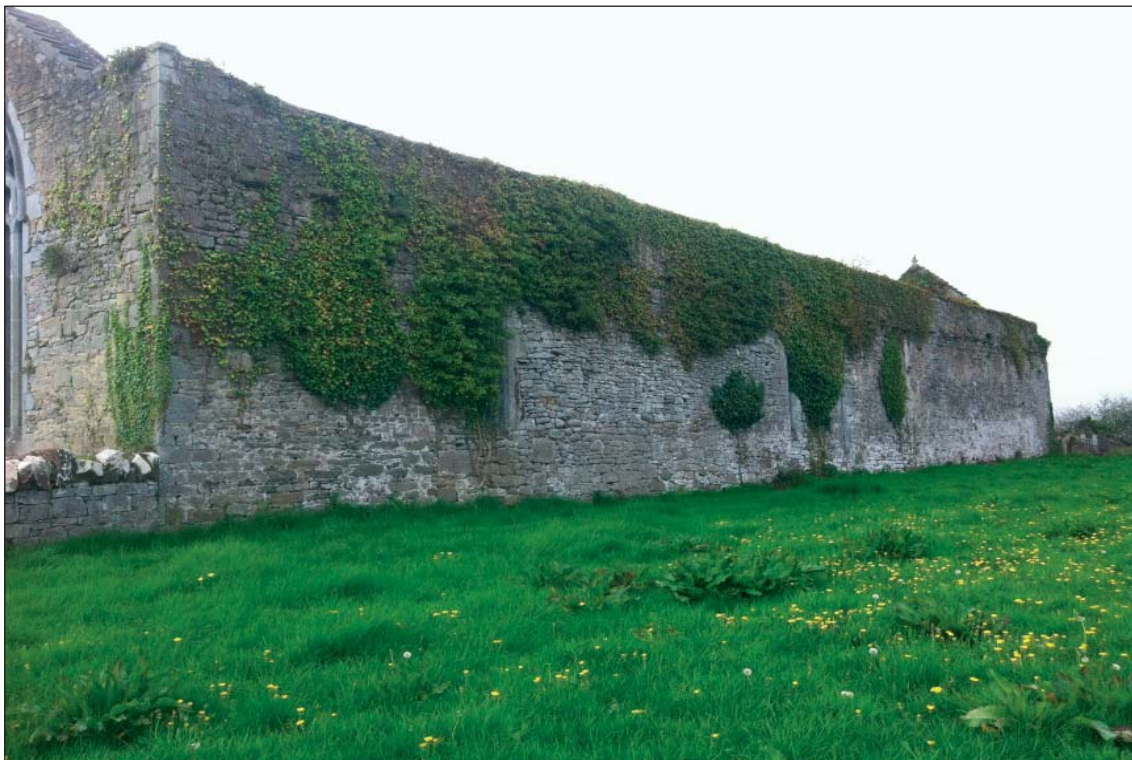
Ivy is established on the entirety of the medieval ruins and along the N, E & S boundary walls.

Plate 5: View of exterior N elevation of Killagha abbey church. Note pervasive extent of ivy cover

The ivy should be regularly kept short on the Abbey structure as a standard maintenance project.

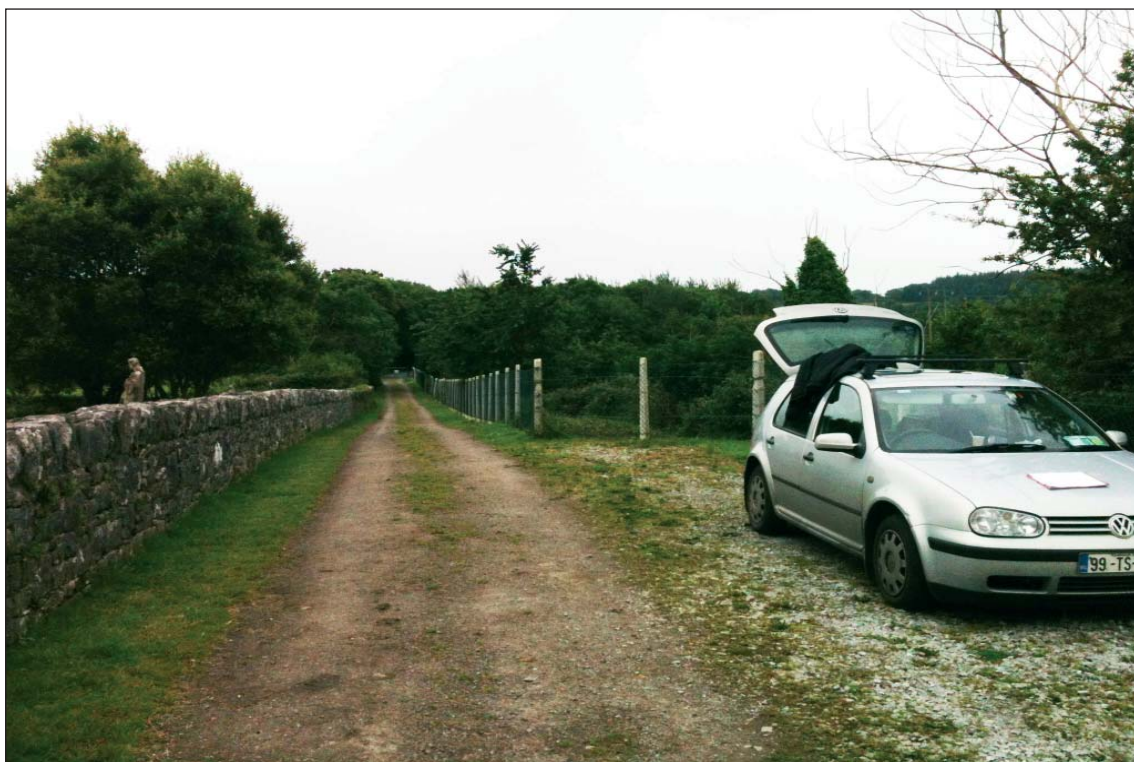
The roadway approach to Killagha cemetery is via a straight narrow grassy encroached trackway . There are a few carparking spaces available for individual visitors or a hearse opposite the entrance gate but generally funeral mourners have to park some distance back on the roadway and walk up the trackway to the cemetery (Plate 6). Adequate vehicle turning is not available.

Plate 6: View S along W boundary wall, access trackway. Note very restricted carparking space

If possible a turning area and a small piece of ground should be purchased to provide adequate carparking.

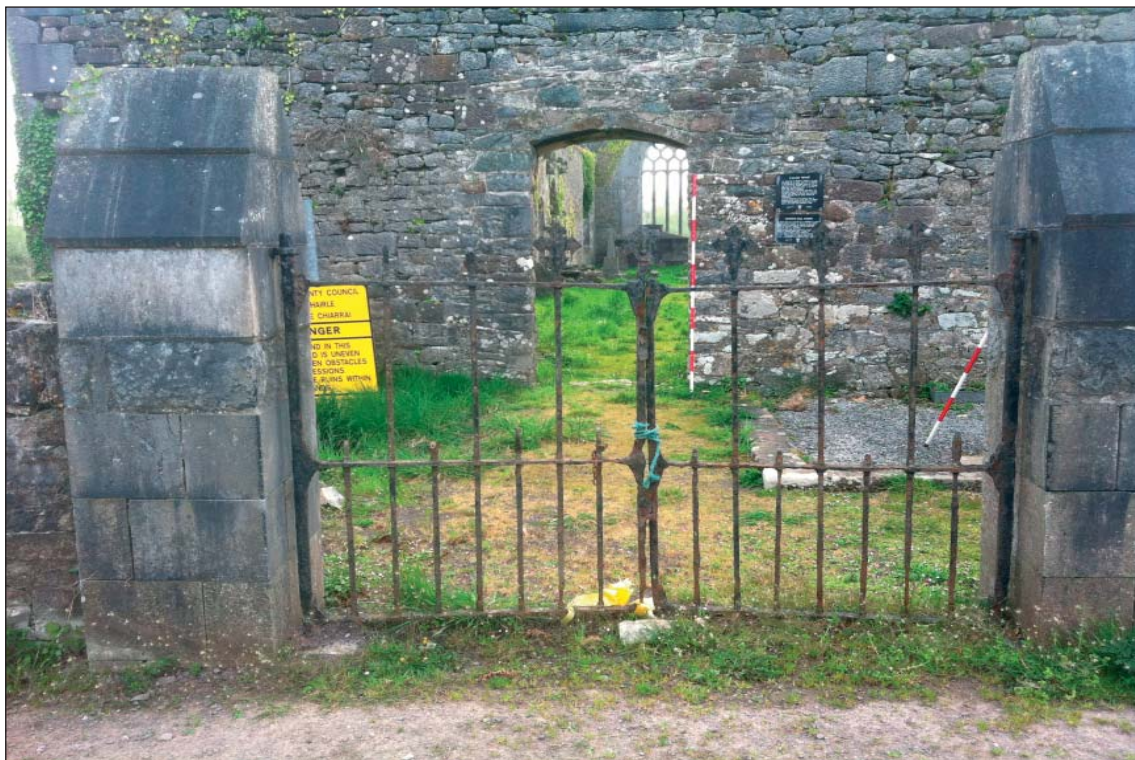
There is one gated entrance and a swing-stile into Killagha graveyard (Figure 2 & Plate 7). A pair of wrought iron gates are set between two tall square ashlar limestone piers with gabled capping. The gates are in poor order, rusty and rusted away in places at the base. No closing latch or bolt is provided (Plate 8).

Plate 8: Exterior view from W of entrance gateway to Kilcoleman cemetery

The wrought iron gates should be conserved, repaired and painted.

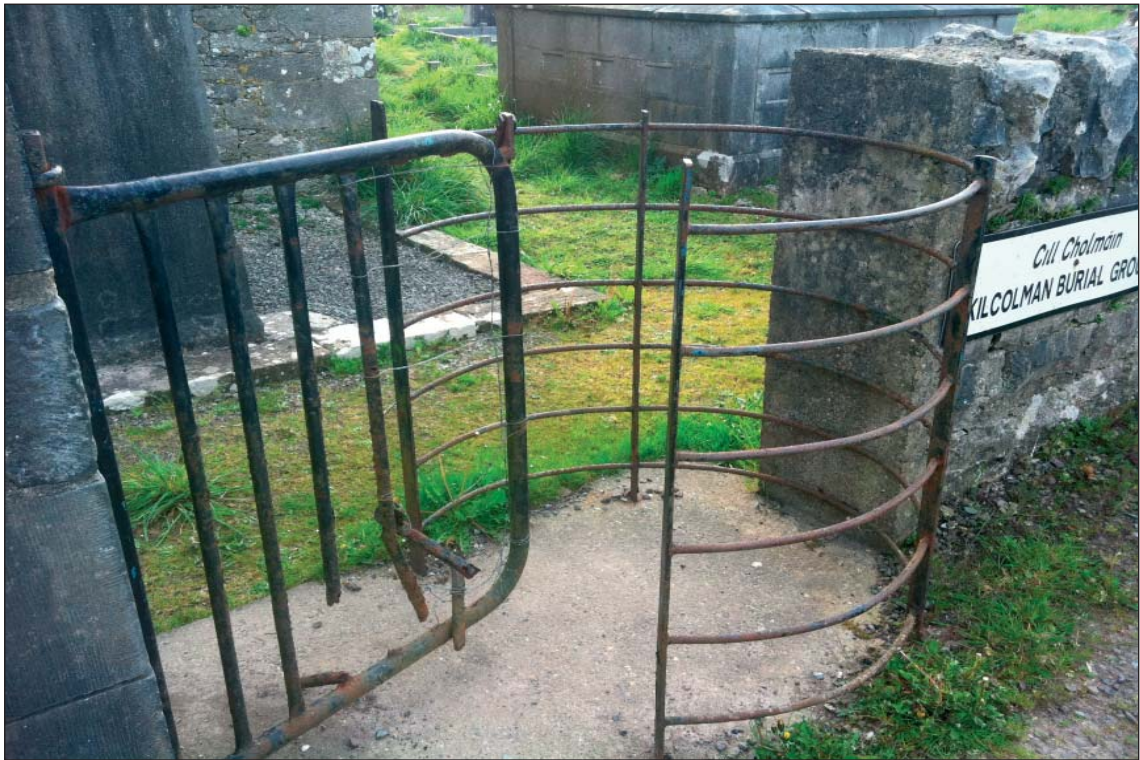
A swing-stile provides for pedestrian access beside the S gate pier. The stile of thin tubular metal is in poor order and rotted in sections and should be replaced (Plate 9).

Plate 9: View of decrepit swing-stile at entrance to Kilcoleman cemetery

The swing-stile should be replaced.

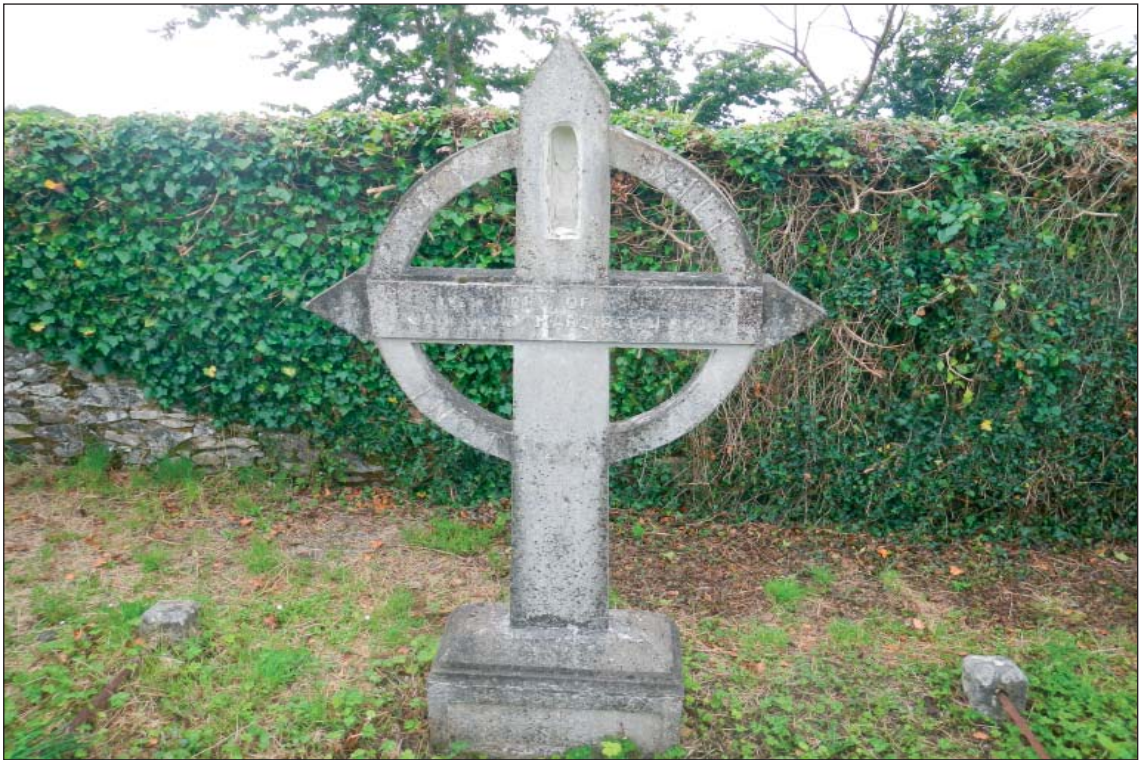
There is a formal internal pathway that provides access around the graveyard perimeter only. There are no internal pathways formal or informal. The existing pathway is hardly discernible due to grass, lack of maintenance and the encroachment of vegetation and bushes and indeed inappropriately positioned graves (Figure 2 & Plate 10).

Plate 10: View of headstone at W limits of Kilcoleman cemetery. Note overgrown pathway and boundary wall

The pathway should be cleared and re-gravelled.

The grass should be kept low throughout. This will enable safer navigation for visitors and also create greater visibility for the various graveyard features.

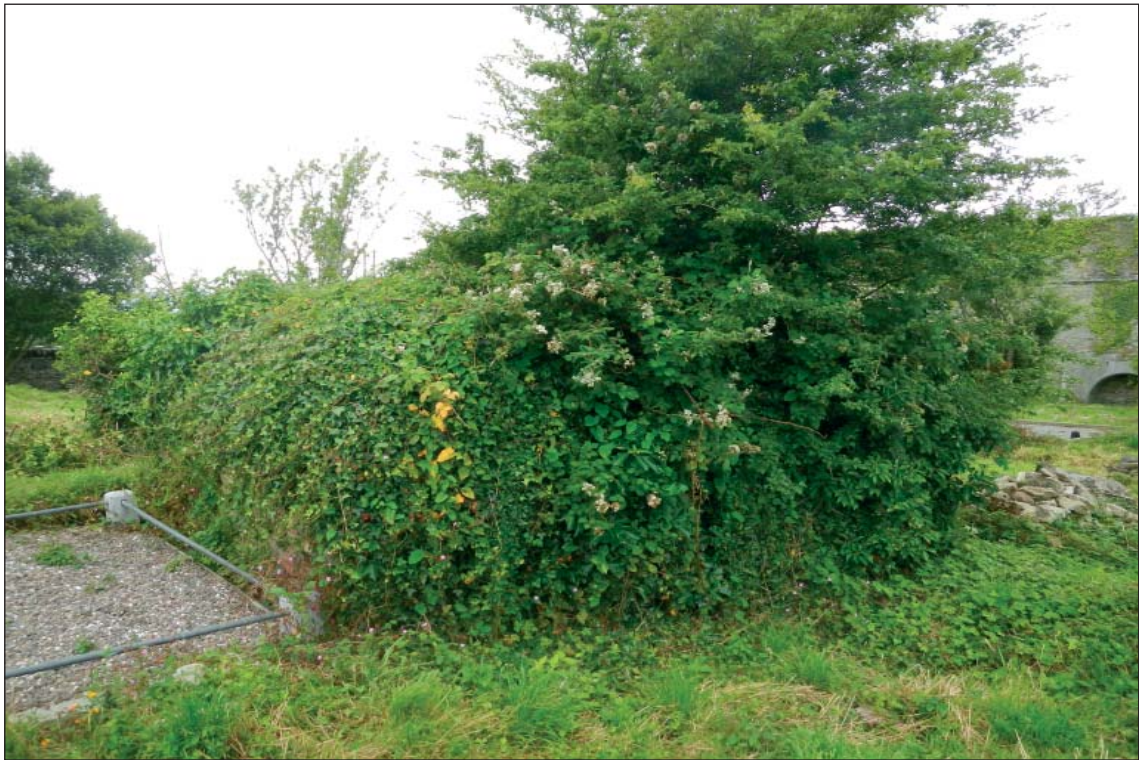
Twelve tombs (12) were recorded in Killagha (Figure 2 & Appendix 1), the owners of seven (7) are unknown. Of these twelve tombs there are eight that require maintenance and minor repairs while six are in an extremely poor collapsed state of preservation, in particular Nos:- 3, 5, 6, 7, 8 and 9 (Appendix 1, Figure 2 & Plates 11-12).

Plate 11: View from SE of overgrown and tree covered unknown tomb no. 6 at the S side of Killagha Abbey church

The growth of grass, ivy, bushes and other vegetation on the tombs should only be fully removed as the primary element of an agreed inclusive strategy of repairs and other conservation and restoration works. The growth should first be cut back short so that a more critical evaluation on the steps necessary to undertake the repairs can be ascertained. Repairs to render should be undertaken under expert archaeological advice and supervision.

It is possible that some of the tombs incorporate medieval masonry from the church that once occupied the site as well as other archaeological artefacts. Consequently, any tombs requiring more substantial repairs should only be undertaken in association with an experienced archaeologist.

A few will only require the removal of ivy and possibly re-pointing. However, several will require careful rebuilding and important repairs are required of others to close them off. Indeed there is some question as to some tombs if they are viable at all and that maybe they should or could not be refurbished.

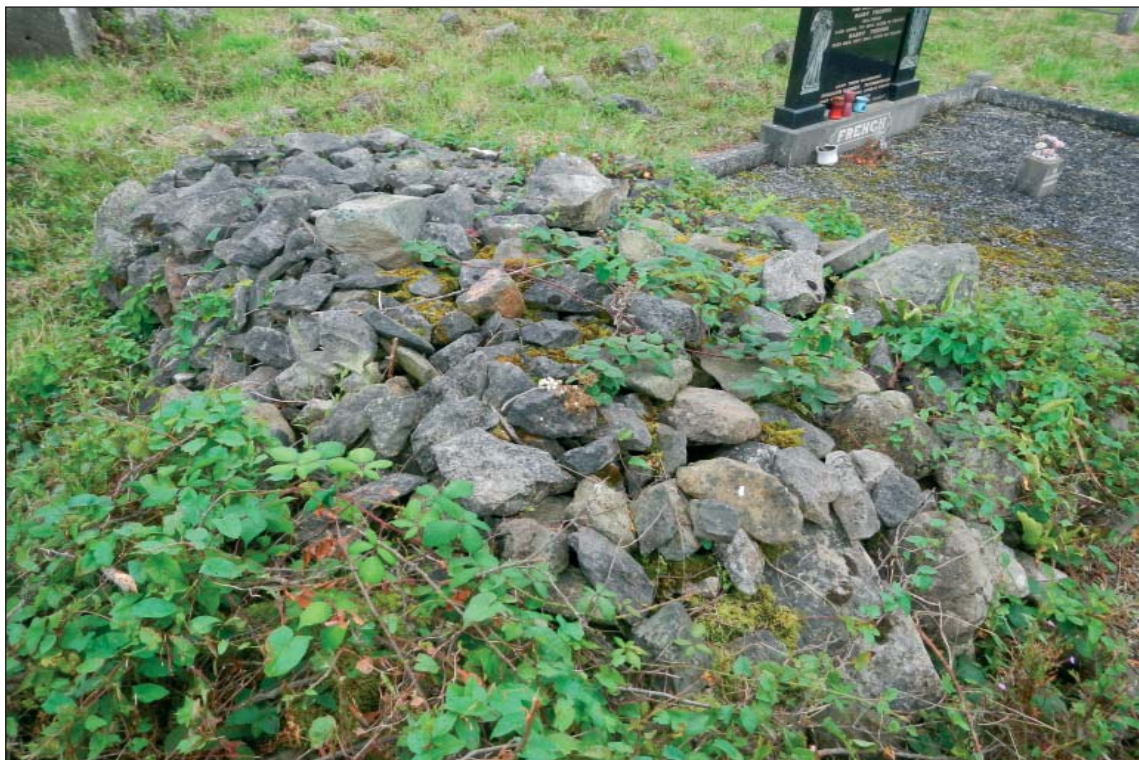
Plate 12: View of entirely collapsed tomb no. 9 in Kilcoleman cemetery

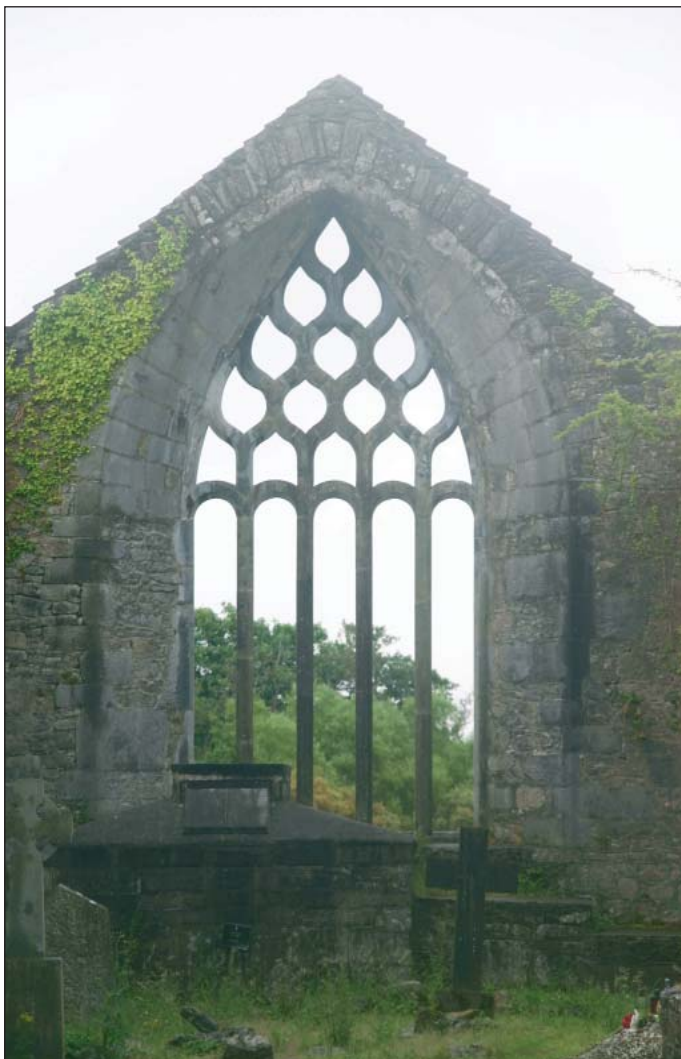
The majority of them are 'strong box' types (Plate 13). Three of them are unfortunately situated in the chancel end of the abbey (Figure 2 & Plate 14). The largest of them is the Barrett family, Tomb 12, that is too big and negatively visually impacts on the wonderful tracery of the E window (Plates 14- 15) while No 11 restricts access and appreciation of the very fine double piscina (Plate 16).

Plate 14: View from W of E window in chancel. Note obtrusive Barrett family tomb no 12

No further burial should be allowed within the medieval abbey ruins.

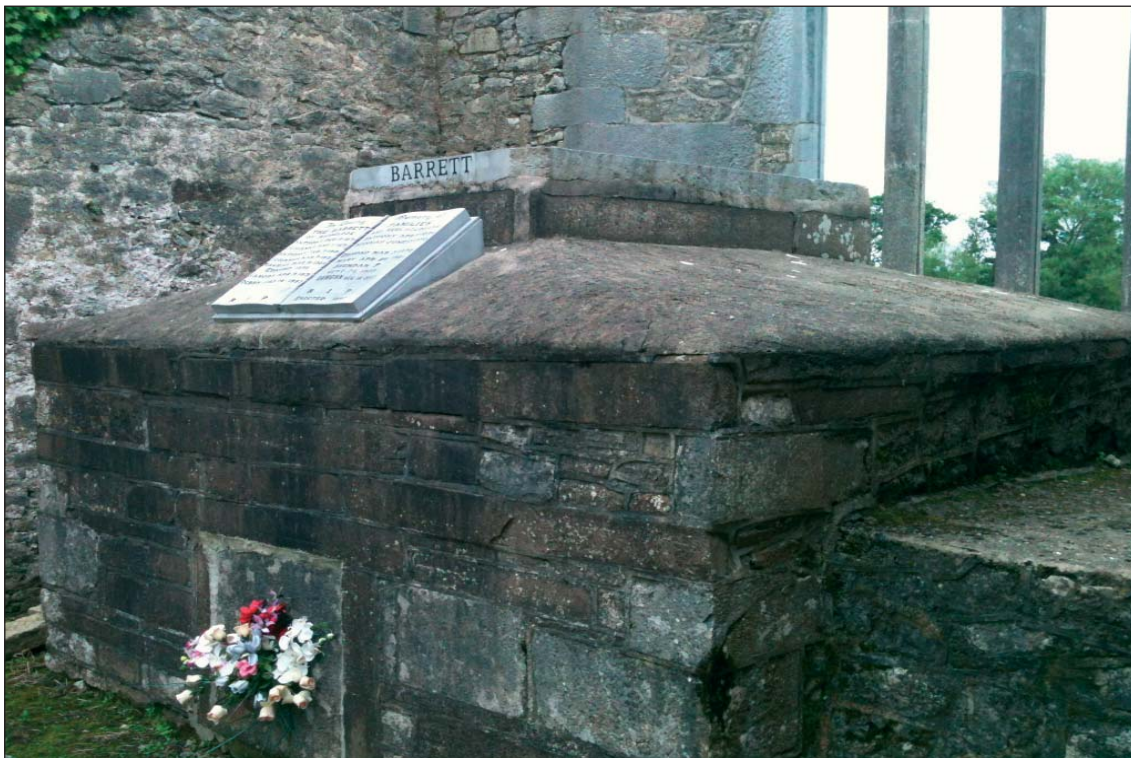
Plate 15: Close-up view of Barrett family tomb no 12 in front of E window in Killagha Abbey church

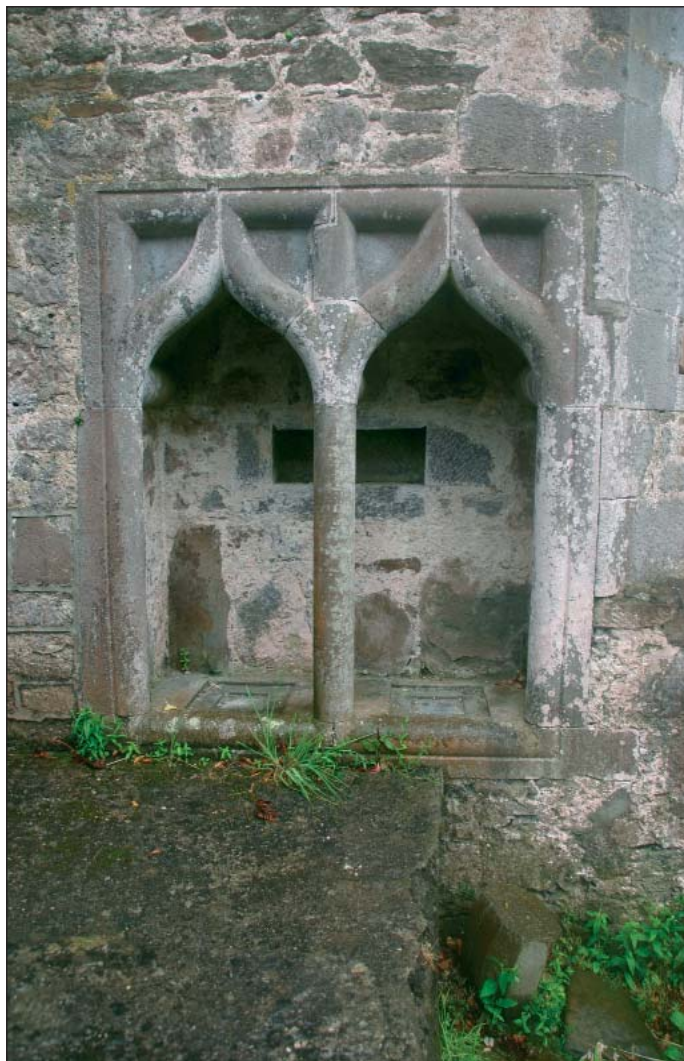
Plate 16: View of double piscina in S elevation of chancel in Killagha Abbey church. Note ugly modern tomb and medieval window fragment beside it

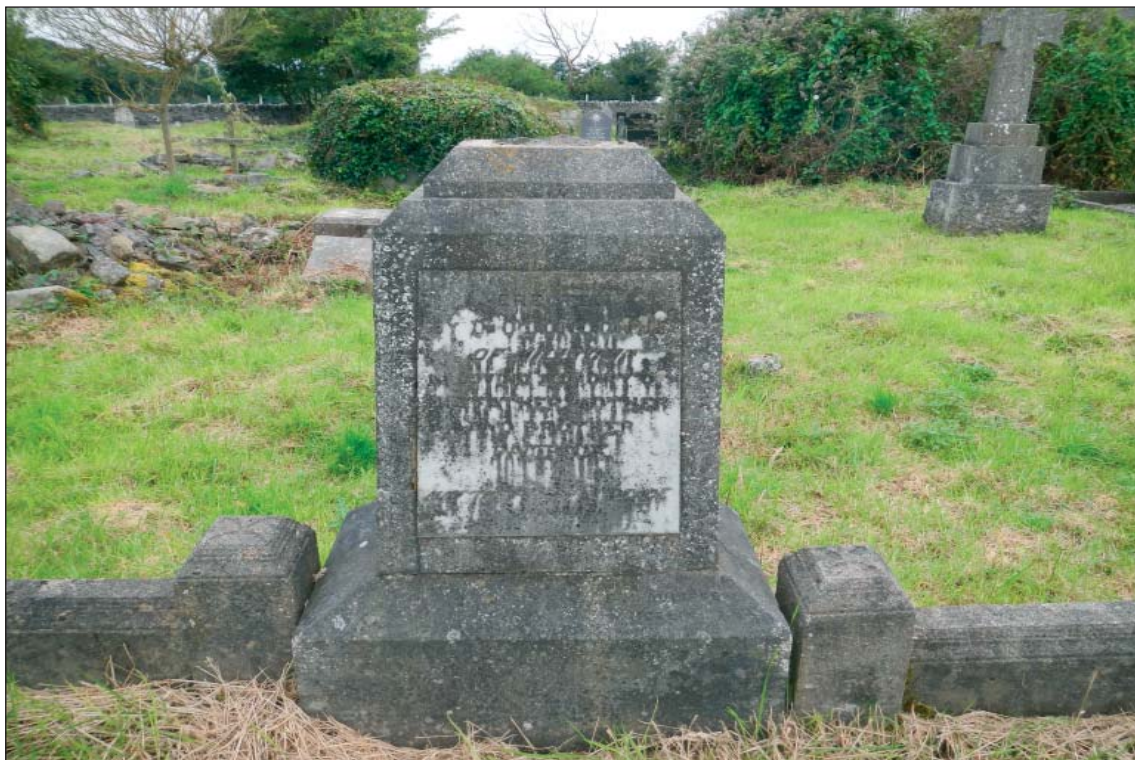
There were ninety-three (93) named headstones recorded at Killagha graveyard of which thirty-three (33) have no formal grave settings (Figure 2, Appendix 2 & Plate 17). All the headstones are in general good condition although the inscriptions on several are very difficult to read and one, No. 81, is illegible. Eight are shattered and the names of twelve are unknown (Plate 18). A few others are concealed and under pressure by the increasing heavy growth of ivy and bushes and trees.

Plate 18: View of shattered 'Celtic' style O'Donoghue headstone no. 78 in Kilcoleman cemetery

The shattered headstones should be professionally repaired.

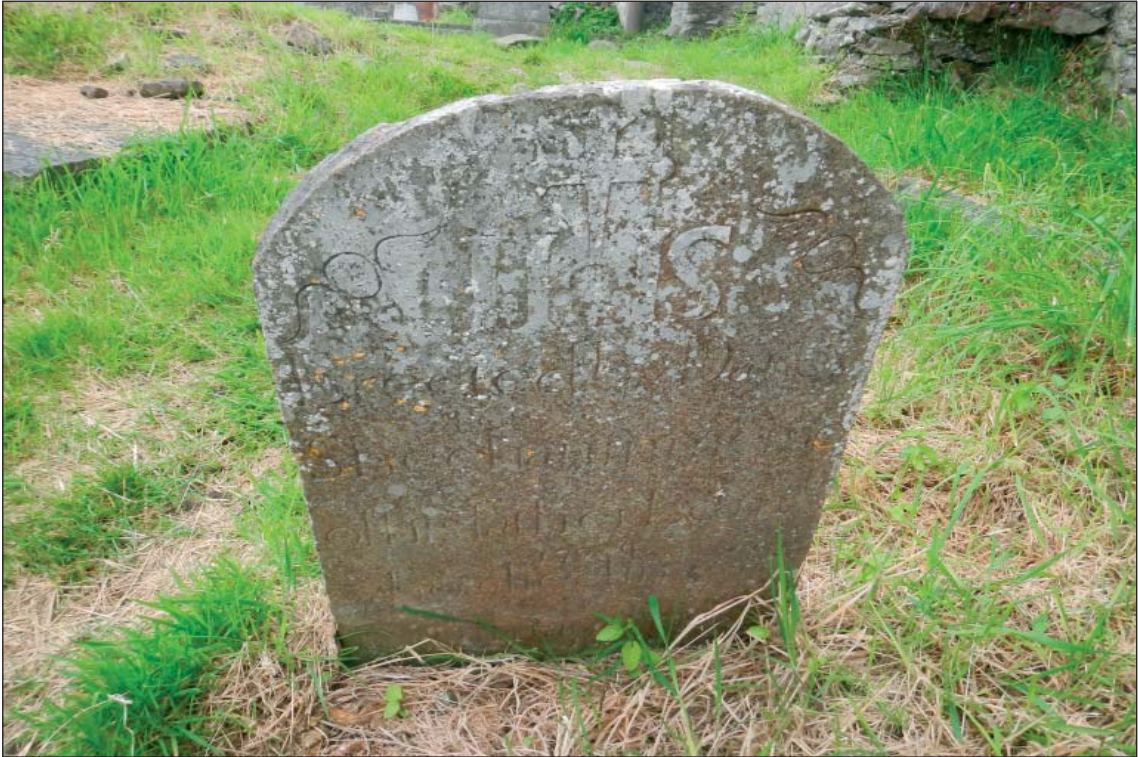
The earliest headstone recorded is Darby Sheehan, No. 76 who died in 1810. This is a typical early 19th century headstone with the IHS monogram featured at the top with an angel or cherub on either side (Plate 19).

Plate 19: View of 1810 headstone no. 76 of Darby Sheehan

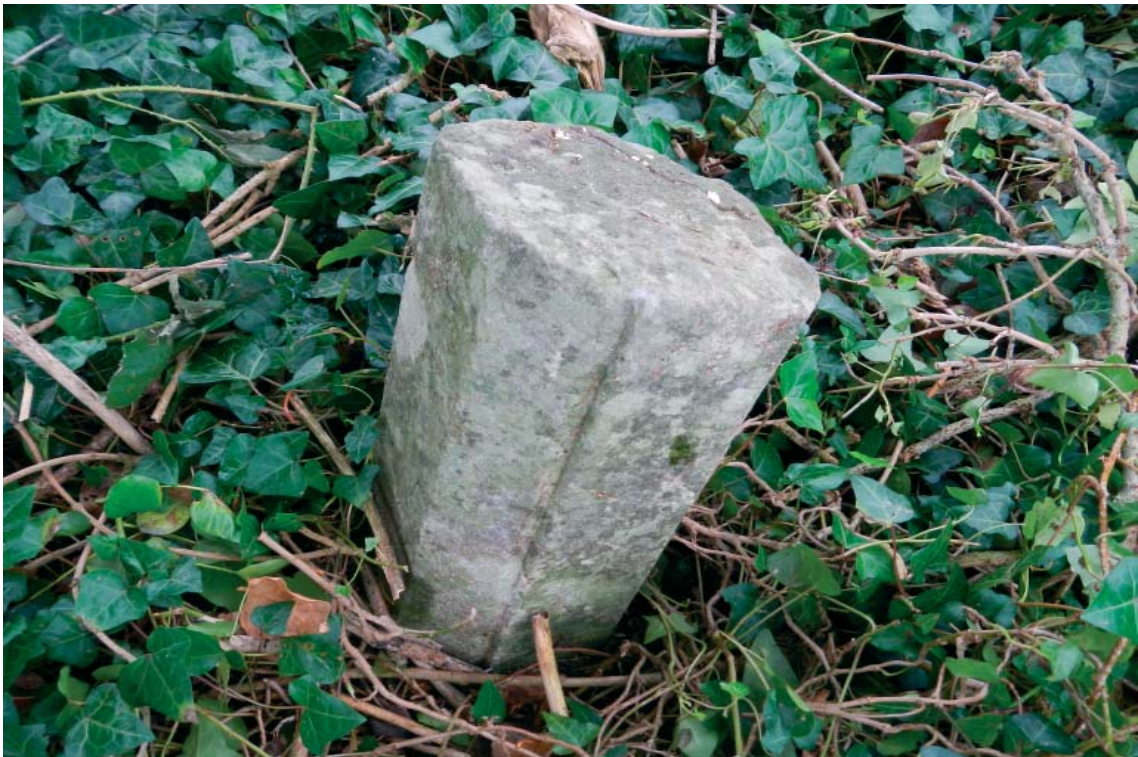
Plate 20: View of window mullion fragment AF 23, re-used as gravemarker in Kilcoleman cemetery

The loose *ex situ* architectural fragments should be collected and removed to the Kerry County Museum for safe keeping storage and individual recording. All of the fragments should be archaeologically illustrated. Further examination of the graveyard should be undertaken after the grass and vegetation has been cut to record and possibly recover the missing architectural fragments.

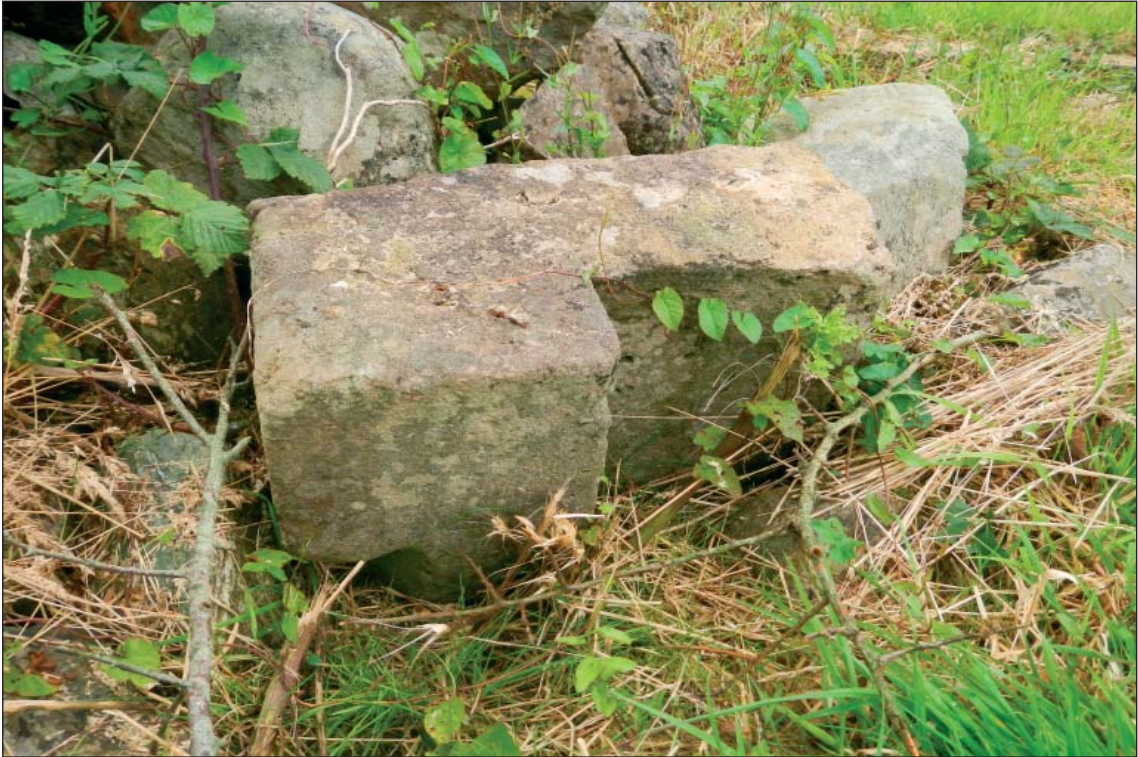
Plate 21: View of architectural fragment AF 22, lying loose in Kilcoleman graveyard

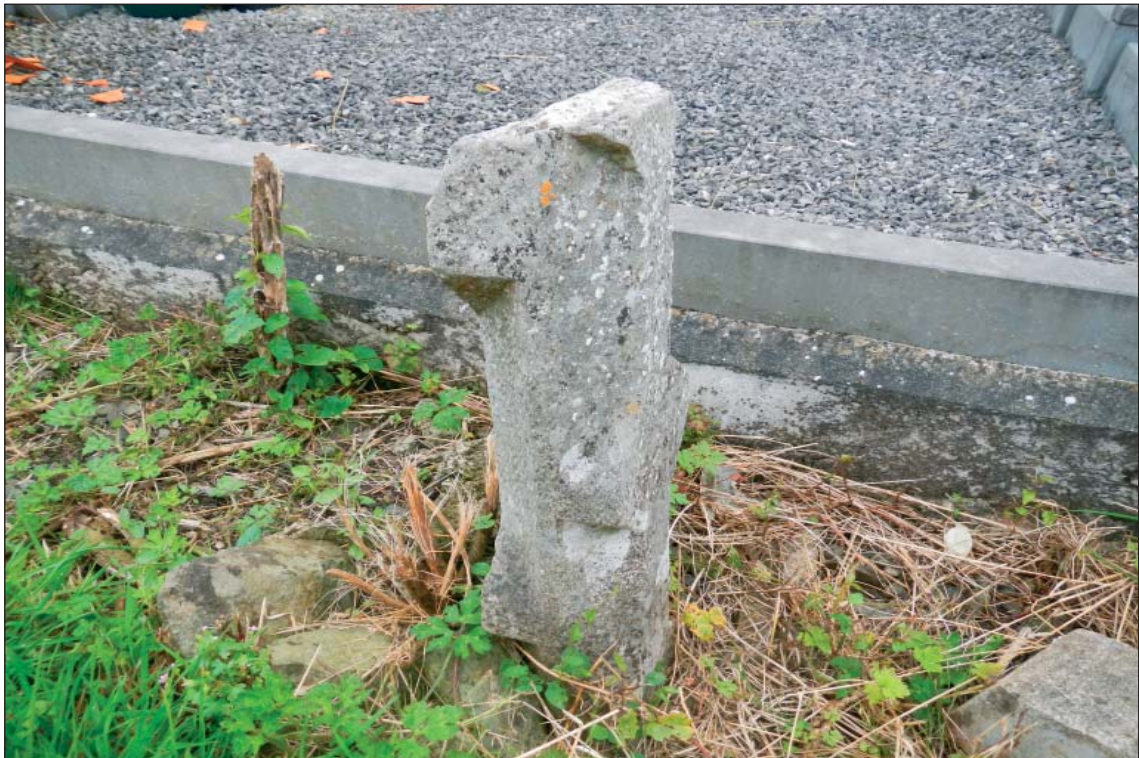
Plate 23: View of architectural fragment AF 17, comprising cill of twin light window re-used as gravemarker in Kilcoleman cemetery
