Archaeological Survey,
Killahan Graveyard,
Tonaknock,
Abbeydorney,
Co. Kerry.

March 2012

Client: The Heritage Office,
Kerry County Council,
County Buildings,
Ratass,
Tralee,
Co. Kerry.

RMP No.: KE015-108

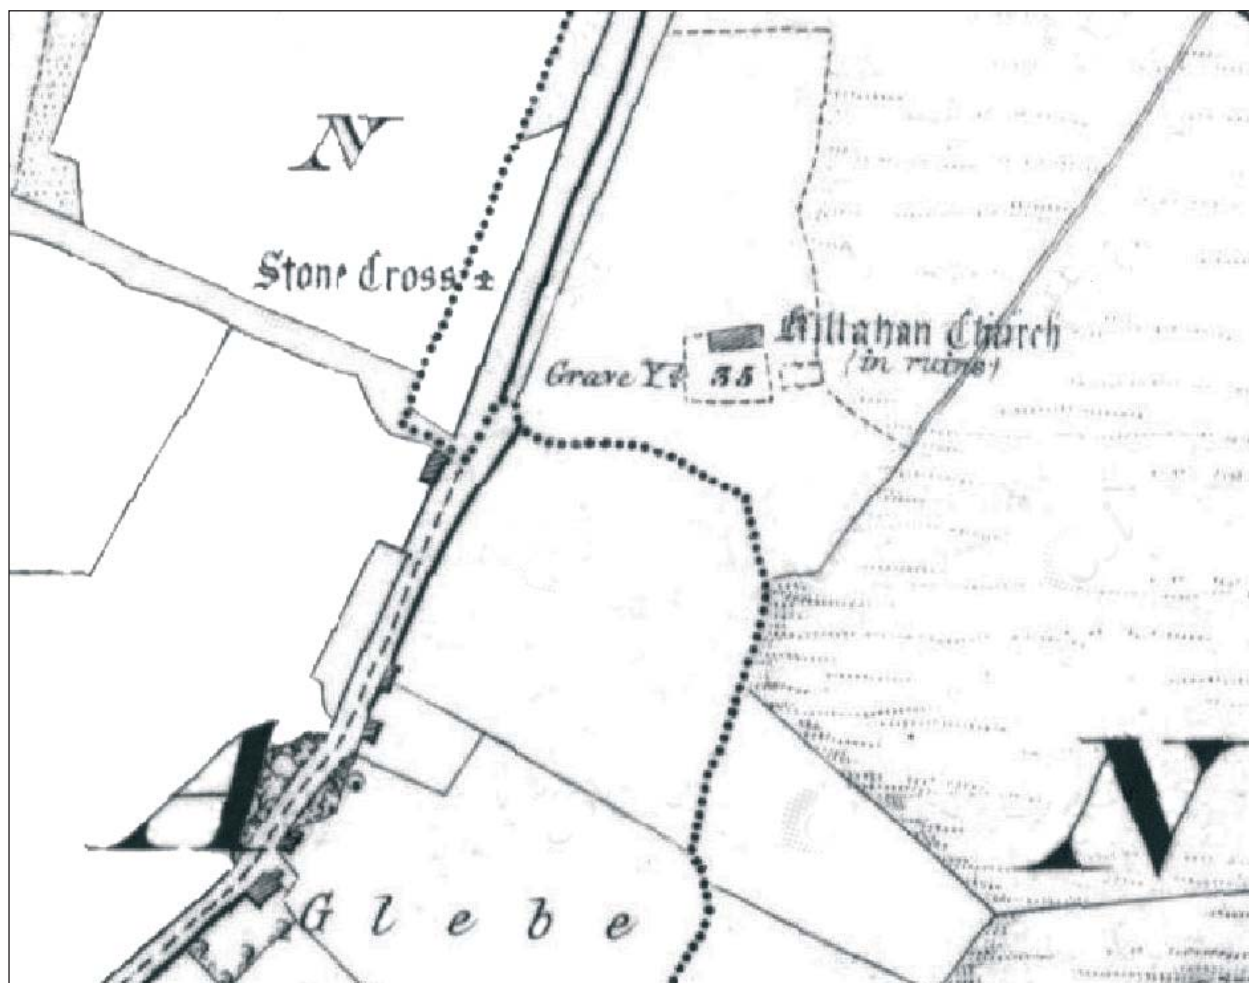
Figure 3: Extract from OS 1st Edition 6" map of Killahan graveyard, 1841.

Apart from the high cross no other monumental or artefactual vestige of the early medieval ecclesiastic site remains. Examination of the 1st Edition of the OS 6" map of 1841 denote a sub-rectangular un-enclosed graveyard, (demarcated by a broken dotted line) with the ruins of the church forming the NE corner with the Glebe House and lands more

or less abutting the S limits of the site. The location of the Stone Cross is also clearly denoted just inside the field near the roadside (Figure 3).

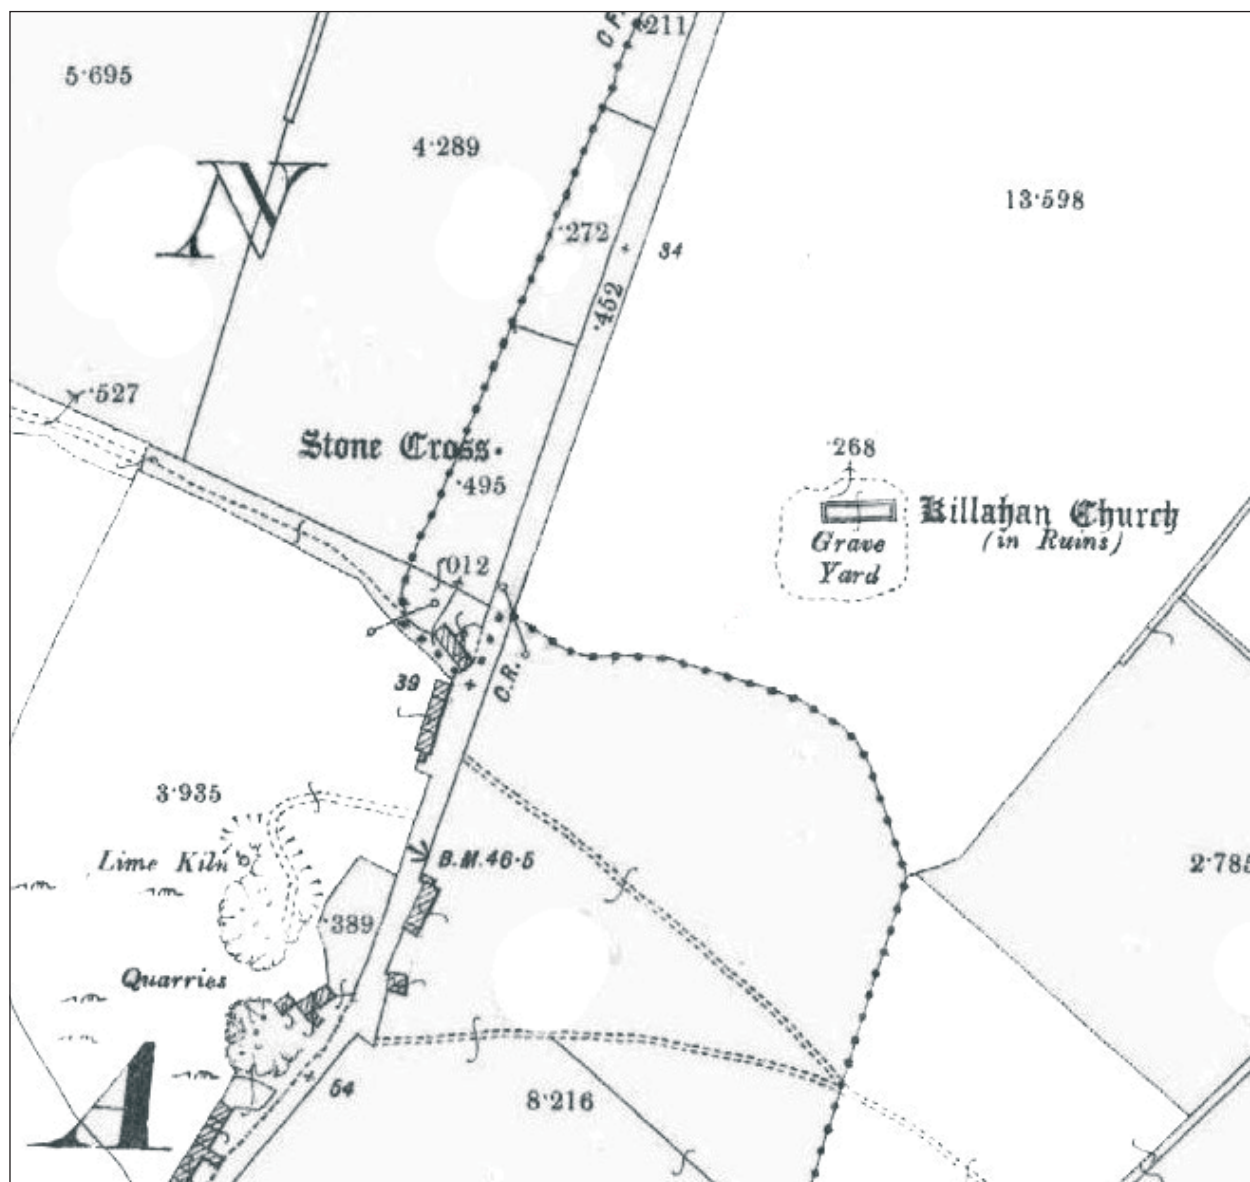
Figure 4: Extract from OS 2nd Edition 25" map of Killahan church and graveyard, 1896.

Examination of the 25" OS map of 1896-7 denotes the graveyard as a dotted line somewhat squarer and with rounded corners but still unenclosed. The long rectangular church is denoted as in ruins. The Glebe is no longer mapped but the Stone Cross is clearly marked in the same location as 1841, (Figure 4).

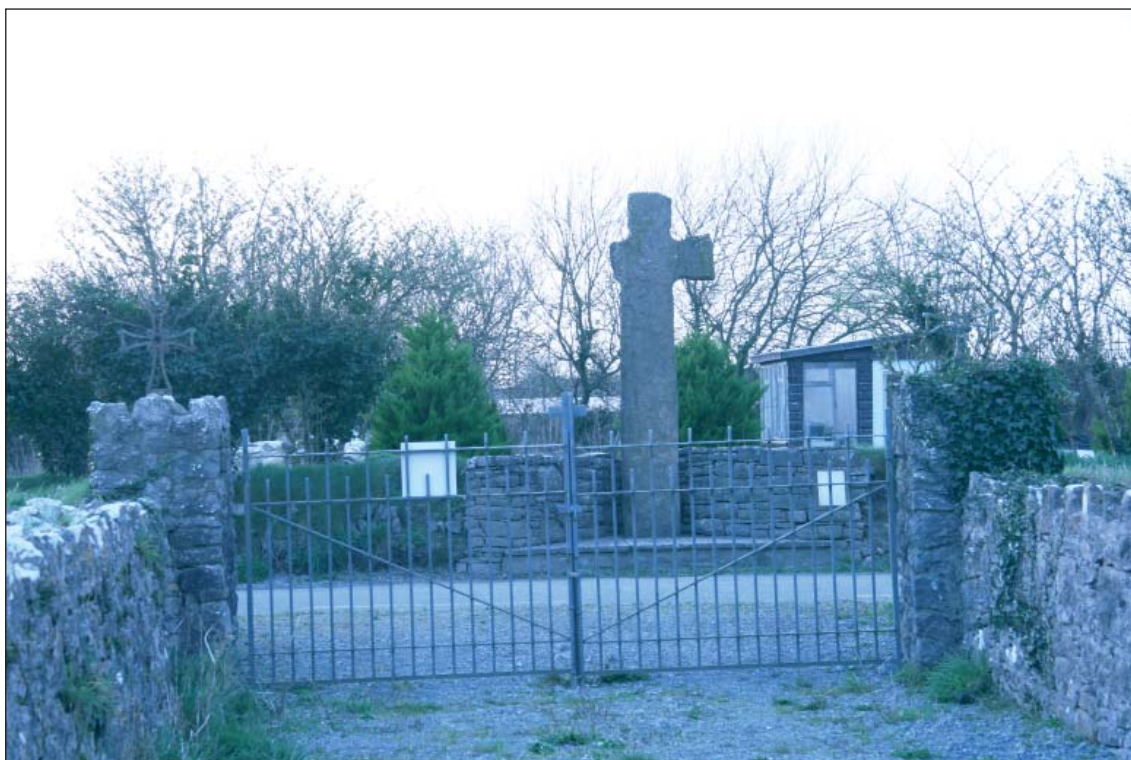
Opposite the roadside entrance to the graveyard is an early high stone cross, 3.5m tall and with a broken width of 0.65m and 0.33m in thickness (Figure 2 & Plate 2). The weathered limestone high cross, has one of its wedge shaped arms broken, was originally found buried in a nearby field and re-erected in its present position by the Commissioners of Public Works. When O'Donovan, (1983, 49), surveyed the site he recorded that the whole cross was white washed.

Plate 2: View from east of Tonaknock high stone cross and entrance to Killahan graveyard.

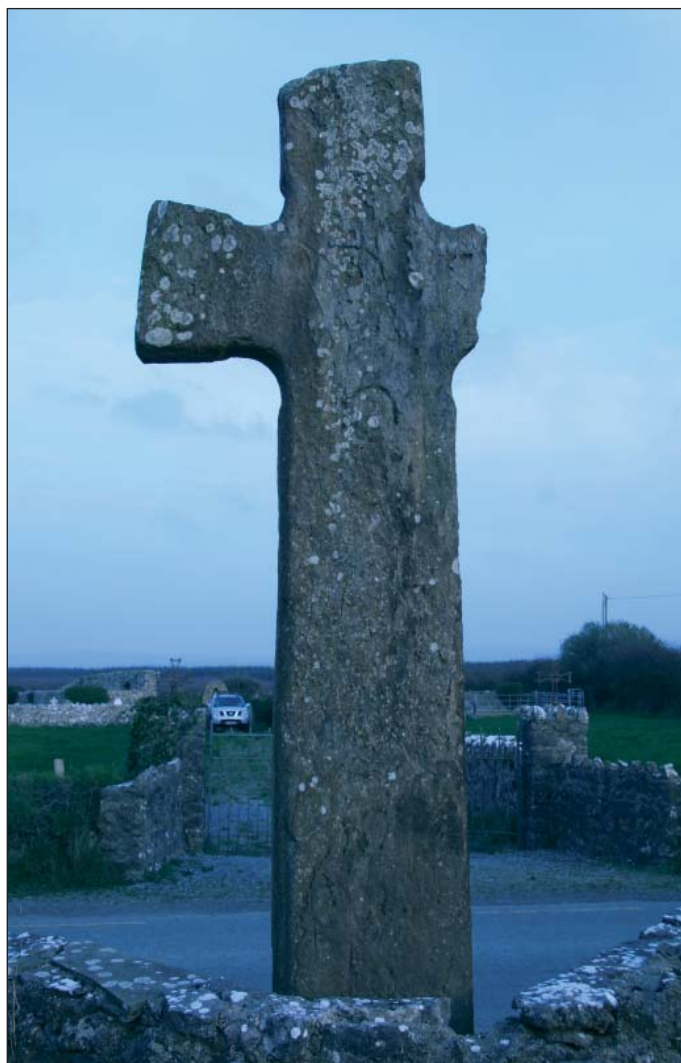
The four angles created by the crossing of the arms of the cross have been pronouncedly rounded - a feature similar to other examples found in Kerry, e.g. Killelton, near Castlegregory.

On the back or west face of the cross are six circular incised motifs two on the surviving arm and four on the shaft starting at the crossing point and descending. It appears that the two on the arm are also connected by a single line, (Plate 3). Toal and Tarrant & O'Connell suggest that they may stylistically represent the figure of Christ and the 'sacred host', (Tarrant & O'Connell 1990, 181; Toal 1996, 225).

Plate 3: Close up view of west face of Tonaknock cross. Note circular inscribed motifs and rounded corners.

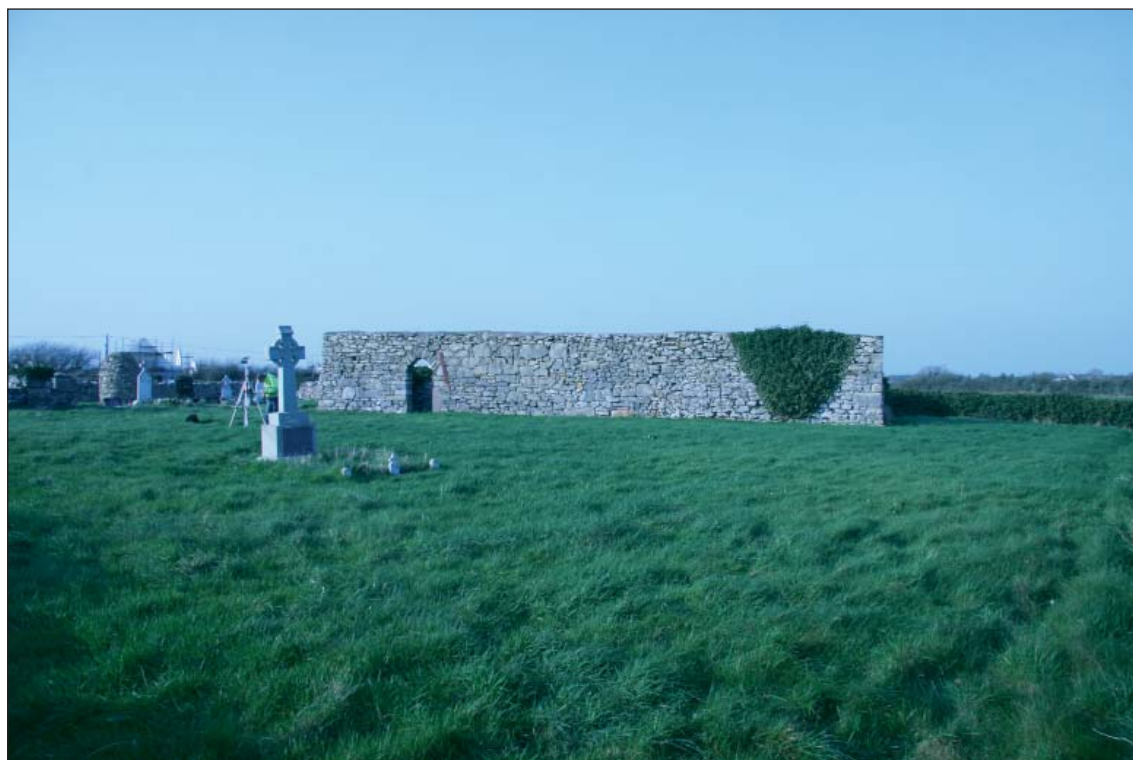
Plate 4: View of Killahan church and graveyard from south east corner.

Today the spartan graveyard is dominated by the upstanding, generally well preserved, walls of a high medieval parish church, a small scatter of modern headstones, three tombs and a recent modern grotto (Figure 2 & Plates 1 & 4)

The ruined parish church of Killahan is eccentrically disposed close to the N boundary wall within an open grass covered graveyard that is virtually devoid of gravemarkers, trees or bushes (Figure 2 & Plates 1 & 4). Ivy has established itself on a section of the S elevation NE corner and W gable as well. The graveyard is enclosed by a uncoursed rubble stone wall in general good order, (see Boundaries below). It contains a three tombs and fifteen named headstones. The graveyard is covered by a dense sward of grass-however it is evident that the grass is maintained.

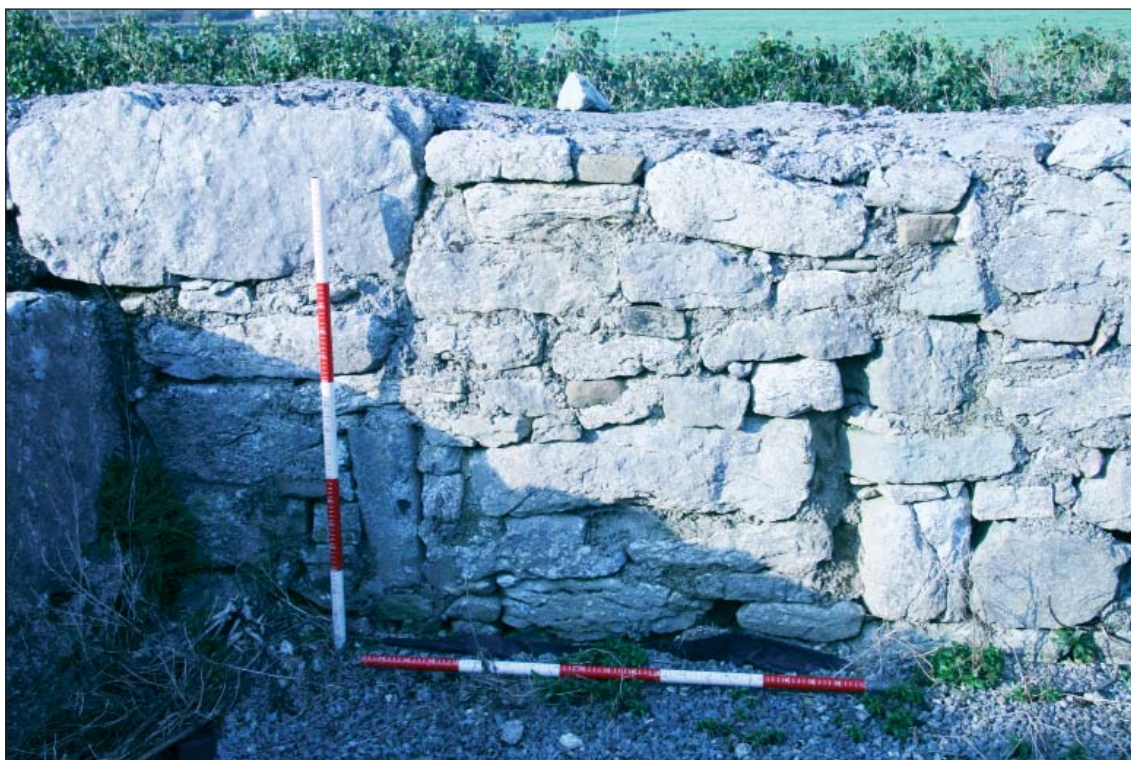
The rectangular parish church measures, 21.95m x 6.8m externally and an average external wall thickness of 0.90m. Internally the church was divided in a 2:1 ratio between nave and choir separated by a party wall, 0.60m in thickness and which still partially survives, (Figure 2 & Plate 14). There is physical evidence for two windows in the choir section on the S and N elevations both of which are blocked up. The most coherent remains is evident on the S elevation and comprises of a four chamfered sandstones making up part of one side of the window (Plates 5 & 14). Interestingly, when O'Donovan surveyed the church in 1841 the S window was exactly the same and he remarked at the time the one side of the E window also survived and that both were the same kind (O'Donovan, 1983, 49). The less conspicuous remains of the window on the N elevation comprises the splayed ingoings of one side as well a vertically disposed straight sided stone opposite, 1.1m apart. The possible window is situated 0.5m E of the party wall between choir and

Plate 6: Interior view of blocked up possible window on north elevation of Killahan church. Note splayed ingoings on right and straight ingoings on left.

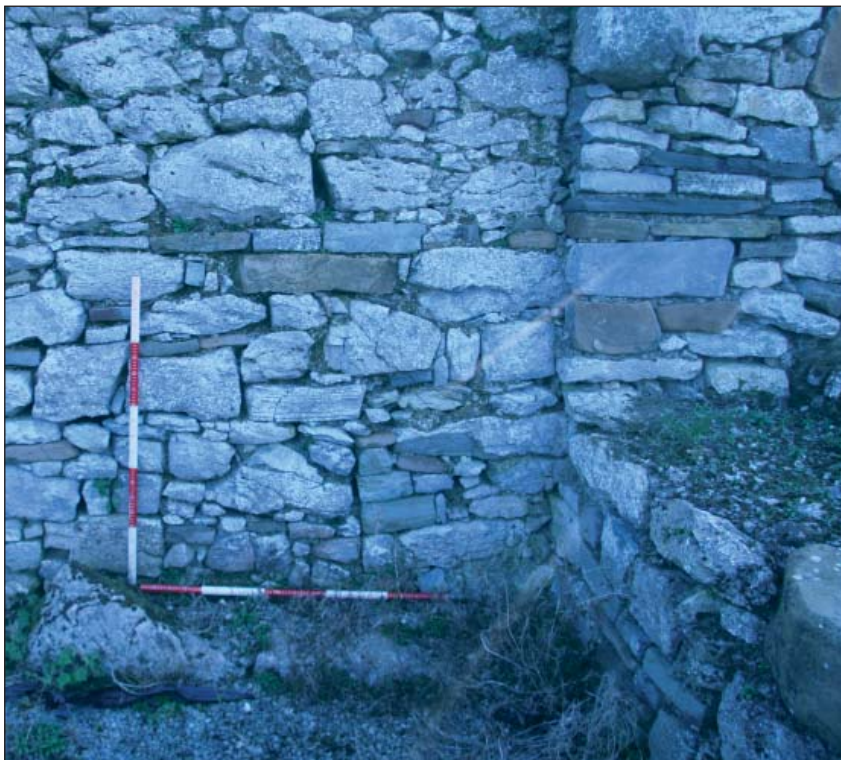
Another blocked up architectural feature comprises two short seam joints that may reflect the sides of an intra mural cupboard or aumbry situated on the S elevation of the choir and 0.60m from the party wall, (Figure 2 & Plate 7).

Plate 7: View of possible blocked up aumbry in south choir elevation in close proximity to party wall between choir and nave.

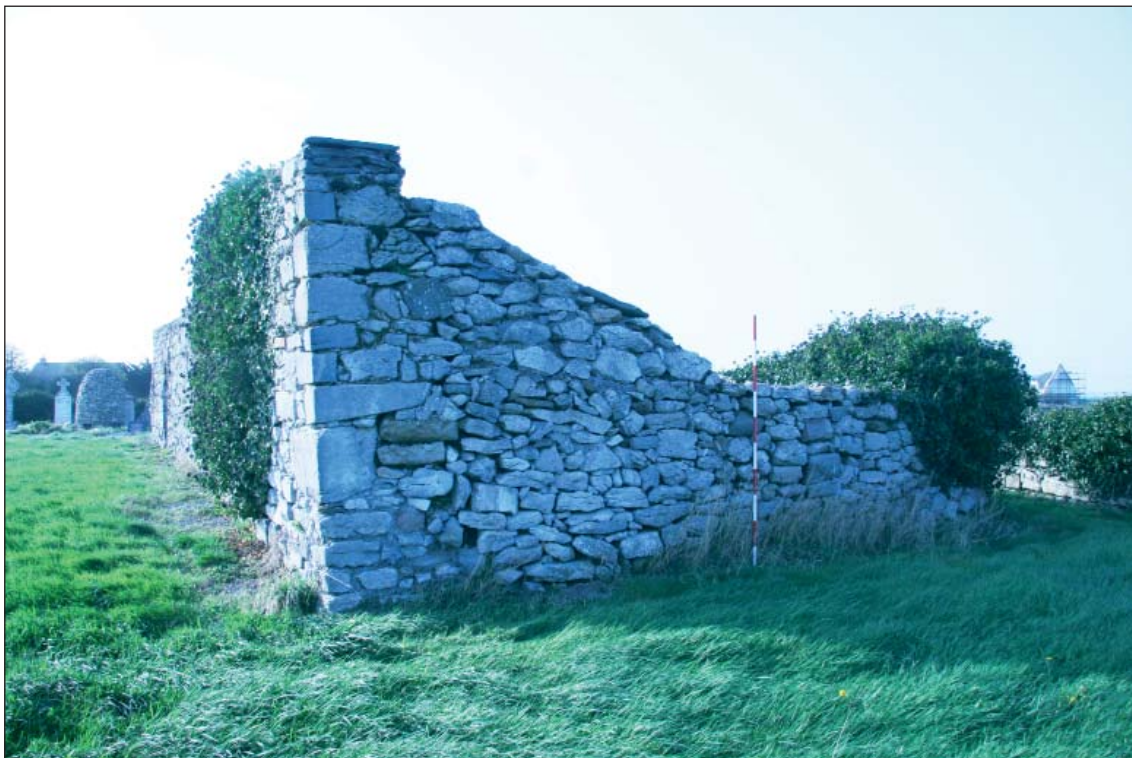
The church is constructed with uncoursed rubble masonry of local limestone and a scatter of sandstone, bedded in lime mortar. Some of the stones are quite massive and are especially evident in the nave, (Plate 8). John O'Donovan recorded that all of the west gable and 50% of the E gable was destroyed to foundation with a breach in the middle of the N elevation down to 0.90m, (*ibid*). In 1995 Toal surveyed the site and recorded that the E gable was gone as well as a section of the N elevation where it abuts the W gable (Toal 1996, 248). Today both these structural breaches have been poorly blocked up, (Plates 9-10).

Sometime after 1995 and possibly in the last five years the church was poorly 'repaired', and the graveyard cleaned. Unfortunately, however there appears to be no record of the works that were done.

Plate 9: View of east exterior gable of Killahan church. The original quoins stand to full height however the remaining masonry is recent, poor and inappropriate.

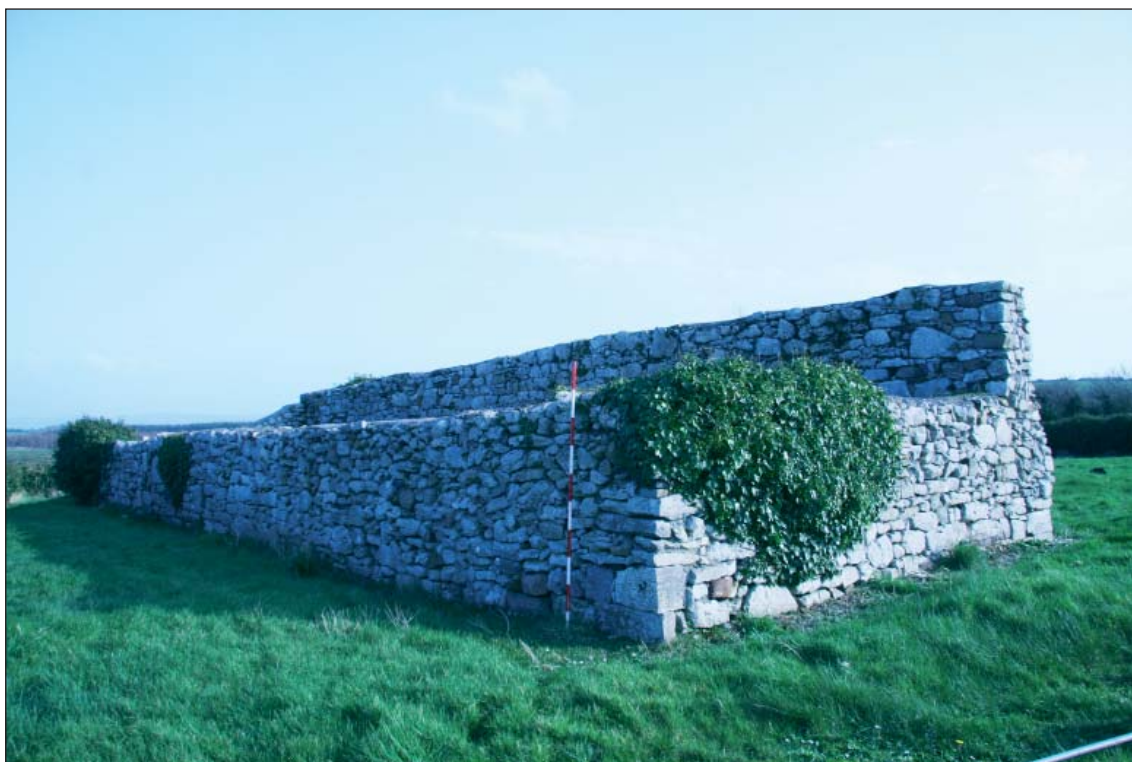
Plate 10: View of north west exterior limits of Killahan church. Scaled ranging rods situated beside recently poorly rebuild breach in north elevation.

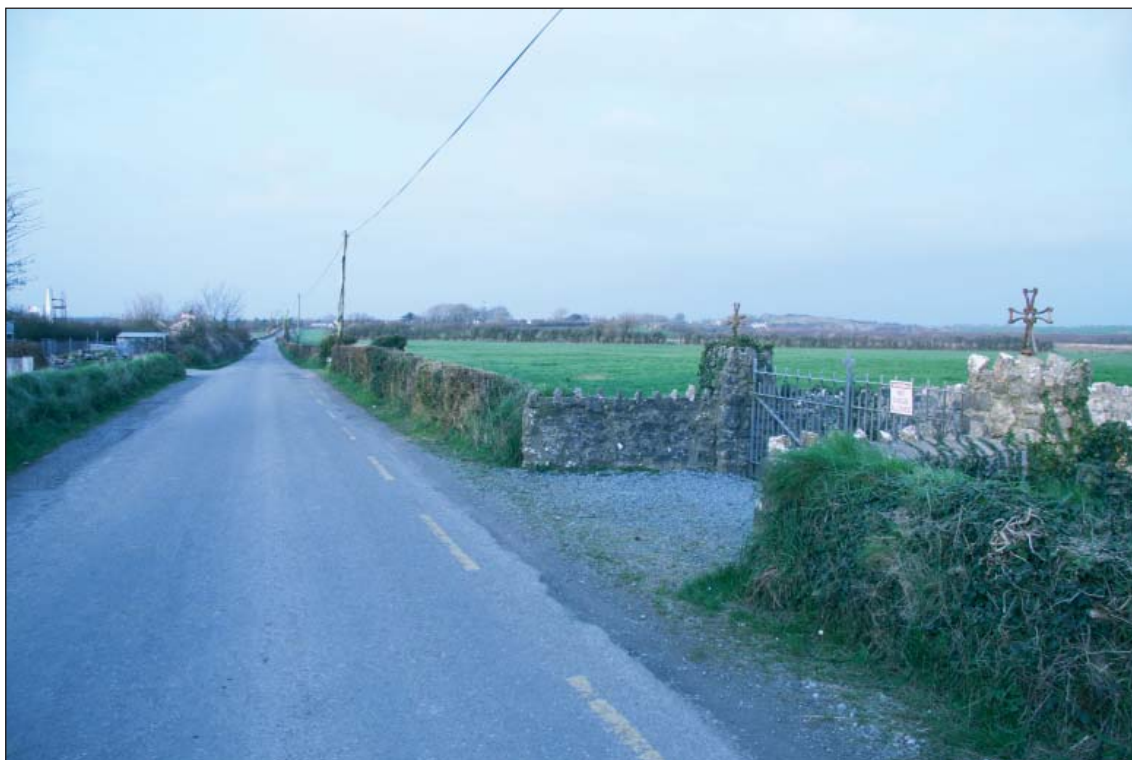
Killahan is approached along a straight section of a third class road from Abbeydorney / Ardfert with a difficult 90° turn. There is no carpark or turning area. Funeral corteges must reverse in or out, (Figure 2 & Plate 11).

Entrance into the graveyard is through a pair of modern galvanised gates pivoting between two square rubble limestone piers that are surmounted by wrought iron crosses. The gateway is slightly set back from the verge of the road. There is no pedestrian stile, (Figure 2 & Plates 2 & 11). Upon passing through the roadside gates, a straight narrow overgrown gravelled track, walled on both sides, leads directly into the walled graveyard.

Plate 11: View of approach and entrance to Killahan graveyard from south.

Although the graveyard is obviously not much used today, the entranceway should be re-modelled for practical and H & S considerations. A minimum turning area could be provided as well as a pedestrian stile.

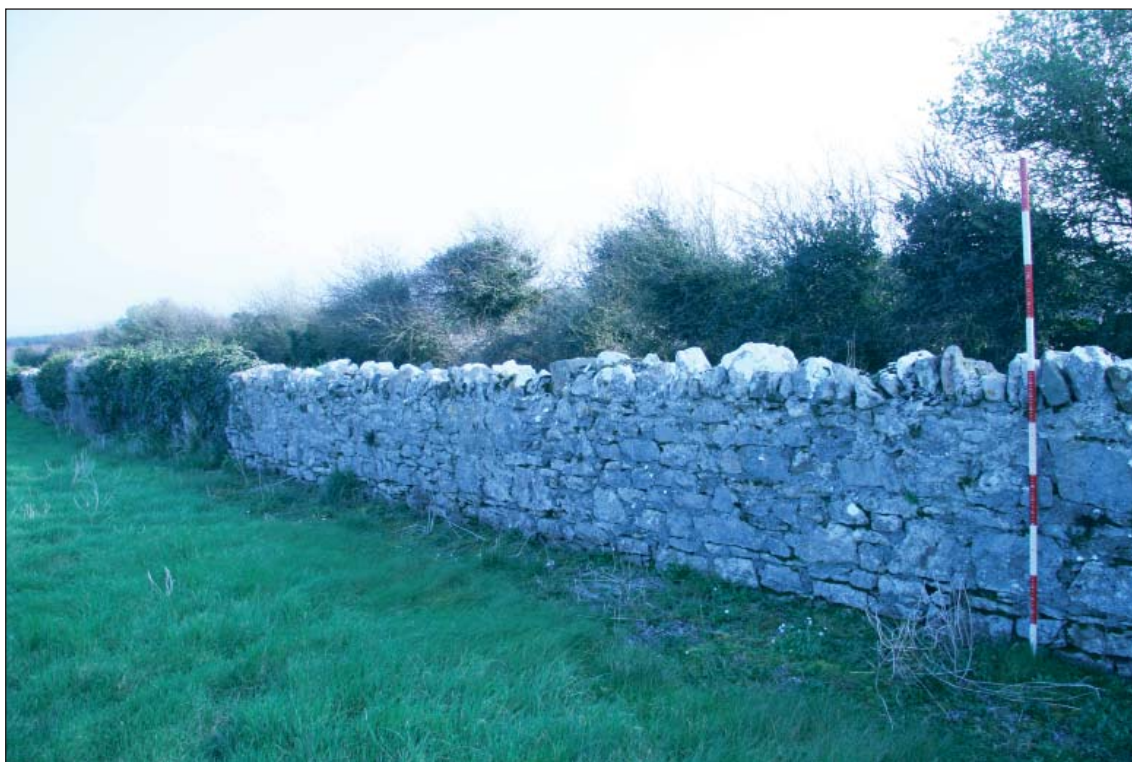
The graveyard and church are enclosed by an uncoursed rubble limestone walls with 'soldier' capping to a general height of 1.0m- 1.2m. Ivy is now prominent at the E boundary in particular but also evident at the SE corner, SW and part of the N boundary wall as well. The walls have no breaches and are in general good repair however a section of the S boundary along the narrow trackway has partially tumbled on the outside and is also badly bulging. (Figure 2 & Plates 12 & 13).

Plate 12: View of section of south boundary wall of rubble stone masonry and 'soldier' capping.

The ivy should be removed or severely cut-back before it gets fully established.

The partial breach in the wall along the trackway should be repaired by a tradesperson skilled in rubble stone and mortar walls.

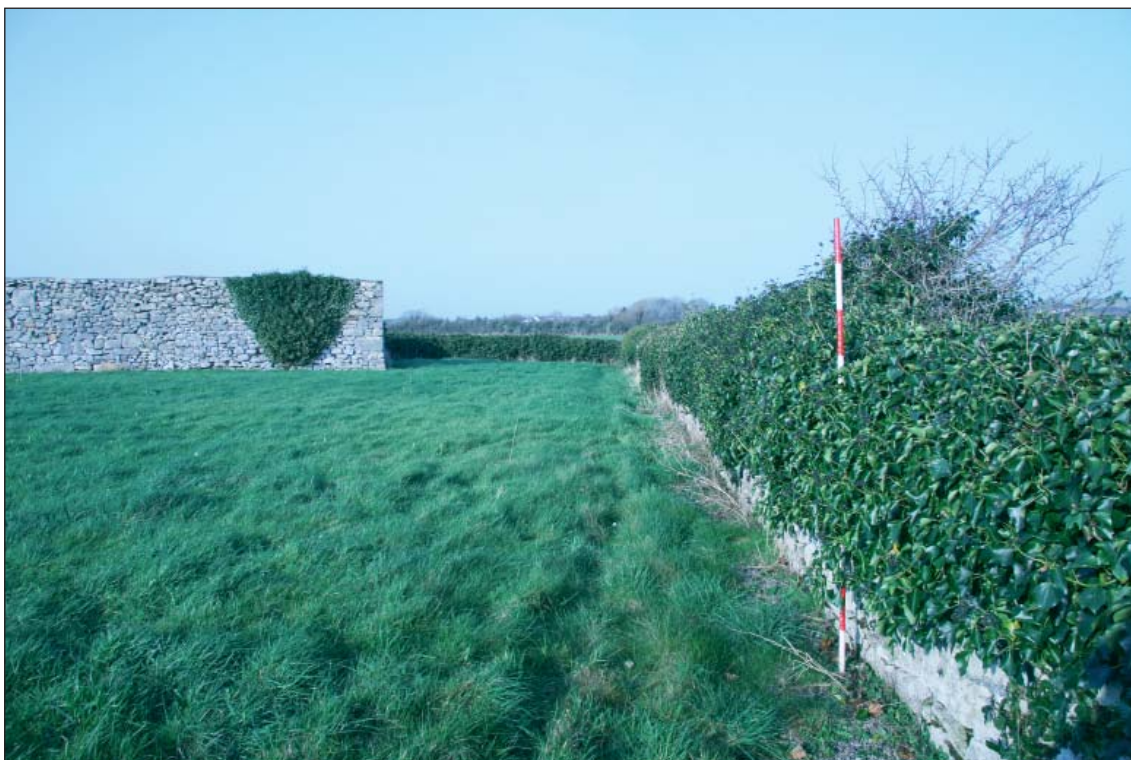
There is a formal gravelled path extending around nearly all the graveyard interior perimeter. The path gravelled path is now nearly covered in grass due to lack of use. There are no desire lines.(Figure 2 & Plate 12).

Plate 13: View from south east corner of graveyard of overgrown gravelled pathway and boundary walls.

The graveyard is little used but the grass on the pathway could be removed and kept down by including its care into the grass cutting and maintenance regime by KCC.

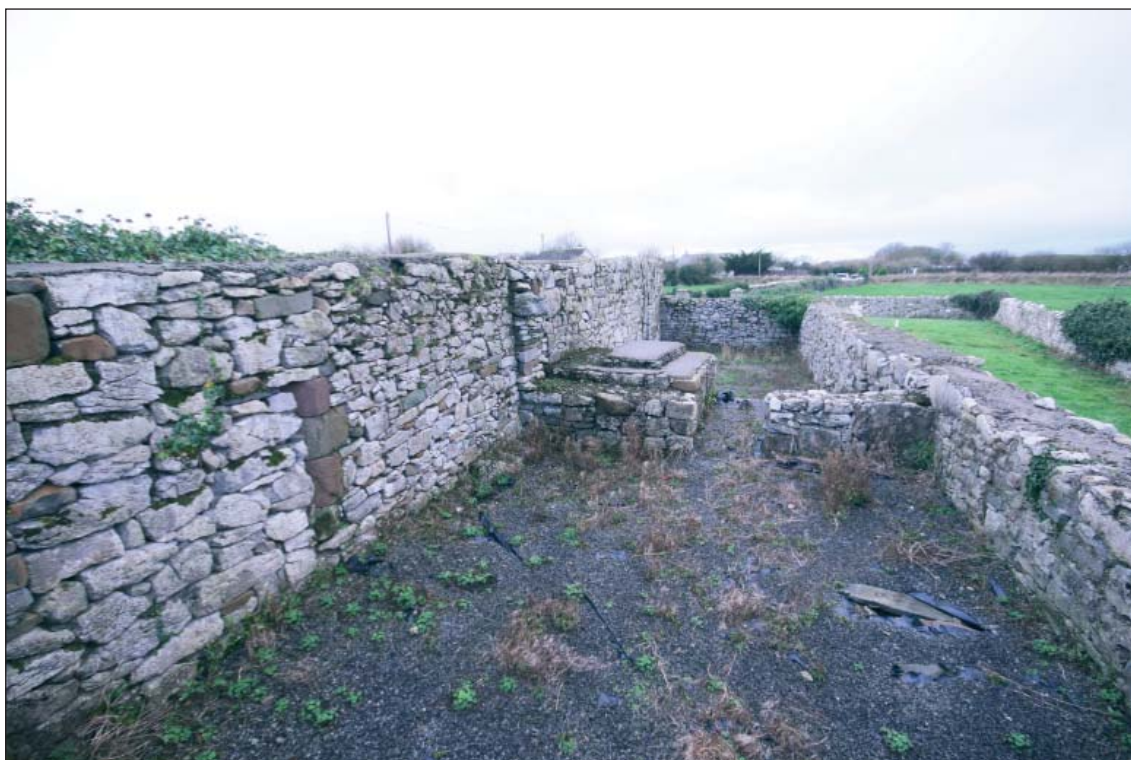
There are three tombs, two of which are constructed against the remains of the dividing wall between nave and choir and separated by three steps. The tombs, in effect, raise the height of the interior of the church at the chancel end. The third tomb is free standing in the graveyard and is poorly constructed with a miss-match of rubble that is partially collapsing the SE & SW corners. All three are unnamed, uninscribed and devoid of any dressed stone or graveyard iconography of any kind, (Figure 2 & Plates 14 & 15).

A single lintel covered grave is visible within the chancel area of the church beside the N elevation. One of the lintels has become dislodged and two others are now partially exposed beneath a thin covering of gravel and black plastic, (Figure 2 & Plate 14).

Plate 14: Interior view of Killahan church from east. Note blocked up window on left, party wall between choir and nave and recently exposed lintelled grave.

The lintelled grave should be repaired and recovered.

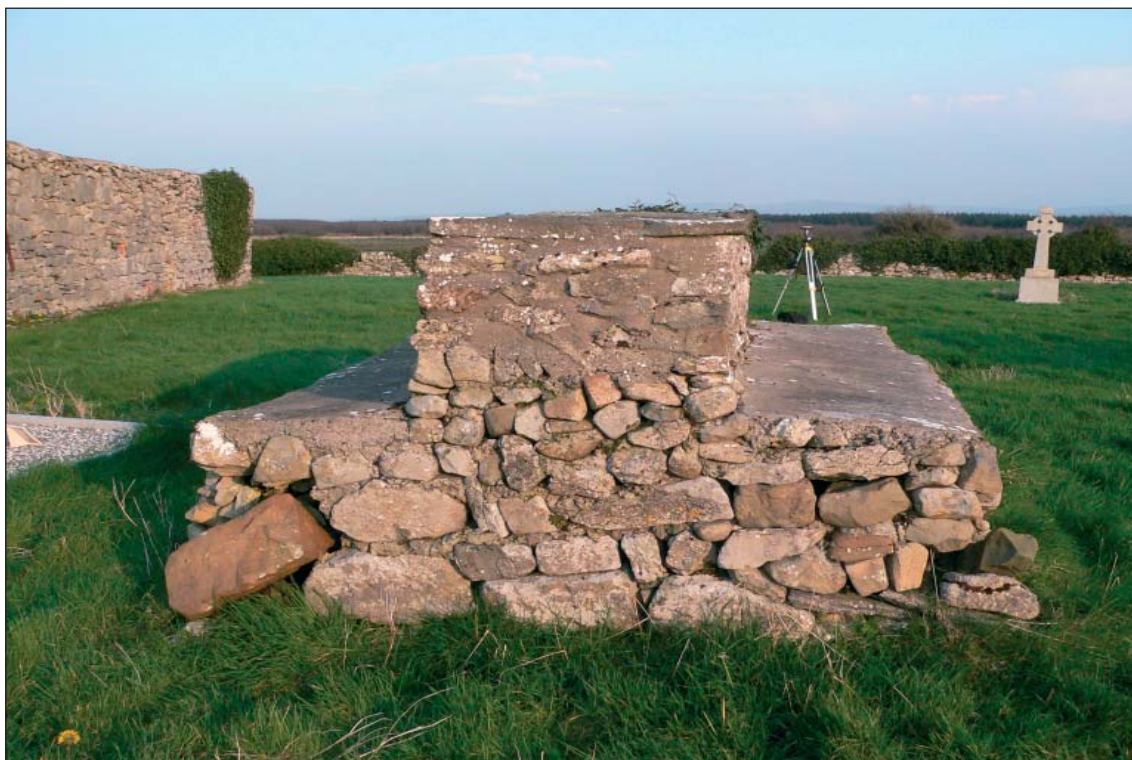
Plate 15: View of tomb in Killahan graveyard from west. Note poor construction and recent masonry tumble at both corners.

The third tomb situated in the graveyard should be properly repaired by an experienced person skilled in working with rubble stone and mortar.

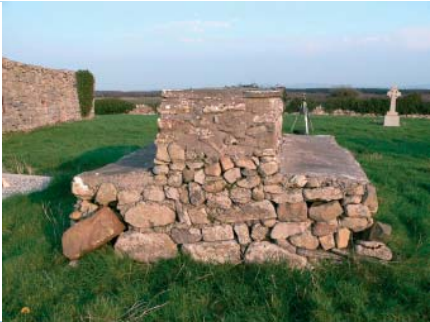
Surname:	UNKNOWN
Tomb No:	1
Photo No:	163-0284

Collapsed P **Open** N **Rendered** P **Overgrown** N

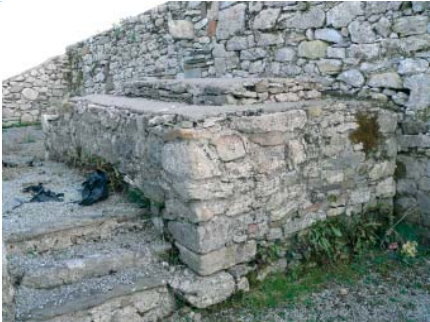
Surname:	UNKNOWN
Tomb No:	3
Photo No:	163-0288

Collapsed N **Open** N **Rendered** Y **Overgrown** N

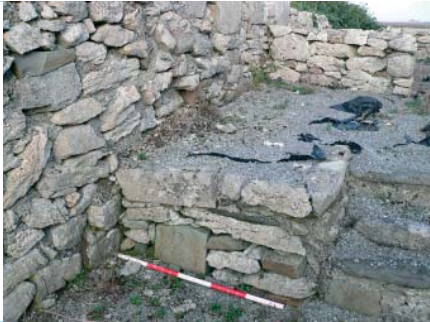
Surname:	UNKNOWN
Tomb No:	2
Photo No:	163-0287

Collapsed N **Open** N **Rendered** N **Overgrown** N
