**Project code:** KCCG11  
**Client:** Kerry County Council  
**Date:** July 2011

## **Archaeological Survey of Killeentierna Burial Ground, Currow, Killarney, County Kerry**

**Surveyors:** Ann Frykler & Robert Hanbidge  
**Report Author:** Robert Hanbidge

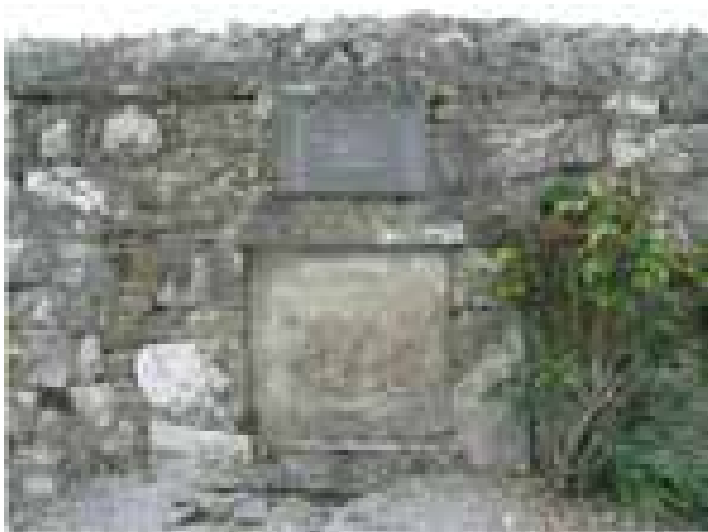
Plate 16-View of damage to Grave No. 132

Grave No. 132 is an example of a named tomb which is in need of immediate conservation. Cracking of the external rendering has resulted in many sections of the render peeling away (Plate 16).

Conservation works including the repointing of masonry and the re-rendering of external surfaces on the damaged tombs will ensure their resistance to the elements.

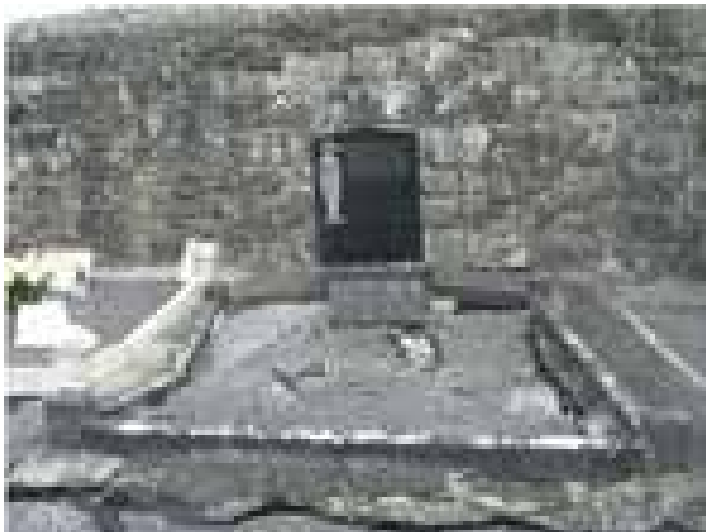
Plate 26-View of Grave No.  
90, from west

large tapering pedestal (Plate 26). However the most striking element are the old red sandstone plinth blocks which define the gravel; these are tooled and chamfered on the upper edges and have contrasting rusticated panels on the sides with inscribed lines creating geometric ornamentation. The unusual positioning of the headstone at the east end of this plot is due to the fact that this grave commemorates a Reverend Brosnan. This is unusual as the majority of the graves are Catholic. Two other Reverends are to be found at Grave No. 71 (Brosnan) and Grave No. 84 (Murphy).

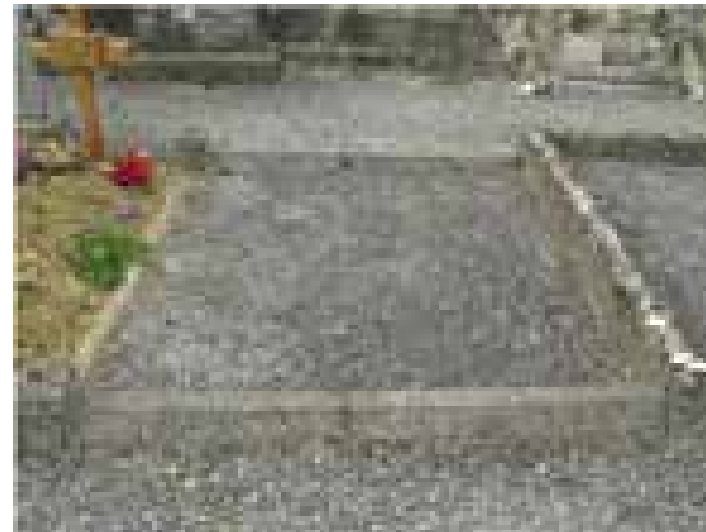
Plate 27-View of damaged plot to Grave No. 80, from  
west

The majority of graves are in good condition though some require attention. These include the subsidence of the rendered basins which have cracked and broken, with some plots unstable to walk across e.g. Grave No. 80 (Plate 27). Some plots also have trees growing in one corner and in some instances the tree growth has been unrestricted e.g. Grave No. 52.

Any leaning headstones or loose plinth blocks should be reset in place.

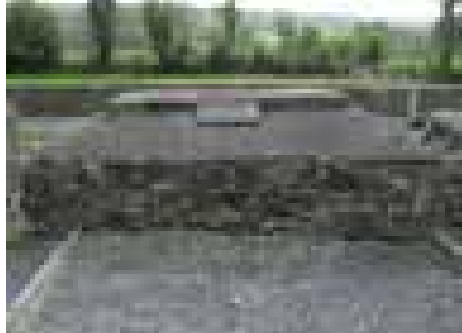
Grave_No	Family Name	Photo_Name
31	Carhy	IMG_0078
<b>Notes</b>		
Good condition, recent repairs include a moulded concrete block with a cross incorporated in the eastern side
