**Project code:** KCCG11  
**Client:** Kerry County Council  
**Date:** August 2011

## **Archaeological Survey of Kilmalkedar Burial Ground, Dingle, County Kerry**

**Surveyors:** Ann Frykler & Robert Hanbidge  
**Report Author:** Robert Hanbidge

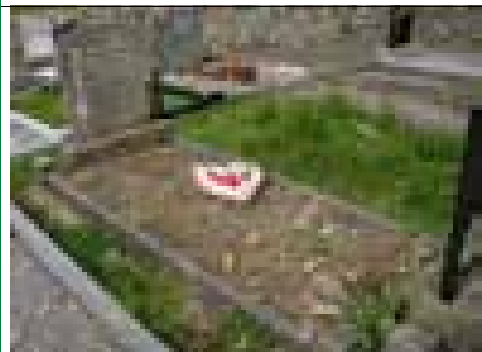
Grave_No	Family Name	Photo_Name
99	Bheaglaioich	IMG_0213
<b>Notes</b>		
Plot in moderate condition, appears to have recently been opened and backfilled

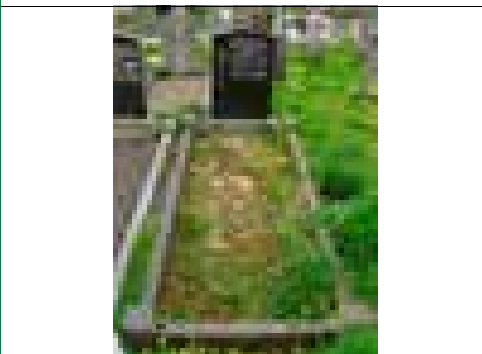
Grave_No	Family Name	Photo_Name
201	Breathnach	IMG_0415
<b>Notes</b>		
Plot in moderate condition overgrown with moss

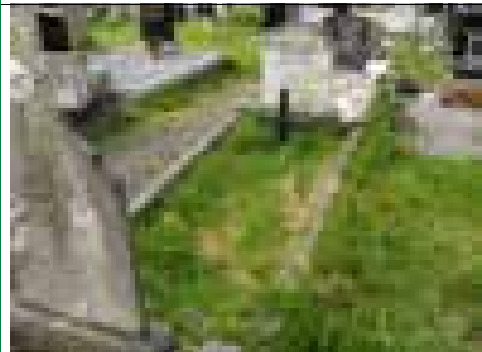
Grave_No	Family Name	Photo_Name
87	Closter	IMG_0184
<b>Notes</b>		
Plot in moderate condition, overgrown by grass and the centre is subsiding

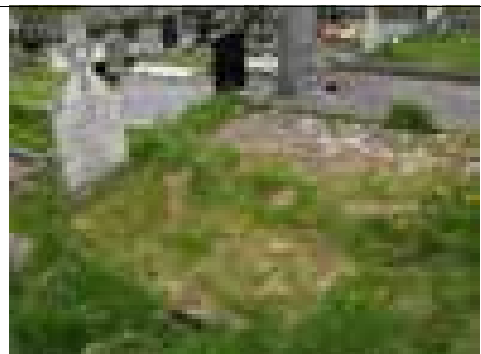
Grave_No	Family Name	Photo_Name
185	Fitzgerald	IMG_0380
<b>Notes</b>		
Plot in moderate condition, overgrown with grass, limestone plinths are falling apart

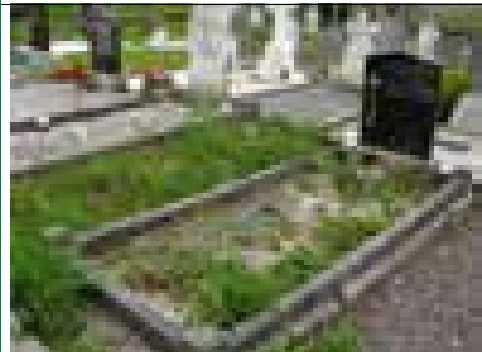
Grave_No	Family Name	Photo_Name
216	MacGearailt	IMG_0448
<b>Notes</b>		
Plot in moderate condition, some weeds growing and concrete collapse has exposed cavities

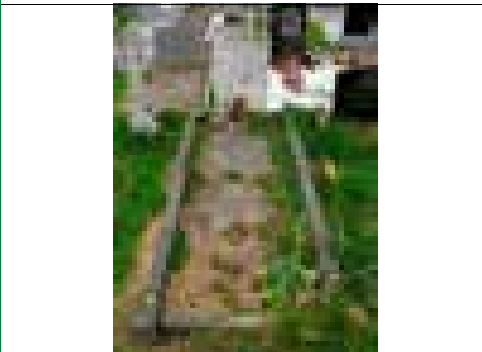
Grave_No	Family Name	Photo_Name
158	O'Sullivan	IMG_0334
<b>Notes</b>		
Plot in moderate condition, some weeds growing and plot is subsiding to the north
