Archaeological Survey of Kilmore Burial Ground, Ballybunion, Co. Kerry.

Archaeological Survey of Kilmore Burial Ground, Ballyduff, Co. Kerry.

Surveyors: Ann Frykler & Robert Hanbidge
Report Author: Robert Hanbidge
Report Status: Final

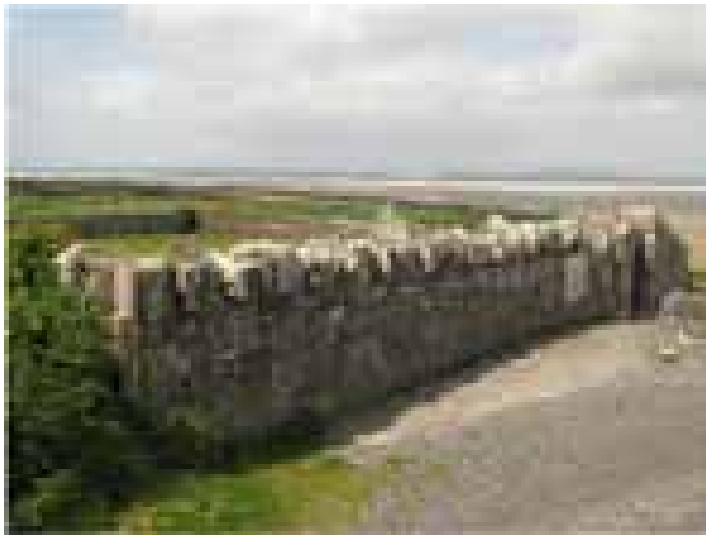
Plate 1-General View of Graveyard from southeast

Kilmore Graveyard also known as the 'Cillín' (Plate 1) is located within the townland of Kilmore, Co. Kerry, situated approximately 4 km to the southwest of Ballybunion and approximately 4 km to the northwest of the village of Ballyduff. The surrounding land is relatively flat with the notable visible rise in the landscape which includes Knockanore Mountain situated approximately 8 km to the northeast.

The boundary walls surrounding the graveyard are of roughly dressed mortared rubble stone with rubble stone coping (Plates 1, 3, 4, 5, 6, and 7). However there are parts of the wall where inappropriate rendering, containing large aggregates has been applied (Plate 6). The northern boundary wall has been reinforced with render and has a substantial base batter on the seaward facing sides to diffuse the wave power which impacts there (Plate 8).

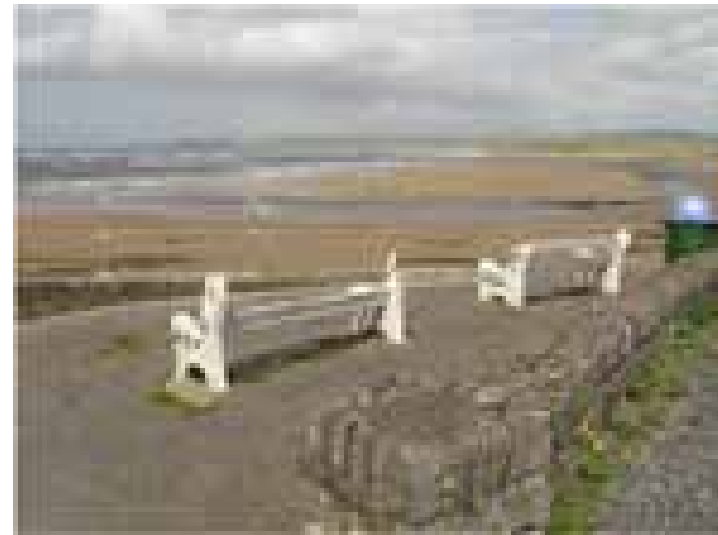
Plate 2-View of seating area from southwest

A seating area is provided overlooking the beach to the east of the graveyard (Plate 2).

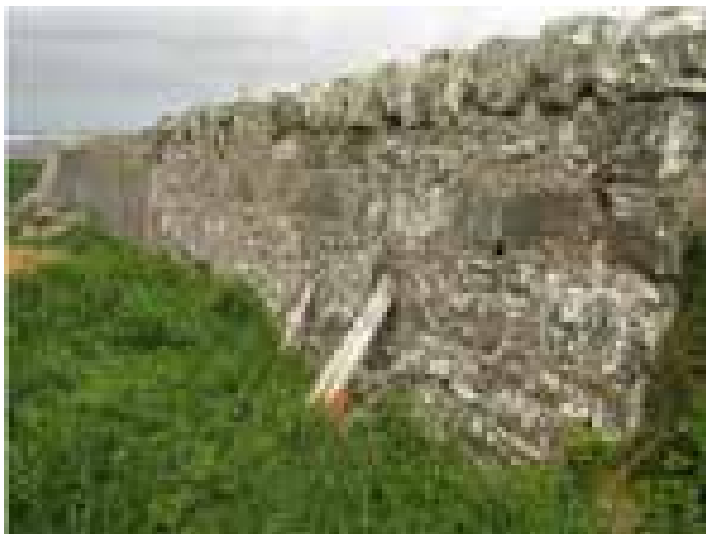
Plate 3-Exterior view of western boundary wall, from southwest

For the most part the boundary walls survive in good condition.

Continued maintenance of the walls using materials and skills which are sympathetic to the character of the historic rubblestone walls.

Spraying or broadcast application of herbicides on the walls must be avoided. Spot-spraying can be used to control noxious weeds but the cheapest and most wildlife-friendly solution is to manually clip any rambling weeds such as brambles, ivy, etc. on the walls. The "Guidance for the Care Conservation and Recording of Historic Graveyards" issued by the Heritage Council (2010) states the following:

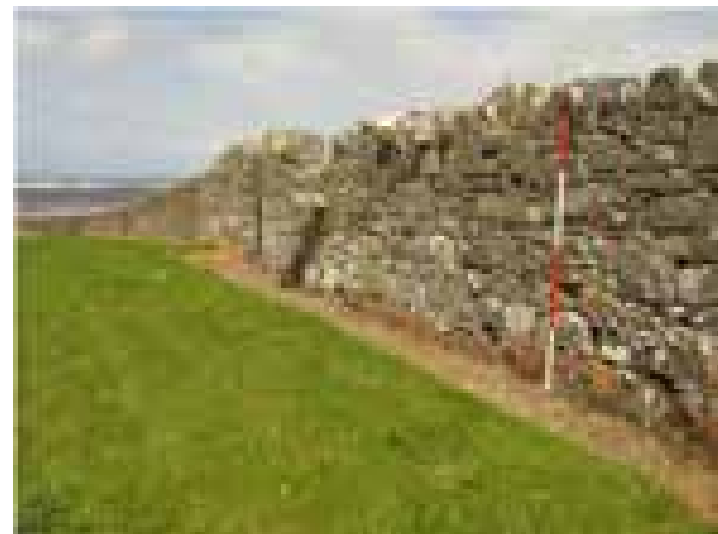
Plate 4-Interior view of eastern boundary wall, from southwest

This entrance consists of square-profile dressed rubblestone and tooled limestone gate piers with dressed rubble limestone coping that support a recent single-leaf timber battened gate with a central cross motif (Plate 9). Unfortunately this gate was locked at the time this survey was carried out. Entrance to the graveyard is only possible through a historic stile which is located immediately to the south of this entrance. This stile is comprised of projecting flagstones protruding from the wall in both the east and west elevations, which form steps to provide access over the wall (Plates 4 and 8).

There is one primary pathway which partially extends around the edge of the graveyard (Plate 4). This pathway has a partial gravel surface.

The replenishment of gravel on the pathways would greatly enhance the visual appeal of the graveyard and would also help in preventing weed growth on the paths. This would also negate the requirement for herbicide use on the paths.

Spraying or broadcast application of herbicides on the paths must be avoided. Spot-spraying can be used to control noxious weeds but the cheapest and most wildlife-friendly solution is to manually clip any rambling weeds such as brambles, ivy, etc. around the walls.

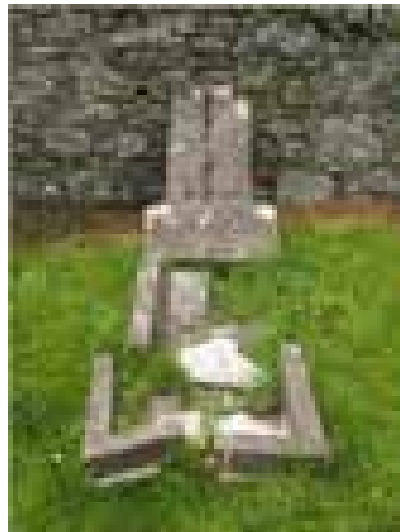
Plate 11-Grave No.1, from east

The plot at Grave No. 1 is constructed from low render enclosing walls with an associated iron reinforced render headstone (Plate 11). The plot survives in poor condition; it appears that the plot may have been deliberately destroyed considering the ruined nature of the plinths, rendered basin and headstone. According to locals, this grave belongs to a young girl from the Traveller community with the family name 'Spring'.

Restoration of the plot and the installation of a new headstone would greatly enhance the appearance of the graveyard and would be respectful to the young girl buried here. Any such works should be aware of the high potential for the discovery of further human remains. Any ground works should be conducted under the supervision of a suitably qualified archaeologist particularly given the potential for the uncovering of children's remains, which can be difficult to distinguish.

- The replenishment of gravel on the pathways would greatly benefit the grounds.
- Restoration of the only plot and headstone at Grave No. 1 would enhance the appearance of the graveyard and ensure that the burial is commemorated.

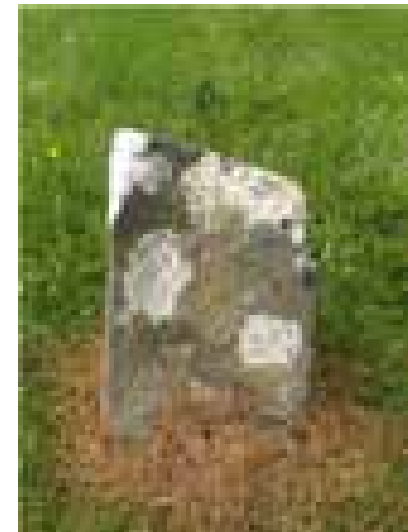
Plate 12-Grave No. 7, from east

There are 19 unnamed gravemarkers within Kilmore Burial Ground. All of these consist of simple locally sourced stone, usually beech cobbles or split stone slabs which are placed in the ground e.g. Grave No. 7 (Plate 12). The majority of these gravemarkers were in good condition.

Continue graveyard maintenance to ensure gravemarkers remain visible.

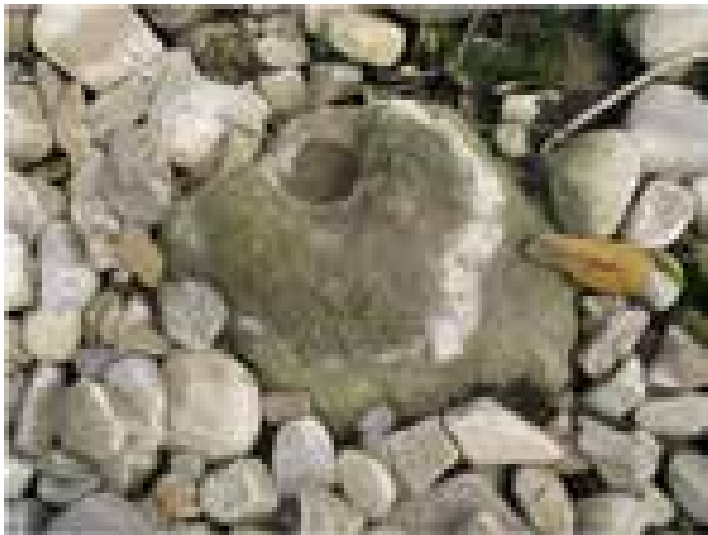
Plate 13-View of possible font-bullaun (Miscellaneous No. 02), from northwest

Miscellaneous No. 02: Situated outside the graveyard on the beach to the west a possible font/bullaun (Plate 13) is located in the tidal zone. This font/bullaun is situated on the edge of a medium sized earth fast boulder. The font is medium sized measuring approximately 20 cm both in diameter and depth. Given the location of this feature in close proximity to a graveyard, it is likely that this is indeed an archaeological object. However there is some potential that it is natural given its location on a stony tidal beach. Water movement can cause smaller stones to spin in a natural depression on larger rocks, a process which is known to have caused natural basins that resemble archaeological font/bullauns. Further investigation is required to establish the archaeological potential of this feature.

Possible bullaun stone, could have been created naturally. Located outside the boundaries of the graveyard and is submerged by the sea at high tides

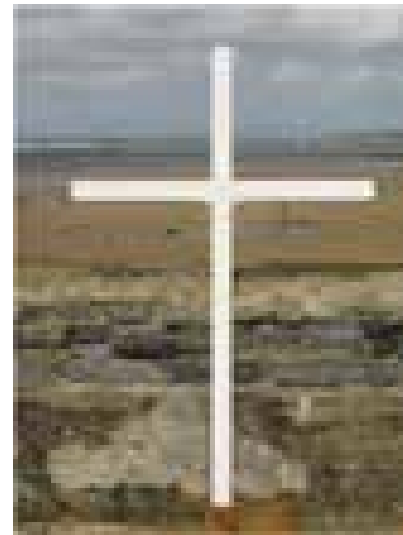
Plate 14-View of memorial cross (Miscellaneous No. 01) from south

Miscellaneous No. 01: Mounted on the interior of the northern boundary wall was a large white memorial cross (Plate 14). The positioning of the cross on the seaward facing boundary is also significant, as its outline would be clearly visible against the landscape if viewed from the sea.

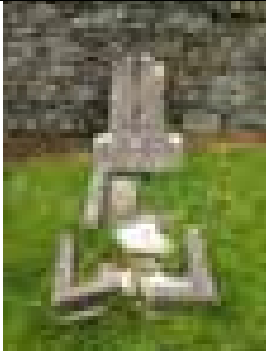
Grave_Type		Headstone
Grave_No	Family Name	Photo_Name
1	Spring	IMG_0001
Notes		
Broken headstone
