**Project code:** KCCG11  
**Client:** Kerry County Council  
**Date:** July 2011

## **Archaeological Survey of Kilnanima, Cordal, County Kerry**

**Surveyors:** Ann Frykler & Robert Hanbidge  
**Report Author:** Robert Hanbidge

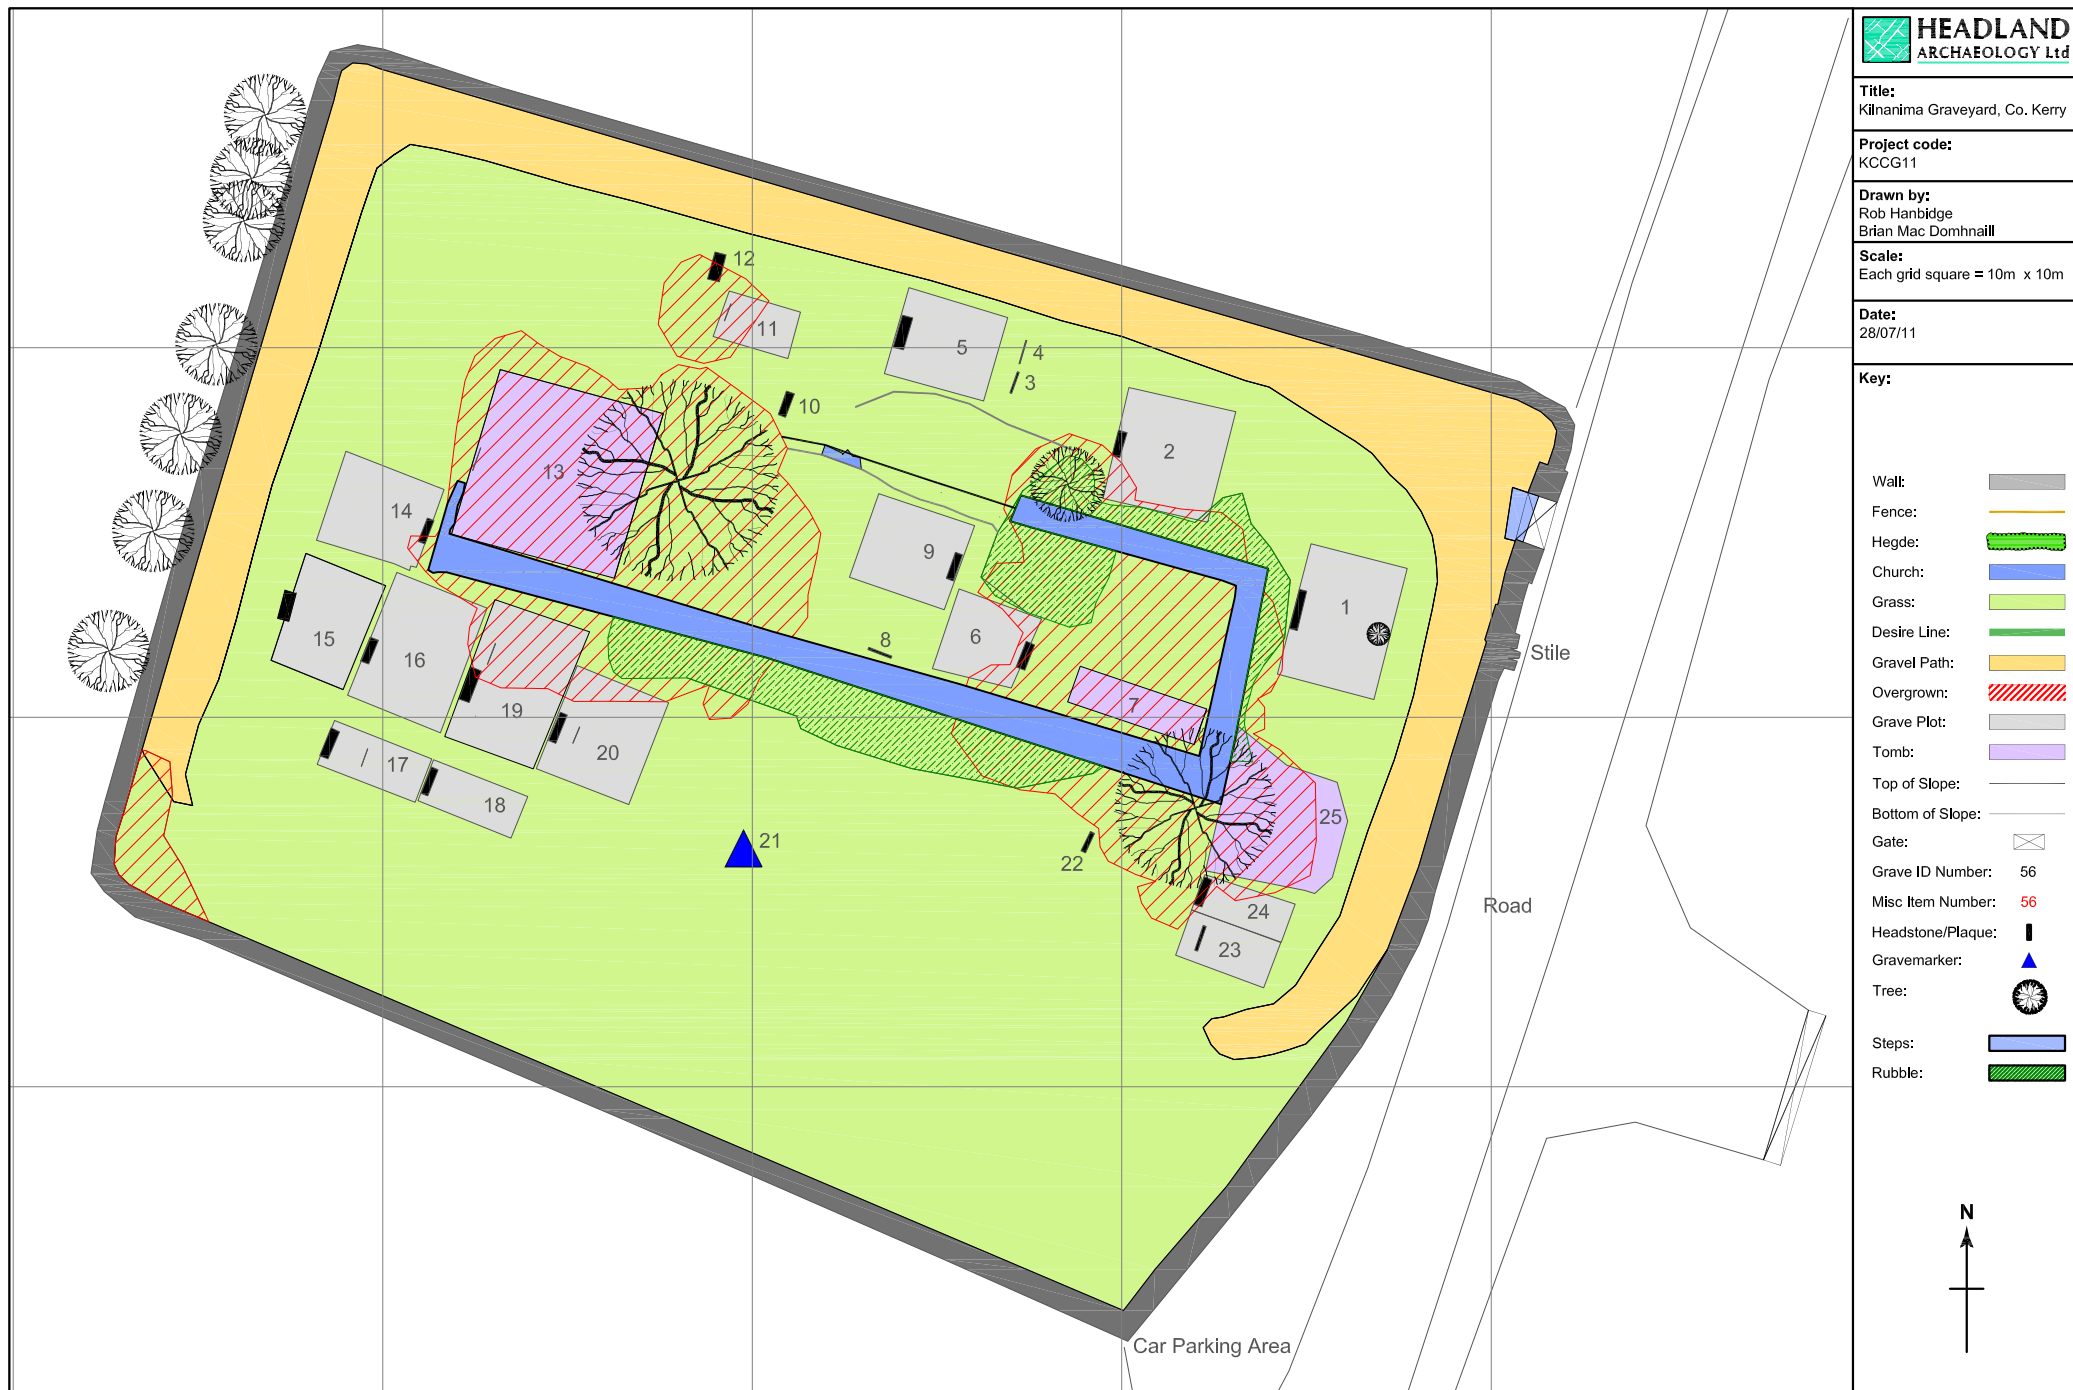
Figure 4.2 -Archaeological survey plan of Kilnanima Graveyard, 2011.

The report comprises a detailed survey including boundaries, location of paths and desire lines, gravemarkers, tombs, architectural fragments, remains of churches or buildings, dangerous areas of ground collapse and a photographic survey of headstones and gravemarkers linked back to survey drawings. Also included are written descriptions of buildings, cross-slabs and early enclosures; statements on the condition of buildings; suggested suitable/necessary remedial action that may be needed to secure these structures; breaches of the boundary walls, open or collapsed tombs and the condition of paths and entrance gates. A photographic survey of damaged and dangerous structures or features is also included.

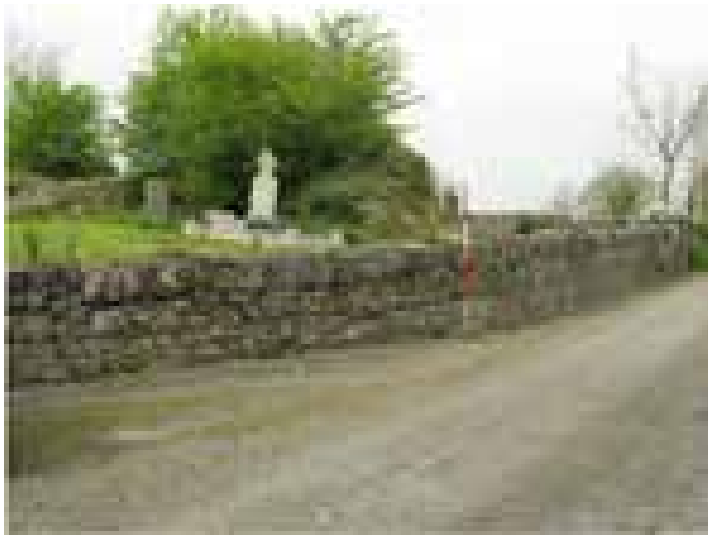
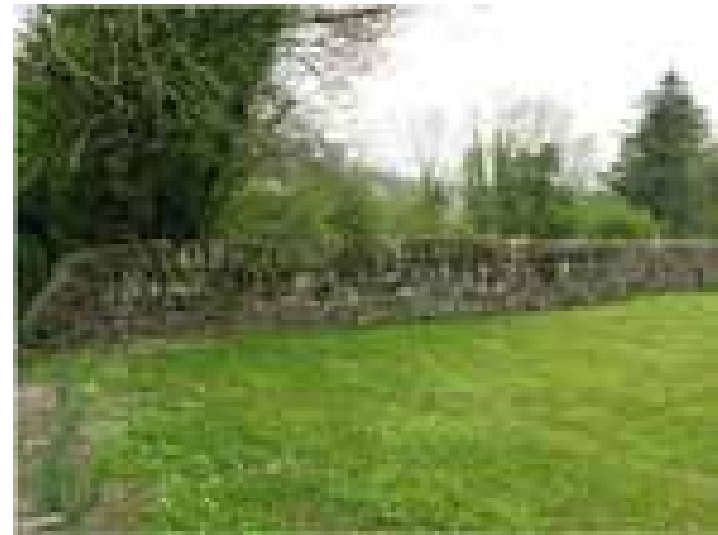
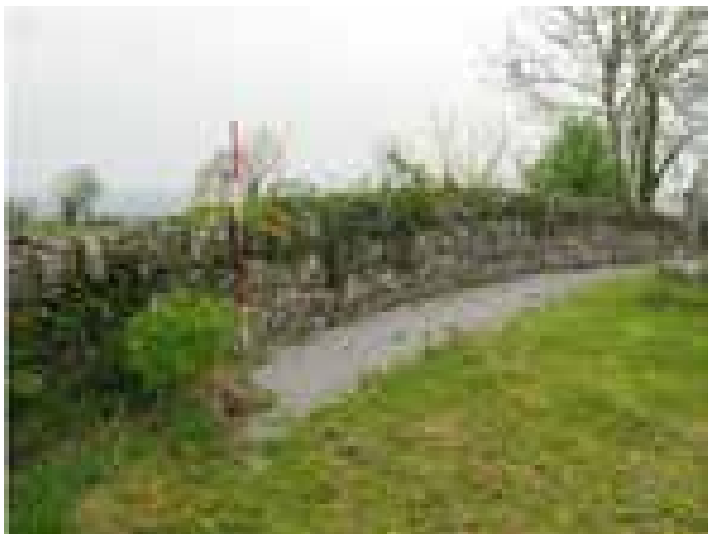
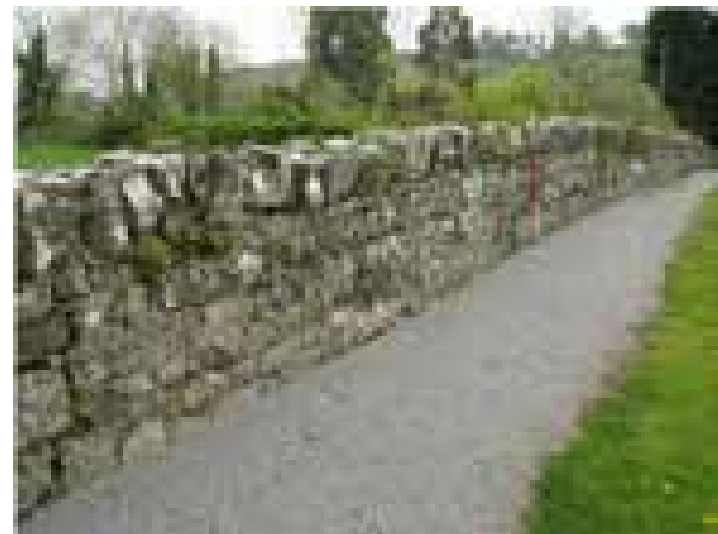
Plate 1-View of graveyard from south-east

The boundary walls surrounding the graveyard consist of roughly dressed coursed rubble limestone with roughly dressed limestone coping (Plates 1-4).

Dressed limestone piers flank the entrance and are surmounted with dressed limestone capping. For the most part the walls appear stable and are in very good condition. There are occasional areas of ivy, however these are insignificant. The occurrence of distinctive pale lichens are a frequent feature of the historic walls and compliment their charm and character.

Continued maintenance of the graveyard boundaries. Areas of ivy growth should be monitored.

Spraying or broadcast application of herbicides on the wall must be avoided. Spot-spraying can be used to control noxious weeds but the cheapest and most wildlife-friendly solution is to clip any rambling weeds such as brambles, ivy, etc. The “Guidance for the Care Conservation and Recording of Historic Graveyards” issued by the Heritage Council (2010) states that:

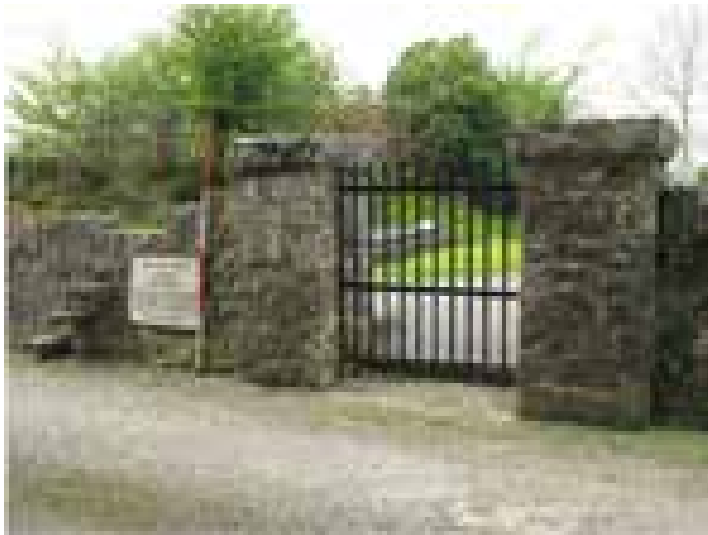
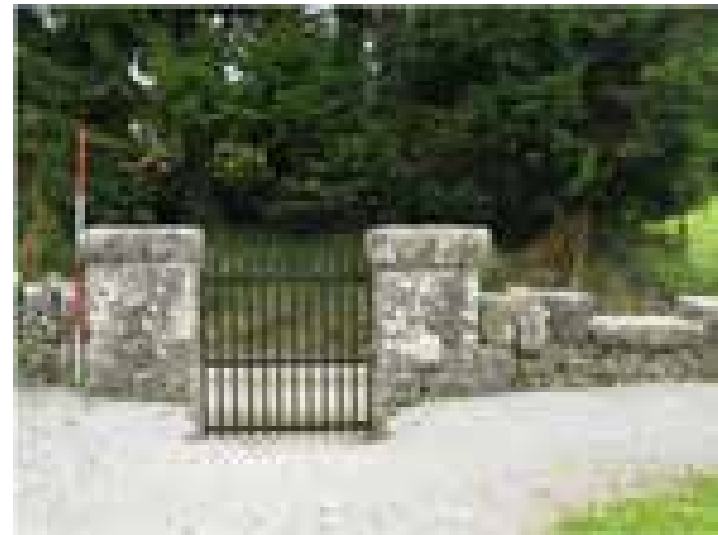
Plate 5-View of entrance from east

The primary entrance consists of a pair of dressed limestone block square-profile piers surmounted by roughly dressed flagstone capping, which support a single-leaf wrought-iron gate (Plates 5 and 6). The entrance survives in good condition. Stone steps are located in the interior of this entrance.

Continued high standard of maintenance.

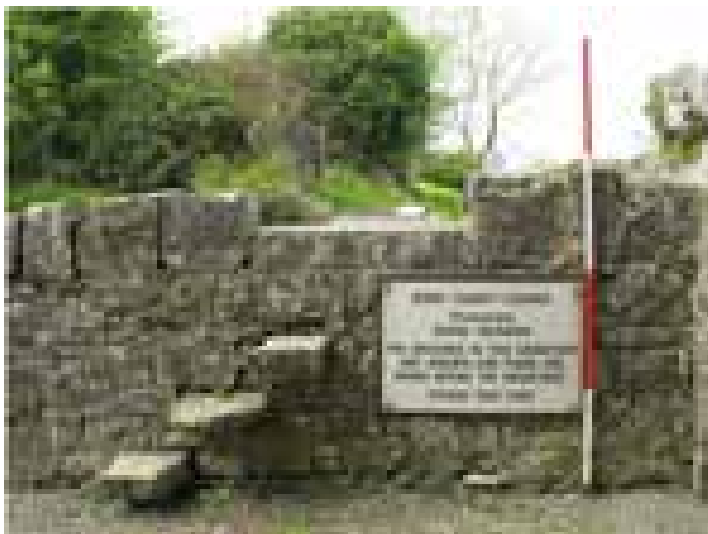
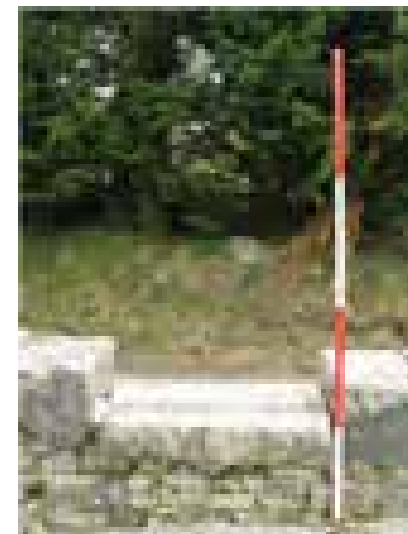
Plate 7-View of stile from east

The second method of entry consists of a historic stile which is located immediately to the south of the main entrance and comprises of projecting flagstones protruding from the wall in the east elevation, forming steps to provide access over the wall (Plates 5, 7 and 8). A large dressed limestone slab forms a level stable surface at the coping level. This entrance is also in good condition.

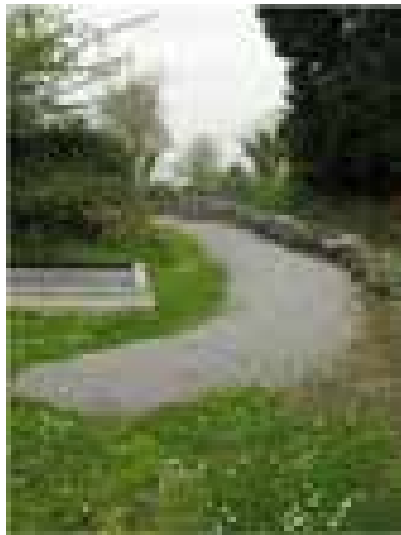
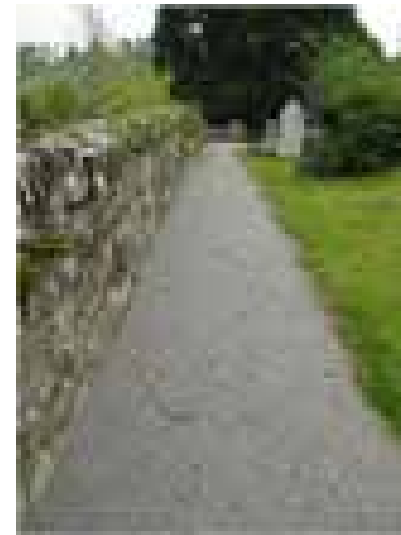
Plate 9-View of eastern section of pathway from south

There is one primary gravel pathway which extends around the east, north and west sides of the graveyard. This pathway is well maintained.

Continued high standard of maintenance.

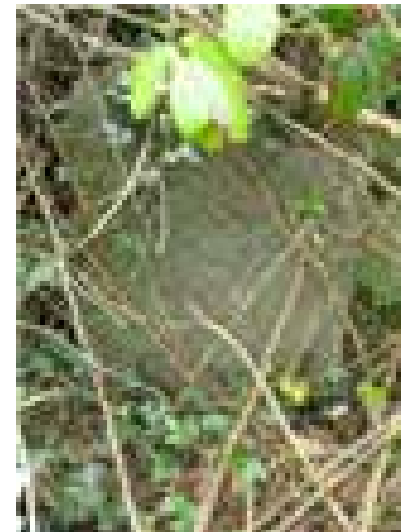
Plate 12-View of entrance stone to tomb (Grave No. 07), from west

The first tomb, Grave No. 7, is located in the south-eastern corner of the church. The tomb belongs to the Fitzgerald Family and is structurally stable, however access to the tomb is restricted by overgrowth (Plate 12).

Access to the tombs is restricted as a result of ivy and tree overgrowth. Excess overgrowth should be trimmed which will improve access to the tombs and allow for any conservation works.

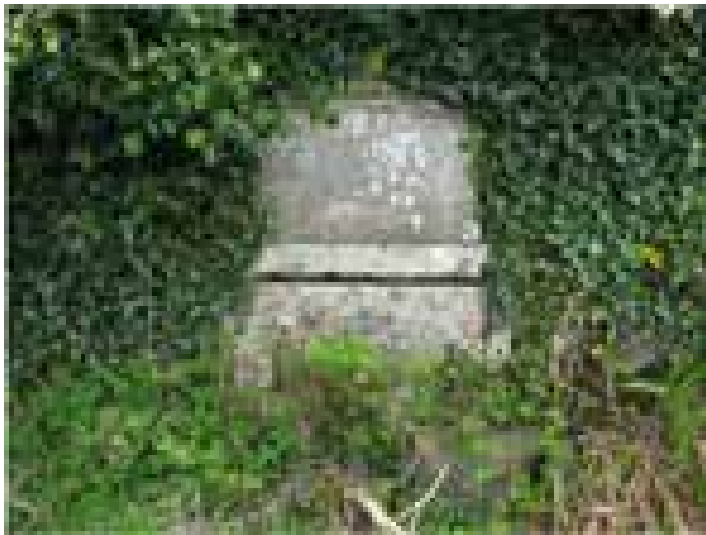
Plate 13-View of tomb (Grave No. 13), from west

The second tomb, Grave No. 13, also belongs to the Fitzgerald family and is distinguished by its very large size (Plate 13). The tomb dates to 1818 and is located on the site of the western church wall. The tomb is quite overgrown with ivy and is excellently constructed utilising limestone blocks.

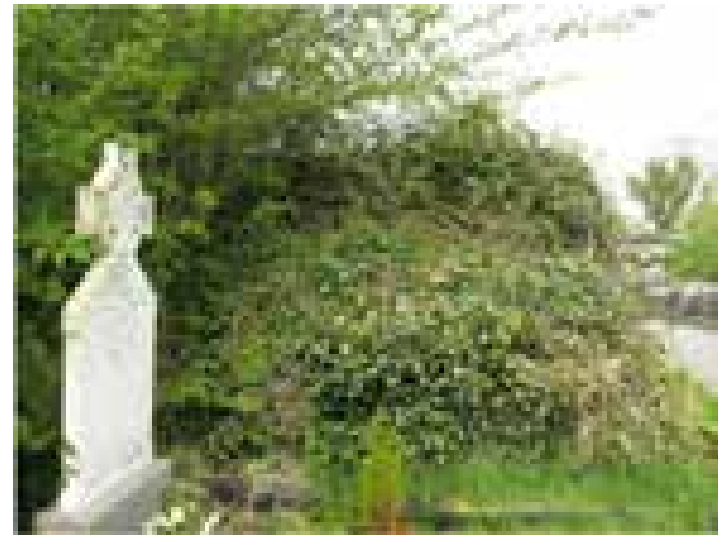
Plate 14-View of tomb (Grave No.) from south

Only one unnamed tomb, Grave No. 25, was recorded within Kilmurry Graveyard. The tomb is situated on the external side of the eastern wall of the church ruin. The tomb is in poor condition and is heavily overgrown (Plate 14).

Management of the overgrowth at the tomb will allow for conservation works on the structure of the tomb.

Any such works should use the necessary skills and materials which are sympathetic to the historic character of the graveyard.

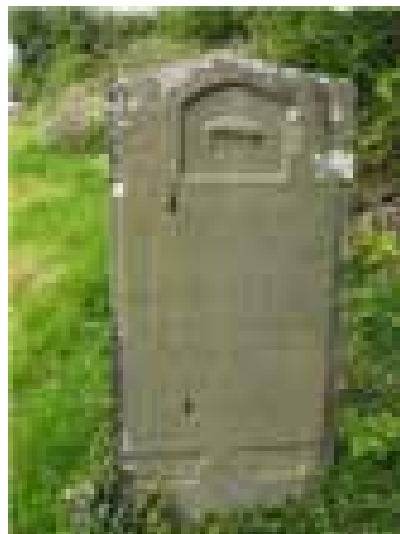
Plate 15-View of headstone to  
Grave No. 22, from east

associated with Grave No. 22, commemorating a member of the Evans family (Plate 15). This headstone is also of artistic value and displays some pleasing artistic ornamentation.

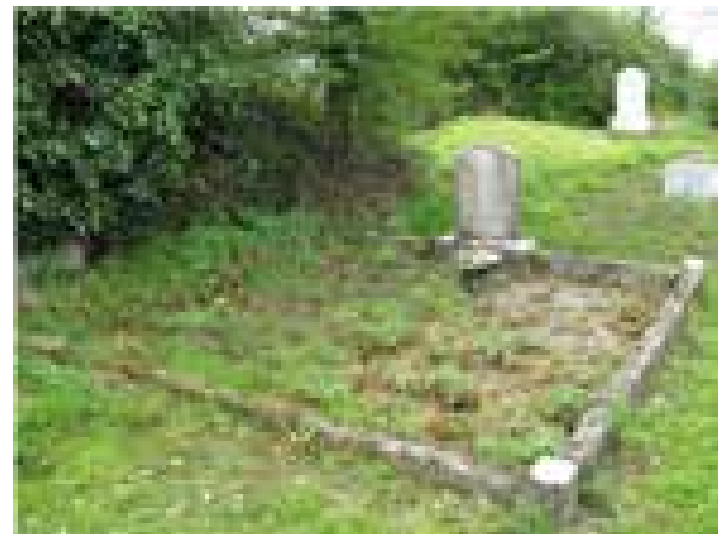
Plate 16-View of plot to Grave No. 2 from east

Most of the headstones and plots within this graveyard are of simple forms consisting of limestone or polished stone headstones. Most of the plots are in good condition with the only exception being the plot of Grave No. 2 which is overgrown with weeds (Plate 16).

General maintenance of the plots including replenishment of existing grave surfaces (gravel) will aid in the prevention of weed growth.

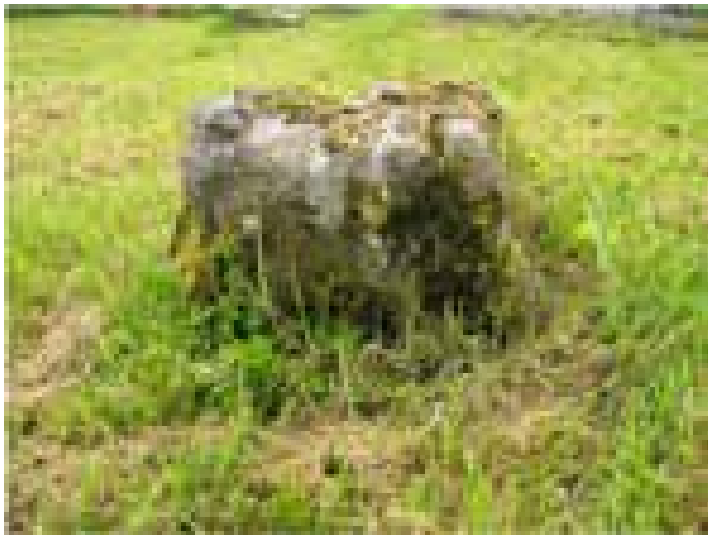
Plate 17-View Grave No.21, from east

Only one gravemarker was recorded within Kilmurry Graveyard and this belonged to Grave No. 21. This was a typical type of unnamed gravemarker and consisted of a simple limestone block (Plate 17).

Continued graveyard maintenance.

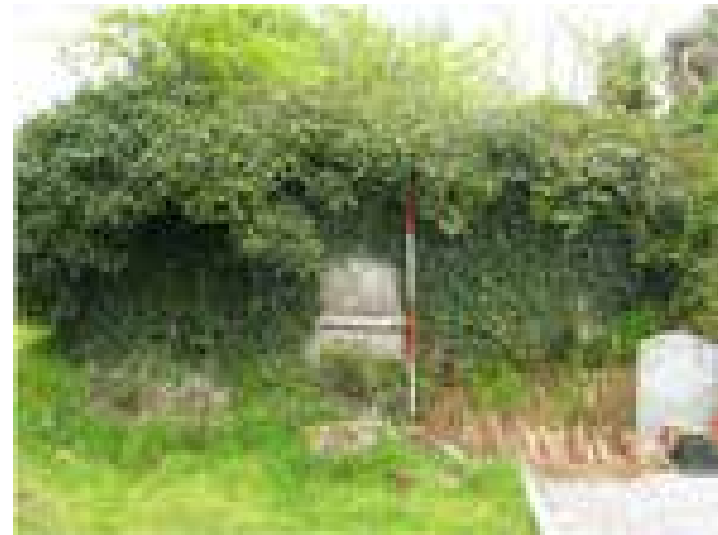
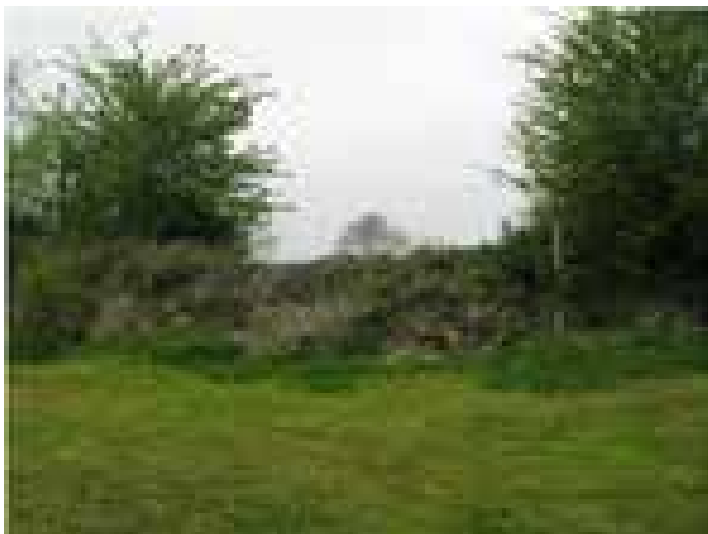
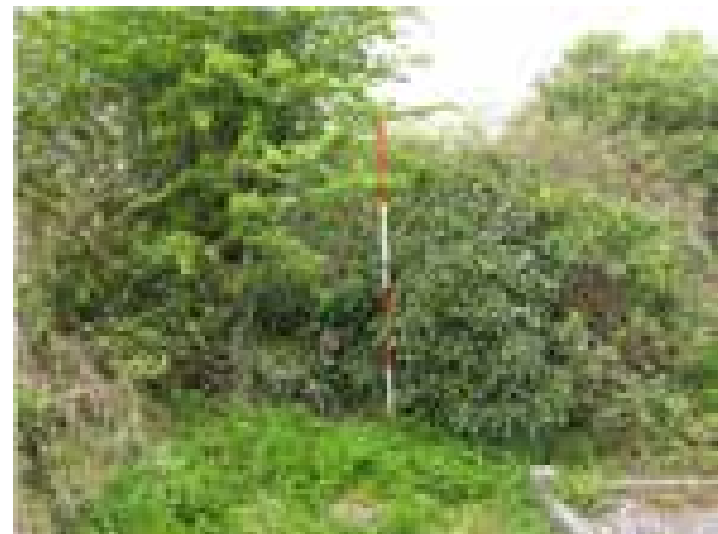
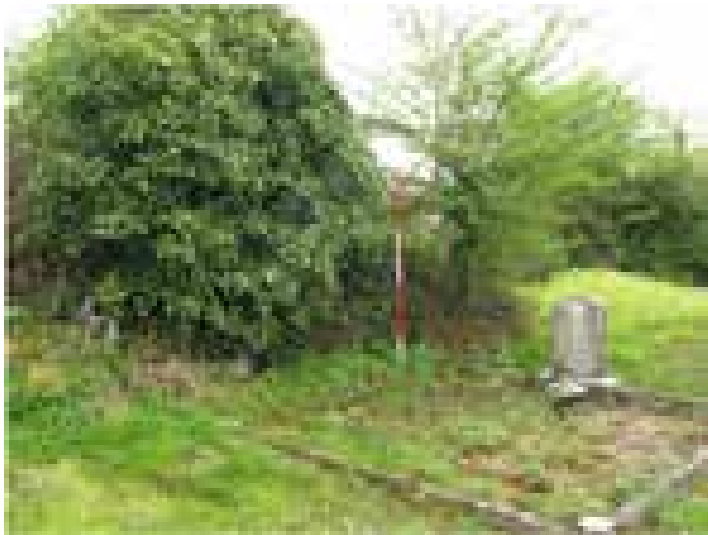
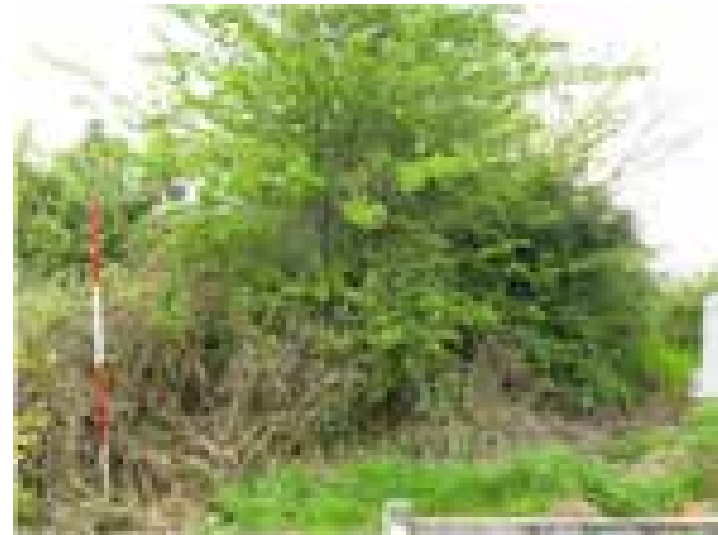
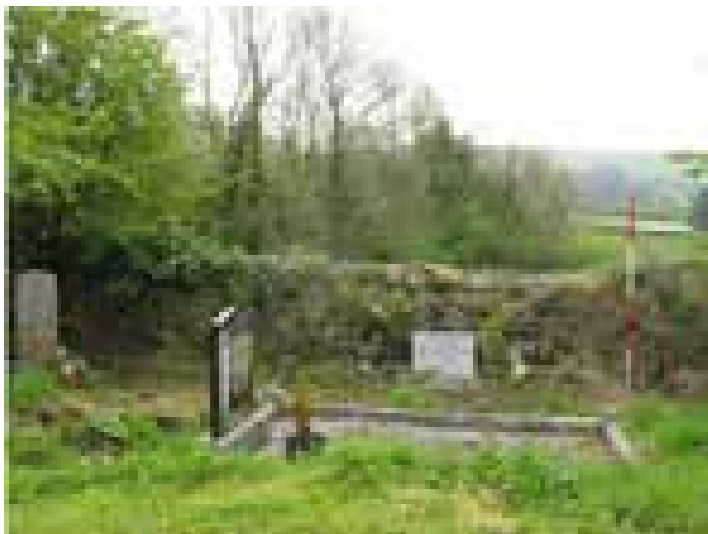
Within the central area of the graveyard are the ruins of a church (Plates 18-21). The ruin is in poor condition and only low portions of the walls survive at the south, east and north. The walls are built from roughly dressed rubblestone. In the interior of the church there are five burials, but access is restricted by overgrowth (Plates 22, 23 and 24). The eastern and western ends of the church ruin are the most impacted on by overgrowth and trees.

Measures should be taken to ensure that all the graves in the interior of the church are easily accessible; this could primarily be achieved through the control and management of the attached vegetation and preventing it from spreading further. The Ivy should not be removed as this would leave the building in need of immediate conservation, and may cause structural collapse. Conservation work would involve the re-pointing of the walls using correct (lime) mortars with flush or recessed pointing. Ribbon pointing must be avoided as its use would damage the structure's historic character. The complete removal of the Ivy would also result in a loss of a natural habitat and should be avoided. Even though the church ruins are not substantial, the structural stability of the building needs to be monitored.

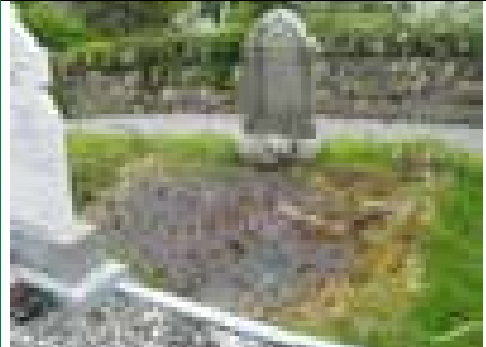
Grave_No	Family Name	Photo_Name
15	Eager/Horgan	IMG_0025
<b>Notes</b>		
Plot in moderate condition, some moss and weeds

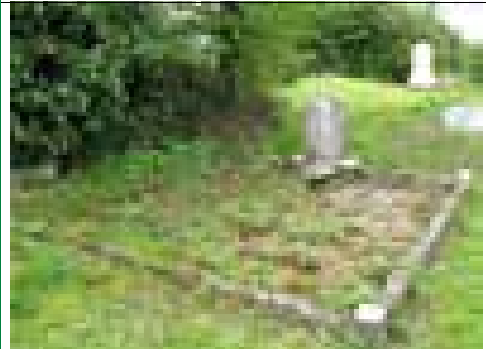
Grave_No	Family Name	Photo_Name
2	Fitzgerald	IMG_0003
<b>Notes</b>		
Plot in moderate condition, overgrown by moss and weeds

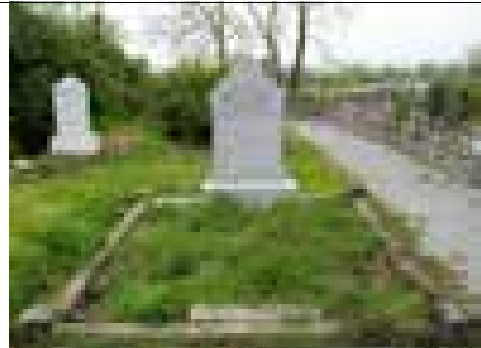
Grave_No	Family Name	Photo_Name
5	Fitzgerald	IMG_0007
<b>Notes</b>		
Plot in moderate condition overgrown by moss, grass and weeds

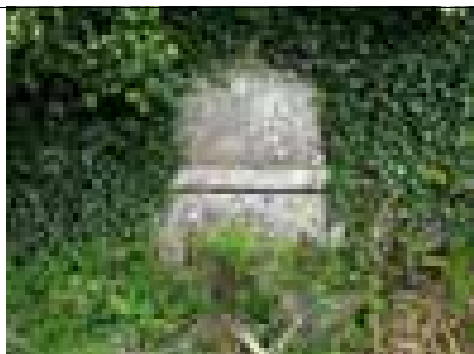
Grave_No	Family Name	Photo_Name
13	FitzGerald	IMG_0021
<b>Notes</b>		
Tomb built into the church ruins west wall, headstone from 1818
