Archaeological Survey,
Kilshannig Graveyard,
Kilshannig,
Castlegregory,
Co. Kerry.

October 2012

Client: The Heritage Office,
Kerry County Council,
County Buildings,
Ratass,
Tralee,
Co. Kerry.

RMP No.: KE027-002

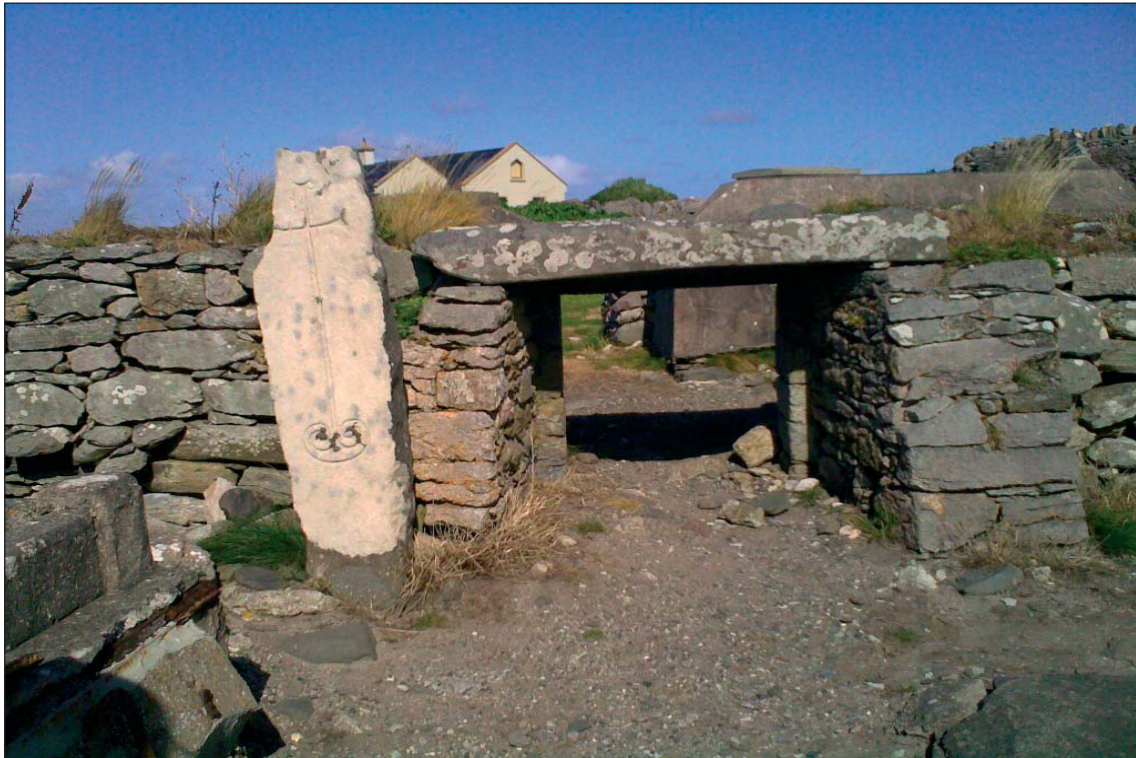
A single free standing early medieval chi-rho cross-slab, that is decorated on both faces, stands immediately inside the entrance to the church on the N elevation at the W side (Plate 1 & Figure 3). No damage occurred to this very important chi-rho slab when the W gable collapsed in 2011.

Plate 1: View of Chi-Rho cross-slab on W side of doorway on N elevation of Kilshannig medieval church

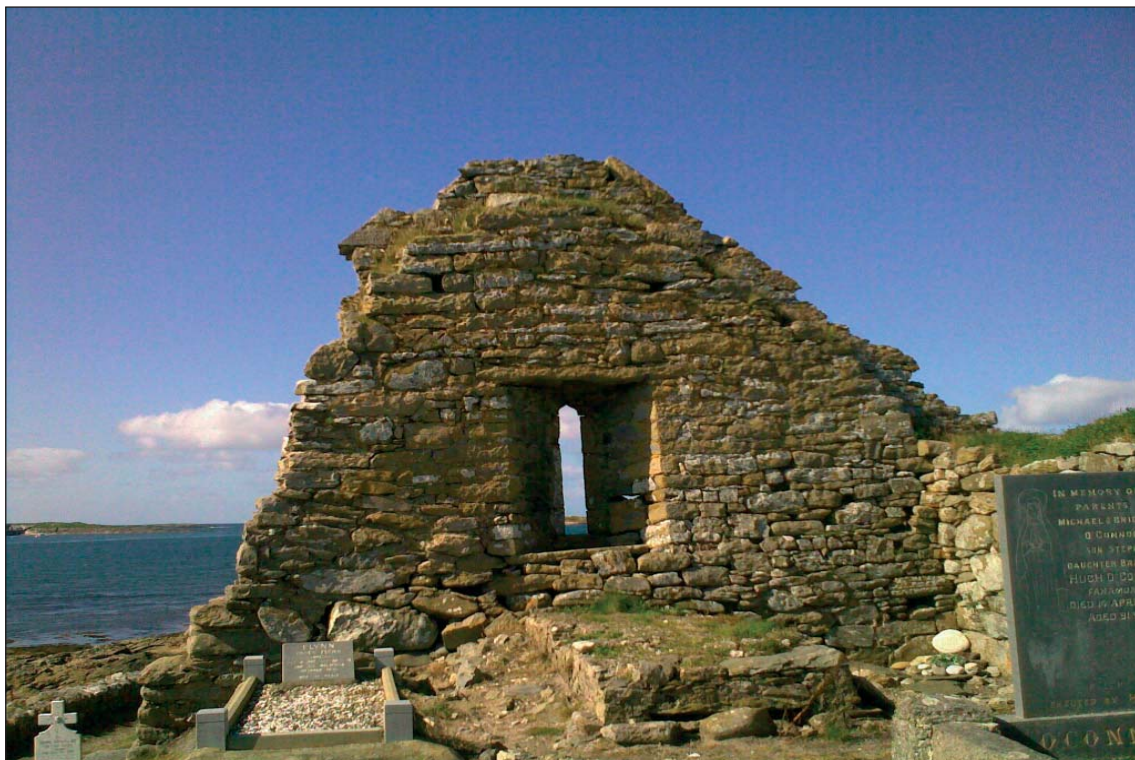
In 2009 the site was inspected by the writer and Fionnbarr Moore who reported that the W gable was seriously fractured, slipped and twisted and was imminently about to collapse (Plates 2-3). The W gable did unfortunately collapse in March 2011 (Plates 4-5). Some of the collapsed masonry fell on top of a tomb (TB13, Figure 2) and also slightly against the modern grave of Paddy Flynn (HN 36, Appendix 2).

Plate 2: View from E of W gable of Kilshannig church. Image taken by author in 2009. The W gable collapsed in January 2011. Note coherent leaning and fracturing on the S side and S basal area of the W gable. Further note low rectangular tomb and Flynn burial plot

- The collapsed masonry should be collected and temporarily stored nearby. An assessment of the viability of the partial or total reconstruction of the W gable should be undertaken.
- The interior of the church requires attention and its structural fabric requires consolidation. This work should only be done by experienced qualified personnel under archaeological supervision.

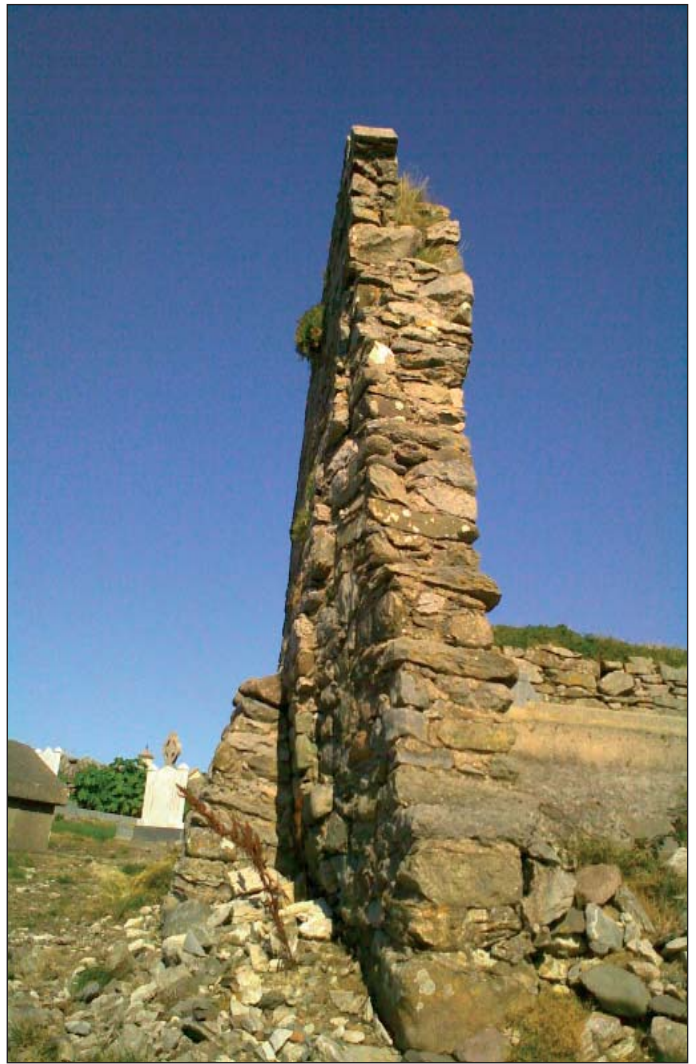
Plate 3: Side view image by the author from the exterior SW corner of extant W gable in 2009. Note inadequate low buttress and outward or westerly bulge

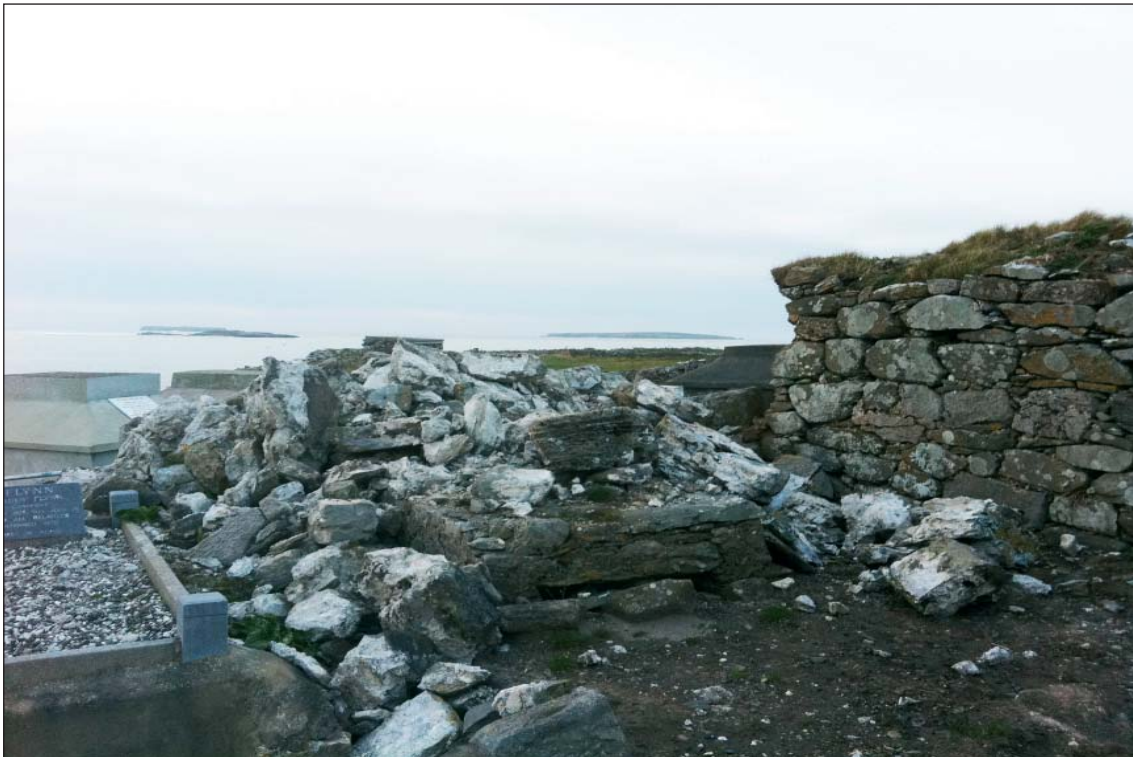
There are eighteen tombs in Kilshannig graveyard and church mainly of the strong-box variety (Figure 2, Plates 16-18 & Appendix 1). There is a single gabled house type also, (Goodwin, TB 1), Plate 17). The majority of them are constructed of local rubble limestone and rendered while (Figure 2). Fourteen of the tombs are in excellent condition; another, the grassed over Kenyon tomb (TB2), requires maintenance. Three other tombs, whose names are currently unknown, are in a poor dilapidated and neglected state (Tombs 9, 12 & 13, Figure 2). One of the three (TB13) is still covered with a mass of tumbled masonry since the W gable collapsed in January 2011.

Plate 4: View of collapsed masonry from W gable straddling Tomb 13 in Kilshannig church

Specialist work is required to preserve, repair and restore four of the tombs at Kilshannig Graveyard. Two will require careful rebuilding and collapsed masonry should be removed from TB 13. Work should only be undertaken by skilled masons with a proven track record of working with historic structures and ashlar masonry.

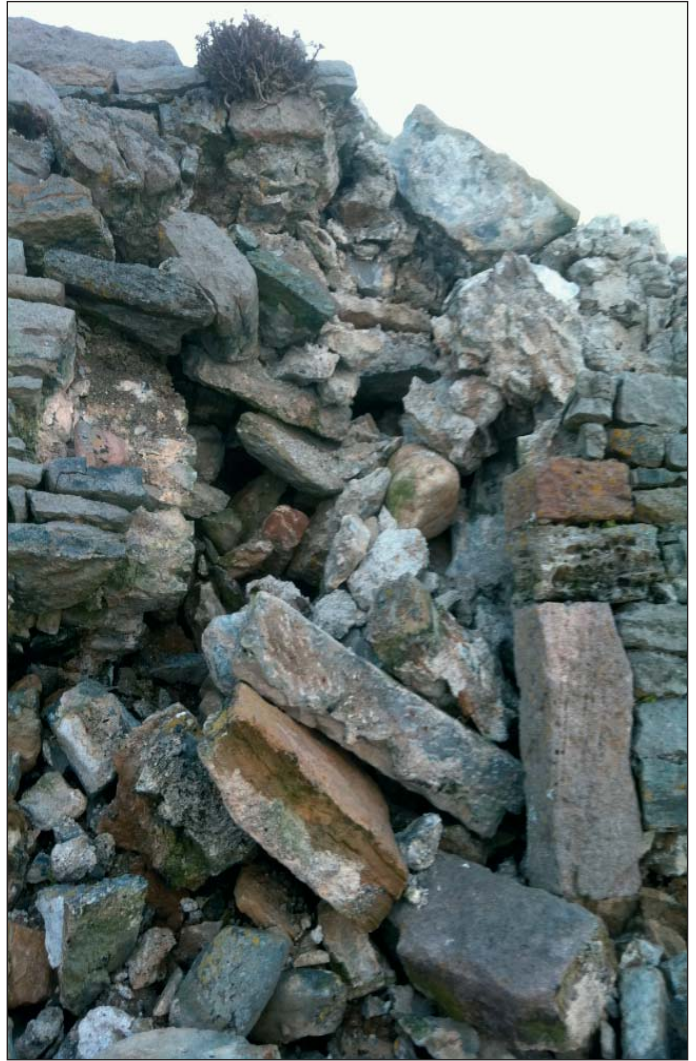
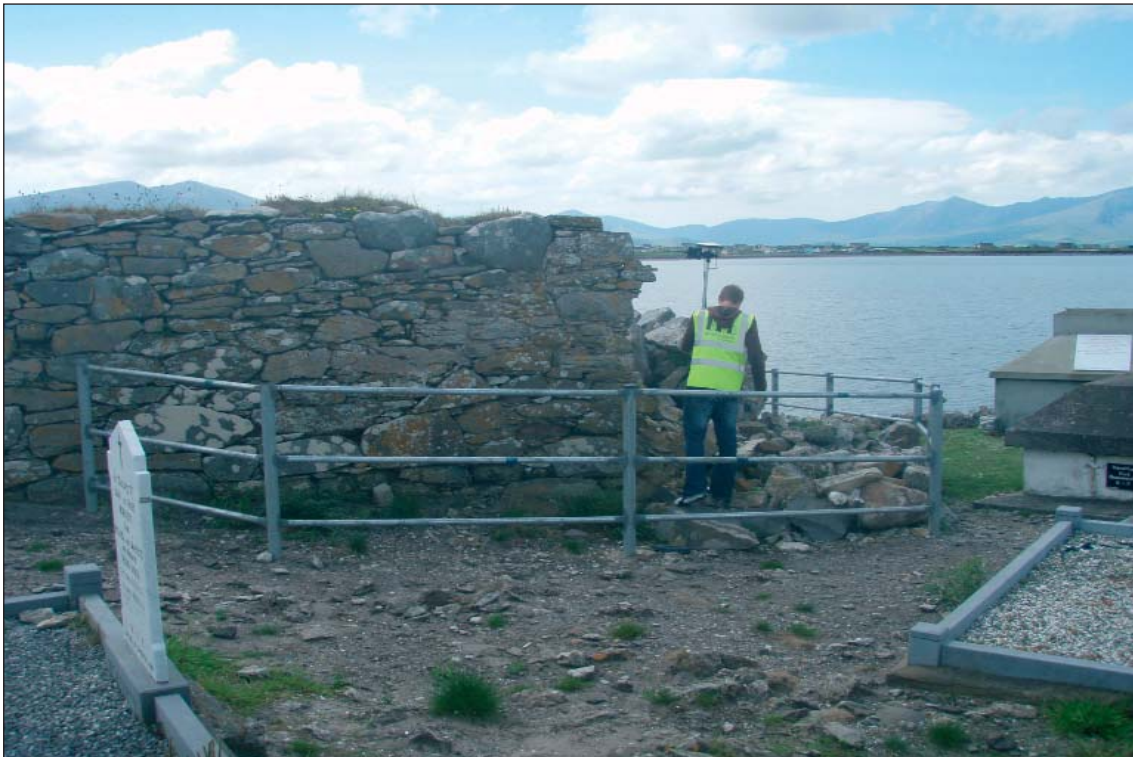
Prior to the collapse of the W gable Kerry County Council had erected a robust metal railing around it and erected warning signs (Plates 6-7).

Plate 5: Exterior close-up view from W of collapsed W gable. Note coherent south side of window still extant

Plate 6: View of collapsed NW corner of N elevation of Kilshannig church from N. Note robust railing around it erected by KCC

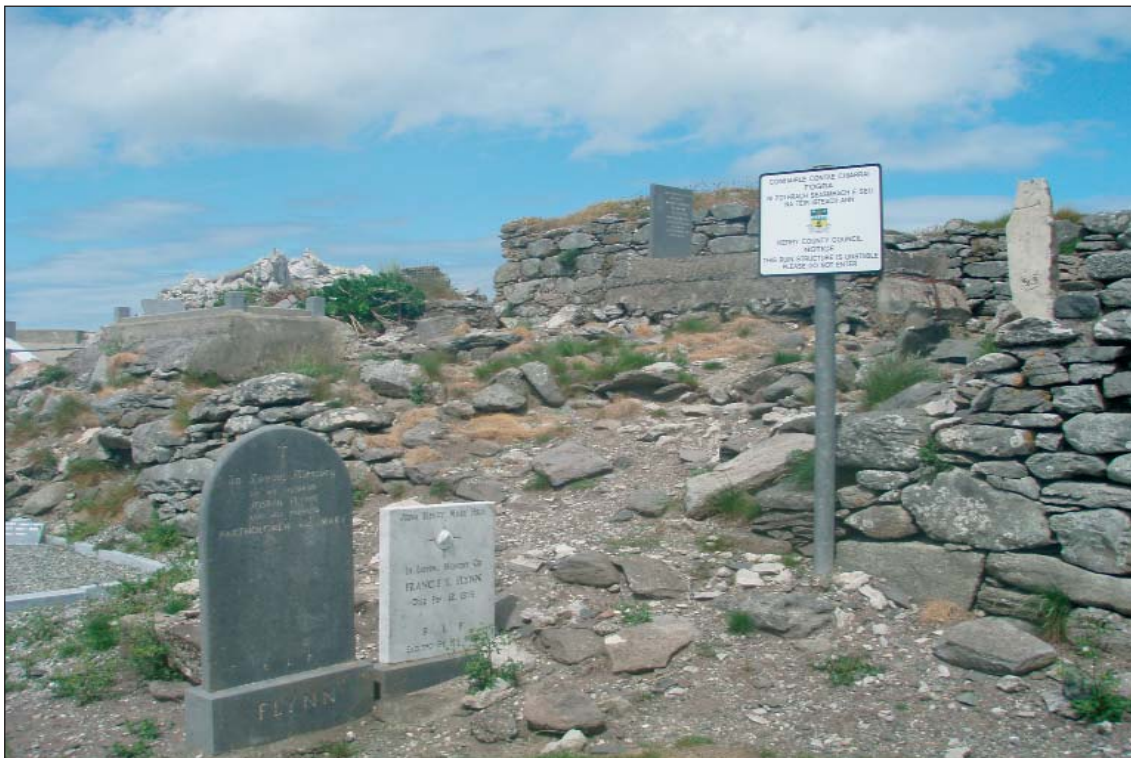
The S elevation is still actively eroding and is the most neglected area of the church (Plate 7). The interior is also neglected with loose stones and bones visible throughout as well as discarded rubbish and other graveyard detritus. Modern burials have also impacted on it.

Plate 7: View from SE of collapsed south elevation of Kilshannig church. Note ragged nature of interior, modern graves and KCC warning sign

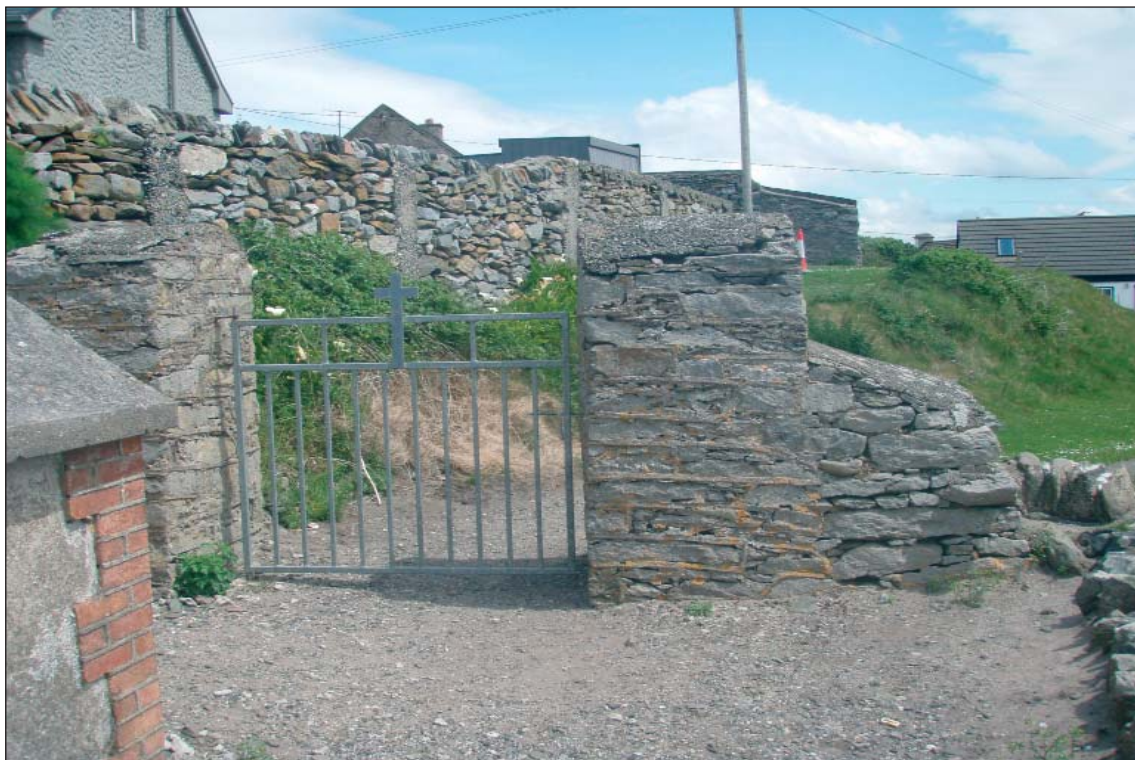
Entrance is through a modern galvanised gate pivoting between two solid square rubblestone piers with forward ribbon pointing and rounded gravel cement capping (Plates 10 & 11). An unused step-stile is provided abutting the N pier however visitors generally use an *ad hoc* sidestep around the S pier on the shore side (Plates 12-13).

Plate 10: View of gated entrance to Kilshannig graveyard. Note ad hoc pedestrian step-aside at S or extreme right hand side of plate

The *ad hoc* sidestep that many visitors choose is a distinct H & S issue as it is possible that some individual will slip and fall down onto the rocky shoreline. The sidestep should be closed off.

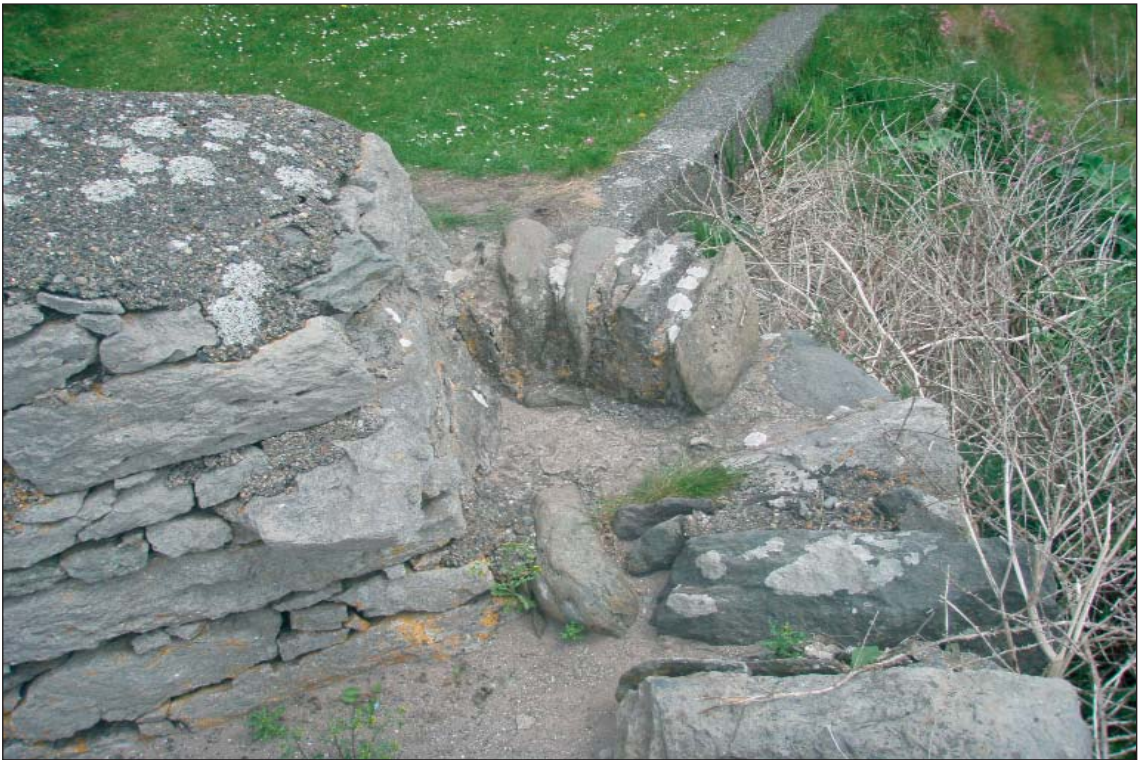
Plate 12: Interior close up view of seaward projecting ad hoc pedestrian step-aside into Kilshannig graveyard

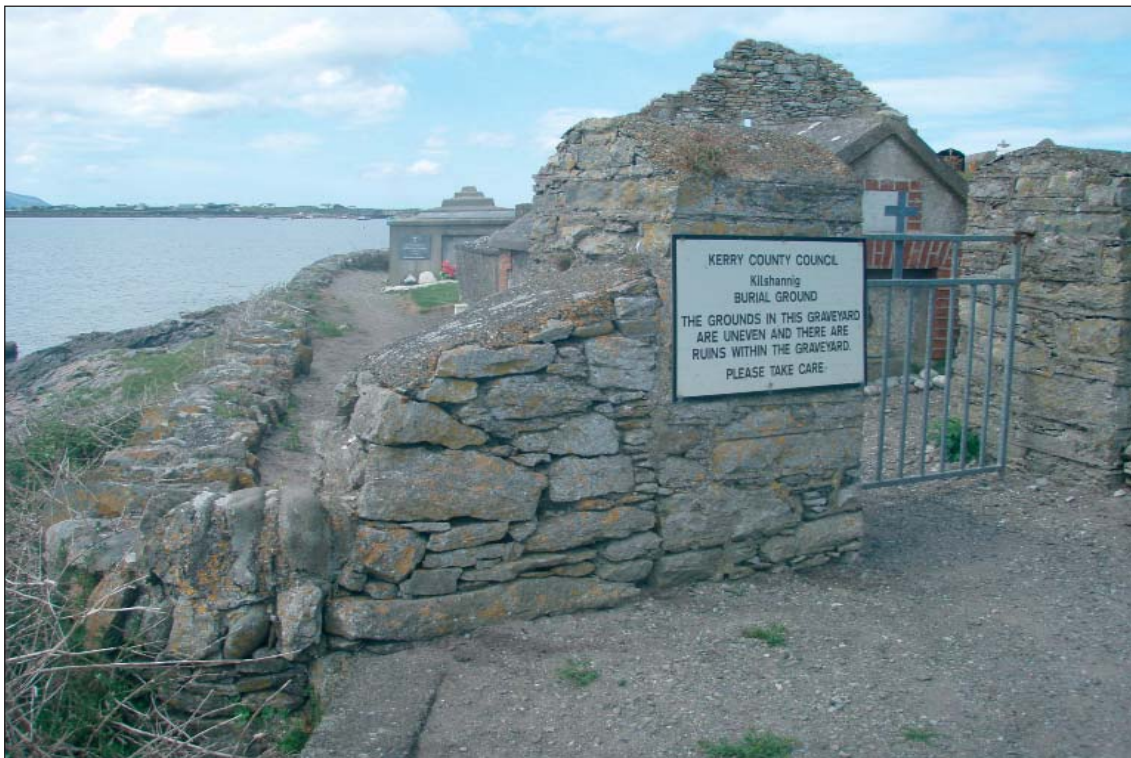
Plate 13: View from E of entrance to Kilshannig graveyard. Note lower ad hoc step-side on left of plate

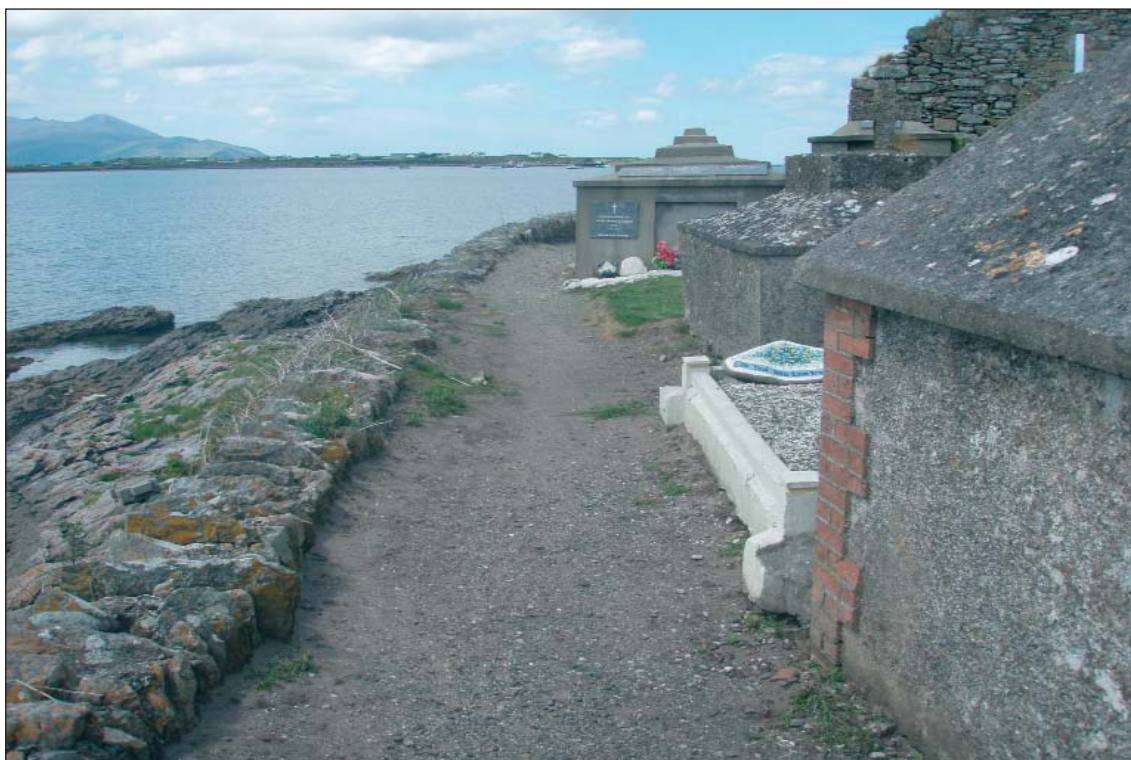
The triangular shaped graveyard (Figure 2) is enclosed by rubblestone walls along all of its boundaries varying in internal height from as low as 0.20 in sections around the curving S shoreline to almost 3m along the E boundary (Plates 14-15). The walls are in general good condition however the low S shoreline boundary wall area suffers from the ingress of blown sand that reduces the effectiveness of the already low wall where the 'soldier' capping is all that is visible in places (Plate 14).

There is an informal sandy gravelled path extending beside the curving sweep of the S boundary while a rougher stony gravelled path extends along the base of the E boundary wall (Figure 2 & Plates 14-15).

Plate 14: View of curving S section of interior gravelled pathway and very low section of boundary wall. Note only 'soldier' capping of wall visible here

Along the S shoreline area of the graveyard the boundary needs to be increased in height. This work should match the existing walls and be undertaken by a tradesperson skilled in rubble stone and mortar walls.

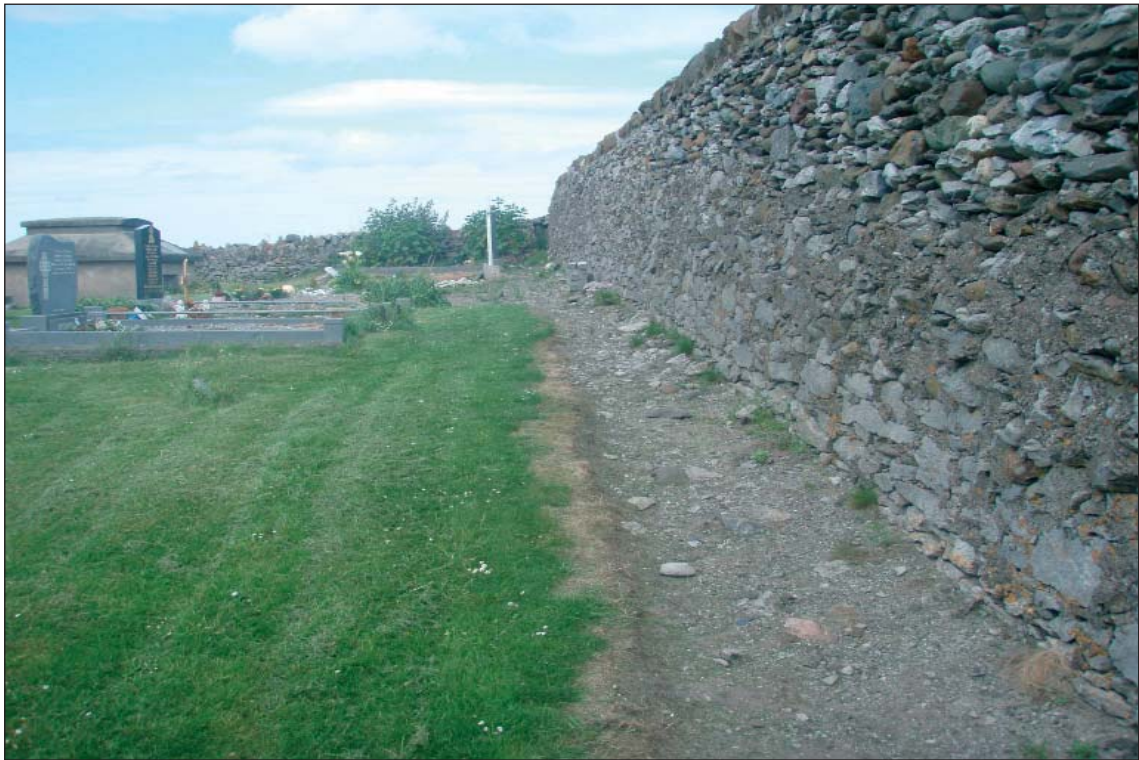
Plate 15: View from S of high rubble stone E boundary of Kilshannig graveyard. Note rough, stony perimeter path

The rough stony path beside the E boundary should be properly metalled with gravel.

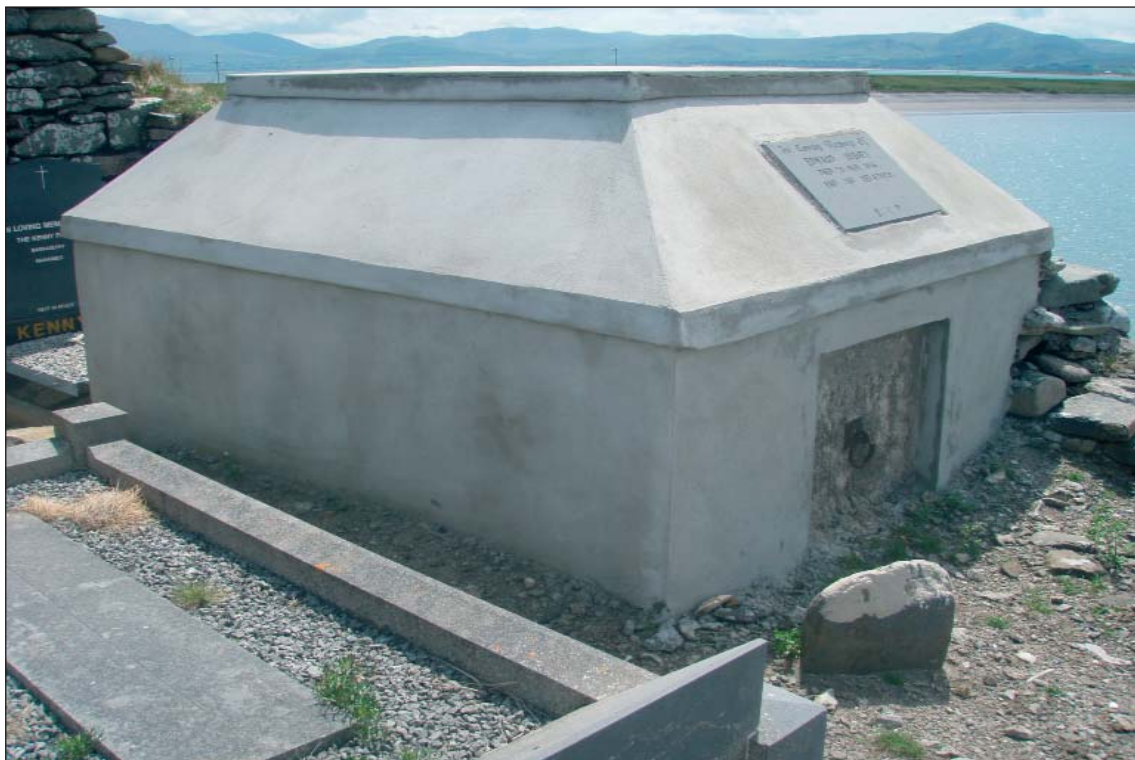
Plate 18: View of recently re-rendered Hussey Tomb 11 in E end of Kilshannig church. Note unhewn unnamed gravemarker beside it and other modern burials

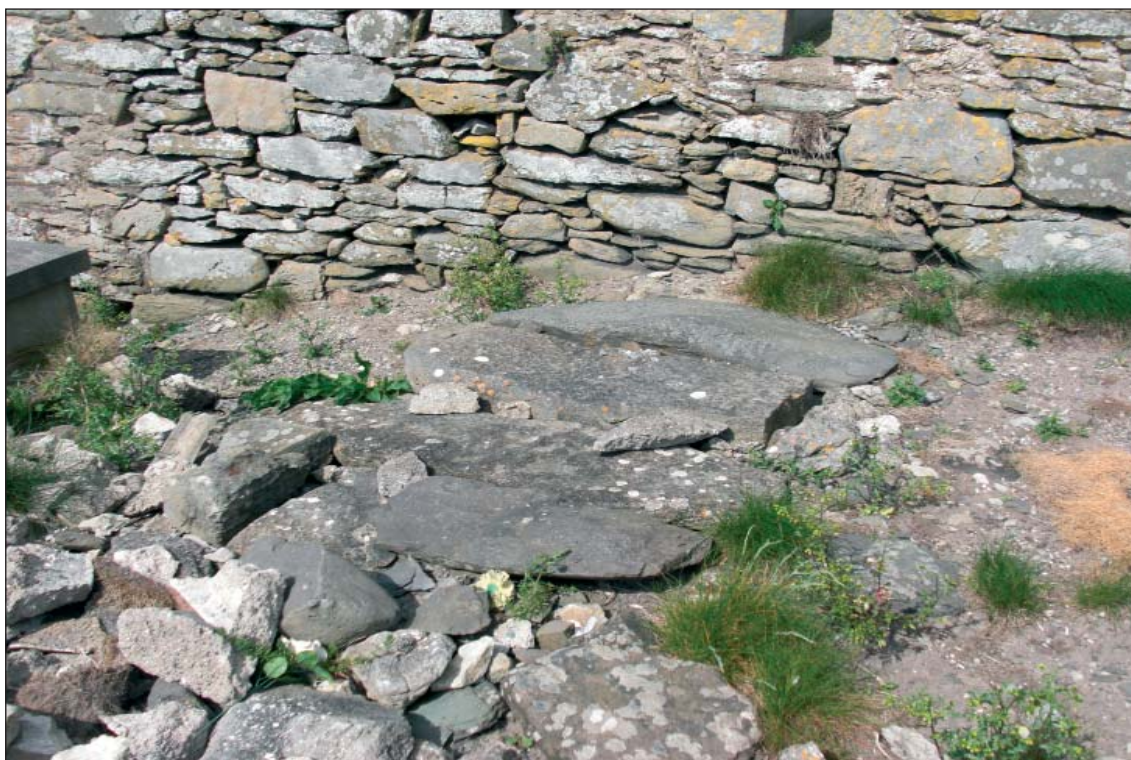
There are four exposed lintelled graves one of which is situated immediately inside the main breach in the S elevation of the church while the three others are situated immediately outside the E gable (Figure 2, Plate 20 & Appendix 3).

Plate 20: View from E of lintelled grave immediately outside E gable of Kilshannig church

The lintelled graves should be covered over with sod following under archaeological supervision. The potential for recording medieval architectural fragments re-used as lintels is regarded as high.
