Archaeological Survey,
Kimoyly Graveyard,
Co. Kerry.

September 2010

Client: The Heritage Office,
Kerry County Council,
County Buildings,
Ratass,
Tralee,
Co. Kerry.

RMP No.: KE014-089

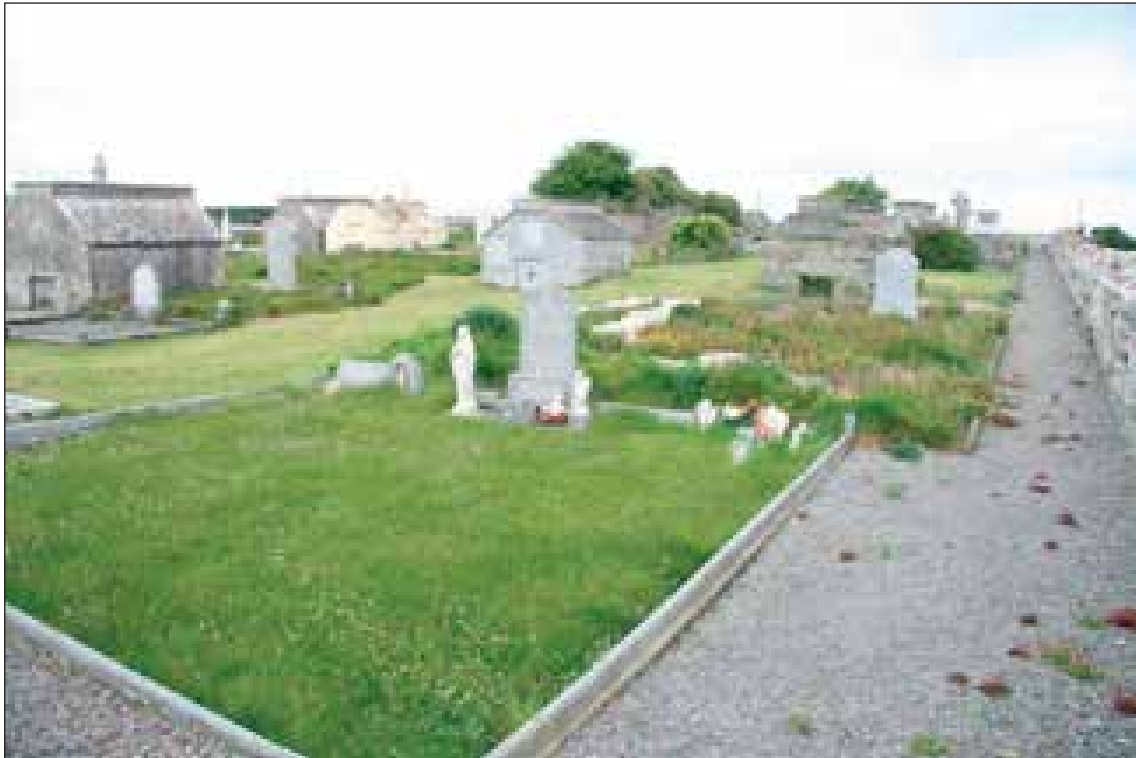
There is a formal gravelled pedestrian path extending around the entire inner perimeter of the graveyard only (Figure 2 & Plates 1 & 10).

Plate 1: View from NE corner of graveyard. Note (1) perimeter gravelled path; (2) overgrown remains of medieval church; (3) general tidy low cut grass of eastern end of graveyard

Informal grassy pathways should be established to negotiate through the interior of the graveyard safely. This can be achieved by regular close cutting of the grass.

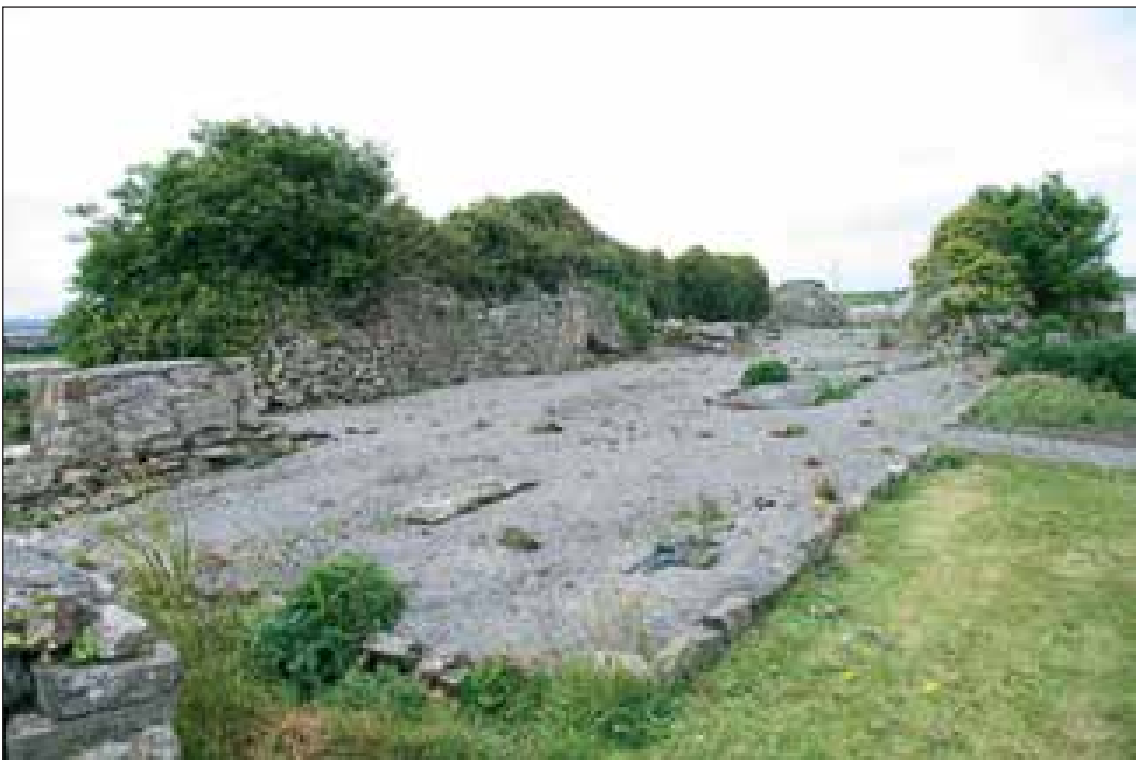
Very little fabric of the rectangular medieval church survives (Figure 2 & Plates 2, 3-4). Coherent sections of the north and south elevations survive but are completely covered in ivy and elder especially on the south wall. The only surviving *in situ* dressed masonry feature is a small pointed doorway on the south elevation (Plate 3). All other dressed

It is clear from the current high ground level within the relict remains of the church that there has been many burials here in the past (Plates 2 & 4). It is also obvious that the church was 'tidied up' in the recent past as the presence of inappropriate sharp limestone chippings laid on now eroding black plastic. Furthermore, the sharp grit is now seriously impacting the level graveslabs in the interior. Indeed one of the graveslabs, to the memory of Ellen O'Flaherty who died in 1818 (GRVS No.3), is very elaborately decorated with sun and moon motifs on either side of an IHS monogram as well many other carved figures and patterns (Plate 5). A similar situation occurs with the earlier 18th century Dulington graveslab (GRVS 8) near the surviving doorway in the church (Figure 2 & Plates 4 & 6).

Plate 2: View of Kilmoily medieval parish church from south-east corner

The ruinous medieval church requires essential remedial / conservation works to retain the existing relict remains. This remedial work should be undertaken by qualified personnel following a targeted conservation structural report.

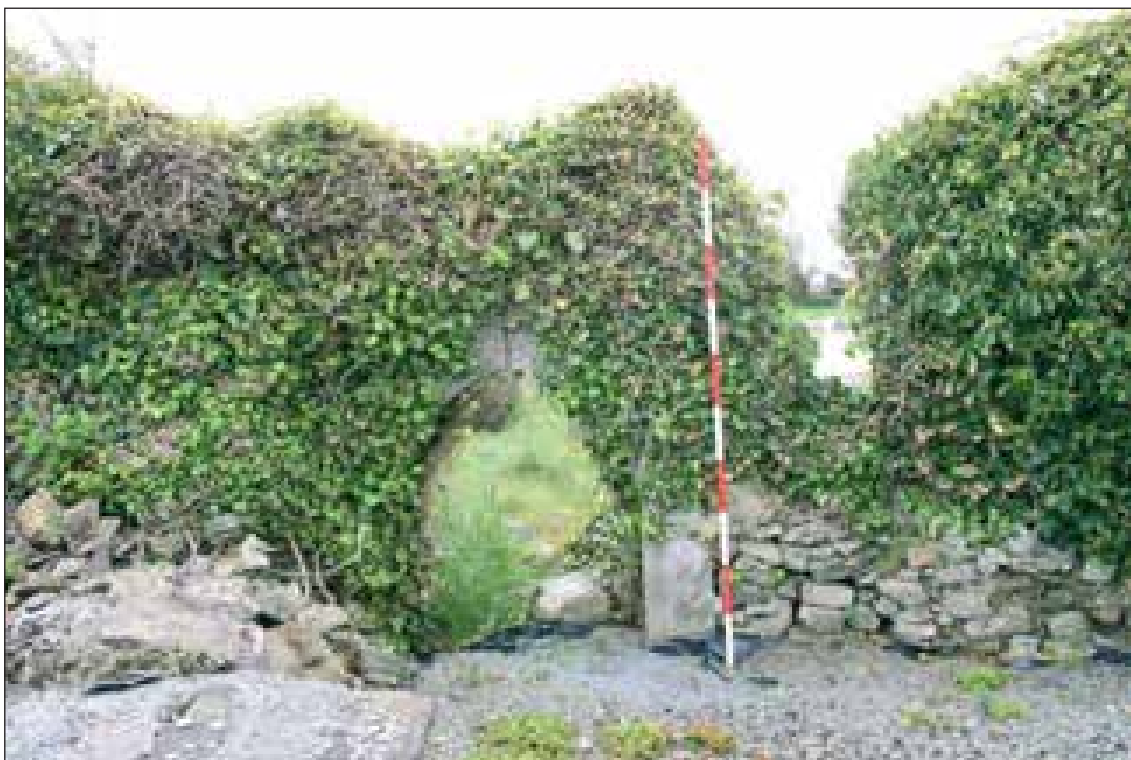
Plate 3: View from north of pointed doorway in south elevation of Kilmoyley church

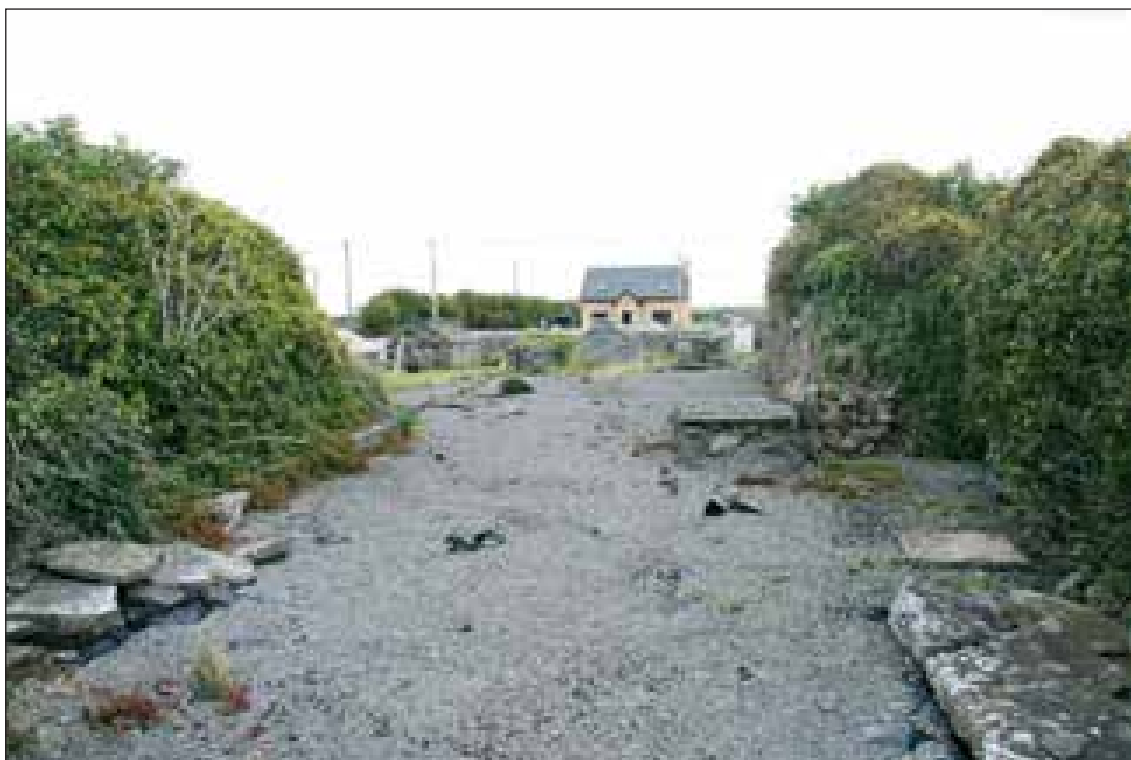
Three exposed lintelled graves were recorded within and beside the medieval church (Figure 2, Plate 4 & Appendix 4). The lintels are partially dislodged and require professional repair.

Plate 4: View of interior of Kilmoyley medieval parish church from west. Note (1) broken lintelled grave on left; (2) small Duling graveslab on right; (3) several areas where black plastic is eroding through the covering sharp limestone grit. Further note the completely overgrown state of the denuded relict remains of the church itself

The lintelled graves should be repaired and covered over.

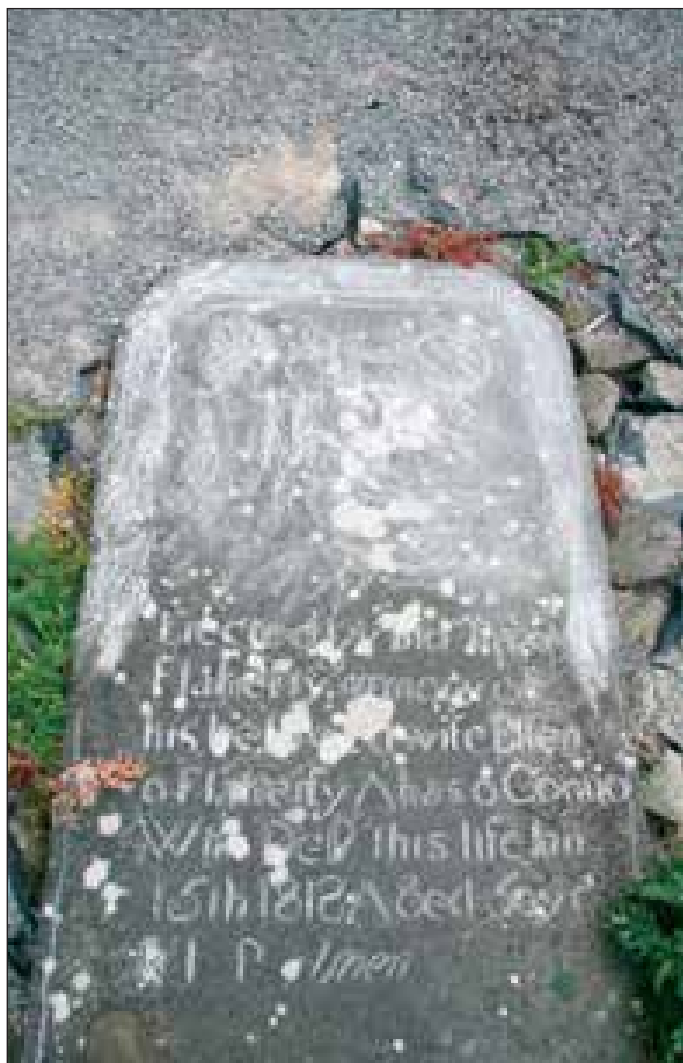
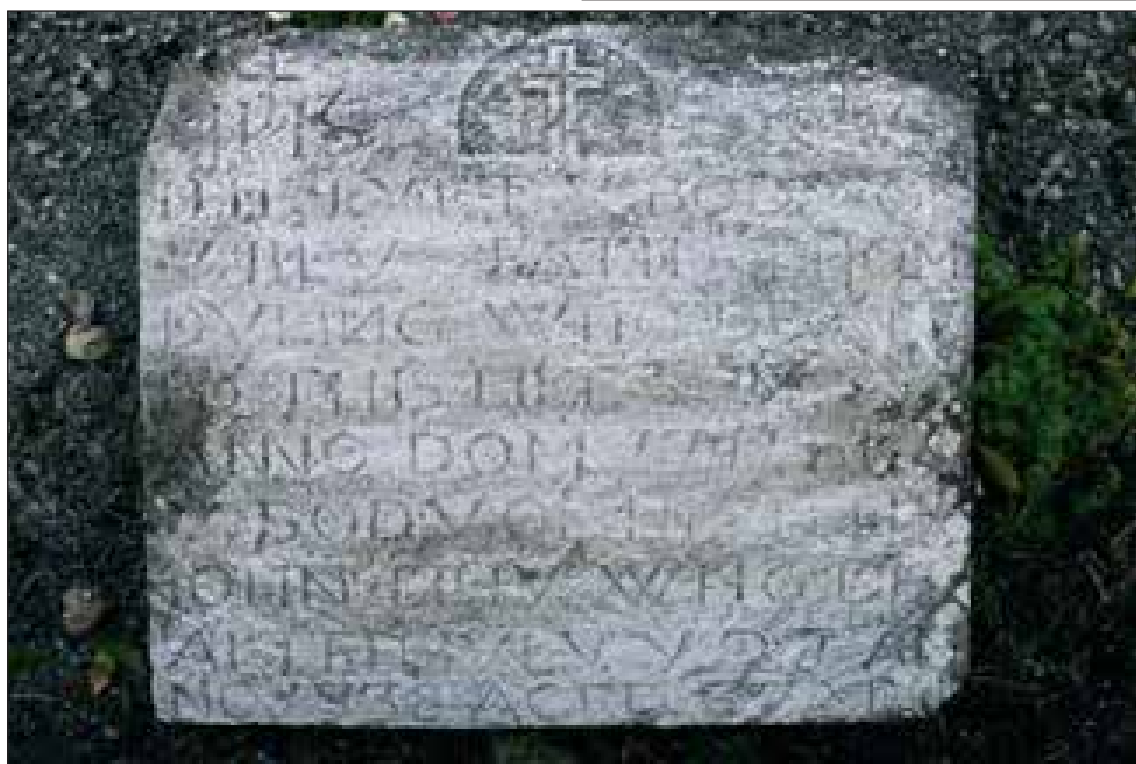
There are ten horizontal rectangular graveslabs in Kilmoyly. The earliest graveslab noted during the survey records the death of *Thom  Dvli g* (Dowling?). The inscription is difficult to read but it appears that there is another earlier memorial on the slab from 1735 (GRVS 8, Plate 6 & Appendix 3). Eight of the ten horizontal graveslabs are within the limits of the medieval church and are subject to constant negative scratching from the sharp grit covering the church area that is carried on visitors shoes. This is having a particular negative impact on the decorated Ellen Flaherty 1818 graveslab (GRVS 3, Plate 5) and on the earlier 1741 Duling memorial slab.

Plate 5: Close up view of the Ellen O'Flaherty 1818 graveslab in eastern limits of the church

Plate 6: Close up view of the Duling 1741 graveslab in the south-western limits of the church

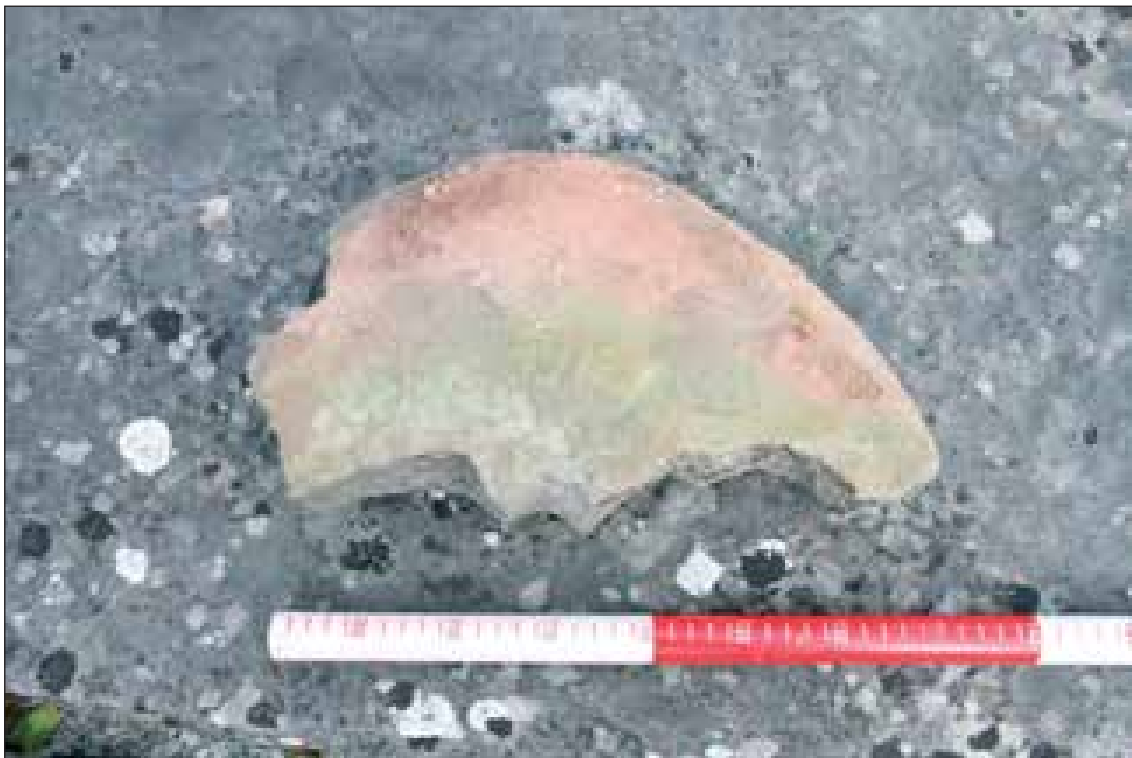
A rotary quernstone fragment was recorded in the east end of the interior of the north elevation in the course of this survey (Figure 2 & Plate 7).

Plate 7: Image of quern stone fragment recorded in the east interior end of the surviving section of the north elevation

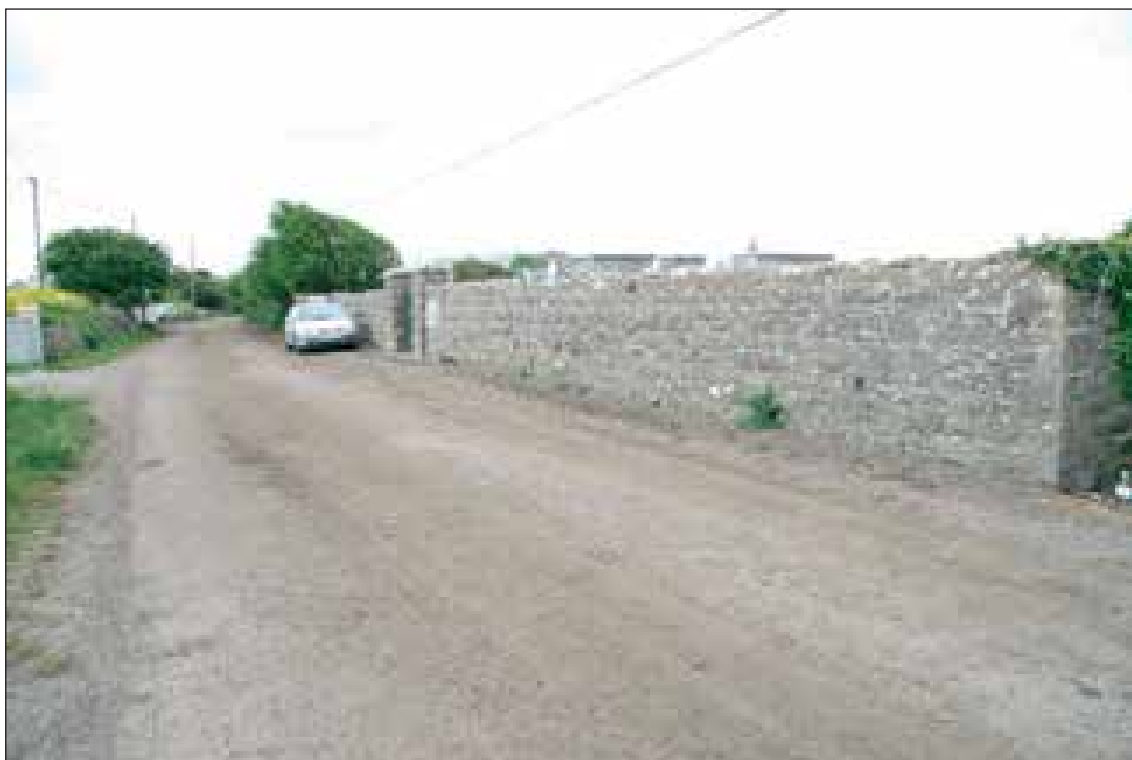
Kilmoyly is approached along a narrow third class road north from Togherbane Cross. The lines of sight approach to the graveyard are poor and restricted. There is very little roadside carparking provided (Plate 8 & Figure 2).

The graveyard is enclosed by a rubble limestone wall in very good order. The eastern roadside section is taller and built to courses. It has a chamfered sloping capping along the west, north and south sections. (Plates 8 & 10).

Plate 8: View of the immediate roadside exterior of the entrance area to Kilmoily graveyard. Note the limited carparking availability

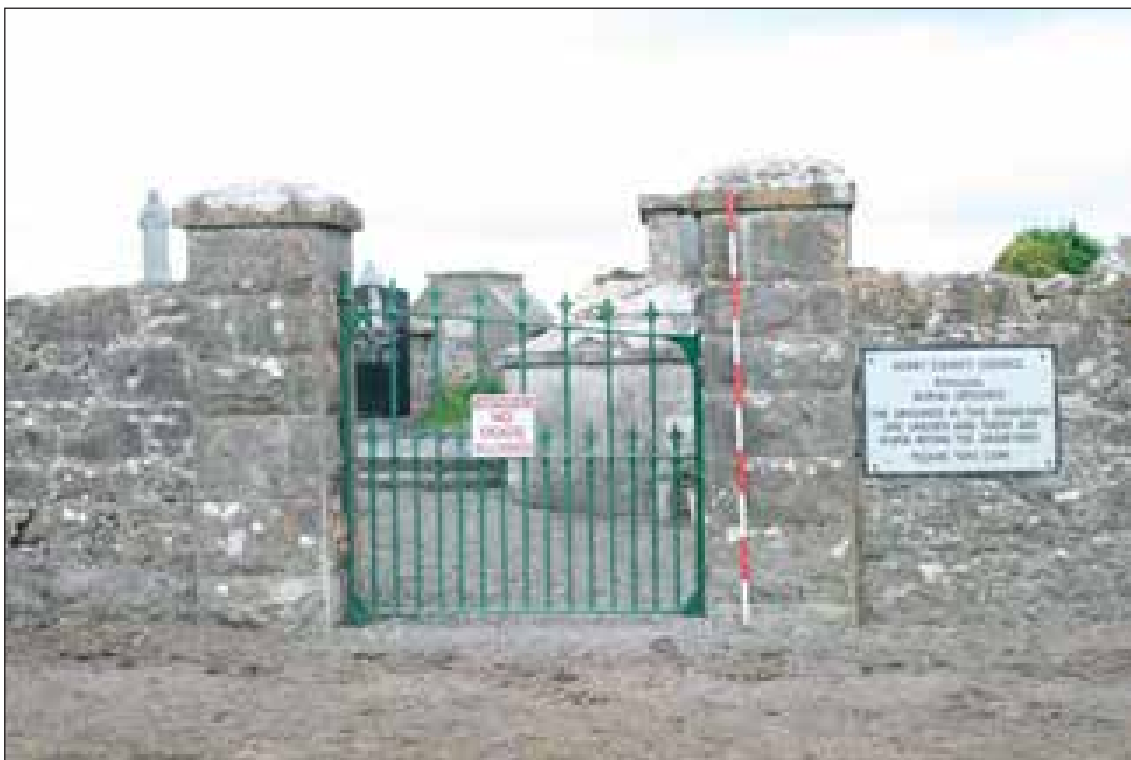
The entrance into the graveyard is provided through an iron gate in good order set between a pair of robust square capped piers, built to courses with squared limestone blocks (Figure 2 & Plate 9)

Plate 9: Exterior view of entrance gate to Kilmoyly graveyard

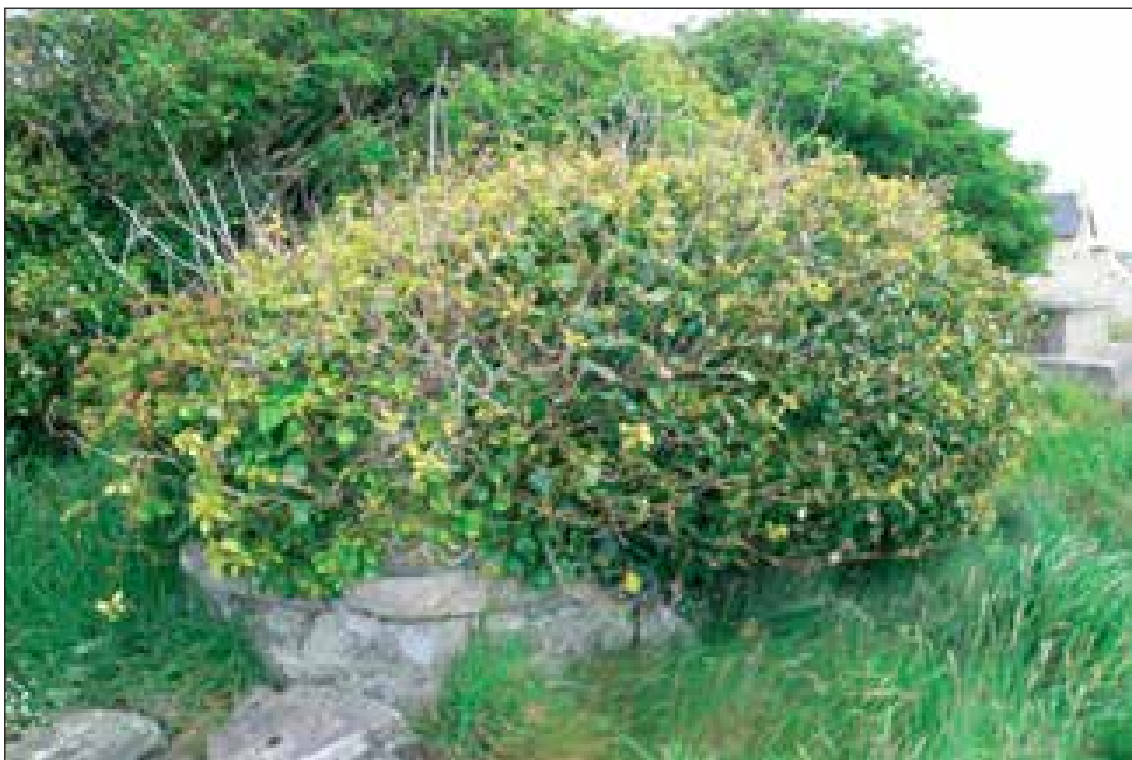
There are fifty-one, (51), tombs within the medieval graveyard of Kilmoily evenly disposed around the interior (Figure 2). Most of the tombs are the 'strong-box' variety while some are of the house shaped and two-tiered types (Plates 1 & 10). Several of the tombs in Kilmoily are in a poor state with many requiring much needed structural repairs while several others are overgrown and neglected e.g. Tomb Nos. 9, 13, 17, 21-28, 35-37, (Plates 11-13). There are no names on thirty of the tombs.

Plate 11: View of overgrown and partially collapsed unknown Tomb 22

Specialist work is required to preserve, repair, clean and restore several of the tombs at Kilmoily. A number will require careful rebuilding. The dense overgrowth on some should be carefully removed and the tombs re-examined by an experienced archaeologist for possible re-used architectural fragments or features.

Work should only be undertaken by skilled masons with a proven track record of working with historic structures, ashlar masonry as well as contemporary materials and lime mortar.

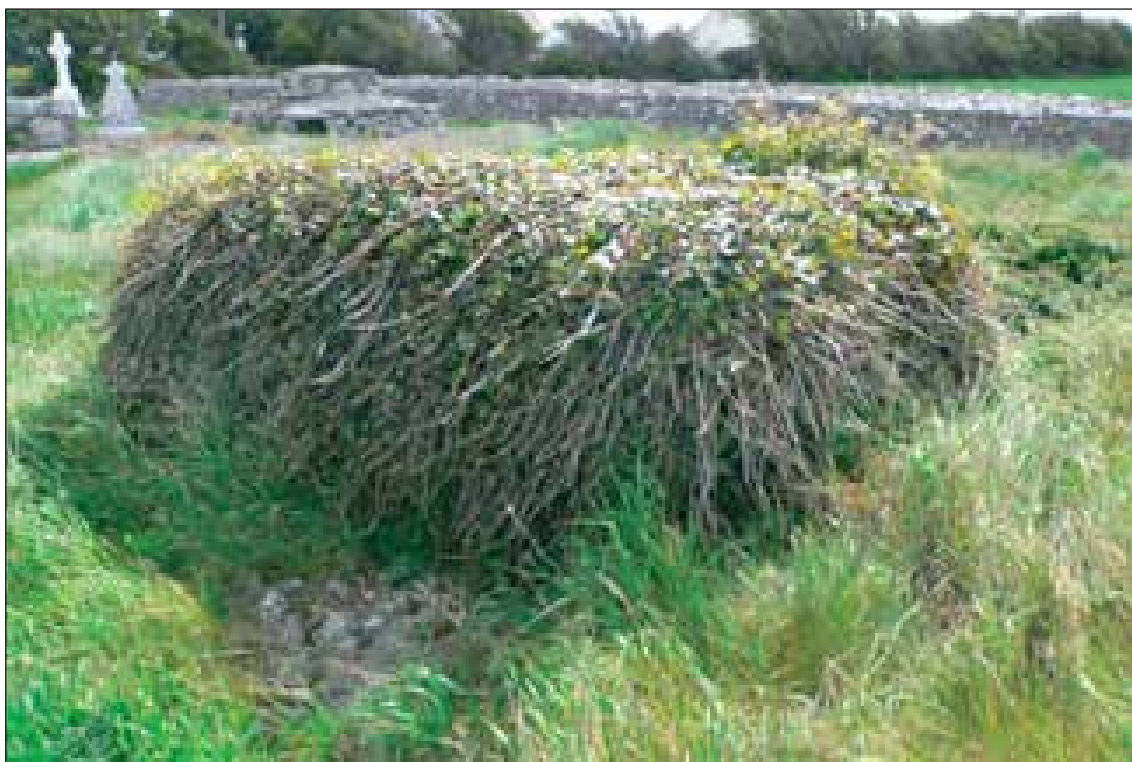
Plate 12: View of overgrown and partially collapsed unknown Tomb 23

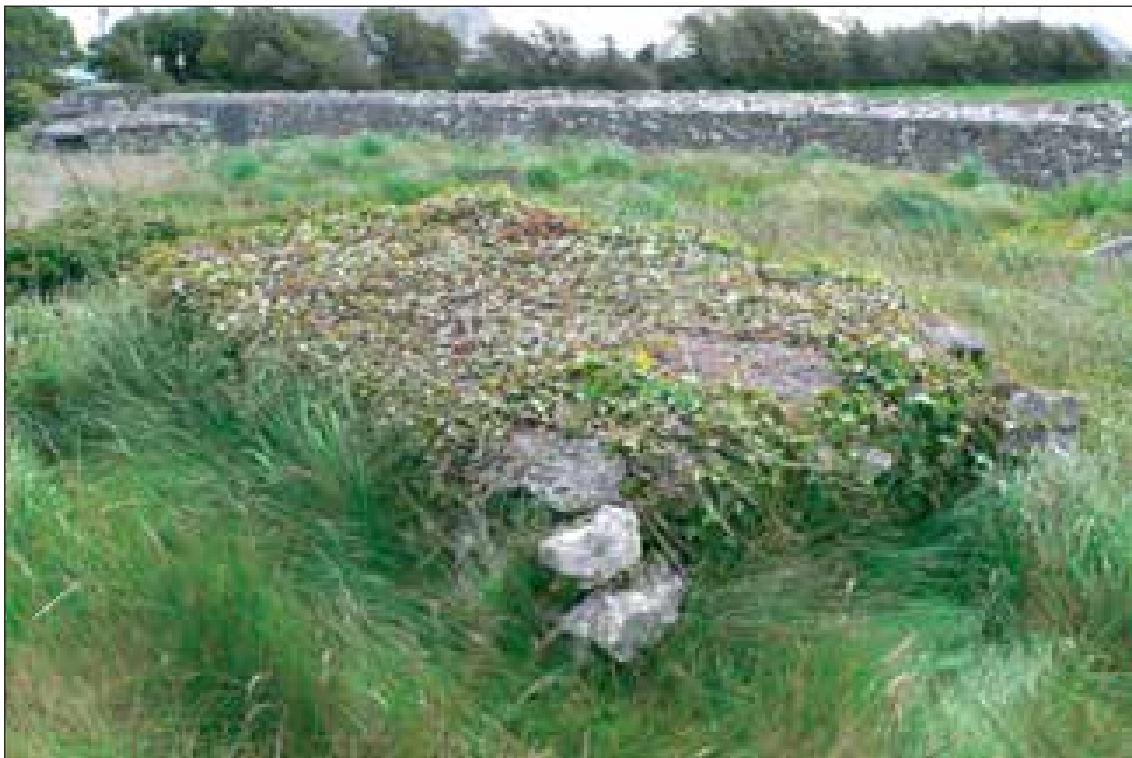
Plate 13: View of overgrown and partially collapsed unknown Tomb 24

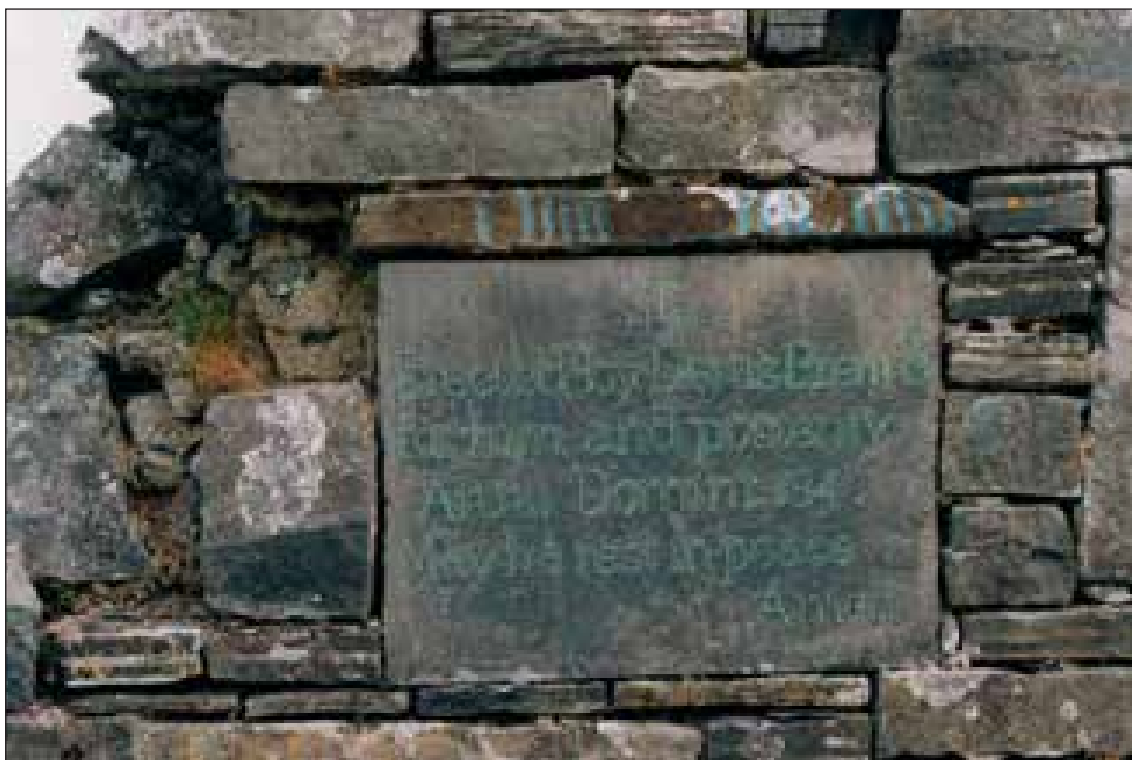
Of particular interest is that six of the tombs are almost entirely built with medieval architectural masonry from the church especially the Corridon tomb(s), 44-45 & tombs 18, 33, 34, 43 Appendix 1 and see Architectural Fragments section below). Another interesting example is the Brennan family tomb (No. 51) that has an ogham stone over the memorial plaque on the west gable of the tomb (Plate 14).

A small ogham stone slab was recorded by the writer in 2004 inserted over the memorial slab of the Brennan family tom (Figure 2 & Plate 14). One of the Brennan family, Seán Ó Braonáin was a noted Kerry poet from the area and it may have been therefore thought particularly appropriate to insert an ogham stone here.

Plate 14: Close-up view of ogham stone over memorial plaque in the Brennan family tomb (TB51)

The Brennan tomb is partially collapsing at the upper north-west corner. Any repairs here should only be undertaken by experienced personnel and extreme care should be undertaken not to interfere with the ogham stone during any repair or potential future cleaning of the memorial plaque.

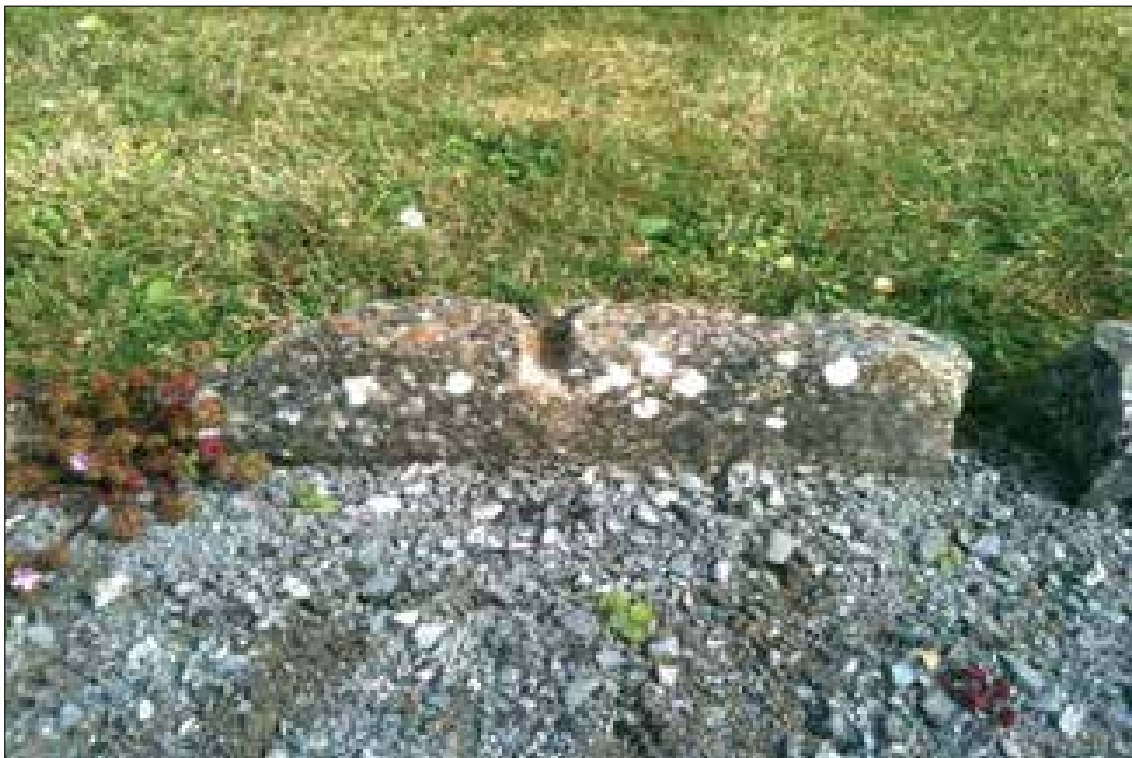
A single notched unhewn and unnamed gravemarkers is situated at the N-E limits of the church area (Figure 2 & Plate15).

Plate 15: View of notched stone in north-eastern limits of Kilmoyley church

Notched unhewn gravemarkers form a particular type of grave marker and are an important aspect of the memorial morphology of gravemarkers. The grass in the interior of the graveyard around the stone should be cut low and maintained at a lower level so that these graves have a greater visibility.

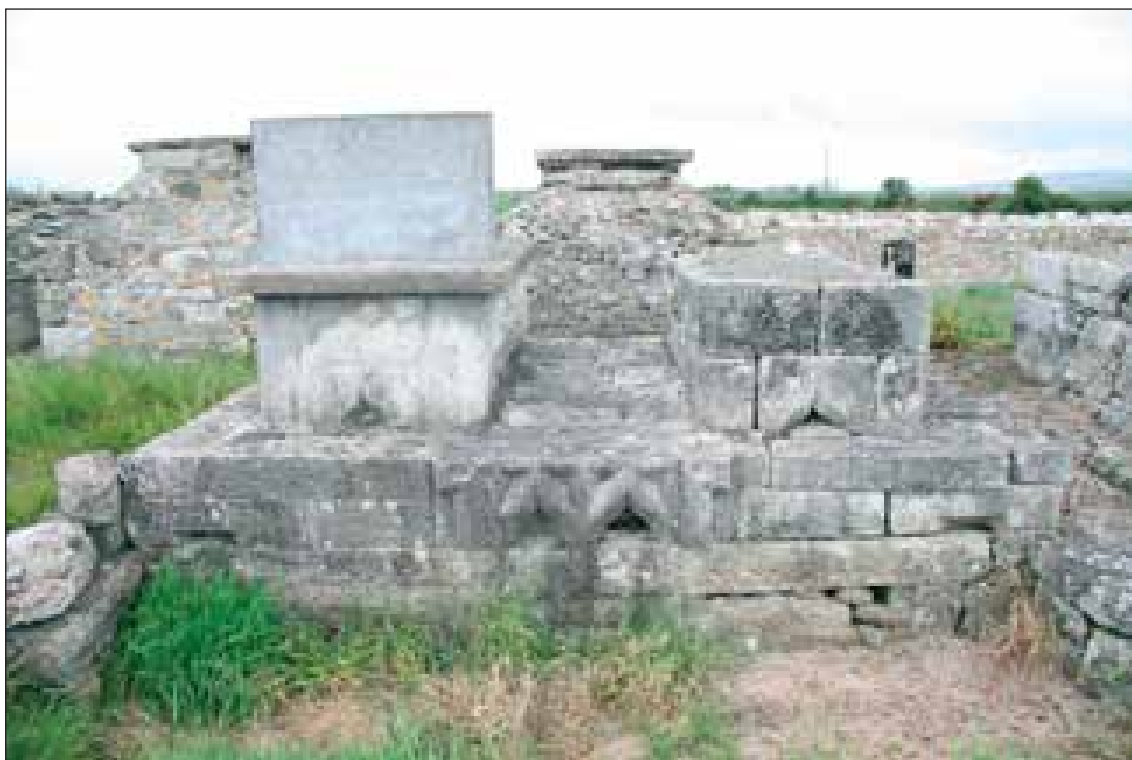
Plate 16: View of the Corridan twin tombs 44 & 45. Note the fabric is virtually entirely made, designed and featured from the removed medieval dressed cut masonry of the church

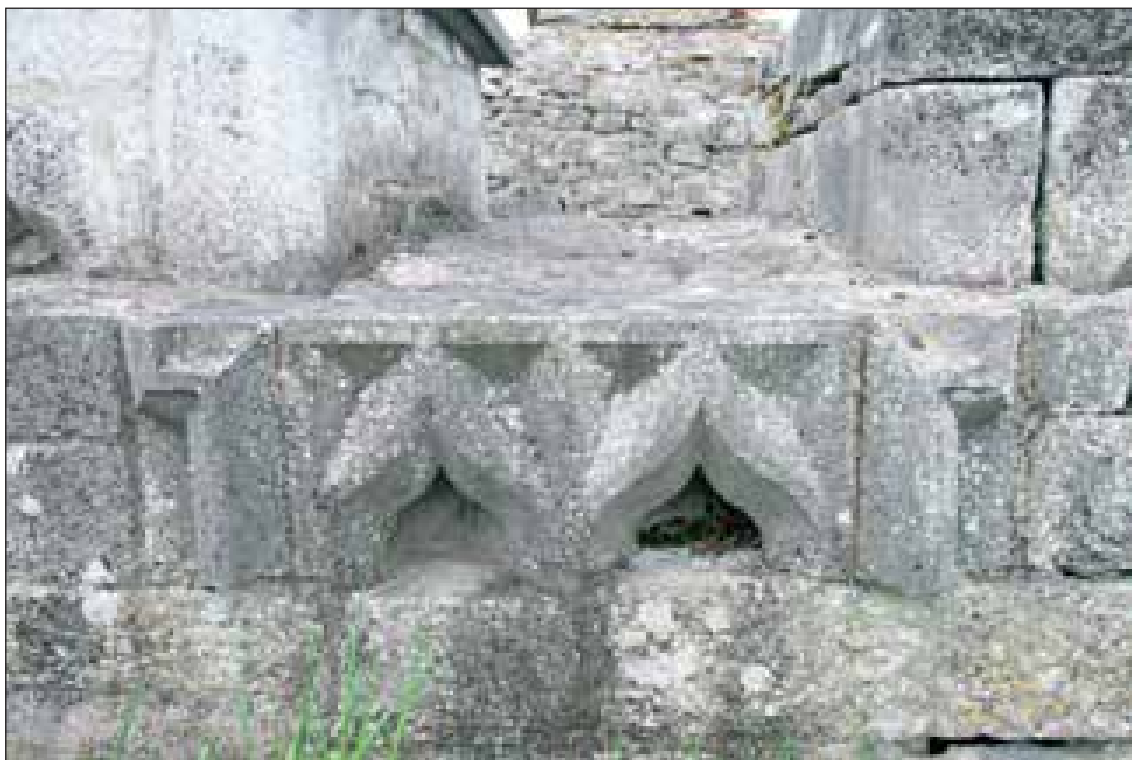
Plate 17: Close up of 15th century twin ogee light with inverted window hood mouldings on either side

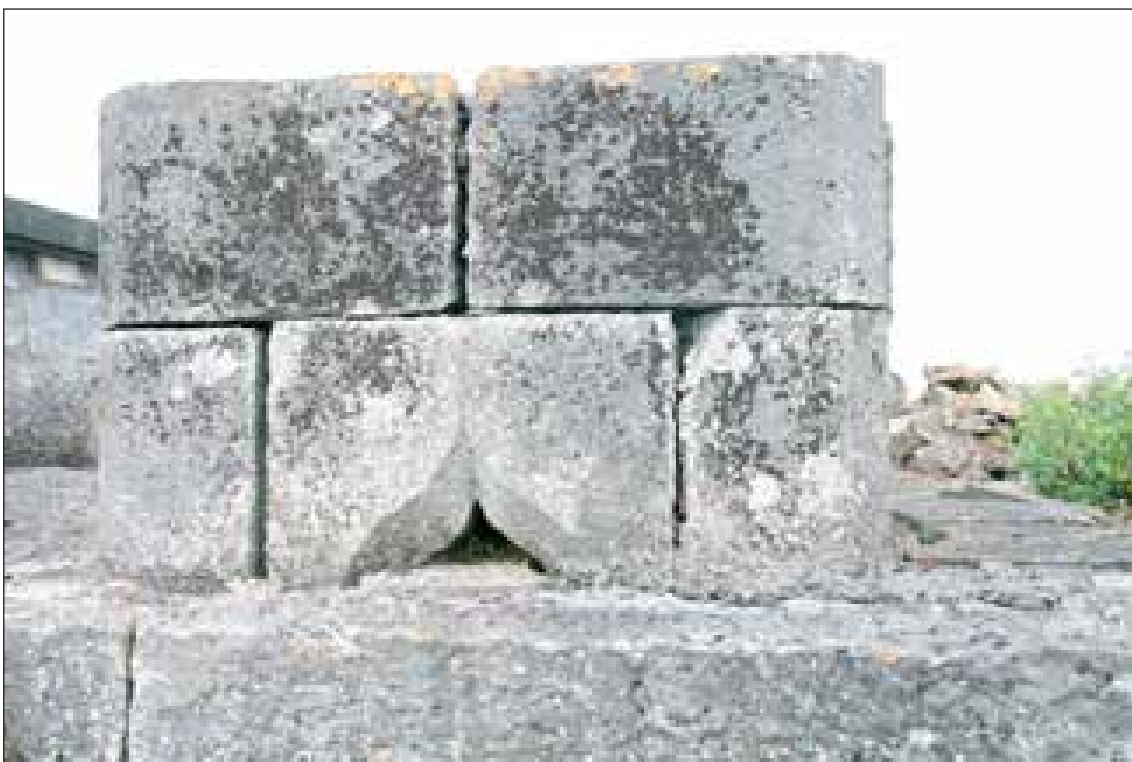
Plate 18: Close up view of upper tier on Corridan Tomb 44. Note all masonry in image constructed with medieval church masonry including 15th century ogee head of single light

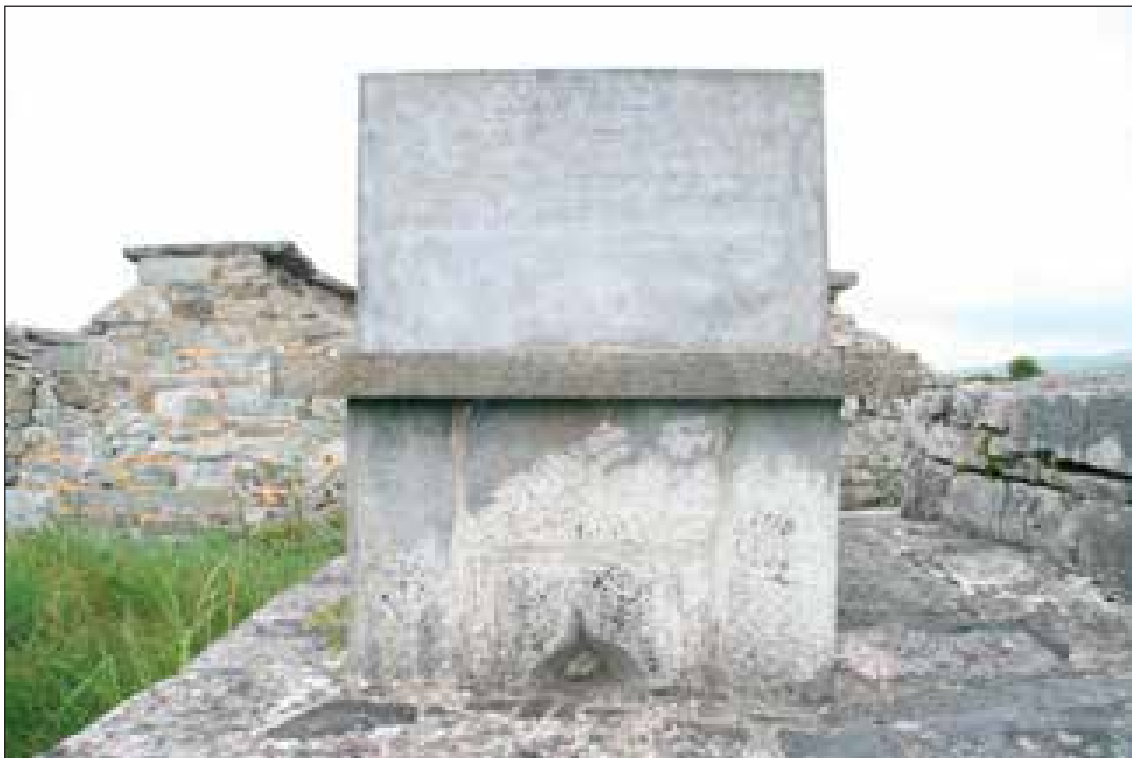
Plate 19: Close up view of upper Corridan tier on Tomb 45 precisely matching with identical masonry the tier on tomb 44 beside it

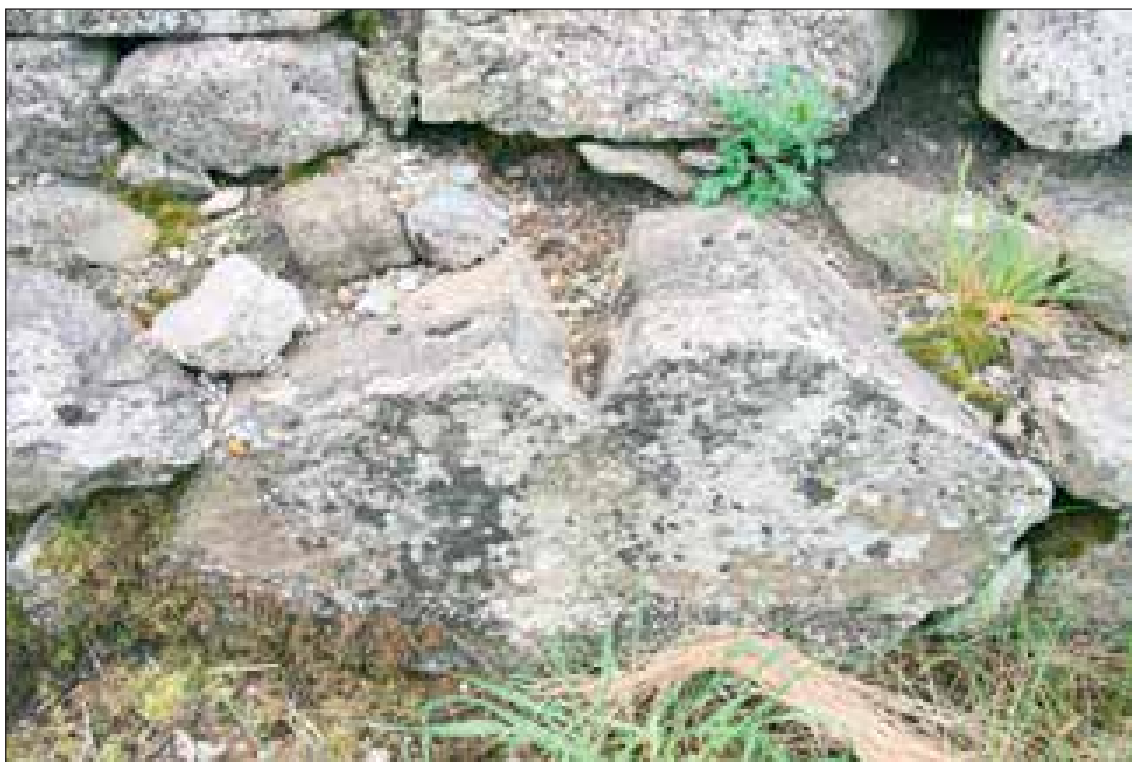
Plate 20: View of multi-faceted chamfered block on Tomb 43

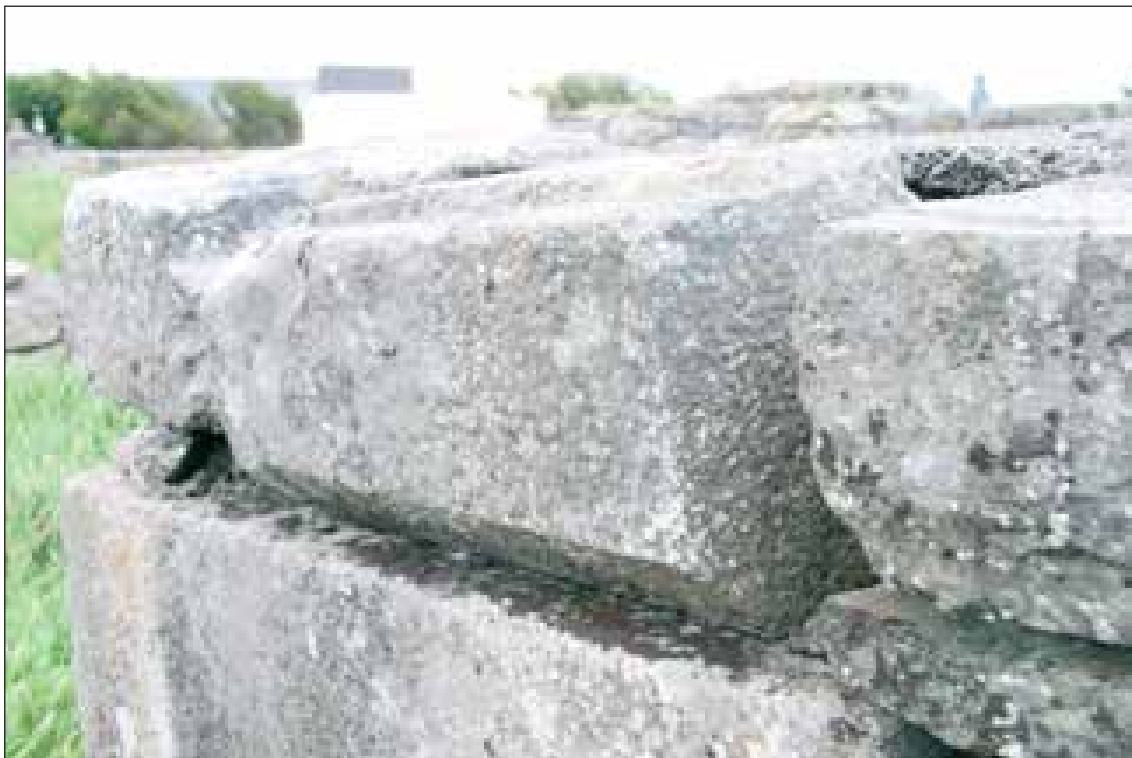
Plate 21: Close-up view of chamfered and rebated medieval masonry on Tomb 43

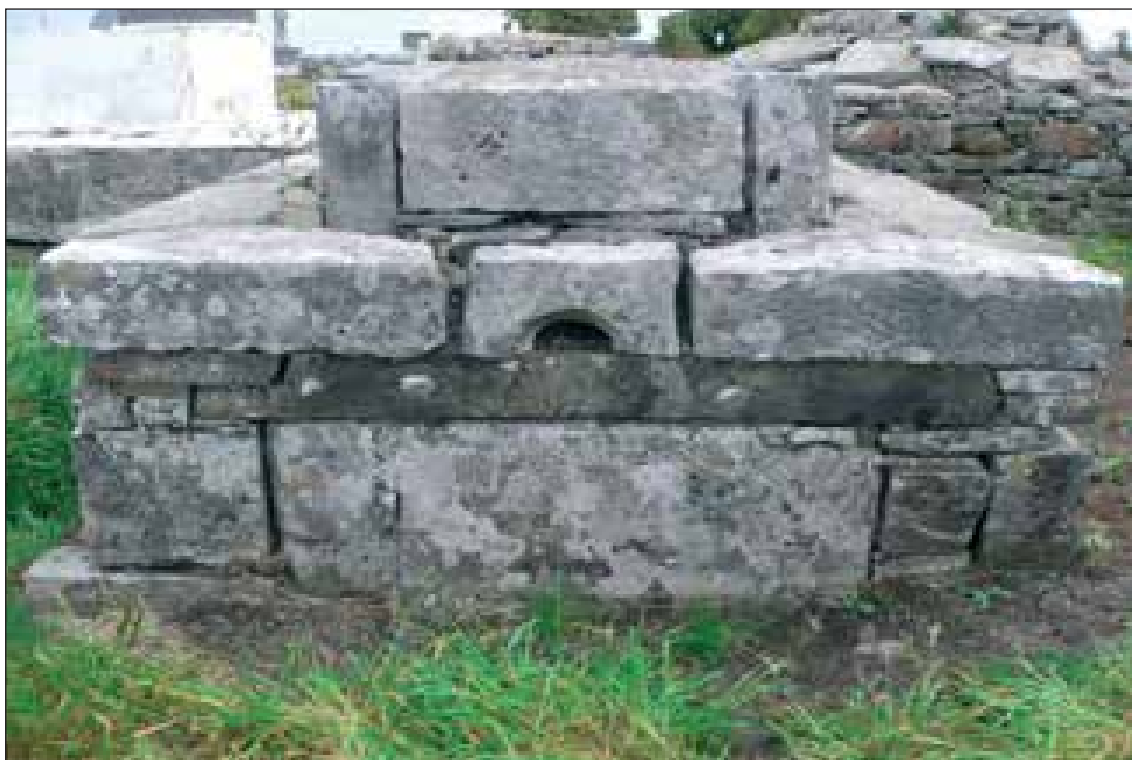
Plate 22: View of Tomb 33. Note similar construction to the Corridan Tombs 44-45 with featured round headed window head and chamfered blocks to upper tier

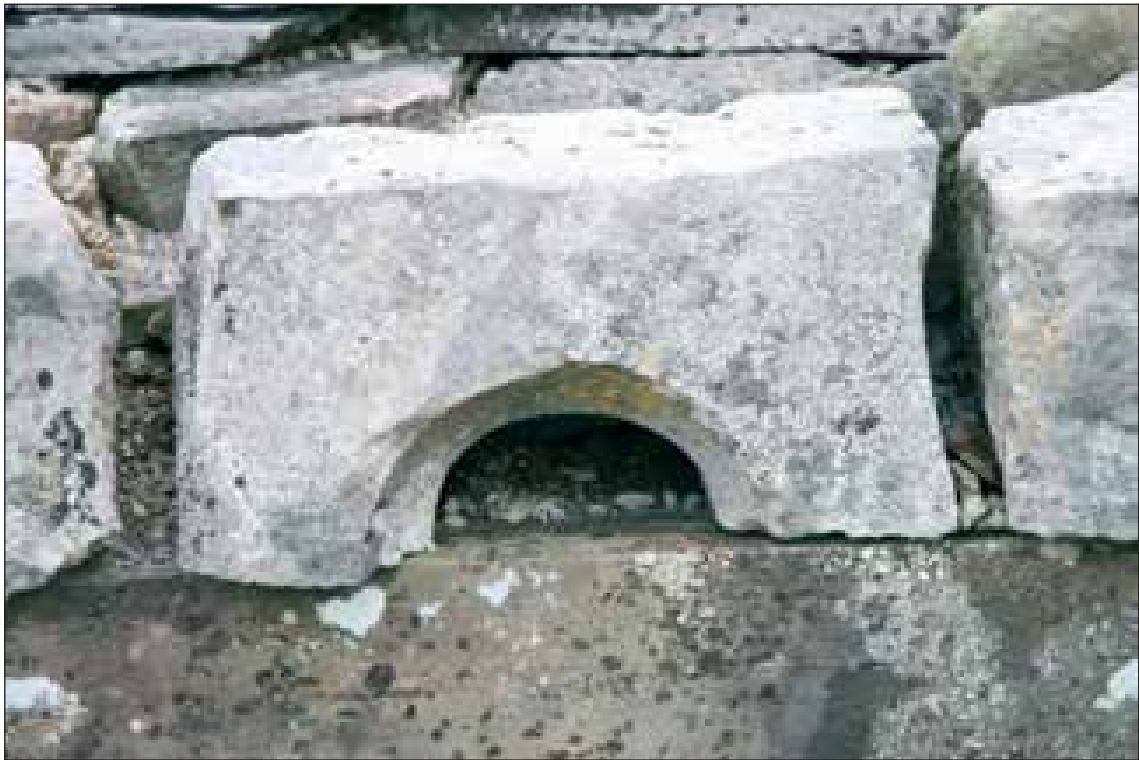
Plate 23: Close-up view of round headed light
