Project code: KCCG11
Client: Kerry County Council
Date: July 2011

Archaeological Survey of Knockanure, Newtownsands, Co. Kerry.

Surveyors: Ann Frykler & Robert Hanbidge
Report Author: Robert Hanbidge
Report Status: Final

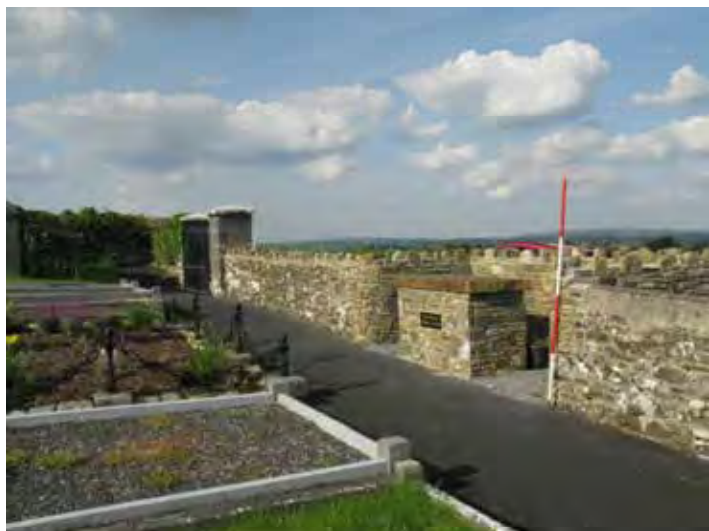
Plate 5-New section of walling to the eastern boundary to accommodate altar, from southwest

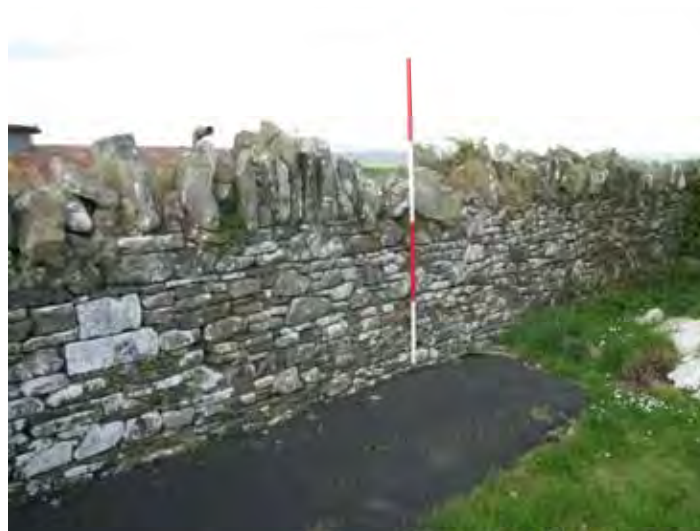
Plate 6-View of disturbed coping to western boundary wall, from east

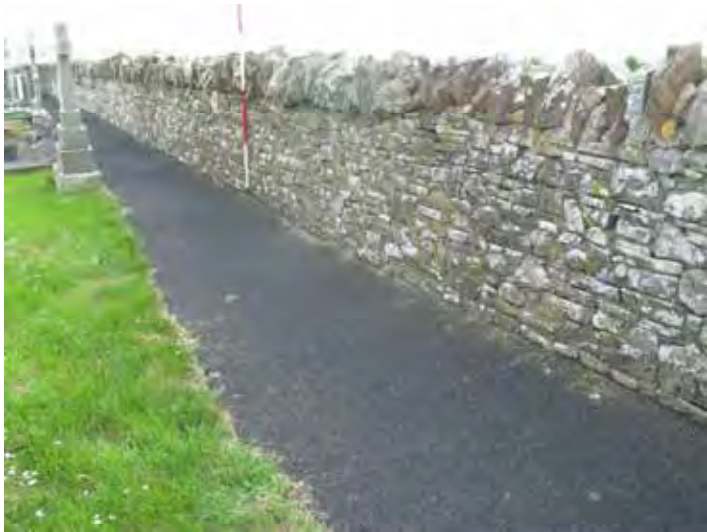
Plate 9-View of path adjacent western boundary, from north

There is one primary tarmacadam pathway within this graveyard which extends around the graveyard interior along the east, south and west boundaries (Plate 9).

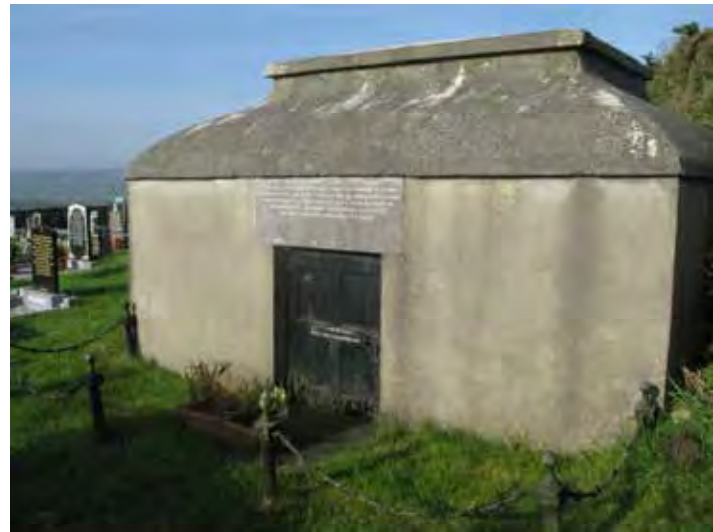
Plate 10-View of tomb (Grave No. 1) from east

The first tomb (Grave No. 1) is located immediately inside the entrance and is in good condition (Plate 10). The tomb has a rectangular shape in plan and is externally rendered. A centrally located limestone plaque is located above the eastern entrance. Cast-iron balustrades with linking chains form a small cordoned off court to the east.

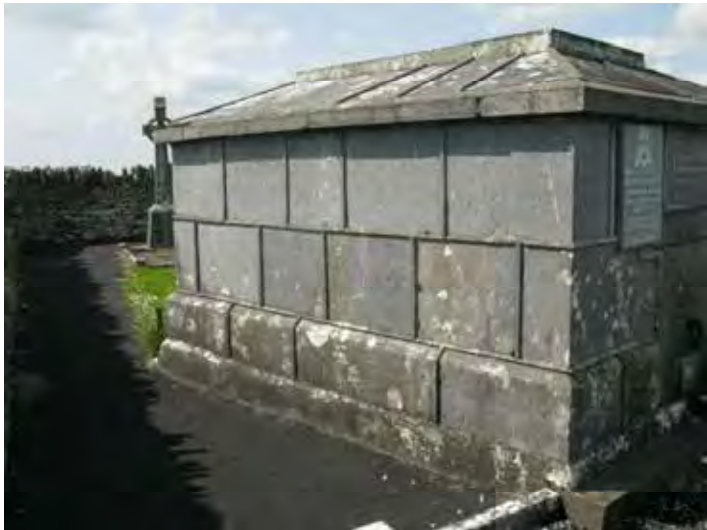
Plate 11-View of tomb (Grave No. 158), from southeast

The second tomb (Grave No. 158) is located in the south-western quadrant of the graveyard close to the southern boundary (Plate 11). This is a more elaborate example of a tomb and is constructed from tooled limestone with ashlar bonded walls which are surmounted by an unadorned cornice and a hipped roof with a central tooled limestone capstone. The tomb has recently been restored; however the original pointing has been replaced with ribbon pointing.

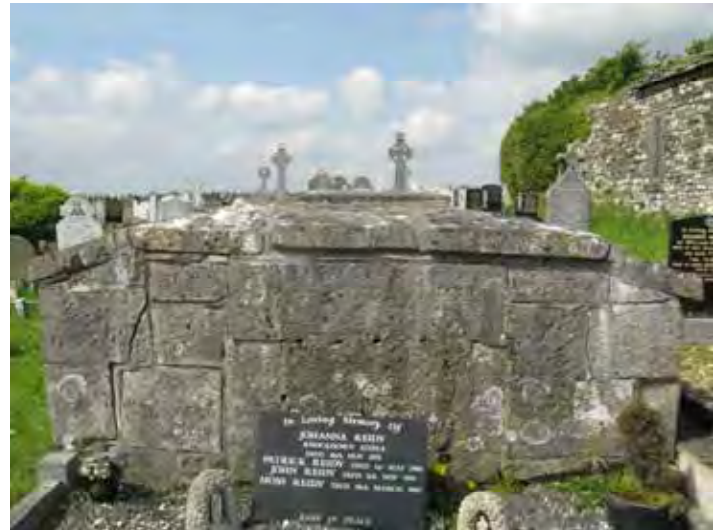
Plate 12-View of tomb (Grave No. 105), from east

The first unnamed tomb (Grave No. 105) is located in the southeast of the church ruin and is in good condition. The tomb is an unusually low example and is constructed in tooled limestone (Plate 12). The tomb has had some restoration works including re-pointing.

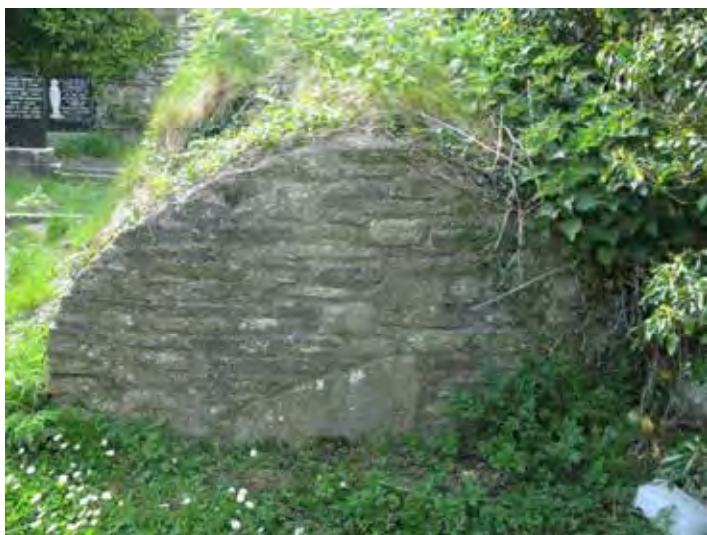
Plate 13-View of tomb (Grave No. 204) from east

The second unnamed tomb (Grave No. 204) is located within the interior of the church ruin. It survives in poor condition and is quite overgrown (Plate 13). This tomb is also distinguished by its unusual shape, as it possesses a barrel vaulted roof, which makes it rather unique within the graveyards of County Kerry. This feature increases its historic architectural and cultural value.

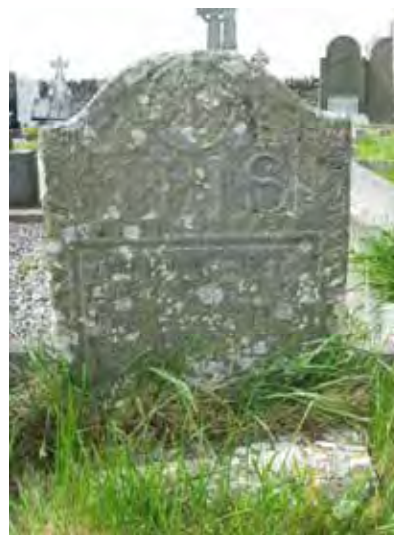
Plate 14-View of Grave No. 132, from east

There are 125 named headstones and plots at Knockanure Graveyard. The majority of these are in good condition and mostly date to the nineteenth and twentieth centuries. The oldest inscribed headstone bears a date of 1803 and belonged to Grave No. 132, commemorating Patrick Kins (Plate 14).

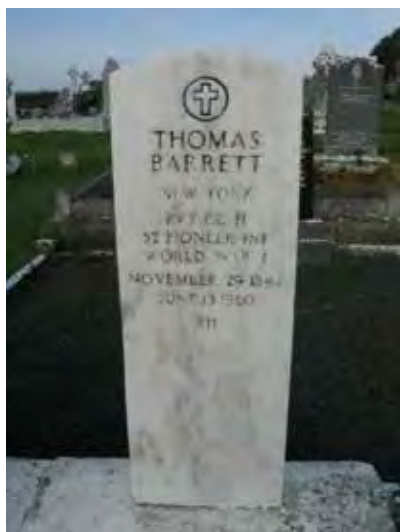
Plate 15-View of Grave No. 10, from east

Several other graves are of special interest. Grave No. 10 commemorates a World War I veteran, Thomas Barrett, 'New York PVT CO H 52 Pioneer INF' (Plate 15).

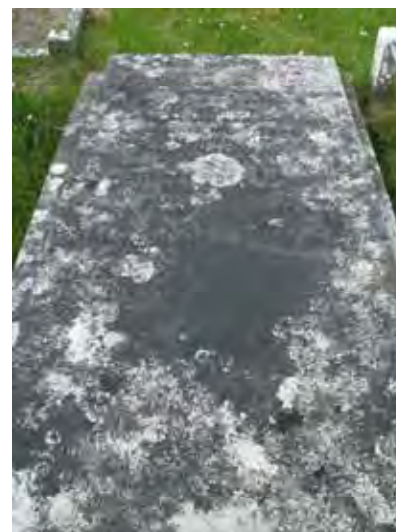
Plate 16-View of Grave No. 117, from east

Grave No. 117 is particularly unusual and consists of a horizontally laid ledger slab (Plate 16). It commemorates Michael O'Connell, 'Knight of Pope Pius 9th', a Papal Order of Chivalry also referred as the Pian Order which was founded by Pope Pius IX in 1847.

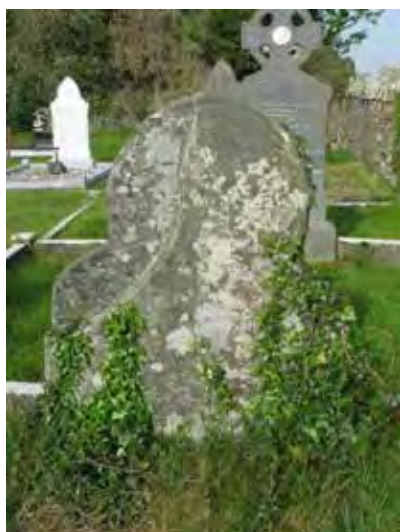
Plate 17-View of Grave No.
28, from east

Overall, there were 20 unnamed or illegible headstones and plots recorded during the survey. The majority of these unnamed headstones did hold inscriptions, however these are now illegible, e.g. the headstone to Grave No. 28 which is also worthy of note due to the unusual trefoil design of the tombstone (Plate 17). Other examples of unnamed plots include overgrown ledger slabs/horizontal placed stones which define a grave; e.g. Grave No. 29 (Plate 18).

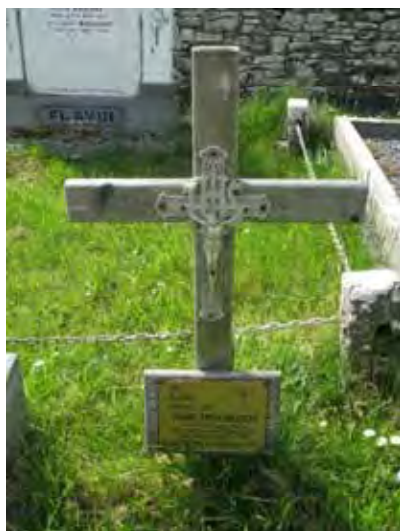
Plate 19-View of wooden cross
(Grave No. 184) from east

There are 4 named gravemarkers within Knockanure Graveyard (Grave Nos. 9, 21, 72 and 184). These are simple gravemarkers which are either wooden crosses (Grave Nos. 9 and 184) or iron crosses (Grave Nos. 21 and 72). Grave No. 184 (Plate 19) commemorates Paddy Owen Sullivan. Grave No. 72 (Plate 20) commemorates 'Mary __ Goody'.

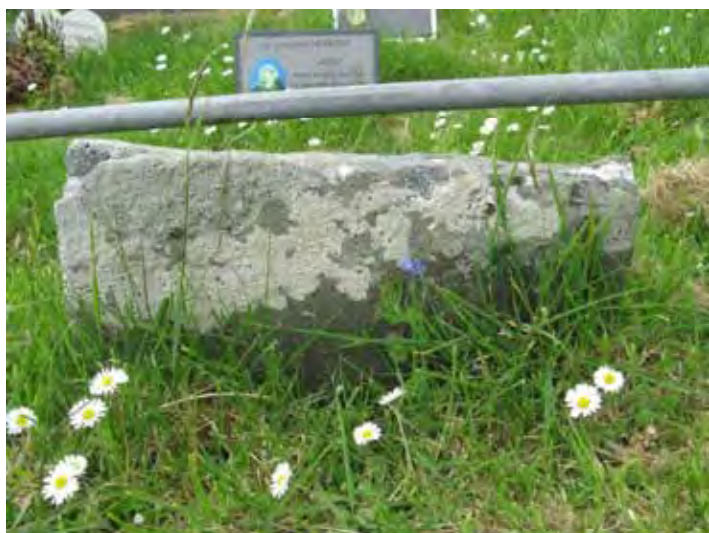
Plate 21-View of gravemarker (Grave No. 114) from east

In total 74 unnamed gravemarkers were recorded within Knockanure Graveyard. The majority of these were scattered throughout the graveyard and generally consisted of simple locally sourced stone, which was split into thin pieces and placed in the ground e.g. Grave No. 114 (Plate 21).

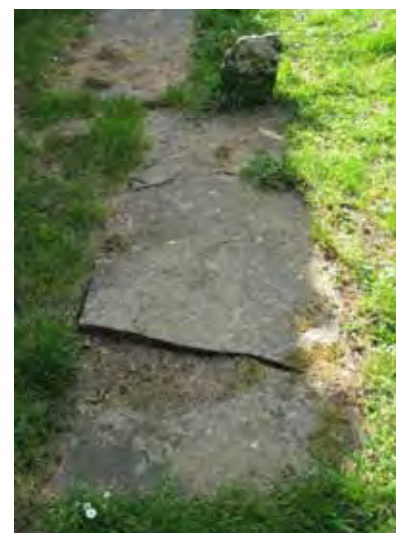
Plate 22-View of Grave No 210, from east

Five lintelled graves (Grave Nos. 88, 203, 210, 214 and 215) were recorded within Knockanure Graveyard. These generally consist of horizontally laid slabs covering an underground burial. Erosion of the soil has resulted in these graves been exposed. The majority of the graves are unmarked however Grave No. 210 did have an unnamed gravemarker identifying the presence of the burial (Plate 22).

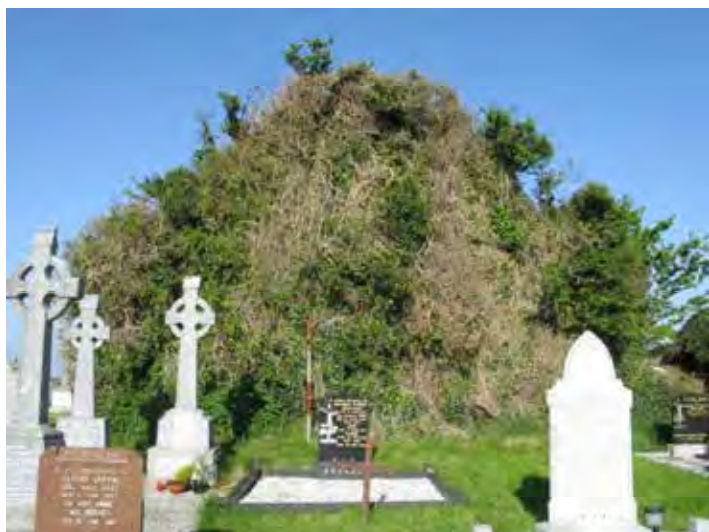
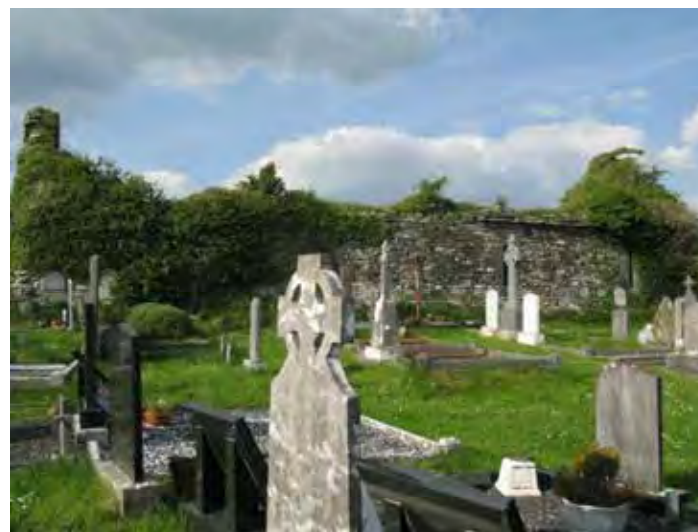
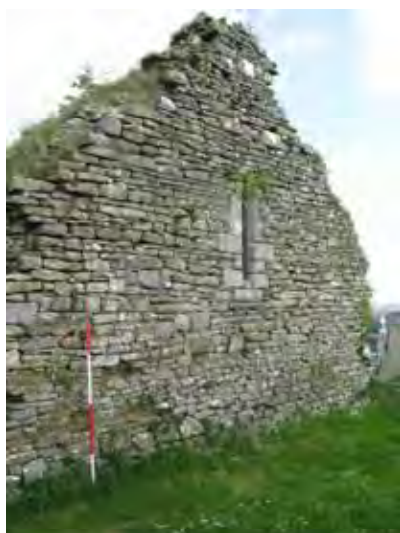
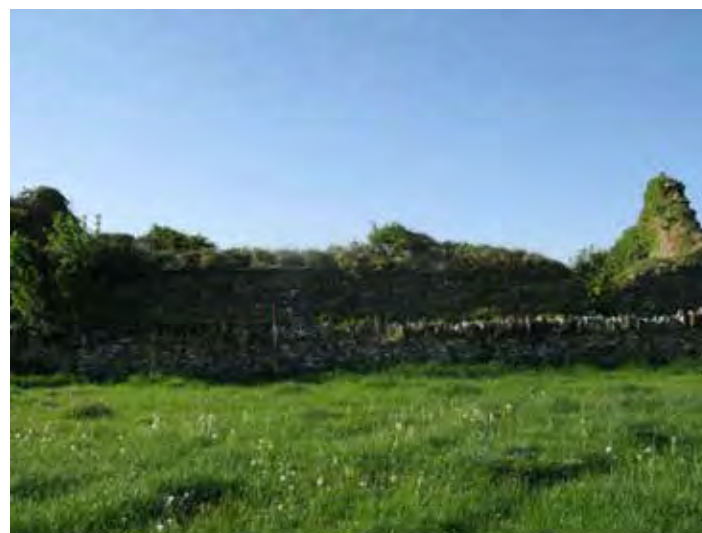
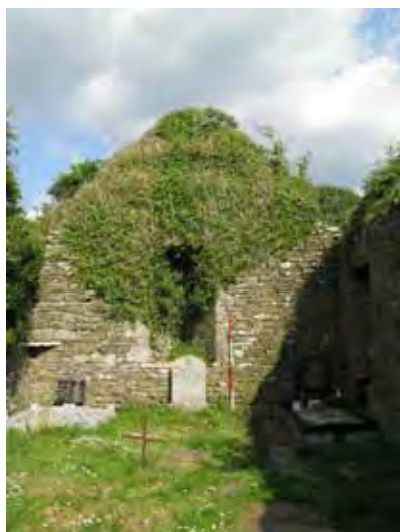
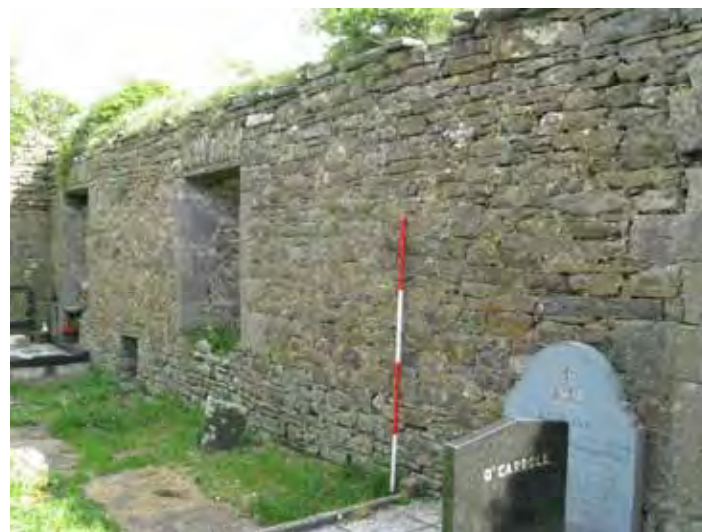
The church ruin is listed in the RMP as KE011-022 and is in good condition, retaining much of its original form including a three-bay nave (Plates 23-30). The standing walls consist of roughly dressed rubble stone with a lime and gravel mortar. The walls are slightly battered at the base. However many of the finer examples of the masonry within the fabric of the walls (mainly the quoins) have been robbed out. The church is orientated on an east/west axis and originally had a pitched roof, the gables of which remain intact at the east and west elevations. Narrow pointed arch-headed windows survive in the south, east and west elevations and consist of chamfered tooled limestone surrounds, voussoirs and sills with splayed internal reveals (Plates 31-34). A gap at the west end of the north elevation suggests that there may have been a window in the northern elevation, but this is unclear (Plate 33). A pointed arch-headed door opening in the south elevation comprises chamfered tooled limestone voussoirs and surrounds with tooled limestone step (Plates 35 and 36). A recent addition of a short concrete ramp improves access to the interior of the church. Within the church, a number of burials are located along with a piscina (Plates 37-39) in the southeast corner. A number of recesses are also situated in the interior walls of the church (Plates 40 and 41).

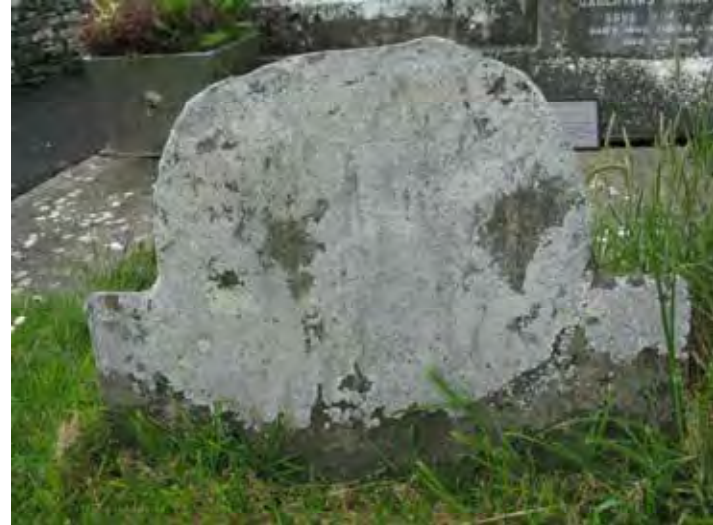
Miscellaneous No. 01: Located in the eastern half of the graveyard is a broken cross slab (Plate 43). The cross slab is currently in use as a gravemarker for Grave No 220.

Plate 43-View of cross slab (Miscellaneous No. 01)
(Grave No. 220), from east

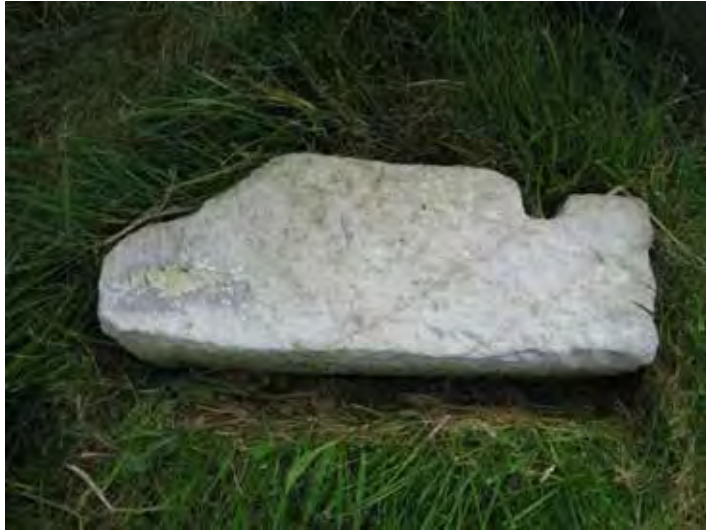
Miscellaneous No. 03: A second cross slab is located to the south of the church and is a rather unusual example which has a broad rounded upright flanked by short horizontal members (Plate 44). An inscribed cross is located in the upper section of the east elevation. This also forms the gravemarker to Grave No. 221.

Plate 44-View of cross slab (Miscellaneous No. 03)
(Grave No. 221), from east

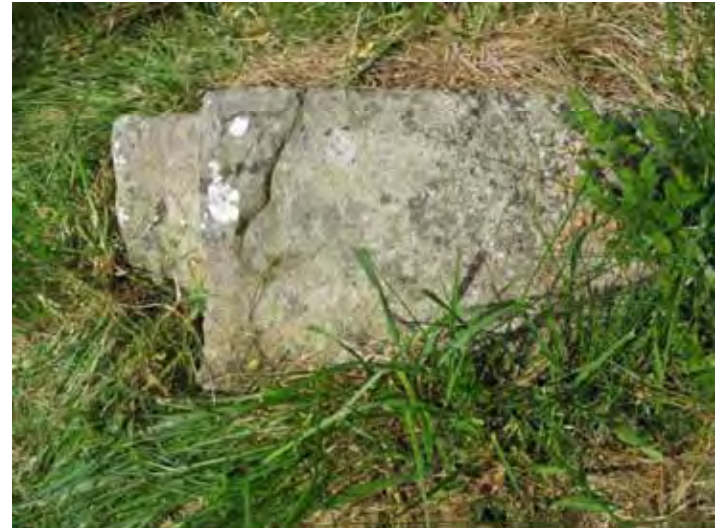
Miscellaneous No. 02: Tooled limestone block which either formed part of a window surround or door jamb (Plate 45). The piece is currently loose and sitting within long grass.

Plate 45-View of architectural fragment (Miscellaneous No. 02)

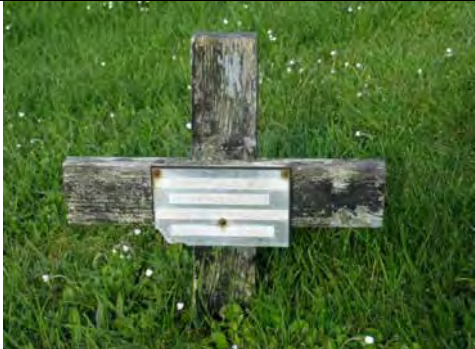
Grave_No	Family Name	Photo_Name
9	Kelliher	IMG_0023
Notes		
Wooden cross with name plaque

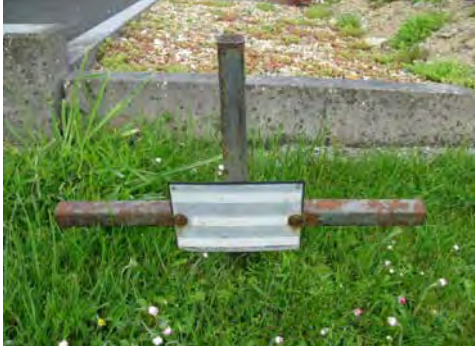
Grave_No	Family Name	Photo_Name
21	Costello	IMG_0045
Notes		
Corroding steel cross

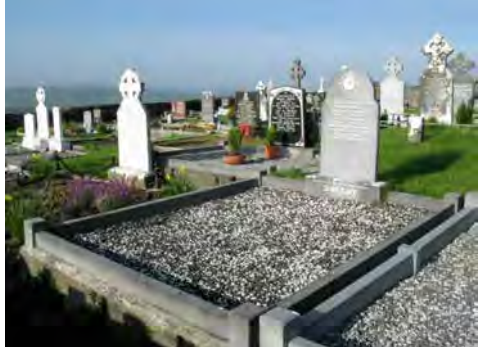
Grave_No	Family Name	Photo_Name
3	Sheehy	IMG_0008
Notes		
Plot in good condition

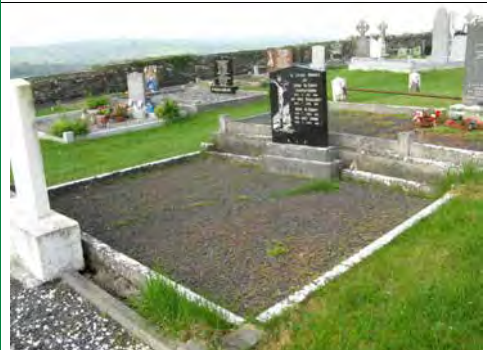
Grave_No	Family Name	Photo_Name
19	McEnery	IMG_0042
Notes		
Plot in good condition, some weeds and subsiding in north

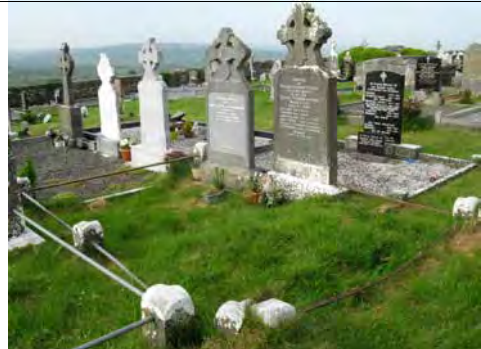
Grave_No	Family Name	Photo_Name
26	O'Connor	IMG_0055
Notes		
Grass covered plot in moderate condition

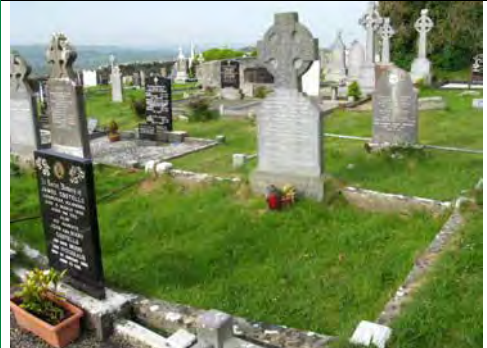
Grave_No	Family Name	Photo_Name
27	Scanlon	IMG_0058
Notes		
Grass covered plot in moderate condition, southern plinth missing

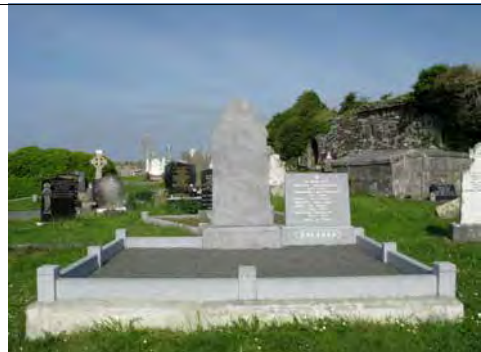
Grave_No	Family Name	Photo_Name
56	Foley	IMG_0105
Notes		
Headstone with three remaining plot markers

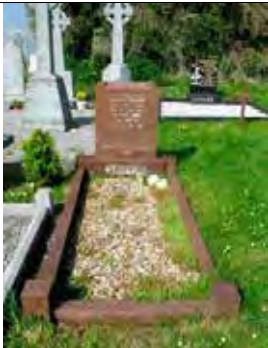
Grave_No	Family Name	Photo_Name
60	Enright	IMG_0109
Notes		
Plot in good condition, some weeds

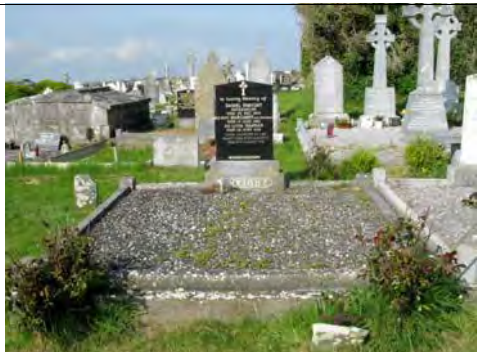
Grave_No	Family Name	Photo_Name
69	O'Connor	IMG_0121
Notes		
Plot in good condition

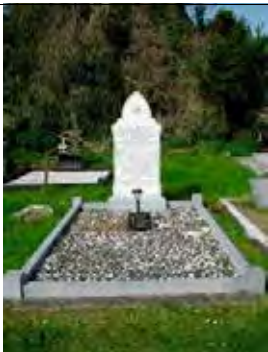
Grave_No	Family Name	Photo_Name
65	Enright	IMG_0115
Notes		
Plot in good condition

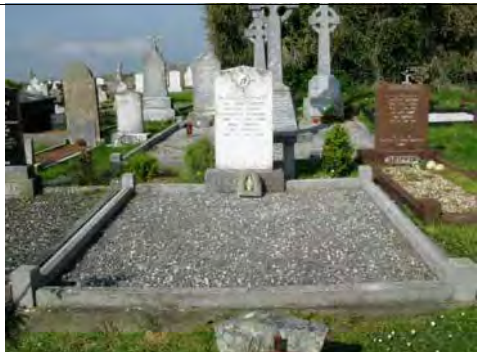
Grave_No	Family Name	Photo_Name
70	Leahy	IMG_0123
Notes		
Plot in good condition, headstone from 1884

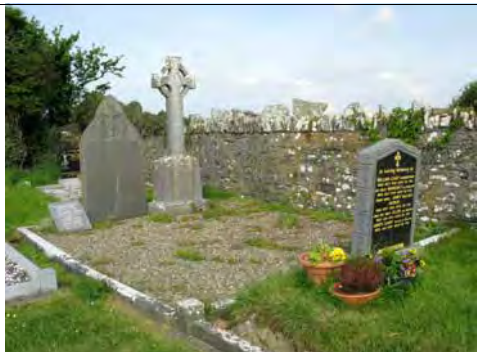
Grave_No	Family Name	Photo_Name
71	Leahy	IMG_0127
Notes		
Grass covered plot in good condition

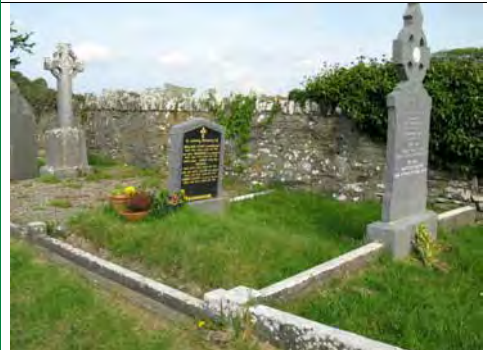
Grave_No	Family Name	Photo_Name
79	Kennelly	IMG_0138
Notes		
Large plot in good condition, some weeds

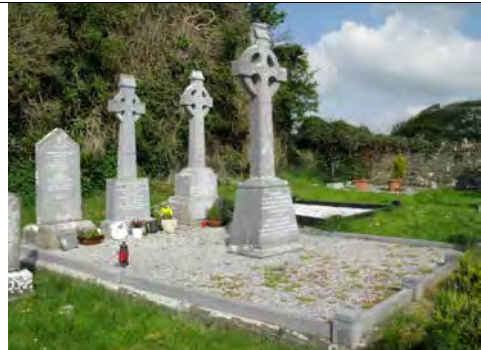
Grave_No	Family Name	Photo_Name
73	Carmody	IMG_0130
Notes		
Plot in good condition some weeds

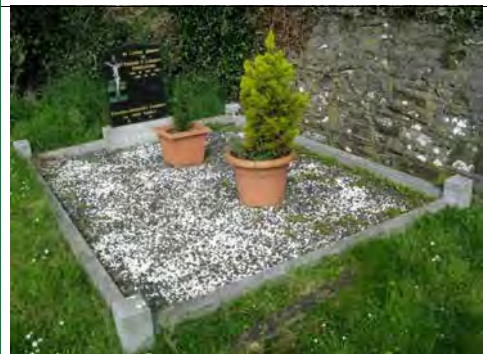
Grave_No	Family Name	Photo_Name
83	O'Connor	IMG_0146
Notes		
Plot in good condition, headstone from 1852

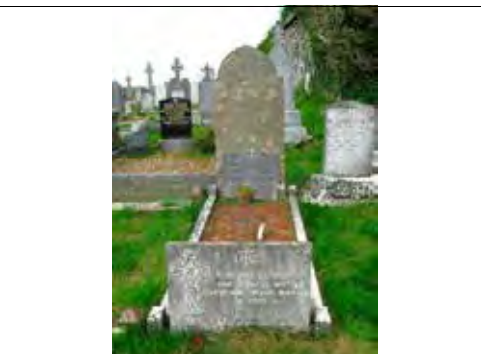
Grave_No	Family Name	Photo_Name
78	Stokes	IMG_0136
Notes		
Plot in good condition

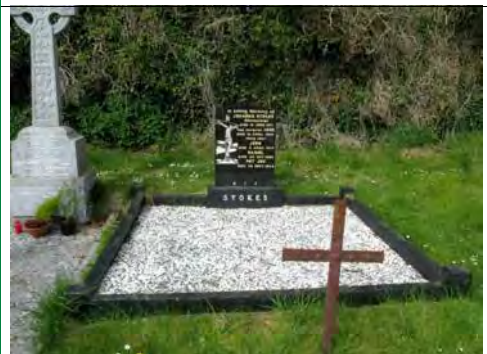
Grave_No	Family Name	Photo_Name
85	Reidy	IMG_0151
Notes		
Plot in good condition, some weeds

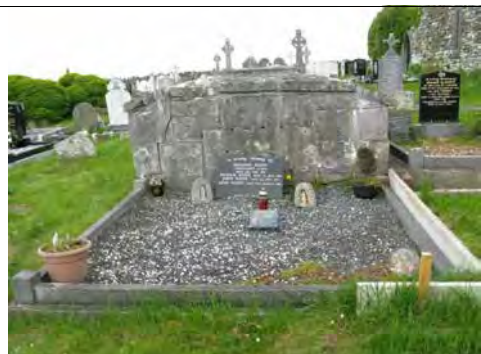
Grave_No	Family Name	Photo_Name
93	Sheahan	IMG_0160
Notes		
Plot in good condition, some weeds

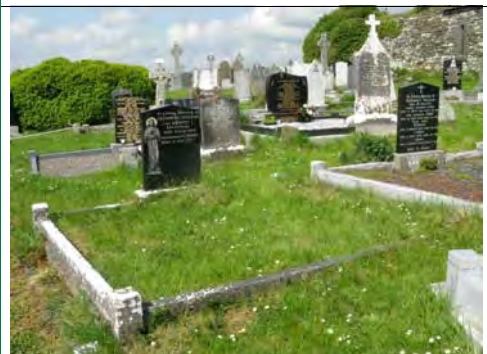
Grave_No	Family Name	Photo_Name
106	McGrath	IMG_0183
Notes		
Plot in good condition, flint based gravel on plot one piece of worked flint was retrieved from plot

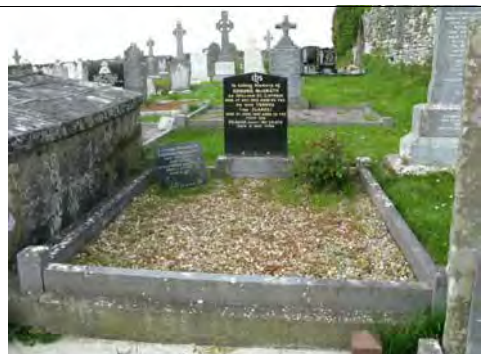
Grave_No	Family Name	Photo_Name
95	Murphy	IMG_0164
Notes		
Plot in moderate condition, concrete cracked and subsiding, some weeds

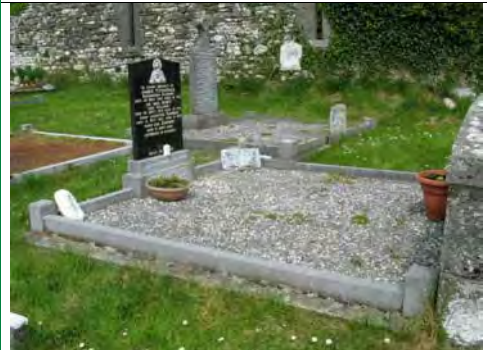
Grave_No	Family Name	Photo_Name
117	O'Connell	IMG_0204
Notes		
Capstone is weathered, partly still legible. chevalier captain Michael O'Connell knight of pope pius ninth died July 1864, sister Mary brandan O'Connell presentation convent listowel died 1904

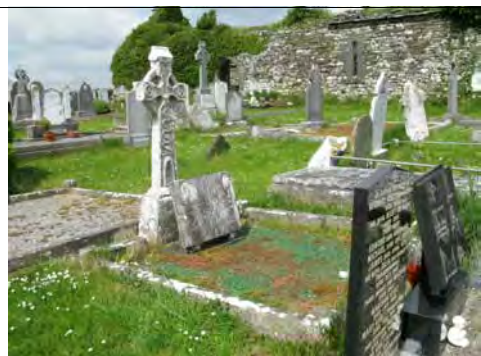
Grave_No	Family Name	Photo_Name
118	Kiely	IMG_0205
Notes		
Headstones almost illegible, plot in good condition

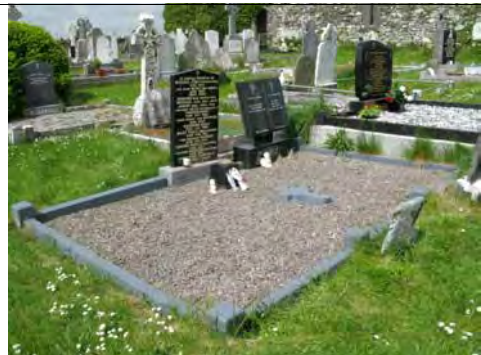
Grave_No	Family Name	Photo_Name
131	Scanlon	IMG_0226
Notes		
Plot in moderate condition, older headstones in poor condition

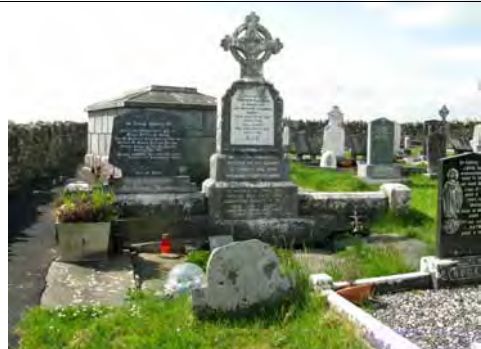
Grave_No	Family Name	Photo_Name
156	McMahon/Bambury	IMG_0267
Notes		
Plot in moderate condition

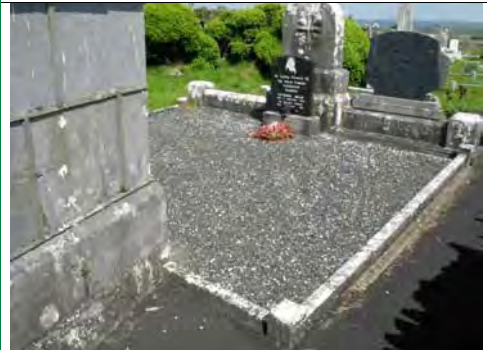
Grave_No	Family Name	Photo_Name
169	Histon	IMG_0294
Notes		
Plot in moderate condition

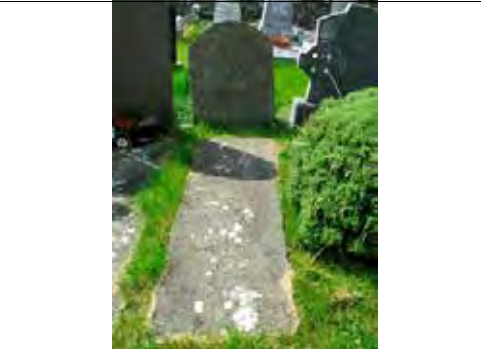
Grave_No	Family Name	Photo_Name
174	Mullane	IMG_0302
Notes		
Old headstone, weathered, soon it will be illegible, 1825

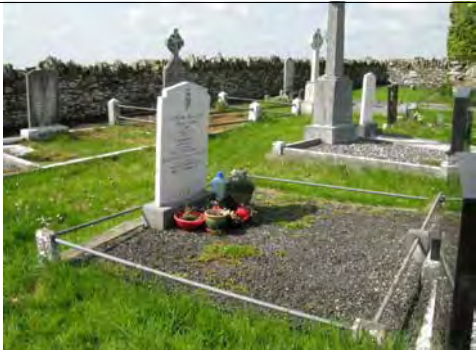
Grave_No	Family Name	Photo_Name
182	Coslolloe/Costello	IMG_0318
Notes		
Grass covered plot in good condition, old headstone 1837 this have been painted and letters filled in

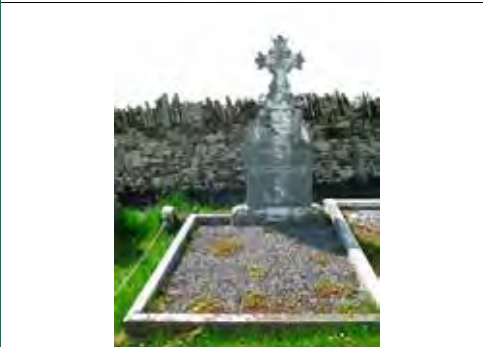
Grave_No	Family Name	Photo_Name
189	Ahern	IMG_0328
Notes		
Grass covered plot in moderate condition, plot markers are low and overgrown

Grave_No	Family Name	Photo_Name
192	Madden	IMG_0334
Notes		
Plot in moderate condition, overgrown and subsiding

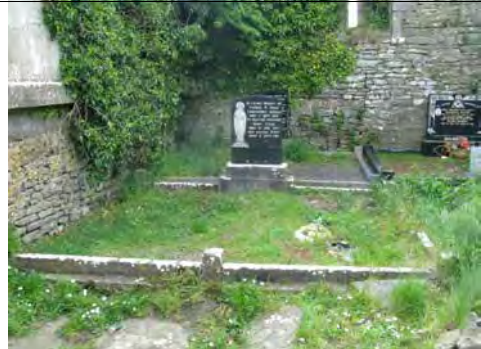
Grave_No	Family Name	Photo_Name
201	Stack	IMG_0355
Notes		
Plot in moderate condition, overgrown by weeds and subsiding

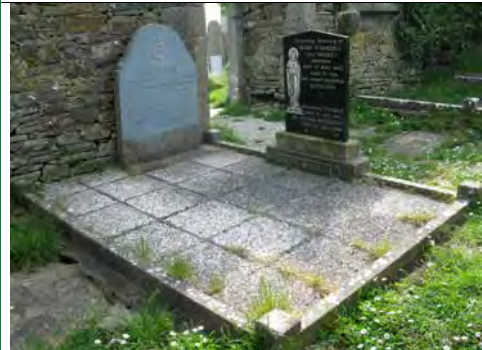
Grave_No	Family Name	Photo_Name
205	Moore	IMG_0361
Notes		
Plot with two headstones, the older from 1837 has been painted

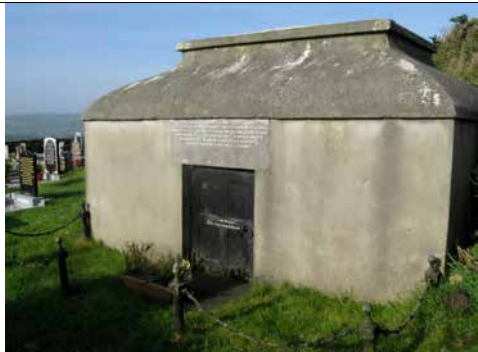
Grave_No	Family Name	Photo_Name
1	Stack	IMG_0001
Notes		
Large tomb in good condition

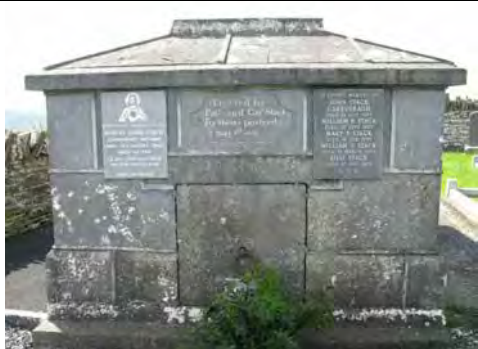
Grave_No	Family Name	Photo_Name
158	Stack	IMG_0272
Notes		
Tomb in good condition

The unsuitable restoration works consisting of ribbon pointing to the fine limestone tomb of Grave No. 158 will have a negative impact on the masonry of the tomb and will result in accelerated erosion to the edges of the limestone blocks. Such ribbon pointing should be removed and replaced with flush or recessed pointing using the correct (lime) mortars which will not have a negative impact on these tombs.

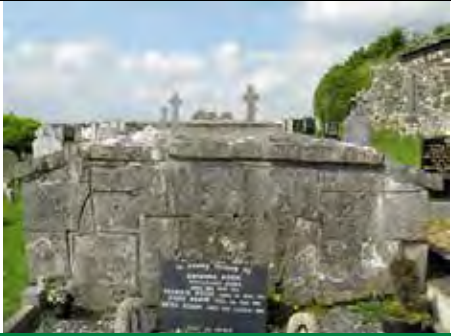
Grave_No		Photo_Name
105		IMG_0178
Notes		
Capstone is illegible, tomb in good condition

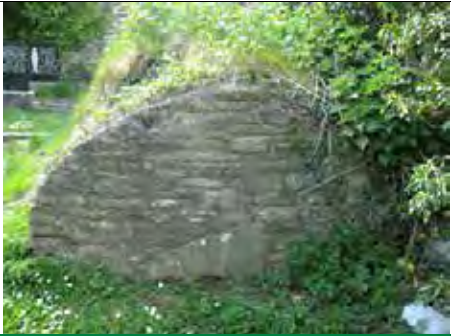
Grave_No		Photo_Name
204		IMG_0359
Notes		
Overgrown tomb in good condition

Overgrowth at Grave No. 204 should be removed and the damaged roof should be restored using the necessary skills and materials which are sympathetic to its historic character.

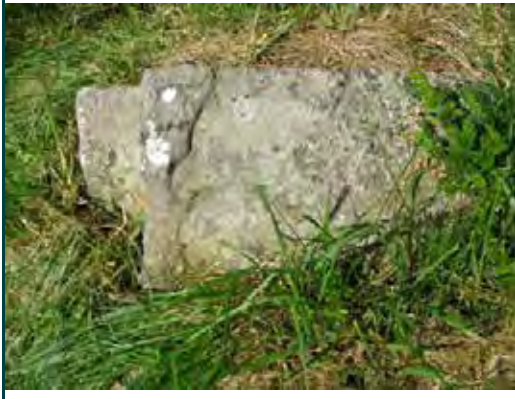
Misc_Item_No	Photo_Name
4	IMG_0242
Notes	
Window surround/Door jam. Forms gravemarker to Grave No. 222.

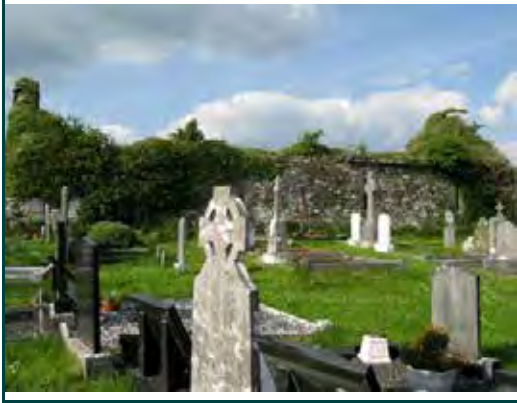
Misc Item No	Photo Name
5	IMG_0402

Notes
Remains of church ruin in good condition

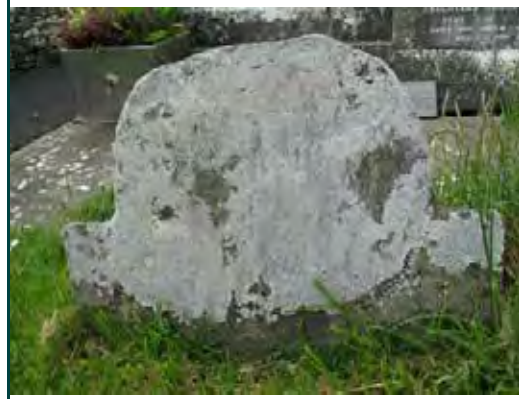
Misc Item No	Photo Name
3	IMG_0237

Notes
Shaped stone slab with inscribed cross. Also forms gravemarker for Grave No. 221
